BREAKSPEAR HOUSE
BREAKSPEAR ROAD NORTH
HAREFIELD UB9 6NA
LONDON BOROUGH OF HILLINGDON
AN ARCHAEOLOGICAL FIELD EVALUATION

AN ARCHAEOLOGICAL FIELD EVALUATION

PLANNING APPLICATION REFERENCE: 7610/APP/2008/1012 (Condition 23)

SITE CODE: BZH09

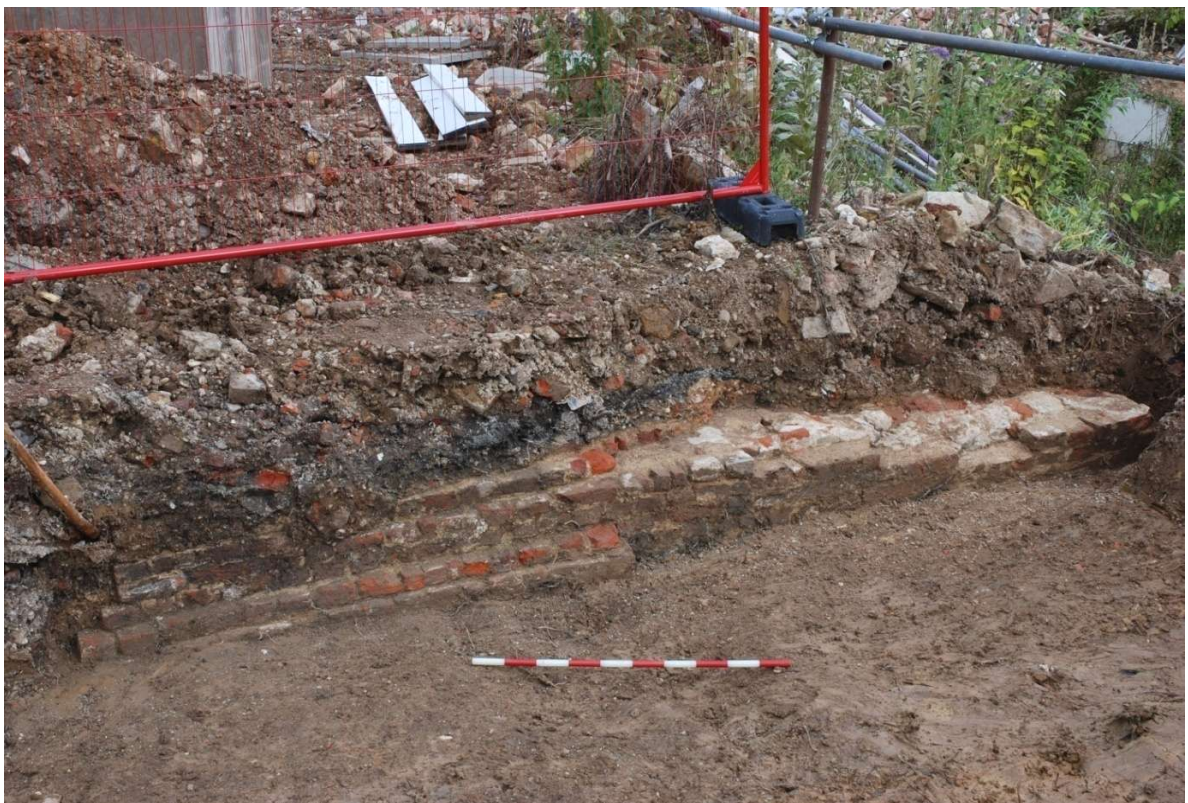
Fig. 37: Brick wall base [2], located along the northeastern edge of Trench 6 (scale 1 m)

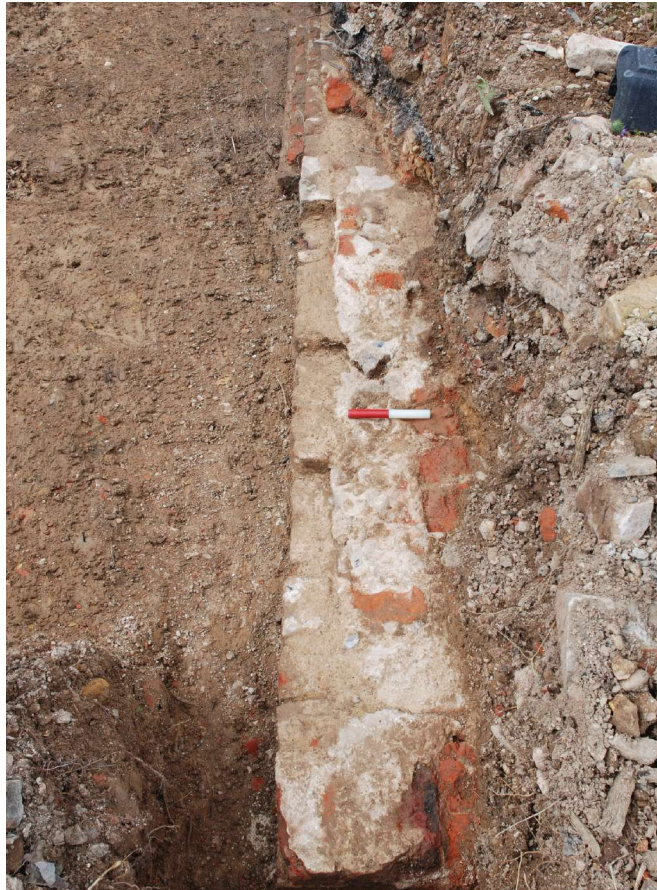
Fig. 38: Trench 6. Overhead view from the eastern end of the wall base [2] (*scale 0.2m*)

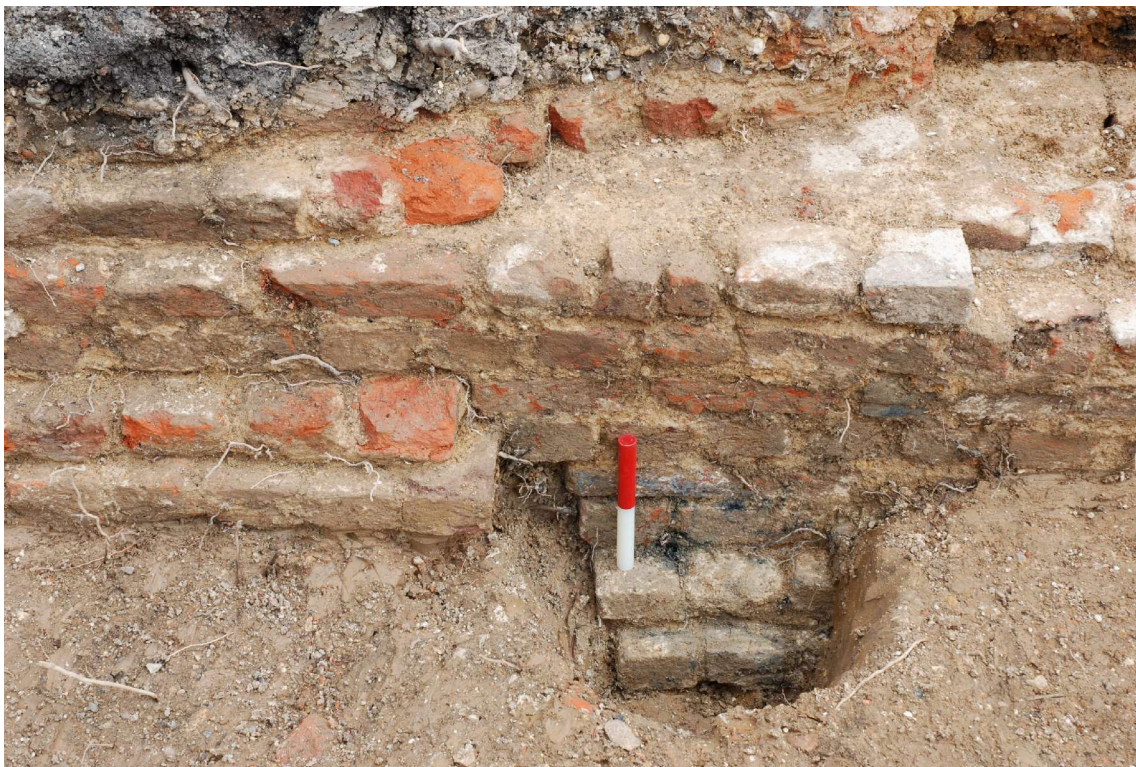
Fig. 39: Trench 6. Detail of exposed face and stepped base of the central section of wall [2] (*scale 0.2m*). The change in level and deeper footing to the east may simply reflect the proximity of the southeast corner of the building.
