**SITE AT THE END OF WEST LODGE AVENUE  
(PART OF ACTON HIGH SCHOOL SITE)  
GUNNERSBURY LANE, ACTON W3 8EY, LONDON BOROUGH  
OF EALING  
AN ARCHAEOLOGICAL EVALUATION**

AN ARCHAEOLOGICAL EVALUATION

SITE CODE: WLX10

PLANNING REFERENCE No: P/2004/4096-ST (Condition 17)

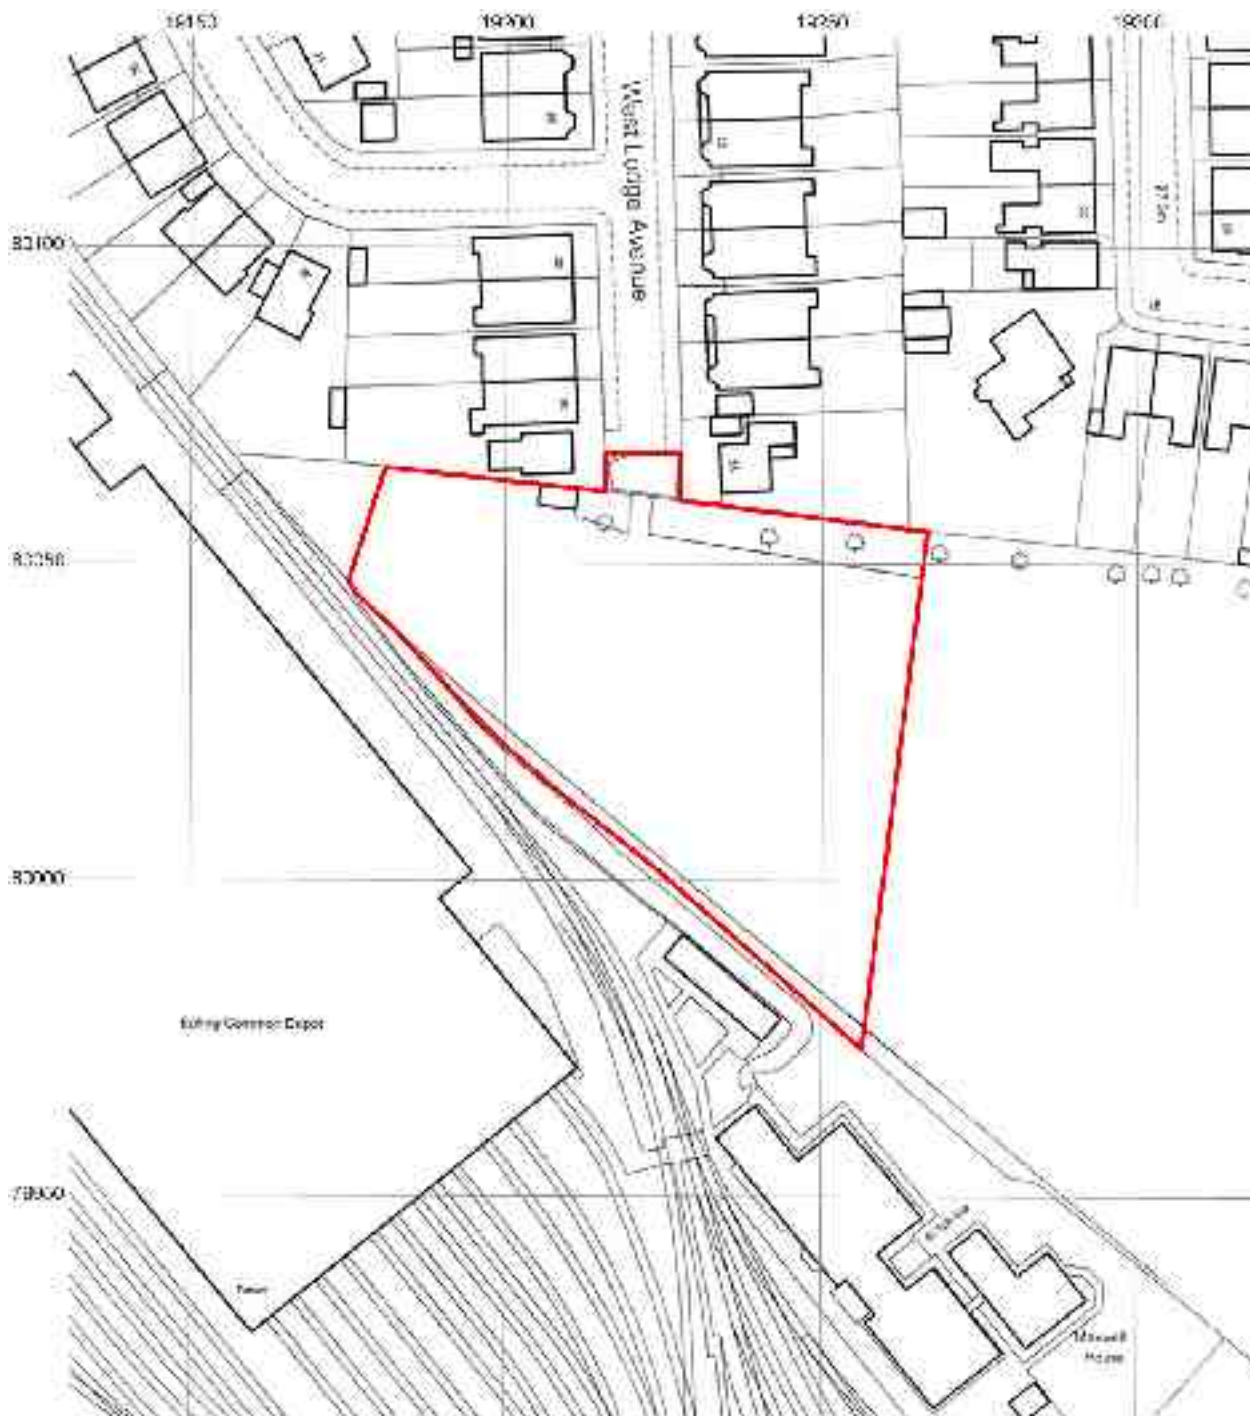
Fig 1 The site location in relation to the current Ordnance Survey map

- 3.1.1** The site occupies a roughly triangular plot, measuring about 100m east-west by 25m to 80m north-south and approximately centred at National Grid Reference TQ 19225 80030 (Figure 1). The land is currently open, the former buildings having been demolished. Ground cover comprised mainly rough grass with some scrub and small trees to the west: there are also some mature trees close to the northern boundary and in the southeast corner of the site.

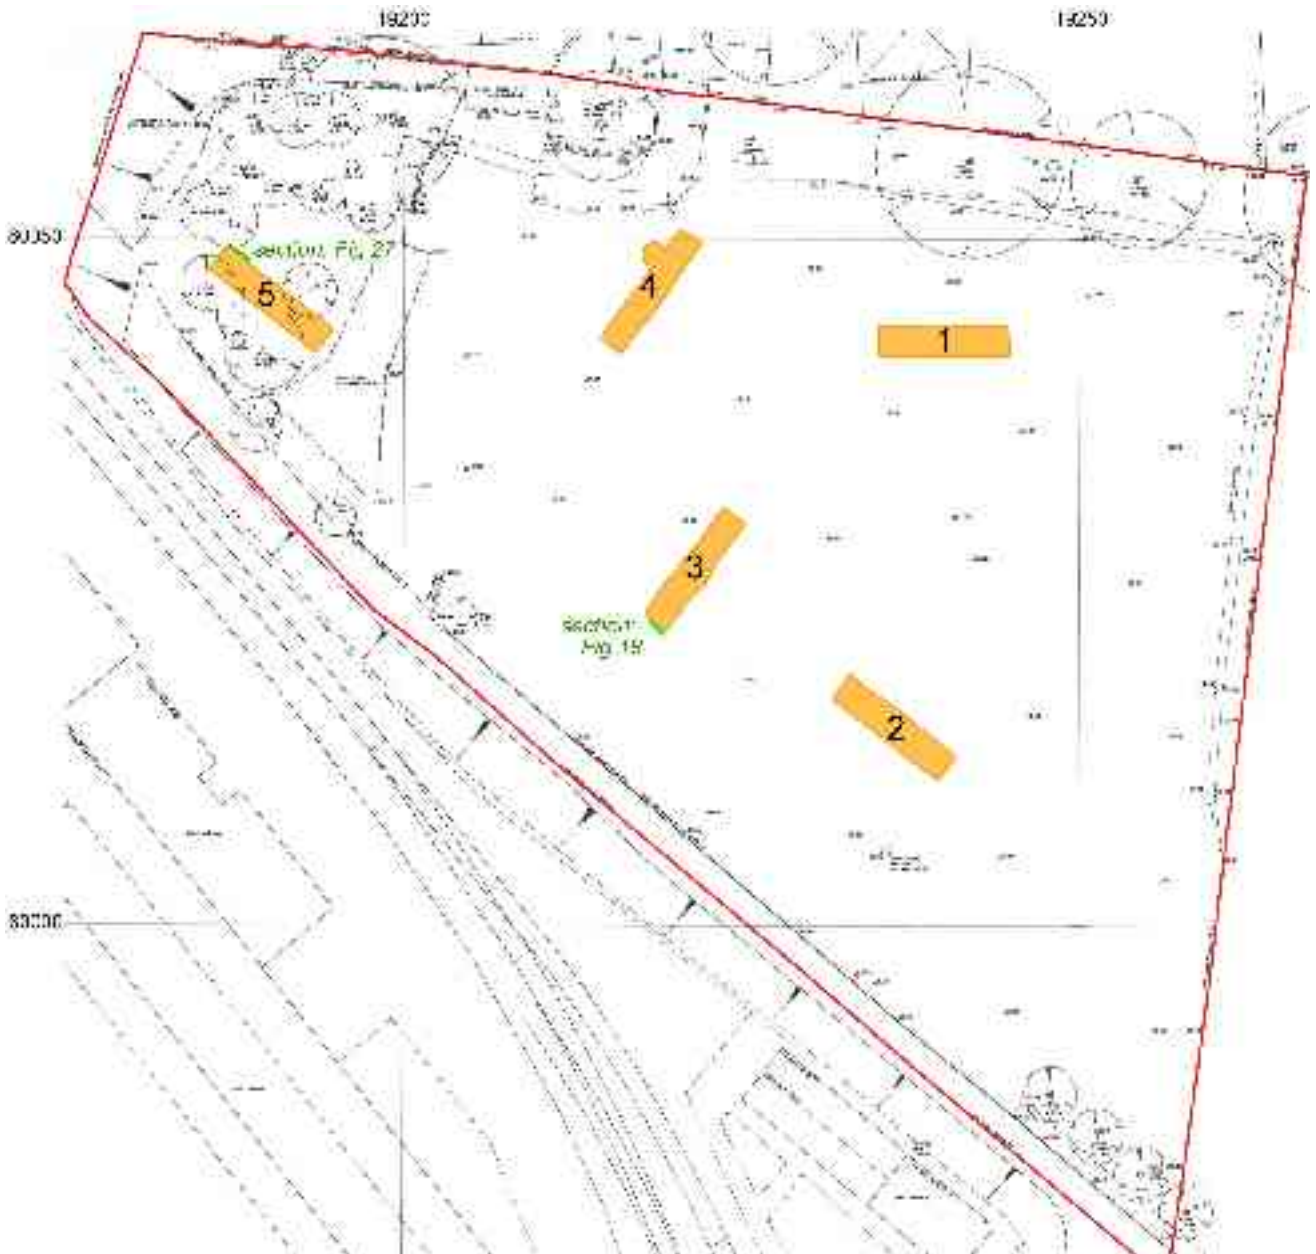
Fig 4 Plan showing the location of the evaluation trenches (1-5) in relation to the present site, and also the positions of drawn sections in Trenches 3 and 5 (for other trenches see separate plans)

The evaluation trench positions were located onto an existing site survey (Figure 4), which was related to the Ordnance Survey grid by resection using OS digital data.

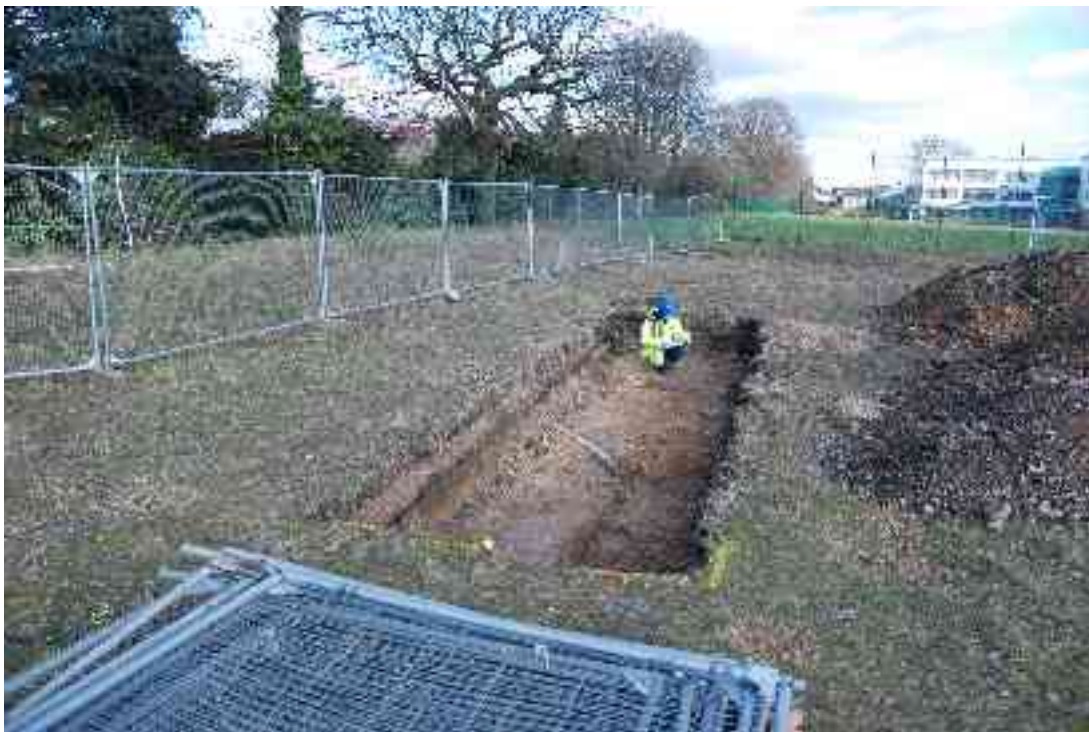
**6.2.2** Natural River Terrace sands and gravels were exposed throughout centre and eastern part of the trench, becoming predominantly sandy to the east. The natural surface was cut by two fairly modern trenches, one containing a sectional concrete pipe land drain, the other a somewhat wider cut (*c* 450mm) packed with brick rubble – and also interpreted as a land drain (see Figure 6).

Fig 5 Working shot of Trench 1, looking east towards Acton High School

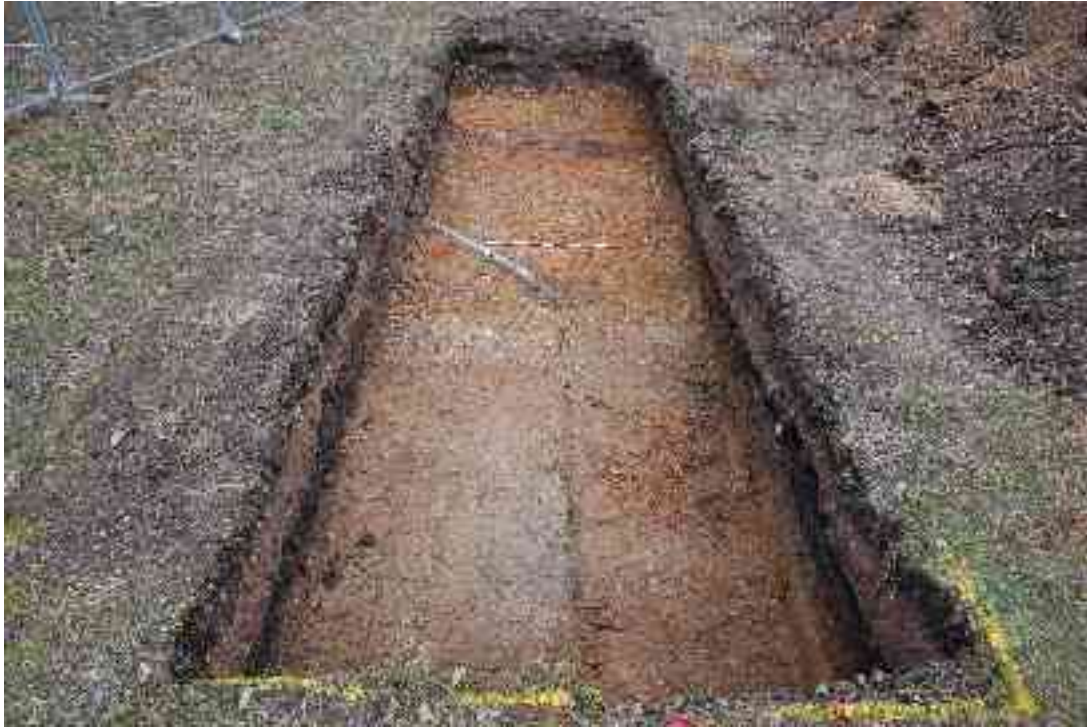
Fig 7 Trench 1: general view looking east, with the silty clay deposits infilling a natural hollow or palaeochannel in the foreground (*1.0m scale*)

**6.2.3** Clearance across the western end of Trench 1 exposed a continuous spread of clean silty clay. This came back some 2m to 3m into the trench but clearly thickened to the west, and appears to represent the naturally accumulated fill within a hollow or possible palaeochannel in the underlying River Terrace Gravels (*cf.* Figure 9). A deeper sondage was cut into this deposit on the southern side of the trench but the material appeared to be quite sterile, and no finds or artefacts were recovered. Probing close to the western limit of excavation indicated that the deposit here was over 600mm thick.

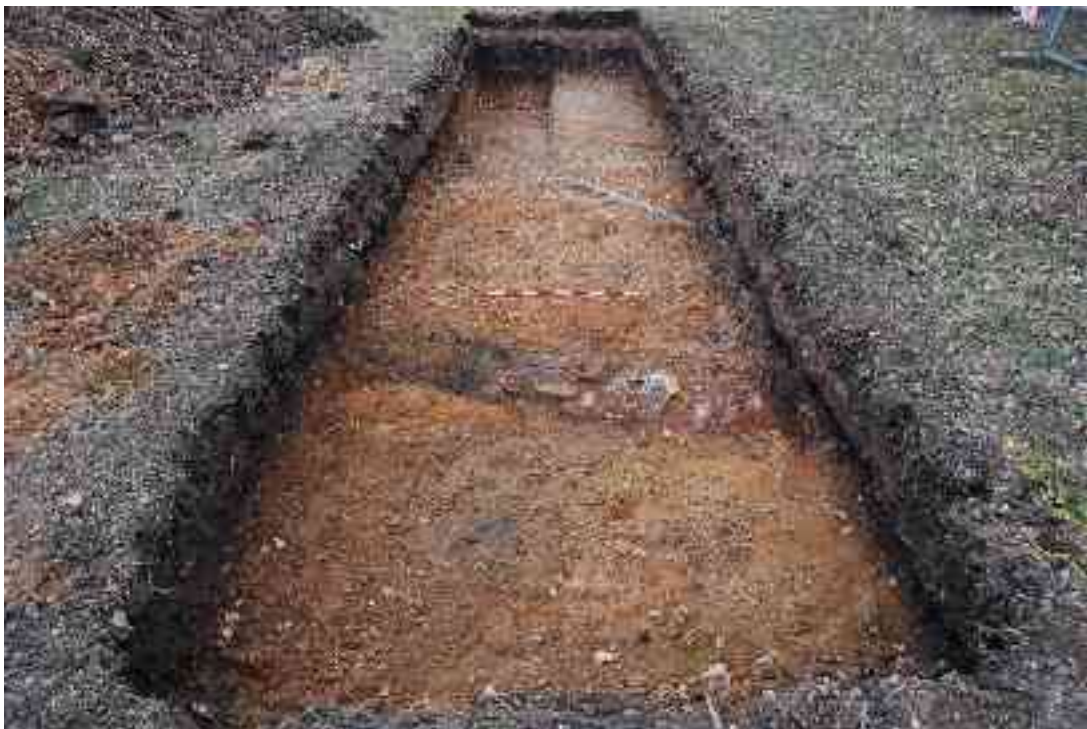
Fig 8 Trench 1: general view looking west (*1.0m scale*)

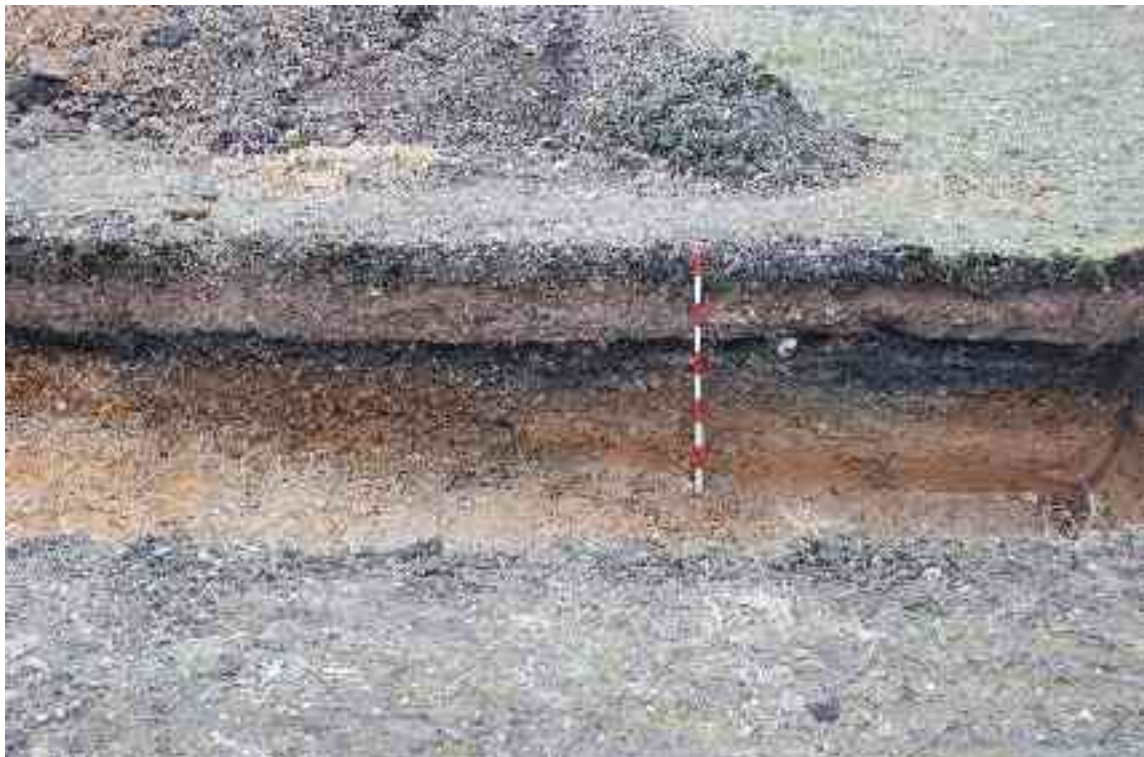
Fig 10 Trench 1: photograph showing the general area of the above section (1m scale)

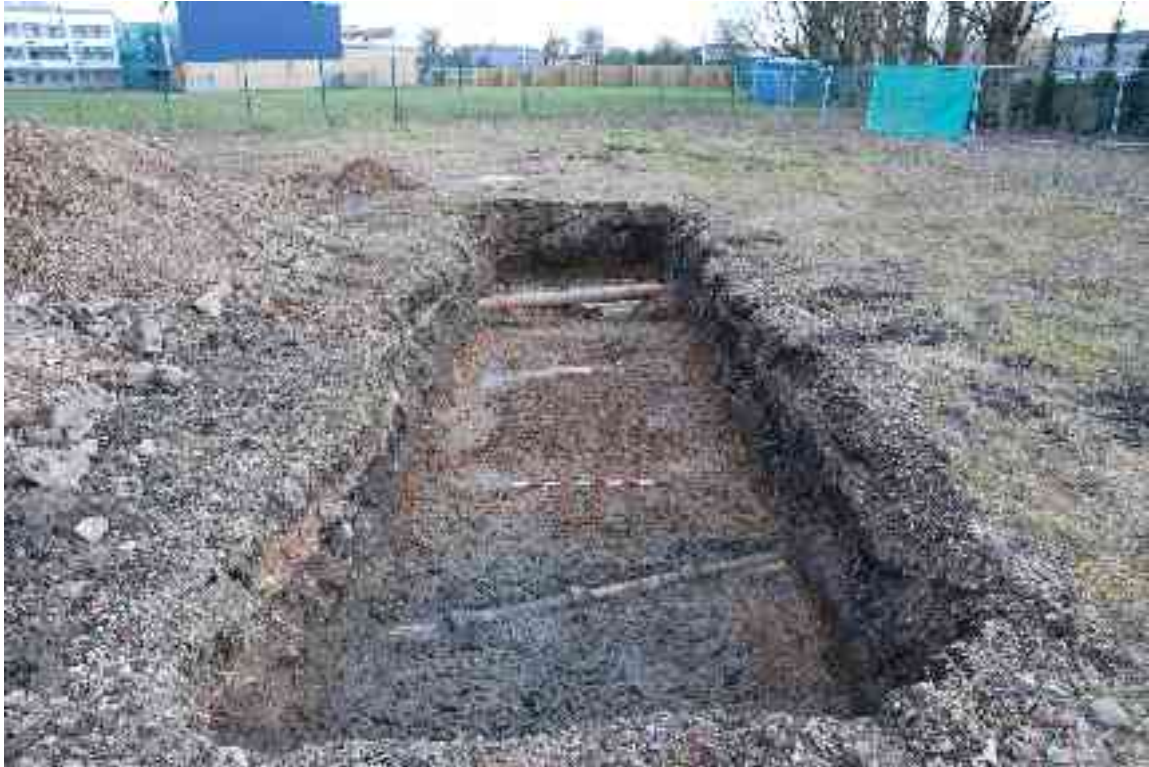
Fig 12 Trench 2: general view looking southeast towards the School (*1m scale*)

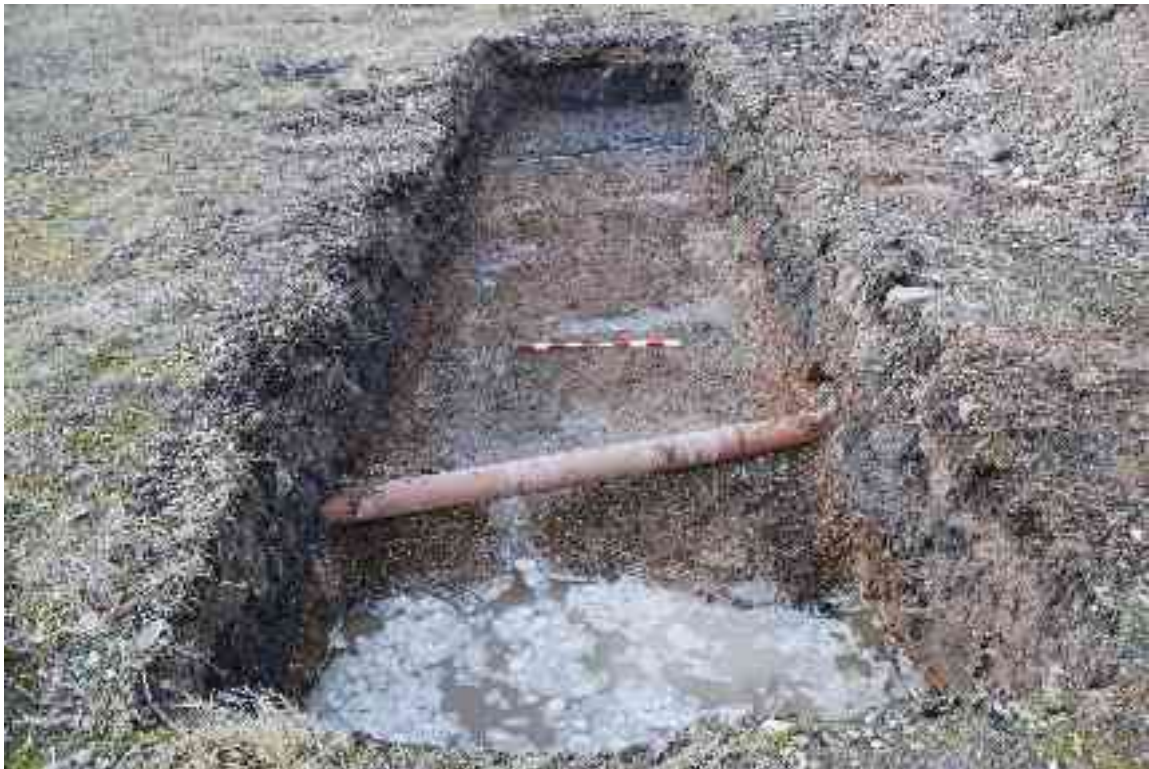
Fig 13 Trench 2: view looking northwest, and showing water ingress from the pipe trench in the foreground (*1m scale*)

Towards and at the base of the modern sequence two north-south pipes were exposed (Figures 11 & 14). Near the western end of the trench was a sectional ceramic pipe set on concrete base, dropping very slightly – *c* 25mm – between the south and north sections. The pipe at the eastern end of the trench was made of plastic and much more recent, possibly 1990s. It was also set within a fine gravel fill which acted as form of land drain, and resulted in the water ingress referred to above (& seen in Figure 13).

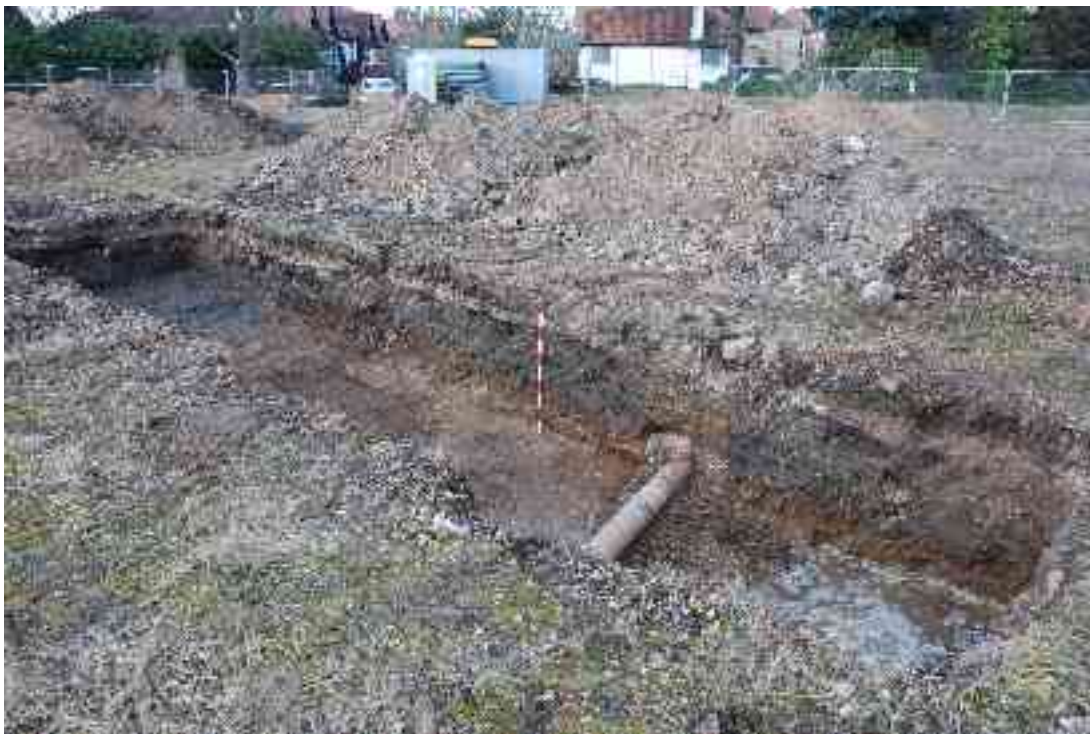
Fig 15 Trench 2: view of the southwest-facing section, showing the disturbed and made ground deposits overlying the natural River Terrace gravels (1m scale)

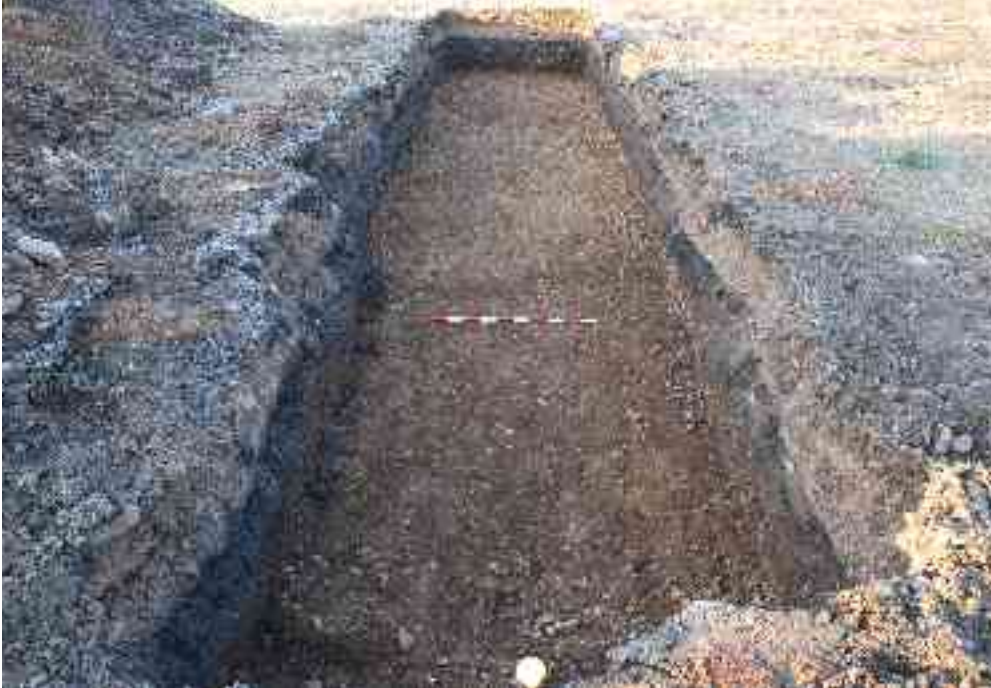
Fig 16 Trench 3: general view looking southwest and showing the exposed natural gravels throughout the trench (*1m scale*)

6.4.1 Trench 3 was dug on a southwest to northeast alignment, at a fairly consistent depth of 0.8m to 0.9m. The natural sand and gravel deposit was exposed throughout the trench, unbroken by any deeper intrusions or disturbance.

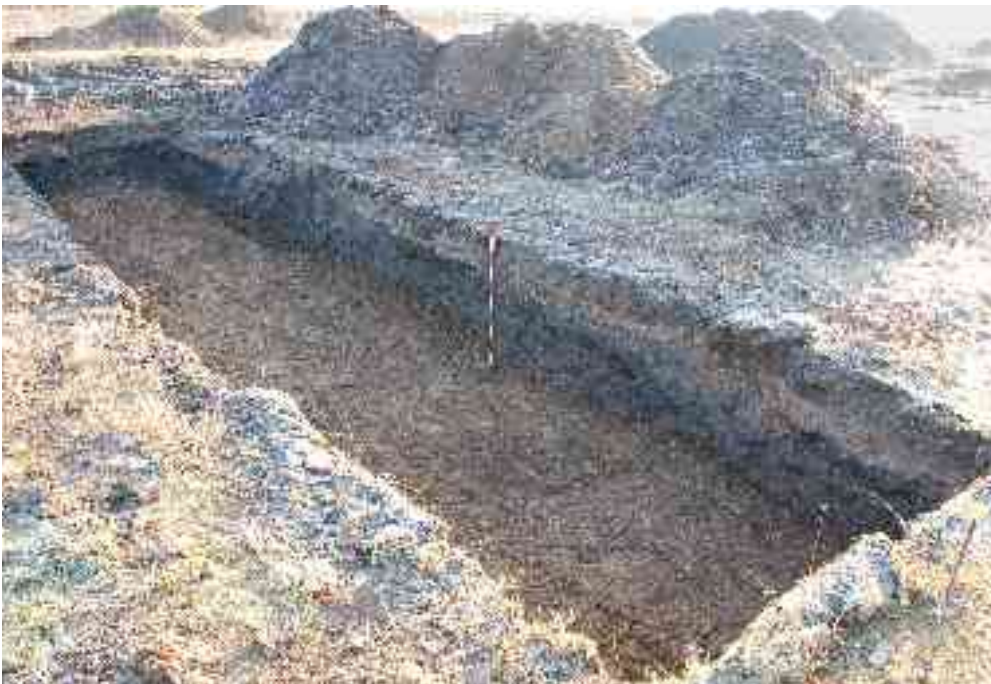
Fig 17 View of Trench 3 looking northeast (*1.0m scale*)

6.4.2 The overlying sequence was very similar to that in Trenches 1 and 2. The original soil profile had clearly been heavily truncated by modern activity, although there appeared to be remnants of a subsoil horizon over the natural in the southern section – a dark silty gravel with some lighter patches and occasional fragments of ceramic building material. Overlying this were several layers of made ground, including the recent concreted hardcore base that appears to cover the whole central area of the site.

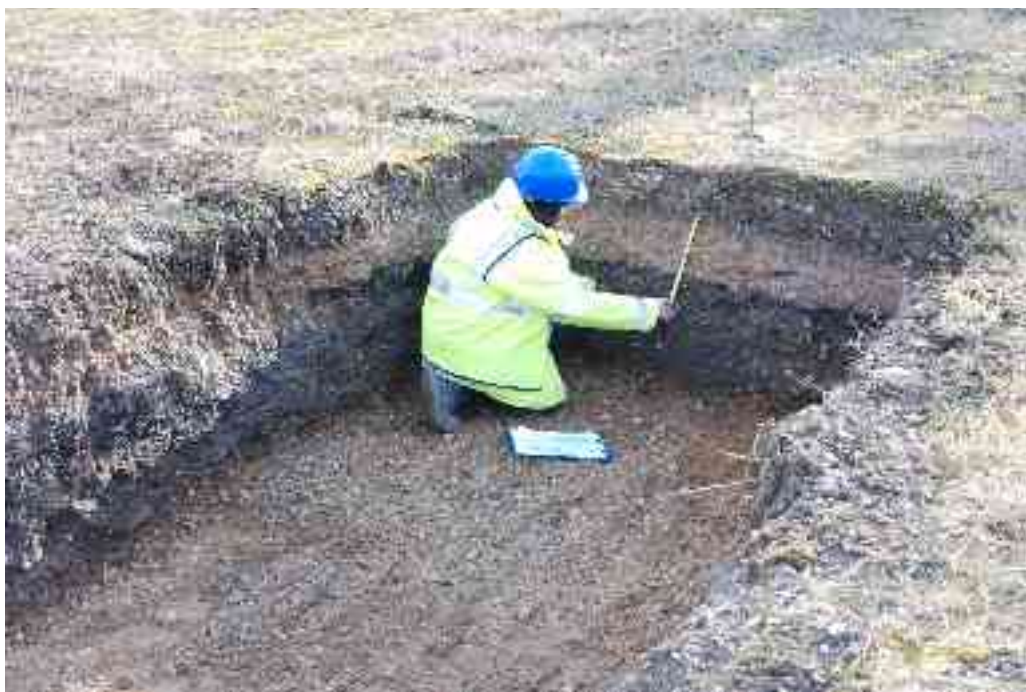
Fig 19 Trench 3: recording of the south section, as illustrated in Figure 18

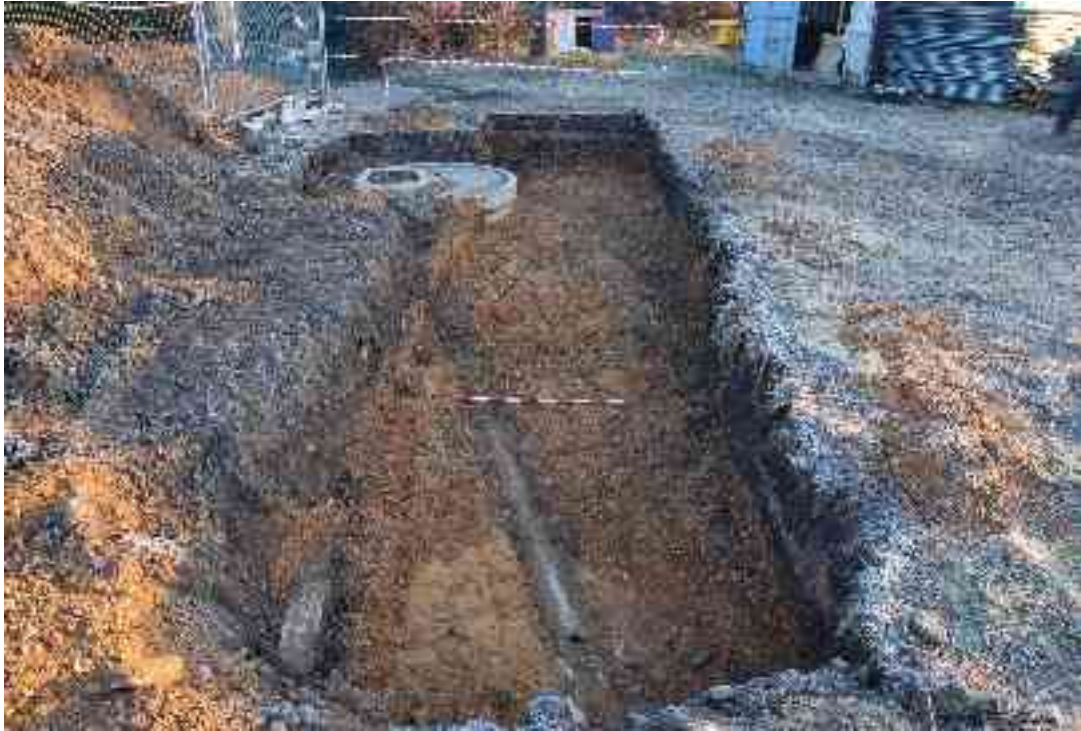
- 6.5.2** Natural River Terrace deposits – predominantly coarse sands with some gravel – were exposed throughout the trench. The natural surface was truncated with no real evidence for a surviving soil profile, and also cut by a number of modern intrusions as illustrated on Figure 20 overleaf.

Fig 21 Trench 4: general view looking northeast (*1.0m scale*)

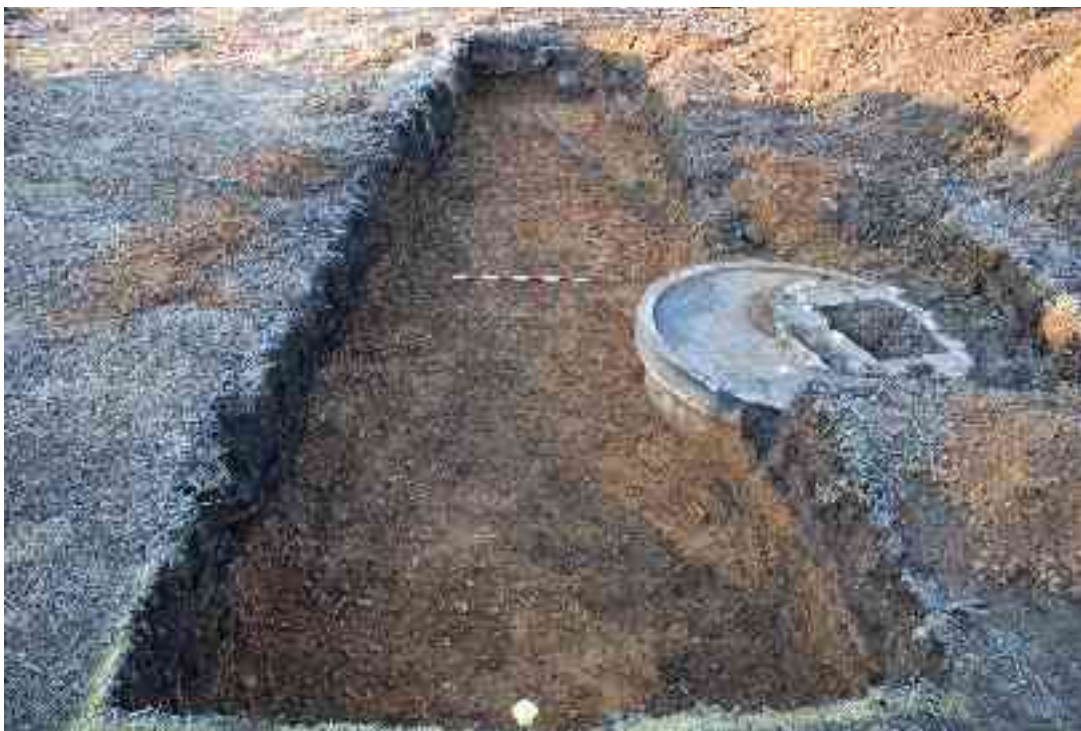
The southern part of the trench contained two land drains, abutting at right angles. Both were constructed from sectional concrete pipes, as also recorded in Trench 1 and noted at the eastern end of Trench 2, and presumably all relate to a single phase of activity – quite possibly contemporary with construction of the pavilion in the mid 20<sup>th</sup> century.

Fig 22 Trench 4: general view looking southwest (*1.0m scale*)

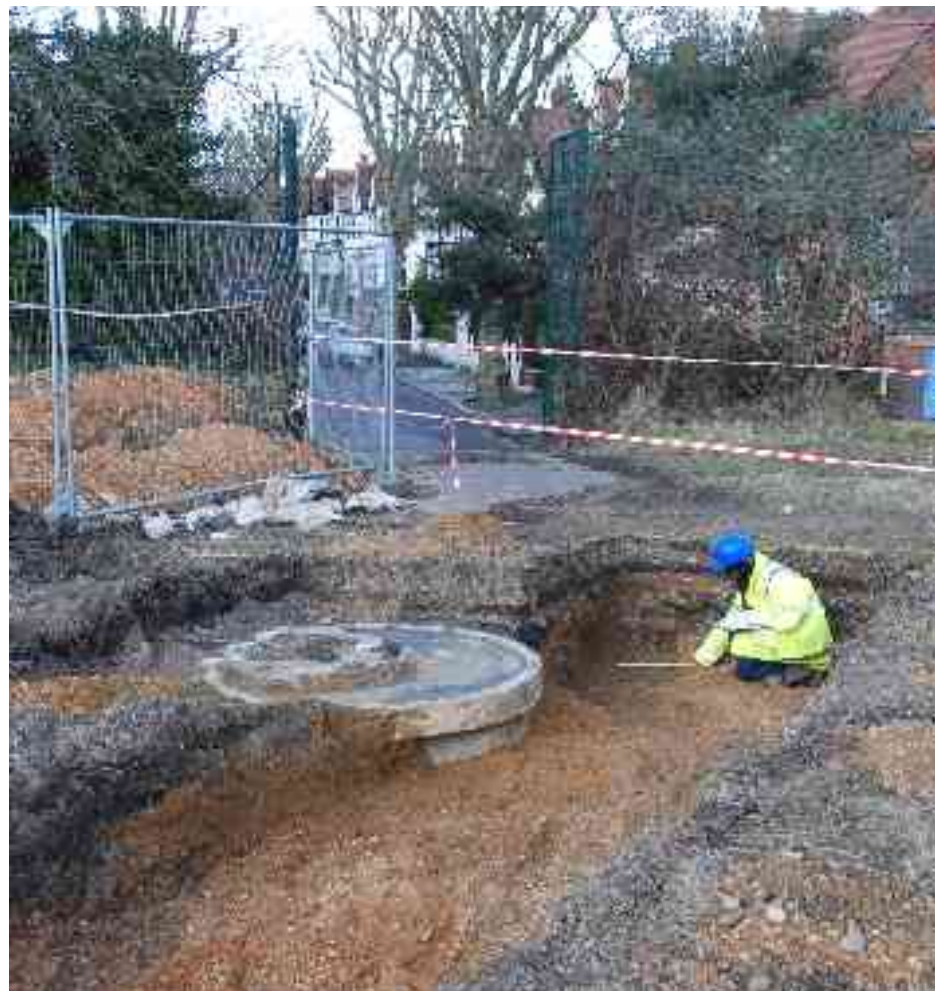
Fig 24 Trench 4: recording of the section illustrated above

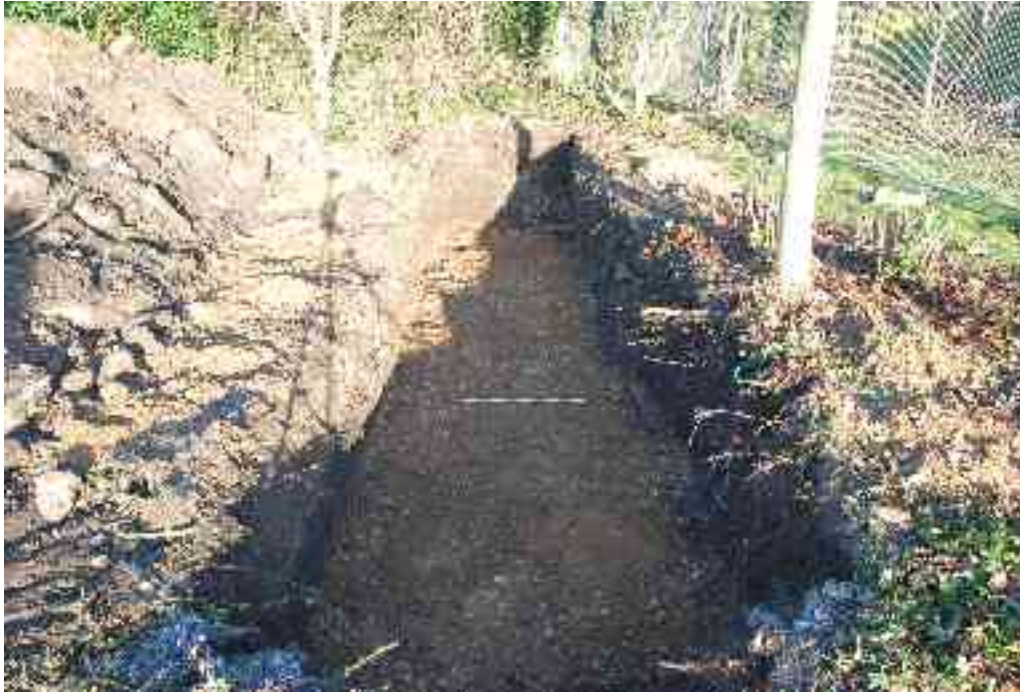
6.6.1 Trench 5 was located near the western end of the site, and was aligned approximately northwest-southeast. The trench was markedly deeper than any of the others – at least 1m and falling to about 1.35m at the western end. This evidently reflects a levelling of the natural topography, which would have dropped towards the small stream – the *Bollo* - that once flowed to the west and southwest (*cf.* 3.1.2 above).

Fig 25 Trench 5 looking northwest towards the site boundary

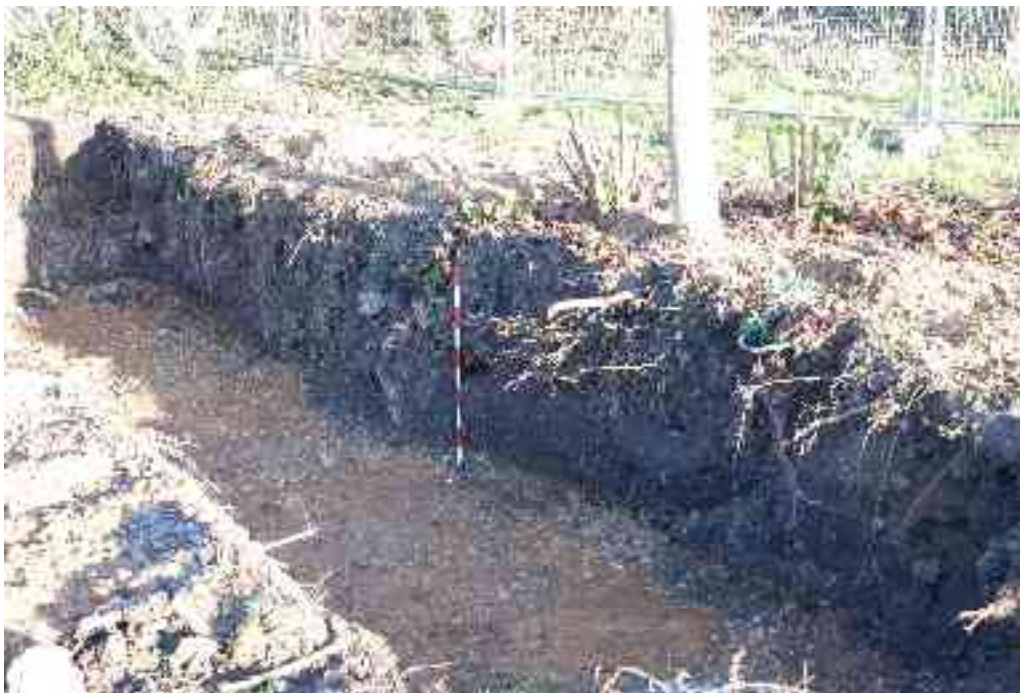
Fig 26 Trench 5: oblique view of the southwest-facing section (*1m scale*)

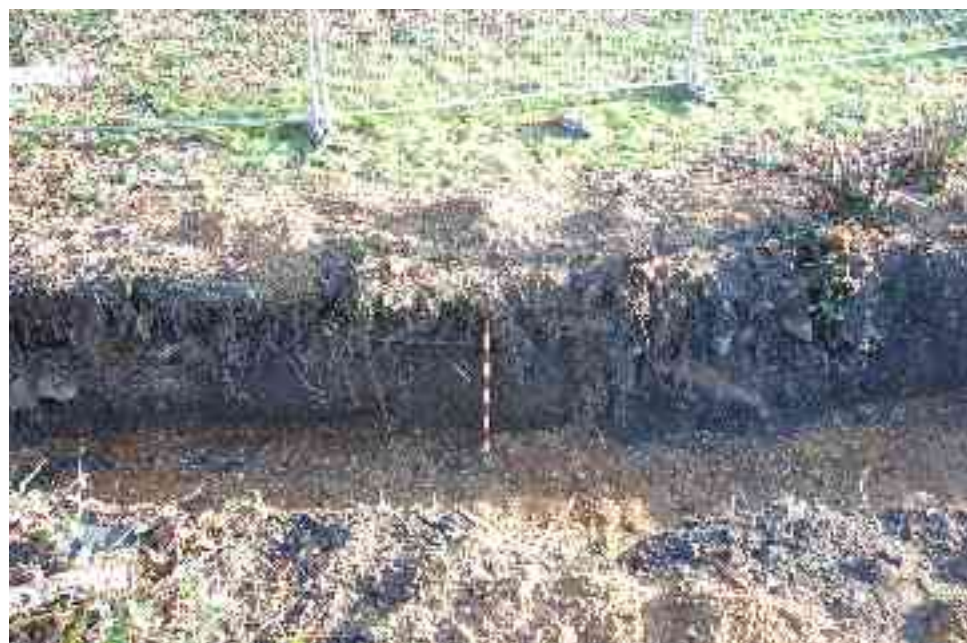
Fig 28 Trench 5: view of the southwest-facing section, including the area of the drawn section to the left of the frame (1m scale)
