Thames Water Utilities: Tulse Hill Trunk Mains Burst Mitigation Project - AO92
Works in the road adjacent to 225 Upper Tulse Hill, London Borough of Lambeth SW2
NGR (site centre): TQ 31302 73444
Archaeological Observation & Recording (site code UTU10)

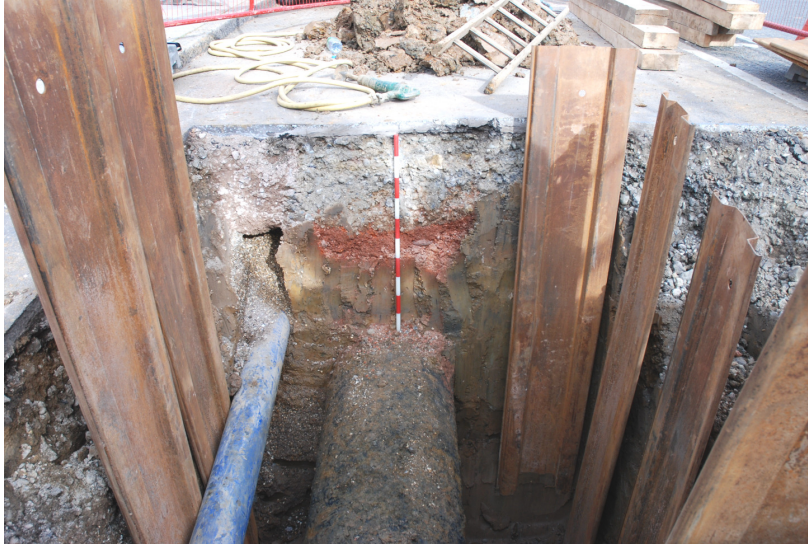
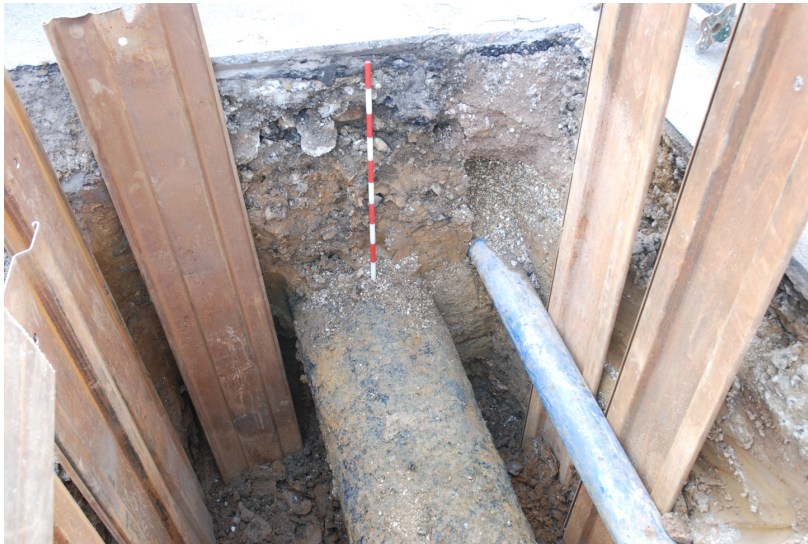
Figs 2 & 3 Views of the excavated pit looking east (*top*) and west. In both the 1m scale rests on top of the existing 24" trunk main.

Natural clay is visible directly below the modern road base, c 0.4m to the right of the scale in Fig 2 and in the bottom right hand corner of Fig 3.
