THAMES WATER MAINS REPLACEMENT WORKS KENNINGTON, NEWINGTON AND CAMBERWELL

HAMPTON 3612 LONDON BOROUGHS OF SOUTHWARK AND LAMBETH

AN ARCHAEOLOGICAL WATCHING BRIEF

COMPASS ARCHAEOLOGY LIMITED

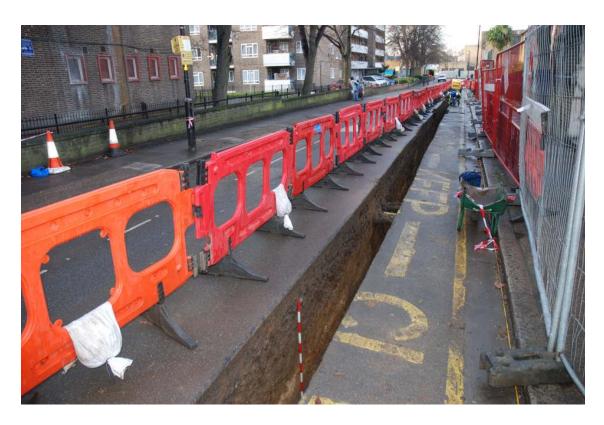
Figure 1: General view of Thames Water Mains Replacement Works open cut trenching along Crawford Street, looking northwest 2nd February 2009 (1m Scale).

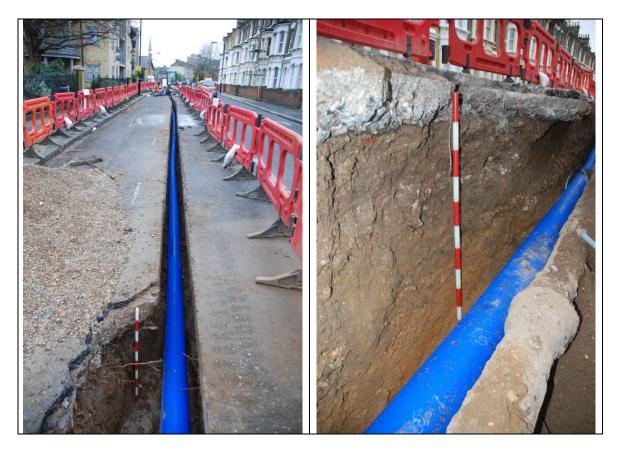
Figure 3: Trenching on Penton Place (26th November 2008 1m Scale), with right: detail of the trench section on Penton Place, shown the natural silty clay appearing at *circa* 0.7m below the current ground surface (Scale 1m).

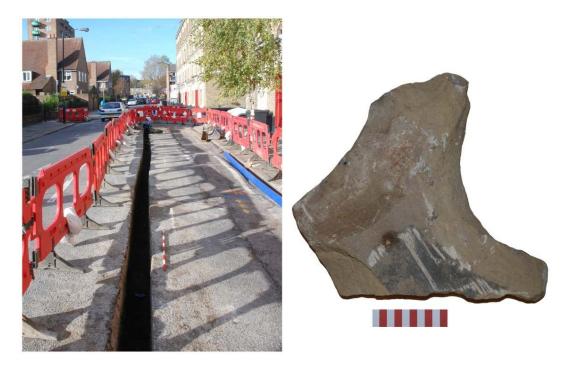
The majority of works on Penton Place exposed the existing tarmac road surface overlying concrete hardcore, in turn overlying a series of service backfill deposits and modern made-ground. Natural gravels were observed at the base of excavations northwest of the Iliffe Street junction (monitoring visits of the 30th and 31st October 2008), and elsewhere redeposited gravels were incorporated in made-ground layers. No archaeological finds or features were observed in Penton Place during the course of the archaeological watching brief, along natural gravels and clays were observed at *circa* 0.8m below the current ground surface below. Made-ground observed during trenching between Iliffe St and Amelia Street (14th November 2008) produced large pieces of York Stone, a very hard sandstone often used in slabs for paving (*cf.* Figure 5 below). The examples retrieved from the Penton Place trenching are of no great significance and appear to be simple residual inclusions in a made-ground deposit.

Figure 5: Trenching on Penton Place (14th November 2008 1m Scale), a sample of York Stone (10cm scale).

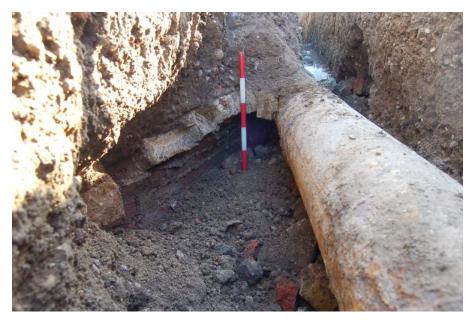
Trenching between Iliffe Street and Canterbury Avenue (31st October 2008) exposed the remains of a brick-built arched drain cut by the cast-iron Victorian mains pipe. The drain clearly predates the water main although the bricks, mainly red and yellow stock bricks, indicate a 19th century date. This may relate to water or sewage works in place before replacement by the later cast-iron pipes. The drain ran approximately north-south crossing the northeast-southwest aligned water main. It was recorded to a height of five courses in the base of the Penton Place trench, running out of the southwest facing section into the trench for approximately 0.9m before being cut by the more recent iron pipe. There were no obvious structural remains south of the pipe, running into the northeast facing section.

Figure 6: Section of brick drain in trenching on Penton Place (view southeast; 0.5m scale).

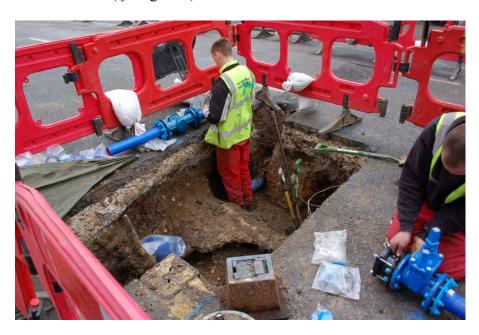
75m of trenching was excavated on the south eastern side of Alberta Street, approximately 0.5m from the kerb and running between the Penton Place junction and the end of the terraced properties (*cf.* Figure 4 above). The trenching was backfilled and reinstated during archaeological monitoring, and a smaller square excavation on the north western side of Alberta Street was inspected and recorded. The pit was located immediately south of the car park entrance on the corner of Alberta St and Penton Place, it measured *c.* 2.5m by 1.5m in plan and was excavated to a depth of some 1.1m. In both these areas tarmac and concrete hardcore were observed overlying modern services and associated backfill deposits – no archaeological finds or features were observed (*cf.* Figure 7).

Figure 7: General view of a VMR launch pit on Alberta Street (26th March 2009).

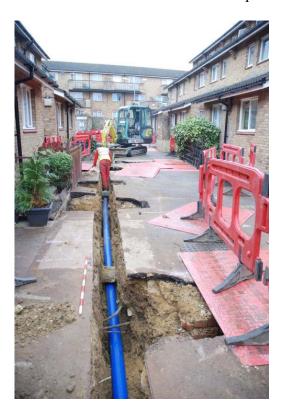
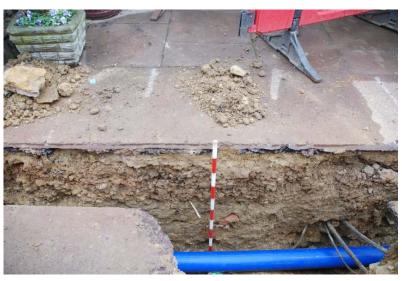
A single open cut trench was observed on Wesley Close, part of the Newington Estate to the north of Penton Place (cf. Figures 4 and 8). The trench measured approximately 50m in length by 0.34m in width and was excavated to an average depth of 1m below the existing tarmac road surface. Exposed deposits consisted of a bitumen base immediately beneath the tarmac overlying concrete hardcore road-makeup, modern services and associated deposits – no archaeological finds or features were observed.

Figure 8: Open cut trenching on Wesley Close, view looking northeast and above view of the east facing section showing modern make-up layers (1m Scale).

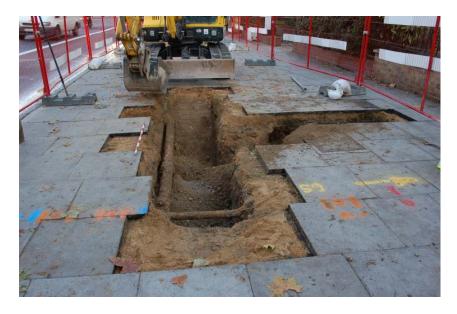
Figure 10 Example of one of the shallow launch pits on Kennington Park Road (1st December 2009).

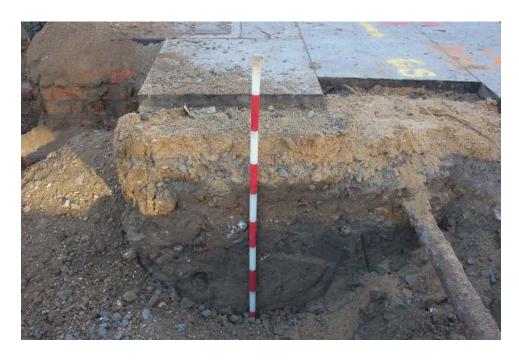
Figure 11 Example of one of the launch pit sections on Kennington Park Road, in the vicinity of no. 161 Kennington Park Road (1st December 2009, 1m Scale).

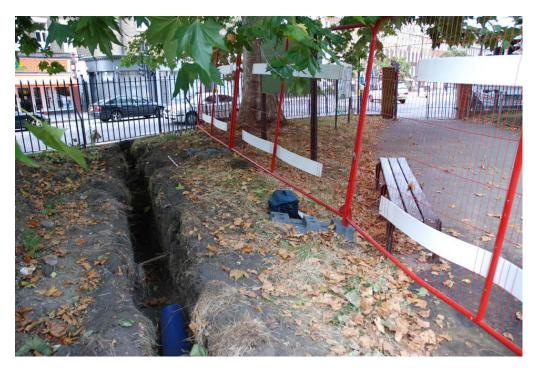
Two areas of trenching were observed in Kennington Park itself, at the northern end (23rd September 2009) and the southern end (28th August 2009). Both excavations exposed topsoil to an average depth of 0.4m below the existing ground level, overlying mixed made-ground deposits containing modern concrete and brick inclusions. Heavy rooting was observed in the sections in both areas.

Figure 12: Trenching in Kennington Park (23rd September 2009, 1m Scale).

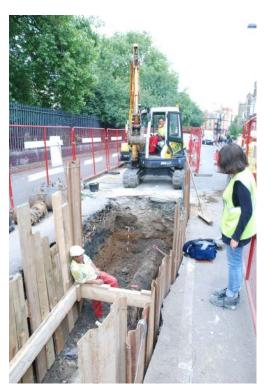
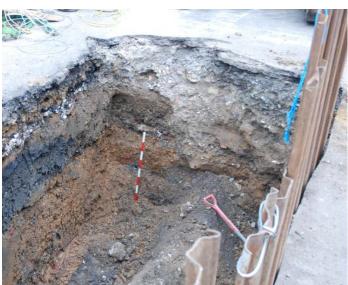
Monitoring on 8th July 2009 observed a large 7.5m launch pit on the north side of Prima Road some 15m east of the corner of St Mark's churchyard. The trench measured some 2.10m in width and was excavated to an average depth of some 1.9m below the existing ground surface. The excavations exposed existing tarmac road surface and concrete hardcore overlying orange/brown sand and gravel natural at a depth of 1.4m.

Figure 15: General view and detail of section of trenching on the north side of Prima Road, with natural sandy gravels visible at 1.4m below the current ground surface. (8th July 2009, 1m scale).

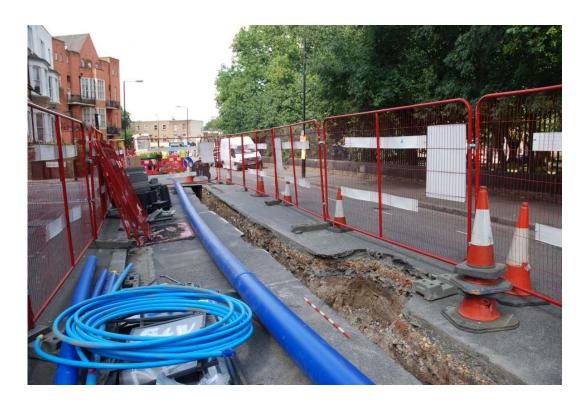
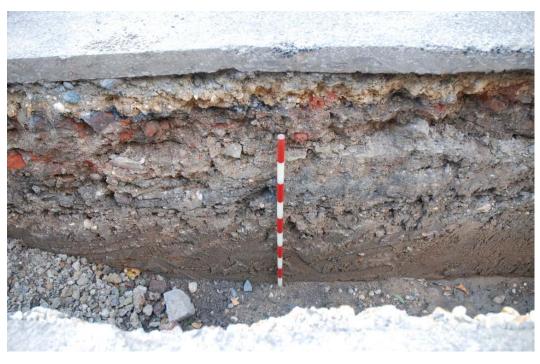
Along the south carriageway between the junction with Clapham Road and east of the Offley Road junction, some 100m of trenching was observed, at an average width of 0.75m and excavating to between 0.95m and 1.4m in depth. Existing road tarmac was

observed overlying coarse concrete hardcore along the full length of the trench. Varying depths and compositions of modern made-ground layers were observed, including yellow stock brick rubble which may reflect demolition or destruction of earlier Victorian buildings in the area. Greyish brown sandy-clay was observed below 0.9m in some areas of trenching with occasional red and yellow brick inclusions. No archaeological finds or features were observed in trenching along Prima Road.

Figure 16: Trenching on the south side of Prima Road and section below, showing natural clayey gravels appearing at *circa* 1m below the current ground surface (12th August 2009, 1m Scale).

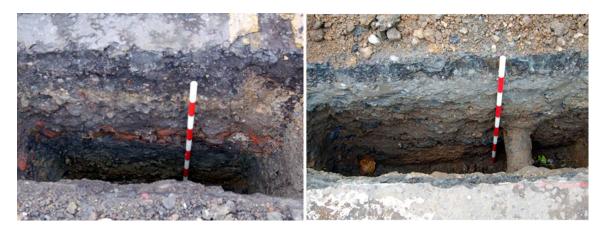
Two excavations (Trial Pits C and D) exposed probable buried soil horizons overlying the natural layers and beneath the more recent ground makeup above. In both cases the deposits contained fragments of stock brick and tile and are considered to be of 19th century date. Camberwell, while an established settlement from as early as the Saxon period, remained small and rural until well into the 19th century, thereafter expanding rapidly – in part due to the arrival of the railways. These deposits may well date from the more rural settlement around Camberwell, reflecting buried plough or agricultural deposits, which were subsequently sealed during the development of the roads and surrounding properties.

Figure 18: Buried soil horizons observed on Warner Road in excavated Test Pits B (left) and C (right). 1m scale

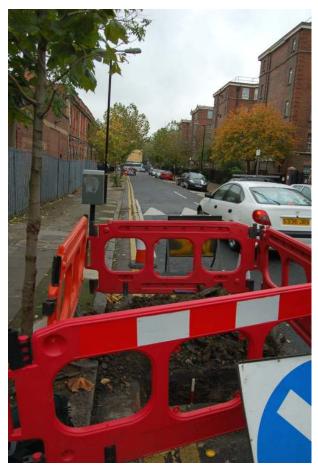
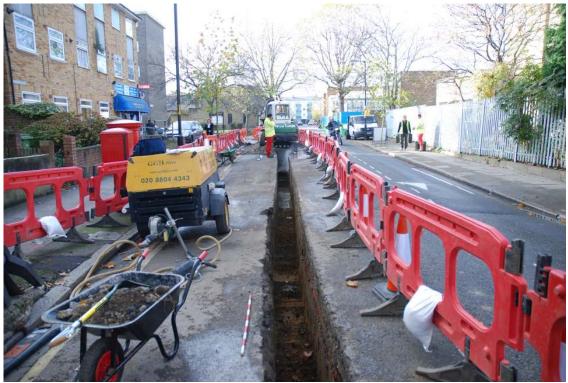
Figure 19: Top Location of Test Pit A on Warner Road and (below)Trenching looking southwest along Warner Road (4th and 14th November 2008, 1m Scale).

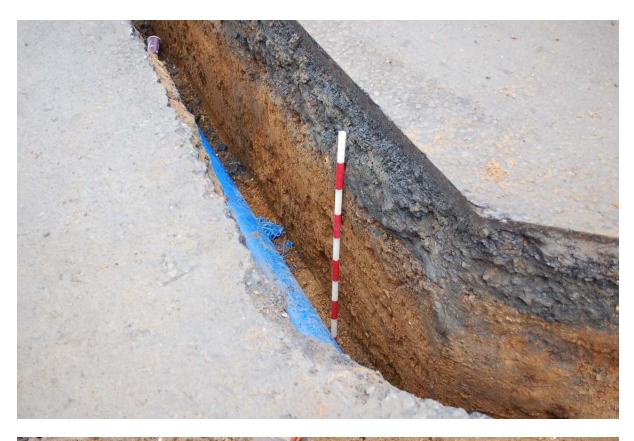
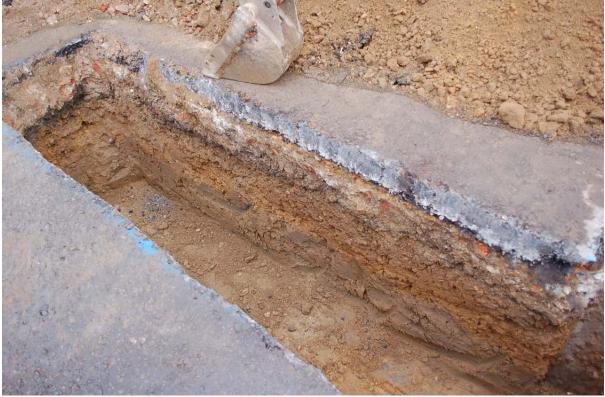
Figure 20: Top Warner Road southeast facing section looking southwest towards the junction with Denmark Road and (below) the southwest end of trenching in Morna Road, both areas revealed silty sandy gravels at circa 0.8m below the current ground (16th January 2009, 1m Scale).

A small 5m section of trench was observed on the southwestern end of Morna Road, adjacent to the south kerb. The trench measured 1.2m in width and was excavated to a depth of 1.1m below the existing tarmac road surface. Exposed deposits consisted of rubble makeup and made-ground overlying natural sand and gravel deposits with occasional clay lenses from 0.7m below the current ground surface (Figure 20). No archaeological finds or features were observed.

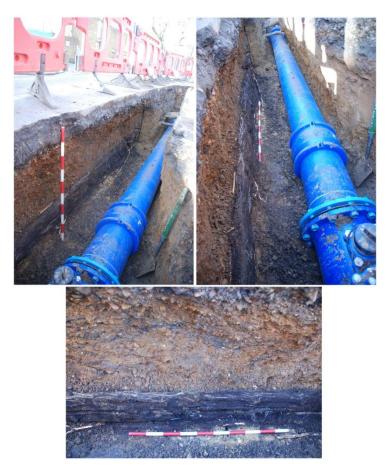
Trenching at the northwestern end of Crawford Road, running southeast from the junction with Warner Road, exposed existing road layers overlying c. 0.5m of redeposited sands and gravels beneath which a length of degraded wood was observed in the southwest facing section. The wood was recorded at a depth of c. 0.65m below the existing ground surface and measured 0.25m in height. It was observed running at length of 6m+ along the section and was c. 70mm thick. Limited rooting was observed in places around the plank and a very dark humic soil was noted underlying the plank to the north, while to the south the wood appeared to directly overly truncated natural gravels. The limited area of investigation makes accurate identification of the nature and use of this feature very difficult, although several possibilities can be suggested. It is possible that the wood represents 'shoring up' or supporting of trench sides during the laying of previous services, and that the present contractors trench was coincidentally located on the line of earlier excavations. Conversely, the wood may be an earlier feature, potentially related to predevelopment 19th century rural occupation. In either case, the condition of the wood is relatively good indicating a fairly recent date of deposition.

Figure 22: Views of the wooden remains observed in trenching on Crawford Road (1m scale).

- 10.2 In Crawford Road a large section of degraded wood was noted in section and is thought to be either the remains of earlier trench shoring or a possible agricultural feature relating to the earlier rural Camberwell, prior to the wide scale development of the later 19th century. However, the good condition of the wood indicates a fairly recent date of deposition, and it is not thought to pre-date the 19th century. In Warner Road two areas of possible buried soil horizon were observed, both of which contained fragments of yellow stock brick and were subsequently dated to probable 19th century origin.

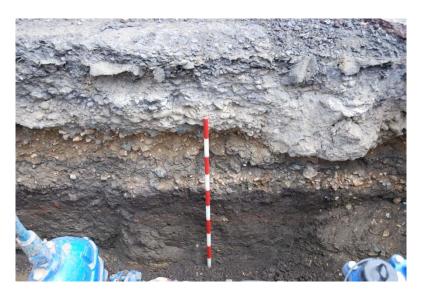
The excavations at the northwest end of Camberwell New Road exposed the existing tarmac road surface overlying concrete hardcore to between 0.3m and 0.55m. Madeground layers and modern service backfills were exposed below this level, and in one trench (22nd June 2009), redeposited natural deposits of brickearth and gravels were recorded below 1.5m in depth. Backfill contemporary with the original pipes was recorded in various locations. No archaeological finds or features were recorded during trenching on Camberwell New Road.

Figure 25: Section of trenching on Camberwell New Road (22nd June 2009), showing road makeup layers overlying Victorian pipe backfill (1m scale).

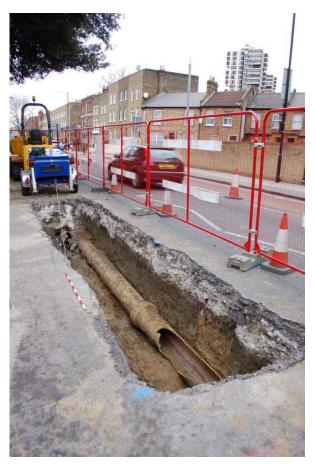
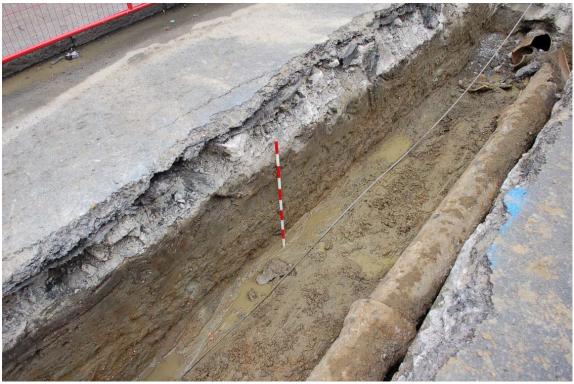
Figure 26: Camberwell New Road showing the old main after removal and sterile natural mid brown clays (12th March 2009), Scale 1m.
