THAMES WATER UTILITIES LTD
COLDHARBOUR LANE FLOOD ALLEVIATION SCHEME
RUSH COMMON SITE, BRIXTON HILL SW2
LONDON BOROUGH OF LAMBETH
AN ARCHAEOLOGICAL WATCHING BRIEF

September 2010

PLANNING REFERENCE: 08/01938/F
SITE CODE: TZU09
SITE CENTRE NGR: TQ 3091 7493

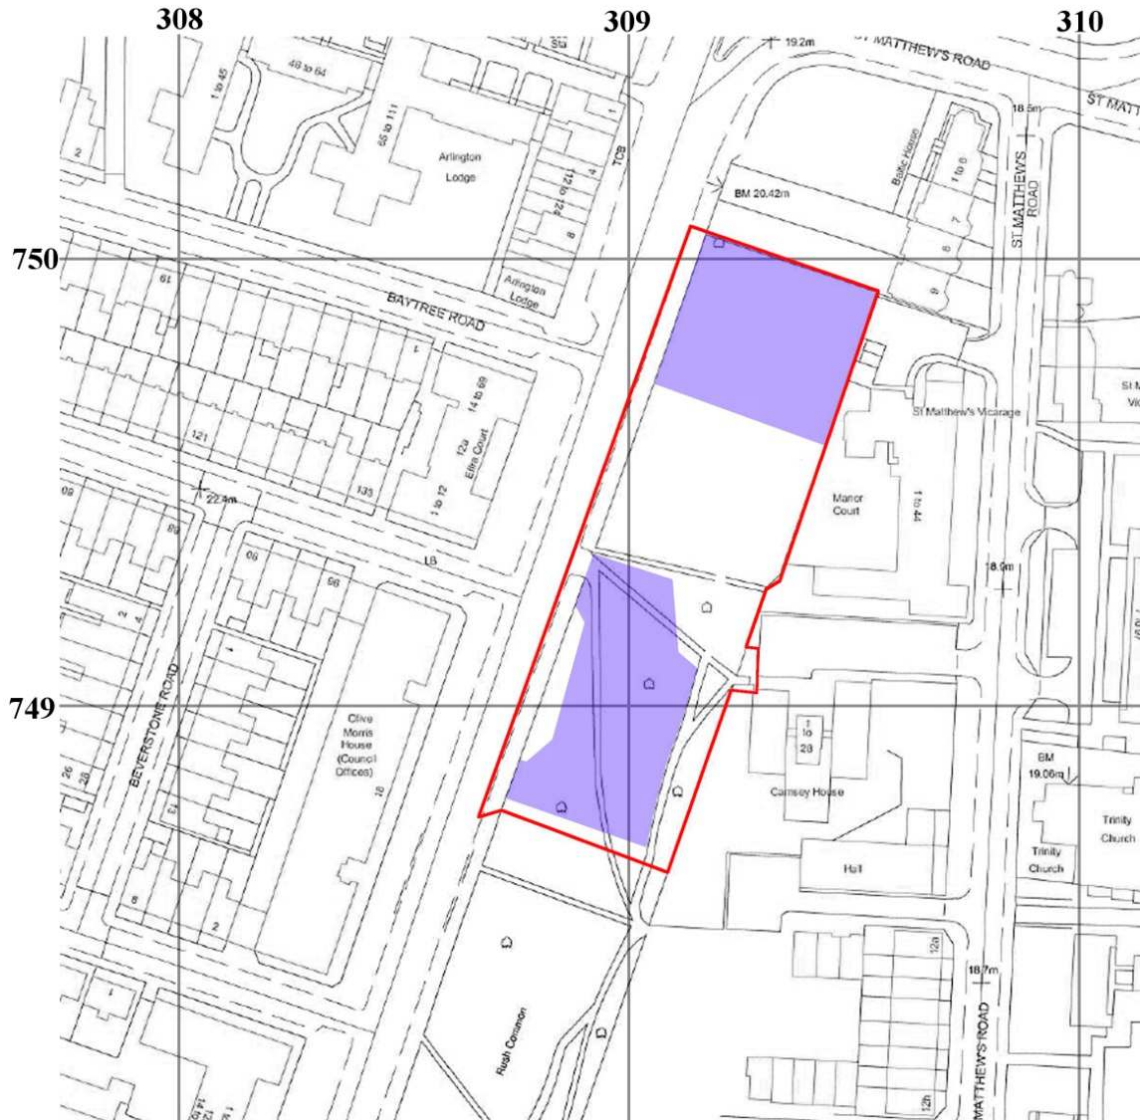
Figure 2: The location of areas A (north) and B (south), subject to initial topsoil strips and subsequent pipe trench excavations.

Figure 2 below shows the location of the two sites A and B, which are described in sections 8.1 and 8.2. The later pipe excavation in area A is described in section 8.3, while pipe excavations in Area B are described in section 8.4 (control kiosk) and 8.5 (ventilation column). A further pipe trench in the southern part of Area B is described in section 8.6, and the drive shaft in section 8.7.

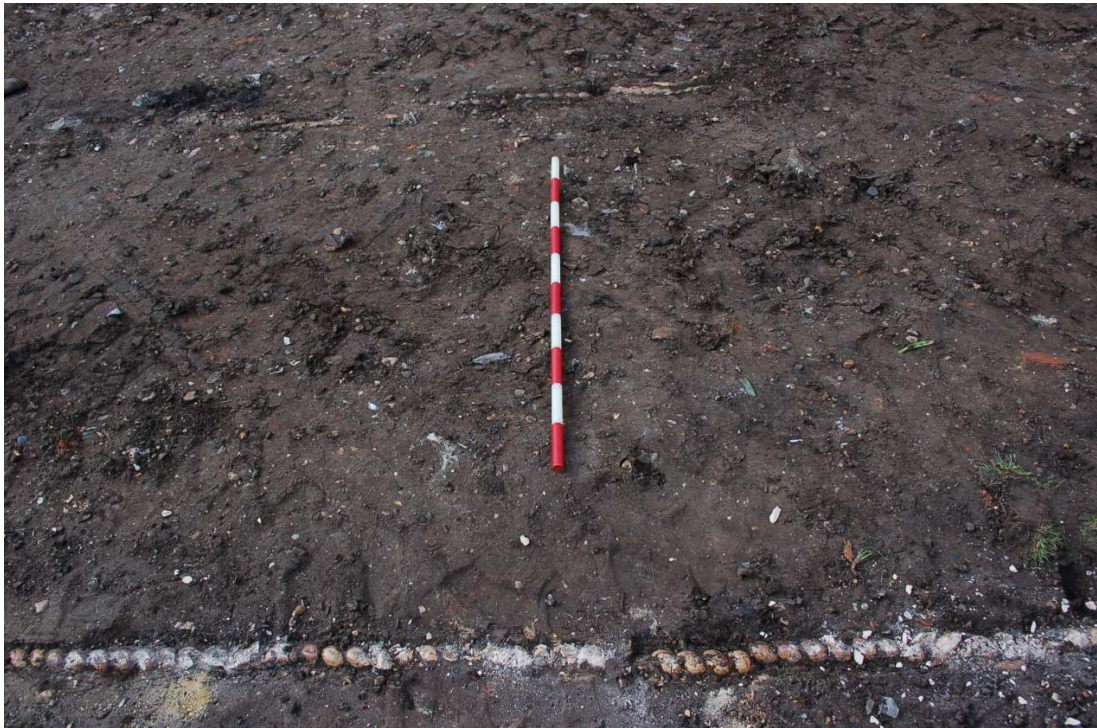
Two parallel lines of salt glazed stoneware moulded path edging tiles were exposed running across the stripped area perpendicular to Brixton Hill (see Figures 3-5 below). The two lines were c. 1.6m apart. The twisted design is known as ‘cable pattern’ and was produced in the late 19th and early 20th centuries (see Figure 5). The distance that the lines were set apart seems to support the conclusion that they delineate a garden path, the original surface of which may well survive beneath made-ground [2]. Unfortunately, the heavily compacted nature of deposit [2] and lack of further machine stripping made deeper investigation impossible. It is likely that the path edging is contemporary with the terraced housing built to the east of the site in the late 19th century. These substantial properties had front gardens extending to the line of Brixton Hill to the west. The Ordnance Survey map of 25-inch map of 1916 shows these houses and front gardens, and when overlain the line of the path edging runs parallel with the boundary of one of the terraced properties (see Figures 5 and 6

below). It is likely that the path edging exposed during machining represented the line of the garden path leading from Brixton Hill to the front entrance of the late-19th century house.

Figure 3: Parallel lines of ceramic path edging, view south (1m scale).

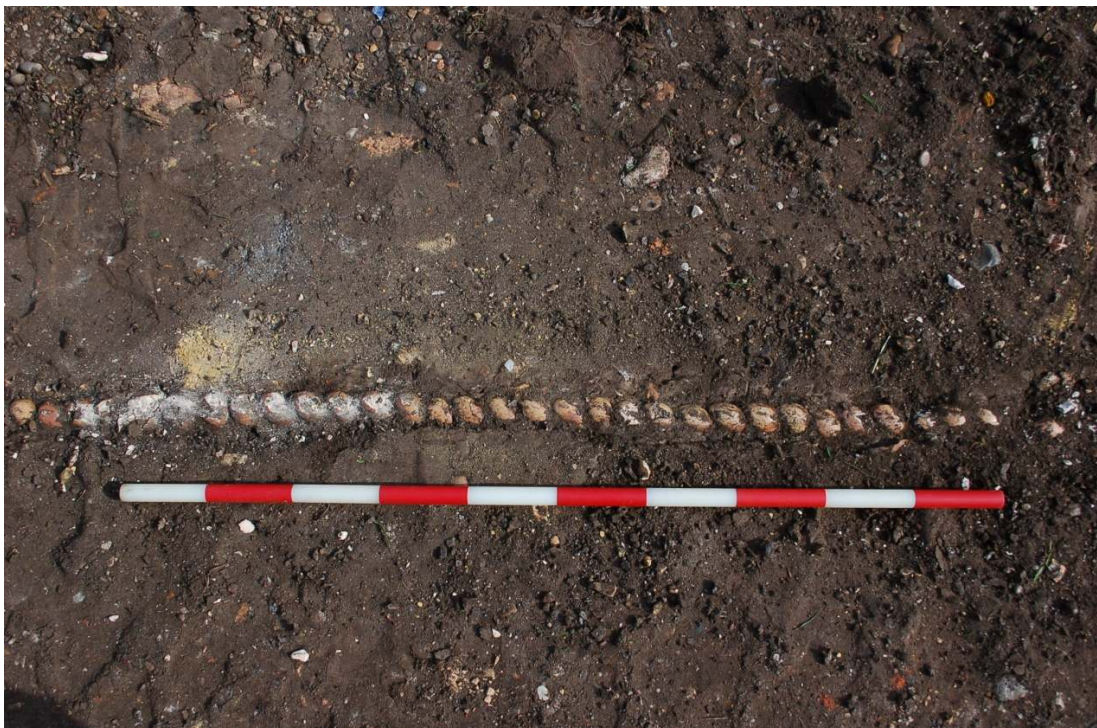
Figure 4: Detail of ceramic path edging (1m scale).

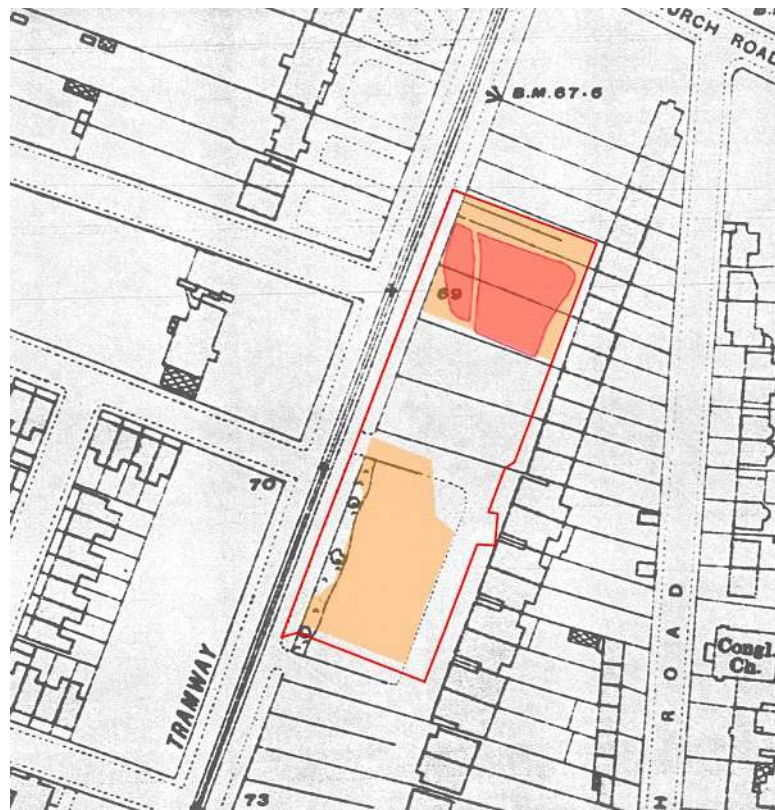
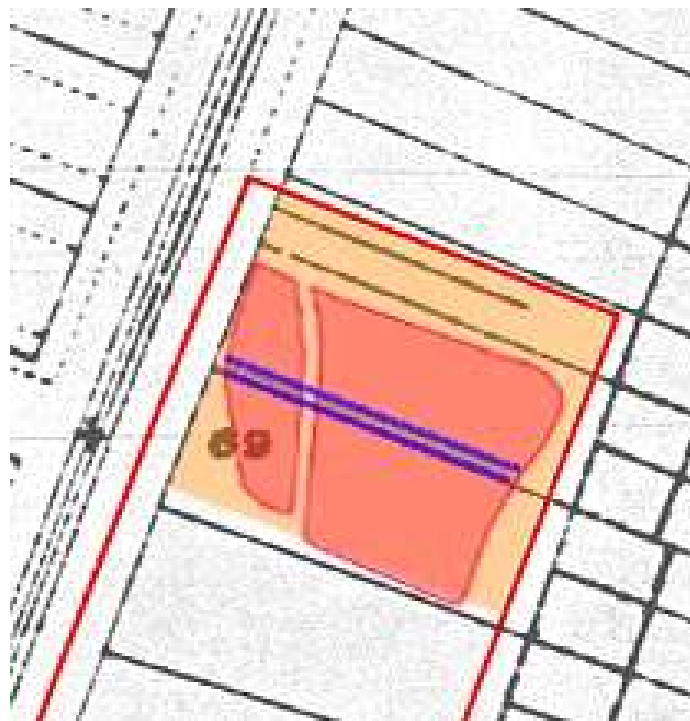
Figure 6 Top: the Stripped Area A in relation to the Ordnance Survey map of 1916. Below: detail of the Ordnance Survey map of 1916 showing the parallel lines of path edging (blue) exposed during machine stripping.

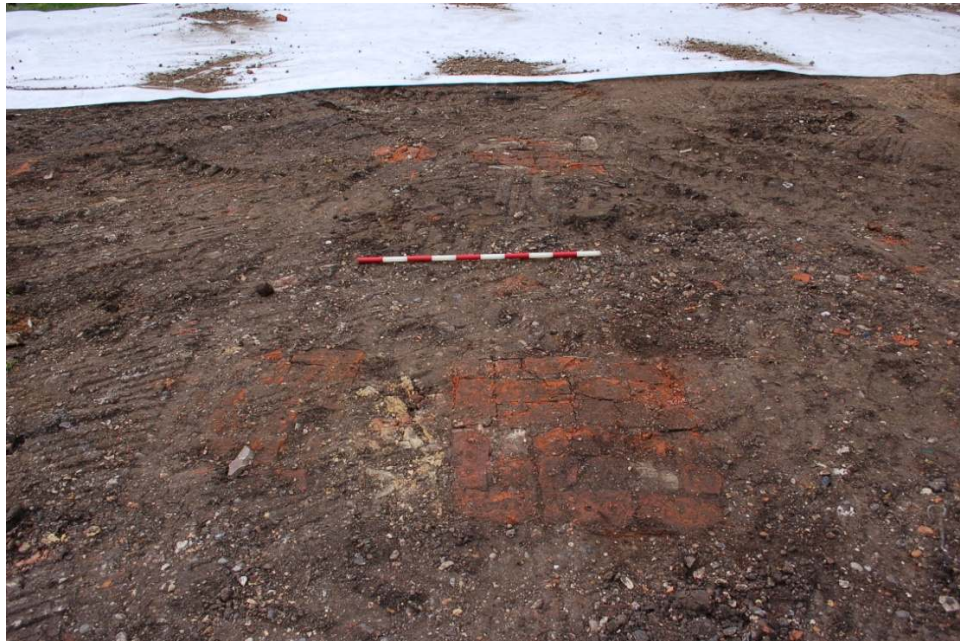
Brick bases [4] recorded during machine stripping consisted of four c. 700mm square sections of red/orange soft bricks (some perforated) in two pairs. Each pair was c. 30mm apart, separated by patches of compacted earth and crushed yellow stock-brick and mortar. The pairs of brickwork were c. 1.78m apart (north-south). Figure 7 (below) shows the two pairs of brickwork and Figures 8 and 9 shows detailed shots of the individual pairs.

Figure 7: Pairs of square brick bases exposed during machine strip, view south (1m scale).

As with the path edging [3], there were no visible cuts associated with the brick bases, suggesting that the made-ground deposit [2] sealed them. The brickwork is then of an earlier phase of occupation, likely contemporary with the terraced properties shown on the Ordnance Survey map of 1916 (see Figure 6 below). Although the location of the brick bases places it within one of the larger gardens of the terraced properties (in the southern most part of machine stripping), there are other buildings or structures shown on the map. The exact nature of the brick bases, or the larger structure/garden feature they were associated with is unknown.

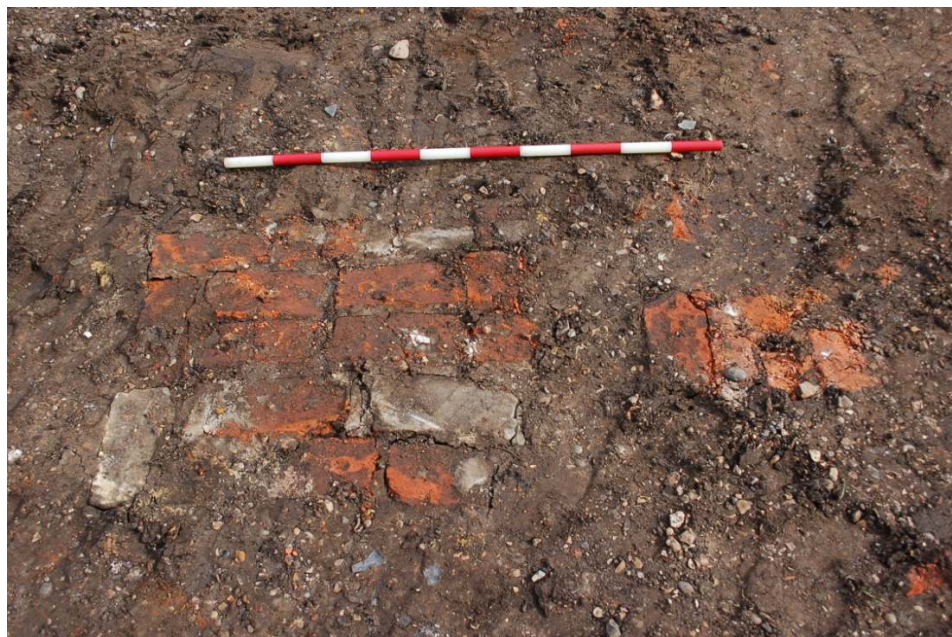
Figure 8: Southern pair of brick bases (1m scale).

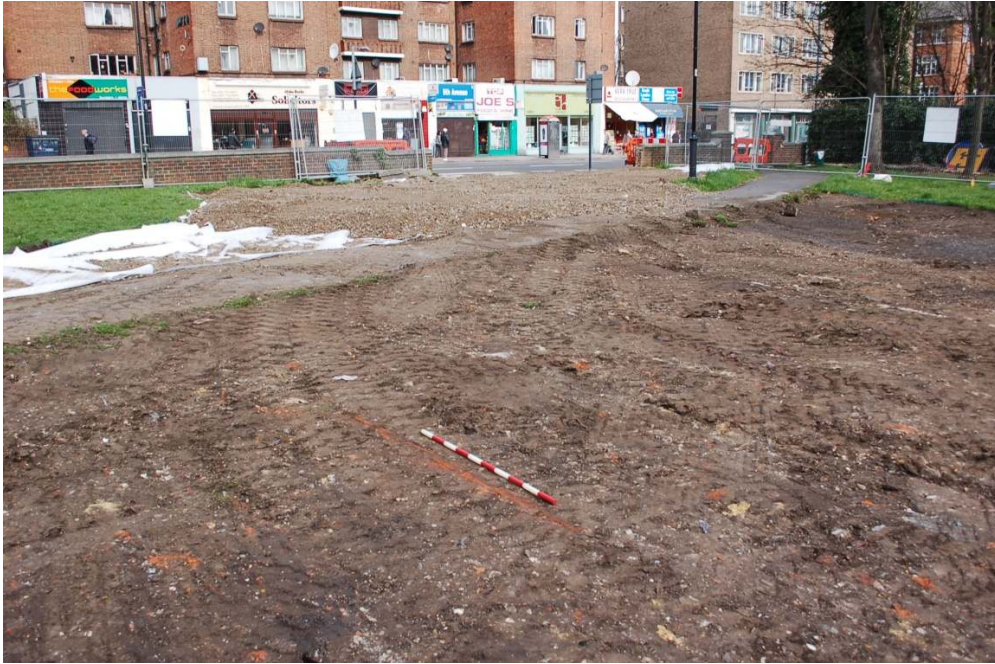
A further small area of brickwork [5] was exposed in the northwest part of the stripped area and consisted of small section of a line red-brick headers, exposed in plan as a single course only. Figures 10 and 11 below show the location and close-up detail of this brickwork. Again, the location of the brickwork places it within the front gardens of the late-19th century terrace properties, and although no structures beyond the site boundaries are shown, it is likely that the brickwork represents surviving remains of garden wall. The alignment, although only partially exposed, seems to be parallel with the gardens shown.

Figure 10: Section of brickwork exposed during machine strip, view northwest (1m scale).

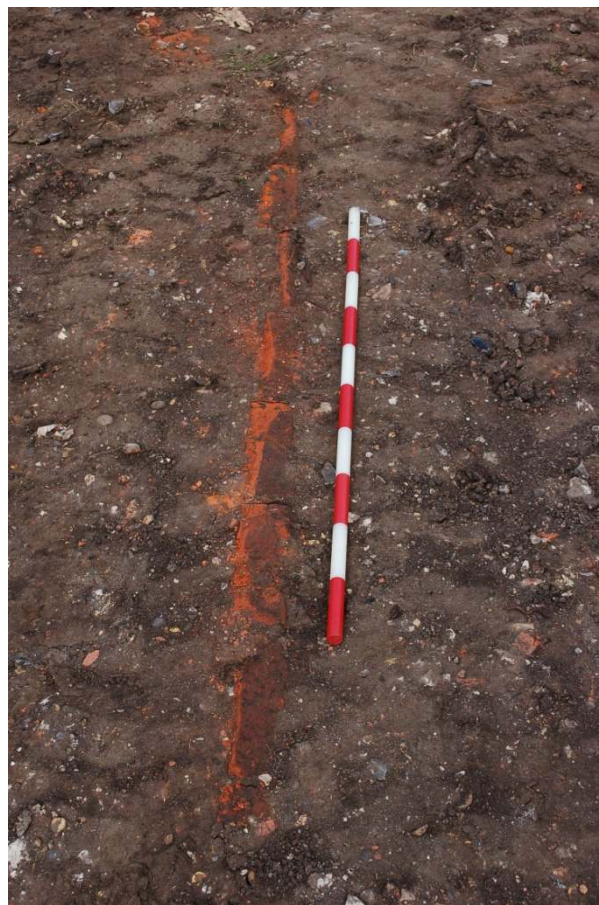
Figure 11: Close-up of linear section of degraded brickwork (1m scale).

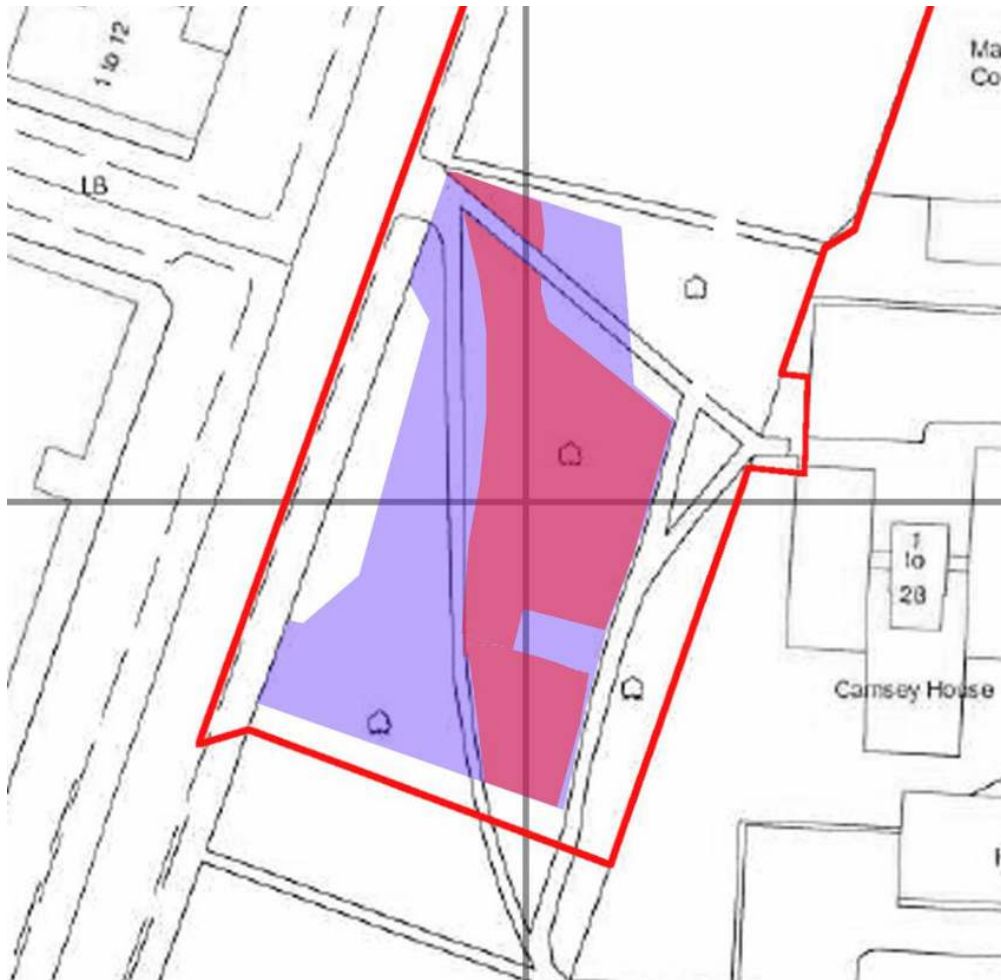
In the southern part of the site an area measuring c. 28m (northwest to southeast) by 50m (north-south), roughly triangular in plan between two existing paths was stripped of turf and topsoil (see Figure 12). Between 30mm and 60mm of turf with underlying topsoil was removed, exposing underlying made-ground. Several small pits for upright supports of wooden site hoarding had been excavated around the site perimeter; these were examined and recorded as part of the archaeological monitoring programme.

Figure 12: Machine stripping in Area B (red) and the perimeter of the site compound (blue).

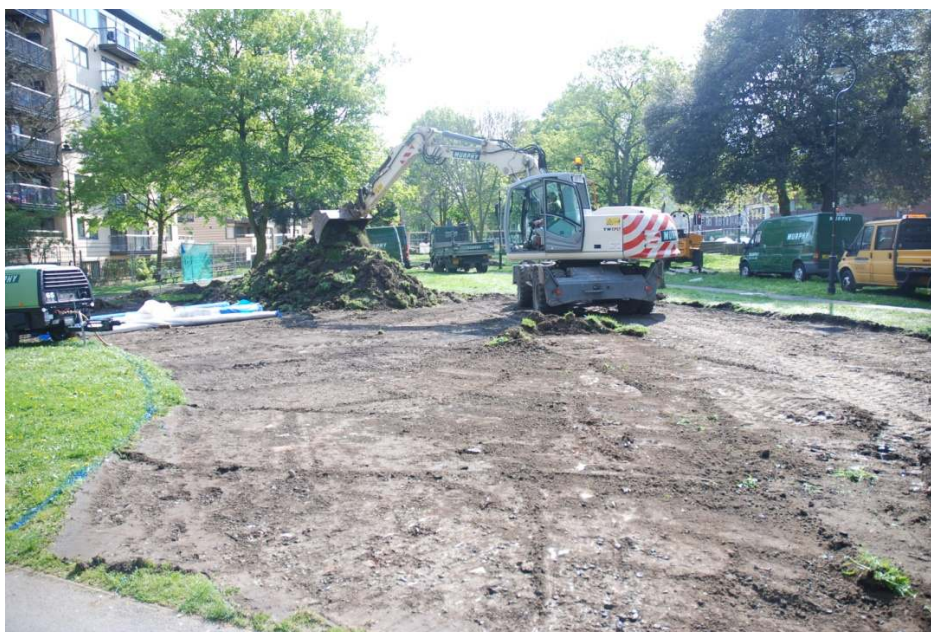
Between 30mm and 60mm of mid-grey brown topsoil [6] was removed across the site, exposing a mixed made-ground [7] below. Deposit [7] was exposed across the whole stripped area and contained modern inclusions of brick and concrete, similar to deposit [2] recorded in Area A. No archaeological finds or features were exposed in the stripped area.

Figure 13: Topsoil stripping in northern half of Area B.

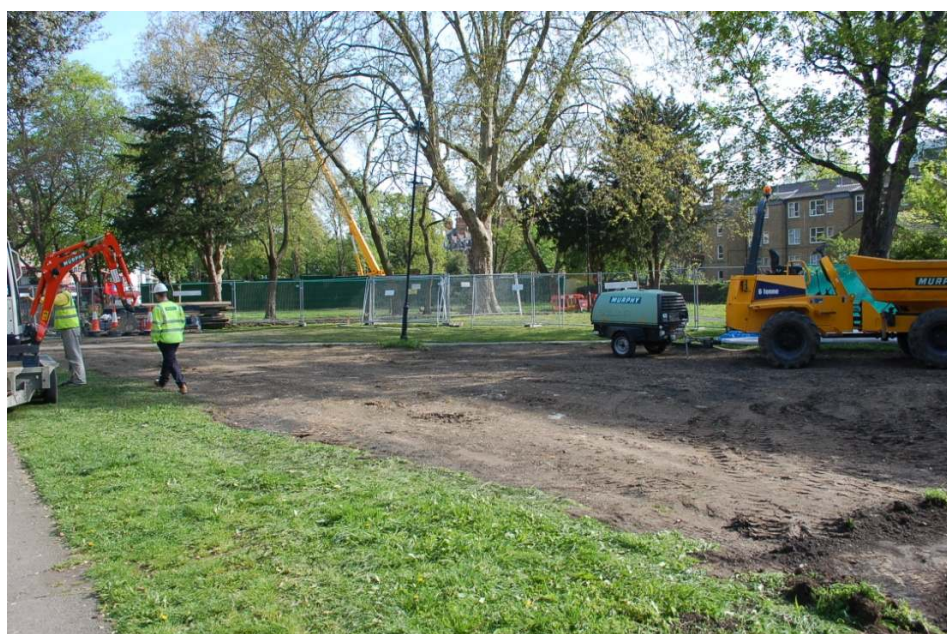
Figure 14: Topsoil stripping in southern half of Area B.

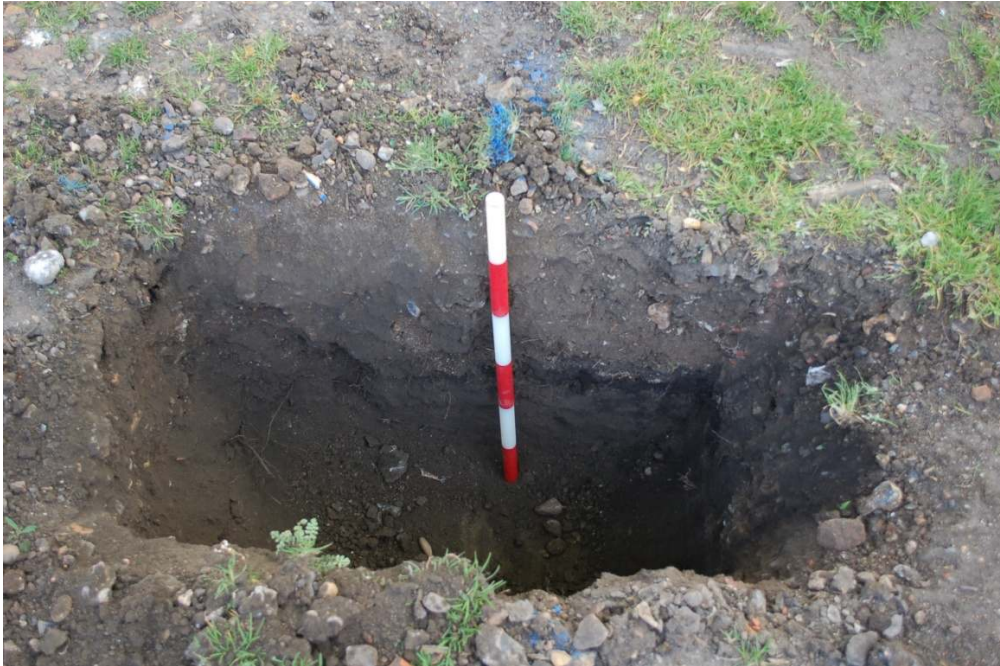
The post excavations exposed a broad sequence of modern topsoil over made-ground in varying degrees of thickness and composition. An orange/grey silt and clay deposit exposed in the base of a number of the excavation may have the top of natural clay deposits, or redeposited natural clay. No archaeological finds or features were recorded during the observation of post excavations. Figures 15-17 below show examples of post hole excavations.

Figure 15: Post hole excavation A (0.6m scale).

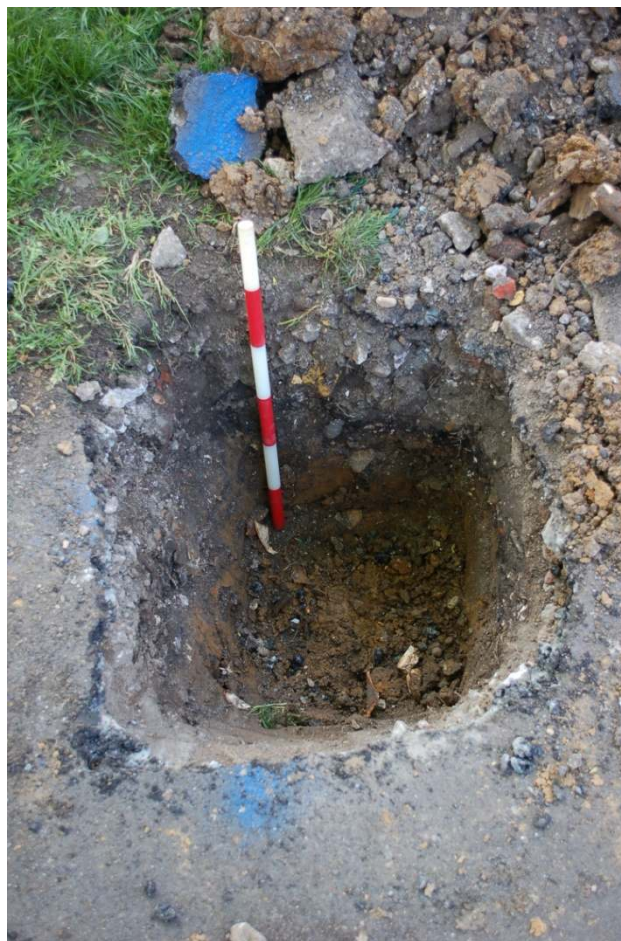
Figure 16: Post hole excavation B (0.6m scale).

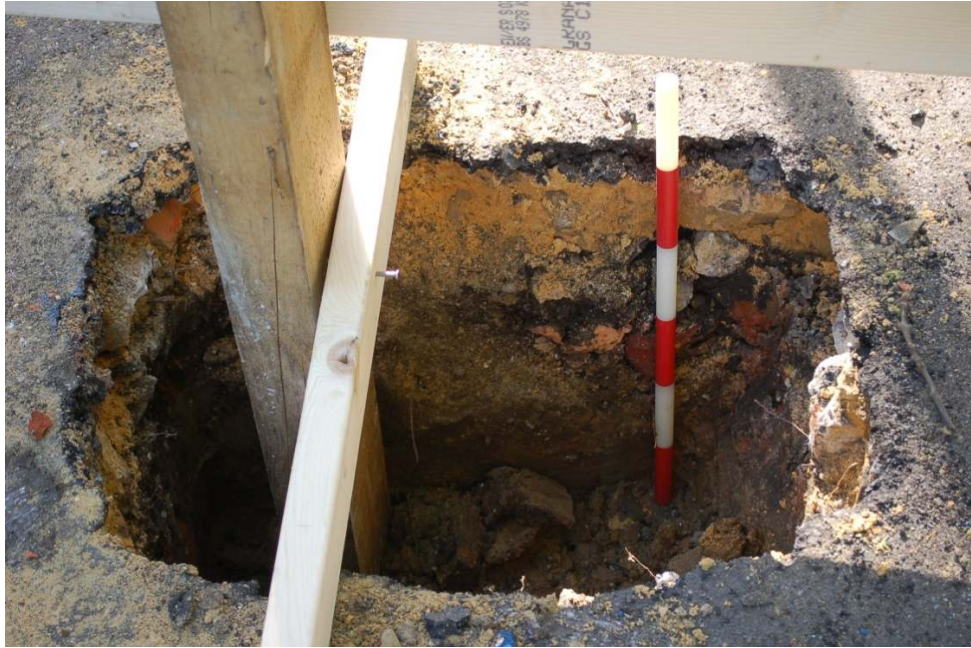
Figure 17: Post hole excavation L (0.6m scale).

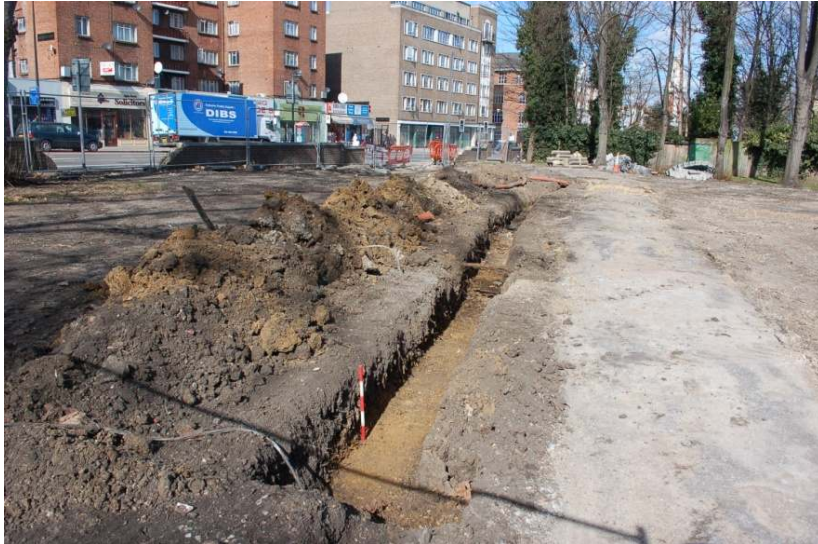
Topsoil [8] was observed for the full length of the trench overlying a similar deposit of made-ground [9], both of which contained modern inclusions and extended to around 0.4m in depth. Below this point orange/brown silty clay gave way to thicker yellow clay natural. The top of natural deposits was noted to be higher in the southern end with a greater depth of overlying made-ground to the north. No archaeological finds or features were observed during monitoring.

Figure 18: Pipe trench in Area A, view north towards Brixton Hill (0.5m scale).

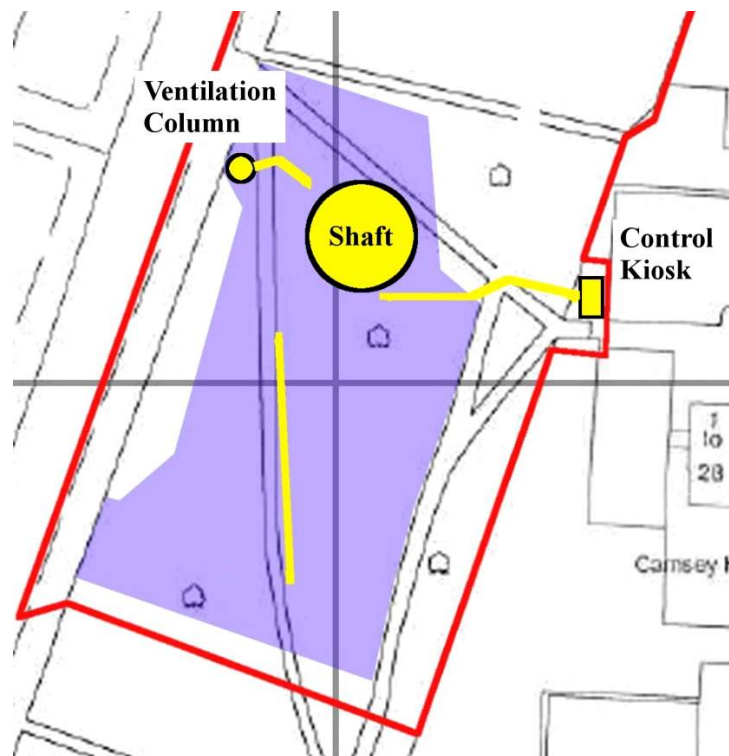
Figure 19: Sketch location plan of the main drive shaft, control kiosk, ventilation column and associated trenches in Area B.

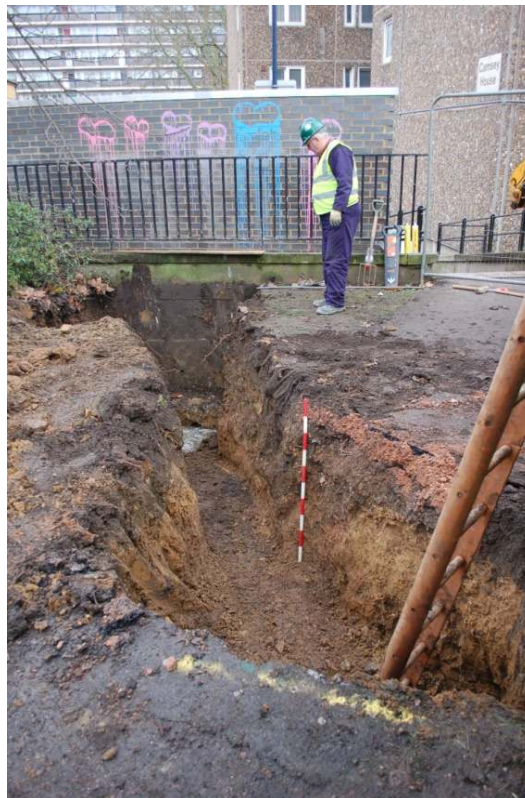
Existing turf and topsoil deposits [11] were observed with tarmac path and bedding [12] to a depth of up to 0.2m below the existing ground surface. Mixed layers of redeposited natural were observed to a depth of between 0.4m and 1.1m below the existing ground level. Natural clay occurred from a depth of 1.1m in the east and at a higher level c.05m in the west. No archaeological finds or features were observed during monitoring.

Figure 20: Connection trenching between the control kiosk and drive shaft outside the site compound (1m scale).

The sharp drop in the profile of natural deposits in the first trench may relate to line of terraced house constructed in the late 19th century. In the second trench the shift to a graduated soil profile from east to west may represent the carriage-drive shown on the 1916 Ordnance Survey map and adjacent garden soils (represented by initial shallow profile of drive to deeper soil profile of garden soils).

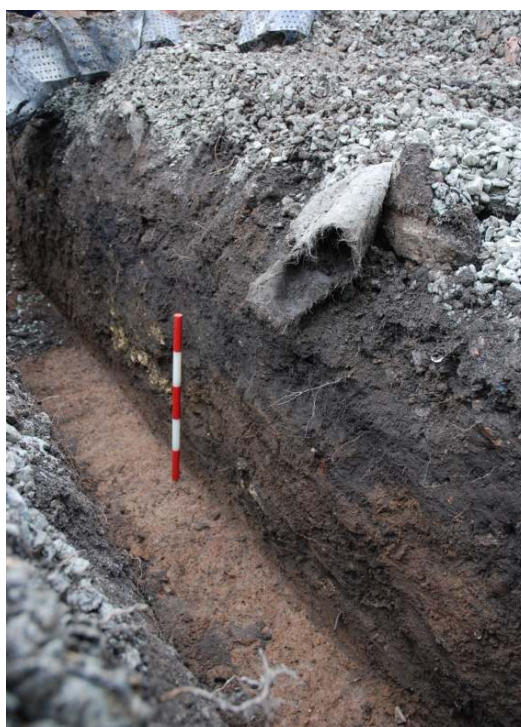
The sequence of exposed deposits in this trench changed c.1.2m inside the compound fence line. In the east end c. 0.3m of imported topsoil [15] was observed directly overlying clean natural clay [19]. In the west end of the trench the soil profile was substantially deeper and more graduated. 0.35m of hardstanding [16] was observed (remaining surface laid by 2009 works) overlying truncated topsoil [17] which in turn overlay subsoil deposit [18] to a depth of 1.05m below the existing ground surface. From this depth natural clay [19] was observed continuing to the base of excavations.

Figure 21: Section of trenching inside the compound (0.5m scale).

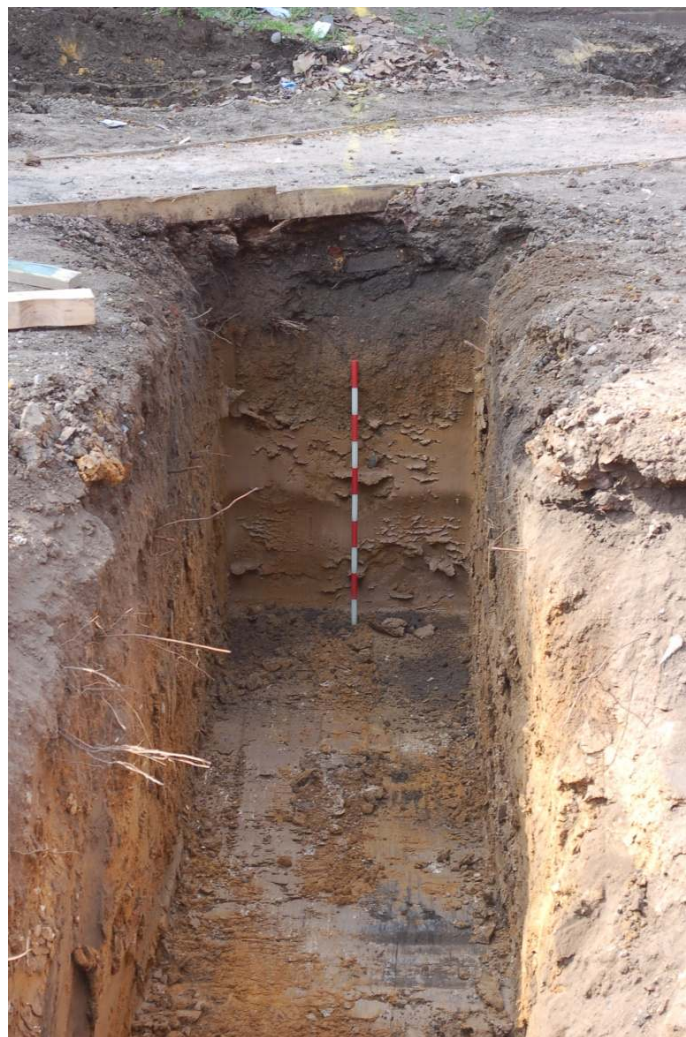
Reduced topsoil and made-ground [20] was observed to a depth of 0.3m overlying reworked natural clay for approximately 0.3m. Natural clay was observed for the remaining depth of excavation. No archaeological finds or features were observed.

Figure 22: Trenching between the ventilation column and drive shaft (1m scale).

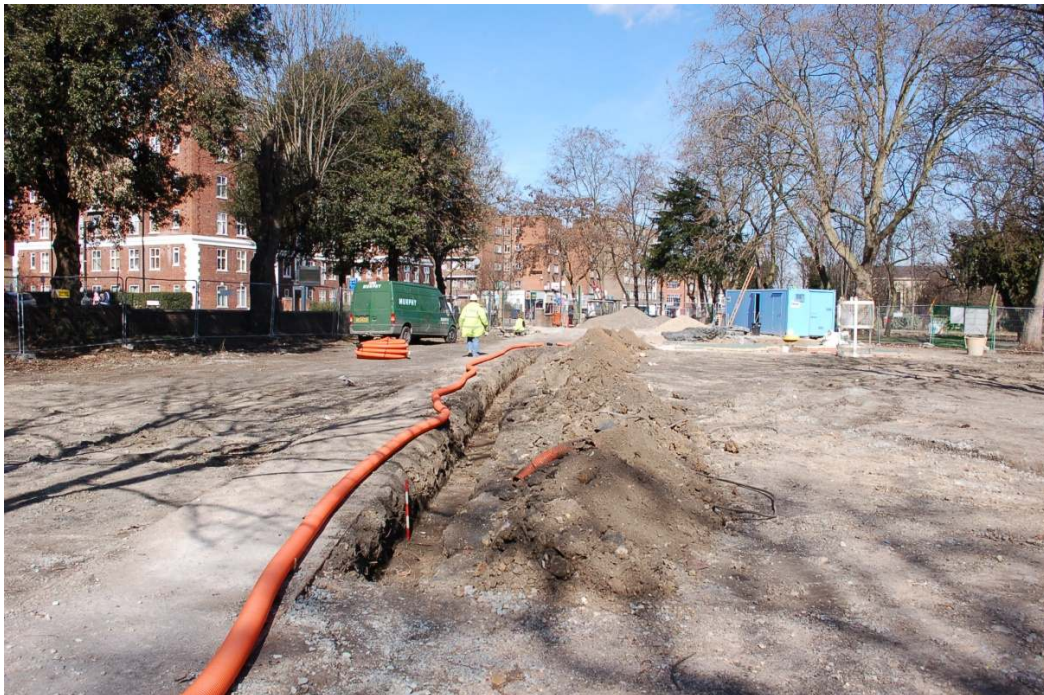
Topsoil and made-ground deposits [23] were observed directly overlying natural clay [24] which appeared in the base of the trench around 0.4m below the existing ground surface. No archaeological finds or features were observed during monitoring.

Figure 23: Pipe trenching in Area B (0.5m scale).

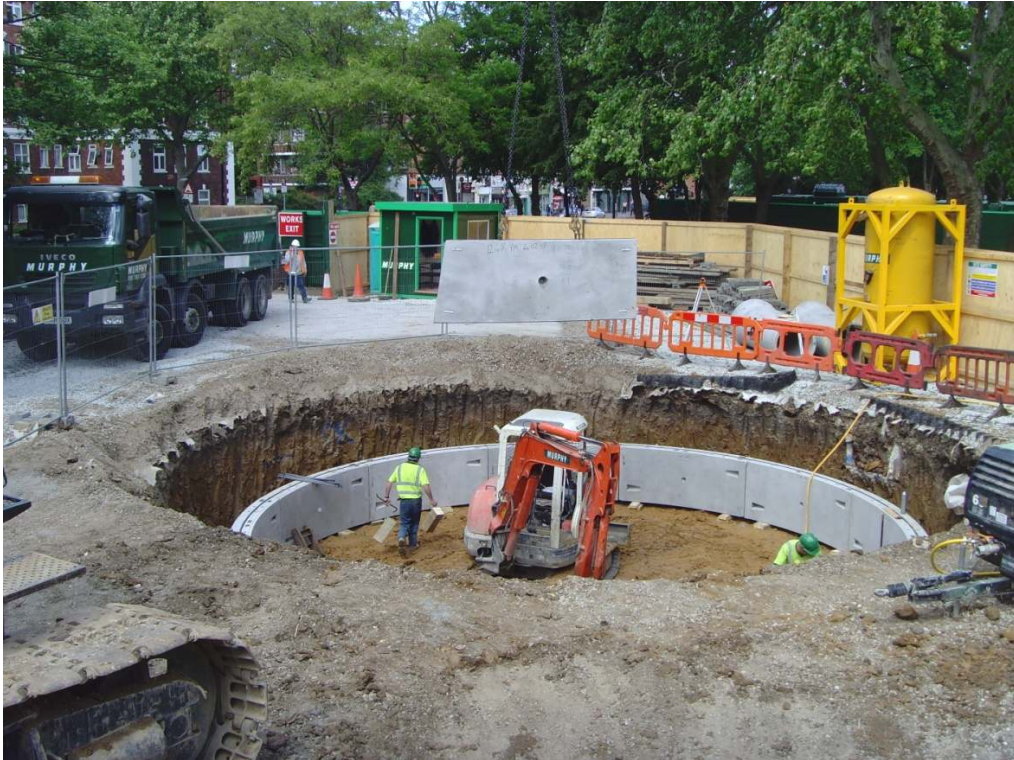
The sequence of deposits exposed in the shaft were broadly the same as that exposed during adjacent works – topsoil and made ground deposits were exposed overlying reworked natural and natural clay deposits. Figures 24 and 25 below show excavation of the main shaft in progress.

Figure 24: Excavation of the main drive shaft.

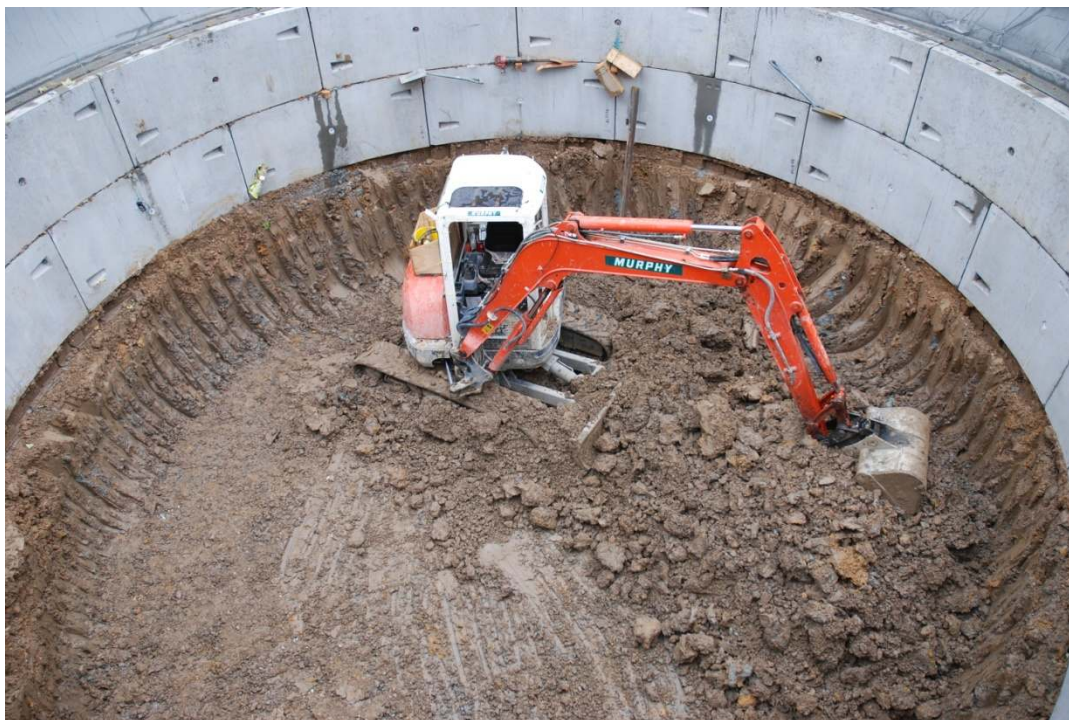
Figure 25: Excavation through natural clay in the main drive shaft.
