**THE GARDENS OF RAINHAM HALL
BROADWAY
RAINHAM, RM13 9YN
LONDON BOROUGH OF HAVERING**

AN ARCHAEOLOGICAL EVALUATION AND WATCHING BRIEF

SITE CODE: RHB10
NGR: TQ 5216 8214

August 2010

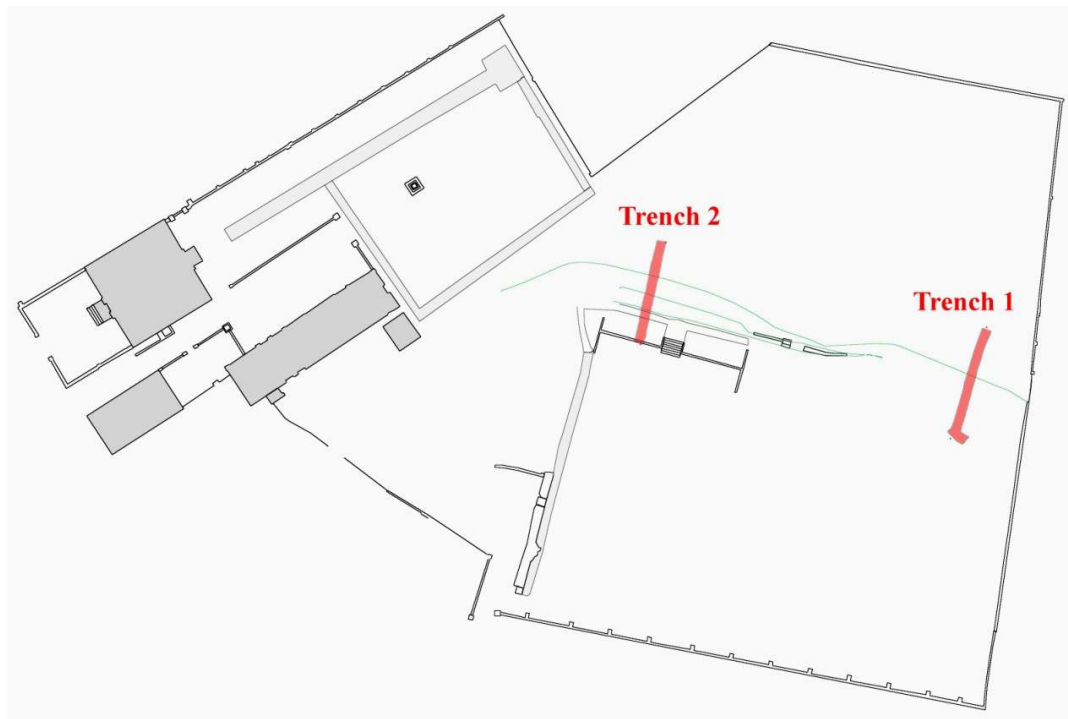
Figure 2: Trench location plan, based on an original survey drawing by Butler+Hegarty Architects (Drawing No: 0910506/SK300-3).

The evaluation carried out in the gardens of Rainham Hall consisted of two trenches excavated in the south-east part of the site, along the line of the existing terracing that runs approximately northwest to southeast dividing the Orchard to the north from the Lower Lawn and overgrown areas to the south (see Figure 2 below). The trenches were orientated approximately northeast to southwest, running from the top to the bottom of the sloped and terraced bank.

The field evaluation consisted of two trial trenches, located as shown on Figure 2. Trenches measured 15.1m and 13.1m respectively by 1.2m in plan at the level of potential archaeology or natural subsoil.

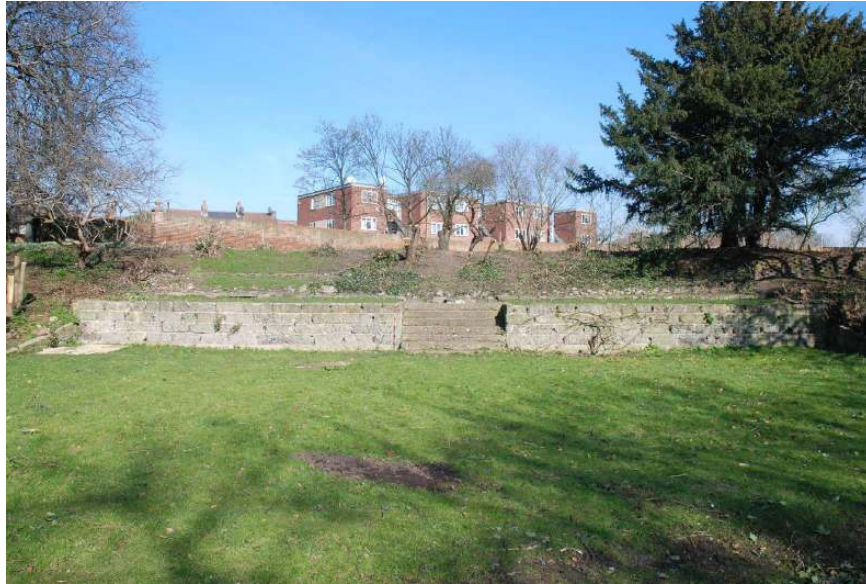
The slope changes in character and structure across its length, and has been subjected to varying degrees of alteration over the years. In the western half of the site the slope has been partly terraced, now consisting of two sloped banks leading to a stone path and grassed terrace supported by a concrete retaining wall and steps (see Figure 3 below). The area was landscaped in this manner in the first half of the 20th century to accommodate a tennis court (shown on the Ordnance Survey map of 1939), although the exact date of the works is not known. At the top of the bank the ground is recorded at *c.* 5.69m OD falling to *c.* 4.20m OD on the stone path. The top of the concrete retaining wall is at *c.* 4.01m OD, and the top of the stairs at 4.00m OD falling to 2.95m OD at the base. Trench 2 was excavated across this sequence of terraces, the southern end located approximately 3m to the left (west) of the base of the steps.

Figure 3: The 20th century terraces, concrete retaining wall and steps to the Lower Lawn, looking northeast.

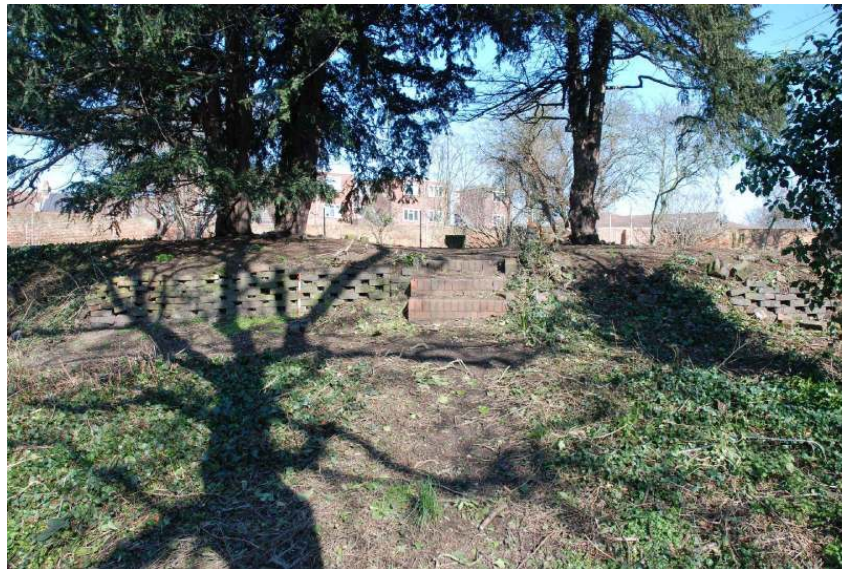
In the approximate centre of the existing bank a brick-lined bastion planted with three large yew trees currently stands. The yew trees stand at the top of the terrace at *c.* 5.69m OD, at the same level as the top of the bank to the west above the Lower Lawn terraces. The level then drops to *c.* 4.78m OD at the base of a modern dry-laid brick wall, set in toothed or Honeycomb brickwork design (probably for drainage). Within the wall a set of 20th century red brick on-edge steps is constructed (see Figure 4 below). The level at this point is slightly above that of the stone path on the terrace to the west, but here the ground is then gently sloped as opposed to terraced, eventually leveling off to the approximately the same height as the Lower Lawn to the west.

Figure 4: The bastion planted with yew trees and retained by a Honeycomb dry-laid brick wall and red-brick steps.

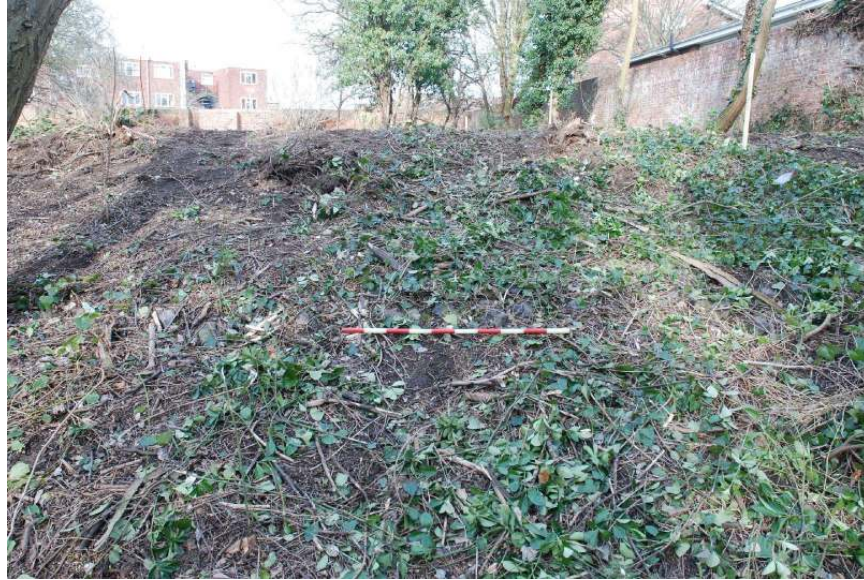
In the eastern half of the site the bank shows no evidence of deliberate terracing or reshaping. Here the land slopes from 5.70m OD at the top (north) to c. 3.00m OD at the base (south). The area is very overgrown, known as the ‘Wilderness’ and featuring numerous mature trees and large areas of brambles and scrub (see Figure 5 below). Trench 1 was located in this area, running from the top of the slope and located approximately 6m from the existing boundary wall to the east.

Figure 5: The sloping bank in the eastern half of the site, very overgrown.

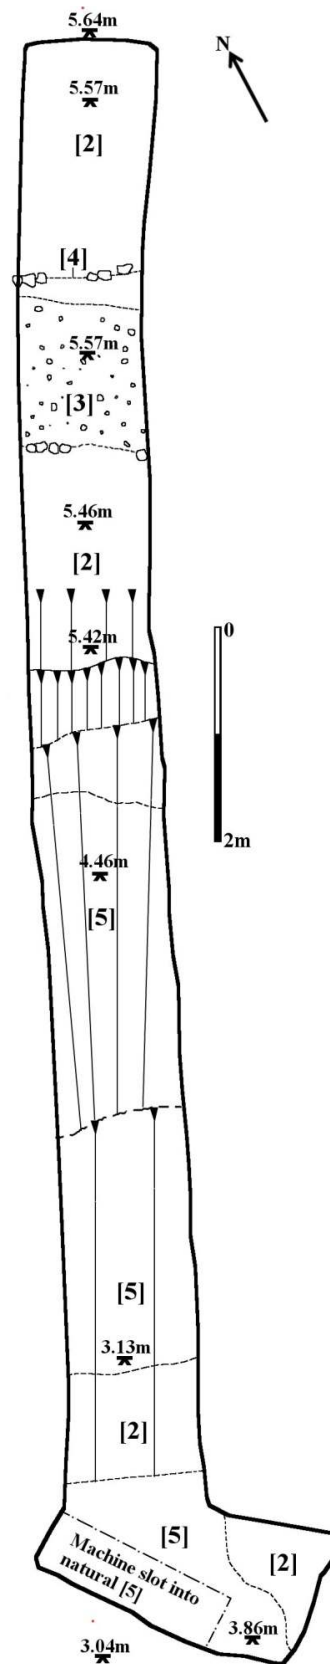
Figure 6: Plan of Trench 1.

Trench 1 exposed a recent garden or top-soil deposit [1] which overlay a subsoil deposit [2] for the majority of the trench. However, in the northern end of Trench 1, at the top of the existing slope, a gravel path [4][3] was observed cutting subsoil deposit [2]. This was in turn cut by [6], bedding soils laid either side of the path and cut into the edges to the north and south. Natural gravels and sand [5] were observed in the base of excavations from c. 6.2m along the trench from the northern end (c.2.6m south of the southernmost path edge), beginning at a height of 4.46m OD and sloping down to a height of 2.59m OD in the southern end of Trench 1. The recorded deposits and features in Trench 1 are shown in plan and section in Figures 6 and 7 below.

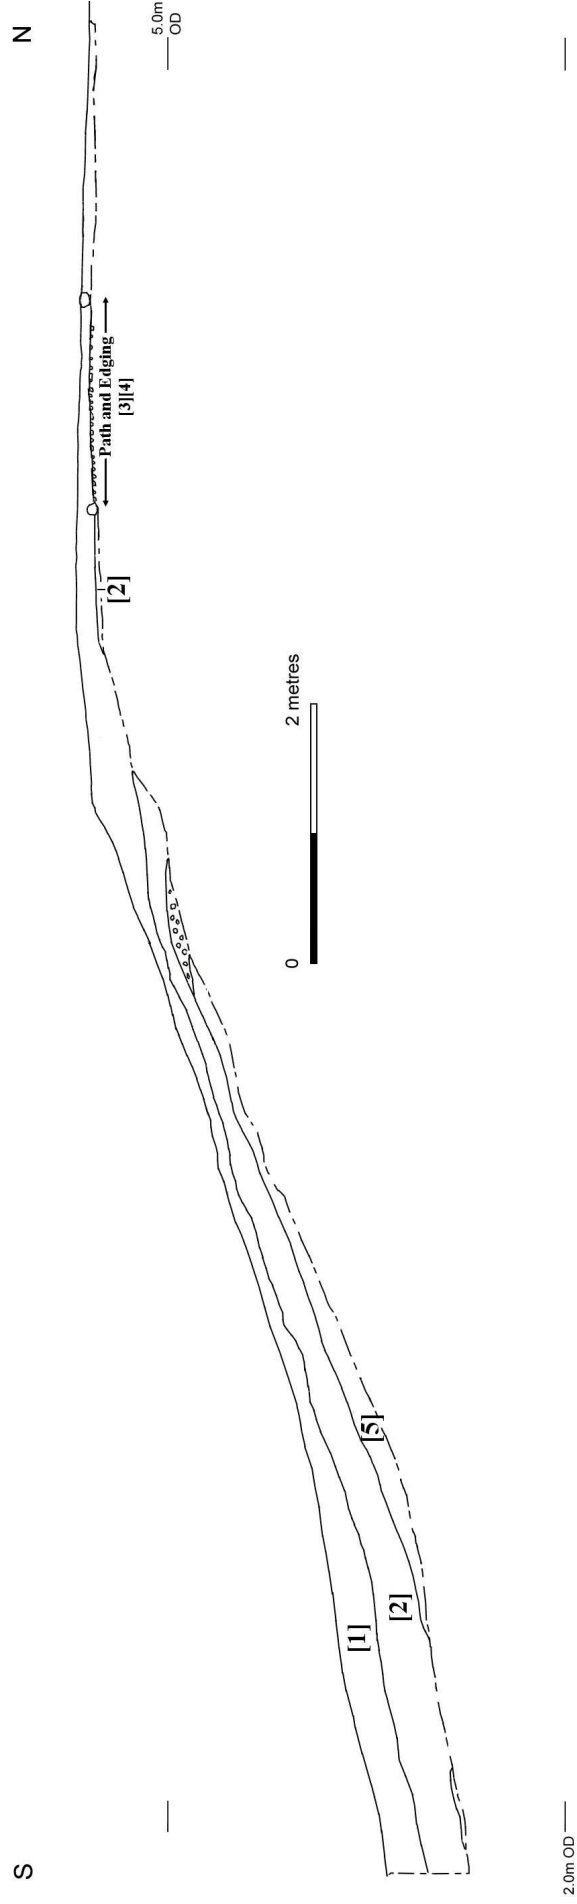
Figure 7: Section of Trench 1.

No evidence for significant building up of the land or other form of terracing was observed in Trench 1, although evidence for some minimal landscaping is possible. It is unclear from the results of the archaeological evaluation whether the natural deposits recorded sloping from north to south represent a natural topographic feature (possibly predating the garden) or whether they have been cut back or sculpted to form the existing bank.

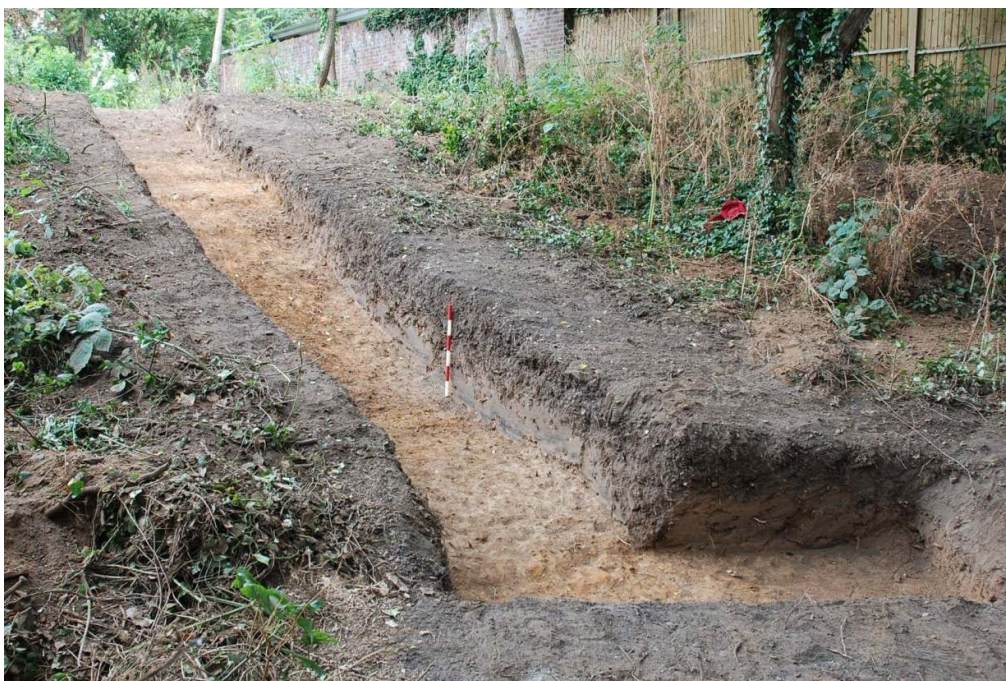
Figure 8: View of the south end of Trench 1 looking northeast (0.6m scale).

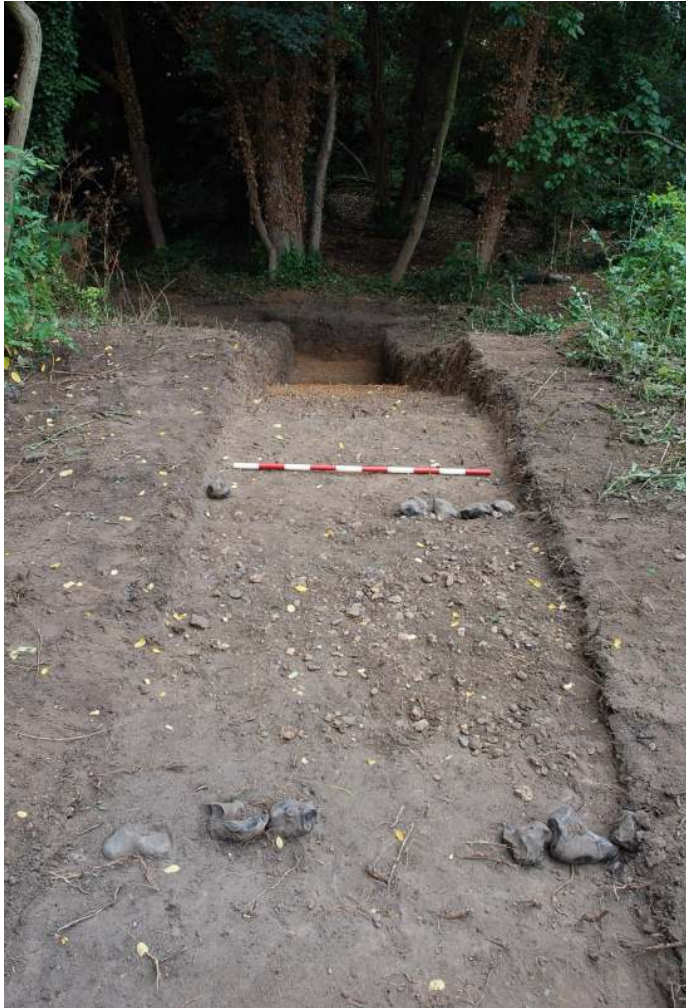
The natural gravels [5] were overlain by subsoil deposit [2] which was in turn cut by the path [3][4]. As no finds or datable material were recovered from the fill [3] of path [4], it is impossible to accurately date the feature or fit it into the timetable of development of the garden. The bedding deposits [6] were clearly a subsequent addition to the path, as they cut the path deposit [3] itself, although at exactly what stage in the process this modification occurred remains unclear. As both the path features and subsoil were directly overlain by topsoil [1], subsoil [2] must represent either an original surface garden soil contemporary with or earlier than the path (both later overlain by topsoil), or a significantly earlier deposit, originally considerably thicker or overlain by other deposits, which was exposed during reduction or cutting back of the slope and subsequent laying out of the path. If the existing topsoil and subsoil were contemporary, the path would not lie stratigraphically between the two deposits, and similarly the upper horizon of the subsoil and path must both have been exposed at the same time in order for topsoil [1] to accumulate above. Whether the path and possible landscaping were contemporary with the original layout of the gardens, or represent later activity is unclear due to the lack of datable material recovered from deposits. However, the survival of the flint path edging so near the surface suggests it was a more recent addition, and not contemporary with the original early 18th gardens.

Figure 9: View of the north end of Trench 1 showing path [3][4] with flint edging in plan, looking south down the slope (1m scale).

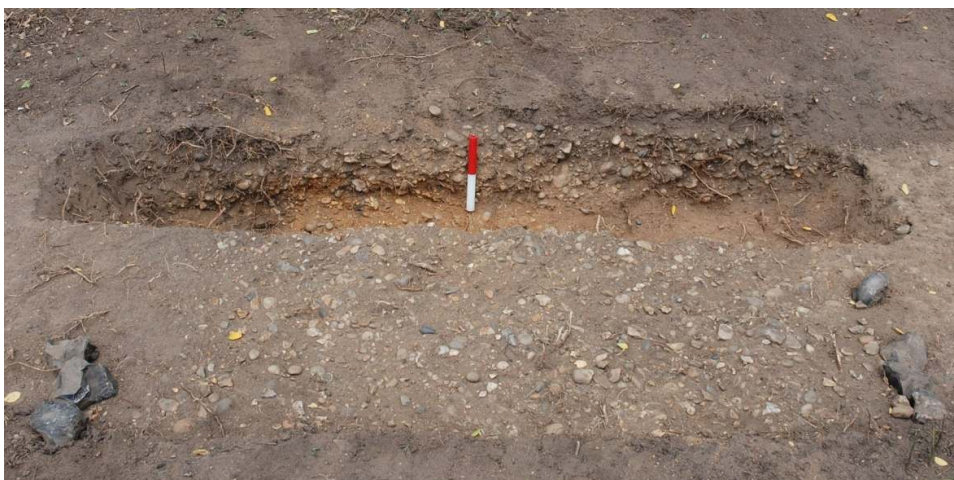
Figure 10: Detail of the initial slot through path [4] and associated fill [3] and bedding soils [6], looking east (0.2m scale) – subsequent excavation was recorded in section (Figure 11 below) to a depth of 1.25m below the existing ground surface.

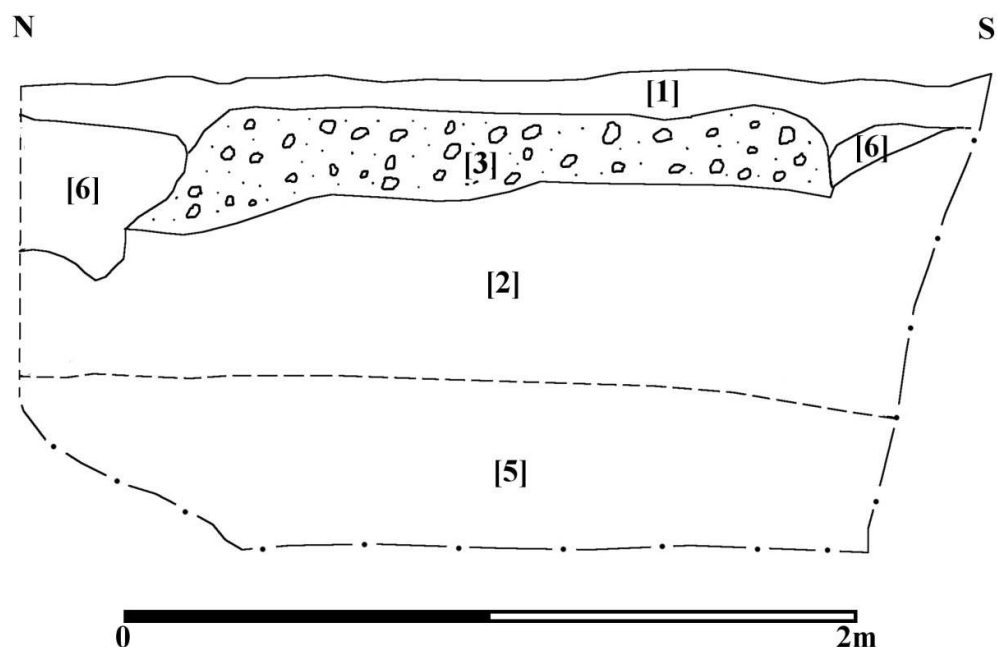
Figure 11: Section through path [4] and associated fill [3] and bedding soils [6], into natural gravels [5].

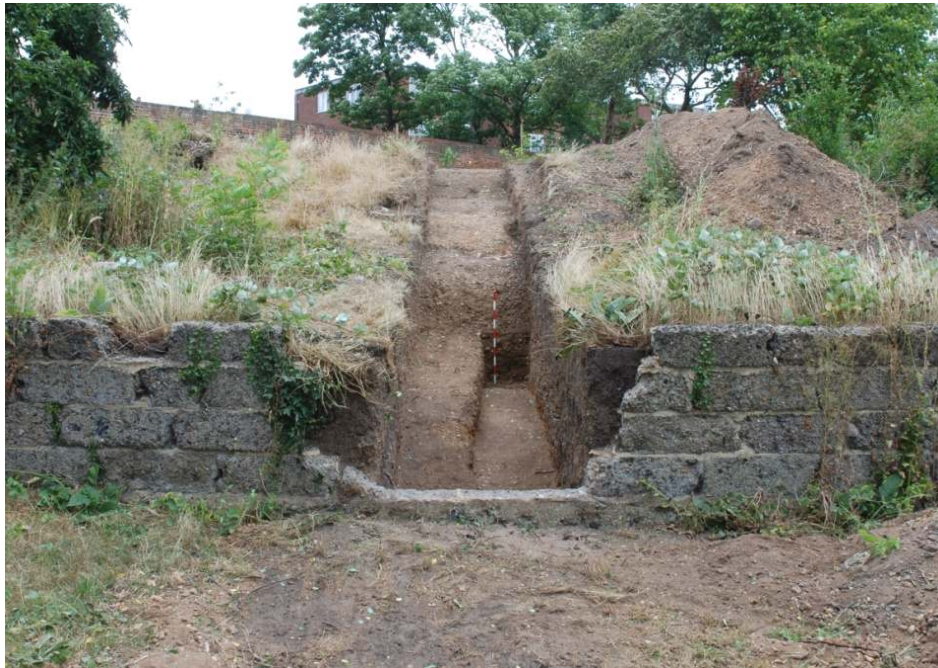
Figure 12: Trench 2 looking northeast up the existing bank (1m scale).

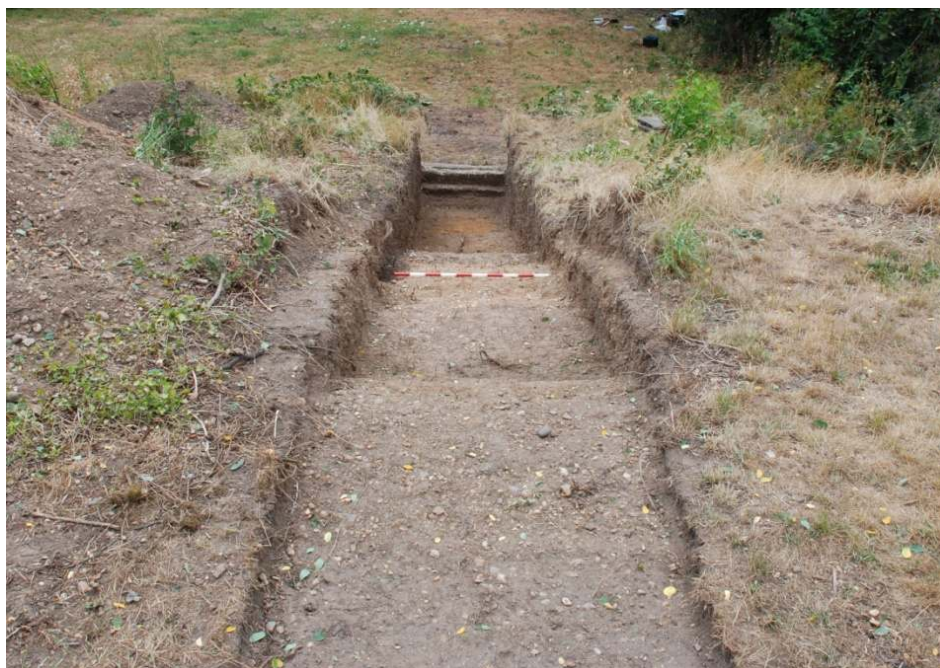
Figure 13: Trench 2 looking southwest down the existing bank (1m scale).

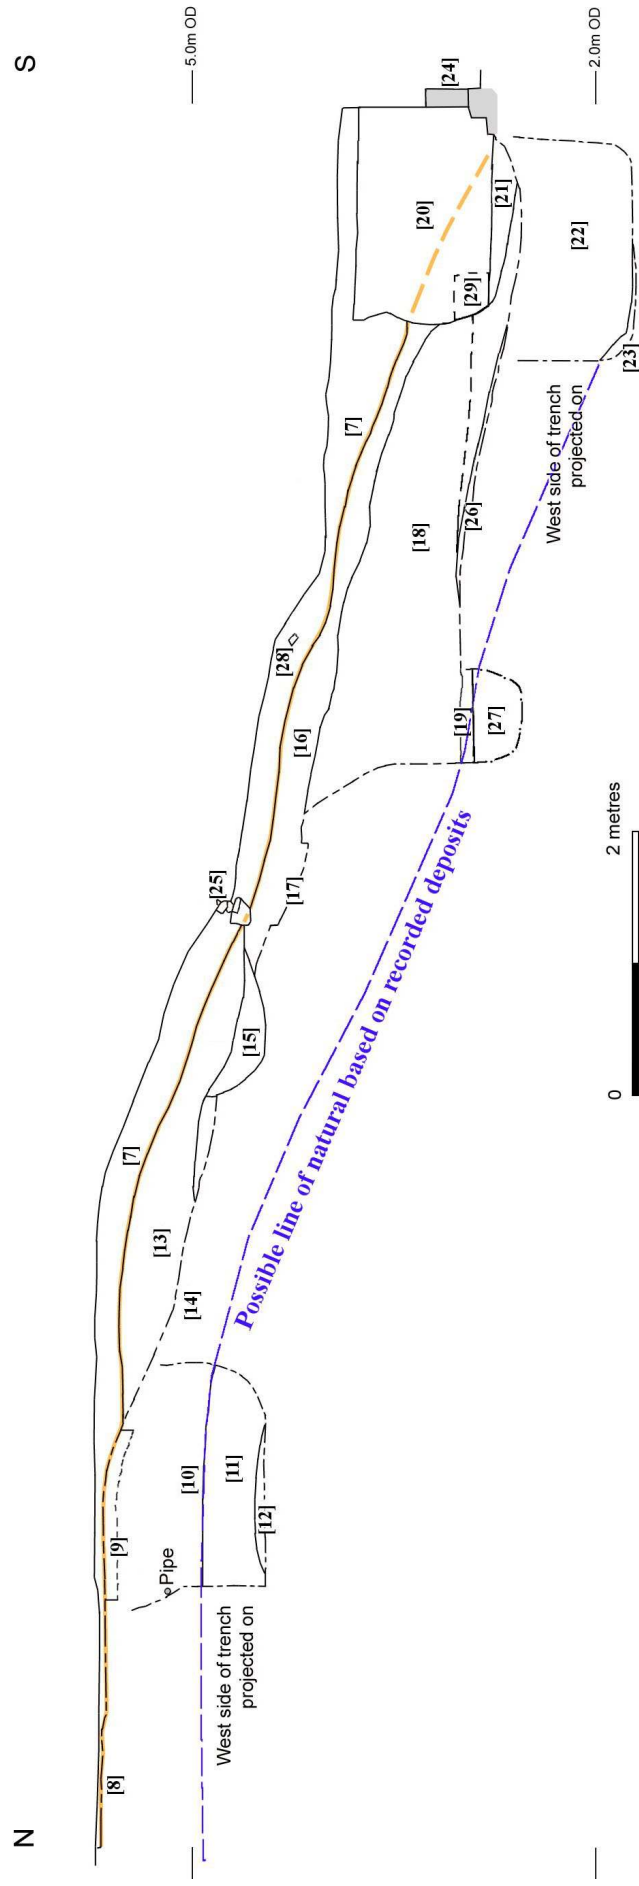
Figure 14: Section of Trench 2 (yellow line indicates line of slope prior to 20th century alterations).

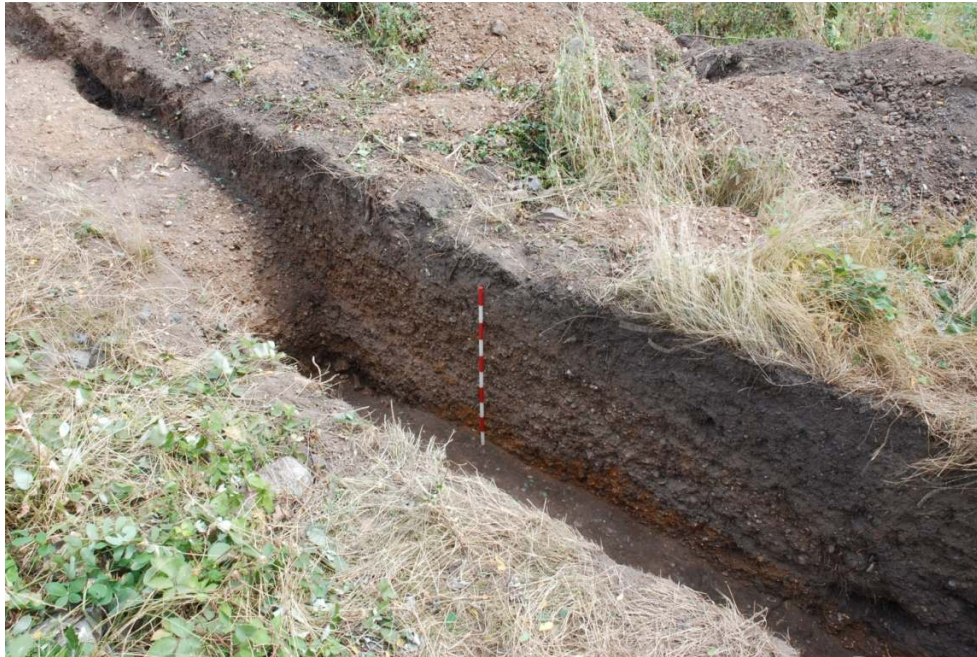
Figure 16: West facing section of Trench 2 showing bank construction deposits (1m scale).

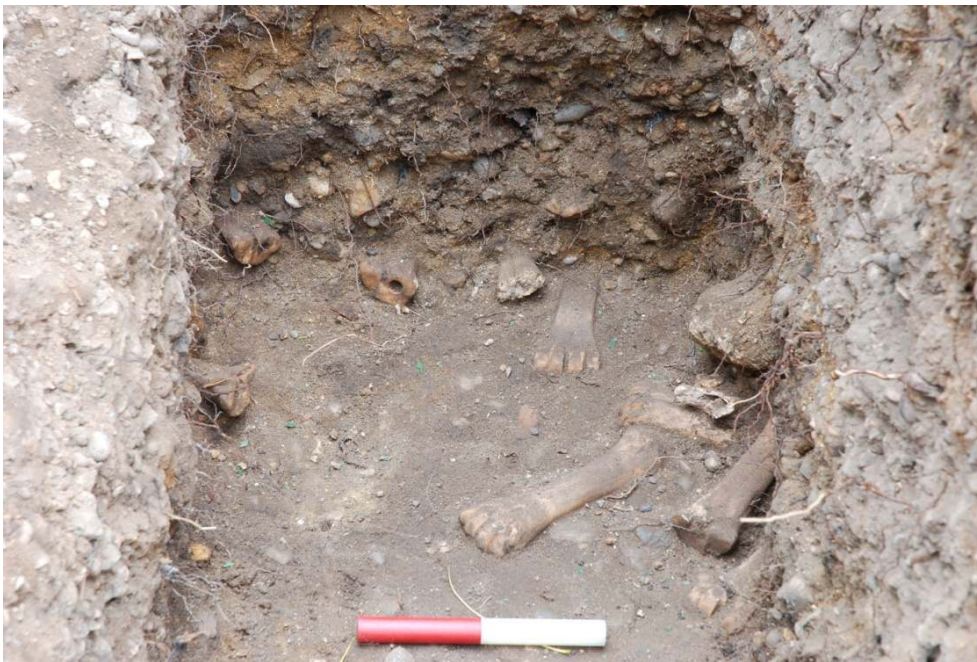
Figure 17: In-situ animal bones in deposit [19] (0.2m scale).

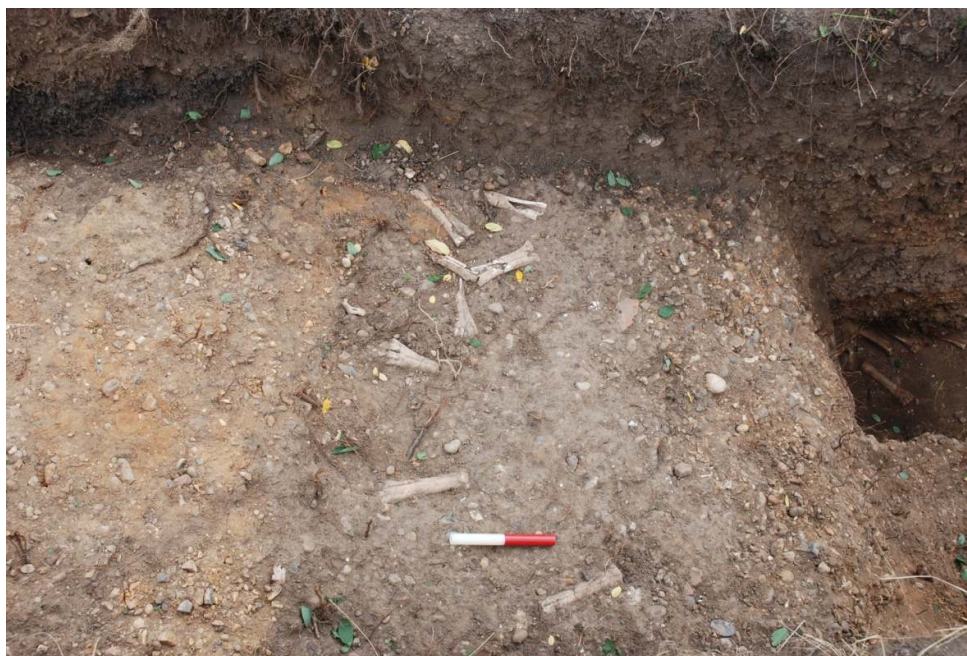
17	Concentration of animal bone with bored hole along length, in light-brown silty clay matrix with frequent pebbles.	Animal bone? Possible part of made-ground [16] and overlying [14]. Part of bank construction?
18	Compact gravels and silty sand beneath [16]. Single sherd of 15 th century pottery recovered.	Made-ground deposit beneath [16].
19	Concentration of animal bones with bored hole similar to [17], recorded below made-ground [18]. Two sherds of early-17 th pottery recovered.	Animal bone?
20	Mixed clay and silt fill behind wall [24].	Construction fill to level bank behind revetment wall [24]
21	Compact mid-brown silty sand beneath [20].	Buried surface/soil associated with chain link fence [29].
22	Dirty gravels and silty sand mixed deposits.	Made-ground deposit, probably associated with 18 th century bank construction, or earlier infilling (possibly gravel extraction).
23	Loose yellow-orange sandy gravel, similar to [12].	Natural sand and gravels (see discussion below for possible evidence of backfill deposits and gravel extraction).

Figure 18: In-situ animal bones in deposit [17] (0.2m scale).

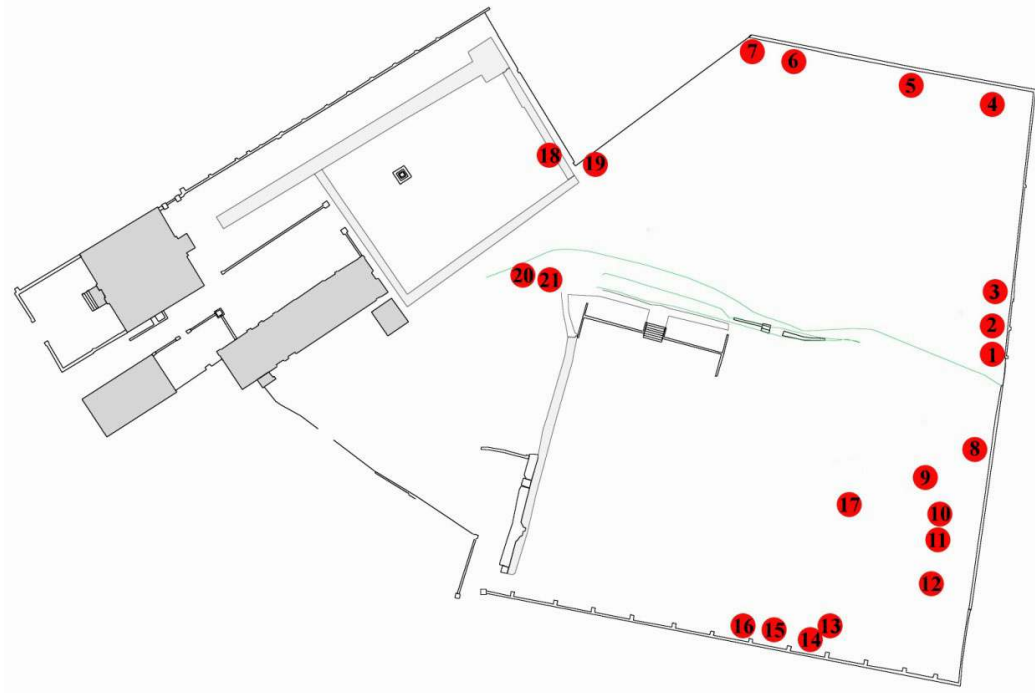
Figure 19: Tree pits locations in relation to a site plan based on an original survey drawing by Butler+Hegarty Architects (Drawing No: 0910506/SK300-3).

9.1 The archaeological watching involved the monitoring of 21 small pits excavated by contractors during a tree replanting scheme underway across the gardens. Of the 21 pits only one produced results of any significance, these are discussed in detail below (9.3: Pit 17). The remaining pits recorded simple sequences of topsoil overlying subsoil and natural gravel deposits. The dimensions and observations of all pits are recorded in the Table below (9.2), and the locations are shown on Figure 19 below.

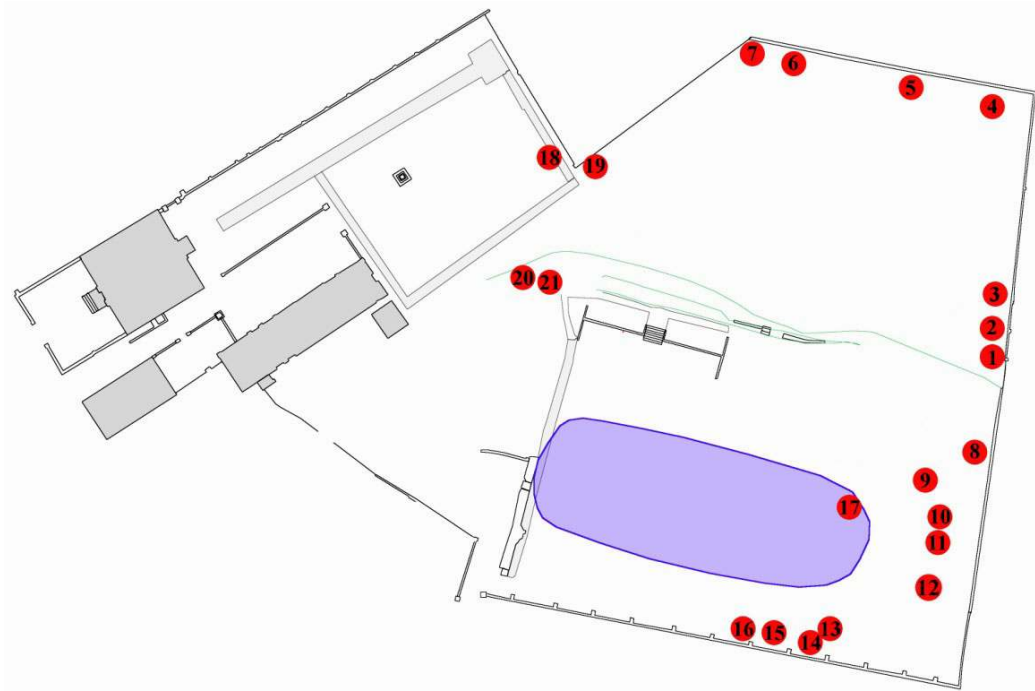
Pit 17 was excavated in the area of a former pond that is known to have existed on the site prior to the construction of Rainham Hall. Rainham rate books of 1716 record the presence of a ‘fishpond’ (Compass Archaeology: 2010) on the site, and a large pond is shown on cartographic sources until 1892, Figure 20 below shows the pit locations with the pond extracted from the Ordnance Survey map of 1892 overlaid in blue. It was presumably backfilled between 1892 and 1920 as there is no pond illustrated on the Ordnance Survey map of this date. The deposits recorded in the section of Pit 17 are listed below.

Figure 20: The location of the 18th century pond as shown on the Ordnance Survey map of 1892 in relation to the existing site.

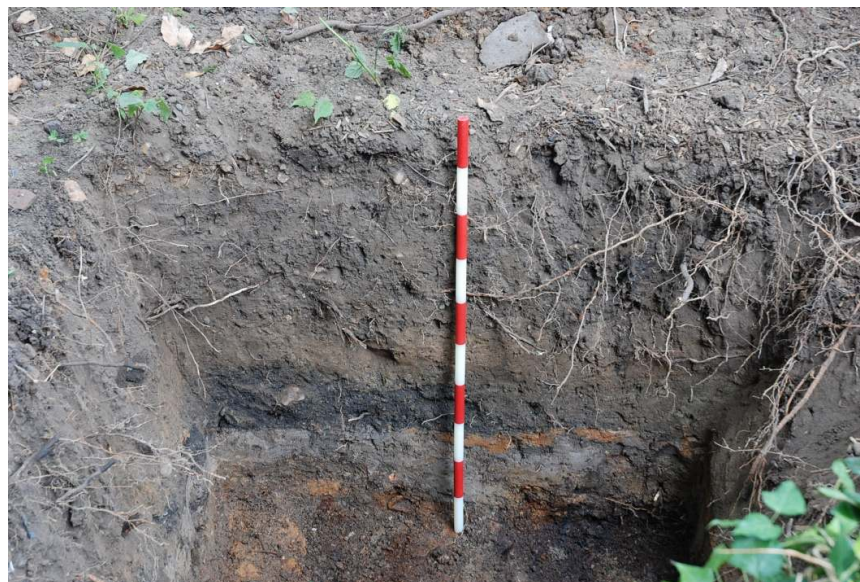
Figure 21: Tree pit 17 (1m scale)

The four deposits exposed at the base of Pit 17 [32] [33] [34] [35] are remnants of the pond known to have existed on the site from as early as the first part of the 18th century. However, pottery and glass recovered from context [35] are of comparatively recent date, *c.*1920s and later, and as such it is likely that these deposits reflect the later use of the feature or backfilling some time before 1939. Several sherds of recent porcelain and a small brown whisky glass were recovered, all of which can be reliably dated to the early 20th century.

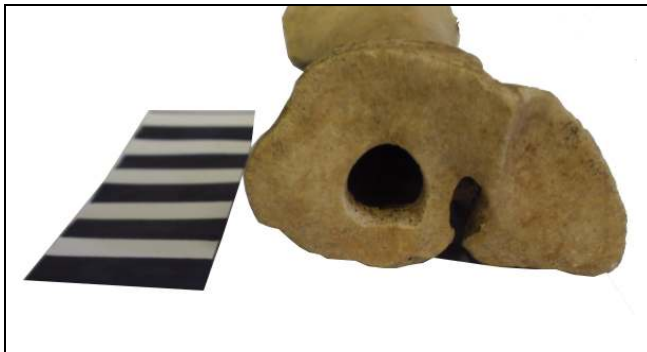
The assemblages from both contexts are very similar, both entirely composed of cattle metacarpals (Table 1). Each of the bones, where complete, feature a somewhat better level of preservation at the proximal compared to the distal end, the latter generally with a slight to moderate level of weathering/abrasion. It can be assumed from the relatively complete state of the broken bones as well as the lack of relevant butchery, that these bones were complete when originally deposited. The other major similarity is that each bone has been drilled through the medial half of the proximal end. Notably, 3 differently sized drill bits were used (Table 1).

Figure 1: Proximal end of bone with drilled hole
