THAMES WATER MAINS REPLACEMENT WORKS

DETAILED REPORT ON THE CHURCH OF ST BENET FINK,
THREADNEEDLE STREET, CITY OF LONDON, EC2

CITY OF LONDON INTERIM REPORT NO. 32: CROUCH HILL
60 (JUNE 2009 – APRIL 2010)

December 2010

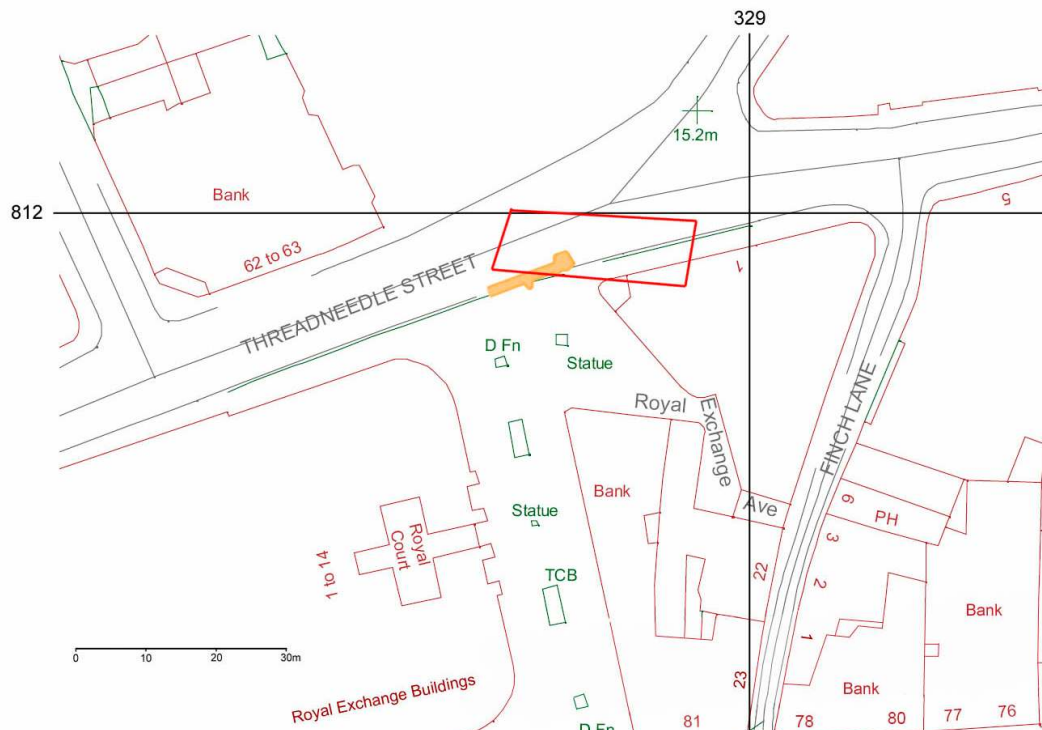
Fig. 12: Approximate location of pre-17th Century Church (taken from Leake's 1667 plan) and trench on modern OS Map.

It is possible that, together, wall-core (1), wall-core (6), and the limestone wall-facing (3), may have formed the southern wall of the church of St Benet Fink. This may have been part of the earliest church, before the 17th Century Wren rebuild, and possibly even before Robert Finke's 13th Century rebuild. When the approximate layout and location of the pre-17th Century Church (taken from Leake's 1676 plan) was overlaid onto the modern OS Plan and compared with the location of features within the trench, it would appear that this corresponds most closely with the southern wall of the pre-17th Century church of St Benet Fink. Care must, however, be taken with this conclusion as error may have occurred in this, both when undertaking the map regression, and in the compilation of Leake's 1667 Map.

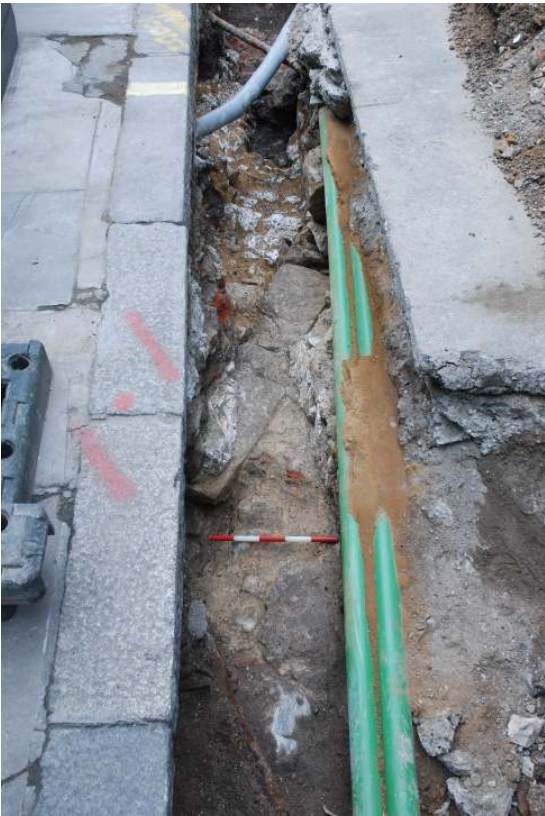
Fig. 13: View of wall (1) and (3) in the foreground, and context (6) looking west

4.1.1 The eastern wall-core (1) is part of the same construction as wall (3), with the large roughly cut ragstone fragments uncovered on the north side of wall-core (1) possibly forming the parallel edge to (3). This is because these fragments are located approximately 0.75m to the east of wall (3) and are on the same alignment. The limestone-facing of wall (3) was far more obvious than the fragments uncovered in wall-core (1), but it is possible that (1) was part of the internal wall line, and less obvious because of this.

Earlier Roman material was reused in the construction of this wall. A string of Roman tiles was uncovered beneath the limestone blocks of wall (3). Similarly, tiles with opus signinum adhered to their faces were uncovered in wall-core (1). The reuse of such Roman material suggests an early, possibly pre-Norman, date for the construction of this part of the church.

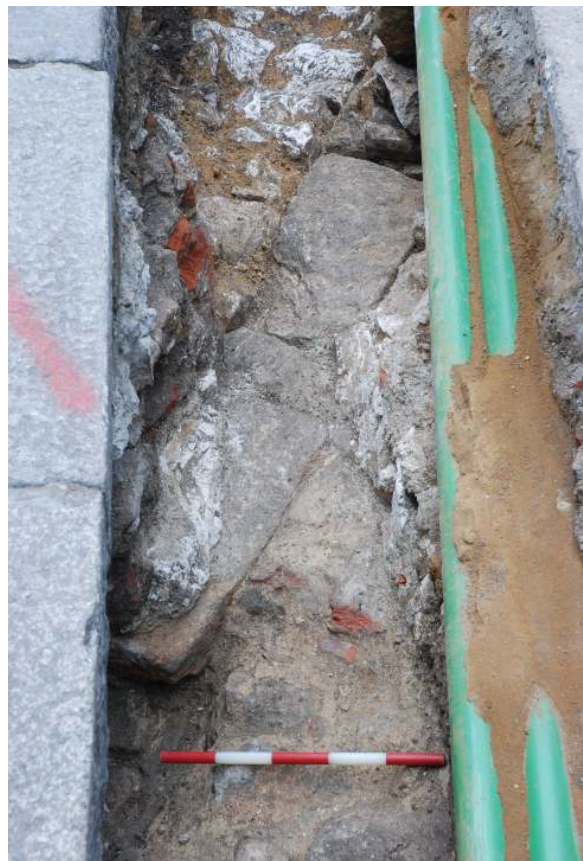
Fig. 14: Close-up view of wall-facing (3) and context (6) looking west

subtly different to the wall-core (1) which forms the rest of the interior of this wall. It consists of large chalk blocks in a concreted grey-cream lime mortar, in contrast with wall-core (1), which consists of stone rubble within a yellow mortar. This does not, however, necessarily suggest that it was part of a different phase of construction of the wall. It is possible, instead, that slightly different building materials or methods were used in the construction of the same wall at the same time.

Both wall-core (1) and (6), however, are distinctly different from that on the western side of the limestone wall-facing (3) (context 10). This consists of large chalk blocks set within a coarse yellow sandy mortar. This suggests that wall-core (10) is of a different construction phase to wall-core (1) and (6). Moreover, (10) abuts what must have been the originally exposed southern face of the limestone blocks (3).

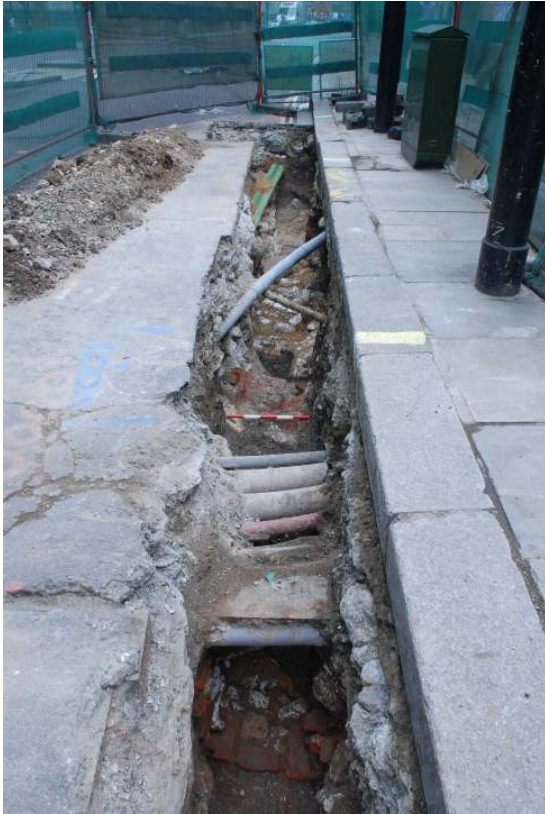
Fig. 15: View showing contexts 17-20 (foreground) and 10, looking east along trench

- 4.1.3** A small red brick wall facing was uncovered at the western end of the trench, at least 5 courses deep, and running north-south across the trench (context 19). Directly to the east of this, and associated with it, is a patch of chalk and brick rubble, set within a loose sandy mortar (context 17). This abuts context 18.

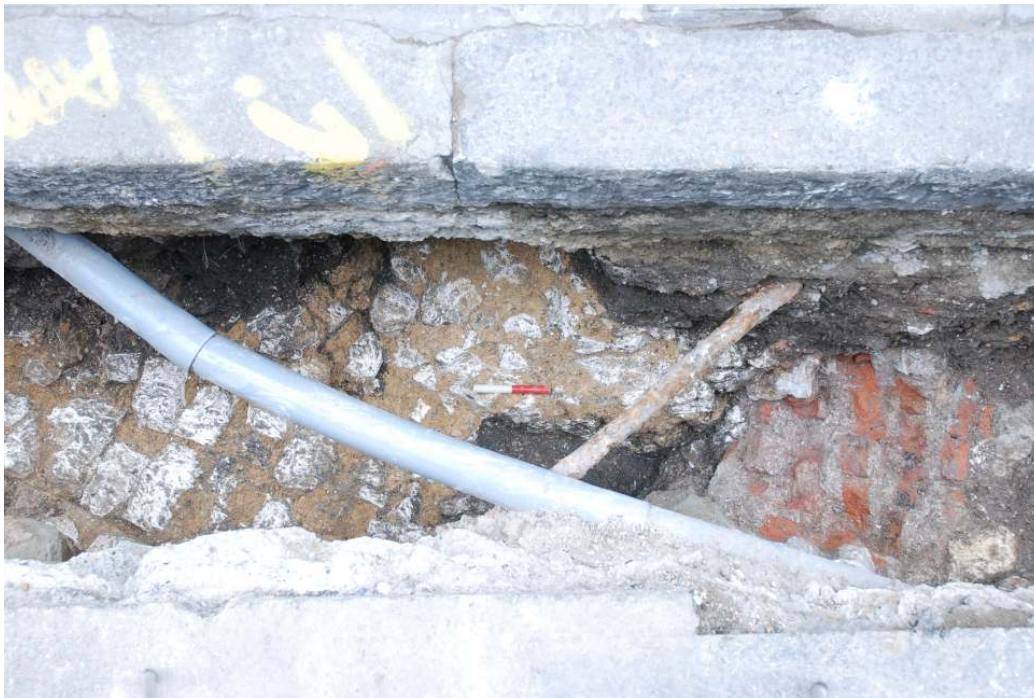
Fig. 16: View of context 10, showing it being truncated by brick-drain (context 14)

4.1.2 Wall-core (10) consists of chalk blocks set within a coarse yellow sandy mortar. A layer of crushed chalk (9) was recorded overlying this.

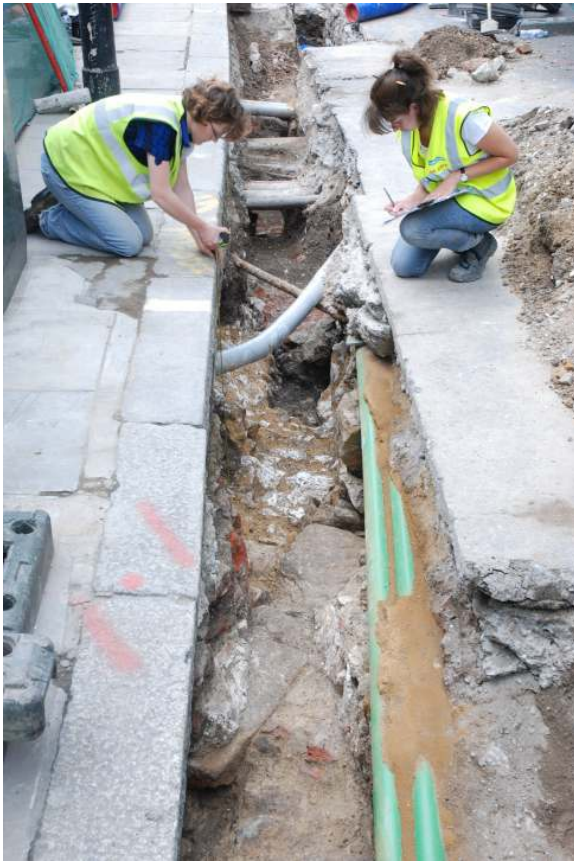
Fig. 17: View showing difference between contexts 1 (foreground) and 10

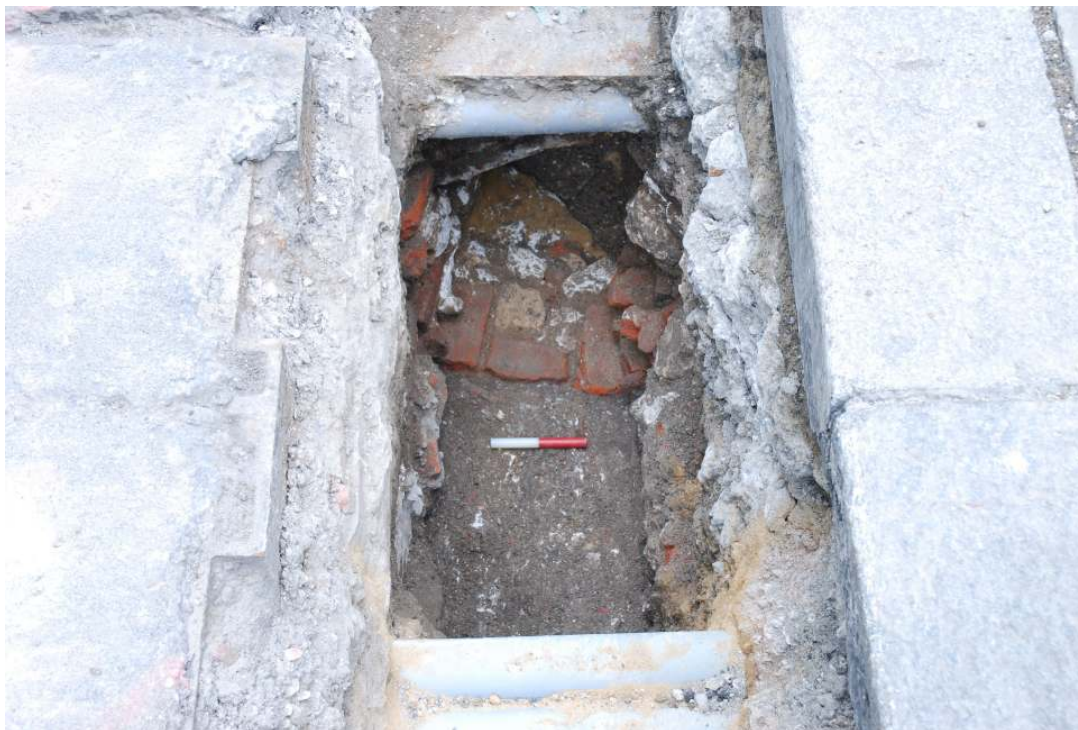
Fig. 19: View of brick wall (19) looking east

It is probable that this wall (19) and associated chalk and rubble patch (17) is later in date than context 18, thought to have been part of the pre-17th Century extension of the southern wall of the church of St Benet Fink. Context 17 and 19 may therefore have been constructed after the destruction of the pre-17th Century Church in the 1666 Great Fire, as otherwise would have been located within the church or crossing the southern wall on an unexpected alignment.

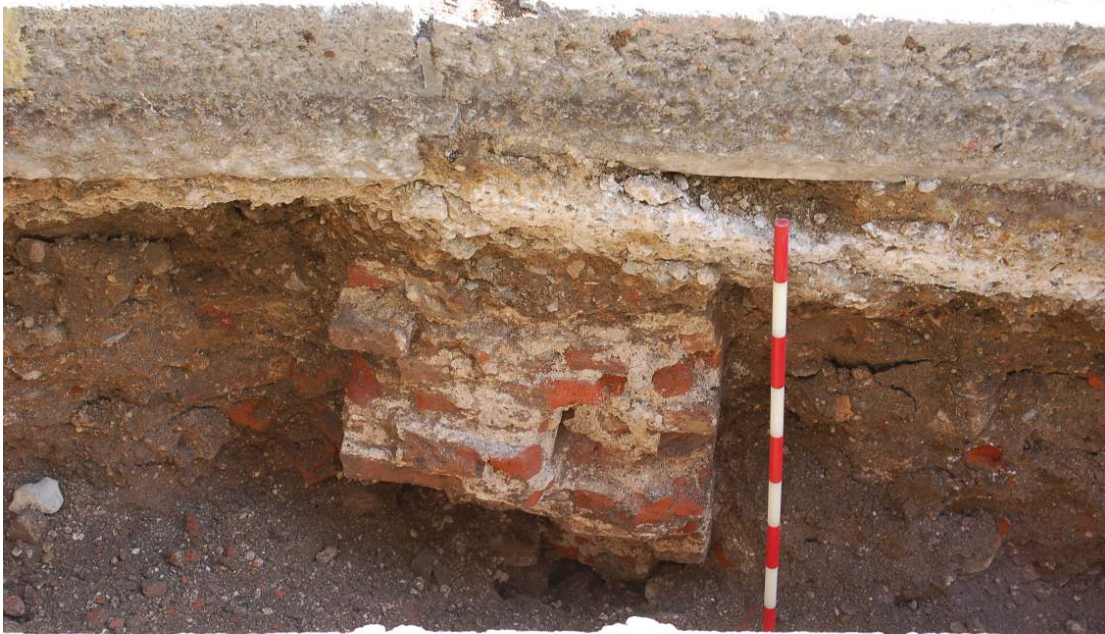
Fig. 21: Photo of wall in trench 2

4.2.1 Another trench was recorded to the west of trench 1, on the southern side of Threadneedle Street and just to the north-west of the Royal Exchange and opposite the Bank of England. This uncovered a red-orange brick wall set within an off-white lime-sand mortar, running north-south at a slightly oblique angle to the western front of the Royal Exchange, uncovered approximately 0.62m below the pavement. This wall measured approximately 0.88m wide and 1.09m deep, although the base was not exposed during excavation. It consisted of at least 15 courses.

4.2.2 The structure is likely to be part of a basement/external wall. Examination of brick samples by a specialist (John Brown) suggest that they consisted of fabric 3034, and date from the late-17th to mid-18th Century. Contemporary map evidence (fig. 22) indicates that the associated structure was part of the block adjacent to the Sun Fire Insurance offices and immediately to the west of the old Royal Exchange.

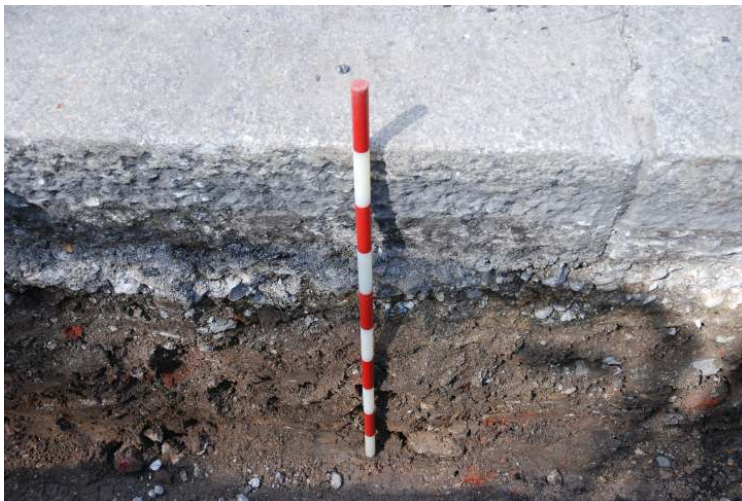
Fig. 23: View of Threadneedle Street trench (made-ground deposits under road-surface)

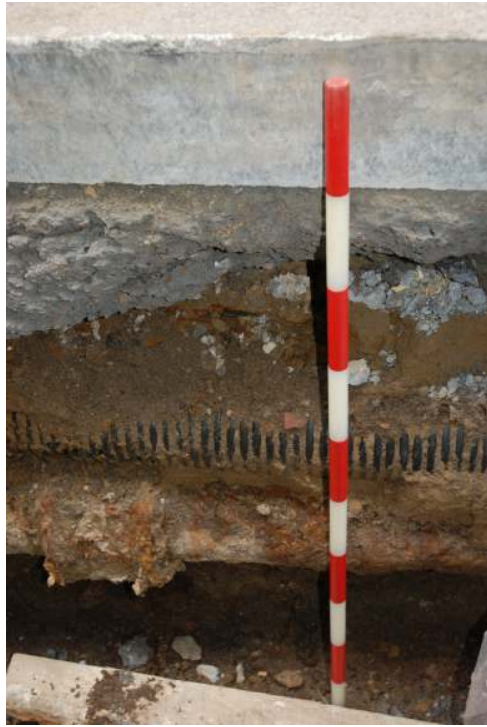
Fig. 24: View of Throgmorton Street trench (made-ground deposits cut by services under road-surface)

14m of trenching was observed on the north side of Throgmorton Street, running east-west opposite No.29 Throgmorton Street. The trench measured an average of 0.62m in width and was excavated to a depth of 0.7 – 1.2m below the existing road surface. Paving bricks and a concrete hardcore was exposed, overlying dark-brown sandy made-ground deposits, with frequent gravel and ceramic building material inclusions, and being cut by sandy yellow service-backfills. No archaeological finds or features were observed.

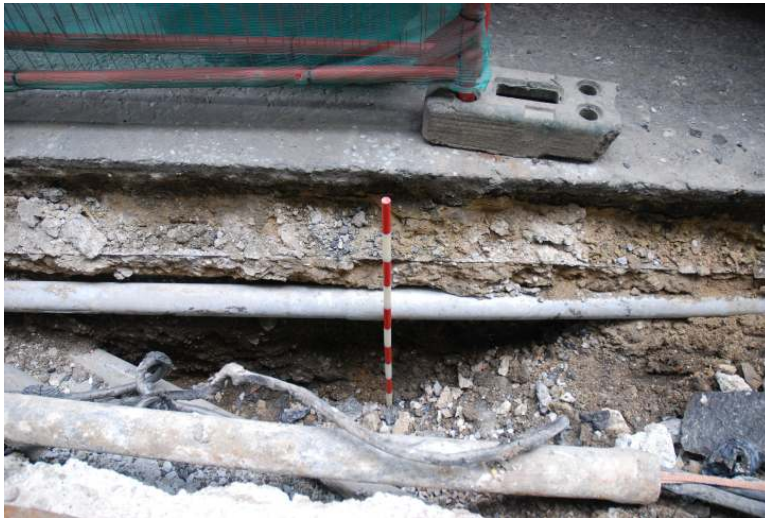
Fig. 25: View of Austin Friars trench (made-ground deposits cut by services under road-surface)

Approximately 8m of trenching was observed on the west side of Austin Friars, running north-south outside No.27 and No.28. The trench measured an average of 0.8m in width and was excavated to a depth of 1.2m below the existing road surface. Tarmac and existing hardcore was exposed, overlying grey-brown made-ground deposits, with frequent gravel inclusions and having been cut by services. No archaeological finds or features were observed.

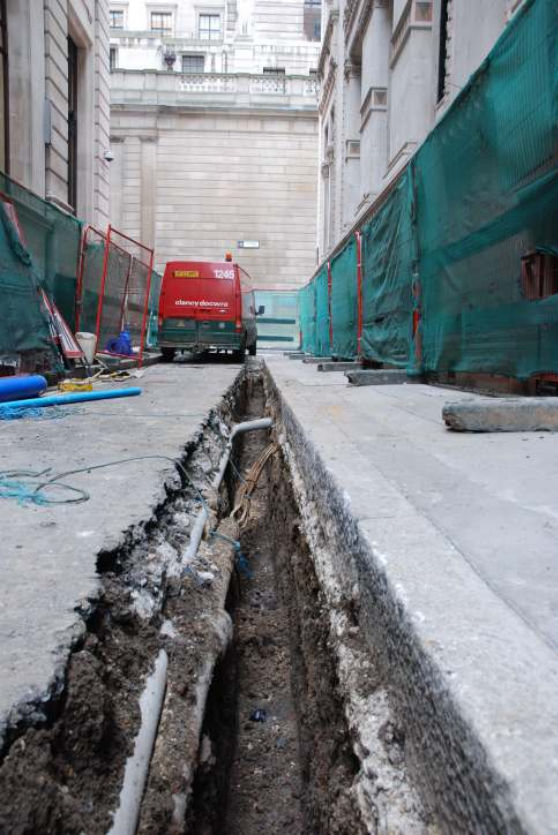
Fig. 26: View of Token House Yard trench, looking towards the Bank of England

20m of trenching was observed on the west side of Token House Yard. The trench measured an average of 4m in width and was excavated to a depth of 0.8 - 1m below the existing road surface. Tarmac and existing hardcore was exposed, overlying silty made-ground deposits, with gravel and ceramic building material inclusions, and having been cut by services. No archaeological finds or features were observed.
