THAMES WATER MAINS REPLACEMENT

**In the vicinity of Edgware Road, Aberdeen Place and Lyons Place
(DMA Shoot Up Hill 34)**

AN ARCHAEOLOGICAL WATCHING BRIEF

THAMES WATER MAINS REPLACEMENT
VICINITY OF EDGWARE ROAD, ABERDEEN PLACE AND LYONS
PLACE (DMA SHOOT UP HILL 34)
CITY OF WESTMINSTER, NW8
AN ARCHAEOLOGICAL WATCHING BRIEF

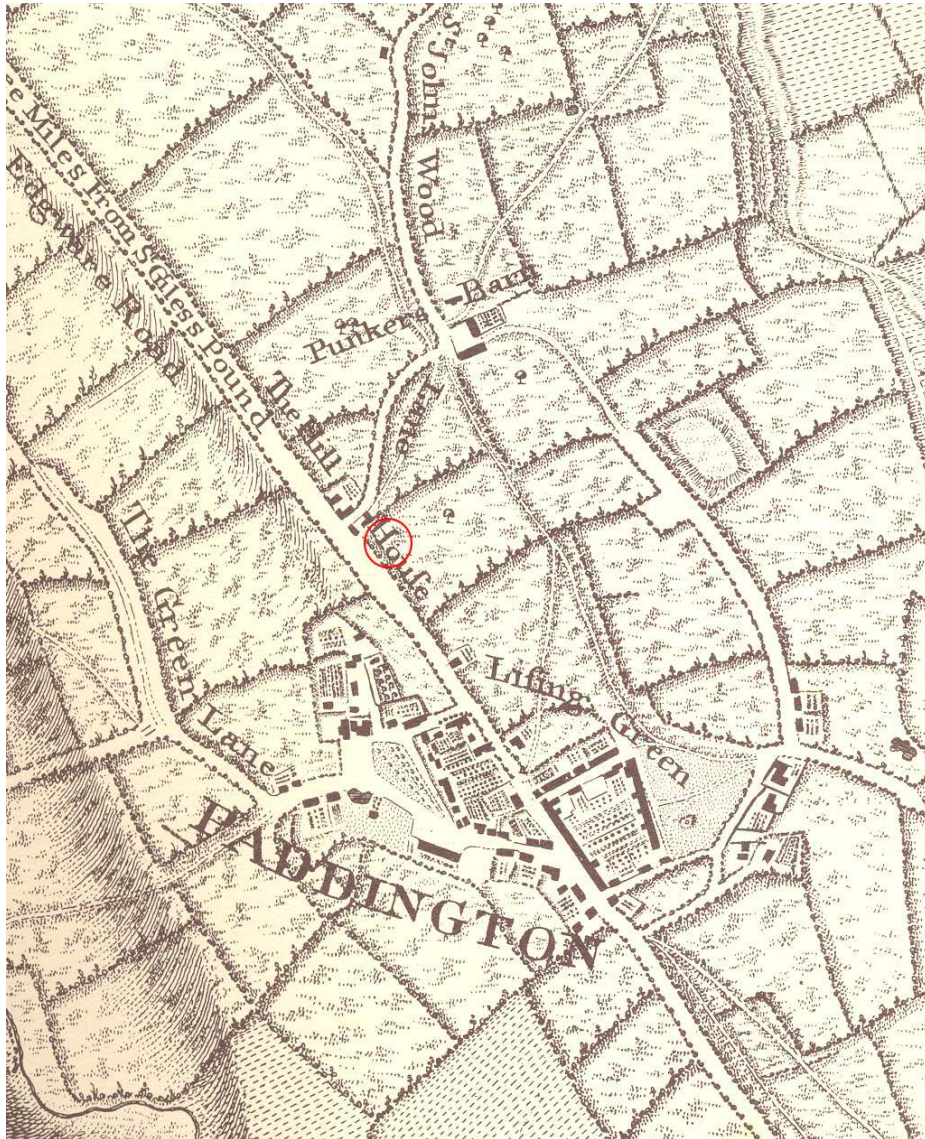
Fig. 2 – Extract from John Rocque's, *A Plan of the Cities of London, Westminster, and the country ten miles round*, 1746

This extract shows the line of Edgware Road. 'Lifing Green', 'Paddington', and 'St John's Wood' are also depicted. The area of the DMA appears to lie in open land – presumably pasture – just to the east of Edgware Road. Some houses, including 'The Hill House', are also depicted in the vicinity of the DMA.

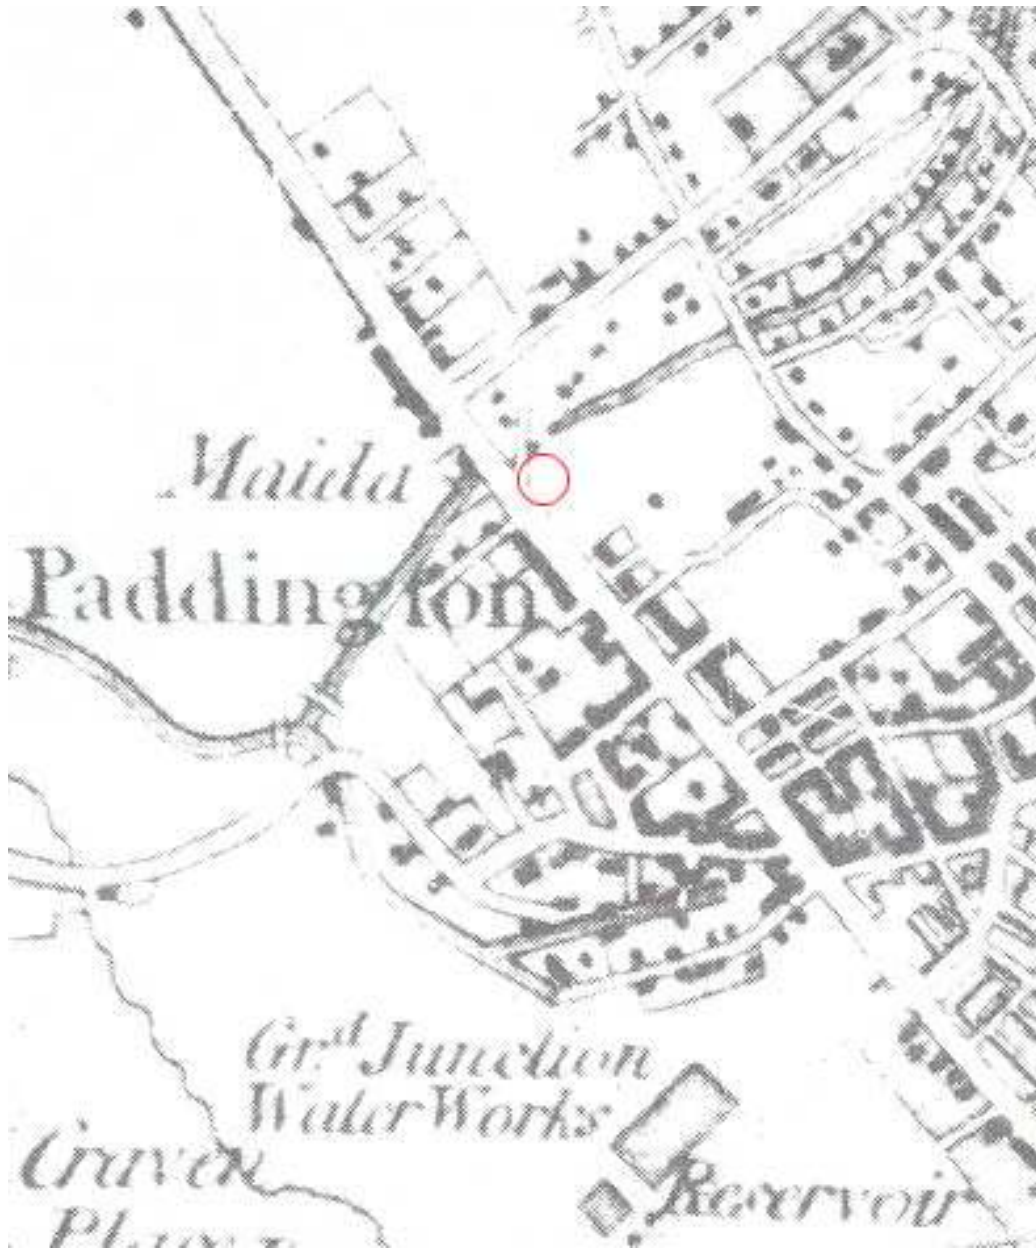
Fig. 3 – Extract from the Ordnance Survey (2inch:1mile) Plan, 1822

This extract shows the line of Edgware Road, and far greater development around the area of the DMA. The settlement at Paddington has grown substantially, and spread to the north along the line of Edgware Road towards the DMA. Furthermore, the Regent's Canal is depicted running east-west across the DMA.

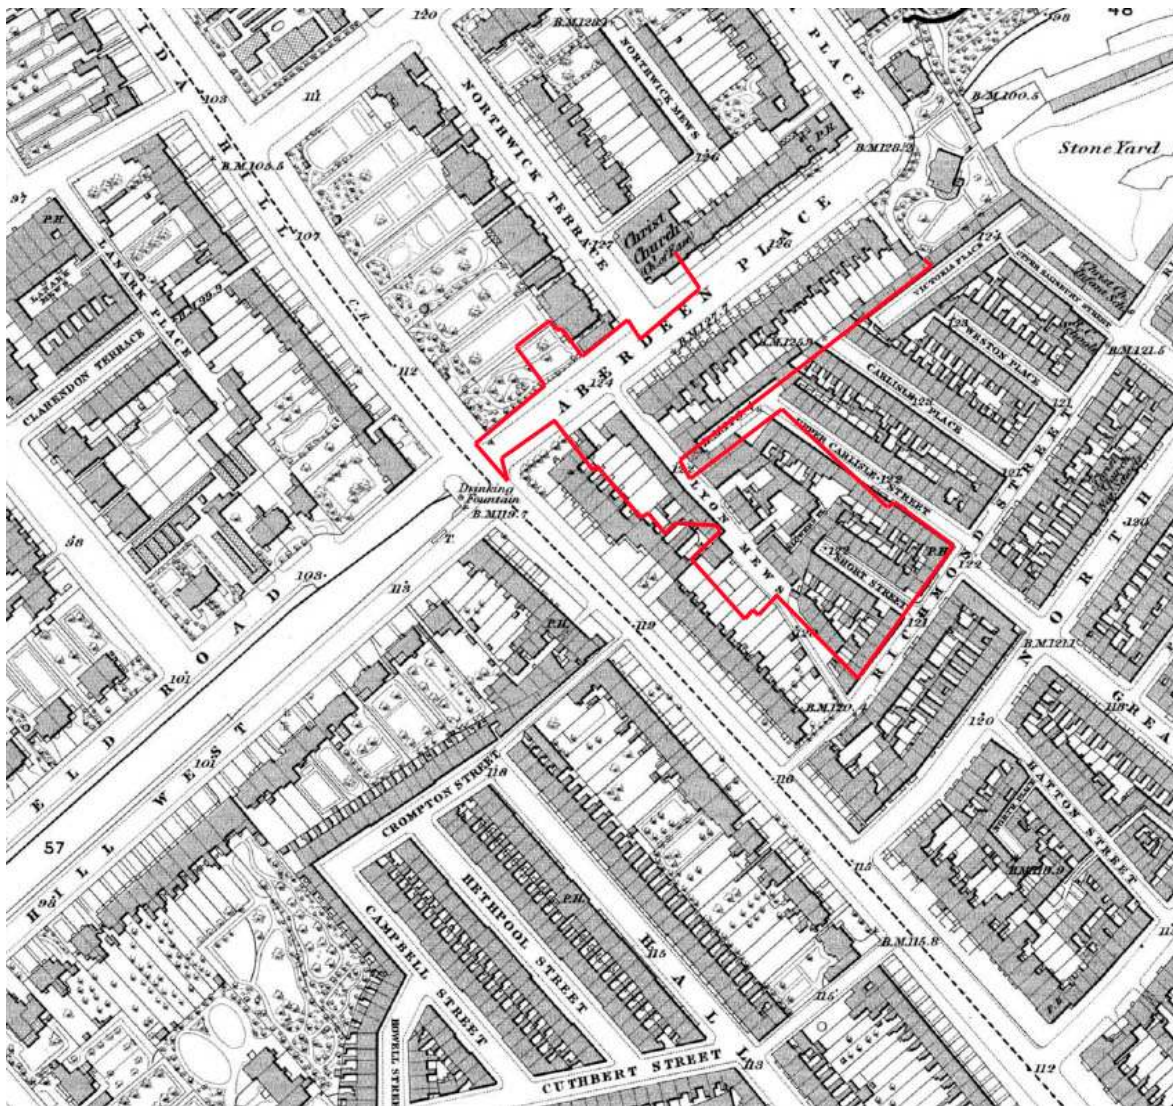
Fig. 4 – Extract from the First Edition 25inch Ordnance Survey Map, surveyed 1872

This extract shows the DMA in a broadly similar way to how it is today, though with Lyons Place (called Lyon Mews here) forming a narrower and less regular route. Residential development is depicted around the whole DMA. The main roads – Edgware Road and Aberdeen Place - are also depicted, along with the Regent's Canal to the west of the DMA. The Canal, at this date, had been enclosed and ran underneath the DMA, as it does today.

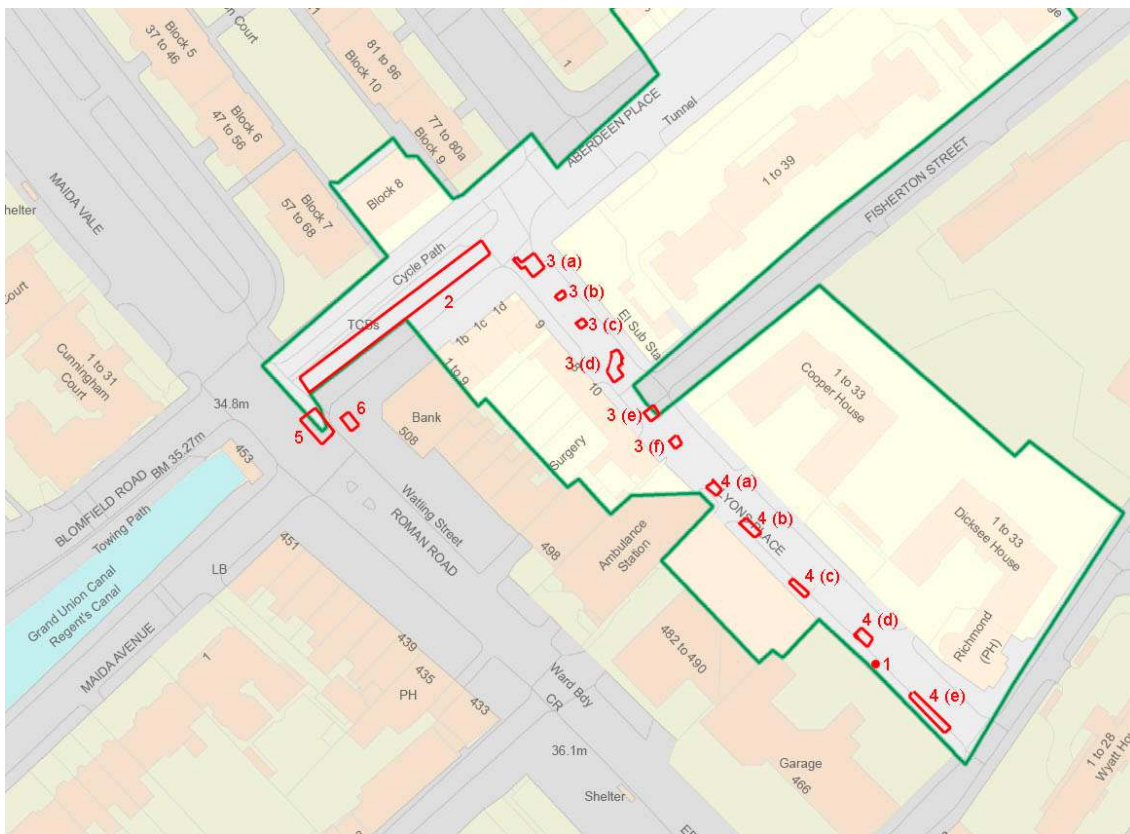
Fig. 5 – Location of trenches monitored during the watching brief

The archaeological watching brief was undertaken during contractors' groundworks along Lyons Place, the western part of Aberdeen Place, and the eastern part of Edgware Road adjacent to Aberdeen Place. The groundworks took place as part of a Thames Water Utilities Ltd scheme of Victorian water mains replacement. Contractor methods included open cut trenching, directional drilling, pipe-bursting and insertion. Archaeological monitoring was undertaken on areas of open-cut trenching, trial pits and in launch pit areas, access pits and exit points of other methods. Approximately 100m of trenching was observed within the study area. The results of the archaeological watching brief are listed below, and are discussed in the order in which they were monitored.

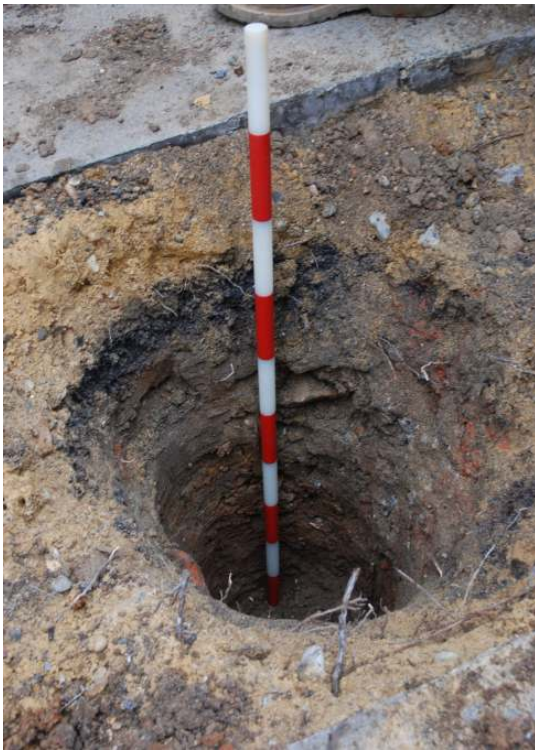
- 8.1** One small trial-pit, near the southern end of Lyons Place (labelled 1), was observed. This measured approximately 0.5m in diameter, and c.0.9m in depth. It revealed a modern road-surface – concrete paving slabs in a sand bedding (c.0.15m) overlying a tarmac and crushed red brick make-up layer (c.0.14m). This overlay a mixed sandy light yellow-brown deposit with brick, tile and pebble inclusions, including blue transfer printed pottery fragments. This may have been demolition rubble following levelling or clearance after bomb damage during World War II. No significant archaeological finds or features were uncovered.

Fig. 6 – Photo of trial-pit at southern end of Lyons Place (1), showing modern road-surface over light sandy mixed deposit

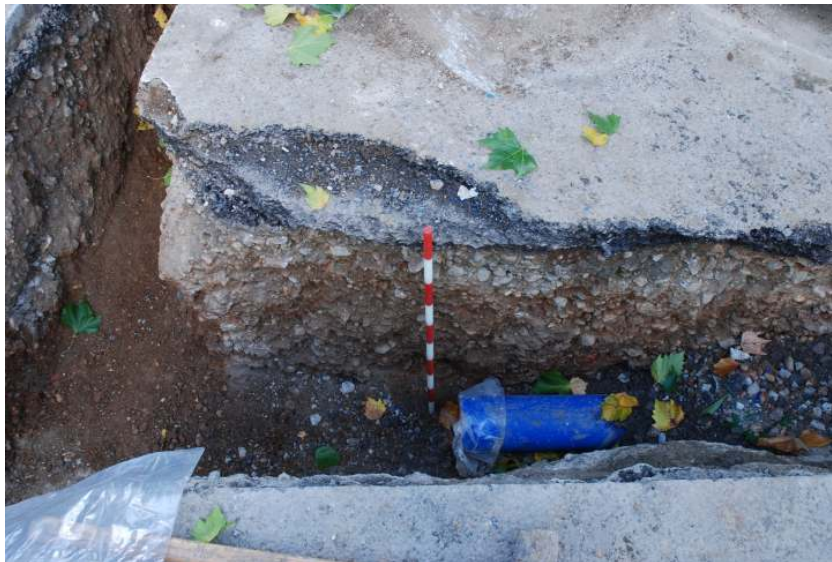
8.2 A long trench was monitored on Aberdeen Place (labelled 2), which ran along the southern carriageway of Aberdeen Place from Edgware Road to the junction with Lyons Place. This measured approximately 47.6m in length, by 0.57m in width, and to a depth of *c.*1.2m. This revealed a modern road-surface (tarmac over concrete), over gravel subsoil. The trench followed the line of the old water pipe, so archaeological deposits had been removed, and mixed service backfills were observed throughout. No archaeological finds or features were uncovered. Reference to the general site map shows that any archaeological deposits here would already have been removed by the cutting for the enclosed section of the Regents Canal.

Fig. 7 – Photo of trench on Aberdeen Place (2), showing modern road-surface over gravelly subsoil

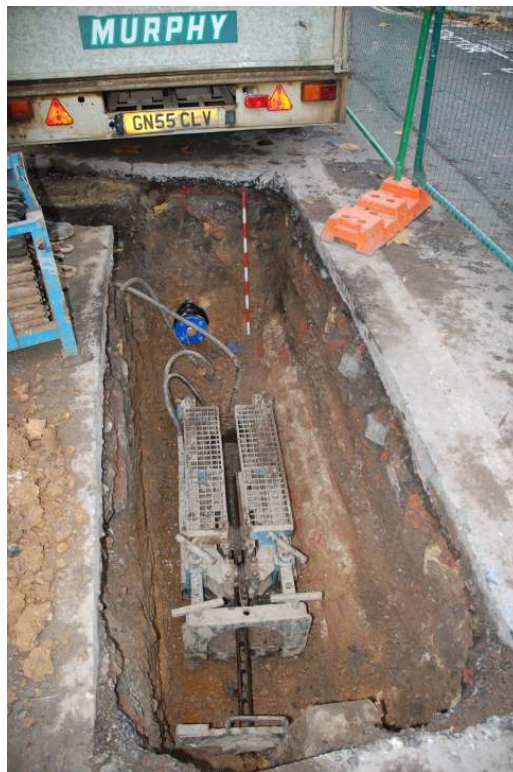
- 8.3** Six small launch pits (labelled 3a-3f) used for pipe-bursting were observed in the northern part of Lyons Place. One of these, the most northern at the junction with Aberdeen Place (labelled 3a), was recorded in detail. This measured approximately 8m in length, 1m in width, and 1.2m in depth. This revealed a modern road-surface, over very disturbed subsoil, over natural clay, recorded at *c.*0.7m. A brick barrel-vault ran north-south along the line of the trench, and probably represents part of a sewer or drain which may have discharged into the canal immediately to the north. The brickwork was uncovered approximately 1m beneath the modern road-surface, and approximately 3m from the western kerb.

Fig. 8 – Photo of pit at northern end of Lyons Place (3a), showing modern road-surface over part of a sewer

Part of a north-south brick vaulted drain/sewer, of probable early 19th Century date, was exposed at the northern end of Lyons Place. At the southern end of Lyons Place a single course of 19th Century brickwork was recorded – this appeared to form part of an east-west line, though the brick themselves may have been reused here in a later foundation.

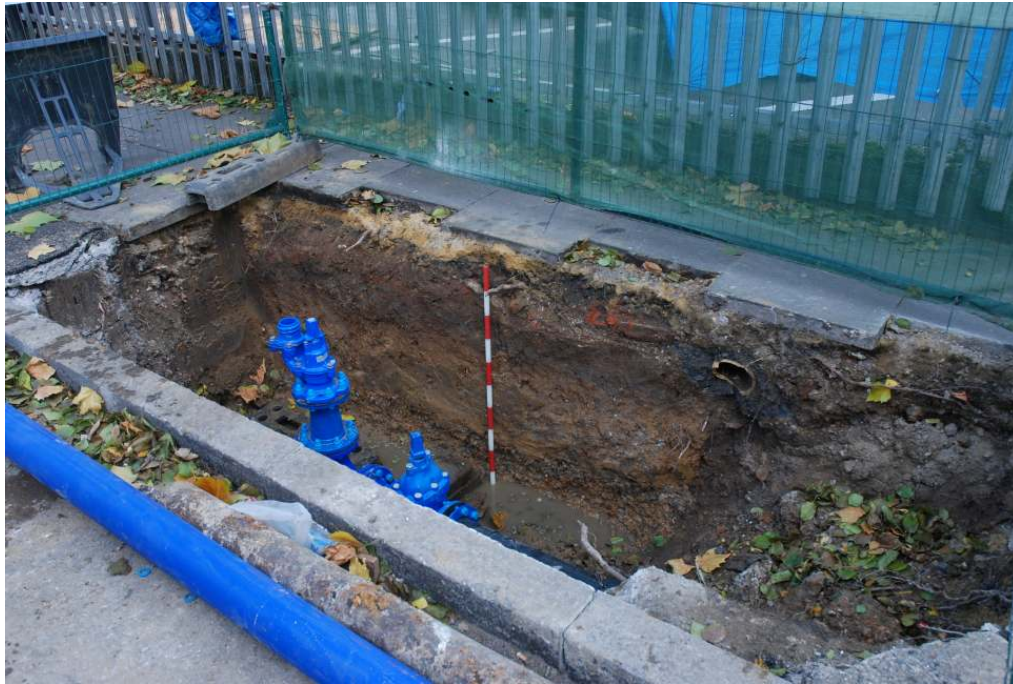
- 8.4** Another five pits were observed in the southern part of Lyons Place (labelled 4a-4e), up to the junction with Orchardson Street. The southern-most of these, at the junction with Orchardson Street (labelled 4e), was recorded. This measured 3.6m by 1.35m, and was 1.08m in depth. This revealed a modern road-surface (paving slabs over a sand bedding, *c.*0.14m), overlying a shallow soil profile for 0.31m (consisting of a black layer, a mid-brown silty-sand layer, and a layer of crushed brick rubble and mortar). A reworked layer of clay was observed at 0.45m beneath the ground-surface, overlying the natural yellow-brown clay. This overlay gravels, at 0.86m beneath the ground-surface. A couple of bricks were observed just beneath the modern road-surface. These were apparently part of a single course on an east-west line (*c.*0.35m wide) that ran back from the western edge of excavation, and which

may have formed the base for a small building. The bricks were identified by a brick specialist (John Brown – see appendix III) as part of the fabric-type 3046, and were unfrogged with sunken margins. They were set within a yellow-grey lime/sand mortar, with occasional lime and charcoal inclusions. They were dated to approximately 1600-1700. It seems likely that these bricks were re-used in a later structure, and that this is what was uncovered in the trench.

Fig. 9 – Photo of pit at southern end of Lyons Place (4e), looking south-west and showing modern road-surface over shallow soil horizon, over reworked clay, natural clay, and natural gravels. The single course of 17th Century brick noted above is visible just below the modern made-ground and about 0.4m to the right of the 1m scale.

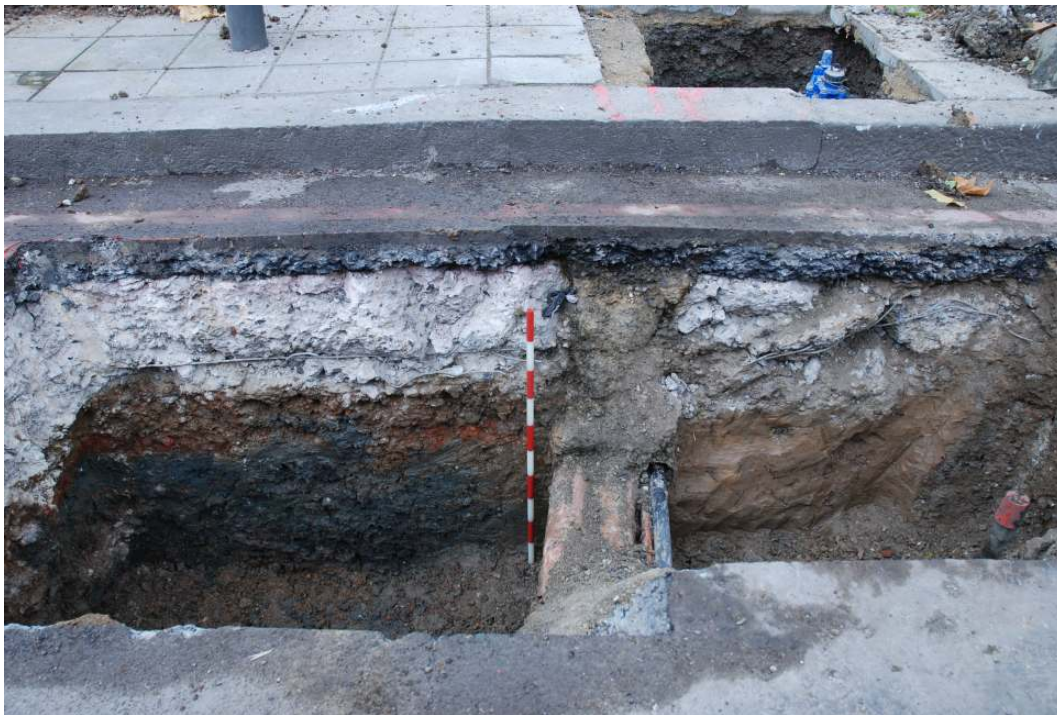
- 8.5** A pit was observed on Edgware Road, at the junction with Aberdeen Place (labelled 5). This was in the roadway on the eastern side, and measured 3.1m by 1.21m, and was 1m deep. A road-surface consisting of tarmac over an earlier tarmac surface (c.0.14m), over concrete and reinforced concrete (0.39m thick) was uncovered. The northern half of this pit was slightly disturbed by service fills, but mainly consisted of crushed brick overlying mixed blue-grey gravelly-clay, from c.1m beneath the ground-surface. This may have been the fill within the cut for the canal, especially as its alignment fits with the basin of the Regent's Canal to the west. This was distinctly different from the southern end of the pit, which consisted of 'natural' mid-brown compact clay, from 0.65m beneath the ground-surface, thereby highlighting the difference with the probable canal cut.

Fig. 10 – Photo of trench on Edgware Road (5), looking east and showing an obvious difference between the canal ‘cut’ in the northern part of the trench, and natural clay in the southern part

The cut for the Regents Canal, created 1812-1820, was observed in a trench in Edgware Road. The fill was a blue-grey gravelly-clay, in direct contrast to the yellow-brown natural clay found in the southern part of this trench, i.e. the part which was not in the Regent's Canal.

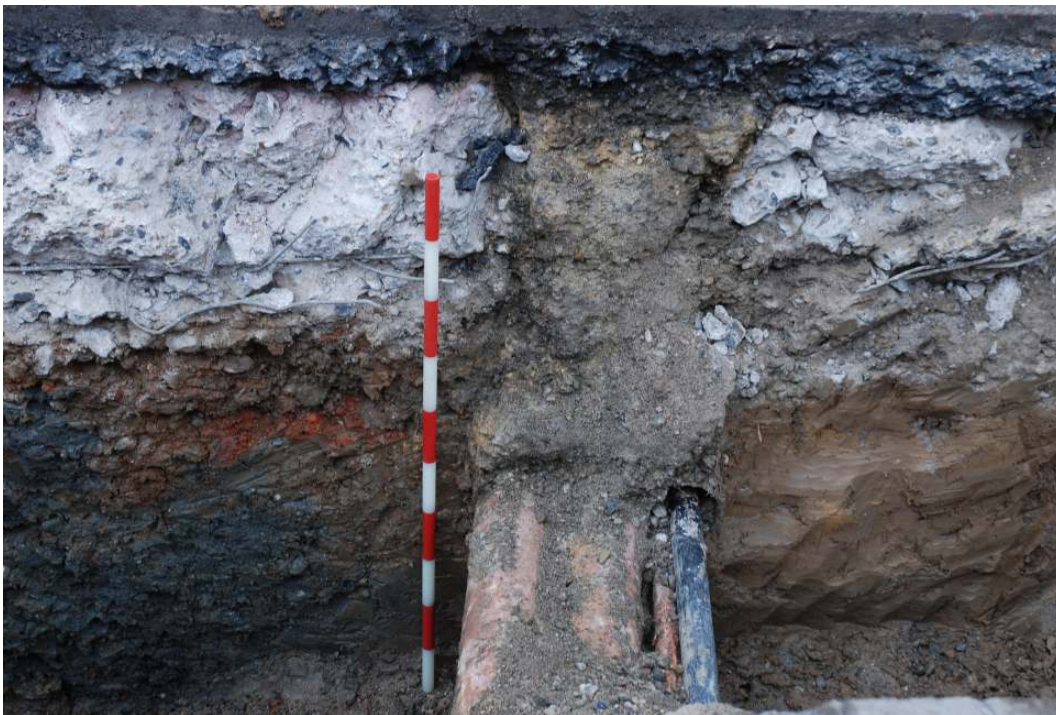
Fig. 11 – Close-up photo of trench on Edgware Road (5), showing an obvious difference between the canal ‘cut’ in the northern part of the trench, and natural clay in the southern part. The actual line of the cut – just to the south of the 1m scale – is largely obscured by later east-west service trenching.

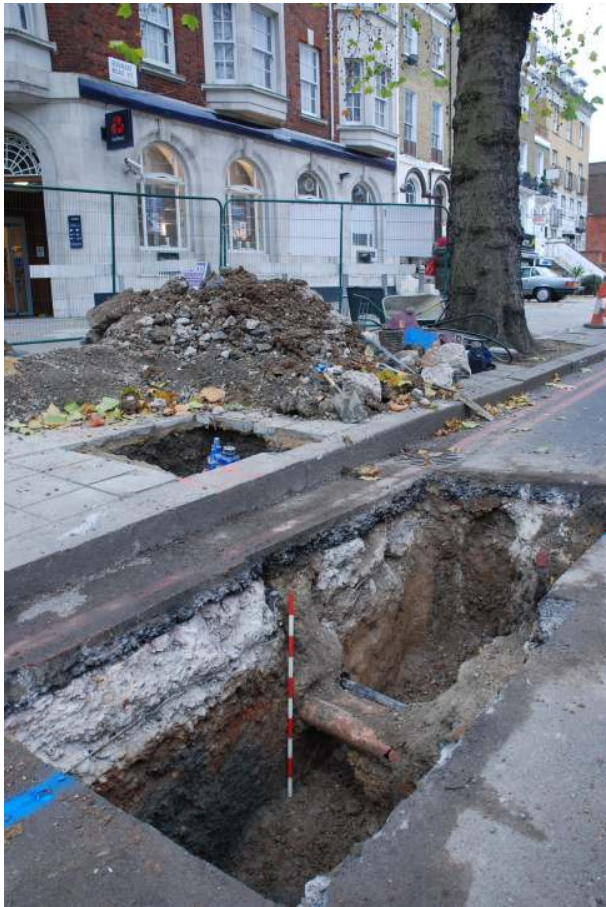
Fig. 12 – Photo of trench on Edgware Road (5) from the north-west, showing an obvious difference between the canal ‘cut’ in the northern part of the trench, and natural clay in the southern part

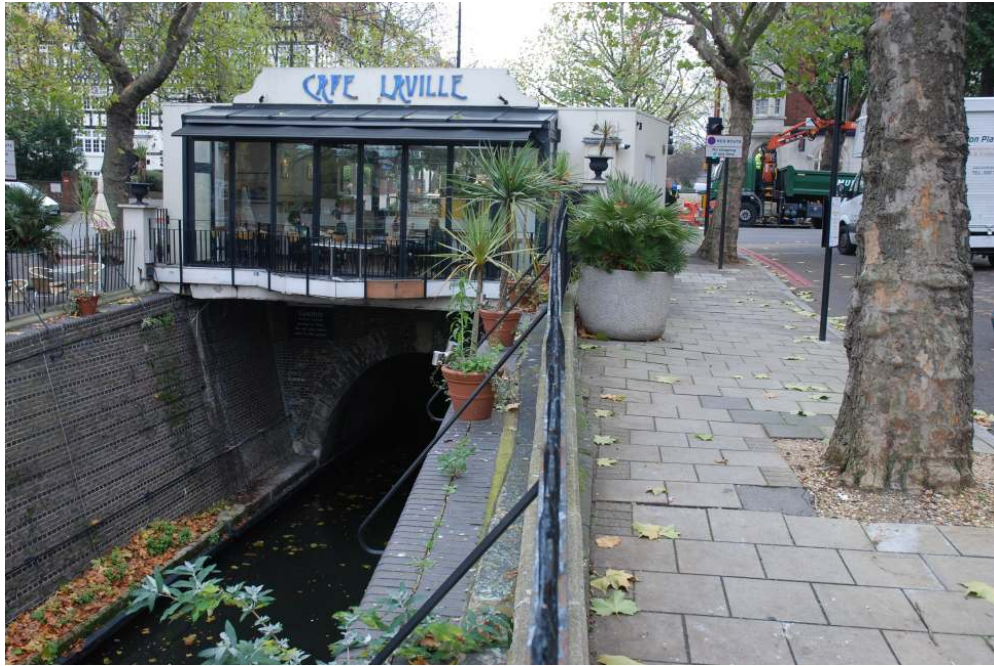
Fig. 14 – Photo of the Regent's Canal (to the west of the DMA), looking across Edgware Road to the trench on Edgware Road (5) (see Murphy's van on the right-hand side)
