WOOD WHARF

HORSEFERRY PLACE / THAMES STREET, GREENWICH SE10

**AN ANALYTICAL STANDING BUILDING RECORD AND
PROGRAMME OF ARCHAEOLOGICAL OBSERVATION AND RECORDING**

April 2005

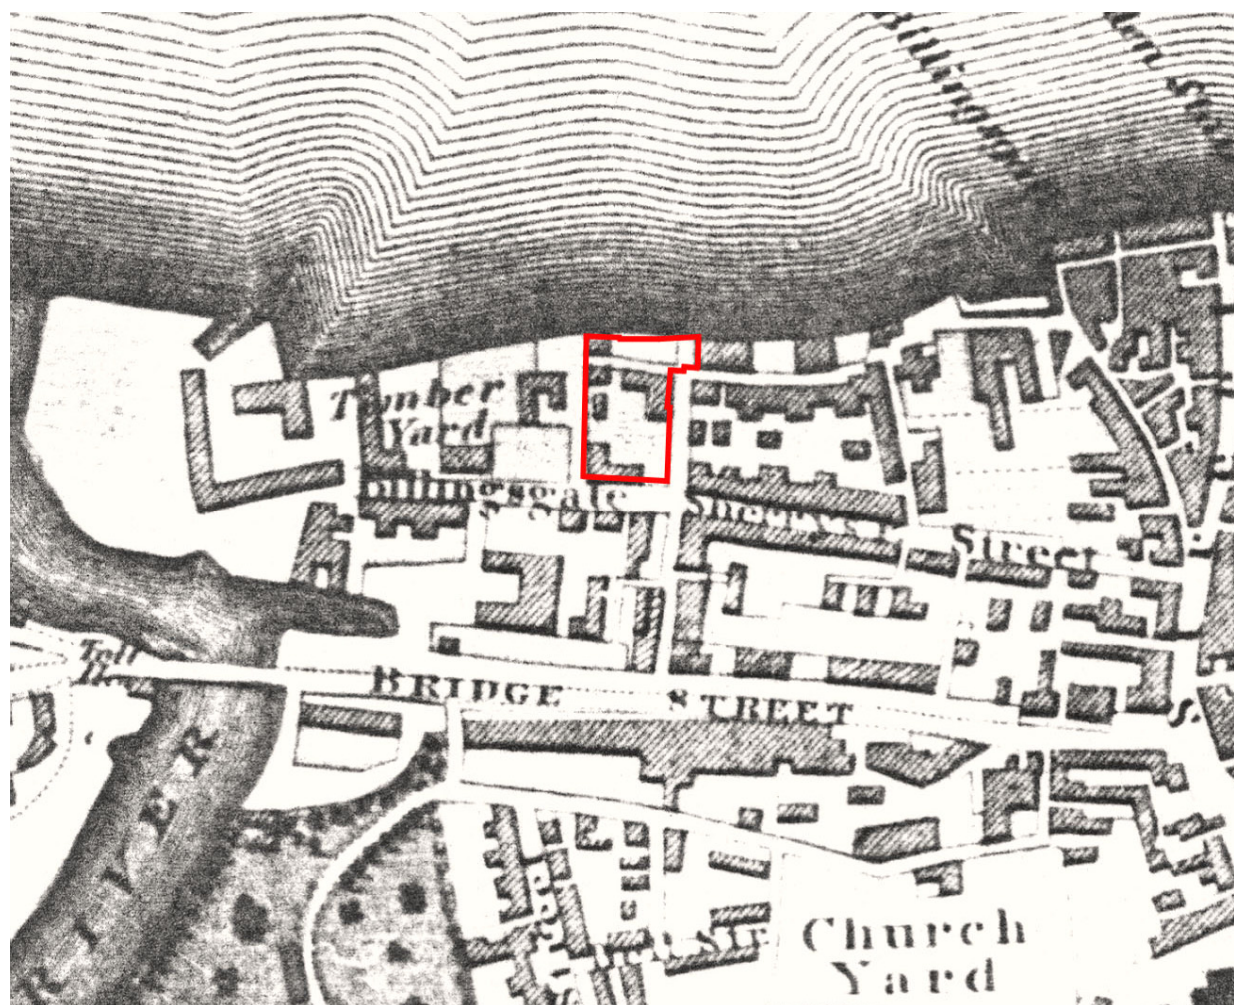
Fig 3 Site location in relation to an extract from Greenwood's Map of London of 1824-26

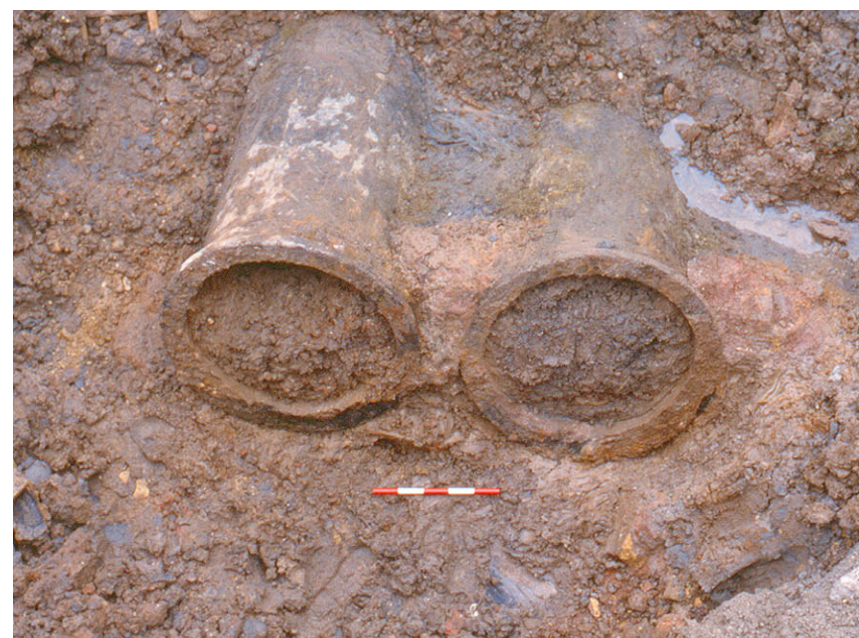
The flanged southern ends of the two cast iron pipes (0.5m scale)

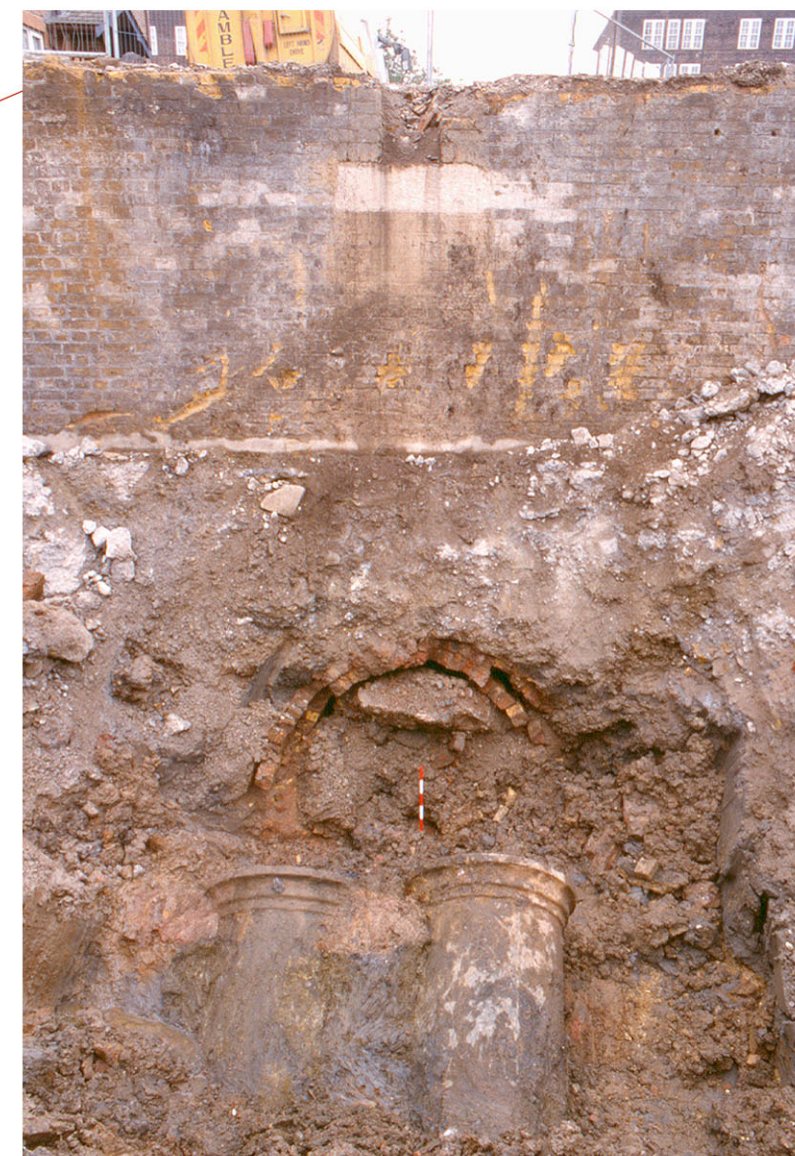
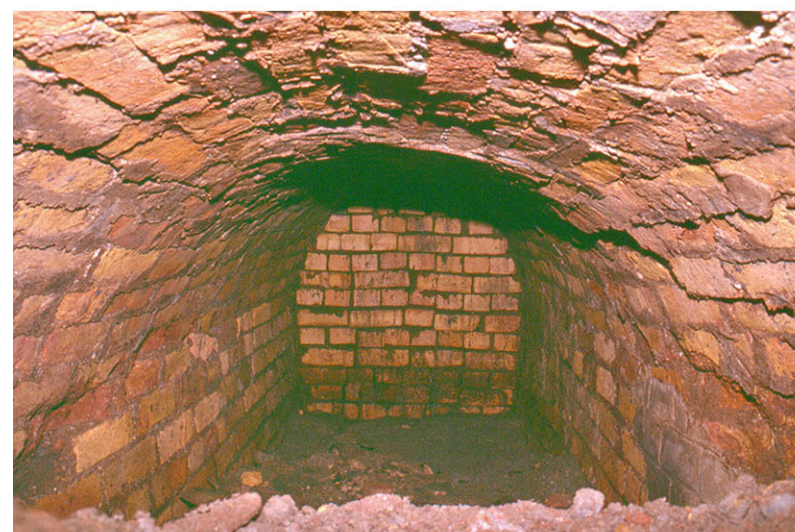
Below: view looking south along the line of Horseferry Place with drain at base of frame, below the southern wall of the Engine Room

Fig 6 The blocked brick-lined drain and adjoining cast iron pipes which were found below the Engine Room (0.5m scale)

The earliest remains recorded within the northeastern part of the site related not to the late 19th century Engine Room but to an earlier outfall drain, probably constructed in the 1840s or 50s. This followed the north-south line of Horseferry Place and was exposed following removal of the Engine Room foundation slab. It is possible that this represents part of a sewer overflow system, discharging directly into the river (Chambers 2004).

One of the iron pipe sections was recorded in greater after removal. The overall length was 2.91m, external diameter generally 0.815m and wall thickness *c* 27mm. Adjoining pipes would have been fixed by a simple and traditional socket joint: one end of the examined pipe was quite plain, whilst the other end flanged outward so as to create an internal rebate some 130mm deep. No maker's mark or other information was visible on the pipe.

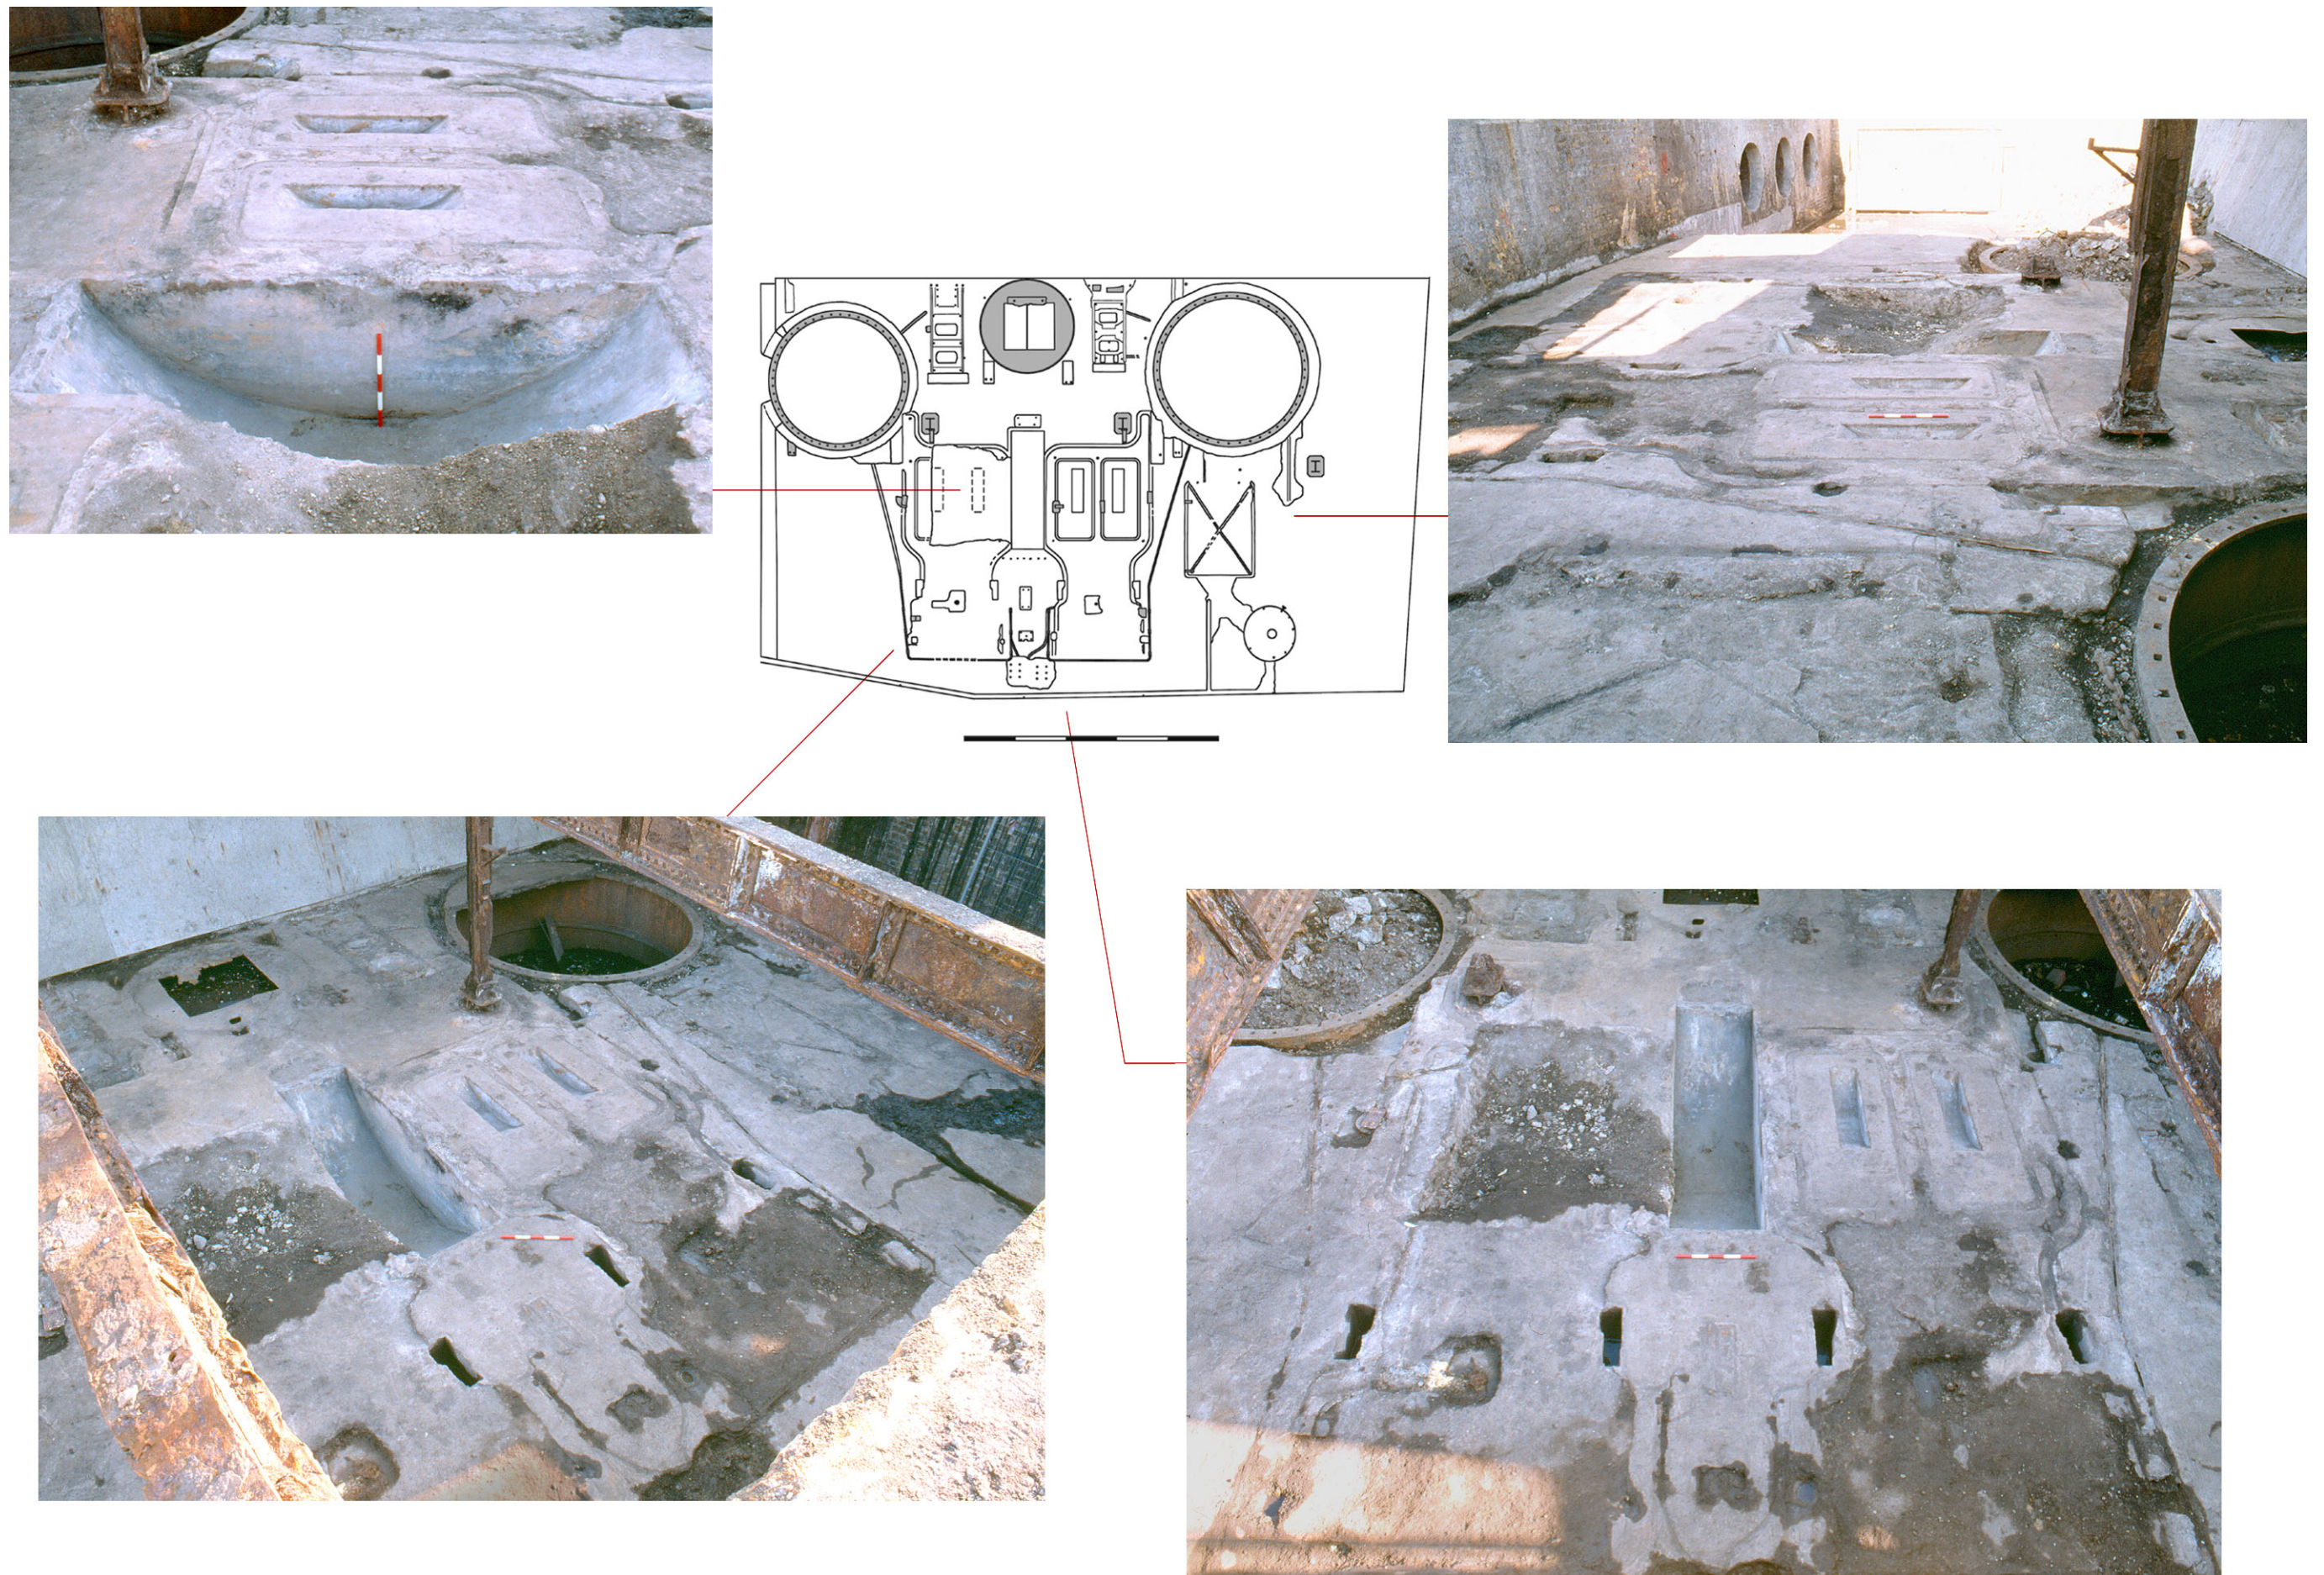
Fig 10 Views of the Engine Room floor, including at top left detail of the flywheel pit (*0.5m scale*)

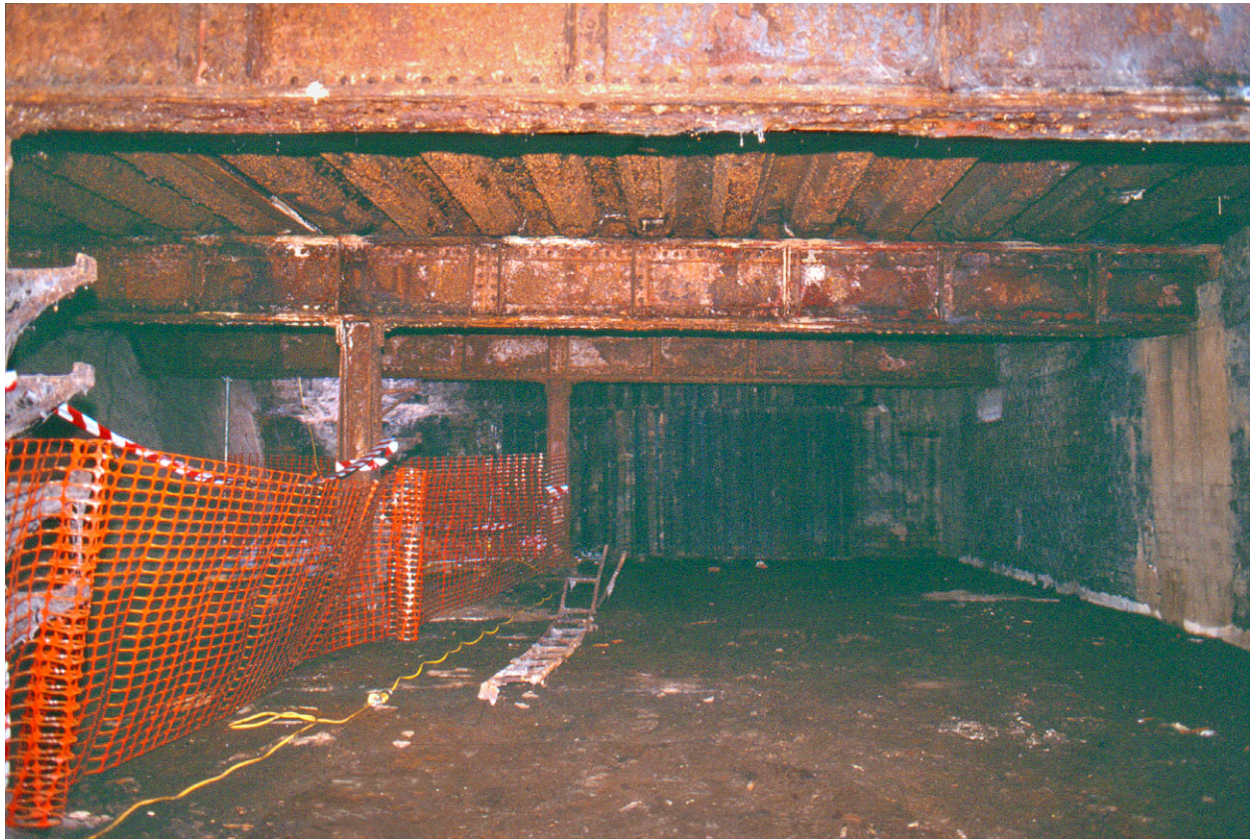
Fig 14 General view of the Engine Room looking east

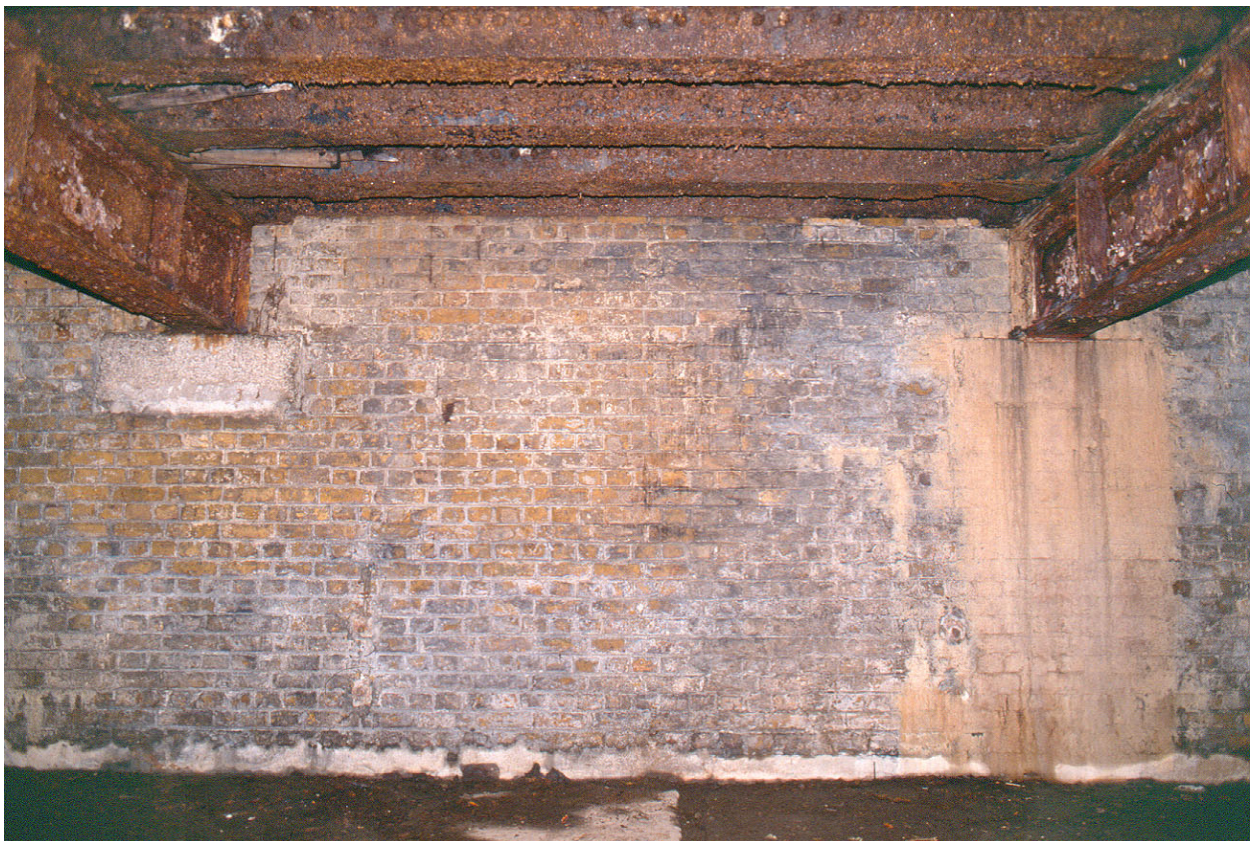
Fig 15 Detail of the southern wall between first and second roof beams from the east

The principal roof support was provided by five north-south iron beams. These were set on granite blocks within the southern wall (Fig 15), although obscured by modern concrete reinforcing works to the north. All but the westernmost beam were also reinforced by intermediate iron pillars, which were attached by brackets at the top and to a separate metal base set into the Engine Room floor (Fig 12).

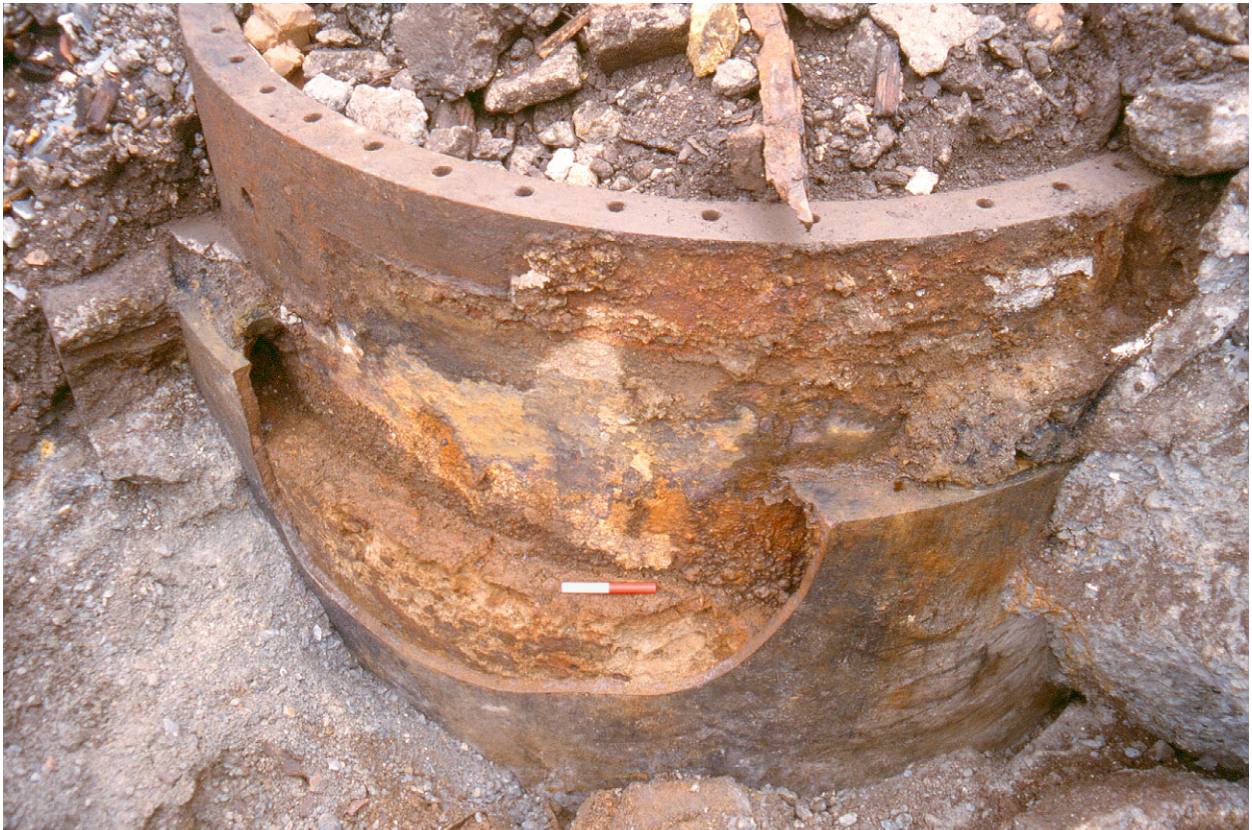
Fig 17 The western counterweight shaft, showing the outer lining exposed and partially broken away during demolition (*0.2m scale*)

Following excavation of the floor slab around the western counterweight shaft a more significant feature came to light. The smaller iron ring (and that directly below) were set within a larger ring, apparently identical to those used in the eastern shaft (Figs 16 & 17). The reason for this is unknown, although it may be noted that the contemporary account given in *The Engineer* (1892) mentions that the shafts increased in diameter by 18 inches from top to bottom.

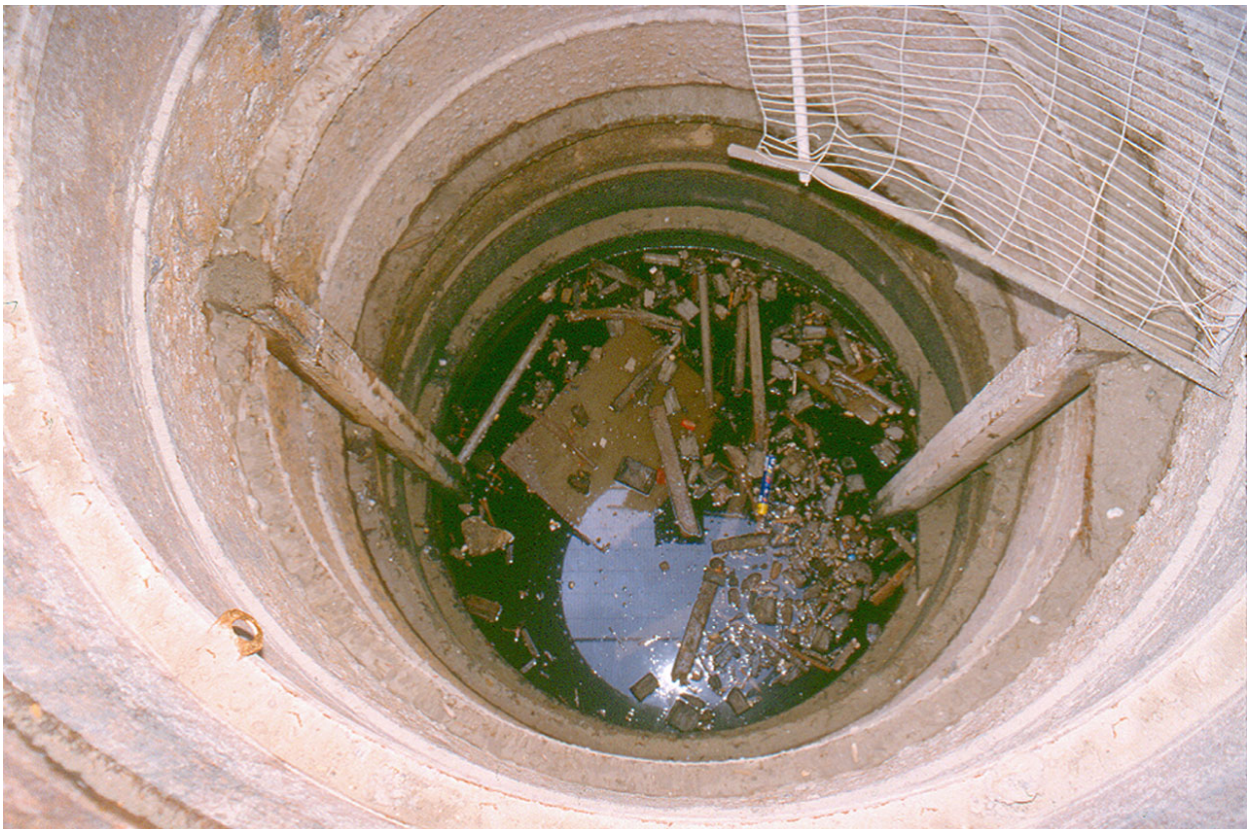
Fig 18 Interior of the eastern counterweight shaft after reduction of the water level to a depth of approximately 6.6m. Four separate lining rings are fully exposed (each 1.53m deep)

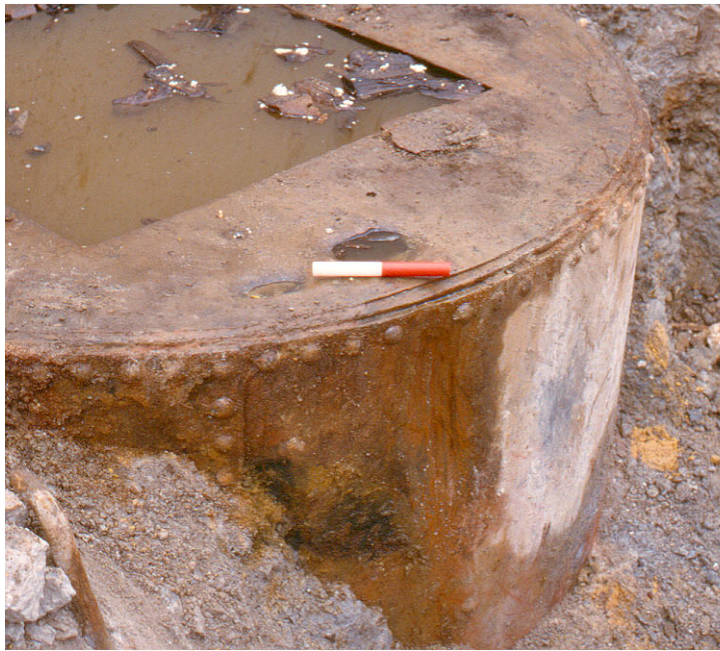
Fig 19 Detail of the smaller central shaft. Unlike the counterweight shafts this was constructed of riveted sheet metal, including an integral top plate with central square cut-out

The shaft lining was constructed from iron plate formed to a cylinder and close-riveted, not unlike the inspection casings set in the southern wall of the boiler area (see above). The shaft included an integral top plate with a central cut-out measuring *c* 0.9m (3 feet) square, and rivet heads cut flush with the external surface (Fig 19). Internally the shaft was divided into two halves by a north-south metal plate, fixed to the adjacent lining. The top of this was just below the central cut-out: the base was not seen although the plate extended down for at least 1m.

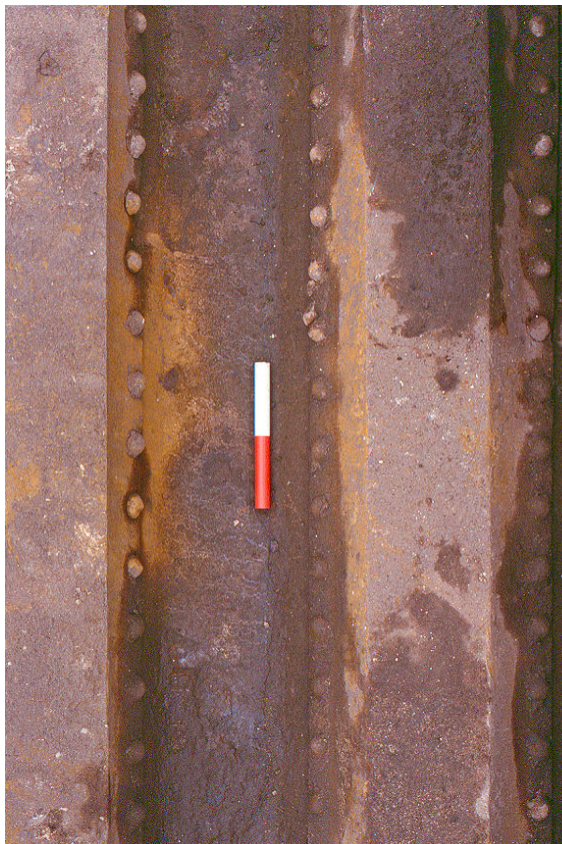
Fig 20 Detail of the corrugated roof, constructed from a series of longitudinal sheets of U-shaped cross section which were riveted together (*0.2m scale*)

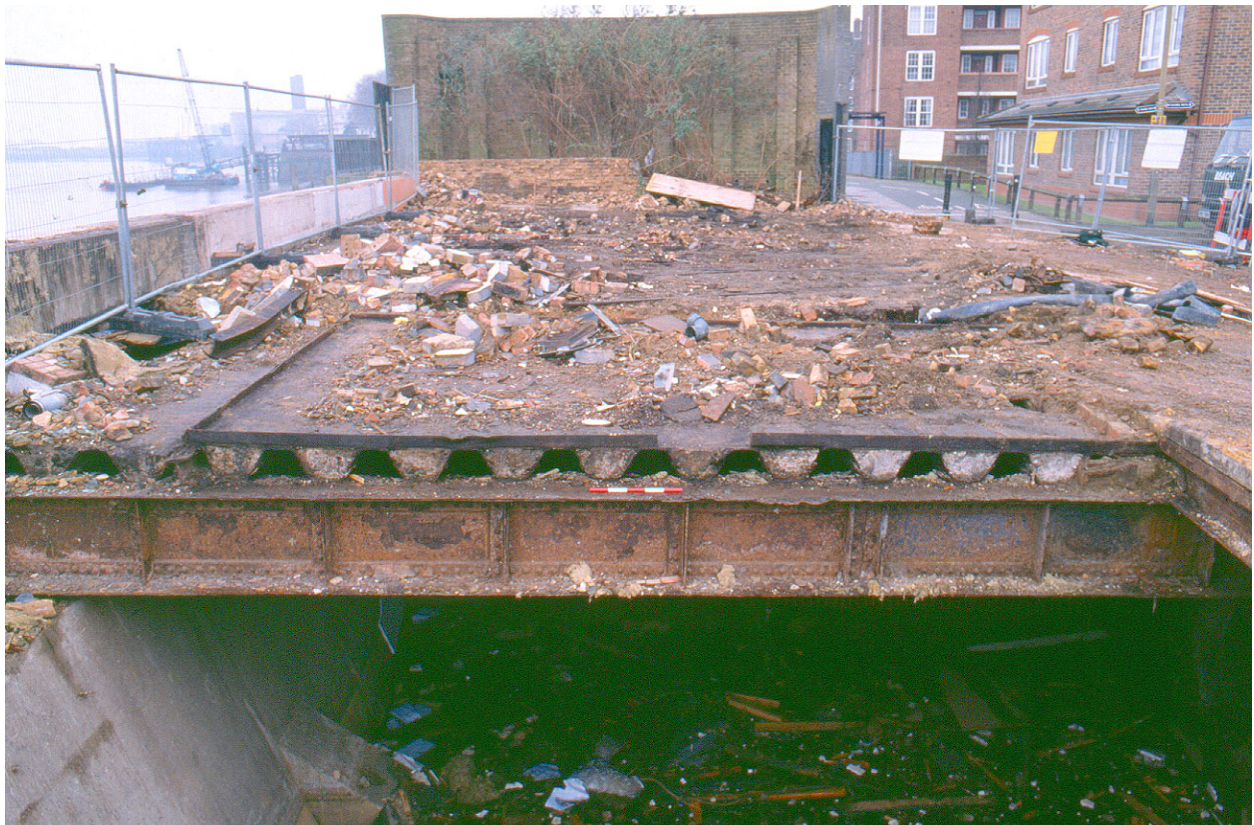
Fig 21 View looking east after collapse of the later roof over the boiler area, showing the first major beam and corrugated construction of the main roof to the east (*0.5m scale*)

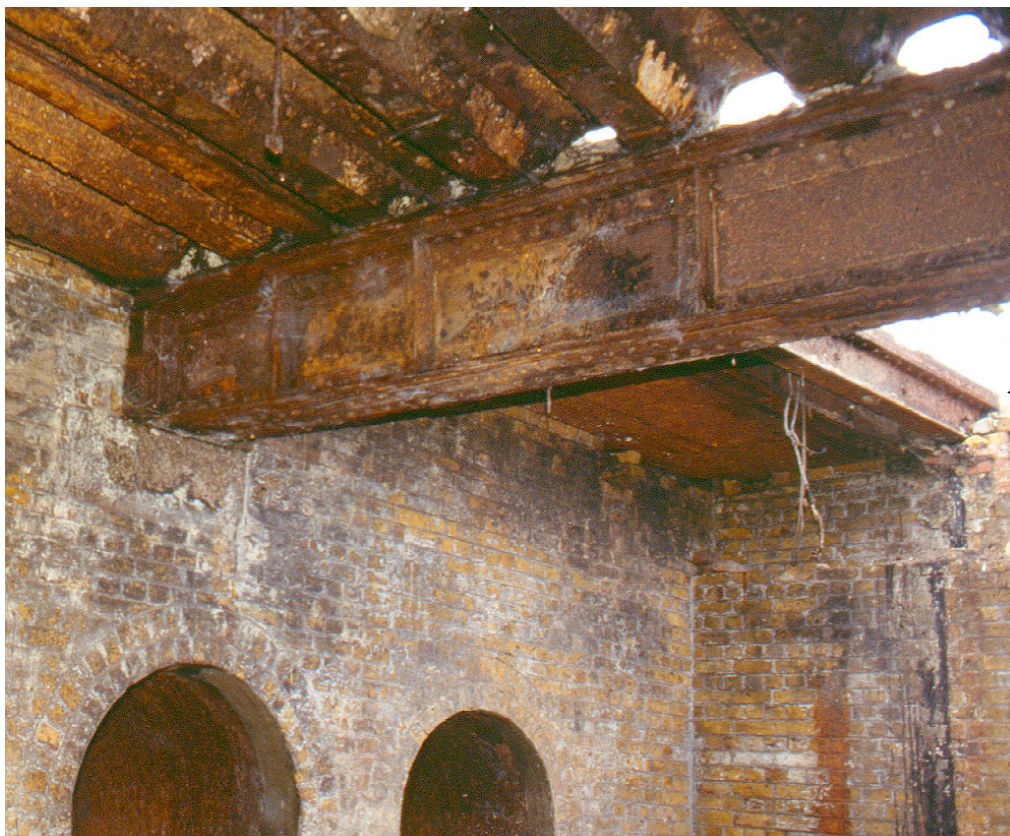
← later roof: reused girders supporting flat iron sheet

Fig 22 Detail of the southwest corner of the Engine Room, showing the surviving section of later roof and reused girders behind the main beam

- At some point following the closure of the Ferry the boilers and engines were removed. They could have been broken up *in situ*, but it is at least as likely that they were lifted out through this open area.
- The surviving section of roof within the southern part of this bay was quite poorly constructed, with a couple of reused girders supporting a plain iron sheet and an overlying wall. The various elements did not appear to have been fixed in position by any rebates, rivets, *etc.* (Fig 22).

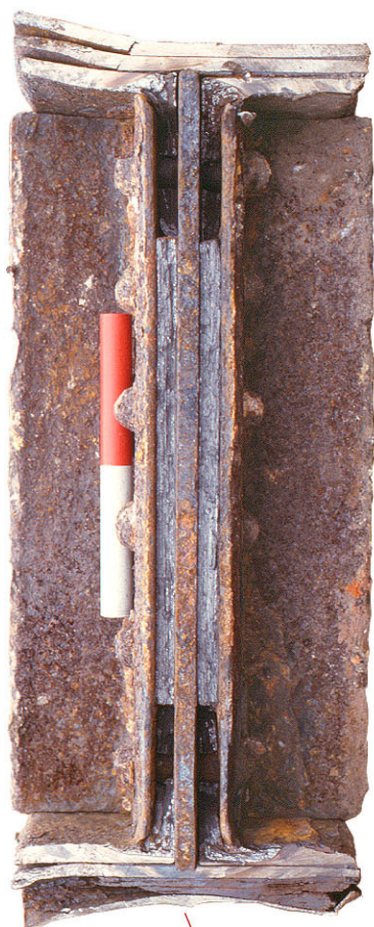
NB. In this exploded view the principal beam elements are shaded grey: the yellow-shaded pieces form additional bracing between the two vertical plates which make up each complete beam

Fig 23 Detail of roof beam construction, illustrated at the point where two vertical plates are joined together. Each beam was assembled from a series of flat and angled elements, close-riveted together

Each beam was prefabricated, formed from a number of pieces flat and right-angled iron that were close-riveted together (Fig 23). No single piece was the full length of the finished beam: the junction between the two vertical plates was given additional bracing, but the horizontal (top & bottom) plates appear simply to have abutted. However, it is clear that the junctions were staggered so as to avoid a point of weakness.

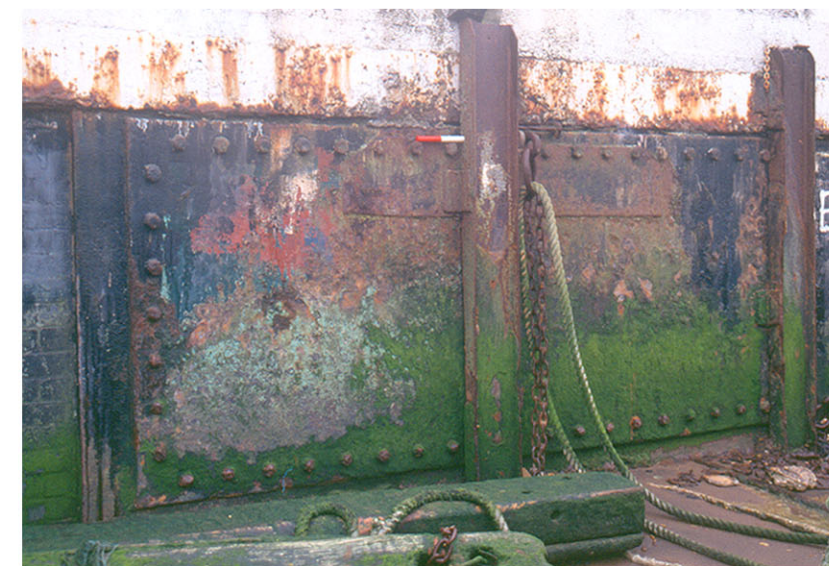
Fig 26 Elevation and views of the riverside wall in front of the Engine Room, including the blocked-off ports for cables which originally attached to the landing stage and moving carriages. The upper iron beam extends the full length of the Engine Room to the east, but only as far as the line of the final roof beam to the west: thereafter it is replaced by yellow stock brick

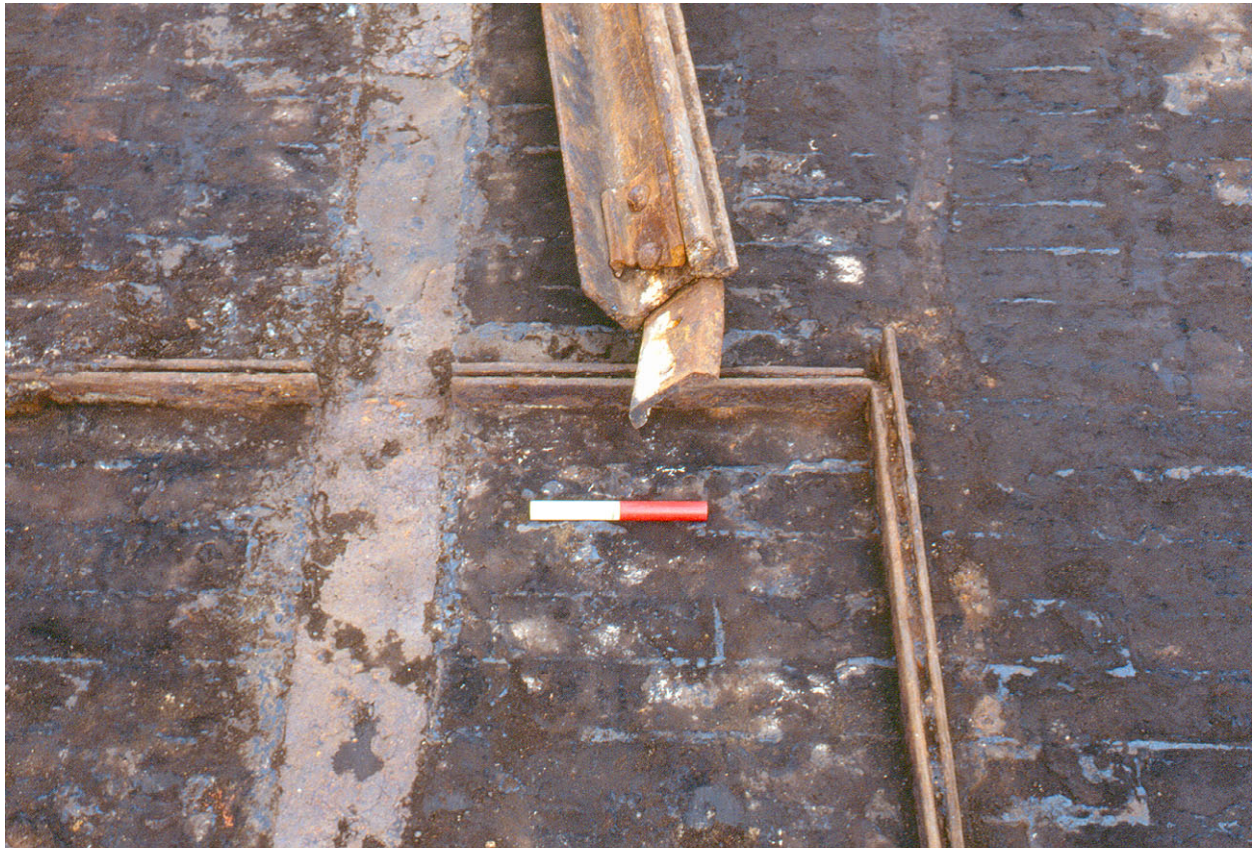
Fig 27 The surface over the Engine Room, showing detail of the base for an original (?temporary) building. This was constructed from two angled girders riveted to the roof, and would probably have supported a timber superstructure.

The photograph also shows a part of a displaced rail with attached fishplates, one of which bore the legend PHÖNIX.R(or B)UH(?N)... (remainder indecipherable)

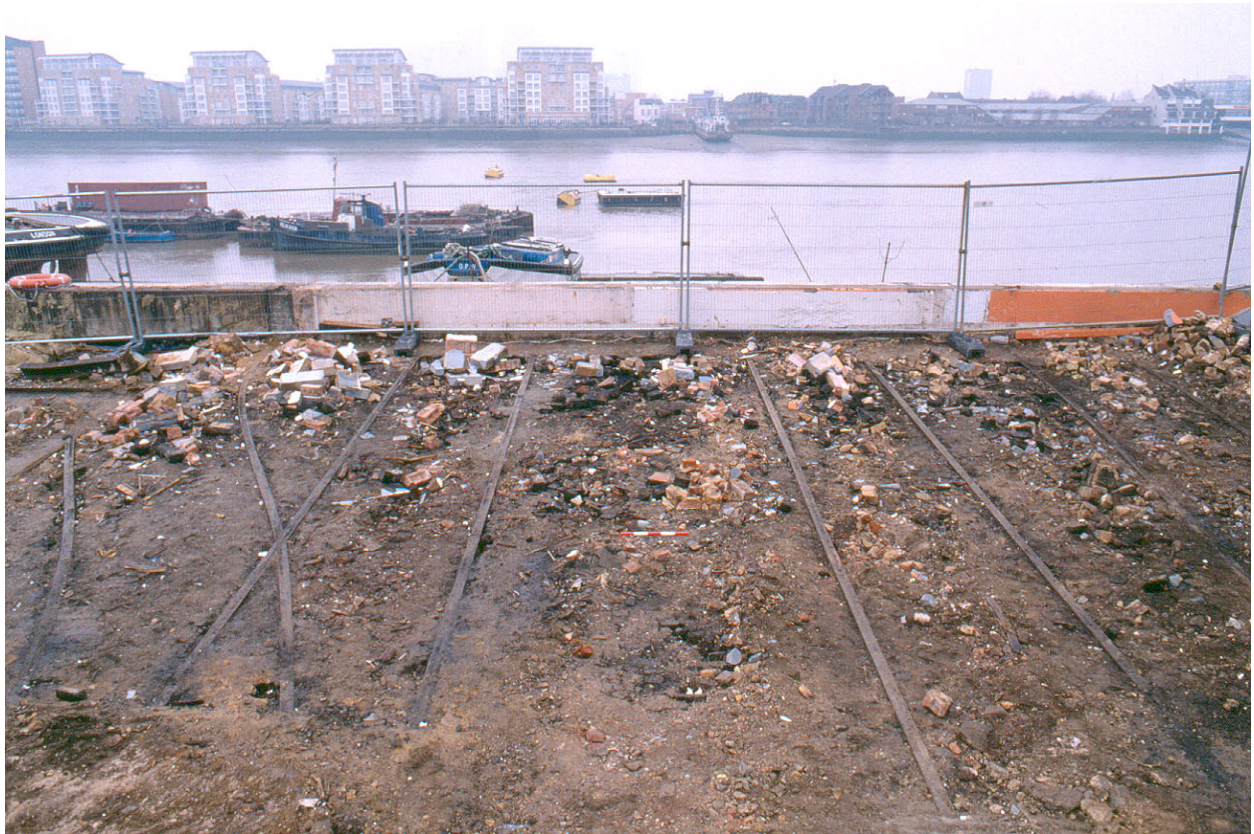
Fig 28 The surface above the Engine Room after demolition of the later buildings, showing the four sets of rails (0.5m scale)

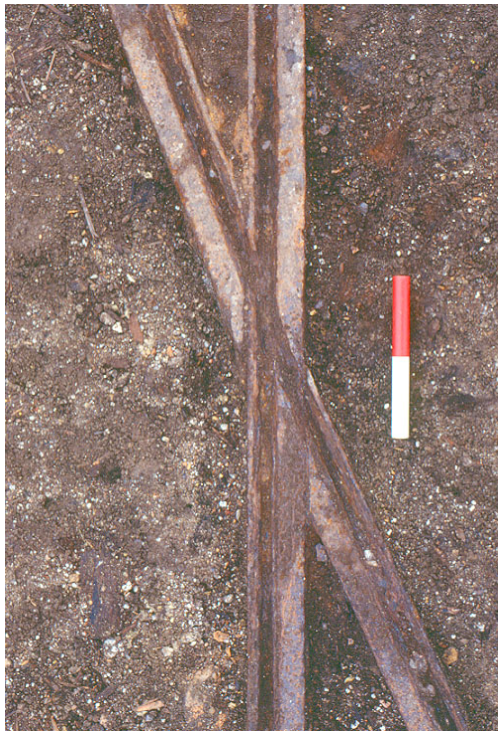
Fig 29 Detail of rails on the western side of the Engine Room: to the left the crossing of two tracks, showing a continuous shallow groove but no cut-out for a wheel flange. On the right the top of the westernmost rail is shown flush with the *in situ* woodblock surface

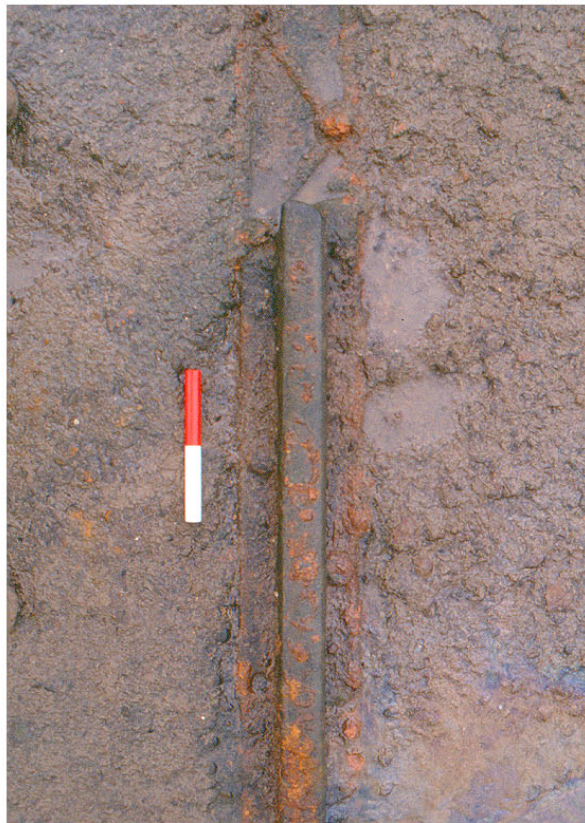
Fig 31 Detail of the foreshore ramp: at the top parallel girders set in concrete to support one set of tracks, each retaining a double line of rivets at 305mm (12 inch) spacing. In the lower view an *in situ* rail, broken away to the top and only seen during particularly low tides at the northern end of the ramp

As already described (section 8.1) four sets of rails were laid along the ramp to support the landing stage and carriages on a standard railway gauge of 4 feet 8½ inches. These have been removed for almost all the observed length, only appearing at the water's edge at particularly low tides (Fig 30). However, the rails had been supported on longitudinal girders that were set into the ramp more or less flush with the concrete surface, and thus survived almost intact. The top of each girder was *c* 160mm wide and retained two offset lines of rivets that had once held the rails, with rivets in each line placed at 305mm (12 inch) spacing (Fig 31).
