WOOD WHARF

HORSEFERRY PLACE / THAMES STREET, GREENWICH SE10

**AN ANALYTICAL STANDING BUILDING RECORD AND
PROGRAMME OF ARCHAEOLOGICAL OBSERVATION AND RECORDING**

April 2005

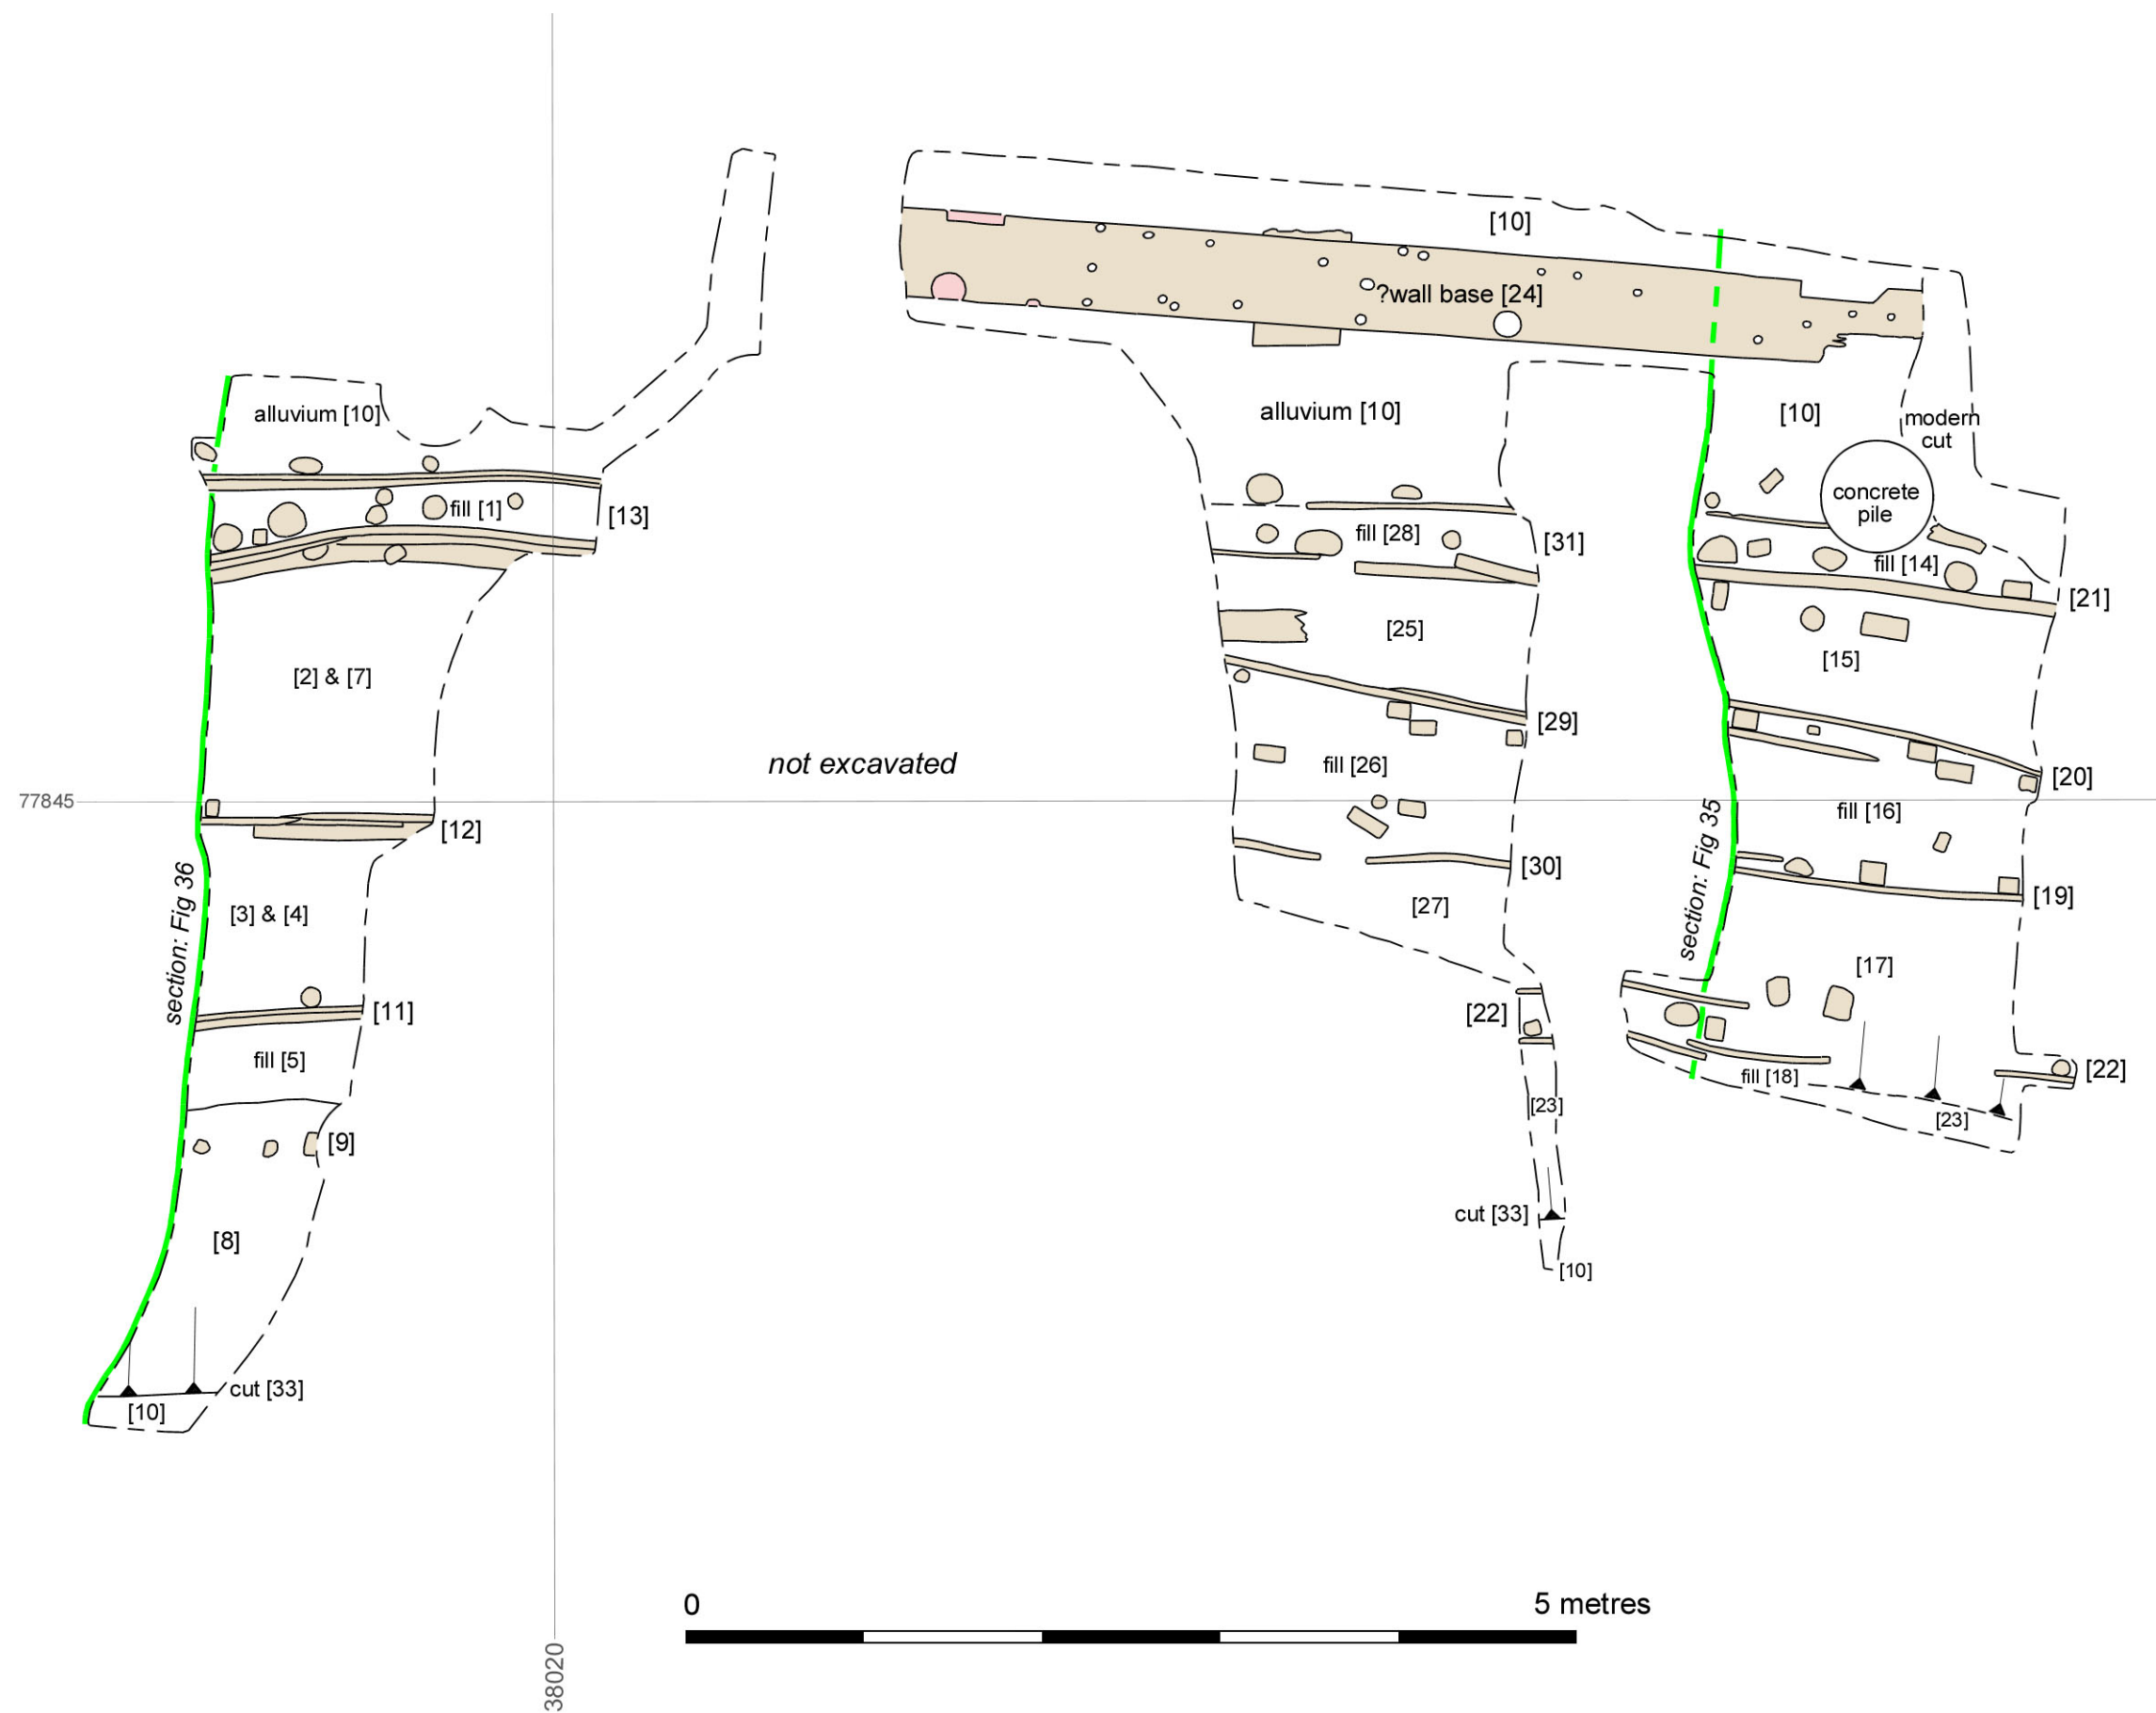
Fig 32 Plan of the main areas of investigation within the new basement, showing the line of recorded timbers and section locations

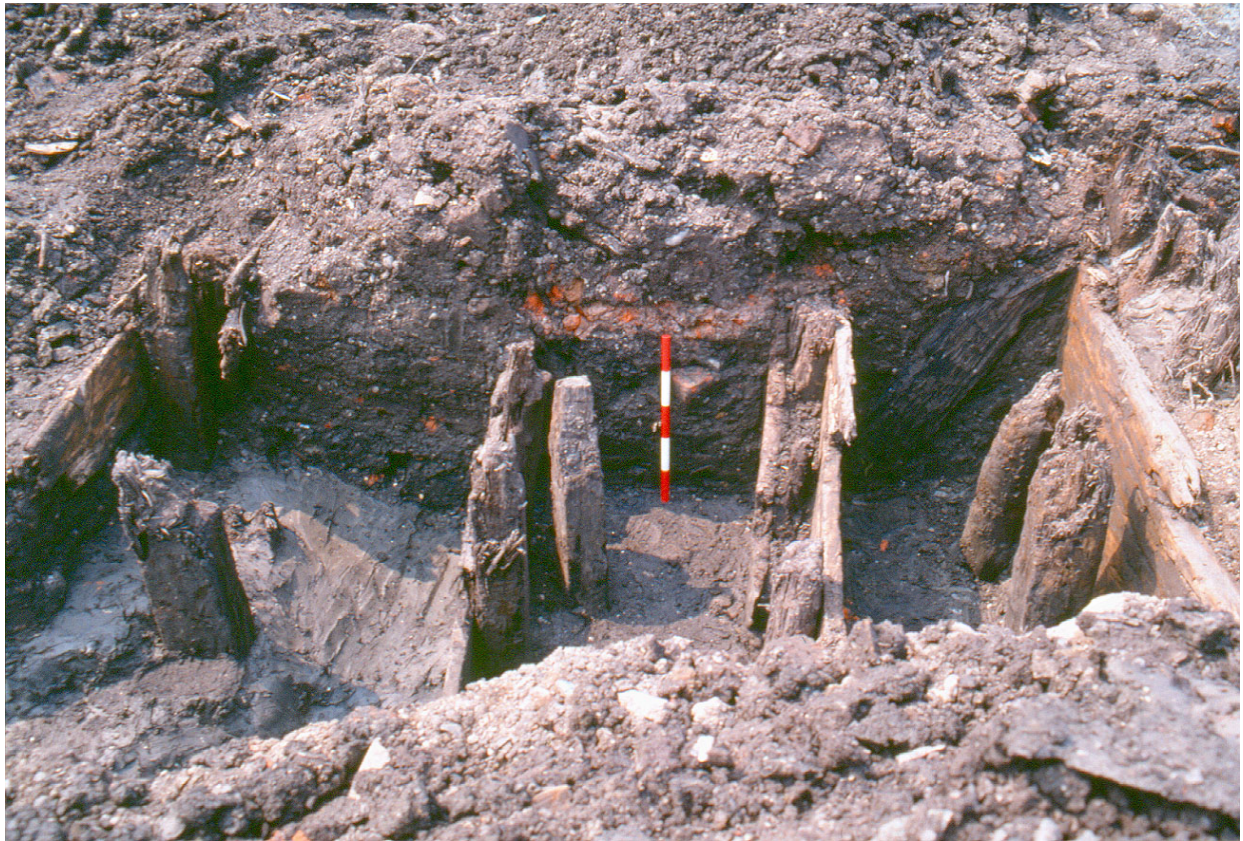
Fig 37 View of the deposits and timbers shown in Figure 35 (*0.5m scale*)

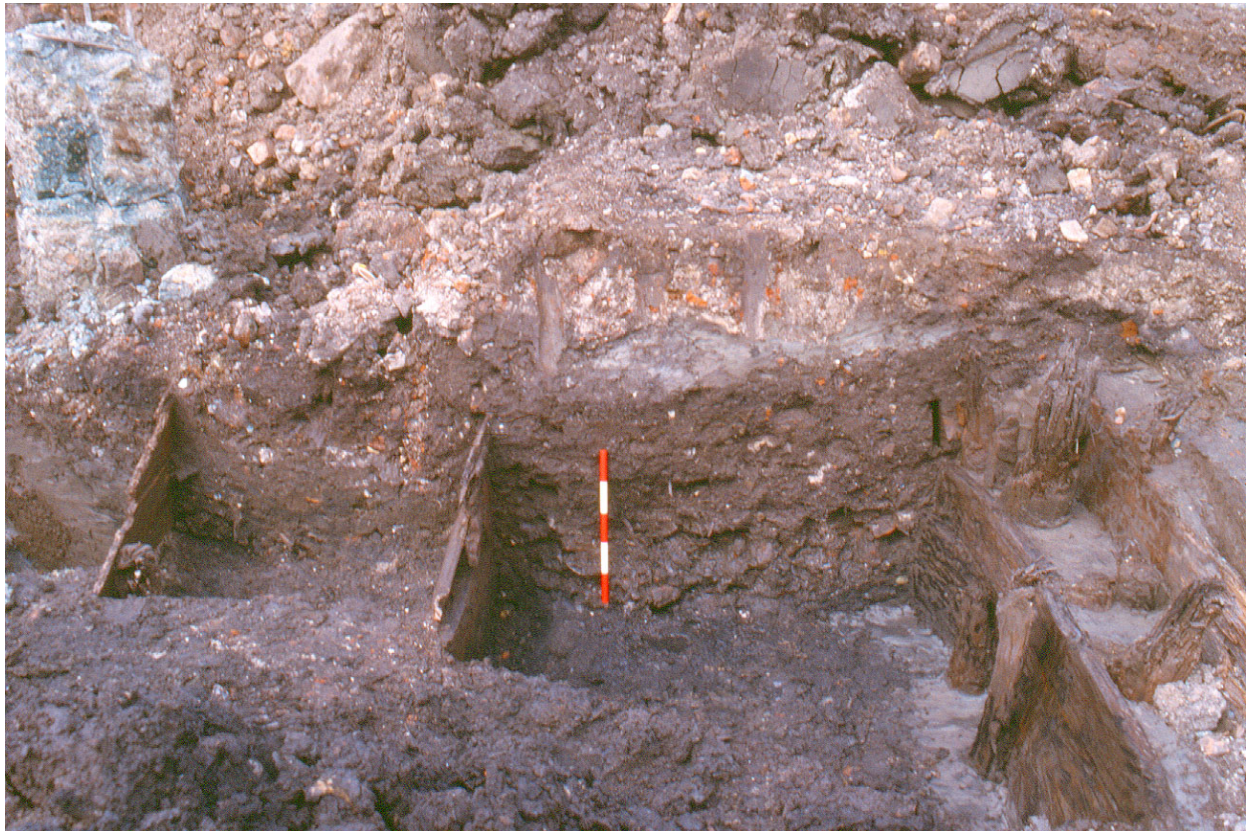
Fig 38 View of the deposits and timbers shown in Figure 36 (excluding southern end)

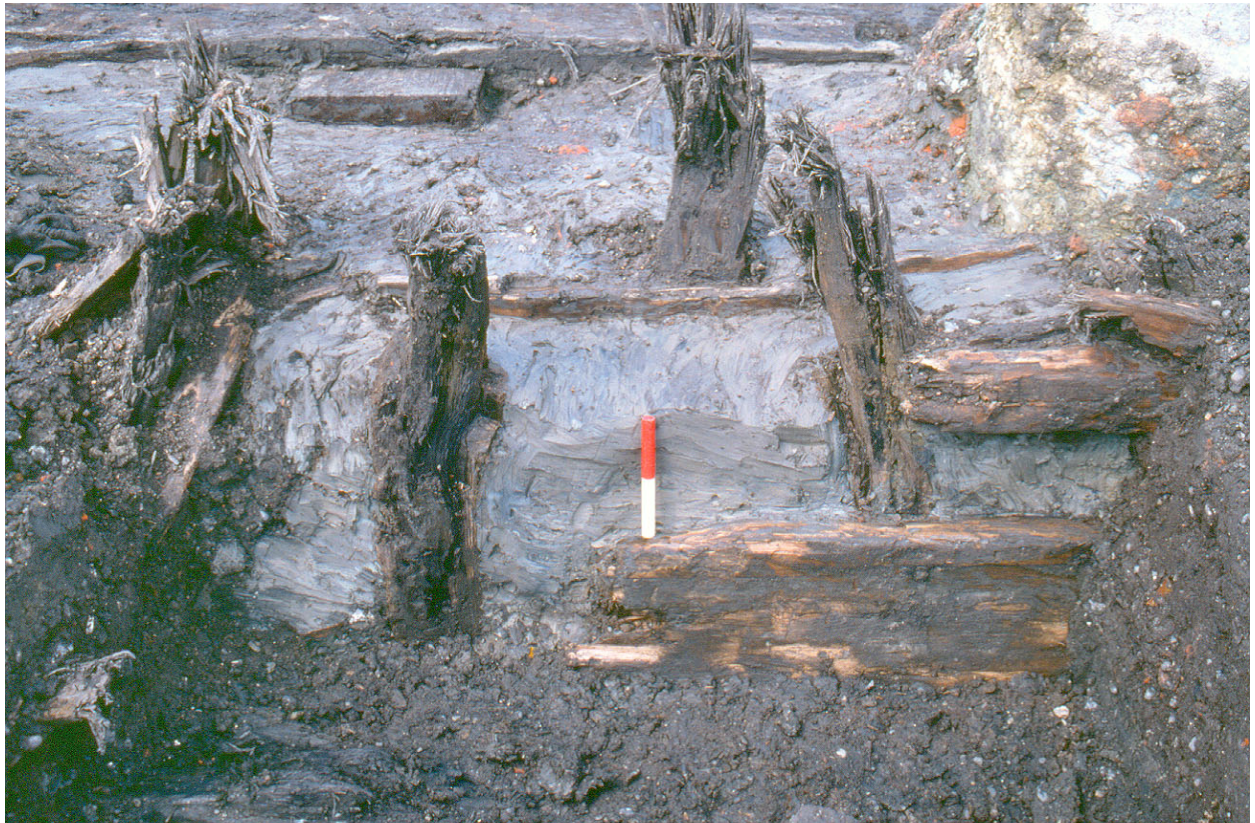
Fig 39 Detail of the northern revetment [31], showing clean alluvial fill between the two lines of timbers (*0.2m scale*)

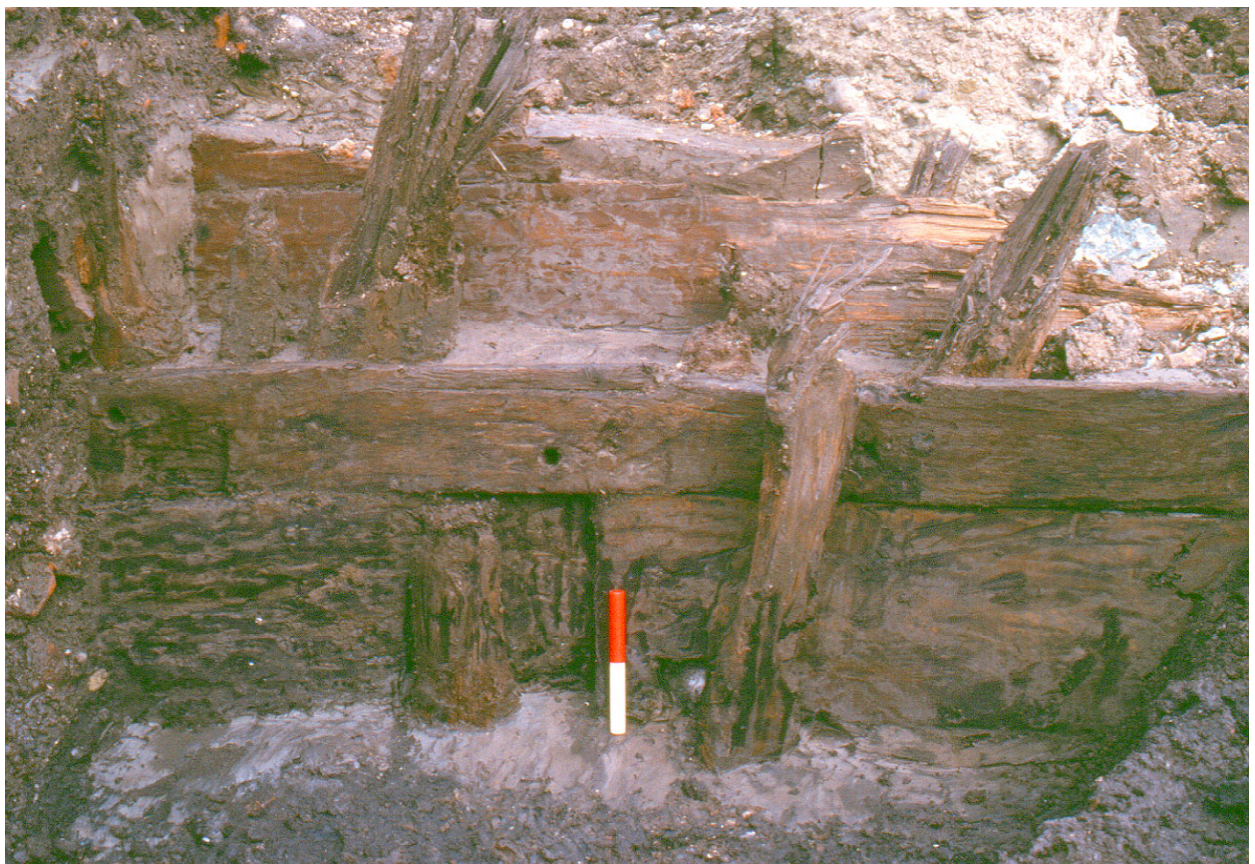
Fig 40 The better-preserved revetment [13], including reused timber with pegholes at upper level
