MATT'S HILL WATER SUPPLY WORKS

SOUTHERN WATER SERVICES

AN ARCHAEOLOGICAL WATCHING BRIEF

SITE CODE: MAT 10

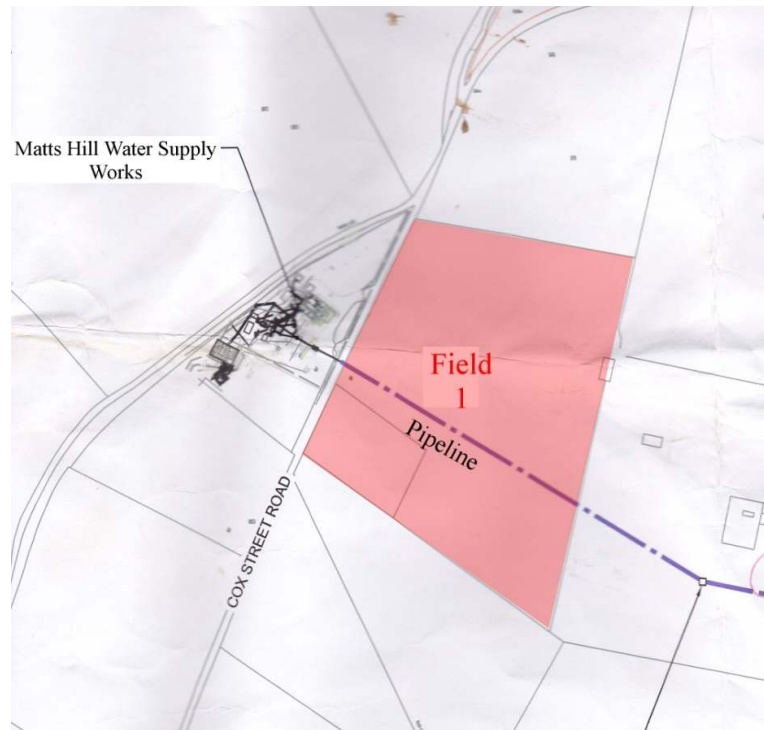
Figure 3: The pipeline route across Field 1 adjacent to Cox Street Road. Based on an original drawing by Southern Water (Pipeline Route to Soakaway AB.41517309.1C0011).

The pipeline excavation began on the east side of Cox Street Road and ran southeast across Field 1 for approximately 160m to the boundary with Field 2 to the east. The trench was excavated within a c.8m wide easement strip within which approximately 0.15m of topsoil was removed. The pipe trench was excavated to a depth of 2.1m below the existing ground surface in two stages, with an initial trench c.1.6m in width to a depth of c.0.5m and a secondary trench stepped in at a width of approximately 1m. Figures 4-6 show views of the pumping station and Field 1 at the commencement of archaeological monitoring.

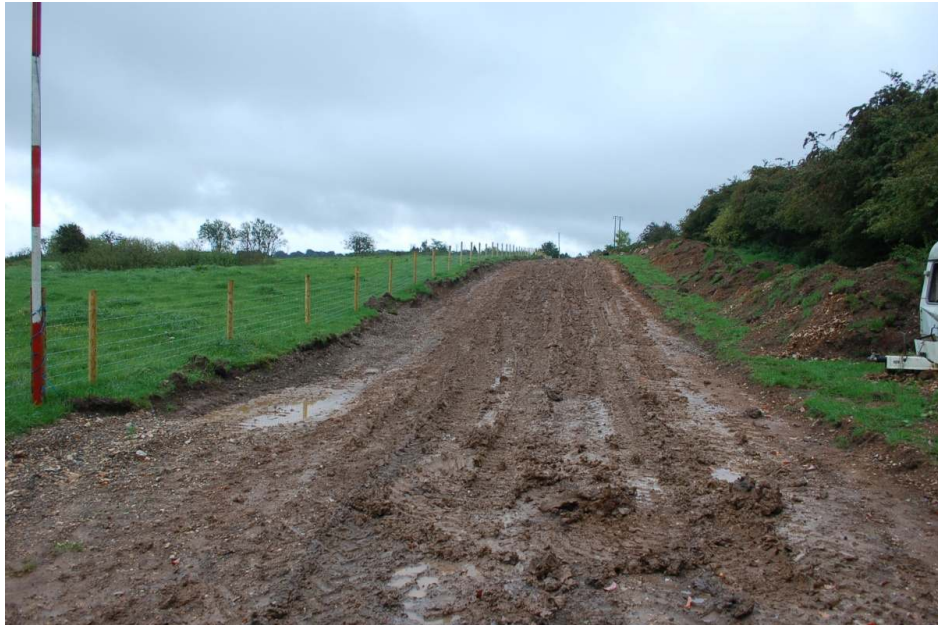
Figure 5: Field 1 from the gated entrance on Cox Street Road, looking southeast along the route of pipeline and easement corridor.

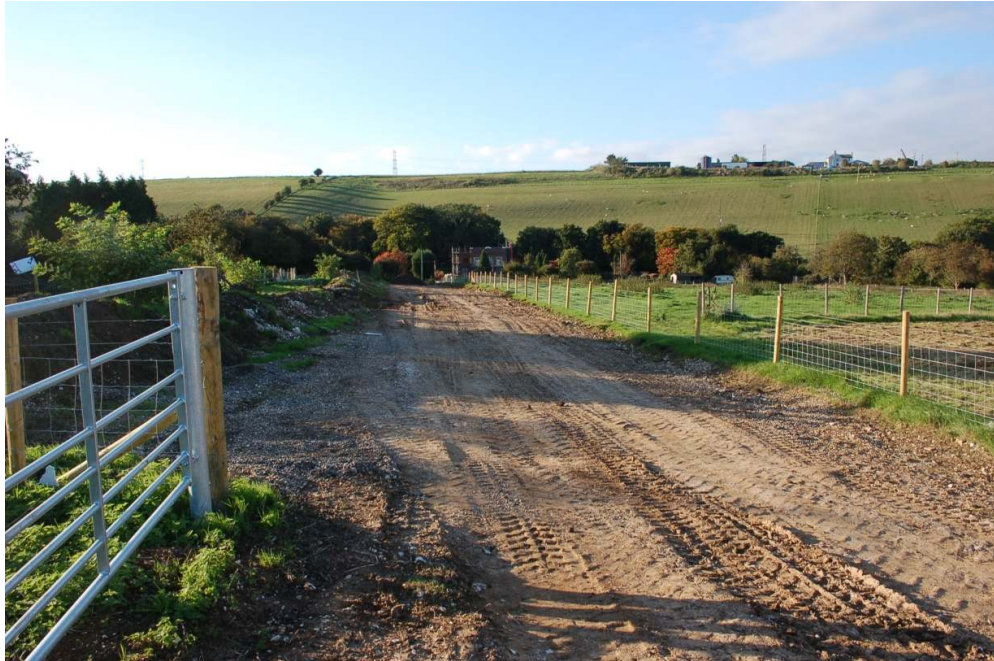
Figure 6: Field 1 looking northwest back towards Matt’s Hill Pumping Station from the boundary with Field 2.

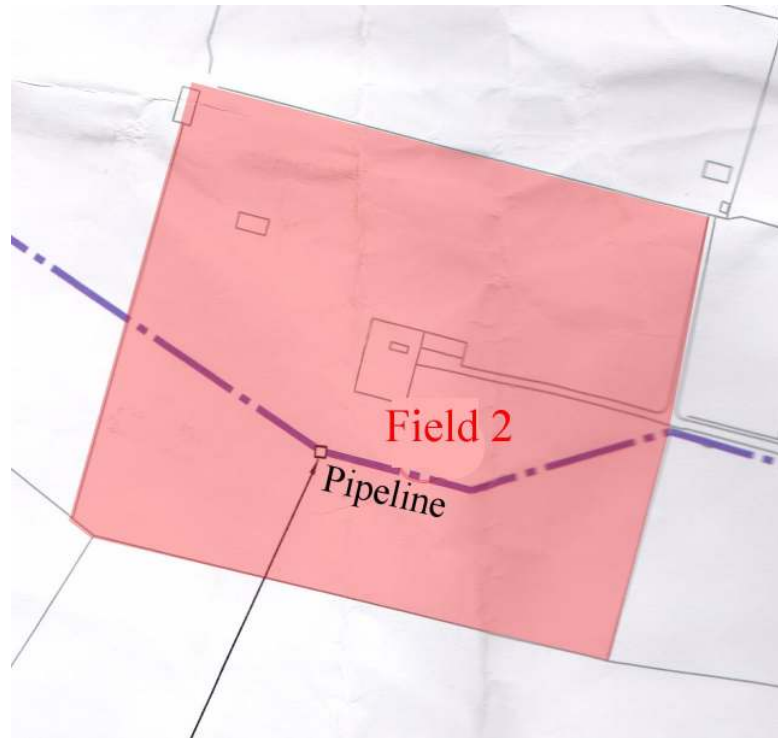
Figure 9: The pipeline route across Field 2. Based on an original drawing by Southern Water (Pipeline Route to Soakaway AB.41517309.1C0011).

The pipeline route across Field 2 ran for approximately 225m, cresting a hill at the western boundary and sloping gradually downhill towards the boundary with Field 3. The pipe trench was excavated within a *c.*8m wide easement strip that removed approximately 0.2m of mid-grey brown topsoil within weathered frequent chalk and flint inclusions. The pipe trench was excavated at an initial width of 1.6m to a depth of *c.*0.5m with a narrower *c.*0.6m trench stepped in to a depth of 2.1m.

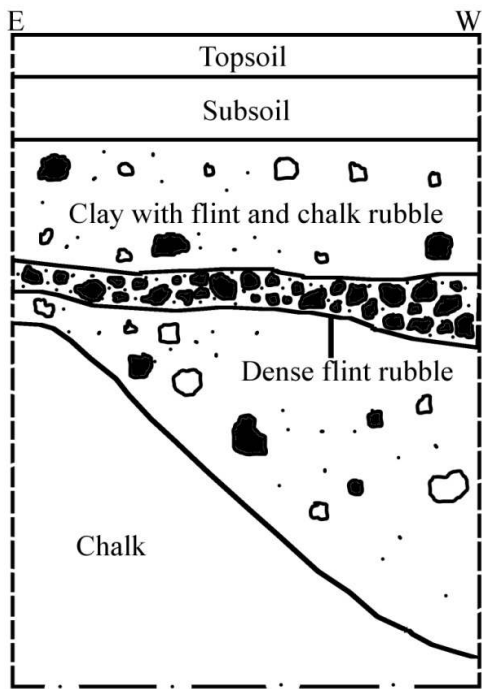
The open pipe trench was excavated from the level stripped topsoil, *c.*0.2m below the existing turfed ground surface. Approximately 0.3m of mid brown/orange subsoil with frequent flint and chalk rubble inclusions was exposed overlying natural drift deposits of clay with flints. The drift deposits consisted of mid-dark brown/orange clay with flint and chalk rubble, with lenses of dense flint rubble and siltier soils. These deposits are likely to comprise hill wash and glacial deposits laid down by river action represented by the now dry river valleys. At the western end of the exposed trench the mixed clay and flints extended to the full depth of excavations (*c.*2.1m), but to the east they overlay rising chalk deposits. The increasing depth of drift deposits corresponds to the downhill slopes, suggesting deposits are deeper towards the base of the dry river valleys. At the eastern end of the trench, along the crest of the hill and high edge of the valley, the chalk deposits were recorded *c.*0.8m below the existing ground surface and appeared soft and degraded with veins of flint and pockets of silt. Figure 10 below shows an illustrative section of the recorded deposits, this drawing is not to scale and is based on observations of the exposed sections from the excavation edge, as accurate recording was not possible, owing to Health and Safety restrictions.

Figure 10: Indicative sketch section of deposits in Field 2. Maximum depth of excavation is 2.1m.

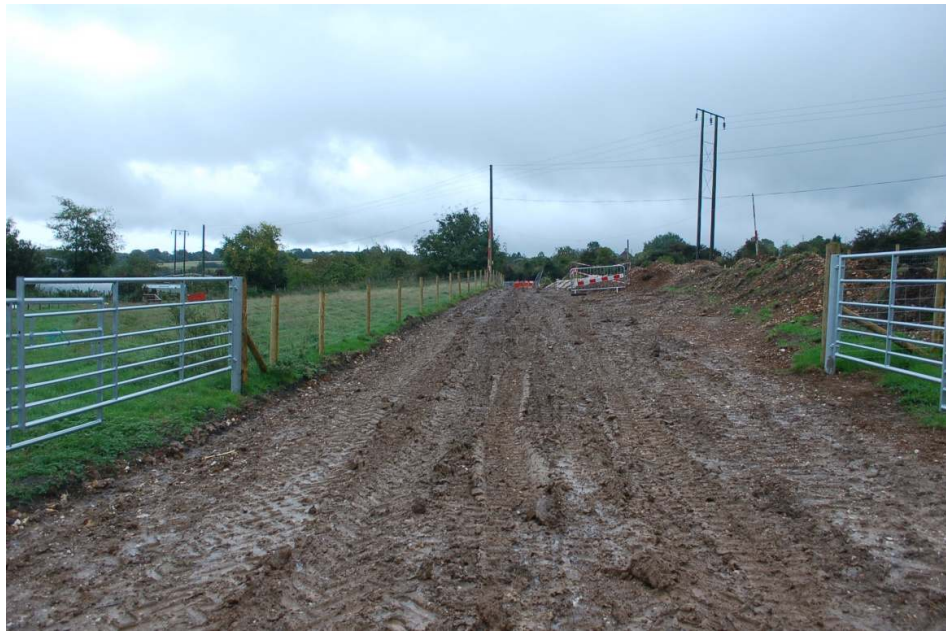
Figure 11: Field 2 looking east from the boundary with Field 1 along the easement strip.

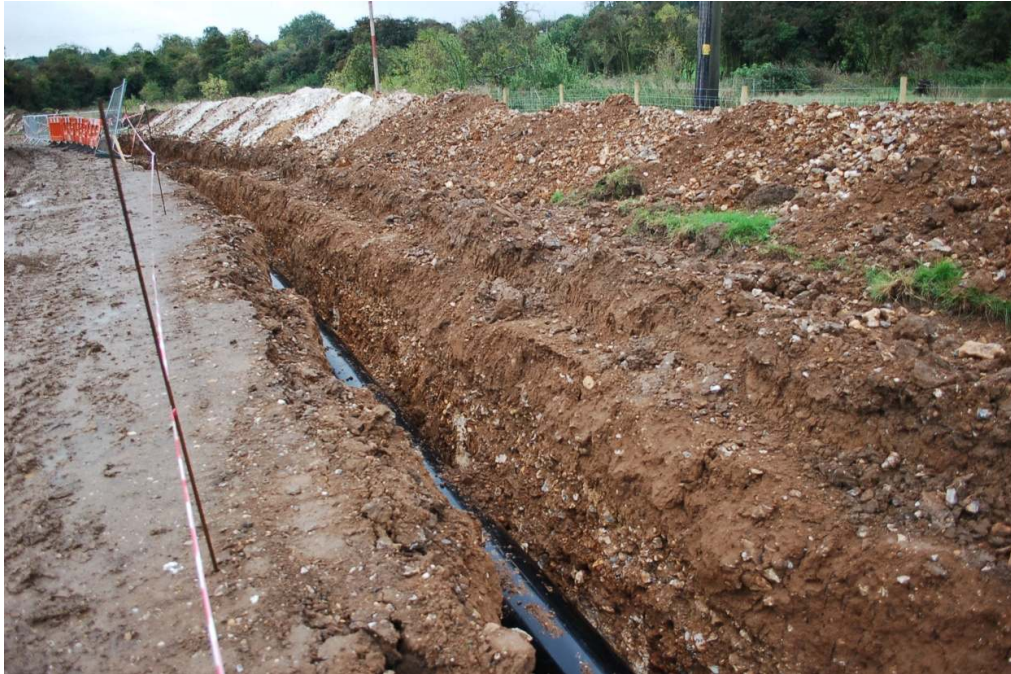
Figure 12: West end of open pipe trench in Field 2 showing clay and flint drift deposits, as can be seen it was difficult to enter the trenches at all locations owing to Health and Safety constraints.

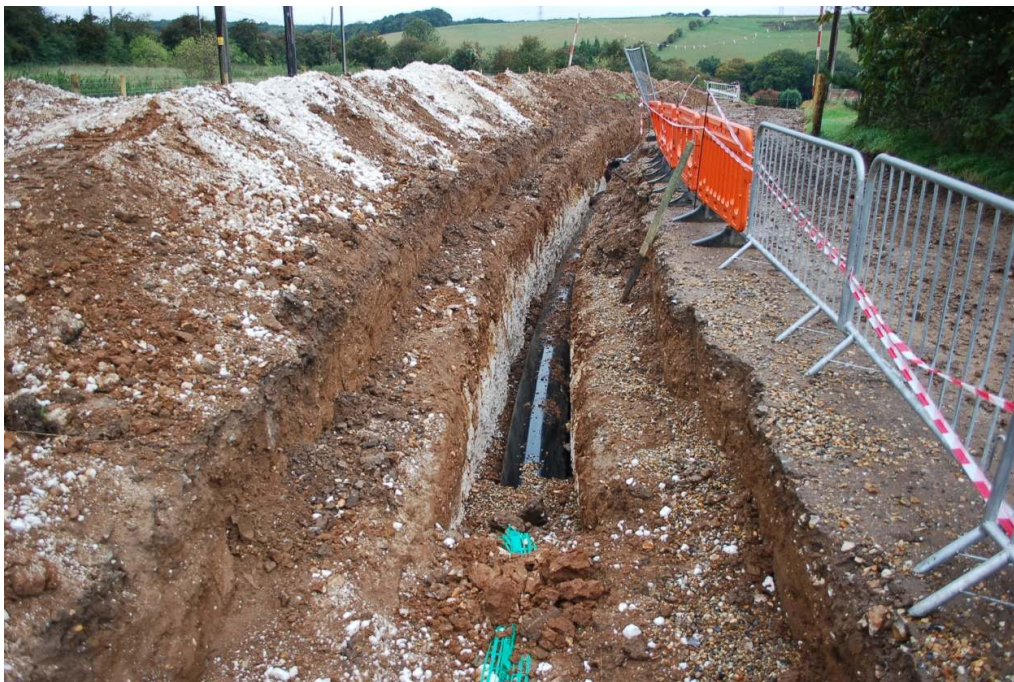
Figure 13: East end of open pipe trench in Field 2 showing rising chalk deposits.

Excavations for an inspection chamber were undertaken in this area, expanding the open trench *c.* 1m to the north and south a further 5m+ into the exposed chalk deposits. The excavations recorded continuing chalk deposits with veins of flint and pockets of silt.

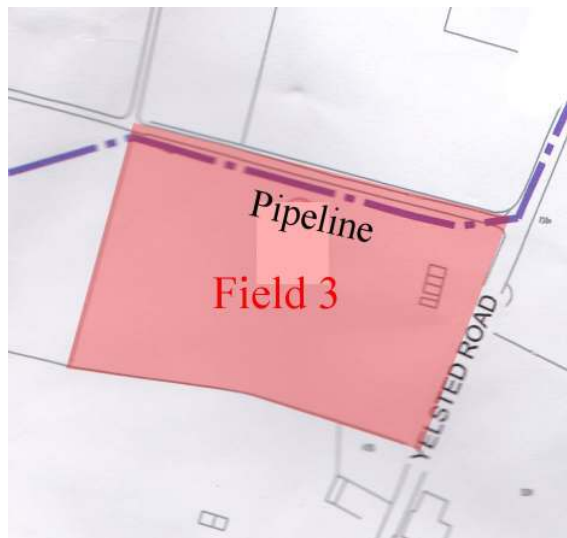
Figure 15: The pipeline route across Field 3. Based on an original drawing by Southern Water (Pipeline Route to Soakaway AB.41517309.1C0011).

In Field 3 the pipeline ran adjacent on the south side to a farm track and driveway, entering Yelsted Road at its entrance for a length of *c.*150m. The excavations in this area were problematic because of the extremely adverse weather conditions at this time and the high clay content of the soil, which made the monitoring area extremely wet and muddy, and it was quite difficult to monitor the works in certain areas of Field 3. Figures 16 and 17 below show the conditions of Field 3 at the time of the initial site visit.

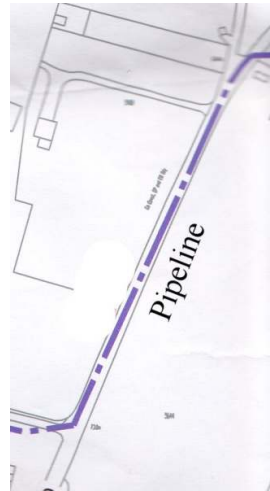
Figure 22: Yelsted Road. Based on an original drawing by Southern Water (Pipeline Route to Soakaway AB.41517309.1C0011).

Approximately 185m of pipe trench was excavated along Yelsted Road, between the farm driveway of Field 3 to the fork-junction where the pipe enters Field 4 to the east. The trench was excavated to a width of *c.*0.8m and to a depth of *c.*1.5m. The trench exposed the existing tarmac road surface over concrete hardcore with underlying road makeup deposits, no archaeological finds or features were observed. No area adjacent to the trench was suitable for metal detecting.

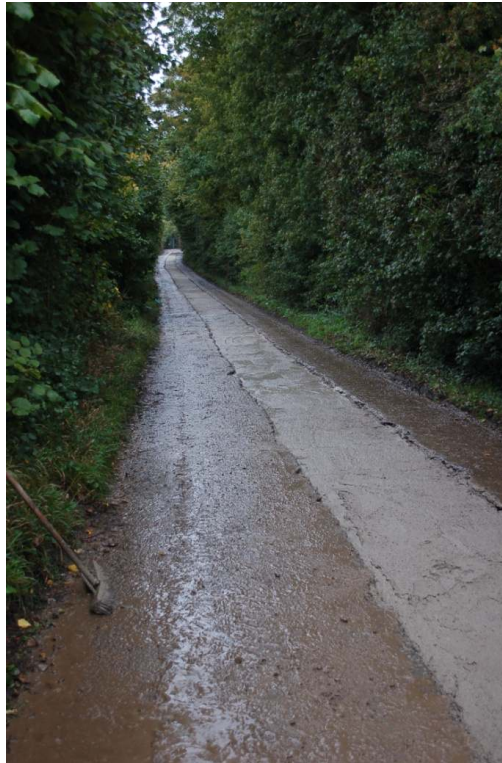
Figure 23: Trenching on Yelsted Road, after backfilling looking north.

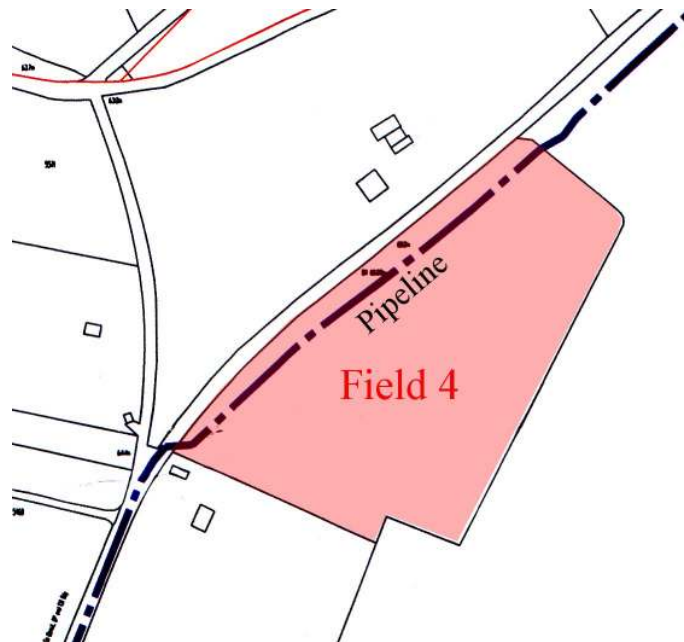
The pipe trench entered Field 4 from Yelsted Road and ran for approximately 185m to the boundary with Field 5. A narrower *c.*4m easement corridor was stripped of topsoil adjacent to the northwest hedgerow to a depth of *c.*0.3m. The topsoil consisted of mid grey/brown silty sandy soil with flint inclusions, occasional chalk flecking and very occasional modern brick, although generally very sterile. At the commencement of monitoring a small area of trenching had already been excavated, the pipe laid and the trench partially backfilled with imported shingle, but the remaining trench was excavated under archaeological supervision using a mechanical mini-digger. The trench was excavated at an initial width of 1.6m and stepped in at *c.*0.5m depth to *c.*1m width, with an overall depth of 2.1m below the existing ground surface. Below the topsoil a shallow *c.*0.3m layer of flinty mid brown/orange silty clay subsoil was observed. The subsoil overlay light orange/brown flint and sand gravels with clay and pockets of darker sandy silt. The observed deposits are Head deposits infilling the now dry river beds and are very mixed comprising gravels and brickearth with mixed hillwash. The deposits varied in colour and composition from north to south. A large service cut was observed approximately halfway along Field 4, presumably associated with a property on the opposite side of Yelsted Road. No archaeological finds or features were observed during the archaeological monitoring.

Figure 24: The pipeline route across Field 4. Based on an original drawing by Southern Water (Pipeline Route to Soakaway AB.41517309.1C0011).

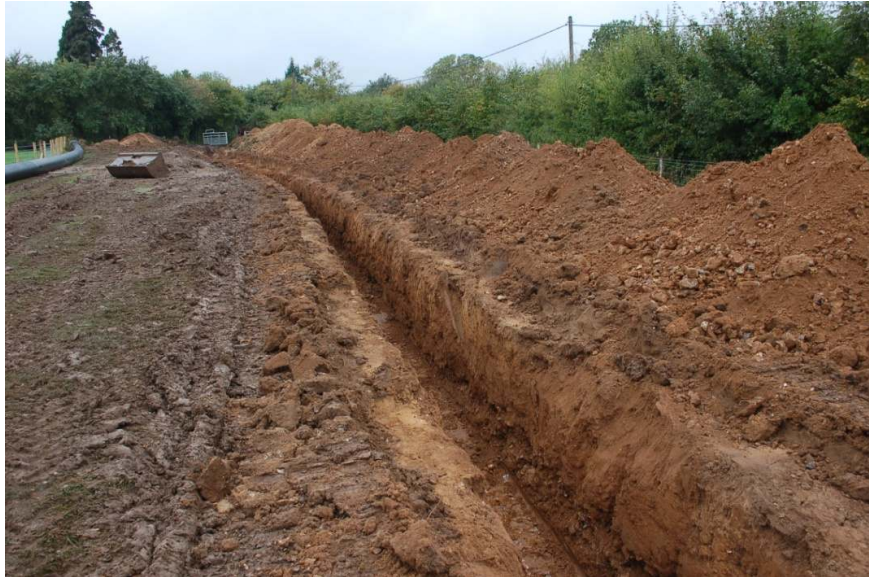
Figure 25: Trenching in Field 4 looking southeast towards the entrance onto Yelsted Road.

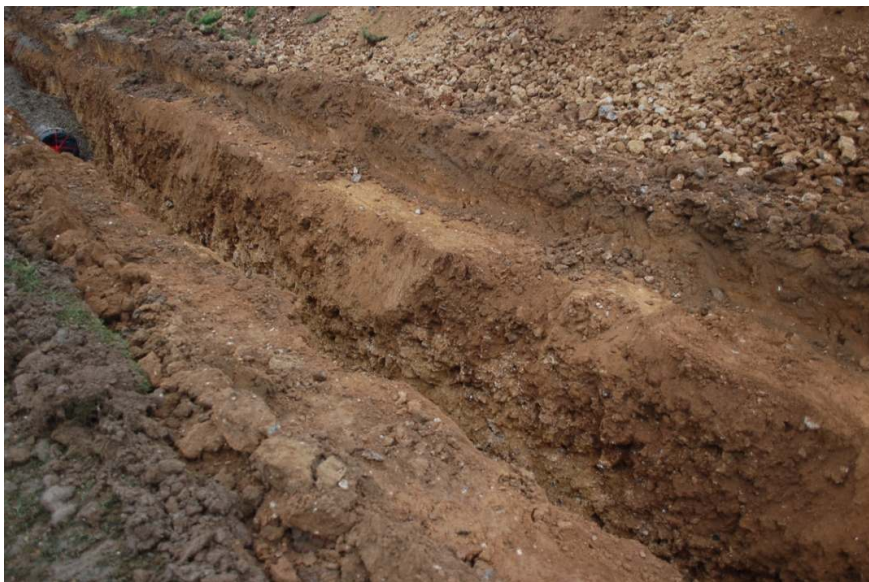
Figure 26: East facing section of pipe trenching in Field 4.

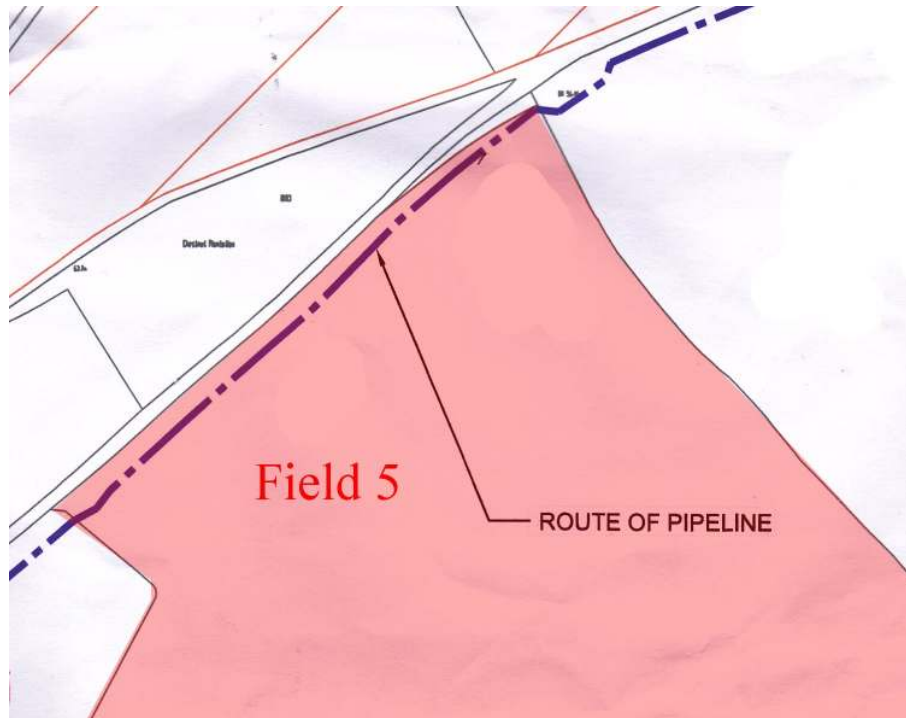
At the commencement of archaeological monitoring a *c.*4m wide easement corridor had been stripped of topsoil along the length of the pipeline in Field 5, *c.*240m. Owing to wet weather and machine movement the exposed soil of the easement was in places submerged in water and mud and observation was restricted here. In order to correct this a sample of approximately 50m was re-stripped prior to excavation of the pipe trench in order to monitor this area. A small area of burning was exposed immediately below the stripped topsoil but this is was modern in origin. The pipe trench was then excavated in Field 5 to a general depth of *c.*2.1m and exposed sterile mid orange/brown subsoil with sand, gravels and clay to 0.3m (below 0.22m of topsoil). Natural Head deposits were exposed for the remaining depth, consisting of varying flint and sand gravels with mixed hill wash. No archaeological finds or features were exposed during either stripping or pipe trench excavations.

Figure 30: Route of the pipeline across Field 5. Based on an original drawing by Southern Water (Pipeline Route to Soakaway AB.41517309.1C0011).

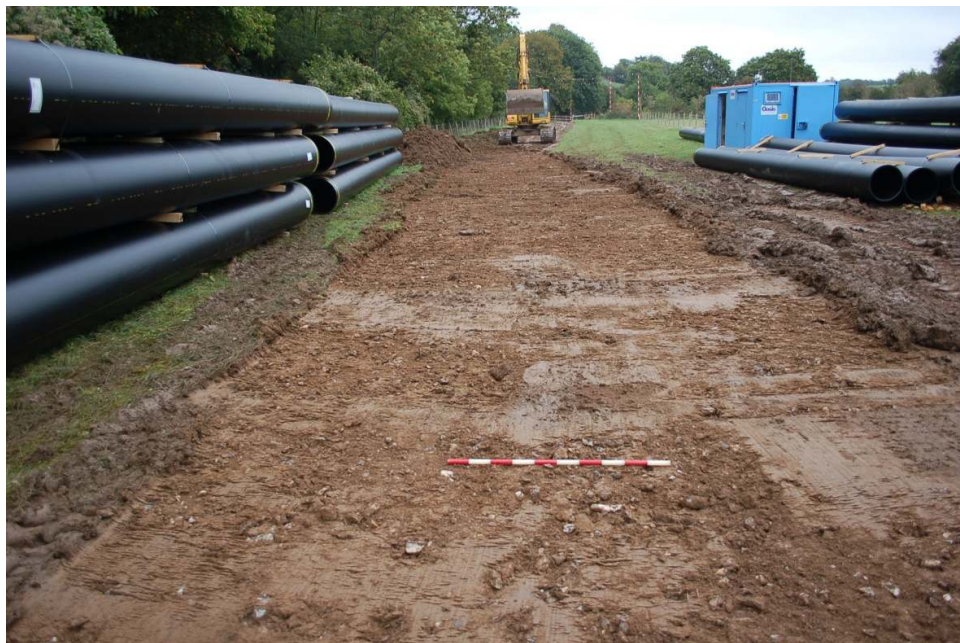
Figure 31: Re-stripping of topsoil, to remove the waterlogged and disturbed overlying deposits (1m scale), looking northeast towards Field 6.

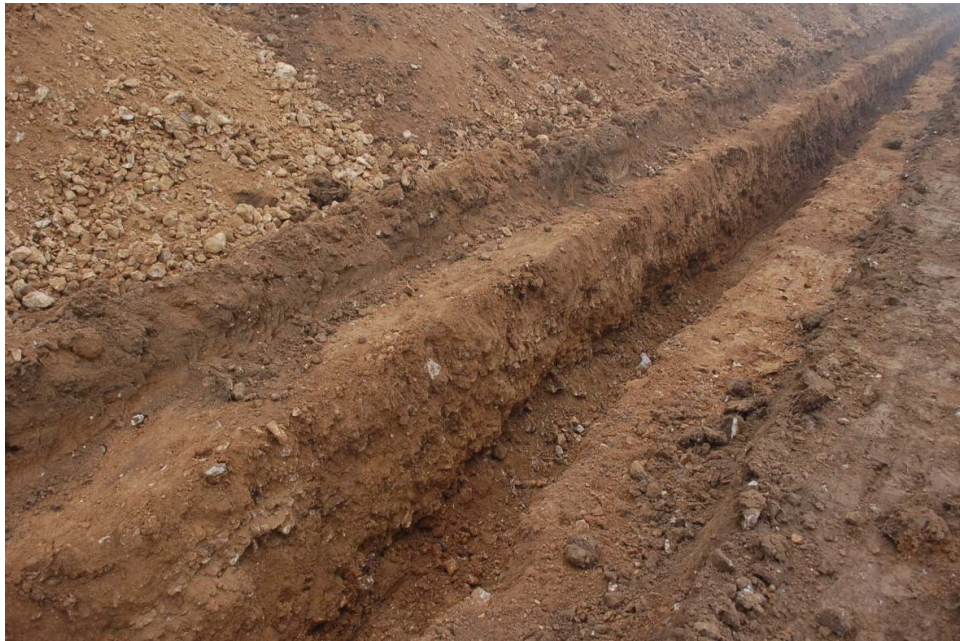
Figure 32: Trenching in Field 5 showing mixed Head deposits.

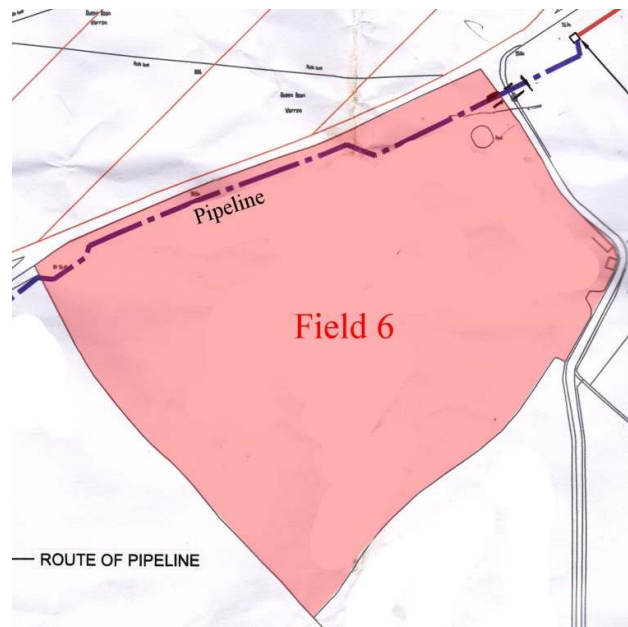
Figure 33: Route of the pipeline across Field 6. Based on an original drawing by Southern Water (Pipeline Route to Soakaway AB.41517309.1C0011).

Approximately 275m of pipeline were excavated across Field 6 between the boundary with Field 5 and the southwest side of Cradles Road. As with previous excavations, the trench was excavated at an initial width of 1.6m, stepped in at a depth of 0.6m and excavated at 1m width to a depth of 2.1m. The initial easement strip removed *c.*0.3m of turf and mid-light grey/brown topsoil with flint pebbles, chalk flecking and occasional modern brick and ceramic. A shallow layer *c.*0.15m in thickness of light orange/brown silty/sandy clay with flints was exposed in section below – this was recorded as subsoil and lies at the interface with the underlying natural deposits. Natural Head deposits of mixed gravels and sand with hill wash were observed from *c.*0.45m below the existing ground surface – these were generally mid brown/orange sand, clay, large flint nodules ranging from 10-200mm. At the southwest end of the trench Head deposits extended to the full depth of excavation, *c.*2.1m below the existing ground surface. As the trench continued northeast rising chalk deposits were exposed in section, generally soft and degraded with flint and sand pockets. Occasional modern services were observed in section but no archaeological finds or features were recorded during trenching.

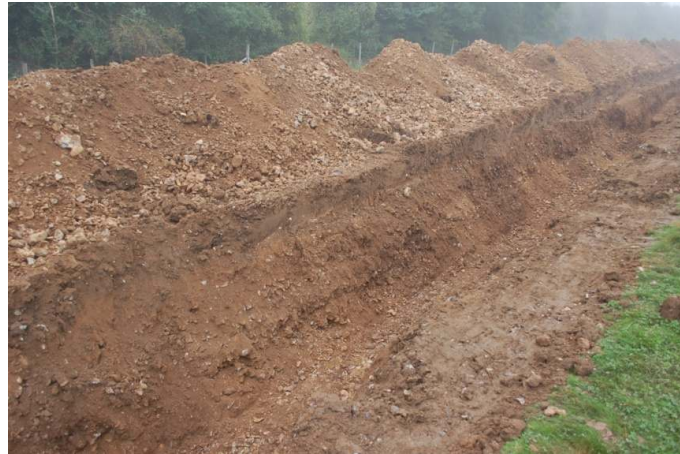
Figure 34: Head deposits in trenching in the southwest half of Field 6 (southeast facing section).

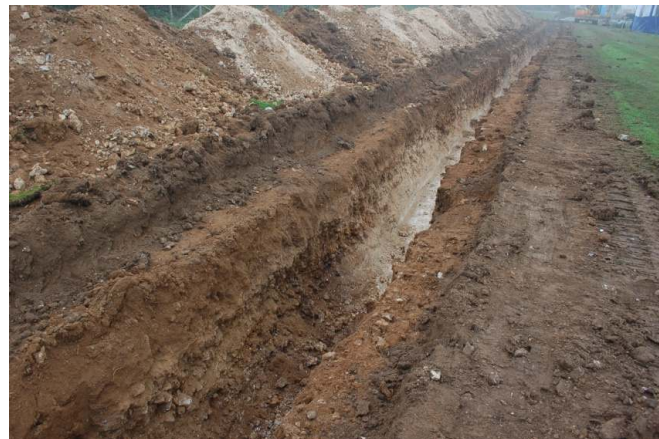
Figure 35: Rising chalk deposits to the northeast of Field 6 (southeast facing section).

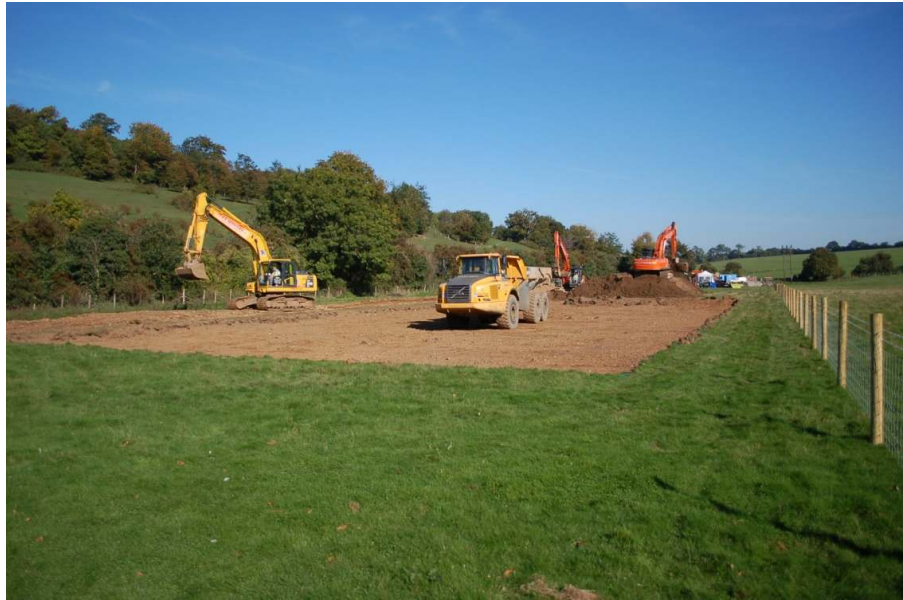
Figure 36: Topsoil stripping for the chalk bund in Field 6.

In the area adjacent and to the southeast of the pipe trench in Field 6, a large 160m by 20m area was stripped for the construction of a chalk bund (or raised embankment) for environmental purposes. An average of 0.3m of turf and topsoil, with an additional *c.*0.15m of subsoil were stripped across the entire area exposing the underlying natural Head deposits. In plan these deposits varied considerably across the exposed area, varying particularly in the density of flint nodules. No archaeological features were exposed in plan but a small assemblage of finds was recovered from the topsoil. The finds included four pieces of burnt flint, a possible Neolithic core fragment, a small assemblage of pottery and a single fragment of modern glass bottle. The pottery comprised two sherds of miscellaneous 19th century wares and a single sherd of Bone China (1770-1925).

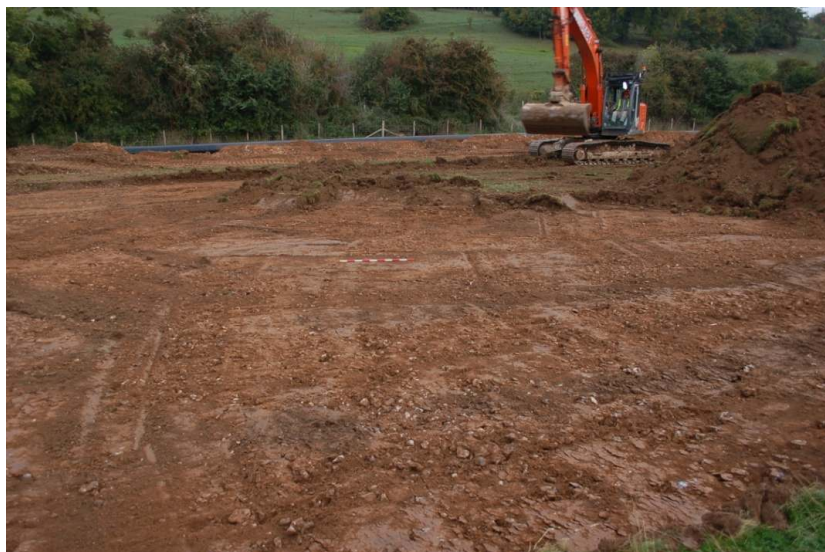
Figure 37: Topsoil stripping for the chalk bund in Field 6.

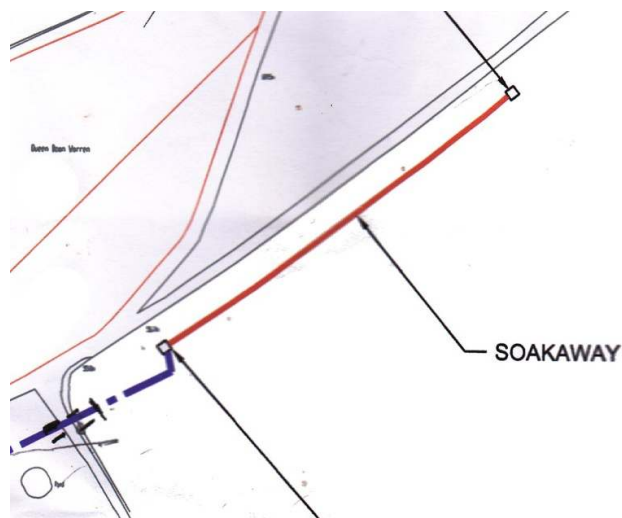
Figure 40: The soakaway excavation in Field 7. Based on an original drawing by Southern Water (Pipeline Route to Soakaway AB.41517309.1C0011).

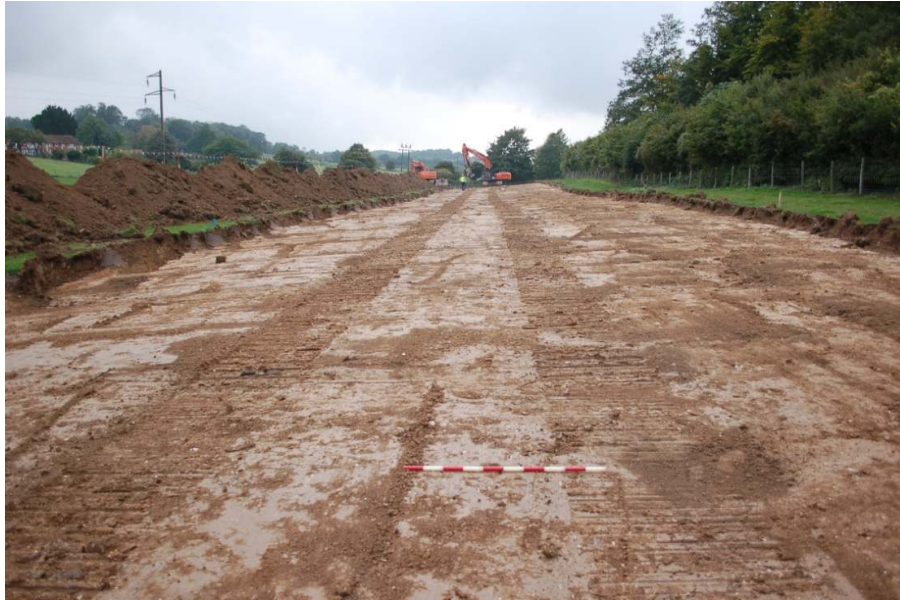
Figure 41: Stripped area for the soakaway excavations, looking southwest towards Cradles Road.

A test-pit excavated by contractors prior to the commencement of groundworks was exposed in the southwest half of the stripped area. Plough furrows were exposed in plan across the majority of the stripped area, with varying degrees of preservation. No datable material was recovered from these features but all were aligned northeast to southwest and indicate that the field (currently meadow) was farmed at some point in the past. The furrows may represent historic land use from the early post-medieval period, but as no datable material was recovered they may well be more recent – the field has certainly not been ploughed in recent years.

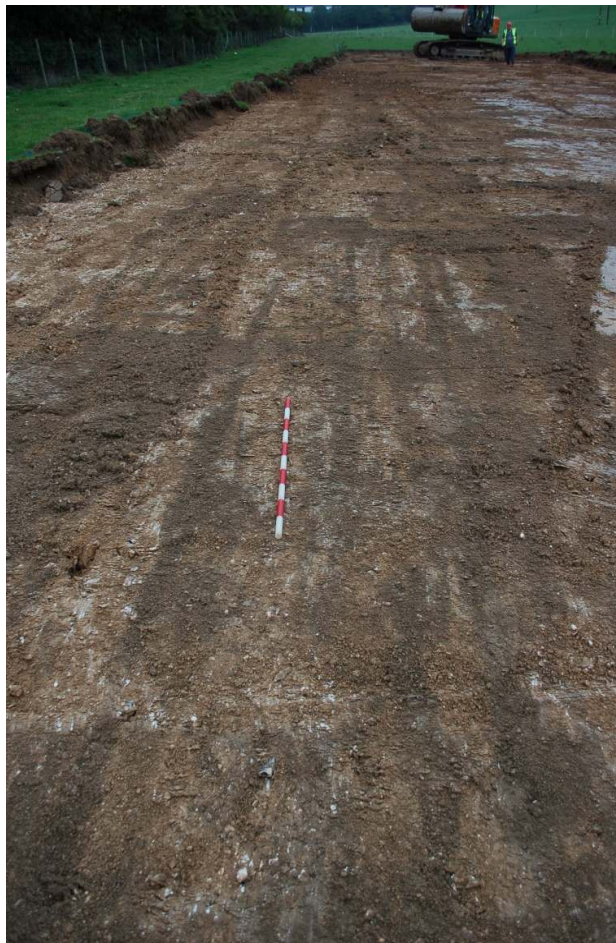
Figure 42: Plough furrows exposed during topsoil stripping in Field 7.
