Archaeological Evaluation Report

**10 – 14 WESTERN ROAD
Romford, RM1**

Project: HN540
Site Code: WRF05
NGR: TQ 51430 88695
LPA ref.: P1509/03

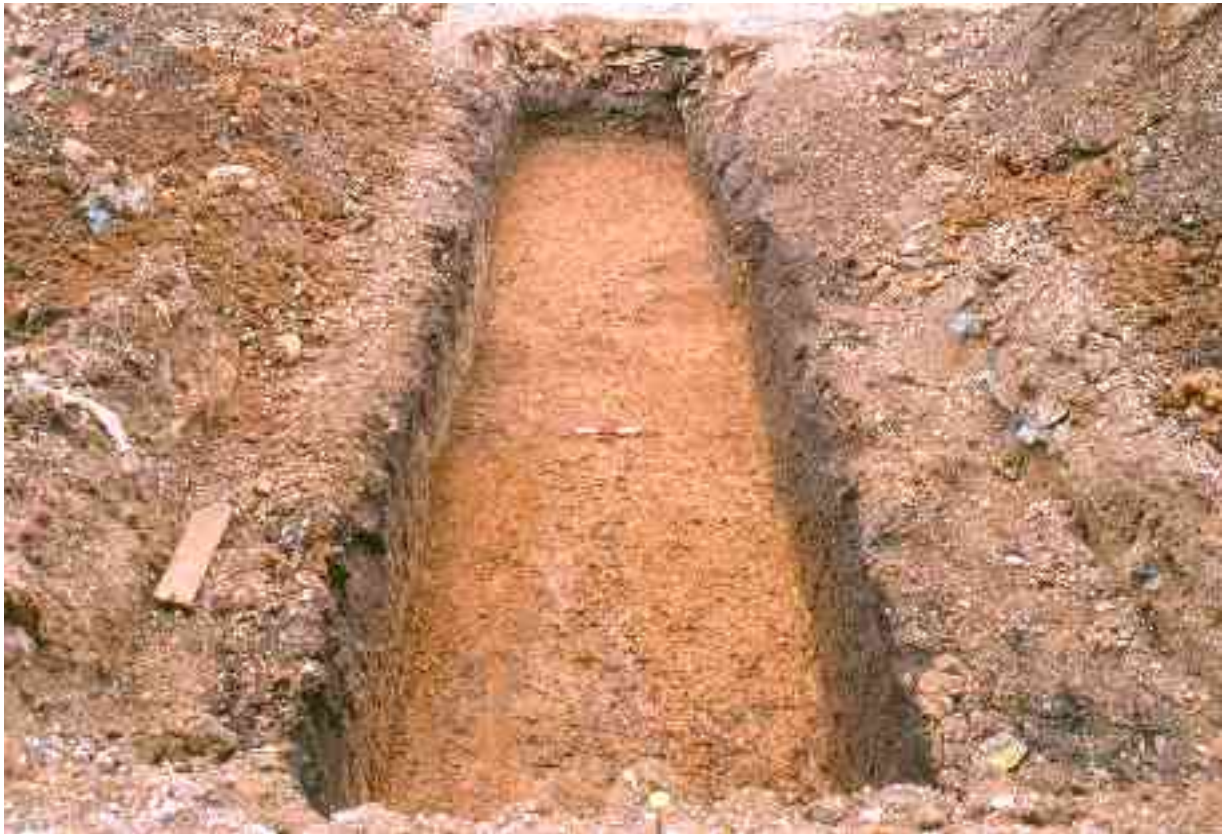
Fig 5 General view of Trench 1, looking southwest and showing the exposed surface of the natural sandy/clayey silt (*0.5m scale*)

The lowest deposit exposed in the trench was a compact sandy/clayey silt with occasional patches of sandy medium to fine gravel, and apart from some root traces quite sterile. This deposit was recorded at about 16.2m OD – some 1.0m below present ground level – and probably represents the top of the natural Head deposit as recorded by the Geological Survey (1.3 above).

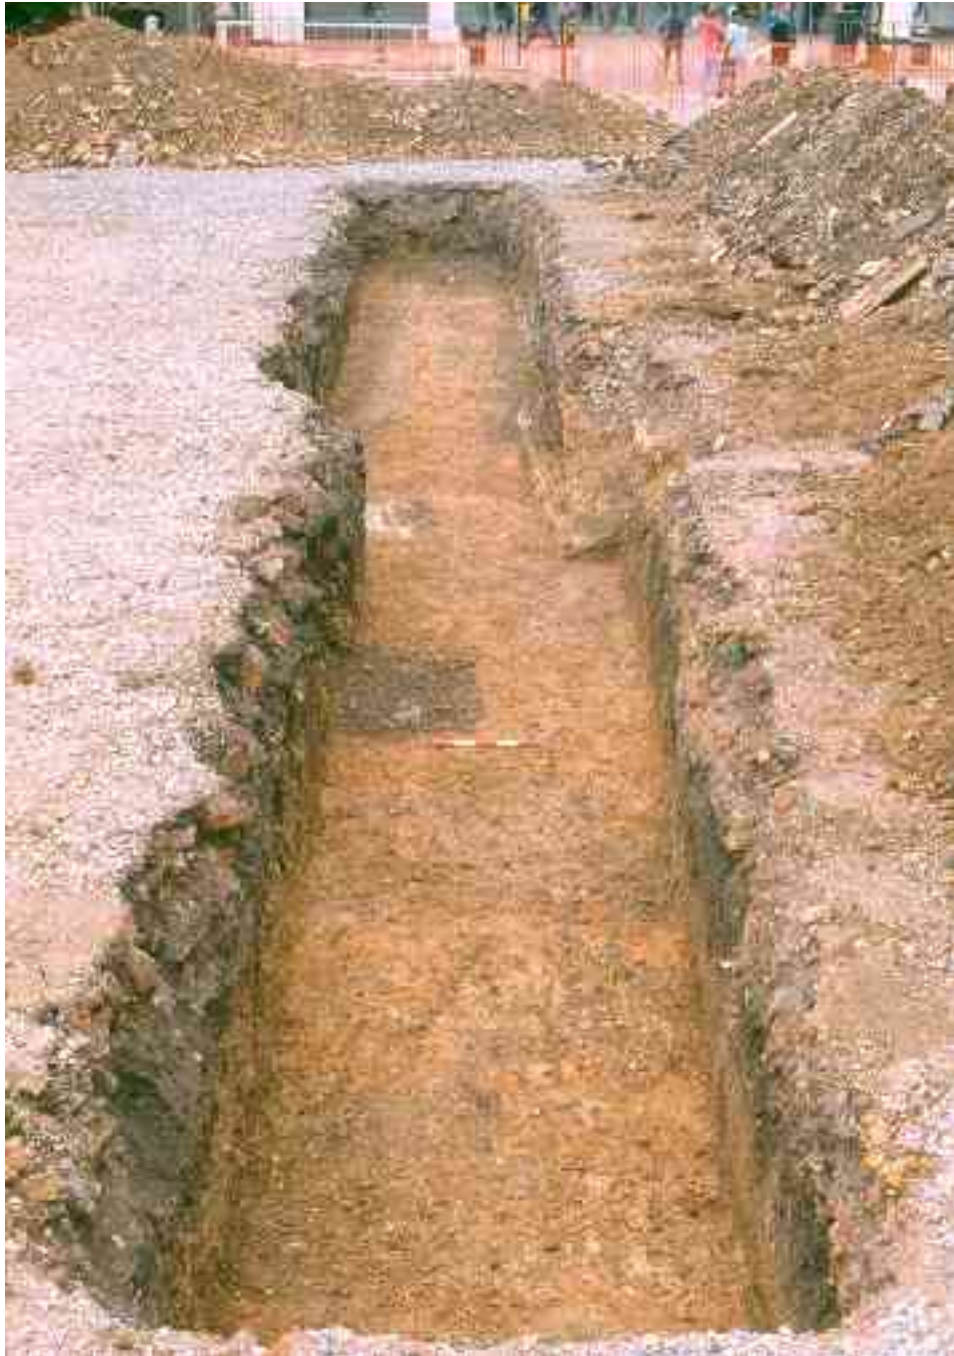
Fig 8 General view of Trench 2 looking northwest towards Western Road (*0.5m scale*)

Within the southern part of the trench the natural surface was comparable to that in Trench 1, *ie.*, a sterile sandy silt-clay with occasional patches of silty sandy gravel, but to the north this was replaced by a homogeneous sandy medium/fine gravel. There was no distinct line between the two areas, but it is assumed that the former is mainly a Head deposit whilst the later represents the edge of the later Hackney Gravel Terrace (*cf.* 1.3 above). Levels also rose slightly from north to south, from about 16.4m to 16.7m OD.

The northern part of Trench 2 – just over half the total length – contained a substantial wall foundation and two disused drains, and had been heavily disturbed by these developments. The wall foundation ran along the eastern side of the trench for nearly 11 metres, and was left *in situ* with a corresponding offset in the line of the trench (see Figure 4). The base was of solid concrete cut into the natural at about 16.5m OD, overlain by yellow stock brickwork that was stepped up to a surviving width of *c* 240mm (= one brick's length). At the southern end there was a corner and return into the eastern section of the trench.

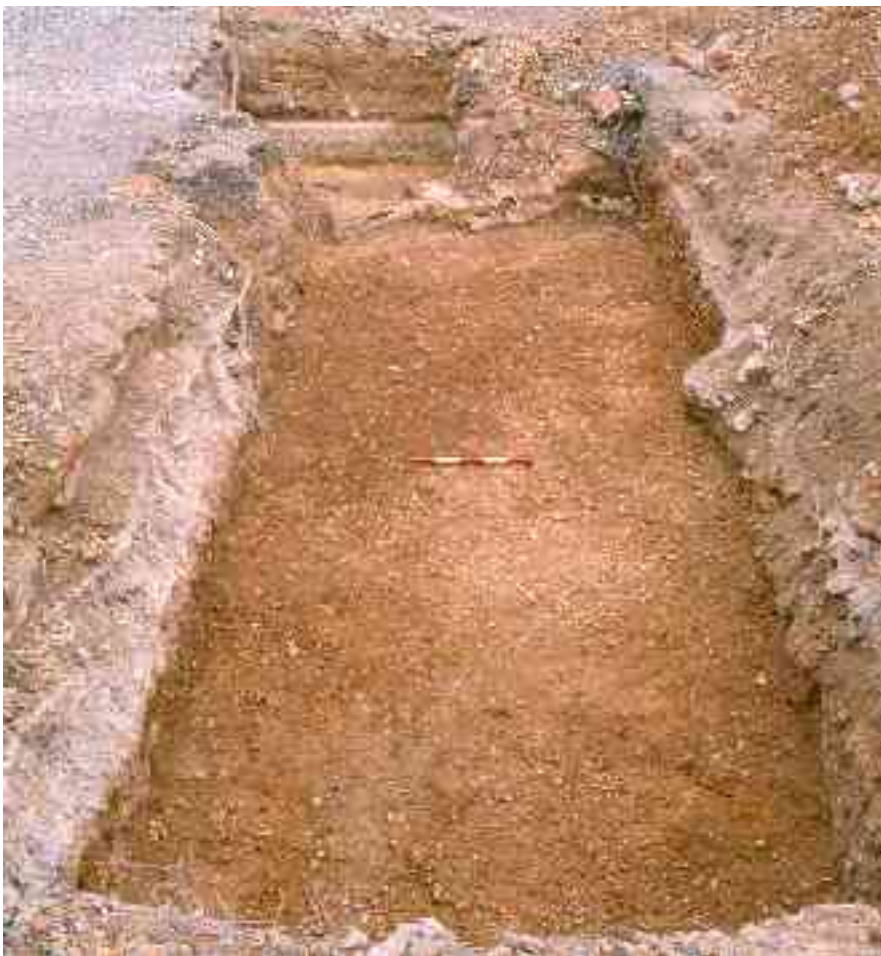
Fig 11 General view of Trench 3, looking northeast and showing the surface of the natural gravel (*0.5m scale*)

The natural surface here comprised a slightly silty sand and medium/fine gravel, much like that in the northern part of Trench 2 and presumably part of the same River Terrace Deposit. Levels were also similar, at about 16.6m OD and 0.8m below the present ground surface.
