26 NORTH ROAD, HIGHGATE, N6 4BE
LONDON BOROUGH OF HARINGEY
AN ARCHAEOLOGICAL EVALUATION

AN ARCHAEOLOGICAL EVALUATION

SITE CODE: NOR 11
SITE CENTRE NGR: TQ 2834 8760
PLANNING REFERENCE No: HGY/2010/1888

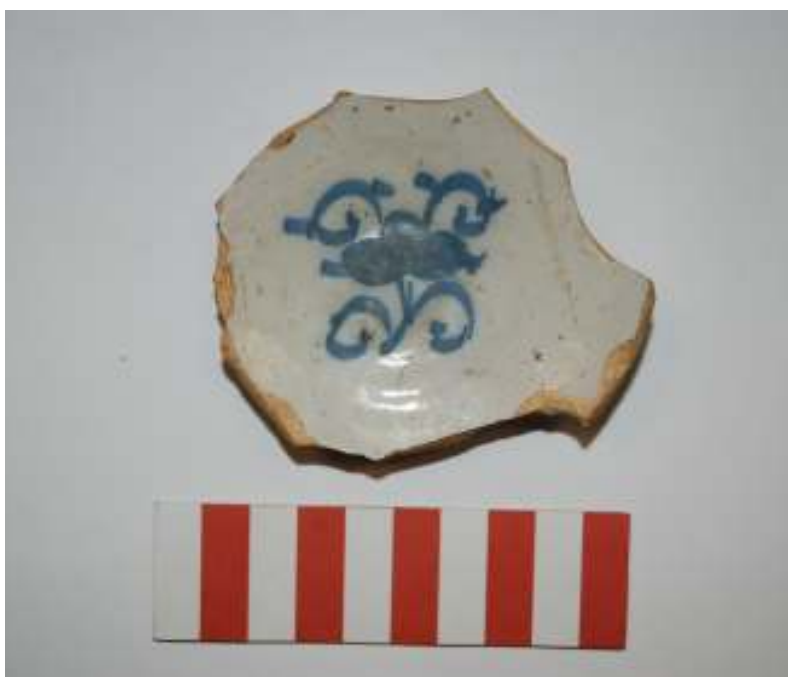
*Figure 8:
Delftware fragment,
from clearance of
trench 1*

6.2.1.5 The pottery recovered from context [11] was dated to the early 18th Century. This included a substantial quantity of post-medieval redware and English tin-glazed ware. The pottery from context [17] was dated to the mid-17th Century, and included an almost complete Chinese Porcelain Bowl and a large fragment of a Staffordshire slipware posset-cup. This pottery therefore suggests that the feature containing [11] and [17] dated from approximately the mid-17th to early-18th Century.

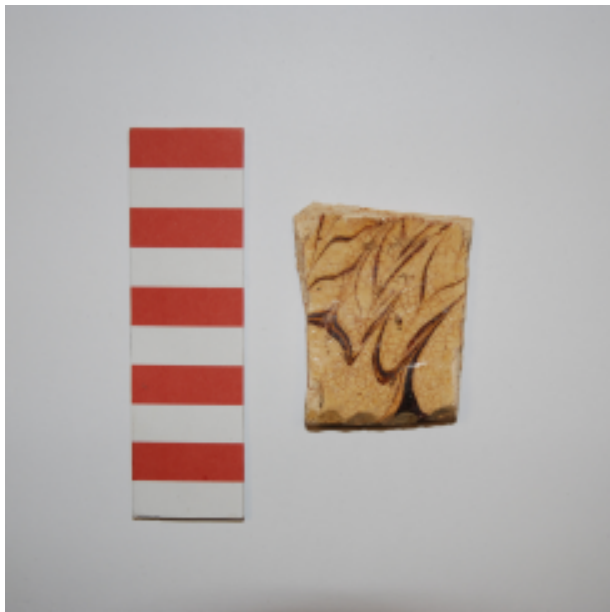
*Figure 10: Pottery fragment
(Staffordshire slipware) from context 17
(ditch fill)*

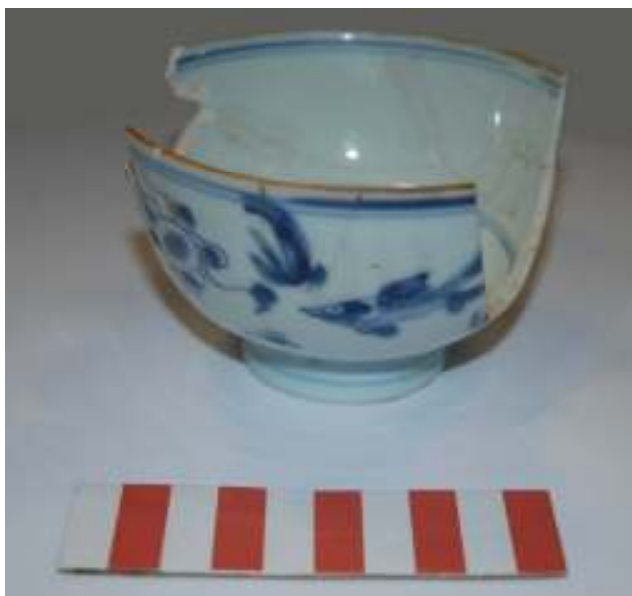
*Figure 11: Piece of Chinese Porcelain
from context 17 (ditch fill)*

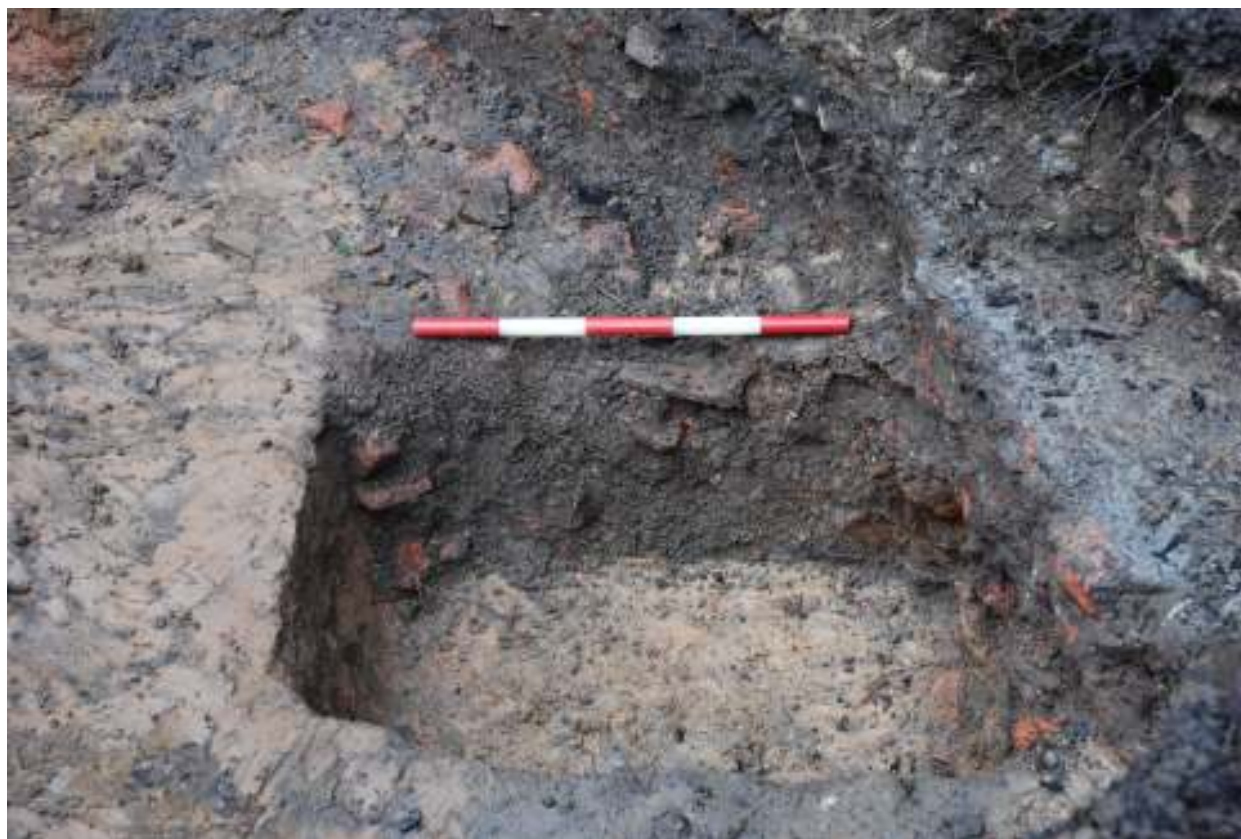
Figure 14: Photo of partial excavation of fill [11]

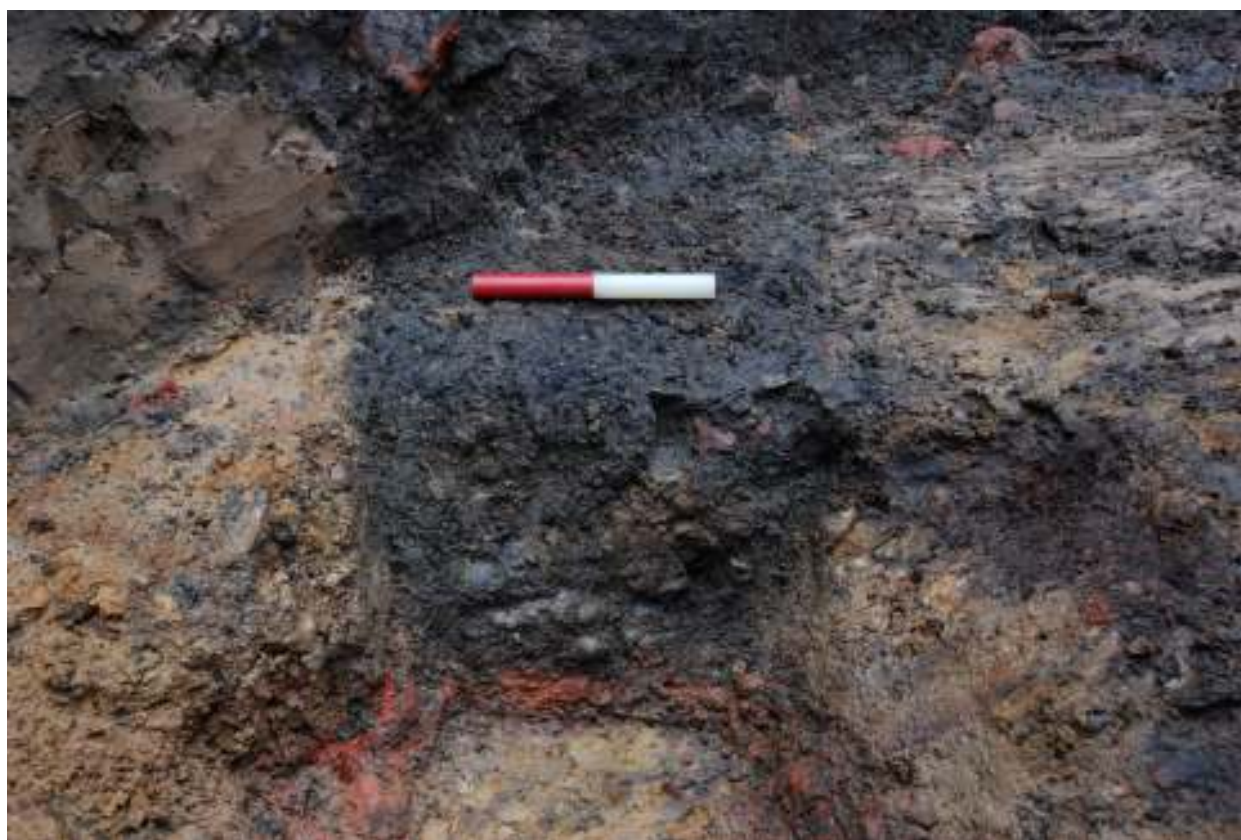
Figure 15: Photo of partial excavation of fill [17]

- 6.2.1.7** The precise function or role of the feature is unknown. It is possible that the feature [17]/[18] is some form of drainage ditch or gully leading into or out of feature [11]/[12] (which may have been far larger than it appeared in plan). Alternatively, [12] may have been a rubbish pit or something similar.

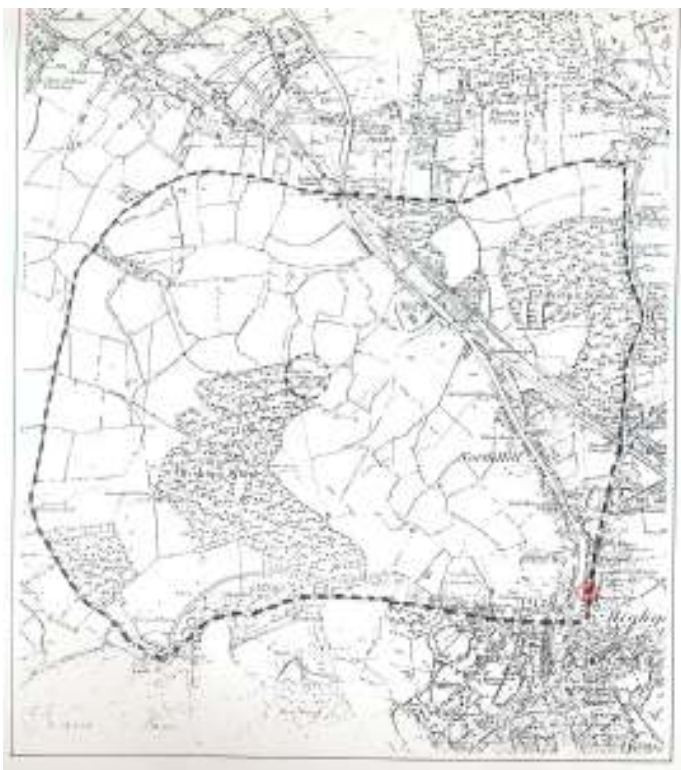
Figure 20: 1873 Map with medieval hunting park boundary traced on (from Stokes, 'Highgate Hunting Ground'), with approximate site location marked

6.2.3.12 The exact location of this eastern boundary is unknown. 19th Century OS maps depict long stretches of unbroken hedges, which may have represented the line of the park. Furthermore, the construction of North Road in 1284 as a toll-road across the hunting park suggests that North Road itself was within the park. It seems sensible that this would have run close to the boundary of the park – so that it interfered as little as possible with hunting within the park. Furthermore, Stokes (1984 article) suggests that the eastern boundary of the park ran very close to the site.

6.2.3.13 It is therefore possible that the depths of ‘made-ground’ deposits uncovered in the trenches (including trench 1 – [27]) may represent the infilling of the eastern boundary ditch of the bishop of London’s hunting park, or at least some landscaping of the slope associated with this park boundary.

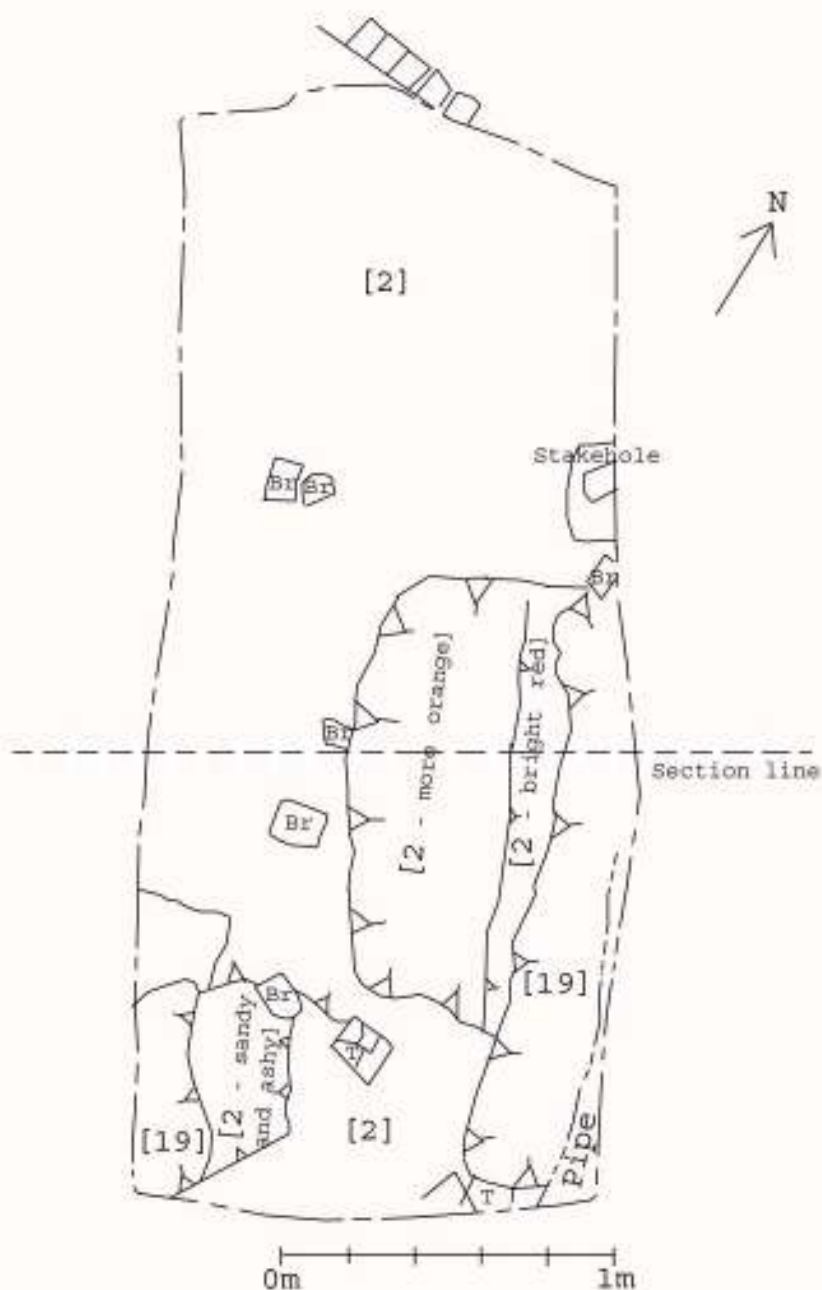
Figure 21:
Plan of first
stage of
excavation of
trench 2

6.3.1.1 The first part of the excavation of trench 2 reduced the area to a height of *c.* 126mOD (*c.* 0.8m beneath the modern ground-surface).

6.3.1.2 The upper layer of this area was a brown-yellow clay [1]. This was found across the whole trench, and peeled off to the lower *in situ* burnt layers. It also contained burnt tile (peg tile) and brick, however was not burnt itself. Instead, it appears to seal the burnt layers. The bricks were dated 1450-1700, and the tile 1500-1900. This deposit seems similar to the clay observed in trench 1 ([13]), which was dated to before the later 17th Century. This therefore means that the burnt brick layers, which underlay this clay, must also be of this date or earlier.

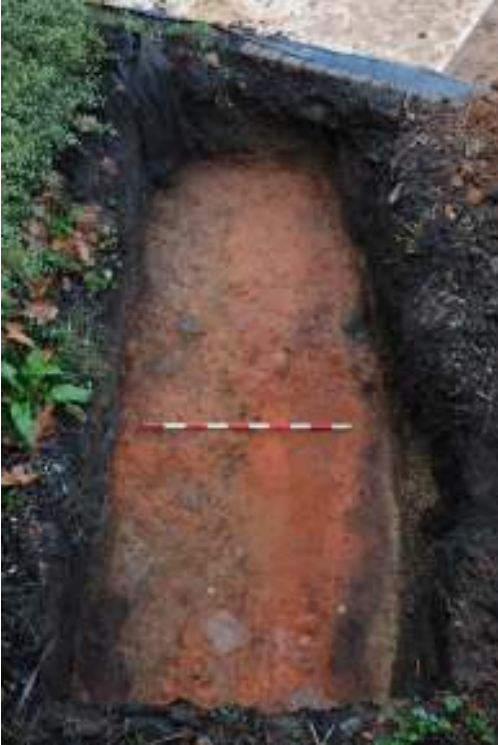
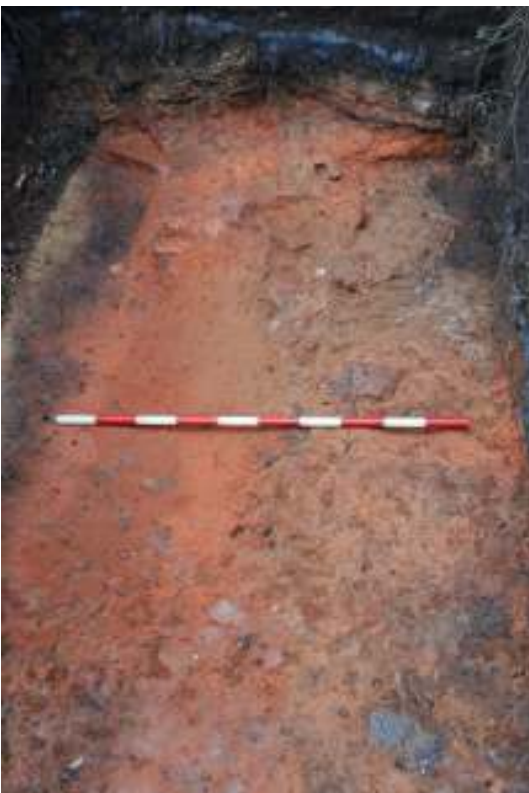
6.3.1.3 The uppermost *in situ* burnt layer was exposed and cleaned (figs. 23 and 24). A slot was then hand-dug across the trench, to a depth of *c.* 125mOD (fig. 22).

Figure 23: Photo of first stage of excavation of trench 2, from the south-east

Figure 24: Photo of first stage of excavation of trench 2, from the north-west

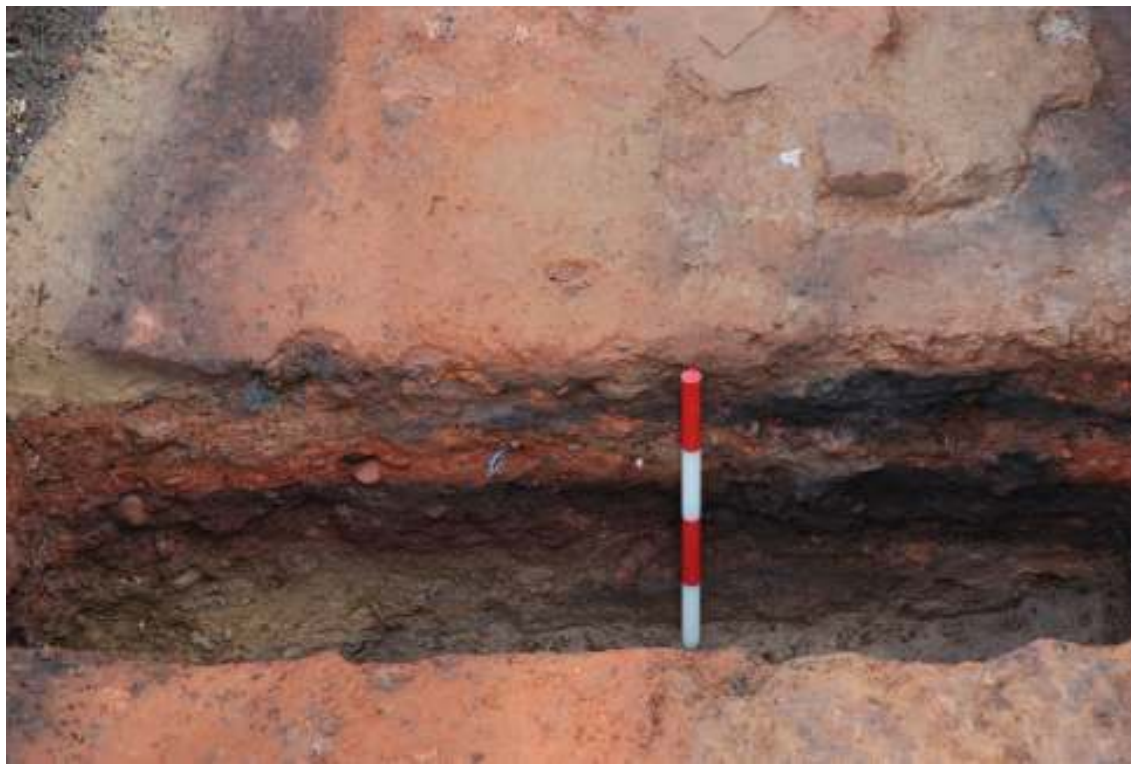
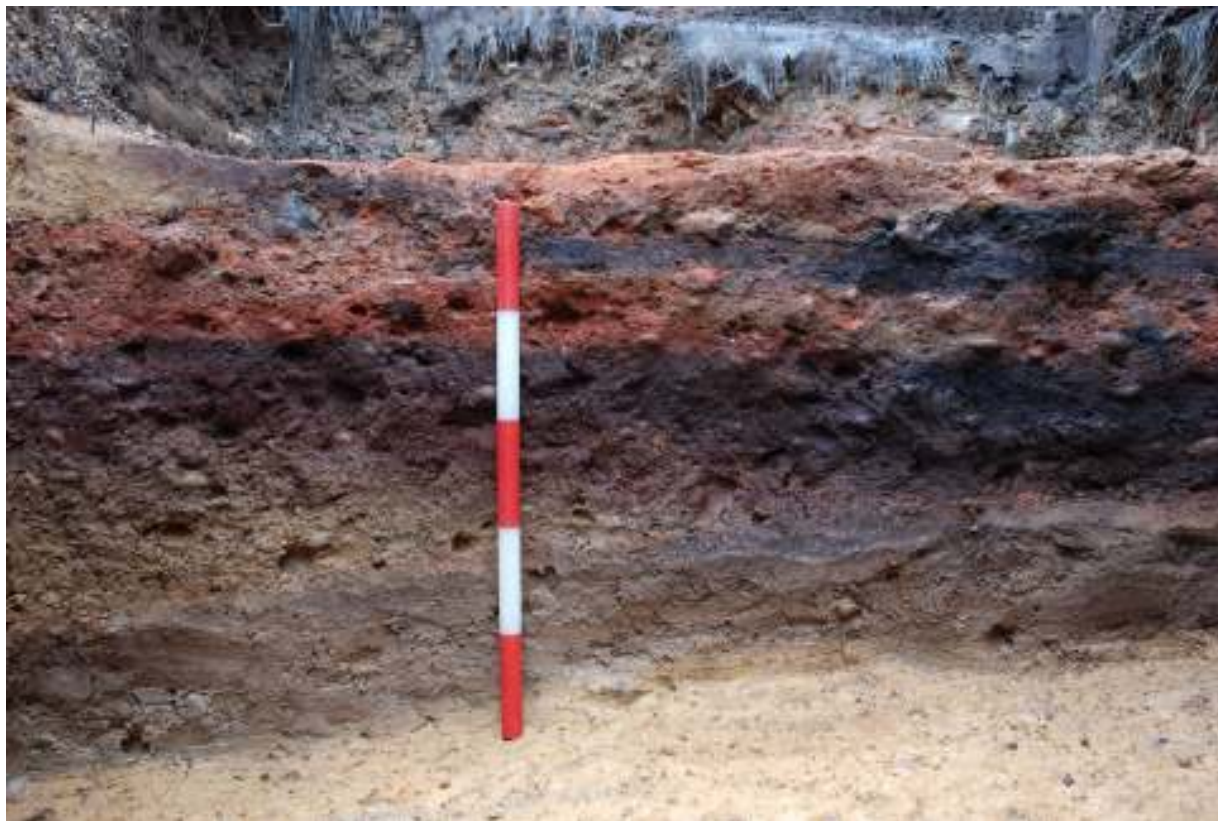
6.3.1.4 The next 7 layers ([2], [21], [22], [19], [23], [20], and [24]) are all burnt layers. They vary between burnt CBM/brick debris layers (such as [2], [21], [23], and [24]), and ashy deposits ([21], [22], and [20]). Furthermore, incredibly burnt and vitrified bricks and very burnt flint were also recovered from these layers.

- 6.3.1.7** These burnt layers indicate the existence of a brick clamp. A clamp was a temporary structure of unfired or green bricks – which was often constructed near the source of the clay, and which was often fairly short-lived. They were typically constructed on flat ground, with a base made of burnt bricks. Channels were often made in the floor and filled with fuel. Three or four green bricks were placed on edge above this, and then another layer of fuel added. The bricks were then closely packed together, and burnt. Some of these clamps could be huge – containing 150,000 bricks, for example, and taking ten – twelve weeks to burn out.

Figure 25: Photo of slot dug to reveal layers of burning, looking south-east

Figure 26: Close-up photo of slot, looking south-east

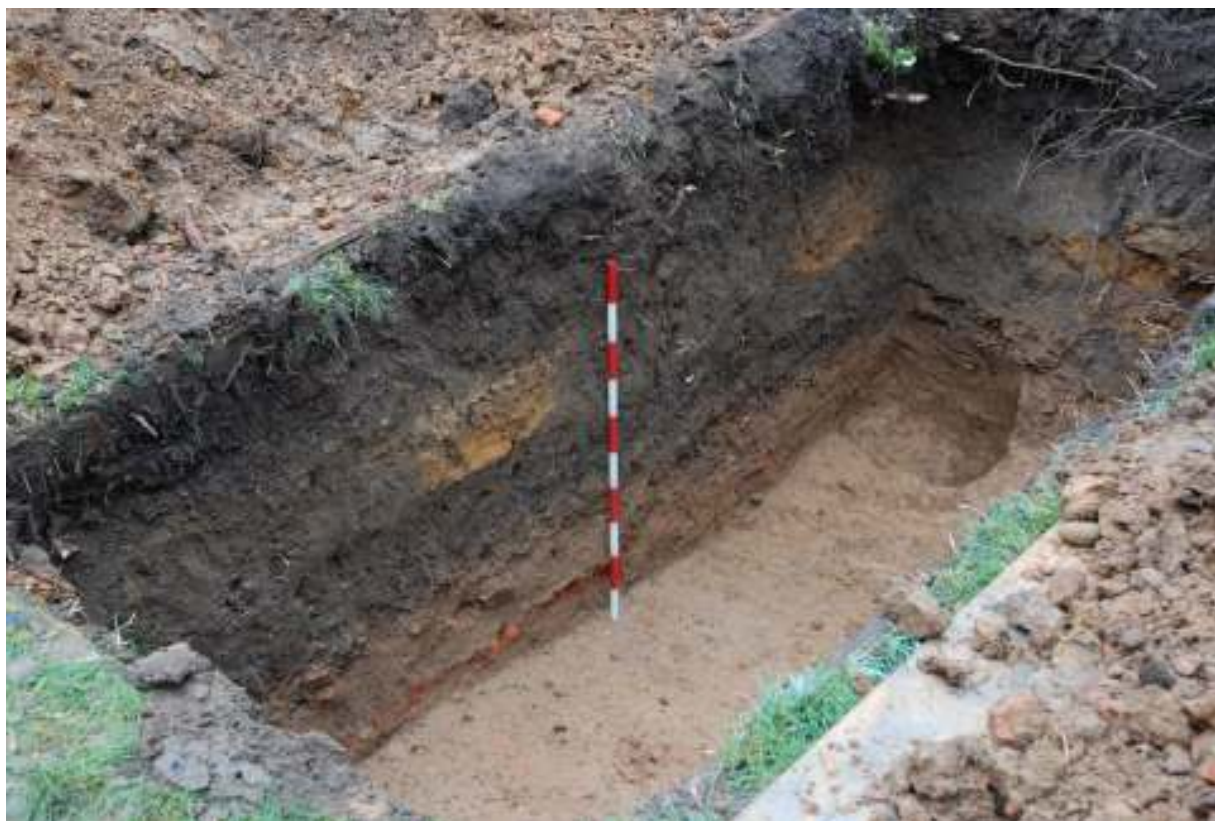
Figure 27: Northern section in trench 3

6.4.1.2 The uppermost deposits in this trench included two contemporary, and probably relatively modern, pits – which included two different types of fills. These were observed directly beneath the topsoil, and were therefore probably modern. The shape and size of them suggests that they could have been tree pits.

6.4.1.3 A ‘made-ground’ deposit ([6]) was observed beneath this (at a height of *c.* 126.59mOD). This appeared to be of little archaeological interest. A buried soil horizon was observed ([7]) at *c.* 126.19mOD. This overlay another ‘made-ground’ deposit ([8]) at a height of *c.* 125.99mOD. Deposit [8] is broadly similar to - and may be part of the same general layer as – contexts [13] and [1] in trenches 1 and 2.

6.4.1.4 A thin layer of red brick debris ([9]) was observed at a height of *c.* 125.82mOD. This was very thin – only *c.* 0.05m. This deposit is similar to the thin layer of brick rubble uncovered in trench 1 ([26]) and the many layers of brick rubble and burnt brick deposits in trench 2 ([2] etc) – and discussed in

Figure 28: Photo of northern section in trench 3

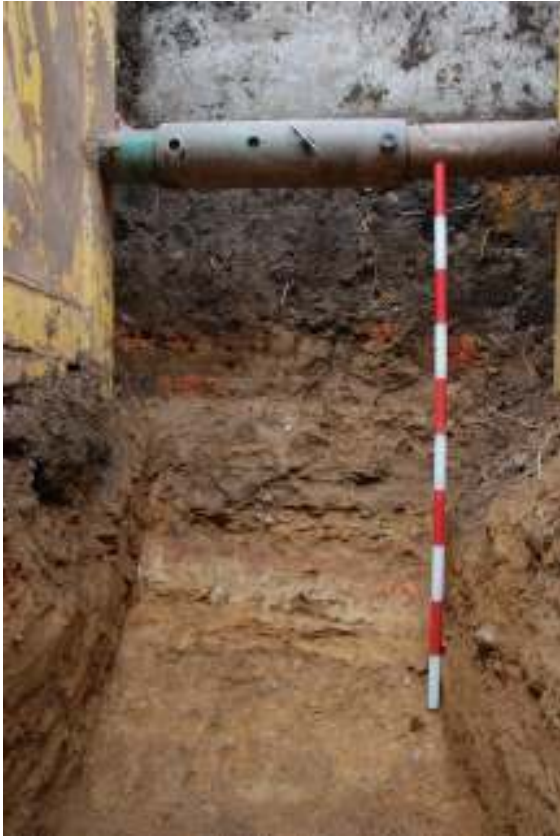
6.4.2.2 A deep deposit of ‘made-ground’ ([10]), similar to that in trench 1, was also observed in this trench – to a depth of *c.*1.5m beneath the modern ground-surface (*c.*125.4mOD; thickness of *c.*0.35m). This deposit also looked ‘natural’ in some respects (i.e. it was very compact, was a clay deposit, and had few visible inclusions), however it also contained chunks of brick rubble and tile which were clearly too large to have been carried down through root action or wormholes. These were generally dated to 1450-1700 (see brick report). It was therefore a ‘made-ground’ deposit. The uniformity of it, in a similar way to that in trench 1, suggests that it was deposited in one single event, at some point after 1450. It is therefore possible that this is further evidence for the infilling of the eastern boundary ditch of the Bishop of London’s hunting park or another type of landscaping of the slope (see discussion in relation to trench 1).

6.4.2.4 Beneath this was the ‘natural’ ([16]), observed at a height of *c.*125.4mOD (1.5m beneath ground-surface). This was a clean silty-clay deposit. It is noticeable that the ‘natural’ was definitely observed in this trench – whereas it was not so definitely observed in the other trenches. This is probably because it was possible to enter this trench, because of the trench-box, whereas it was only possible to monitor the bucket-loads from the other two trenches.

Figure 29: Photo of eastern section in trench 3, showing contexts [10], [15], and [16]
