**103 CHEYNE WALK, SW10 0DQ**  
**ROYAL BOROUGH OF KENSINGTON AND**  
**CHELSEA**  
**AN ARCHAEOLOGICAL EVALUATION**

AN ARCHAEOLOGICAL EVALUATION

SITE CODE: CHE 11  
SITE CENTRE NGR: TQ 2681 7749  
PLANNING REFERENCE No: PP/07/00912

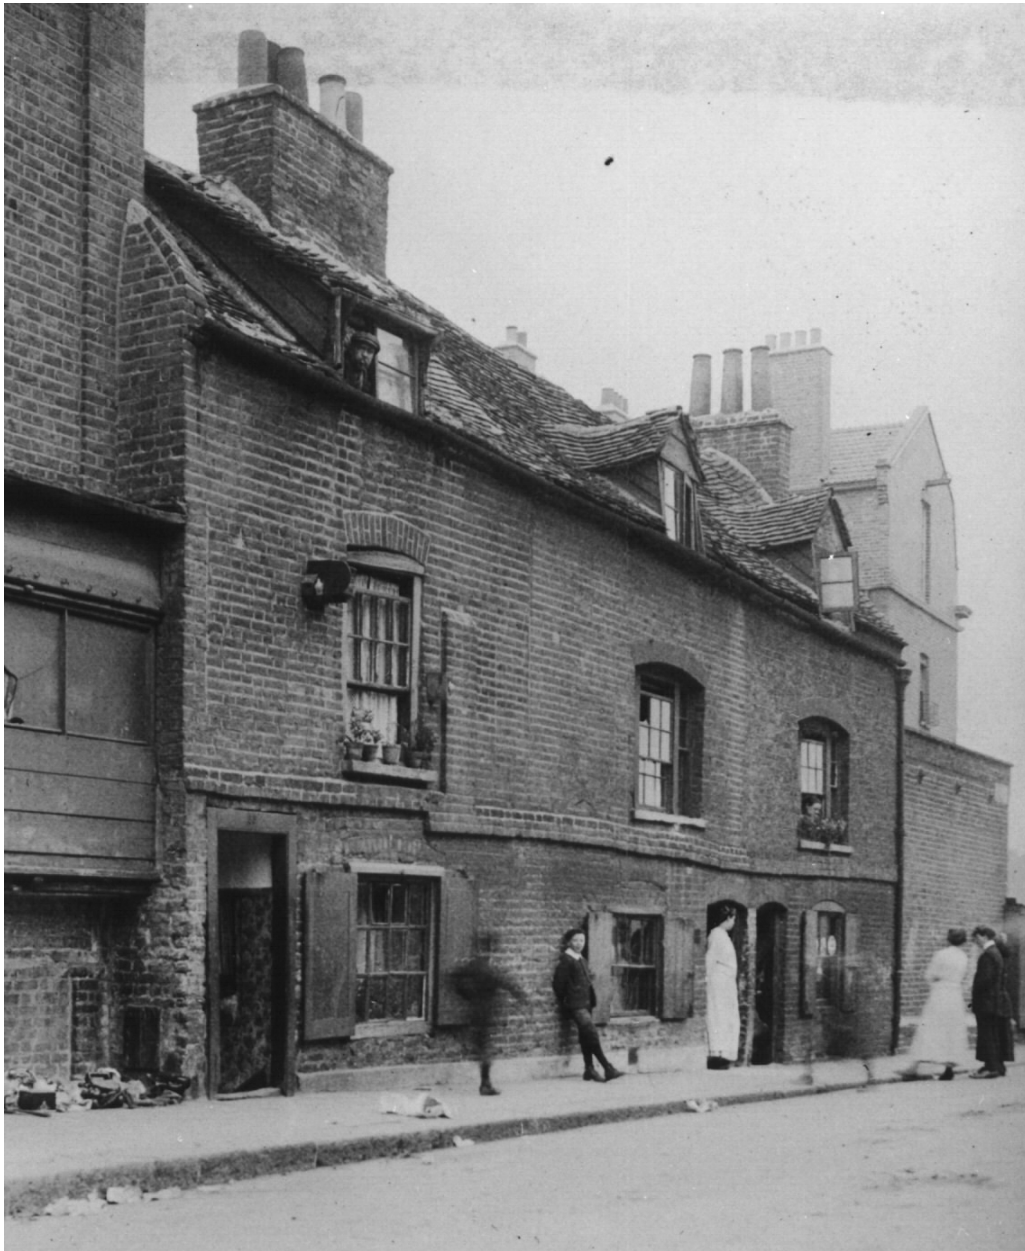
*Figure 2: 19<sup>th</sup> Century photo of cottages along eastern side of Milman Street, copyright English Heritage (NMR.BB013038)*

**3.2.7** In 1646 a plot of land was leased which may well include the present site: this is described as a brick barn and adjoining ground where a dovehouse formerly stood, enclosed with a brick wall. The lessee, a Chelsea bricklayer by the name of William Cox, established five houses on the site. These may well include the three adjoining brick cottages, of two storeys with dormers in the tiled roofs, which are subsequently recorded as Nos. 55-59 Milman's Street. These appear to be shown on Hamilton's map (1664-1717) and certainly appear in two later 19th/early 20th century photographs. The northernmost property may be later – perhaps a rebuild – but those to the south stand within the present site boundary (fig. 1) and may well be of mid 17th century date.

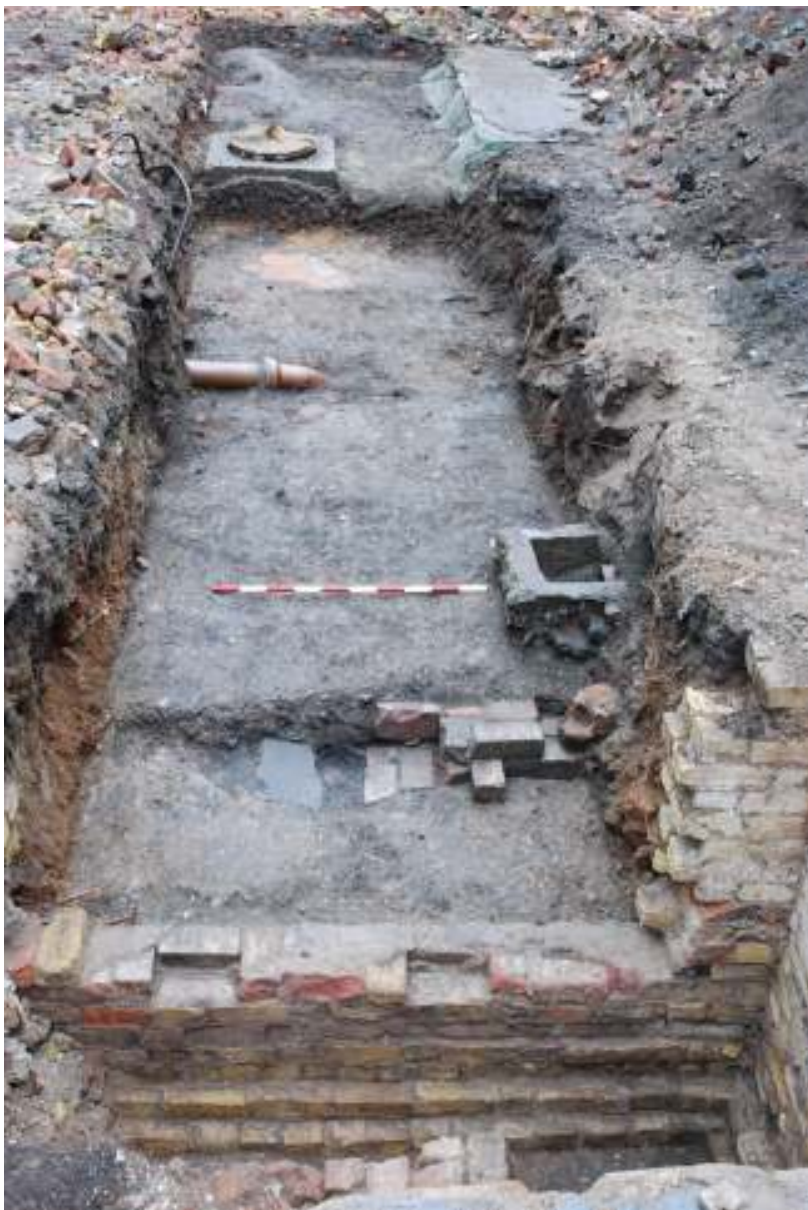
*Figure 6: Photo of trench 1 from the east – clearly showing the modern iron tank [13] at western end*

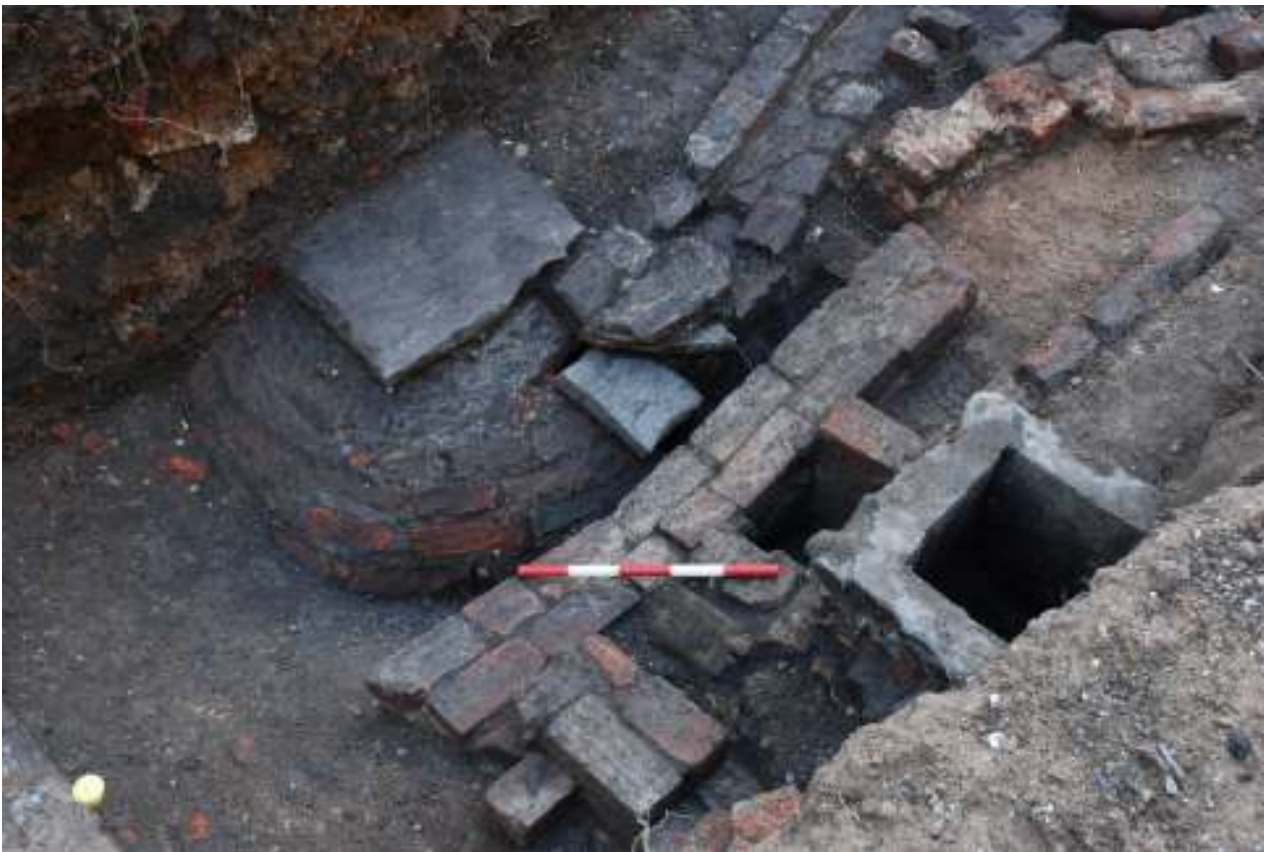
**6.2.2.4** The brick wall [20] that runs east-west down the middle of the trench at the eastern end of the trench was presumably the base of the garden/yard wall that divided the rear of the two cottages. The bricks in this wall were fabric 3032, post-medieval frogged brick, and were dated to c.1700-1800. This would fit the supposed construction date of the cottages (mid-18<sup>th</sup> Century). The approximate location of this wall, when compared with cartographic evidence, places it in the backyard of the property. It may have been the ‘garden’ or ‘yard’ wall that separated the backyards of the two properties.

*Figure 13: Photograph of spine wall [20] (drain pits [14] and [18] in the foreground)*

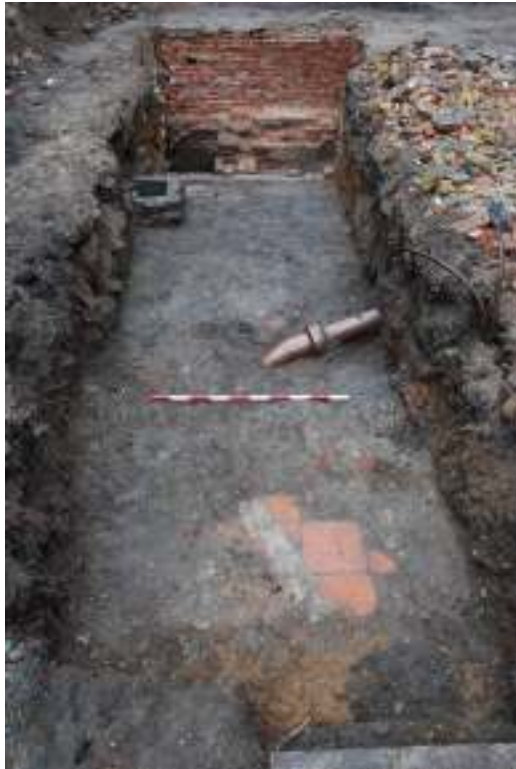
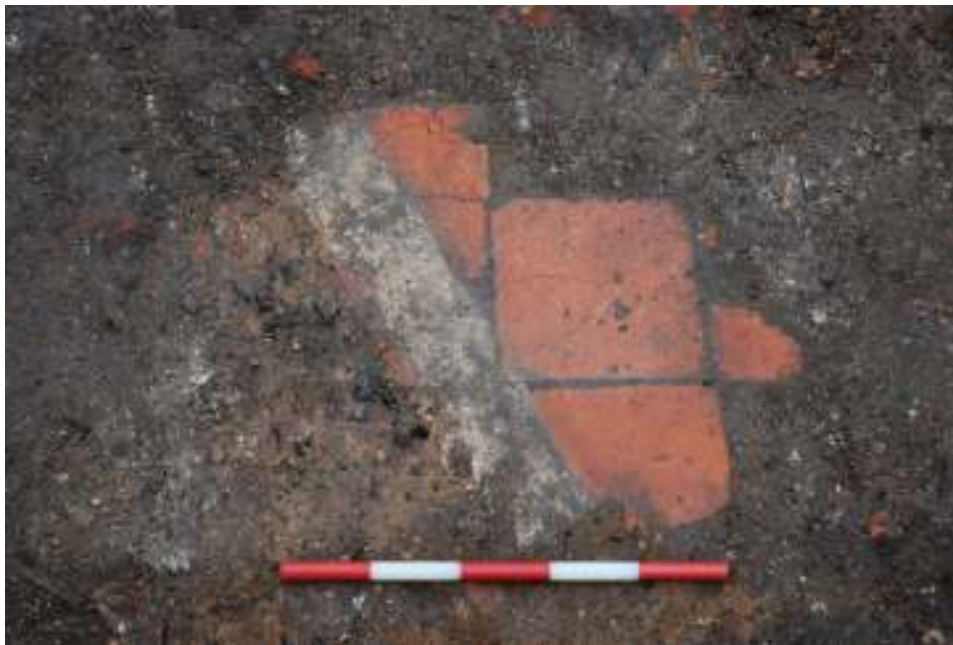
**6.2.2.5** Part of the tiled floor surface of these cottages [22] was also revealed, in the western part of the trench. This consisted of unglazed beveled red floor tiles (fabric type 2850), set flat within grey mortar, and dated to c.1600-1800. These lay within the area of the ‘cottages’ themselves – particularly the

southern cottage. Only a small area of tiles were found as they had been truncated elsewhere, such as by the concrete-lined drain to the north and the iron tank to the west. Furthermore, deposit [23], found directly underlying and to the sides of the tiles, may have been related to this tiled floor. This may have been the base make-up under the cottage floor surface. Overlying the surface of the tiles, to the north, was an oblique mortar scar, possibly a later feature (although there is no other evidence for this).

*Figure 14: Photo of tiled floor [22]*

*Figure 15: Photo of tiled-floor [22]*

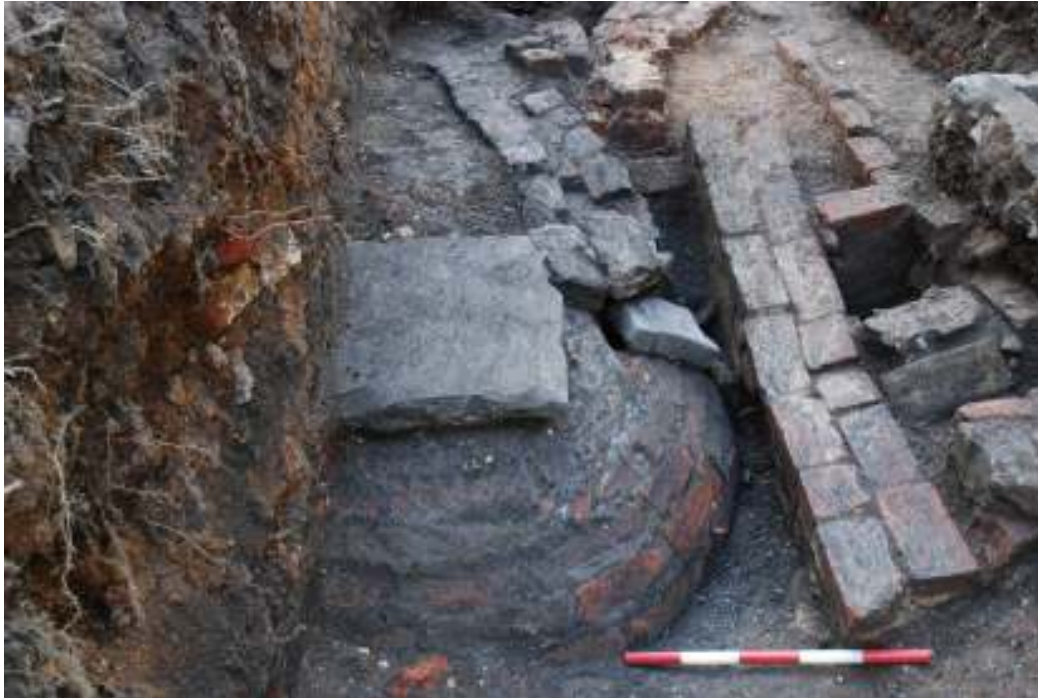
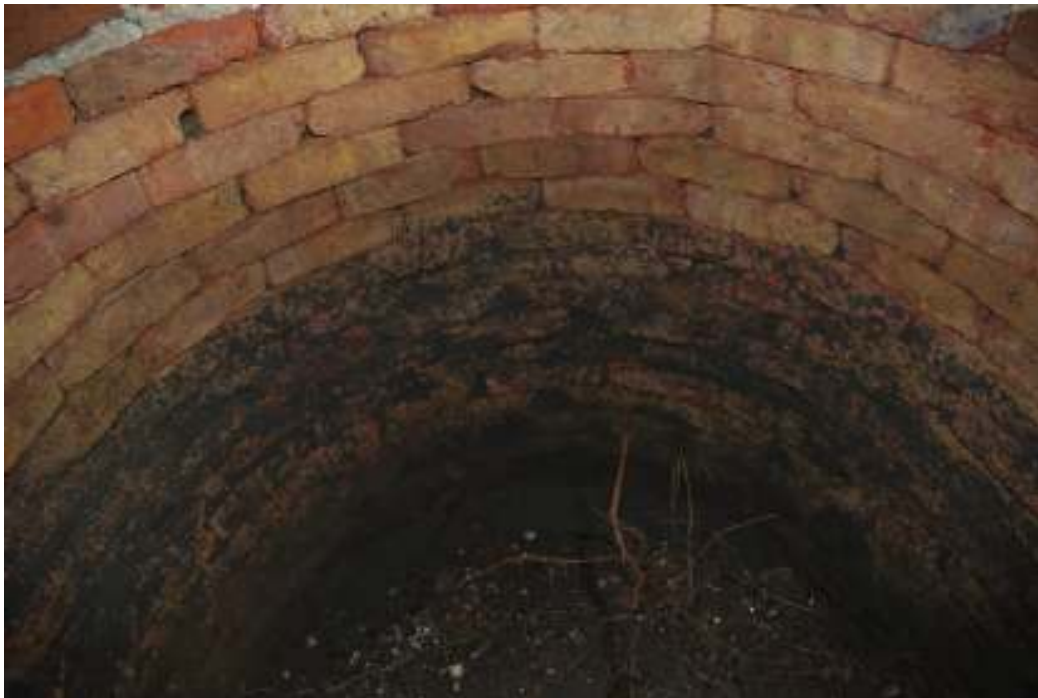
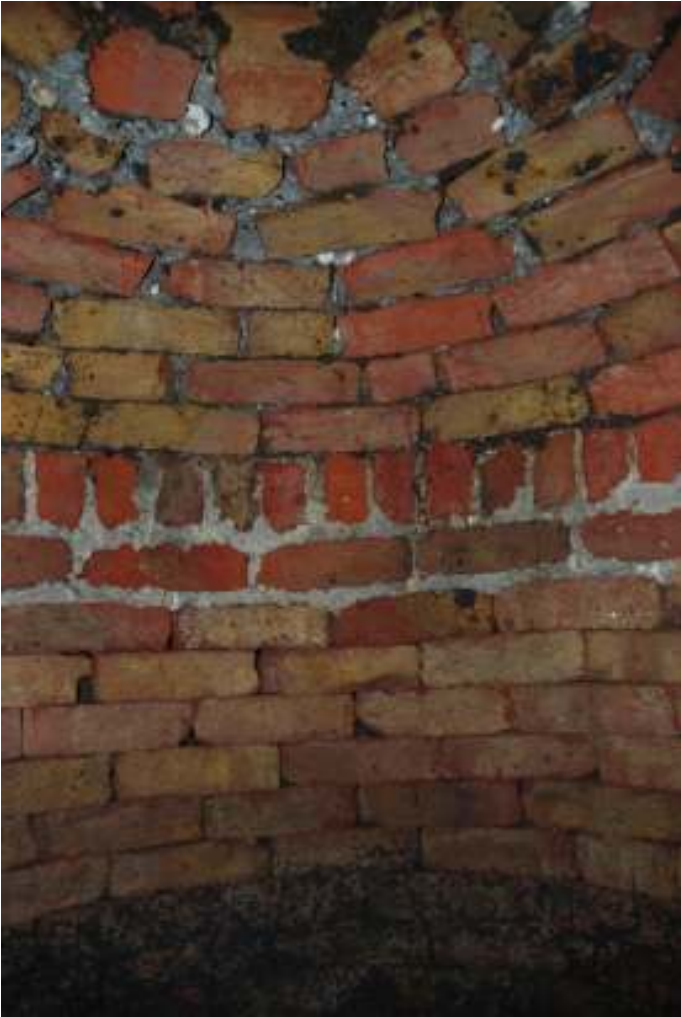
6.2.2.6 The huge red brick domed well [25] uncovered in the eastern part of the trench may also have been related to the 18<sup>th</sup> Century development of the area. The bricks were identified as fabric-type 3032, frogged, and dating to c.1700-1800. The location of this well mainly fell within the back-yard of the southern cottage. It is therefore assumed that this well was located in the yard of this cottage.

*Figure 16: Photo of brick domed well [25]*

*Figure 17: Photo of inside of well [25]*

*Figure 18: Photo of inside of well [25]*

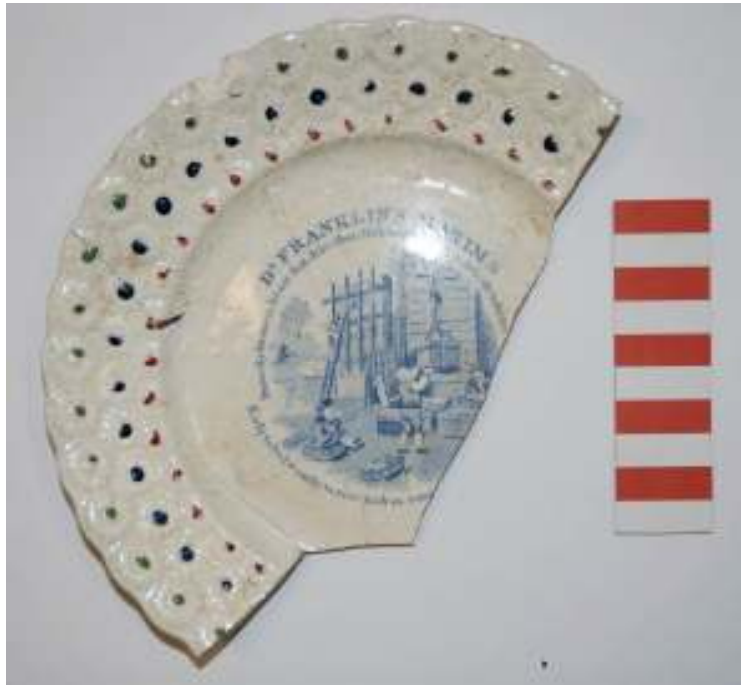
**6.2.2.7** Context [17] – the pit filled with pottery - was also a feature probably associated with the 18<sup>th</sup> – 20<sup>th</sup> Century cottages. A considerable quantity of pottery was recovered from it – all dating from the 19<sup>th</sup> Century. This included relatively whole items, figurines, and children’s items, and other ‘novelty’ items such as the Franklin’s Maxims plate seen in figure 19. It seems likely that this pit was probably some form of rubbish dump possibly infilling an outside toilet/cess-pit. This was located in the rear part of the yards of the cottages, just adjacent to the rear of 103 Cheyne Walk. The deposit was cut by the wall foundation [15], so the conjunction of map and pottery dating gives a date for the dump of 1846-65.

*Figure 19: Photo of pottery from [17] – Franklin's maxims plate*

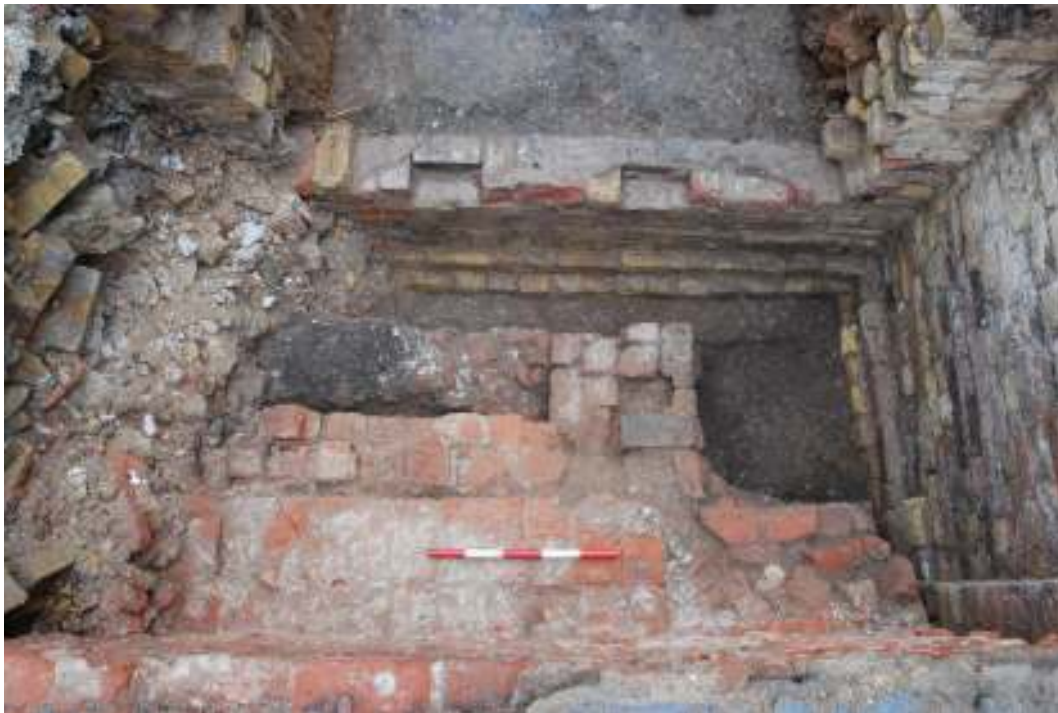
**6.2.2.8** A relatively modern-looking yellow stock brick wall on a concrete footing was found at the eastern end of the trench ([15]). This evidently formed the 'box'-feature depicted on the 1865 OS Map projecting out of the rear boundary wall with No.103 Cheyne Walk. This wall ran north-south across the trench at the eastern end of the trench, and then into the eastern section at either end (forming a 'box'). However, the feature appears to have disappeared by the OS survey of 1894-96. It is possible that this formed some sort of outhouse – possibly providing toilet or washroom facilities.

*Figure 20: Photo of yellow stock brick box feature [15] from above*

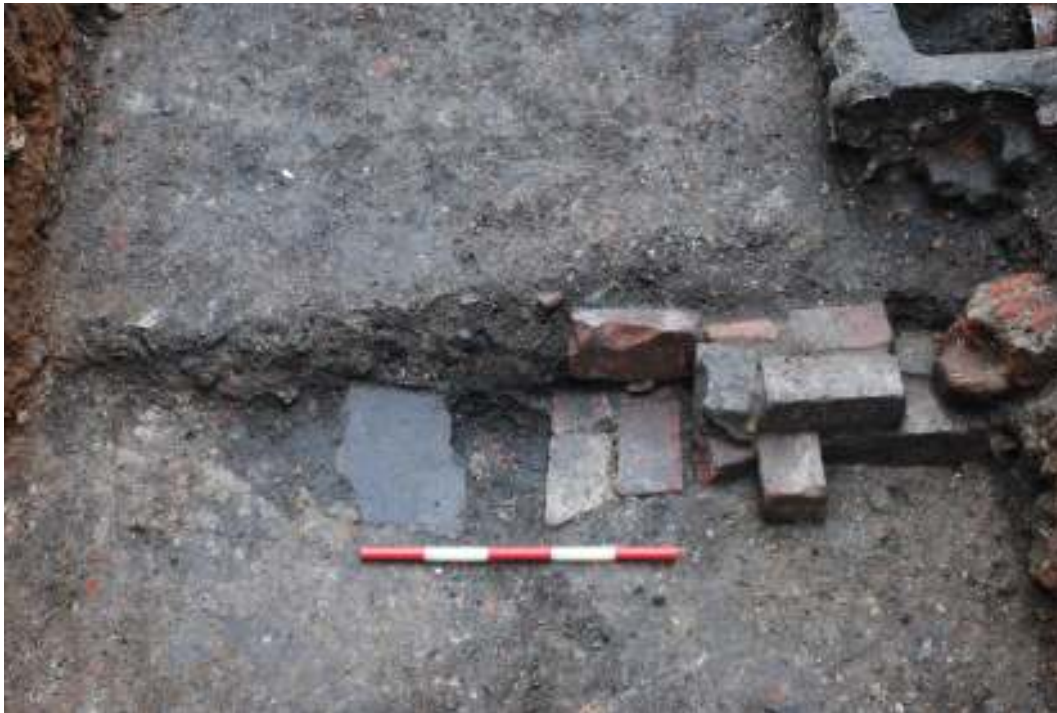
**6.2.2.9** The brick wall [21], which ran for *c.*0.8m north-south out of the northern section at the eastern end of the trench, was presumably associated with the 18<sup>th</sup> – 20<sup>th</sup> Century cottages. This was found at a similar level to the spine wall [20] and the floor surface [22]. It was located too far east to be a back wall of one of the cottages, and too far west to be associated with the rear of 103 Cheyne Walk. Instead, it could well be on a line with the projecting eastern rear wall of the adjacent cottage, perhaps enclosing a small area between this and the boundary wall [20]. This does not appear on any maps.

*Figure 21: Photo of wall [21]*

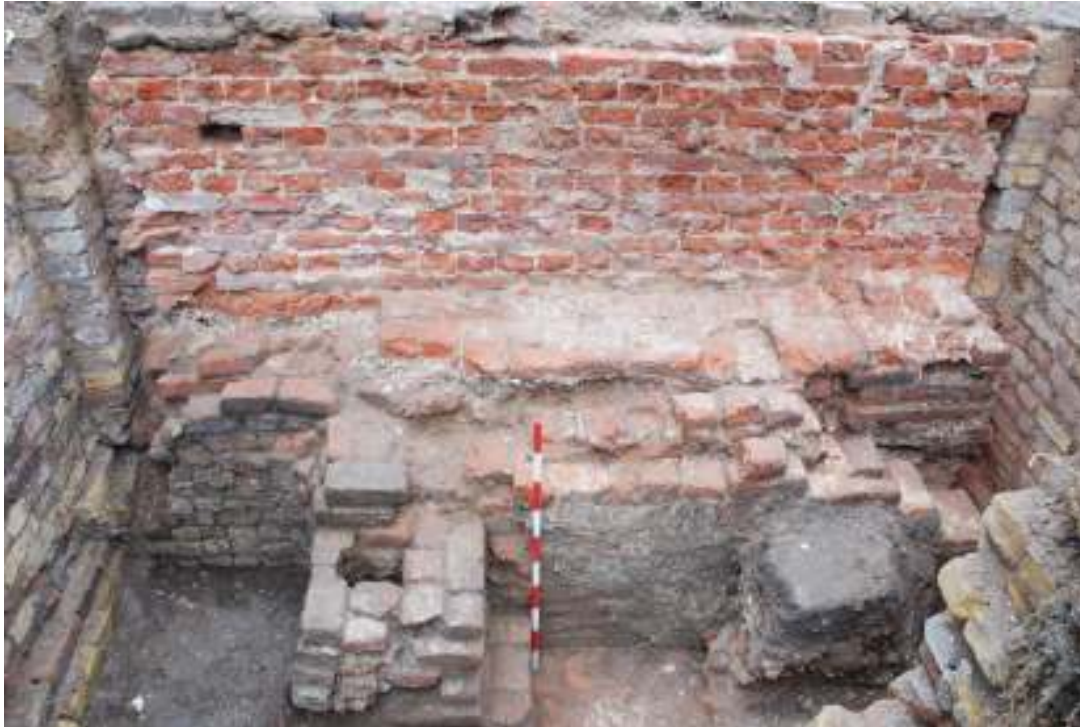
**6.2.2.11** The brickwork [26] was presumably part of the cottage phase of development. The bricks were of fabric-type 3033 and 3034 and dated to *c.*1450-1700 and 1730-1800. The brickwork contained a cut-out, presumably for a timber post, and the adjoining earlier wall [31] appeared to have been cut back and refaced (without render) immediately to north. It is possible that these features may be part of an outbuilding in the yards of the cottages – presumably an earlier outbuilding than that represented by wall [15].

Figure 22: Photo of brickwork [26], to the left of the scale

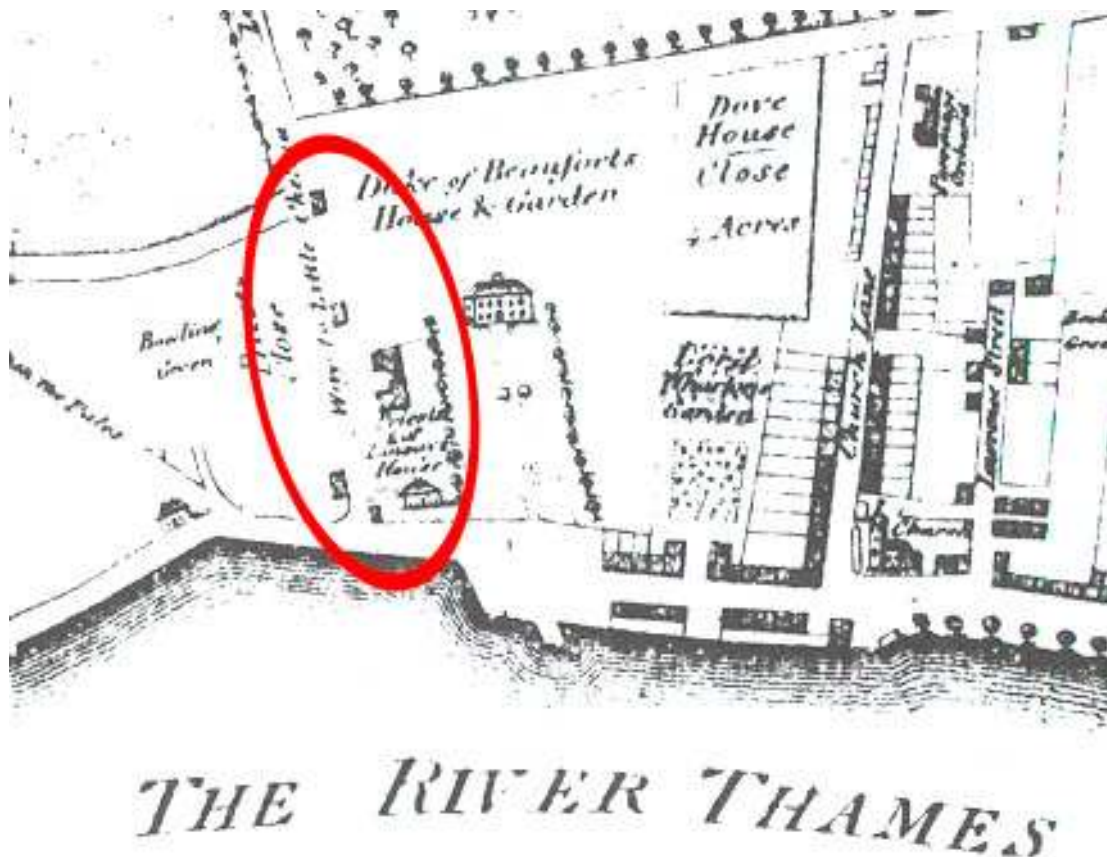
Figure 24: James Hamilton's Survey of Chelsea, 1664-1717 (with Milman Row highlighted)

- 6.2.3.5** James Hamilton's 1717 Survey of Chelsea (fig. 24) clearly shows the existence of Beaufort House to the north-east of the site, Lindsey House to the south/south-east, and another large house (possibly Gorges House) around the site-area itself. This shows the survival of large buildings in the site-area until the mid-18<sup>th</sup> Century, after which the cottages were constructed (see discussion above and Richardson's Survey of Chelsea 1769).

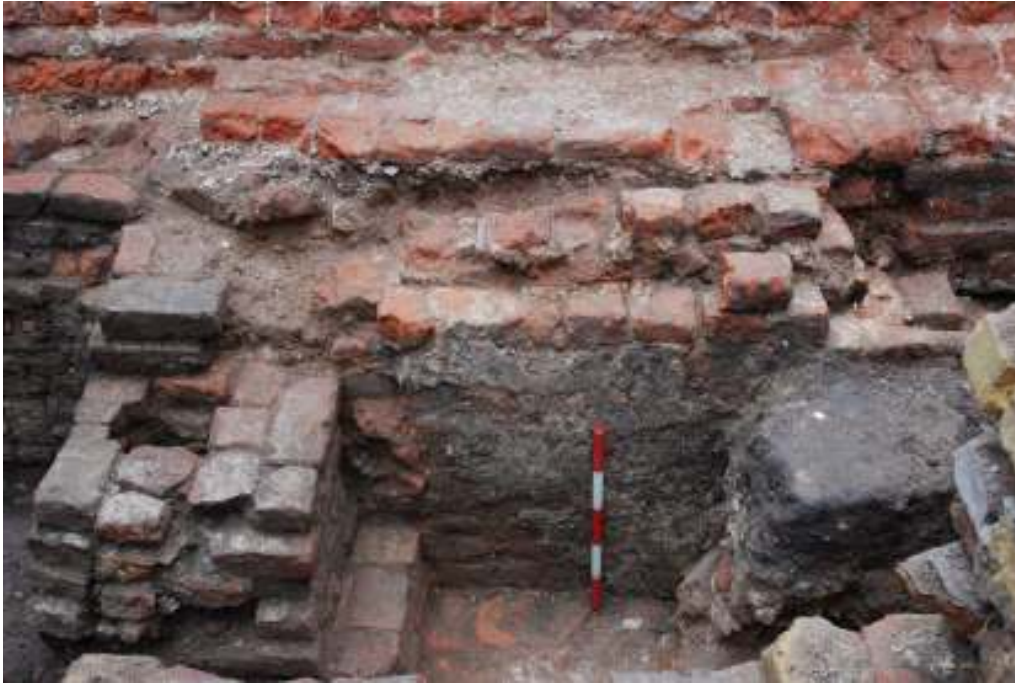
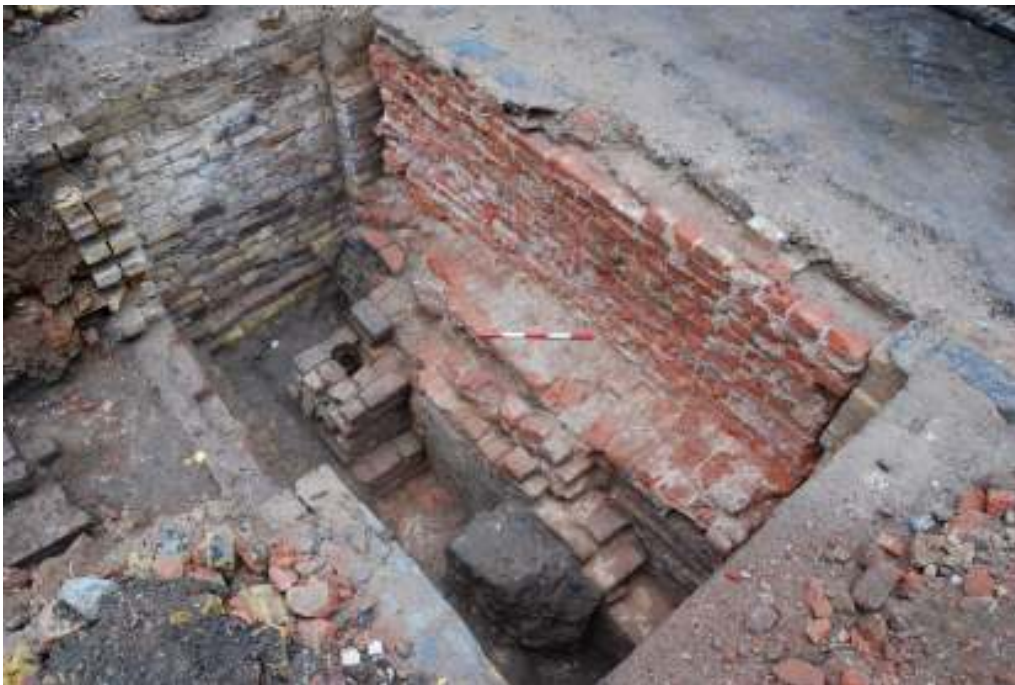
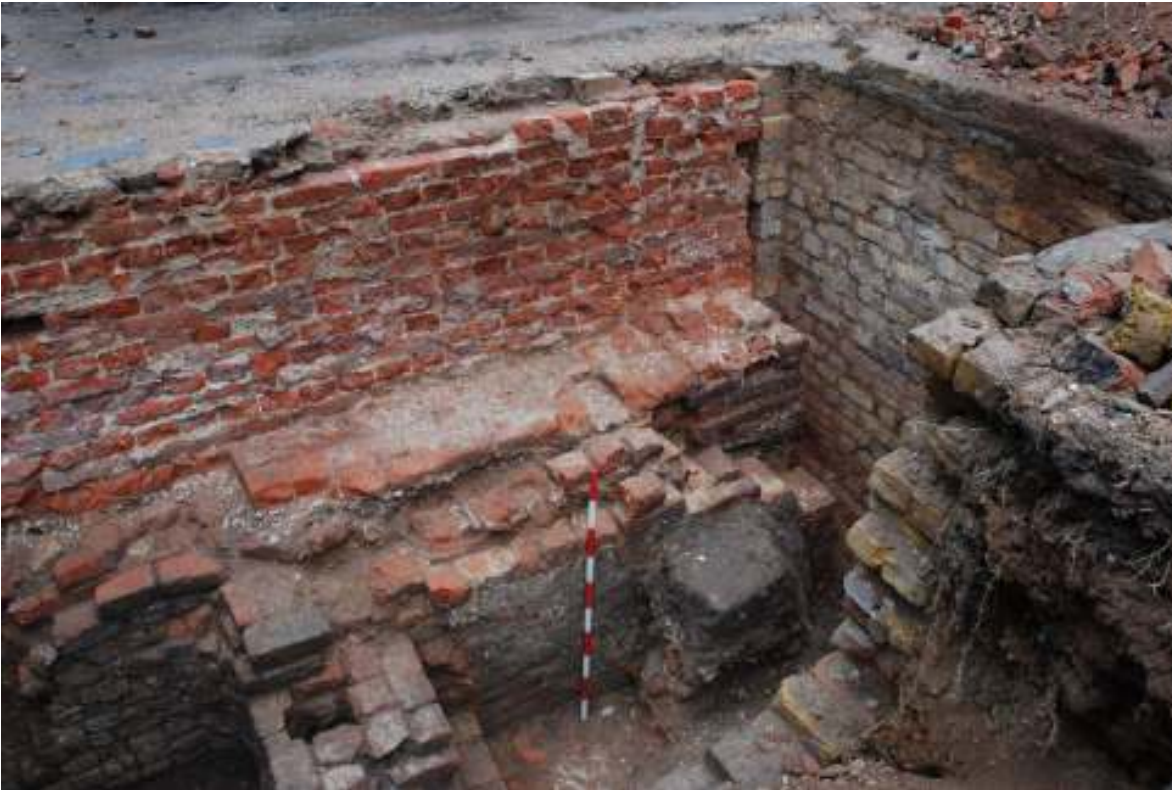
**6.2.3.9** It is thought that these two walls may have been corresponding, and that they formed the eastern and western walls of a basement. The plastered face of [31] suggests that this was the internal side. Furthermore, the substantial nature of wall [30]/[31], stretching from a depth of c.5.55m-5.63mOD to c.4mOD (c.1.5m in depth, and continuing further down), suggests that this wall may have been a basement wall.

*Figure 25: Photo of plastered face of wall [31]*

*Figure 26: Photo of walls [31] and [26], and later wall [15] to the rear*

*Figure 27: Photo of walls [31], [26] and [15]*

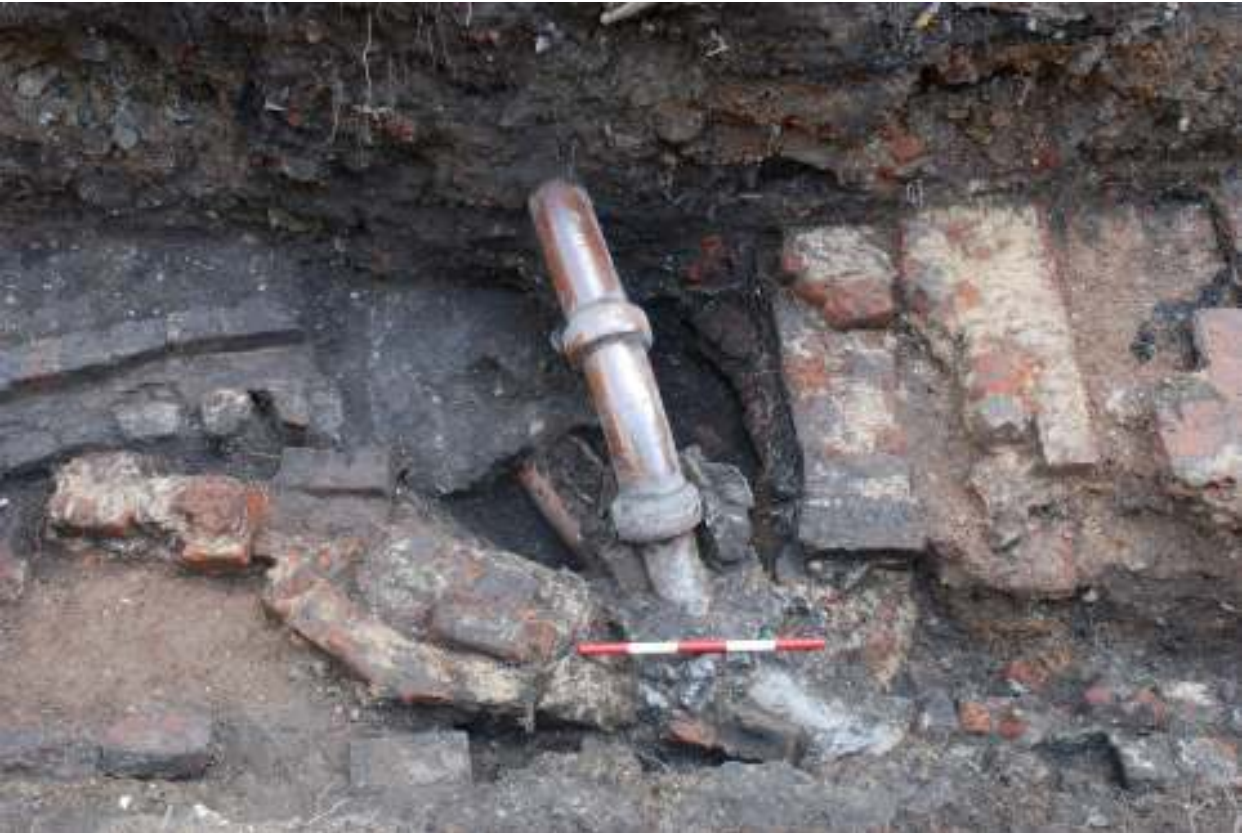
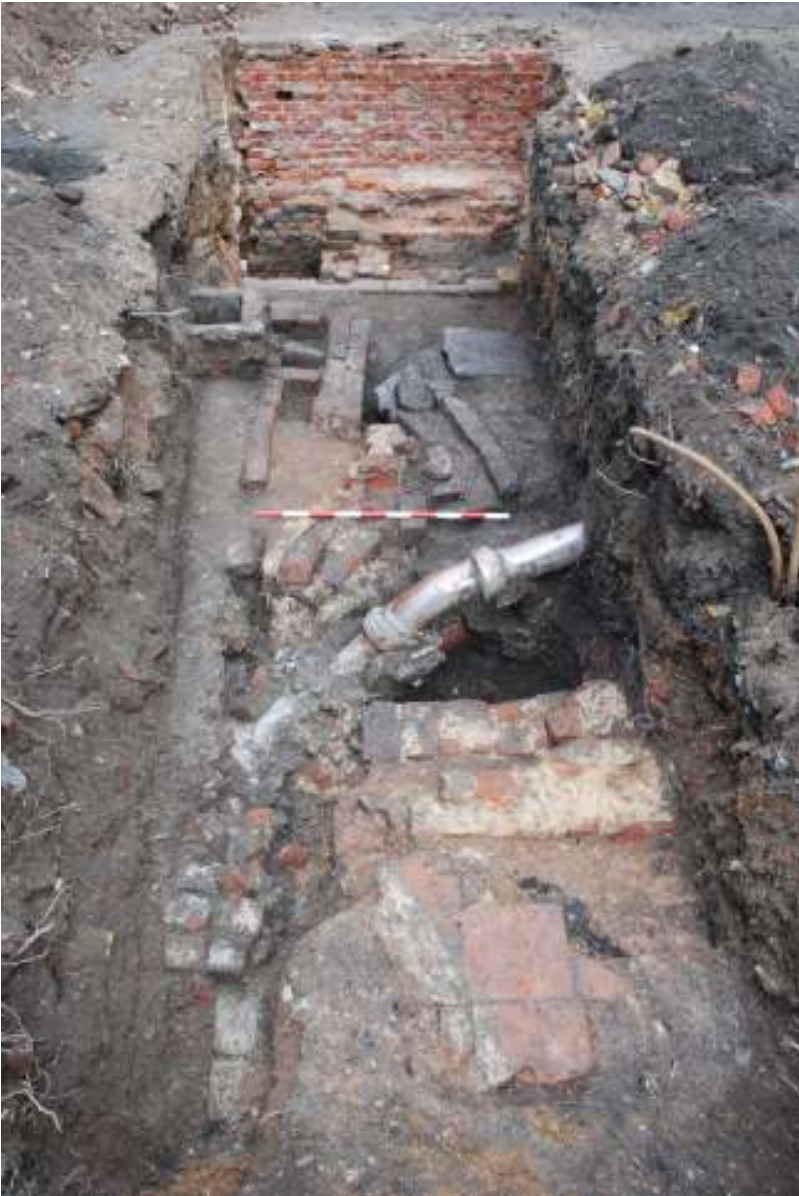
**6.2.3.8** It is very probable that wall [32], at the western end of the trench, was the corresponding wall of wall [31]. This was not quite as substantial as that at the eastern end of the trench, possibly partly because the cottage had been built over it, and possibly partly because of the disturbance caused by the concrete-lined drain. The bricks from this wall were more closely dated, as fabric types 3033 and 3046, and dating to c.1630-1700, although the similar type of mortar to wall [31] suggests that the bricks might be earlier in date (possibly earlier 17<sup>th</sup> Century).

*Figure 28: Photo of wall [32] (to the right of the frame) – with unexcavated oven [28] overlain by modern drains in the central area*

*Figure 29: Photo of trench from the west, clearly showing walls [32], and [31] – thereby showing the extent of the basement*

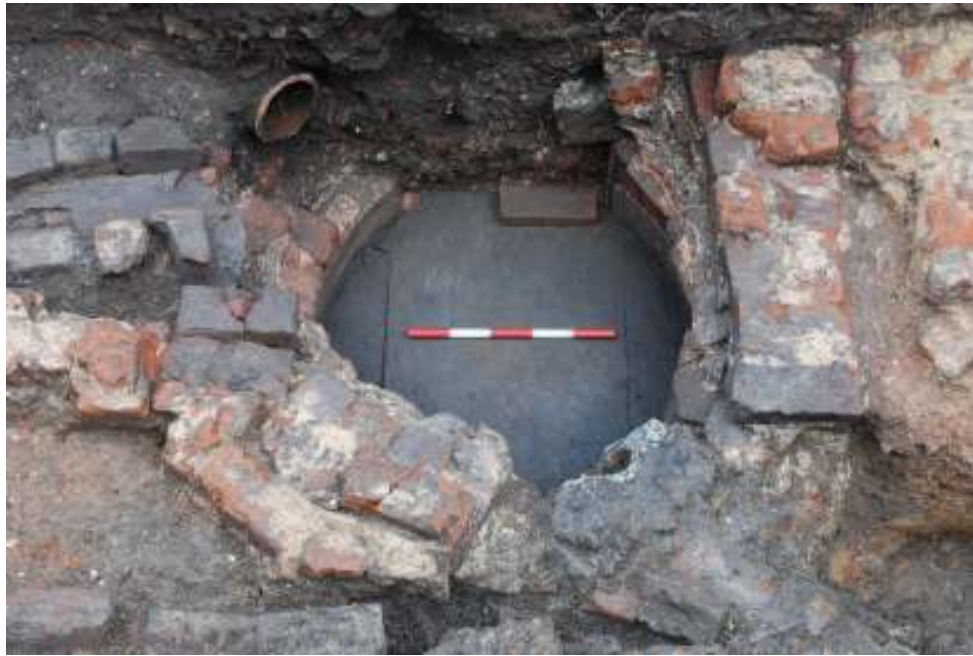
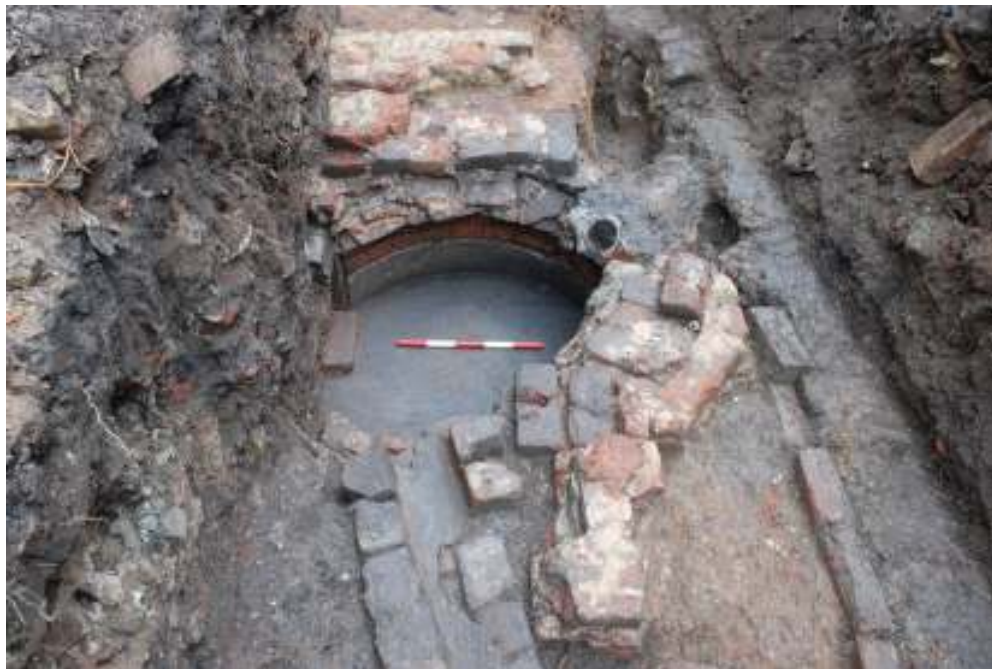
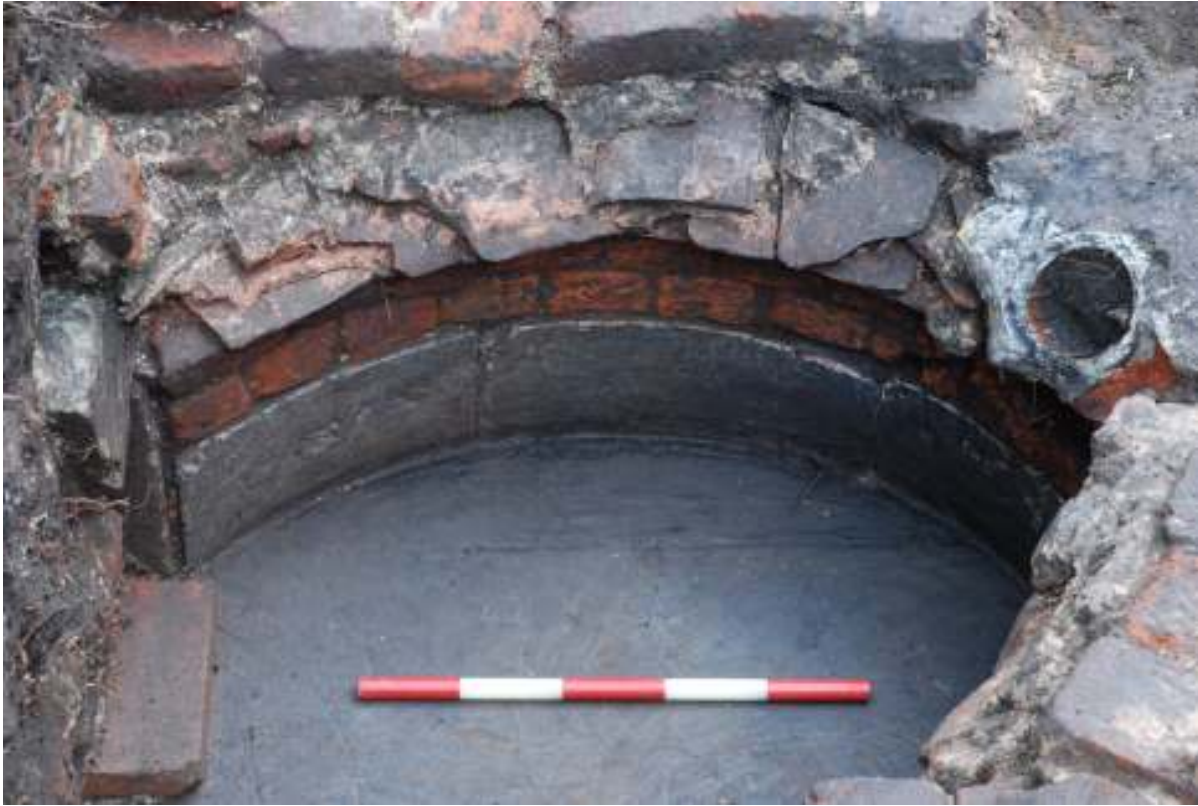
**6.2.3.11** Within this ‘basement’ area, an oven was uncovered ([27] and [28]), butted against the eastern face of [32]. This was very well-preserved, and consisted of a stone floor, with stone blocks, bricks, and sloping tiles making up the sides of the oven. A small cut-out was also observed in the southern part of the oven, which would have given access to the oven from the adjacent room.

**6.2.3.12** The bricks of this oven were of fabric-type 3033, and dated to *c.*1630-1700 (therefore fitting with the dating of the bricks of the rest of the basement). The mortar used for this oven is also the same as that for the basement walls. Furthermore, the stone base of the uncovered section of the oven was uncovered at *c.*4m OD (at a level significantly below the later cottage floors). Although the pottery uncovered from the oven fill [27] was generally dated to the 19<sup>th</sup> Century, it is possible that this was because the area had been disturbed by the later brick-drain running into it ([19]).

**6.2.3.13** The uncovered part of the oven would probably have been the upper part, in which the bread (or other food) was inserted. This would have stood either directly above the fire or adjacent to a larger fireplace (beyond the present southern limit of excavation). Artistic depictions (fig. 33) clearly show this set-up. Depictions of similar features are also shown on contemporary building plans, for example the Treswell plans, which depict several ovens adjacent to fireplaces (fig. 34). Furthermore, this theory would fit with the idea that the oven stood in a basement, as only the top part was uncovered during this evaluation.

*Figure 30: Photo of oven [28] with the opening to the rear (south)*

*Figure 31: Photo of oven [28]*

Figure 32: Photo of oven [28]

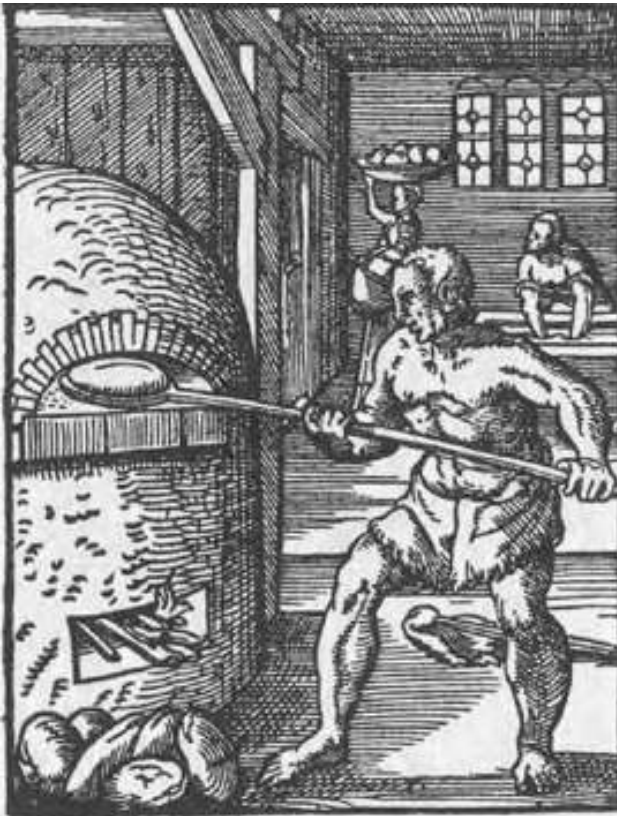
Figure 33: Artistic depiction of oven, 1568

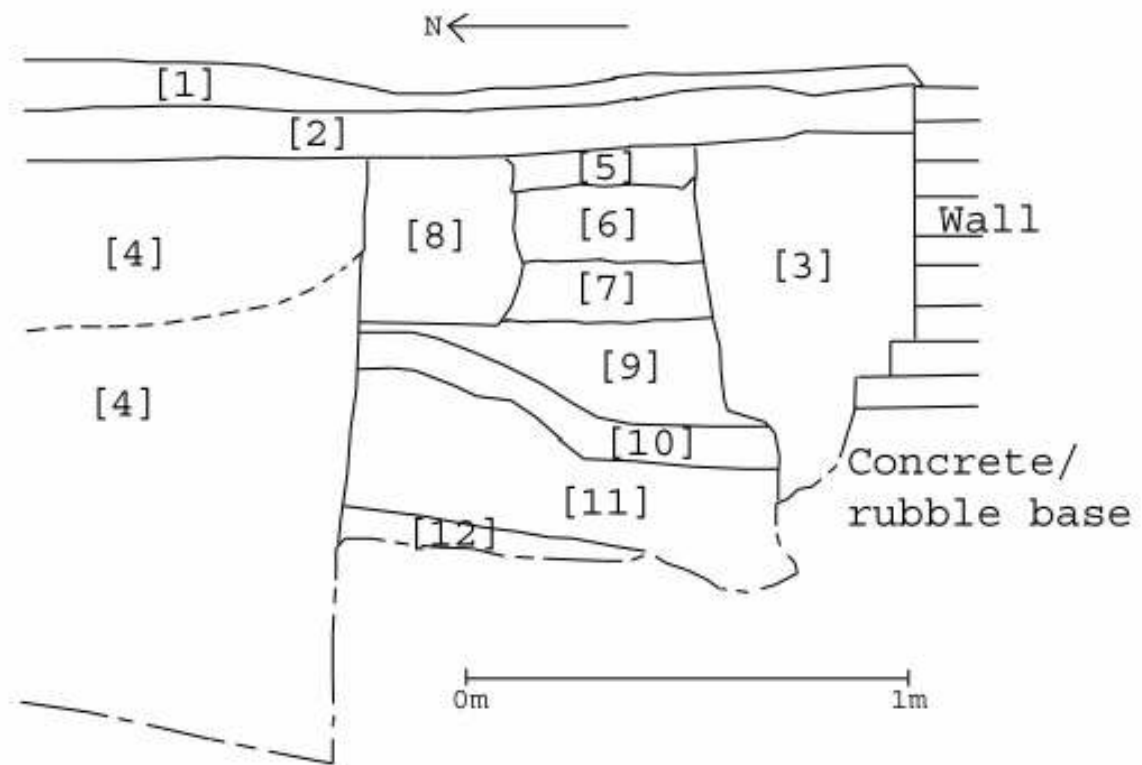
Figure 35: Eastern section of trench 2

| Context Number | Description | Interpretation |
|---|--|--|
| 1 | Loose black garden-soil, with organic material and roots in the northern half of the trench (but not in the southern half). Thickness of <i>c.</i> 0.05m-0.1m | Topsoil. The difference between the deposit in the northern and southern half of the trench is because the northern half lay in a 'garden' area whereas the southern half was within a building (just before the pre-development demolition of the buildings). |
| 2 | Loose dirty brown-black gravelly deposit. Across whole trench, for a thickness of <i>c.</i> 0.1-0.2m. Directly underlay [1]. | Quite a modern deposit, possibly a previous soil horizon/garden soil deposit. |

| 12 | Compact light yellow-brown sandy deposit, with no obvious inclusions. Uncovered <i>c.</i> 1m beneath the modern ground-surface, however only seen in a small area in the eastern section for <i>c.</i> 0.7m N-S. | Natural deposit. |

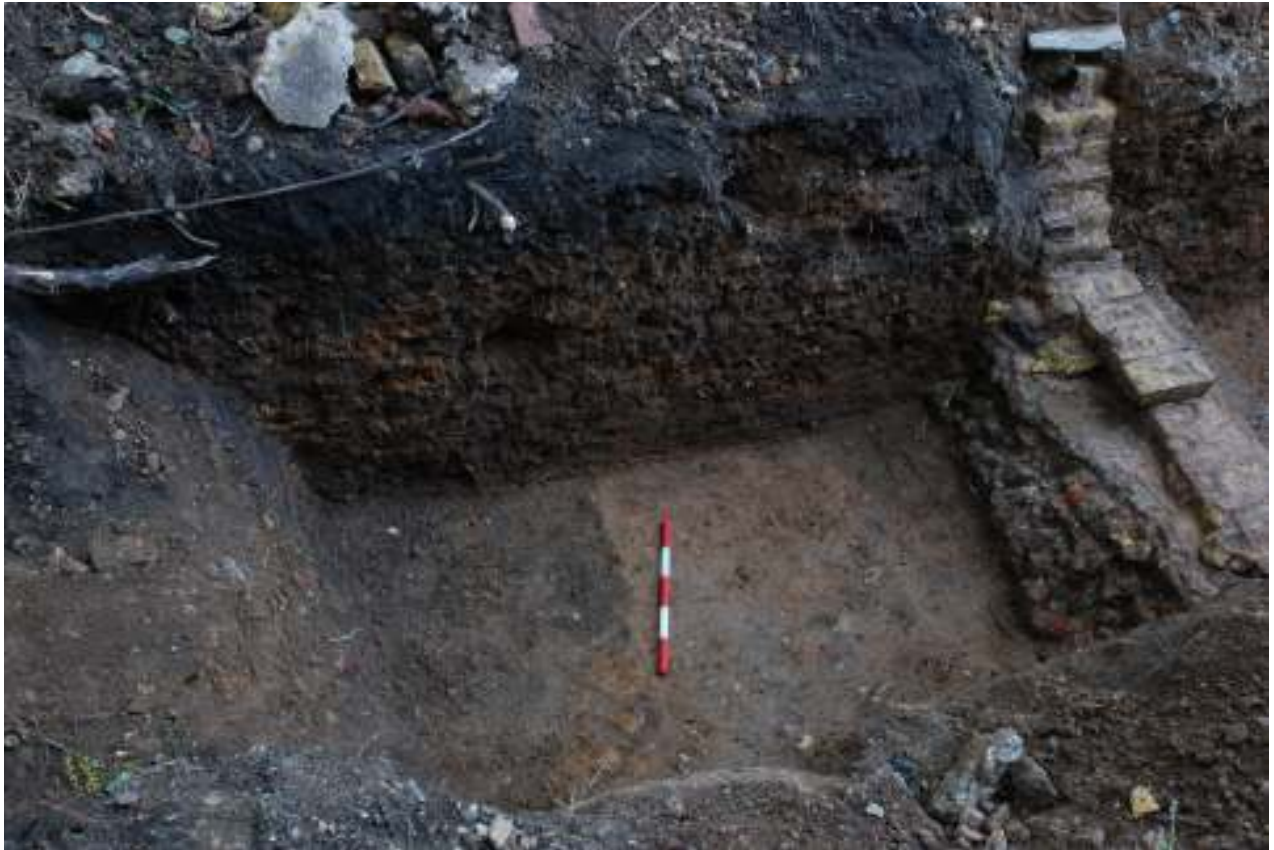
- 6.3.3** The only feature of any possible archaeological significance was context [4]. This was some form of pit, which stretched down to at least 1.5m beneath the ground-surface (*c.*3.8mOD). This was cut through all of the upper deposits (except [1] and [2]), which suggests that it may have been relatively modern in date. The fill of this feature consisted of two distinct deposits, suggesting that it may have been in use at two distinctly different times, or filled in at two different points. It was cut down through the ‘natural’ deposits [12]. The handle of a S. Herts/Limpsfield Grey Ware jug was recovered from this context. This could be medieval (1140-1300), although the sherd was abraded so could easily be residual. This fits with the level that the pit was cut from.

*Figure 36: Photo of northern half of trench 2, clearly showing pit [4] to the left of the scale*
