**103 CHEYNE WALK, SW10 0DQ**  
**ROYAL BOROUGH OF KENSINGTON AND**  
**CHELSEA**  
**AN ARCHAEOLOGICAL EVALUATION**

AN ARCHAEOLOGICAL EVALUATION

SITE CODE: CHE 11  
SITE CENTRE NGR: TQ 2681 7749  
PLANNING REFERENCE No: PP/07/00912

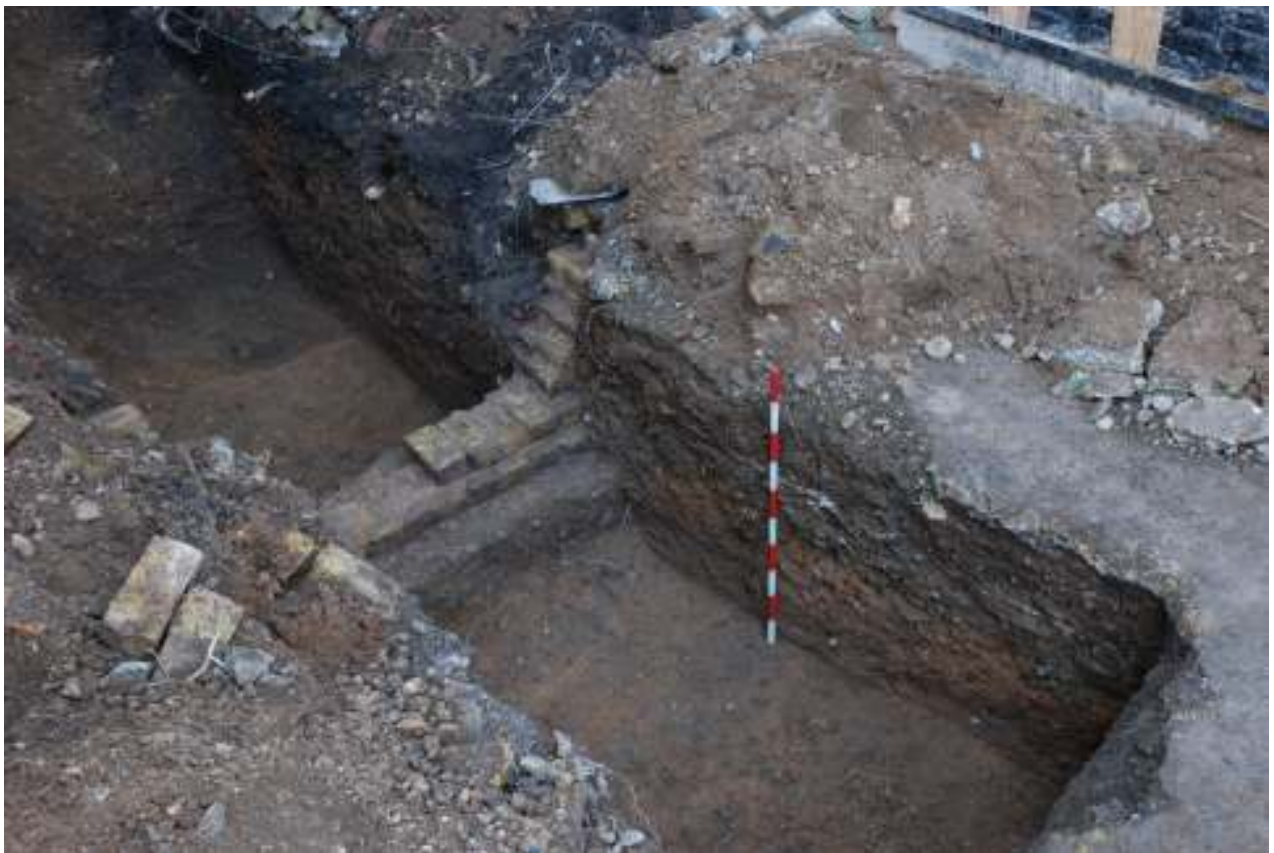
- 6.3.1** Machine excavation of trench 2 reduced the area to a height of approximately 4.6-4.7mOD (*c.*1m below the modern ground-surface). Hand-investigation and recording was then carried out at this depth.

*Figure 37: Photo of trench 2 from the south*
