VEOLIA WATER
WATER MAINS REPLACEMENT WORKS
WILTSHIRE LANE, EASTCOTE, HA5
LONDON BOROUGH OF HILLINGDON
DMA MR-09-N08 WILTSHIRE LANE

AN ARCHAEOLOGICAL WATCHING BRIEF

SITE CODE: TXI11
APPROXIMATE CENTRE NGR: TQ 1051 8890

May 2011

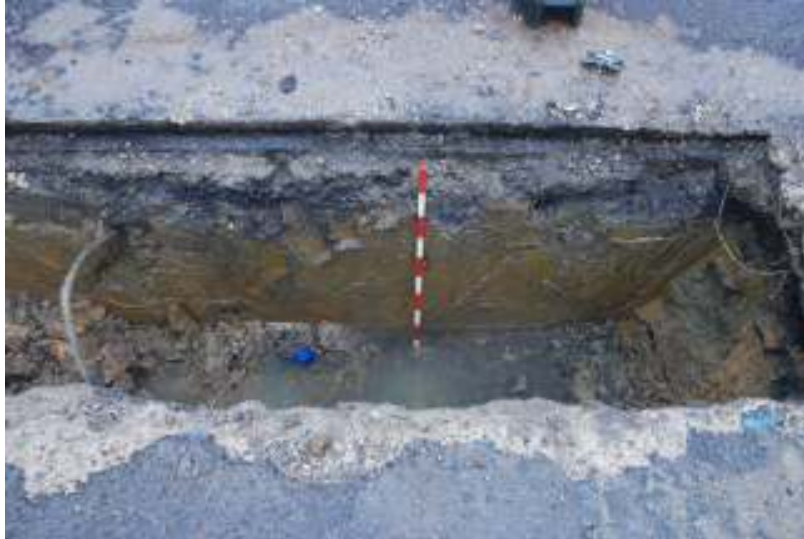
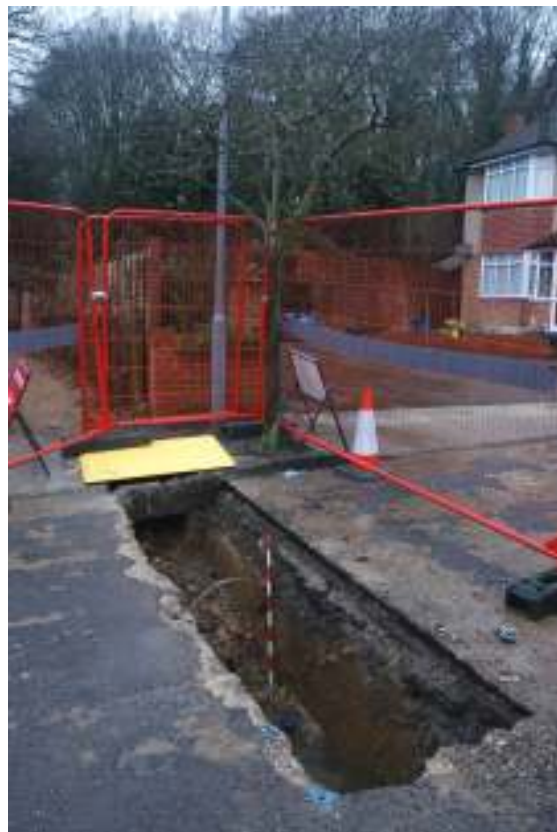
Tarmac and crushed road makeup material were observed to c. 300-400mm below the existing ground level, overlying truncated natural mid-yellow/brown clay. Standing water was observed a c. 600mm below ground level in all trenches, indicating rising ground water.

Figure 8: Water mains replacement works on Wood Rise (1m scale, below view northwest).

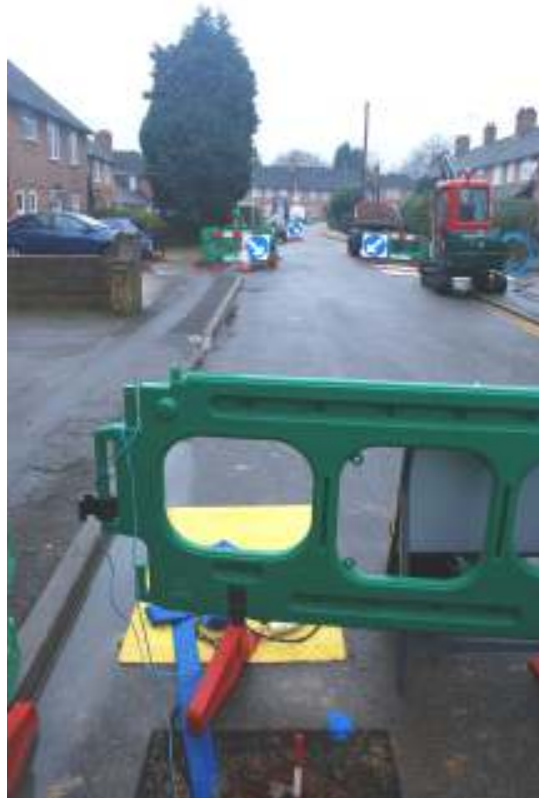
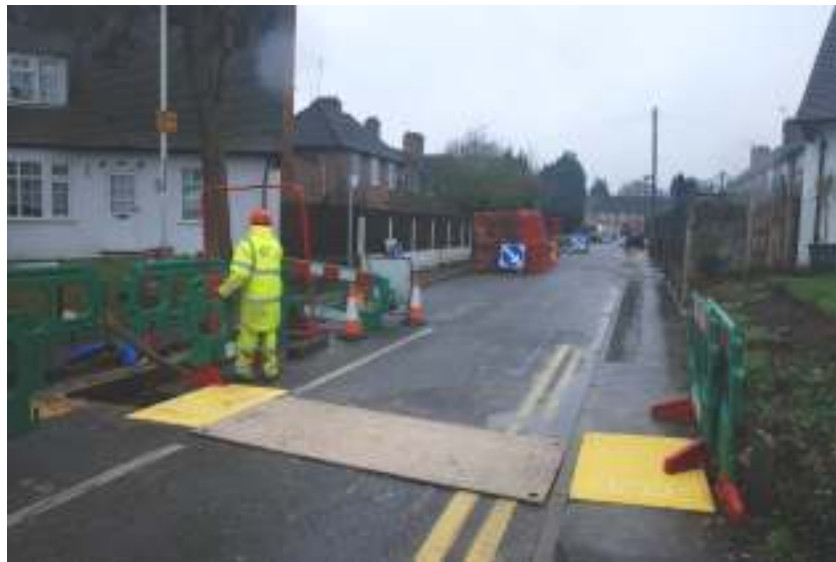
Tarmac and road makeup layers were observed to *c.* 400mm below the existing ground level, overlying truncated natural clay to the remaining depth of excavation.

Figure 9: Water mains replacement works on Coteford Close (view west).

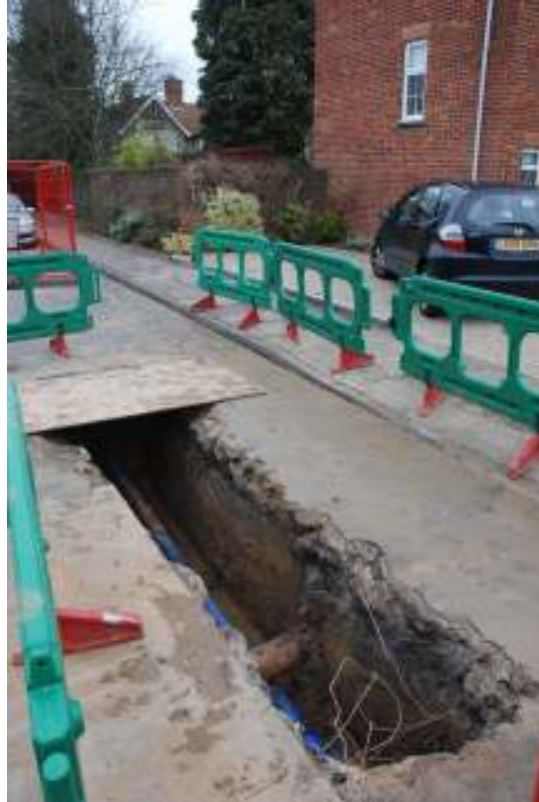
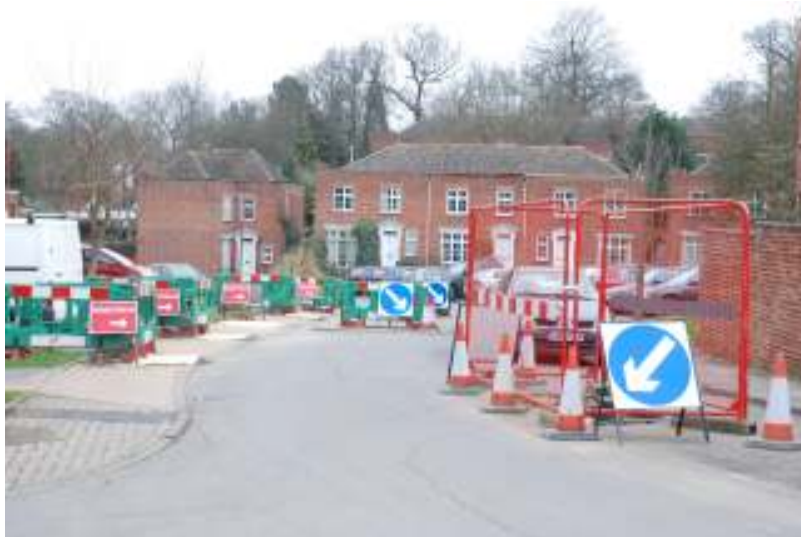
Tarmac and road makeup layers were observed to c. 300-400mm below the existing ground level overlying truncated natural clay. Modern services and associated backfills observed in some trenches.

Figure 10: Water mains replacement works on Azalea Walk (view south above, general view below).

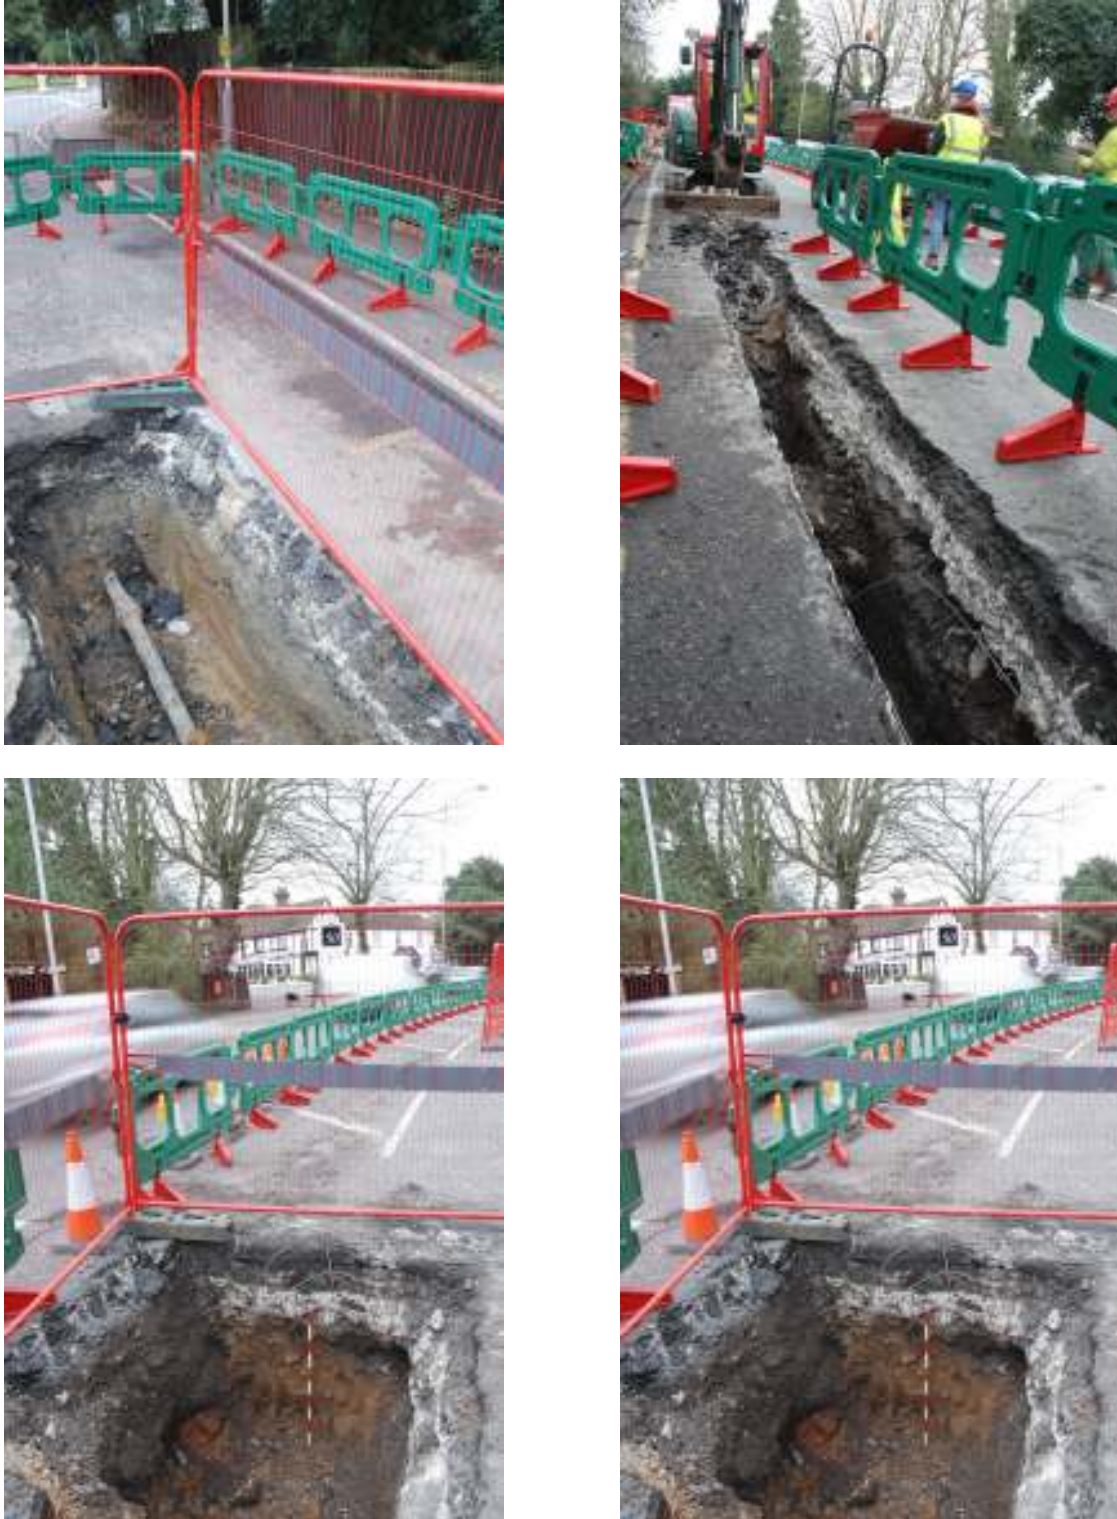
Tarmac and concrete road makeup were observed to *c.* 400mm depth overlying truncated natural clay, the upper horizons of clay were mottled grey indicated contamination for the modern layers above.

Figure 11: General views of water mains replacement works on Field End Road (1m scale).

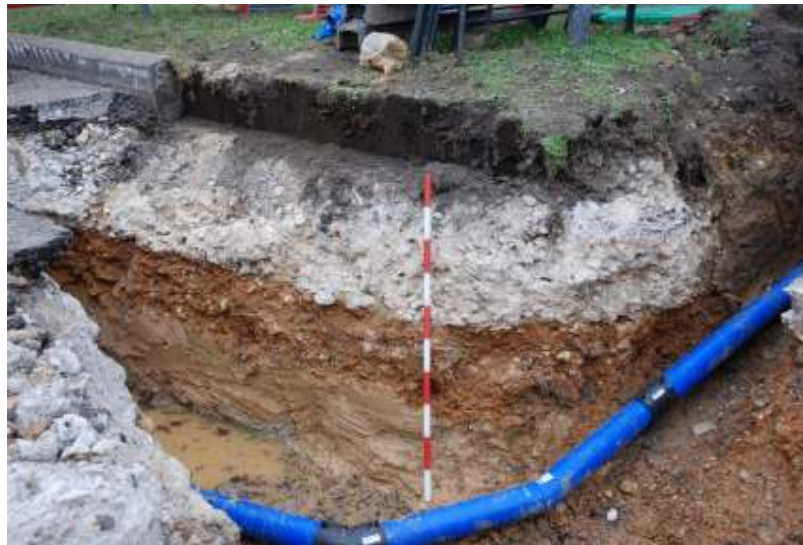
Modern tarmac and concrete hardcore were observed to a depth of *c.* 300mm, except in paved areas where slabs were laid in sand bedding over concrete. Truncated natural clay was observed for the remaining depth of excavation.

Figure 12: Water mains replacement works on Gladsdale Drive (1m scale, view south).

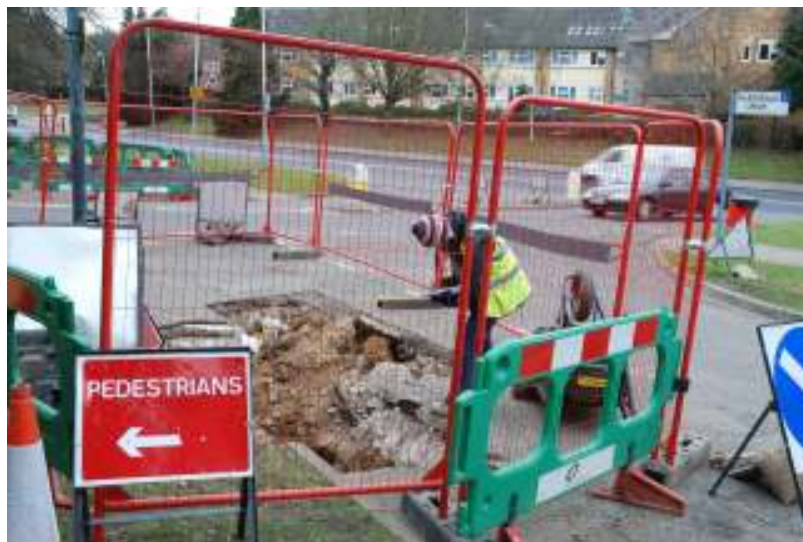
Figure 13: Recording Water mains replacement works on Gladsdale Drive.

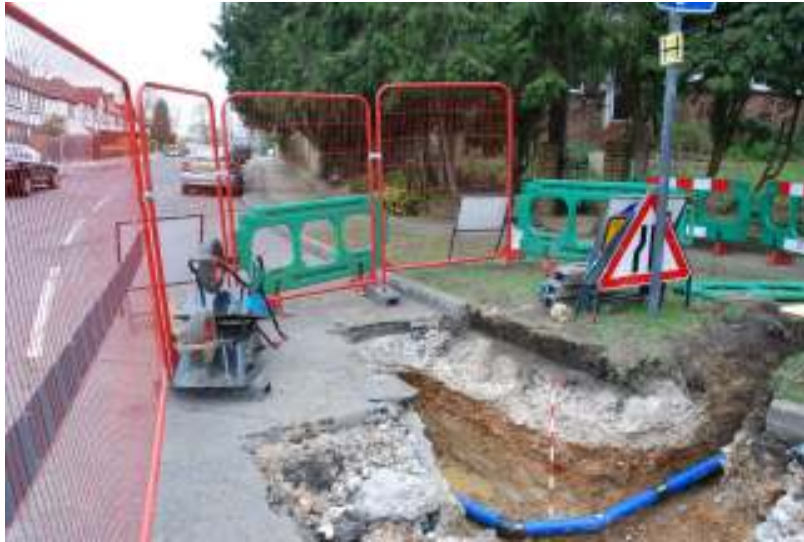
Figure 14: Location of water mains replacement works on Gladsdale Drive (1m scale, view south).

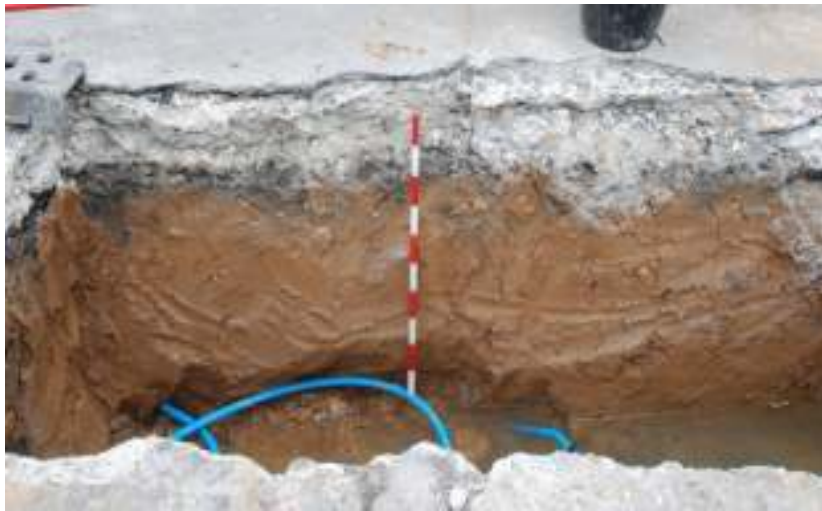
Modern tarmac and concrete hardcore were observed to *c.* 350 mm below the existing ground level overlying compact orange-brown truncated natural clay.

Figure 15: Water mains replacement works on Sutton Close (1m scale, view east).

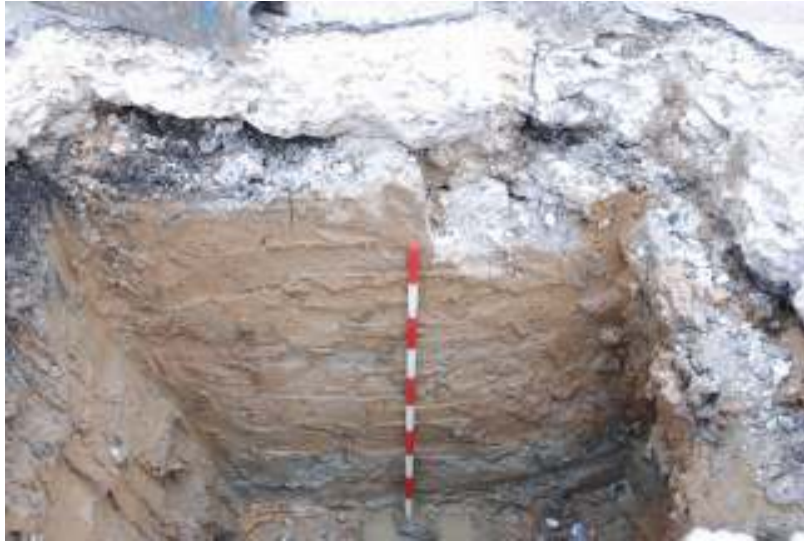
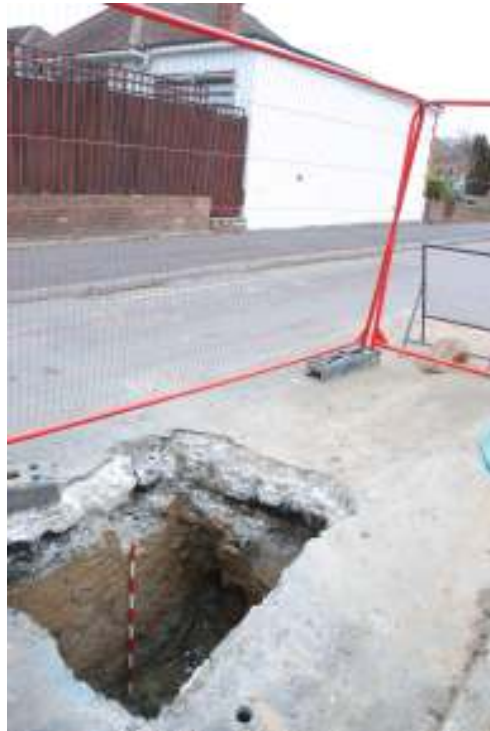
Modern tarmac and concrete hardcore were observed to *c.* 350 mm below the existing ground level overlying compact orange-brown truncated natural clay.

Figure 16: Water mains replacement works on Mount Park Road (1m scale).
