THAMES WATER ENGINEERING WORKS

POST-EXCAVATION ASSESSMENT ON NARROW STREET, TOWER HAMLETS, E14

THAMES WATER ENGINEERING WORKS
POST-EXCAVATION ASSESSMENT ON NARROW
STREET, TOWER HAMLETS, E14

SITE CODE: TZB 08

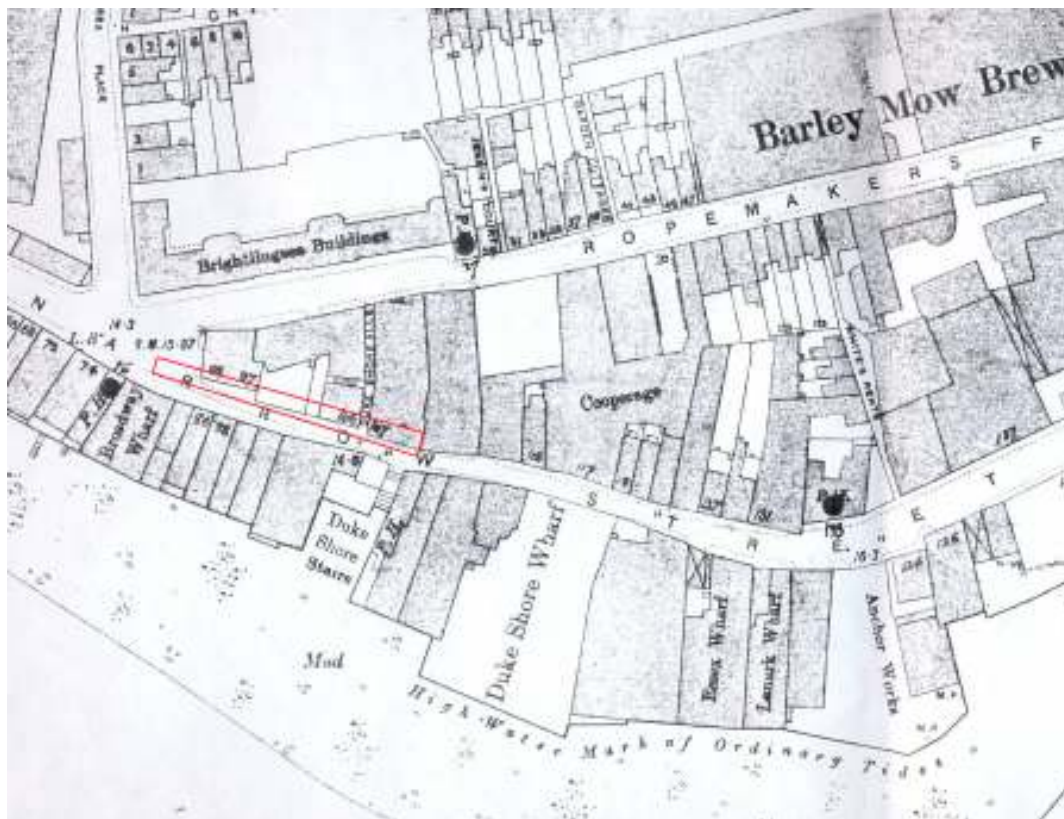
Fig. 8: 1919 OS Map

2.15 Further redevelopment is seen on the 25 inch: mile OS map of 1919 (fig. 8). The second building from the junction with Ropemaker's Fields had been cleared by this date, leaving an open space.

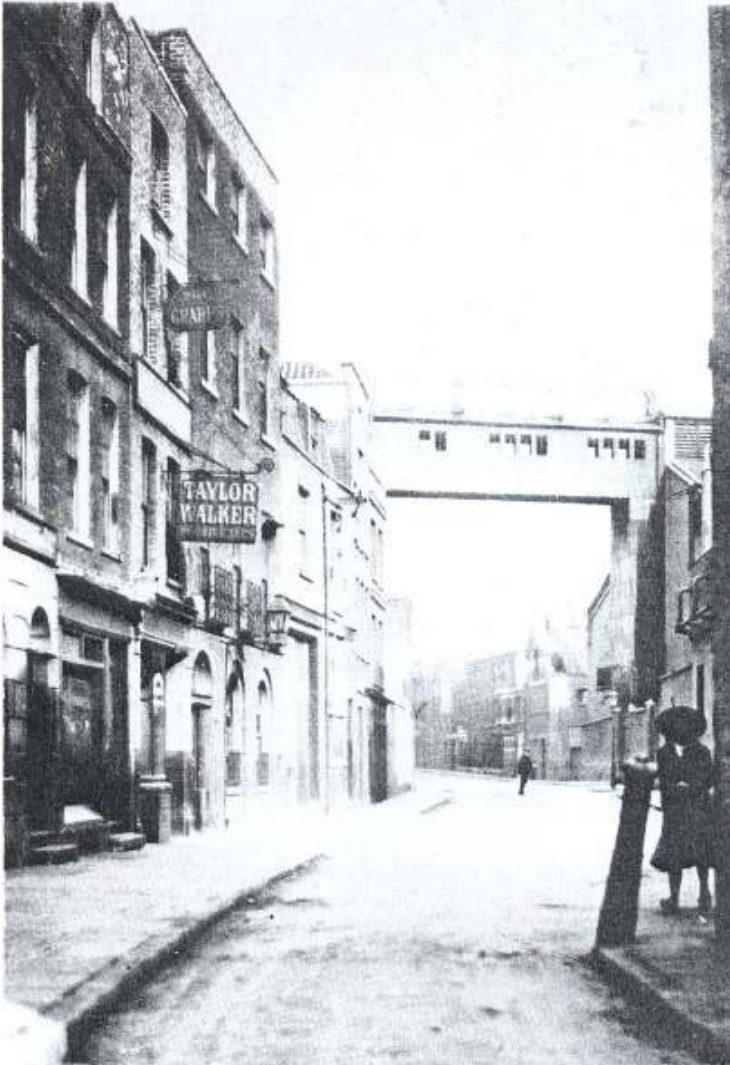
Fig. 9: 1920s photograph of Narrow Street, looking east towards junction with Ropemaker's Fields

2.16 The 1920s photograph of Narrow Street (depicted below, copyright Tower Hamlets Library) depicts the area at the junction with Ropemaker's Fields (looking west along Narrow Street). 'The Grapes' (the public house) can clearly be seen on the southern side of Narrow Street, with the young girl standing on the eastern side of the junction with Ropemaker's Fields.

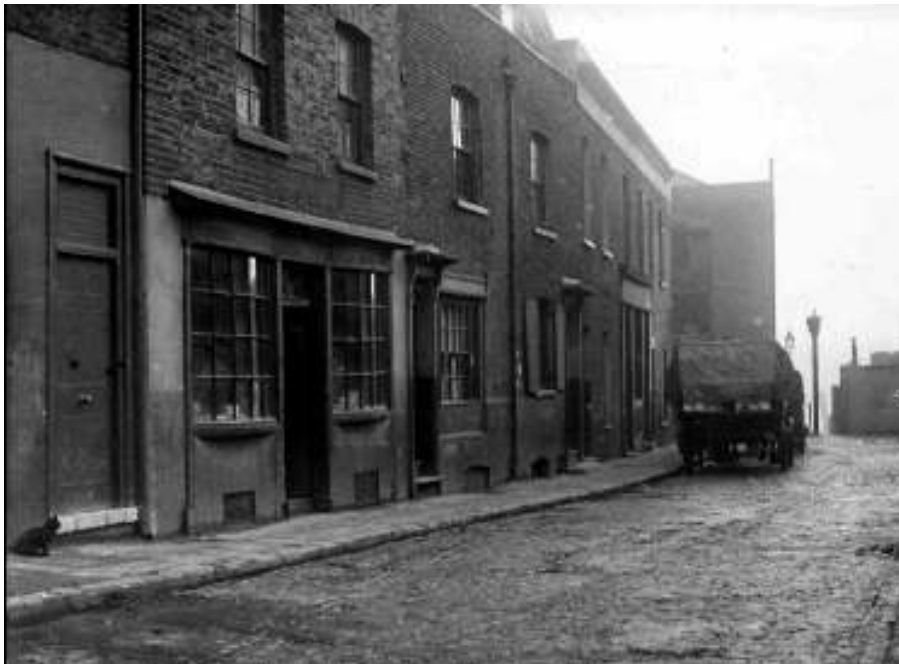
Fig. 11: 1930s photograph of Narrow Street – exact location unknown but probably the southern side of Narrow Street, after street-widening

2.18 The 1930s photograph of Narrow Street depicted below (Copyright: Tower Hamlets Library) shows the type of buildings that stood along Narrow Street in the early 20th Century. These are all clearly brick-built, with semi-basements, as shown by the grills depicted just above street-level.

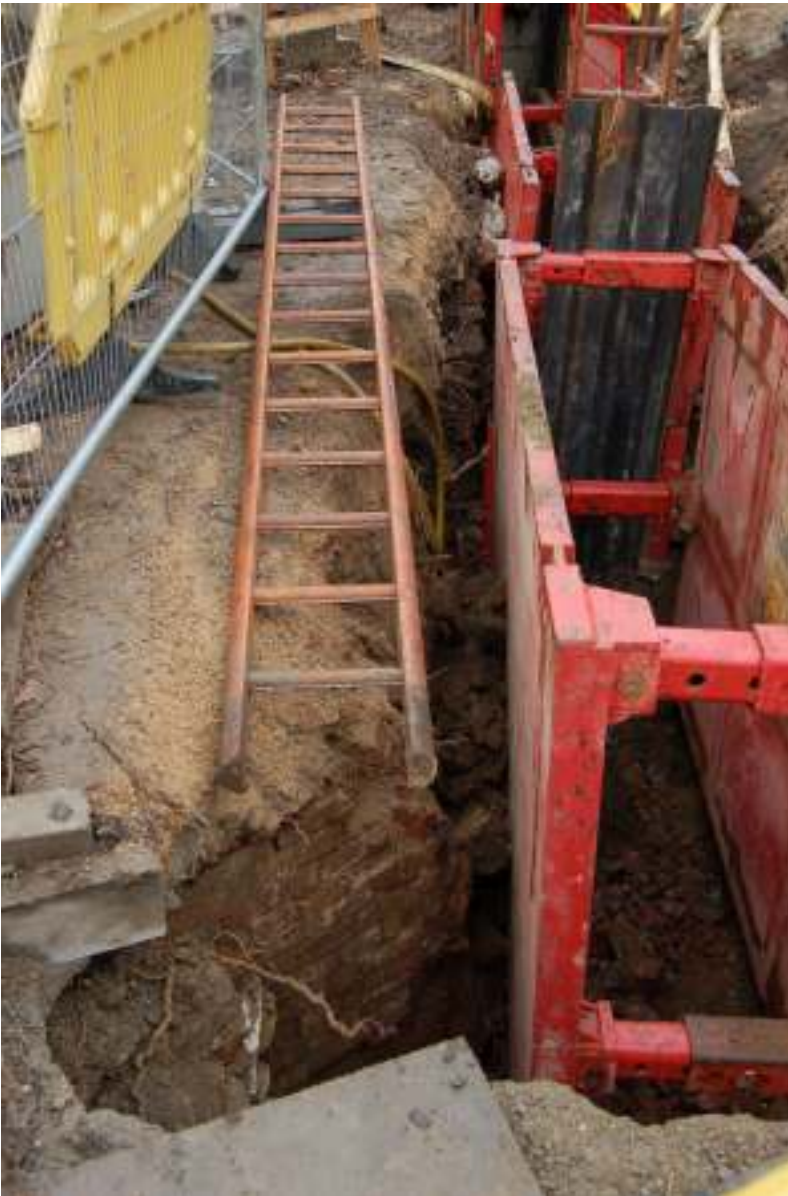
Fig. 14: Photo of basement wall (left foreground below the ladder), in the northern part of the trench running from the northern edge of Narrow Street across the open park

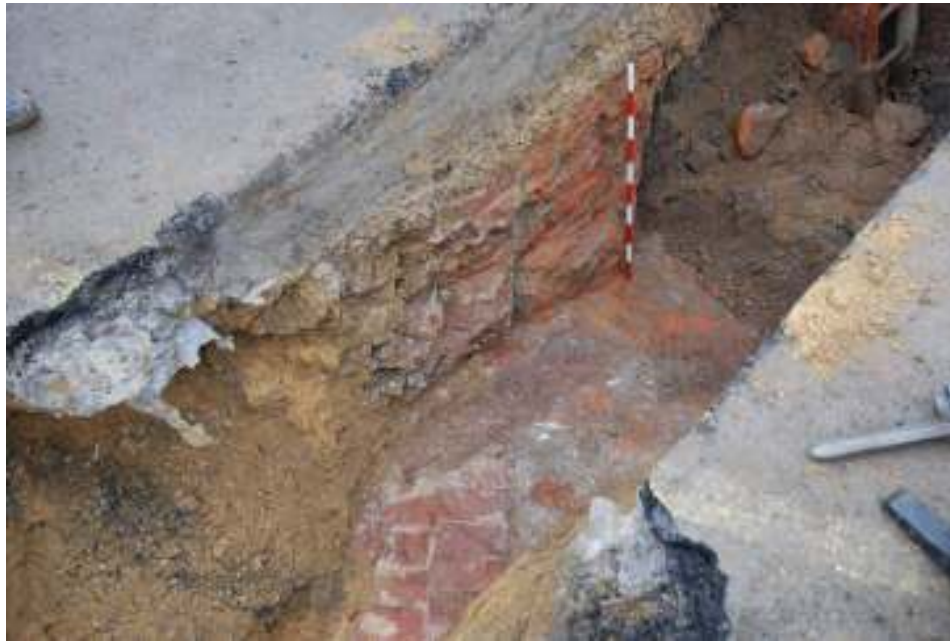
Fig. 17: Photo of walls [1] and [2] looking south

4.3.2 The brick wall [2] abuts wall [1] to the north. This wall [2] is of later date than [1], and may have acted as a later replacement to wall [1], i.e. formed the northern wall of the cellar at a later date, after the original wall [1] had been damaged or fallen into disrepair. There is, however, no evidence for wall [1] having been damaged, although it must be remembered that only the foundations of the wall were uncovered in the excavation, and it is possible that wall [1] had been damaged above the surface.

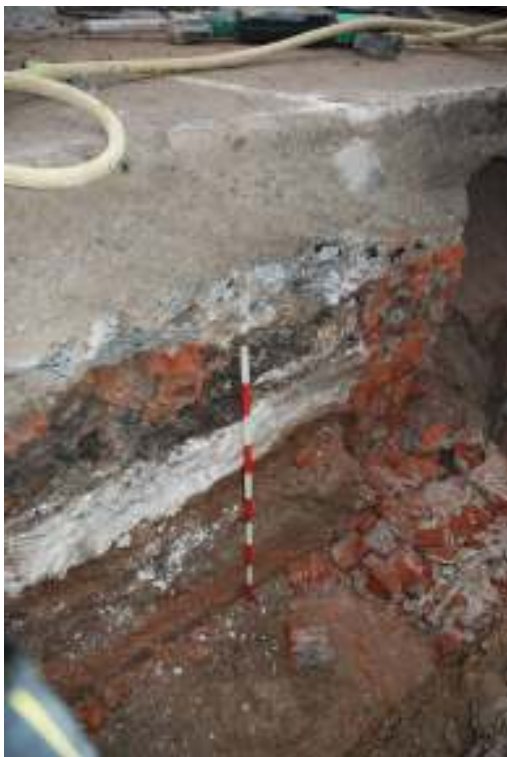
Fig. 18: Photo of wall [6] in the background

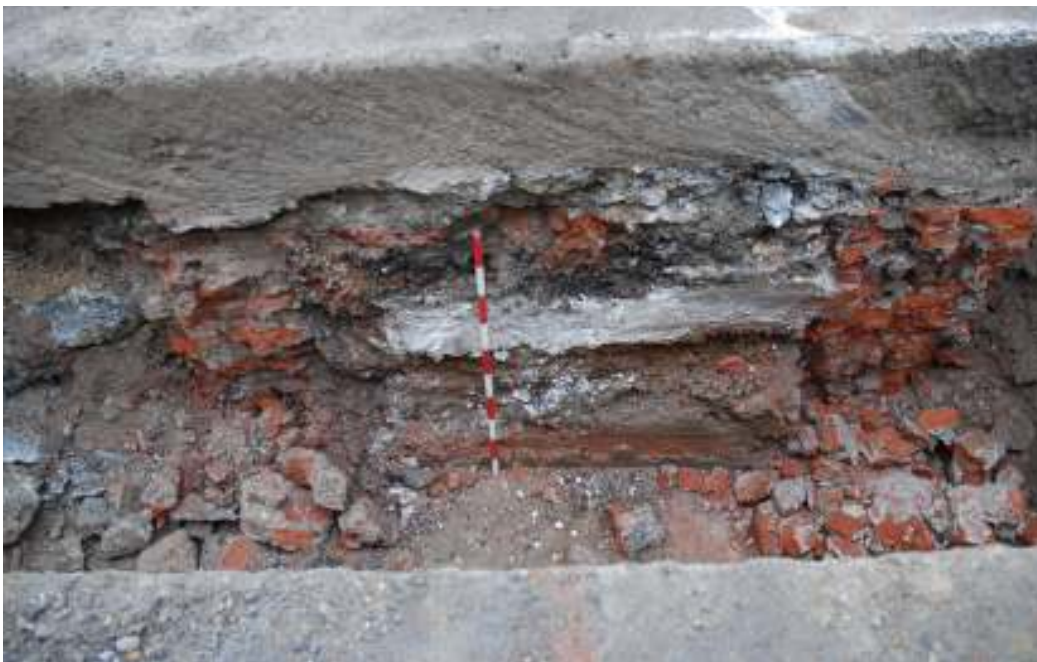
Fig. 20: Photo of contexts [7] and [8], between walls [6] and [9] – the passageway

- 4.4.3 This passageway was “Duk Shoar’s Alley”, clearly depicted on Rocque’s 1745 Map. The passageway, and the deposits encountered in this watching brief which made up the passageway, must therefore date to at least the mid-18th Century. It is possible that such a passageway existed from before this date, however nothing is depicted on Newcourt’s 1658 Map. Nonetheless, the passageway continued in existence, and continued to be depicted on maps, until at least 1956 – yet had disappeared by the 1971 OS Map, along with the buildings along the northern side of Narrow Street. This was therefore part of the total clearance/destruction of all buildings and features in this area of Narrow Street between 1956 and 1971.

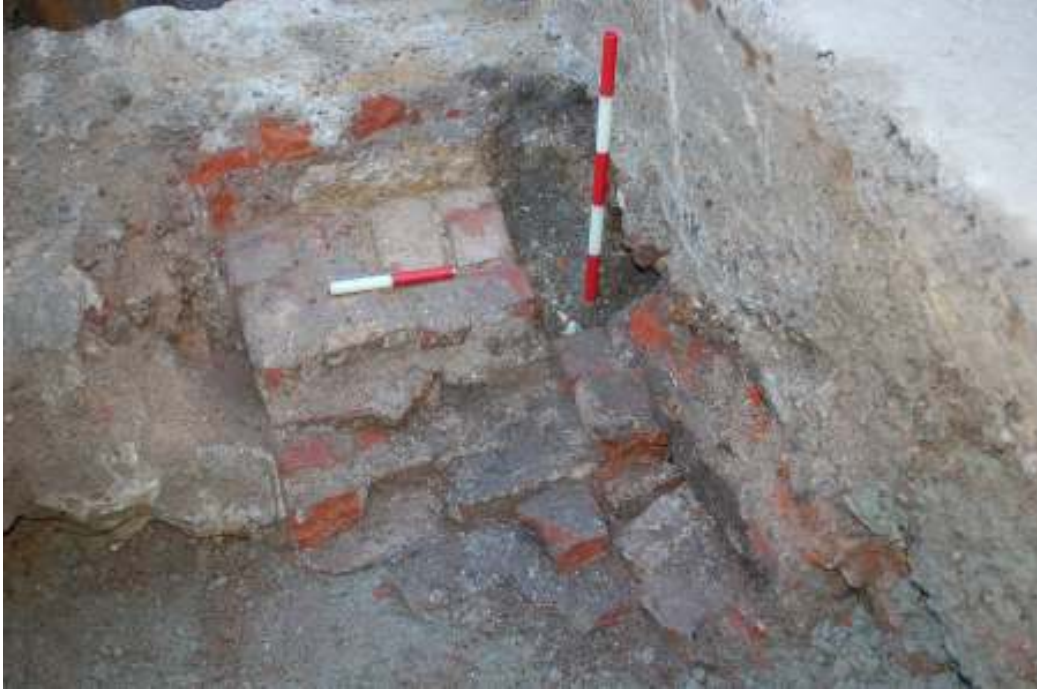
Fig. 23: Photo of contexts [9] (brick wall running along photo) and context [11] (brick step in right part of photo), looking east

- 4.5.4** [11] is an interesting feature found along the wall [9]. It is a small brick step that runs north out of the wall. This may have formed a step out from the building into the street.

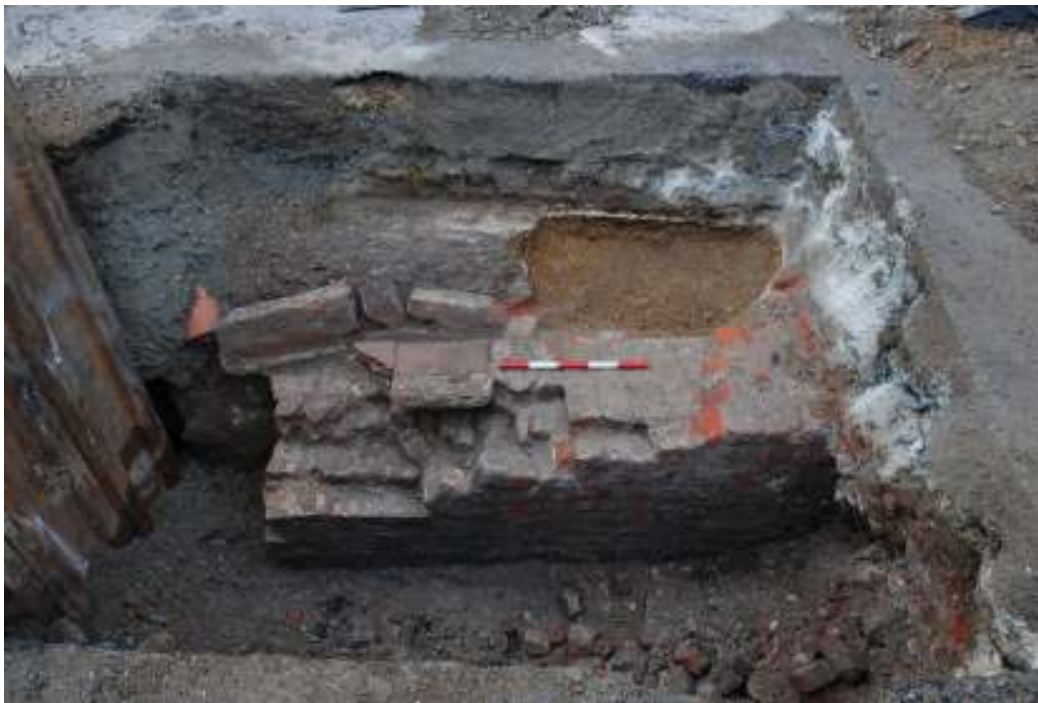
Fig. 24: Photo of contexts [24] (brick wall running across photo) and contexts [23] and [18] (ceramic tiles which formed cellar window in left part of photo), looking south

18	Formally laid large red ceramic tiles. Only three surviving, but were originally more. Lay horizontally on top of [24]. Each tile measured 30.7cm X 31cm X 35-37cm. Tiles overly crumbly loose mortar/tile rubble.	Later feature (as overlies rubble make-up where wall had been cut away at a later time). Possibly formed the base of an inserted cellar window in [24], facing into Narrow Street.
20	Construction cut for [24]. Just visible as a clean cut in the alluvium ([25]) to the north of the wall.	Construction cut for wall (probably cellar wall).
22	Lens of clean river clay lining the construction cut ([20]) of wall ([24]). Extends whole depth of the trench, merging with [25] at base.	Possible by-product of the construction of the wall ([24]), and displacement of the surrounding alluvium to pack the cut.
23	Rubble layer underlying [18]. Loose, grey/yellow, brick and tile rubble. Measures 1.04m E/W and 0.61m N/S.	Rubble cut and fill deposit underlying tiles, for a later window in the cellar wall.

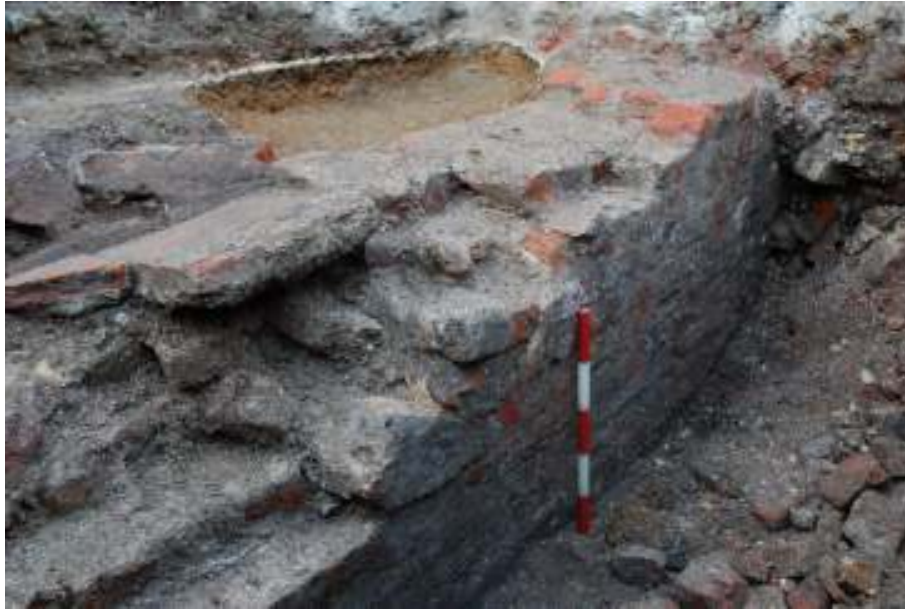
Fig. 25: Photo of context [24] (brick wall) and context [26] (cellar fill) in the foreground

- 4.5.3** The fill between these walls – [10] and [26] – is a probable cellar fill. This overlay alluvial clay (the ‘natural’) at a depth of 1.9m beneath the modern ground-surface. This represents the probable depth to which the cellar extended down to, and is therefore a deep cellar, rather than a semi-basement which is found in other places along Narrow Street.

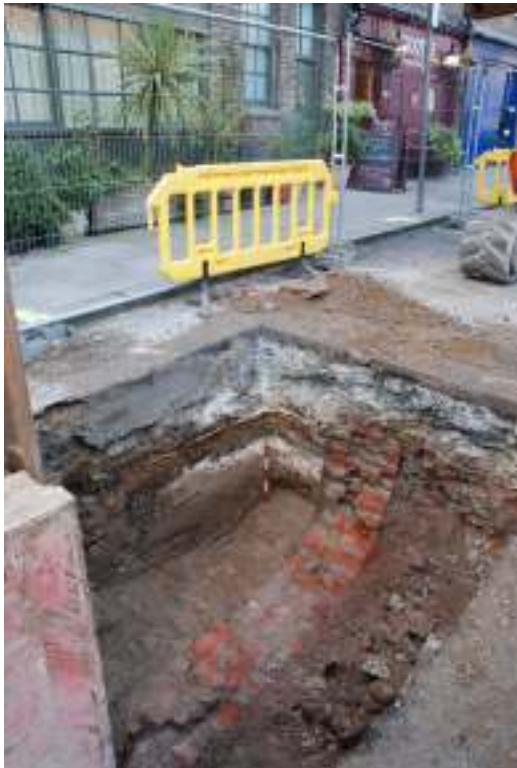
Fig. 26: Photo of context [24] (brick wall) and context [26] (cellar fill) in the foreground – clearly different from the deposits in the background ('street' deposits discussed in section 4), looking south

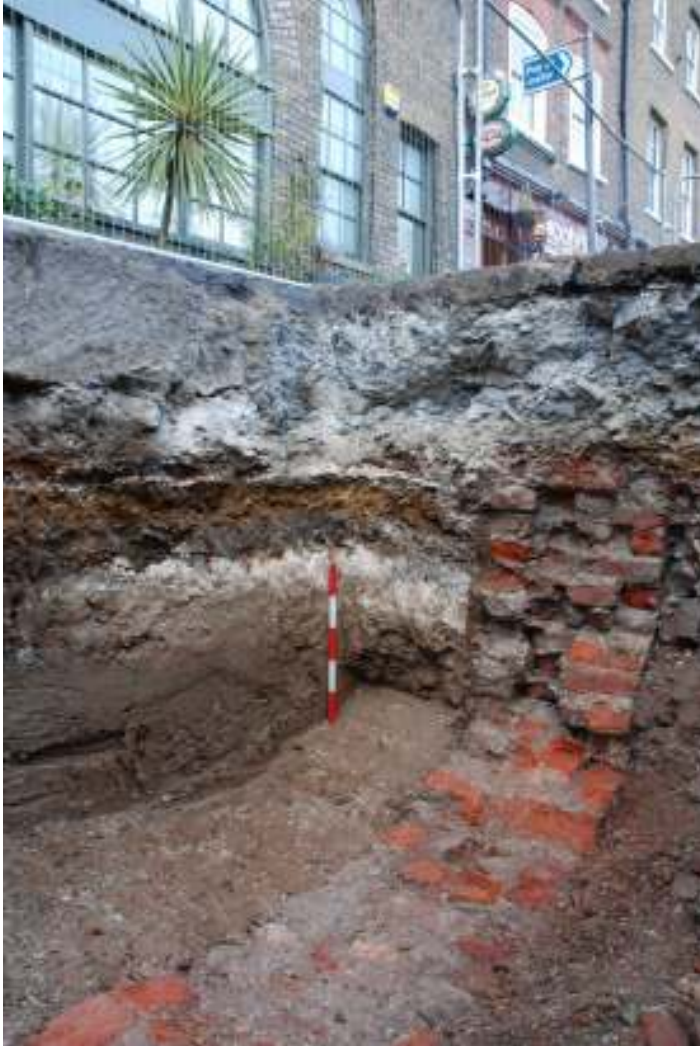
Fig. 29: Photo of context [24] (brick wall) and contexts [14], [15], [21] and [25] (street make-up layers and alluvial clay), looking south

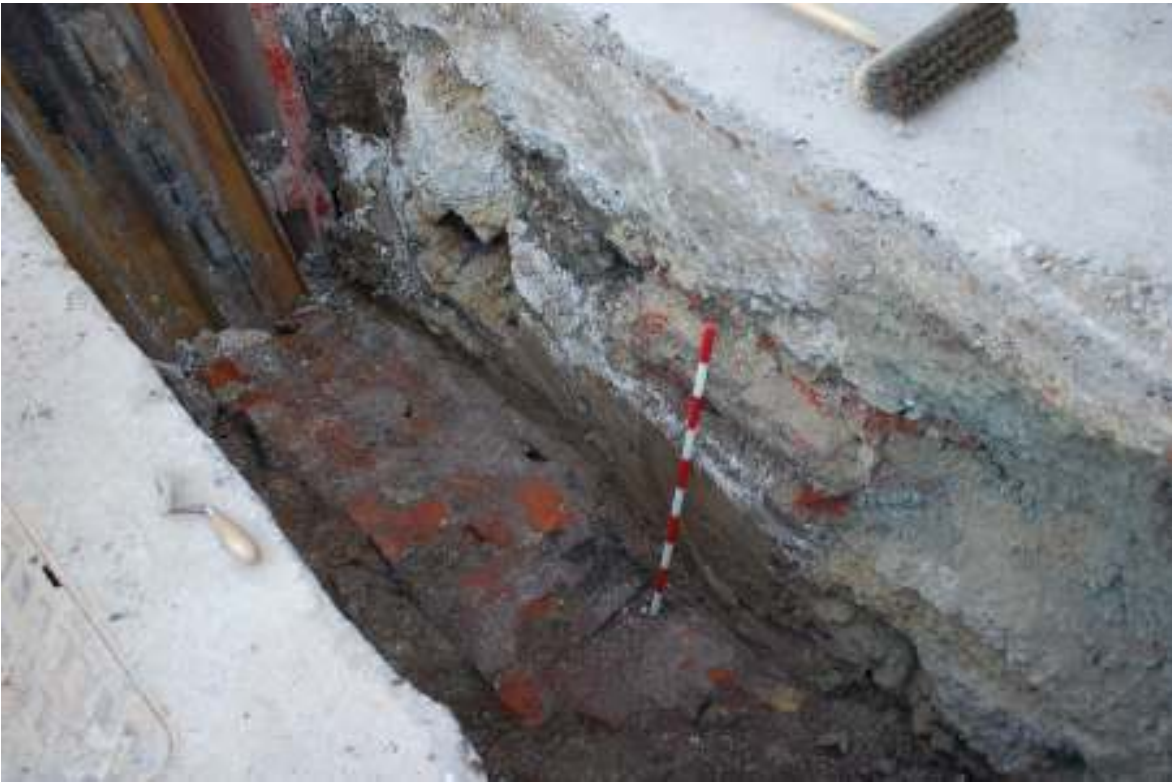
Fig. 30: Photo of context [9] (brick wall), with contexts [12] and [13] (chalk and alluvial clay) to the south of this, looking south

- 4.6.2** At the base of the trench, the ‘natural’ alluvial river clay was uncovered ([25] and [13]). This is probably the same as [8].
- 4.6.3** Above this ‘natural’, a number of different deposits were found, many of which may have been street make-up layers. For example, to the south of [24], [21] and [15] (both puddle chalk layers) were found. These may have been part of the street make-up, possibly used to consolidate the underlying alluvial clay deposits. This underlay [14] (a gravel make-up layer), which may have been further used to strengthen and consolidate the street. It is interesting that a layer of chalk was also found in the passageway section to the east of this (see section 2), and to the south of [9] ([12]), as this suggests that such chalk was often used as a way of consolidating the street make-up.

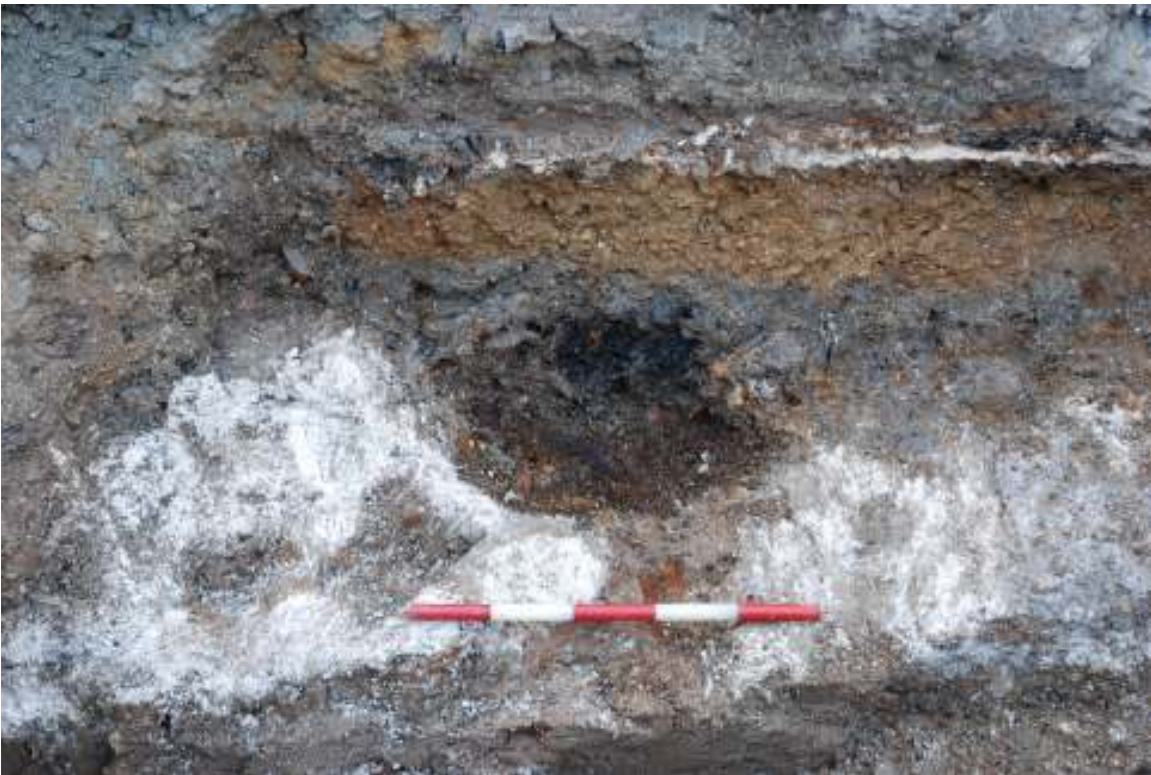
Fig. 31: Photo of context [19] (dumped deposit)

the clay-pipe bowls from [19] to the late 18th Century suggest that this was the date at which these deposits were dumped in the street – and therefore also the date at which industrial activity was taking place in Narrow Street.

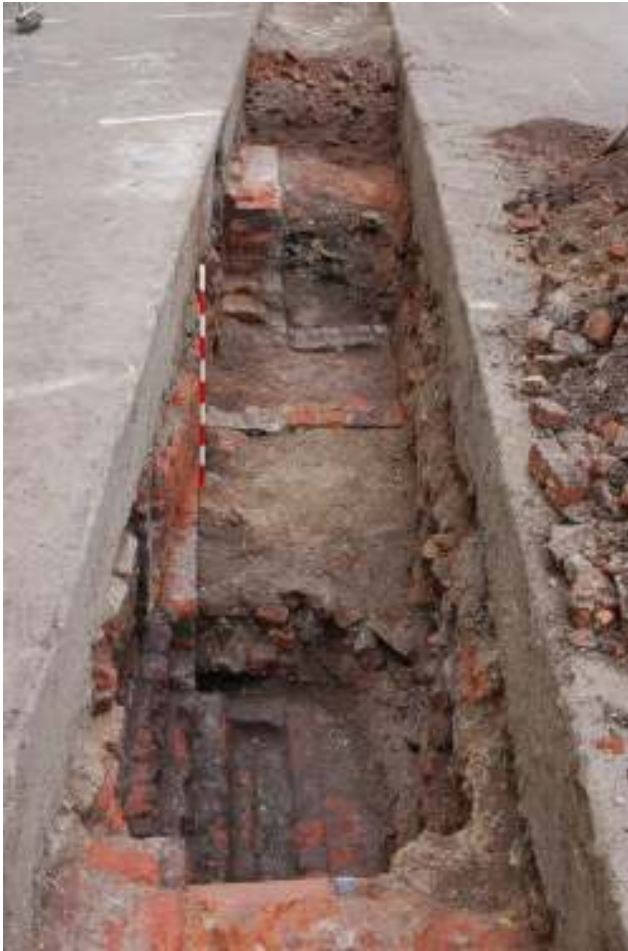
Fig. 33: Photo of section 5, looking west, showing context [28] (brick steps) in the foreground, with contexts [31]/[32] etc (brick walls) in the background

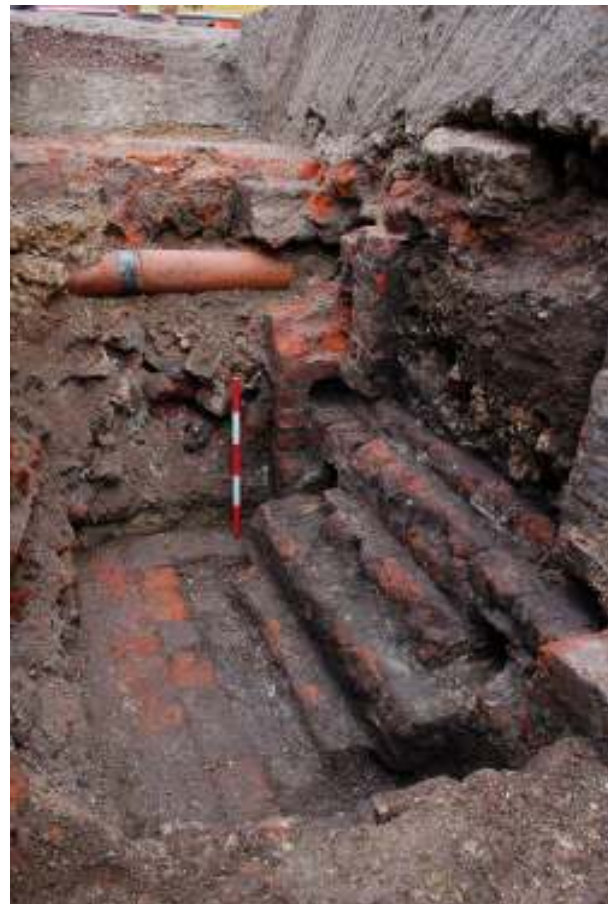
Fig. 34: Photo of context [28] (brick steps) and context [30] (brick floor)

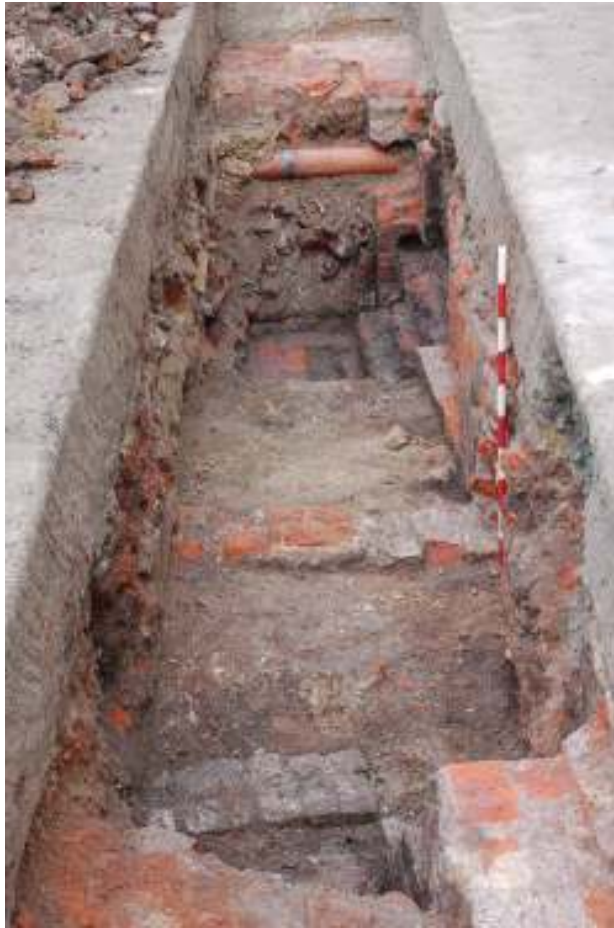
Fig. 35: Photo of contexts [31] and [32] (brick walls) in the foreground, with contexts [28] and [30] (brick steps and floor) in the background, looking east

- 4.7.5 Another wall [32] ran north-south across the trench and was located just to the west of wall [31]. This appears similar to the other walls found (i.e. [27] and [31]) that formed dividing walls between cellars. The problem here, however, is that wall [32] was relatively close to wall [31], such that it seems unlikely that these two walls formed the bounding walls of a single cellar. Wall [32] does, however, form the eastern bounding cellar wall of a cellar bounded to the west by wall [37]/[38].

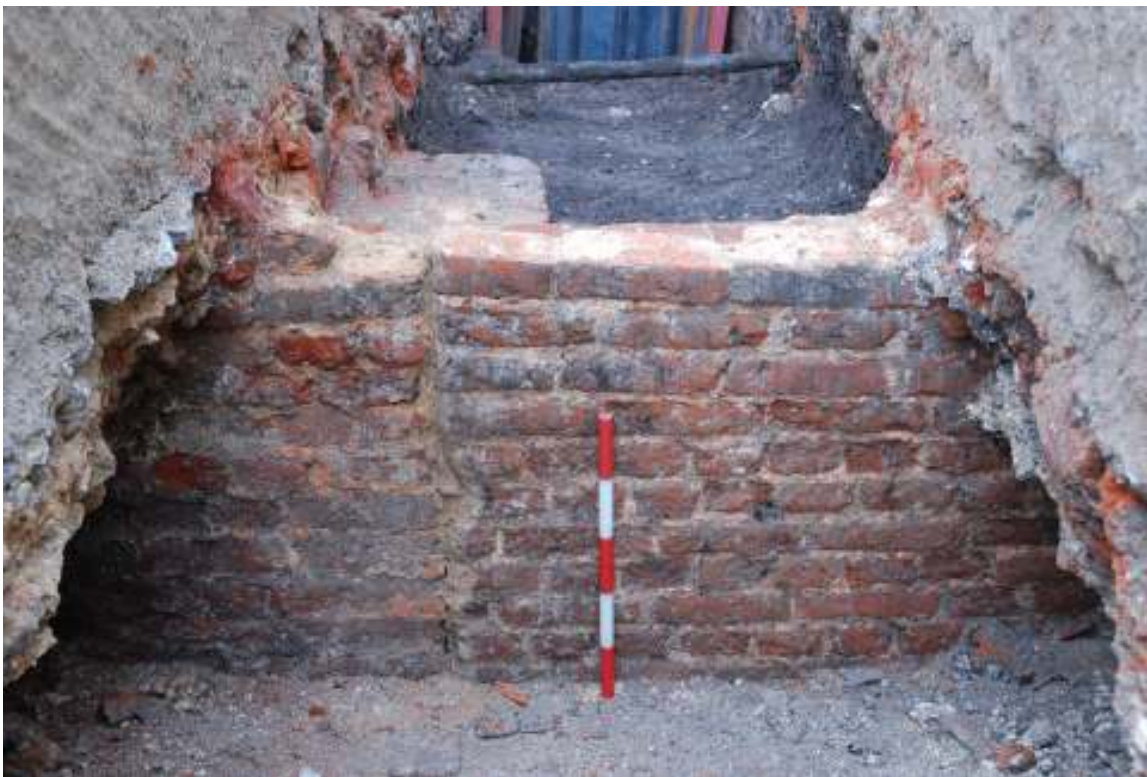
Fig. 39: Photo of the western face of contexts [37]/[38], clearly showing the difference stages of construction of the wall, with the later infill/blocking [37] to the left.

35	Dark ashy/silty fill between [32] + [35], in the northern part of the trench. Relatively loose, with some pebbles/CBM inclusions etc. Finds: three sherds of English Porcelain, nine sherds of Ironstone China (20 th Century); glass; animal bone; iron nails; clinker.	Probable cellar-fill, in the cellar bounded by [32] and [37]/[38].
36	Rectangular brick base abutting and running east of [37] in the northern part of the trench. Slight 'step' up in the wall, with western half of the wall base approximately 0.1m higher than the eastern half. Red brick, set within grey mortar (lots of which spills over the bricks). Measures approximately 0.6m in length (E-W), by 0.3m in width (N-S). Bricks dated <i>c.</i> 1630-1730.	Unknown function? Later than both [37] and [38], as abuts them.
37	Brick wall running north-south, north of [38] and into the northern section. Continued some way into the northern section (for at least 0.9m, where it is cut away by modern services). Red brick, regularly coursed (mainly stretchers), orange-grey mortar, 10 courses high, approximately 0.3m long (N-S), and 0.45m wide. Bricks dated <i>c.</i> 1630-1730.	Clearly of different construction from [38] (different type of brick/mortar, and with a clear division between the two contexts) – probably later than [38] as abuts it? Possibly the blocking of an earlier doorway between the two cellars.

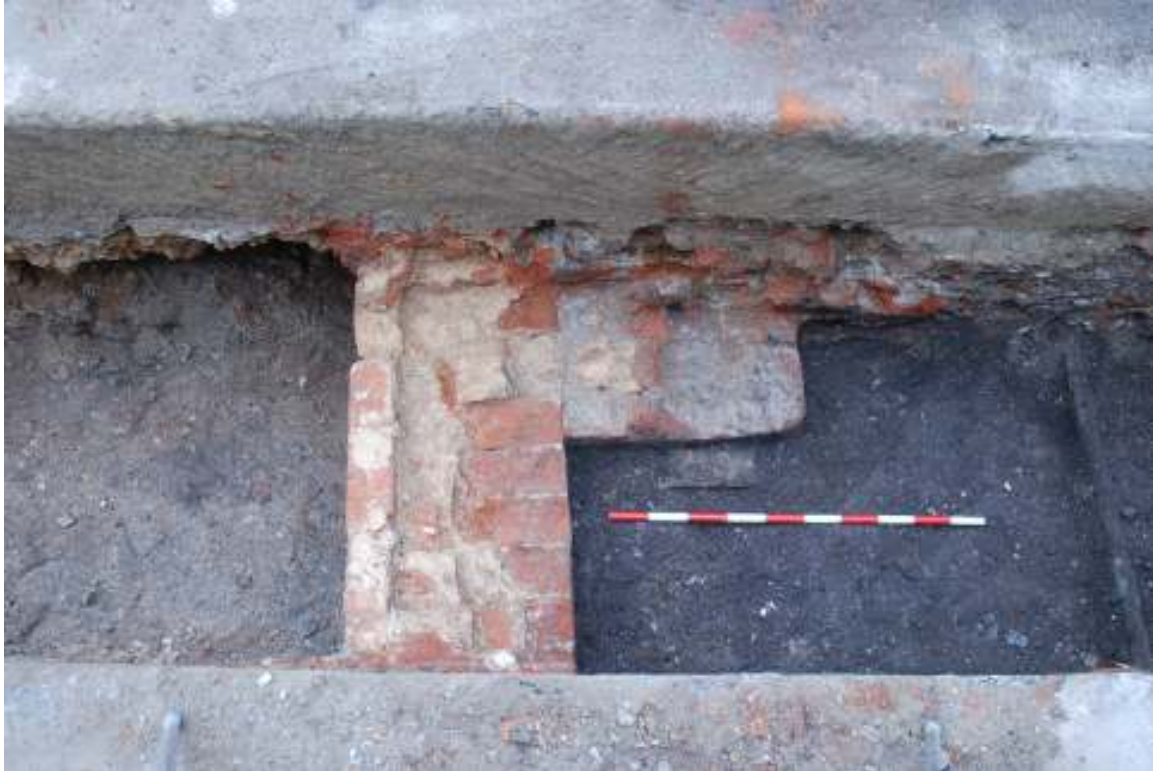
Fig. 40: Photo of contexts [37]/[38] (brick wall running north-south across trench), with context [36] (brick base) to the east

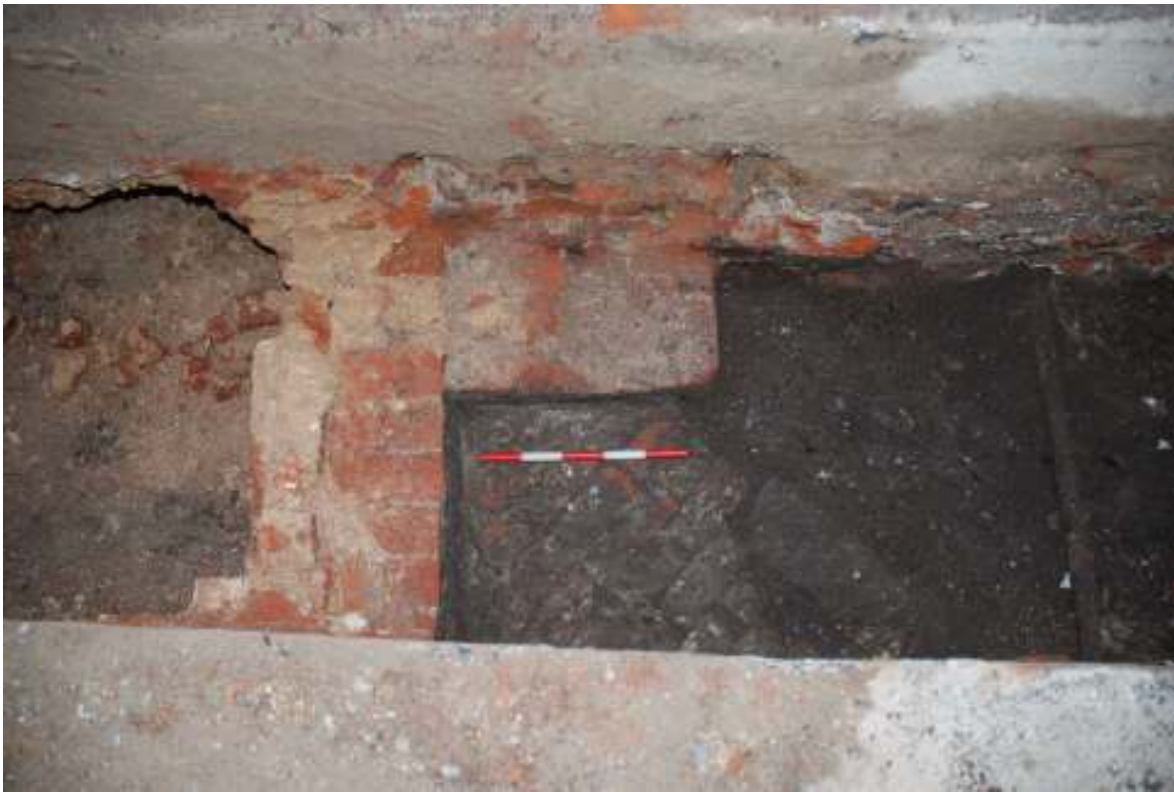
Fig. 41: Photo of contexts [37]/[38]/[36]/[39], after removal of some of the overlying deposit [35].

39	Triangular patch of solid brick to the east of [38] and south of [36]. Layer of red bricks laid flat at the base of the walls, within some patches of mortar and stone blocking at the eastern edge. The diagonal edge to the east appears to be original, with stone and brick here resting on a decayed timber and forming a step down to the lower level. Measures approximately 0.6m at northern end (E-W) to 0.9m at southern end (E-W), and approximately 0.7m N-S.	Unknown function? Possibly some form of ledge or cupboard or other feature within the cellar? Not a floor of the cellar as [35] (cellar fill deposits) are far deeper than [39].
----	---	--

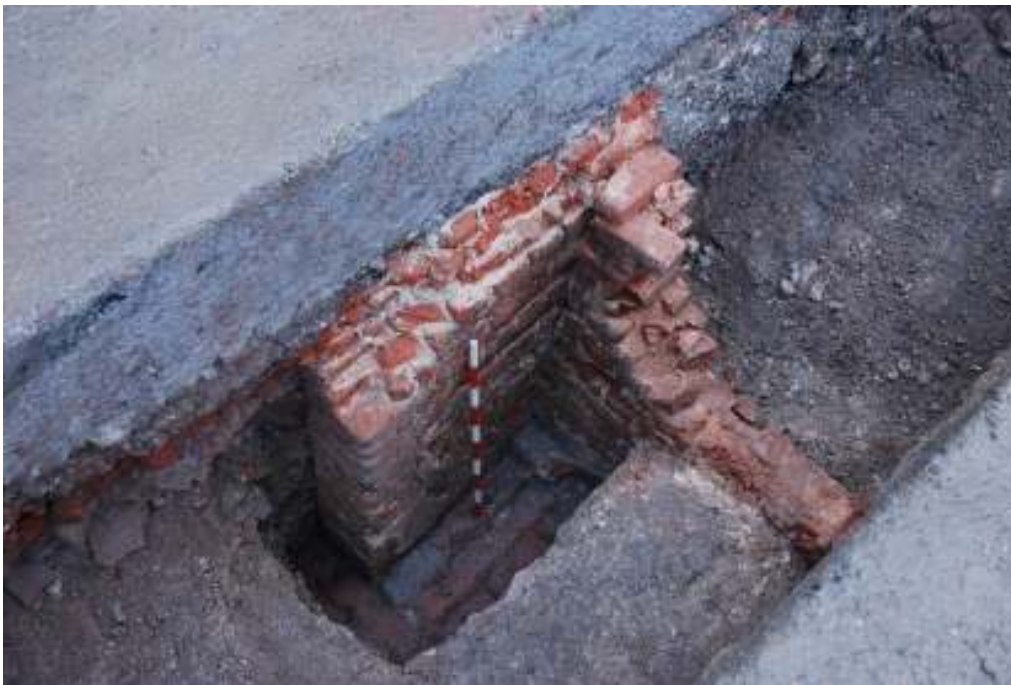
Fig. 43: Photo of contexts [41]/[42]/[43], showing the brick walls and brick floor

- 4.9.2** Part of the probable brick floor of this basement was also uncovered ([43]). This is similar to that observed in the previous sections, and is at a high enough level to suggest that it was a semi-basement rather than a cellar as such.

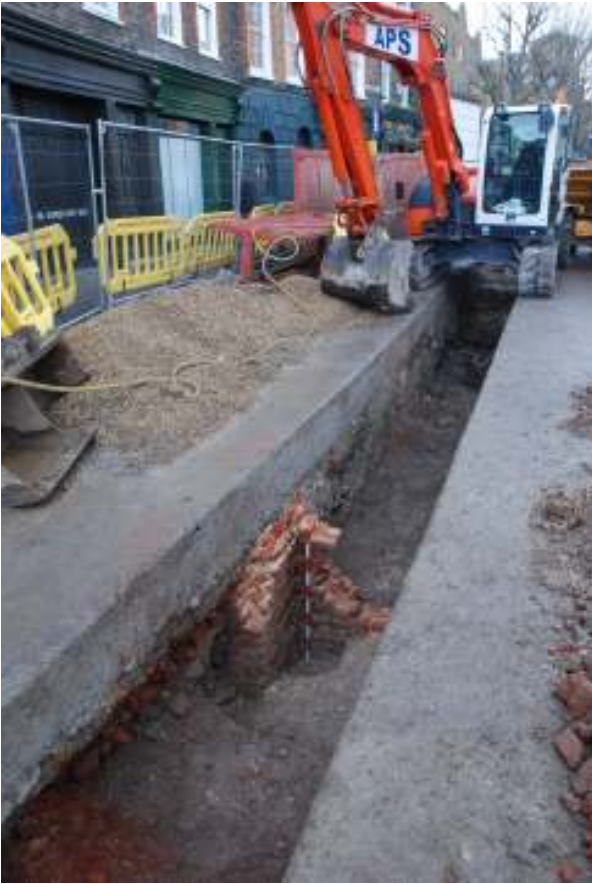
Fig. 44: Photo of contexts [41]/[42]/[43] (brick walls and floors), with context [40] (basement fill) in the foreground, looking west

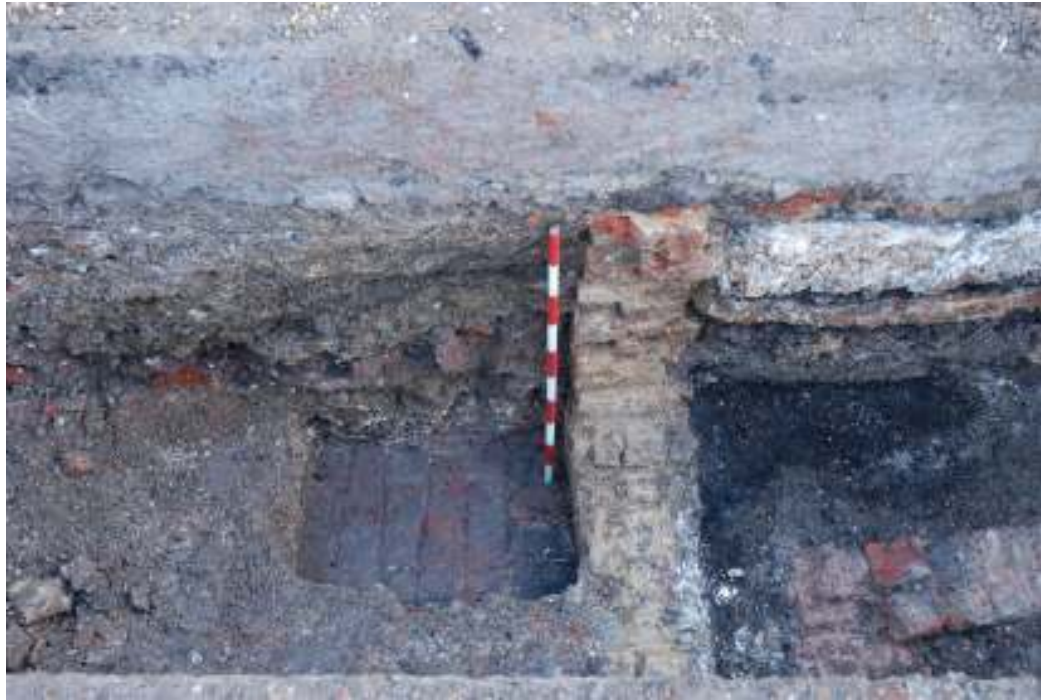
Fig. 47: Photo of brick wall [46] and brick floor [47]

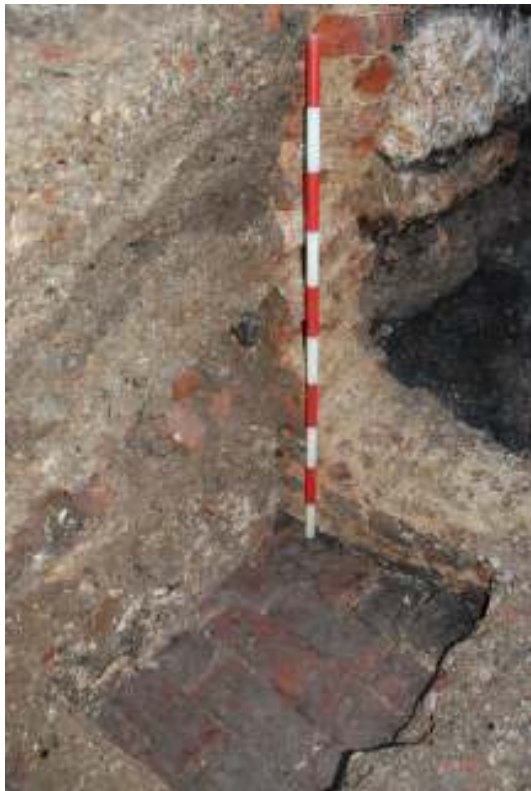
Fig. 48: Photo of brick floor [47]

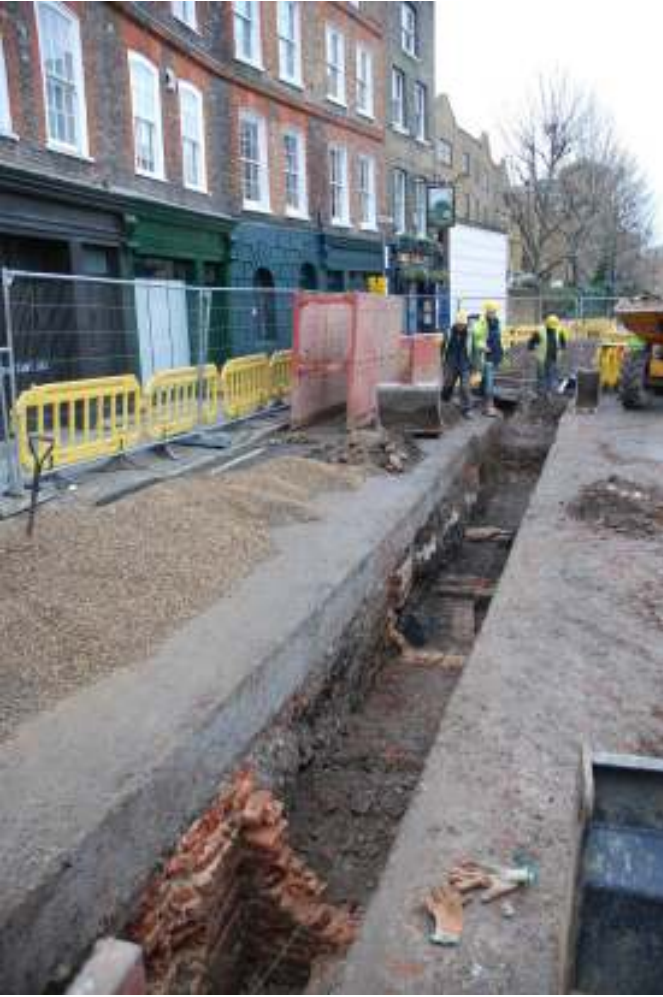
Fig. 49: Photo looking west along trench, showing context [41] in the foreground, and context [46] in the background, with fill [45] between them

1875 OS Map etc), yet the archaeological evidence suggests that it was part of two buildings (or at least two basements). Wall [41] appears to divide the basements into two – whereas the cartographic evidence suggests that it was only one building. Furthermore, the 1919 OS Map hints that, although the maps depict it as one building, it may have been two – as it is labelled as No.95 and No.97. The history of this building (both its construction and later destruction) is discussed above in relation to the previous section.

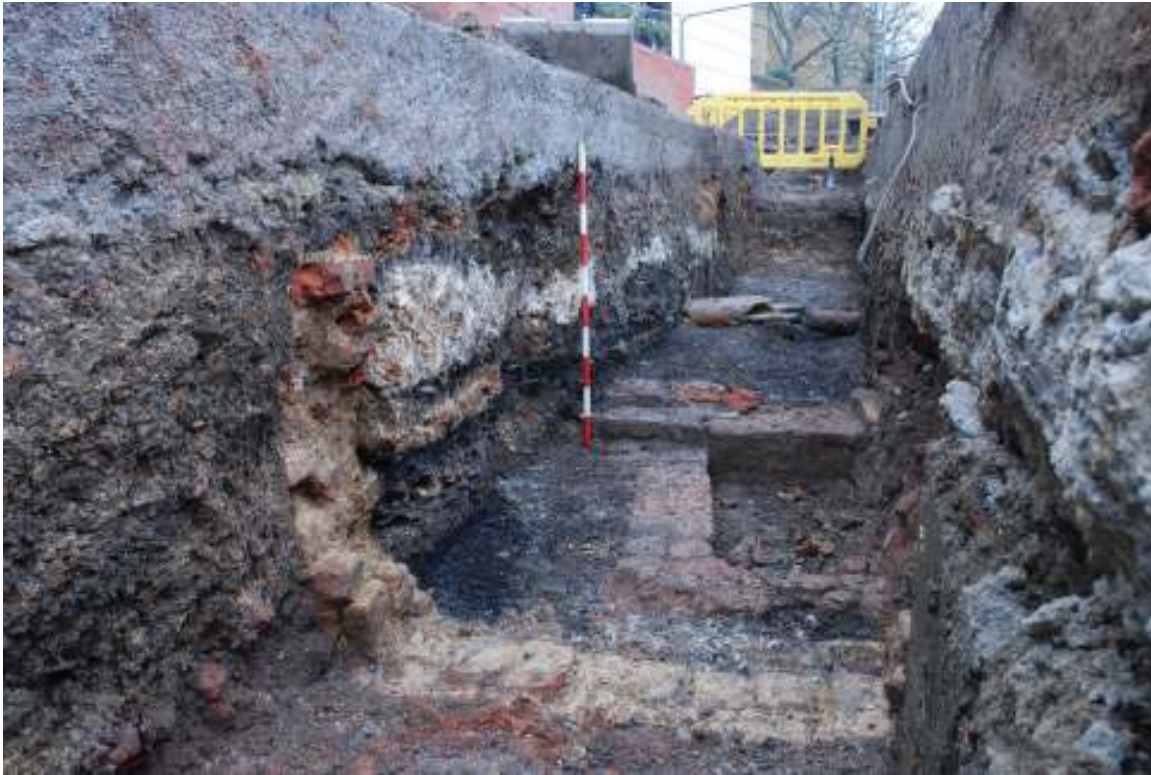
Fig. 52: Photo of section 9, looking west along the trench, with context [46] in the foreground, the modern feature [52] behind this, and the stratified deposits [49] in the southern section

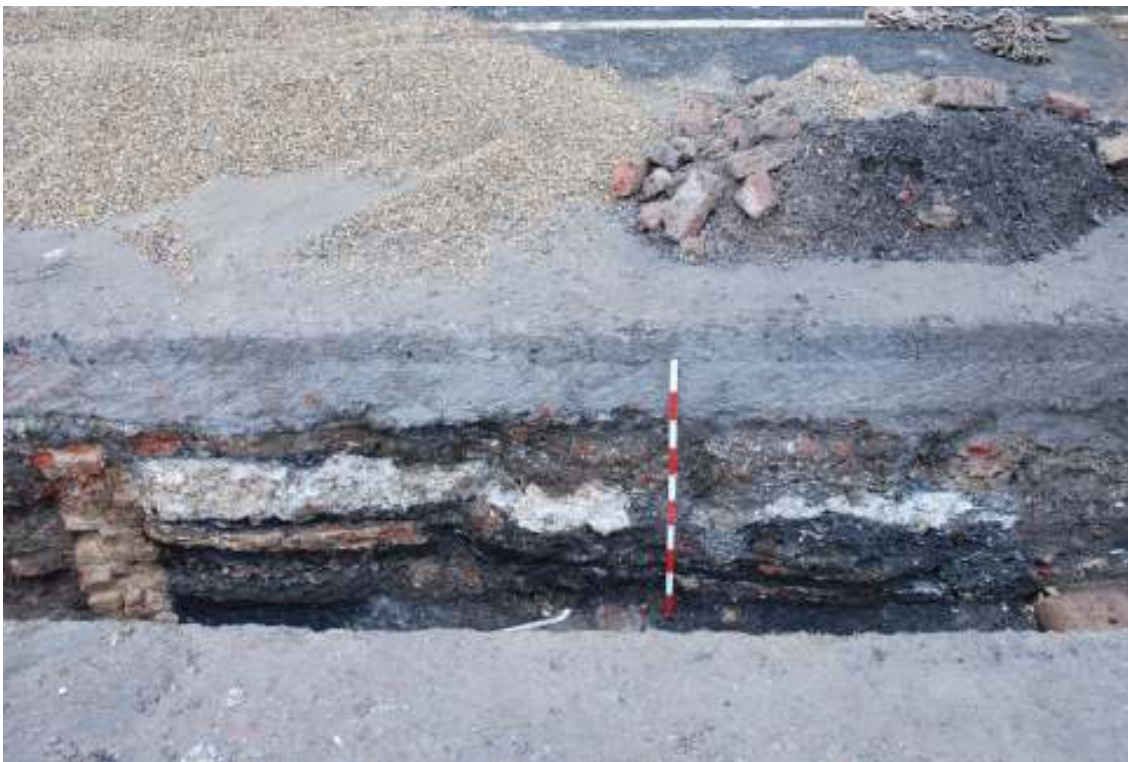
Fig. 53: Photo of stratified deposits [49] in the southern section
