THAMES WATER ENGINEERING WORKS

POST-EXCAVATION ASSESSMENT ON NARROW STREET, TOWER HAMLETS, E14

THAMES WATER ENGINEERING WORKS
POST-EXCAVATION ASSESSMENT ON NARROW
STREET, TOWER HAMLETS, E14

SITE CODE: TZB 08

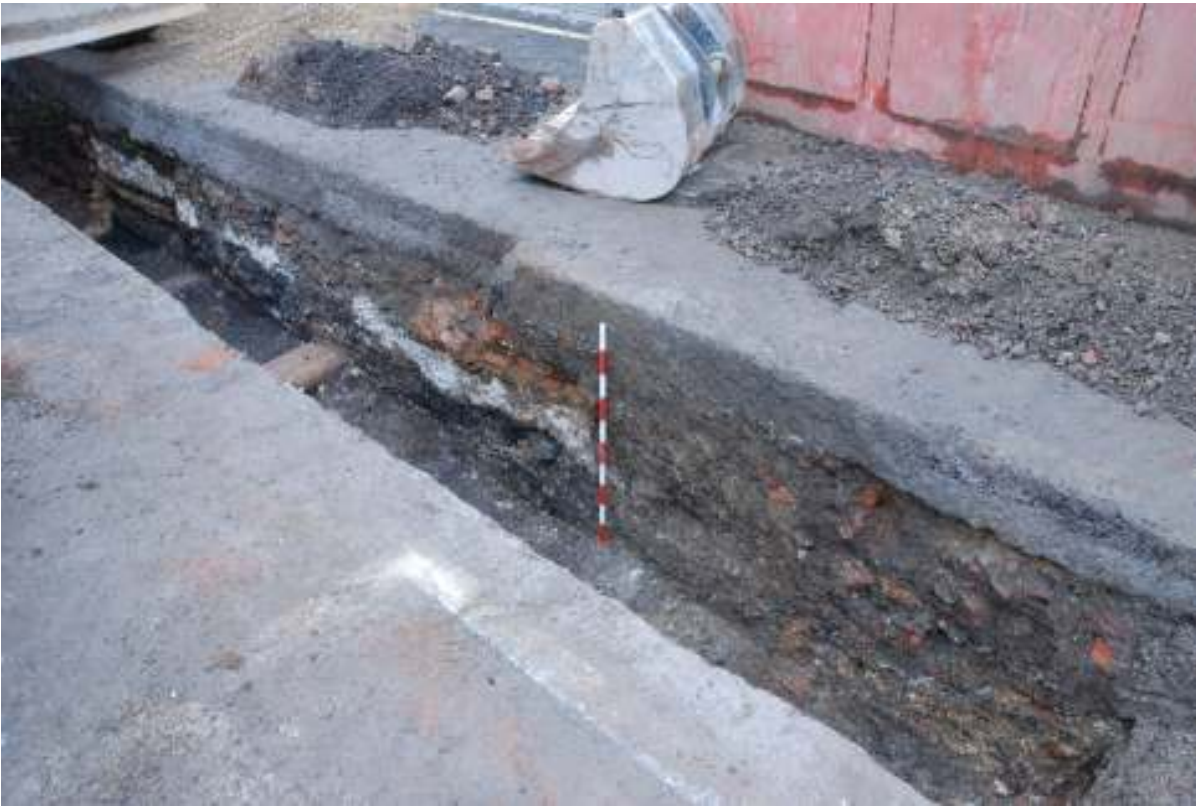
Fig. 54: Photo of possible robbed-out wall [56], clearly showing the difference in deposits to the east and west of this

56	Wide feature (approximately 1m wide) which runs north-south across trench, and which is found in section up to the modern road-surface. Mid-green-brown silty-sand with lots of pebbles. Distinctly different from deposits to the east and west of it. The deposits to the east and west of it ([55] and [58]) are also distinctly different from each-other.	Possibly a modern cut / fill? However, the obvious differences in deposits to the east and west of the feature suggest that it may reflect something earlier, such as a robbed-out wall?
----	--	--

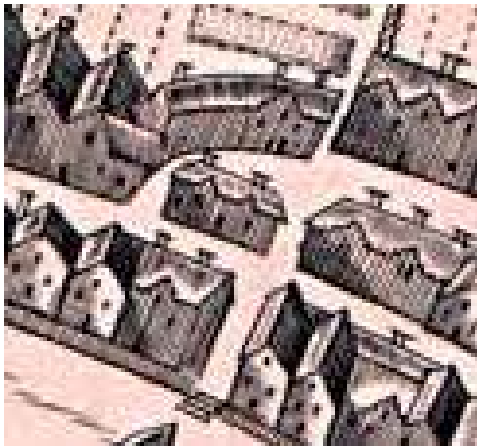
Fig. 55: Newcourt's Map, 1658, clearly showing the roadway and further two houses on the northern side of Narrow Street

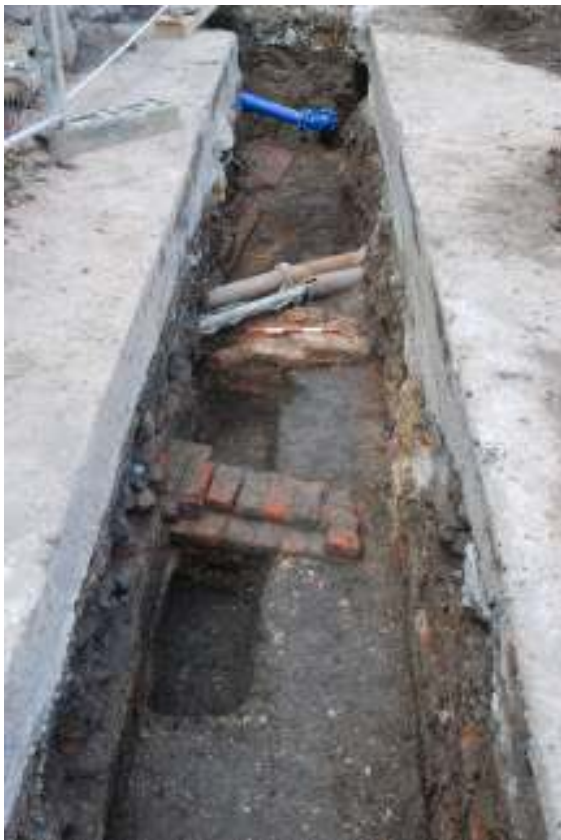
Fig. 57: Photo of brick wall [60], with sondage that revealed the natural river alluvium

60	Brick wall running north from southern section. Red brick, set within a dirty brown-coloured mortar. Measures 1m N-S (whole width of trench), 0.49m E-W. Maximum height of survival was 6 courses (0.48m). 2 stretchers wide (only 2 stretcher-width remains in upper course). Bricks dated late 17 th Century – 1780.	Possible wall foundation of a building?
61	Deep waterlain clay. Underlies [58] and [59] (west of [56] and east of [60]). Starts at a depth of 2.31m, down to a depth of 2.65m.	Natural river alluvium?

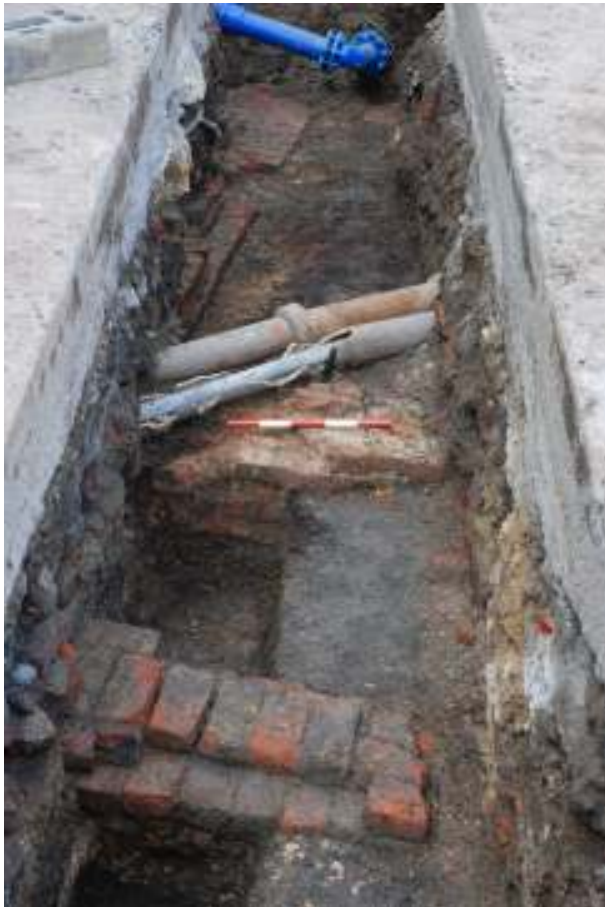
Fig. 59: Photo of context [60] in the foreground and [63] in the background

4.13.2 The small distance between [60] and [63], however, makes it seem unlikely that there was any form of basement or passageway between them. Instead, the two walls may have just been from different phases of building. It is therefore possible that [63] (the earliest wall) originally formed both the eastern wall foundation for the building to the west, and the western wall foundation for the building to the east, and was then replaced in both functions by [60].

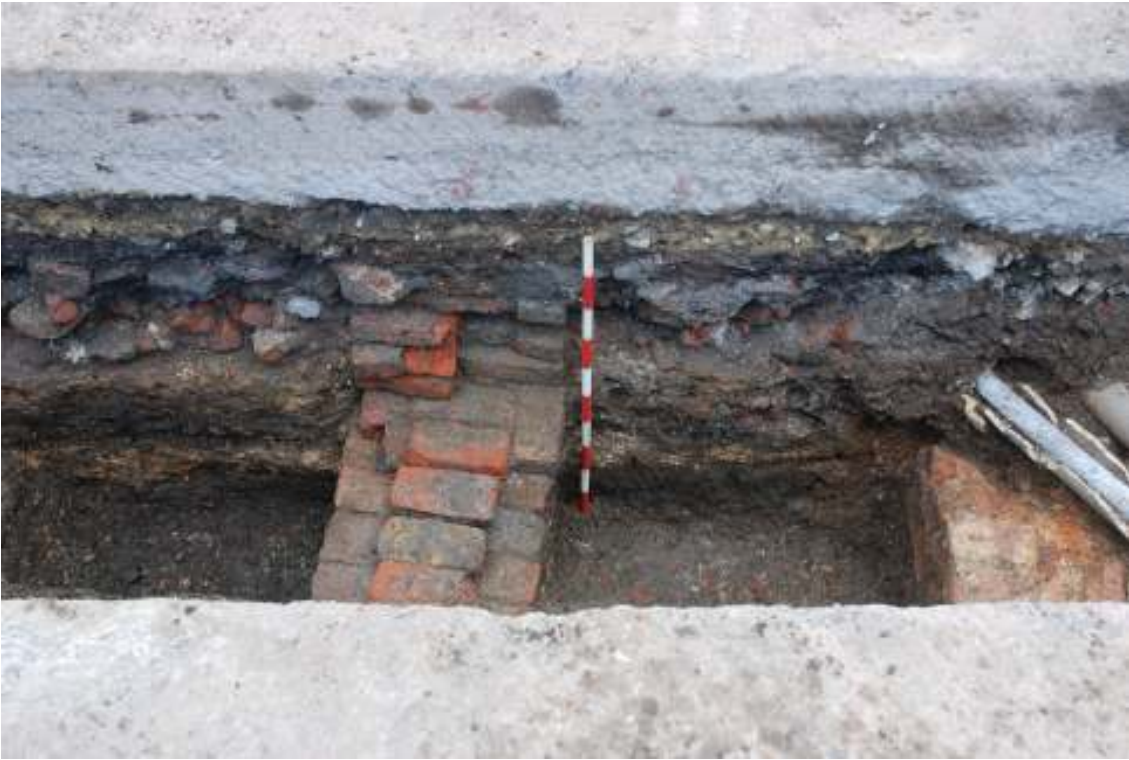
Fig. 60: Photo of contexts [60] and [63], with [58] in-between

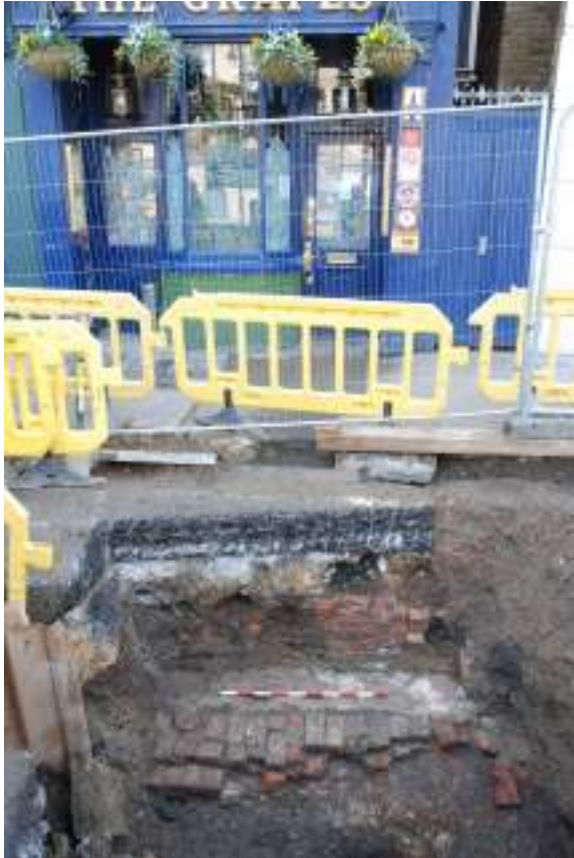
Fig. 62: Photo of context [67] (wall running east-west and then north-south), with natural river alluvium to the south in the area of Narrow Street itself [69]

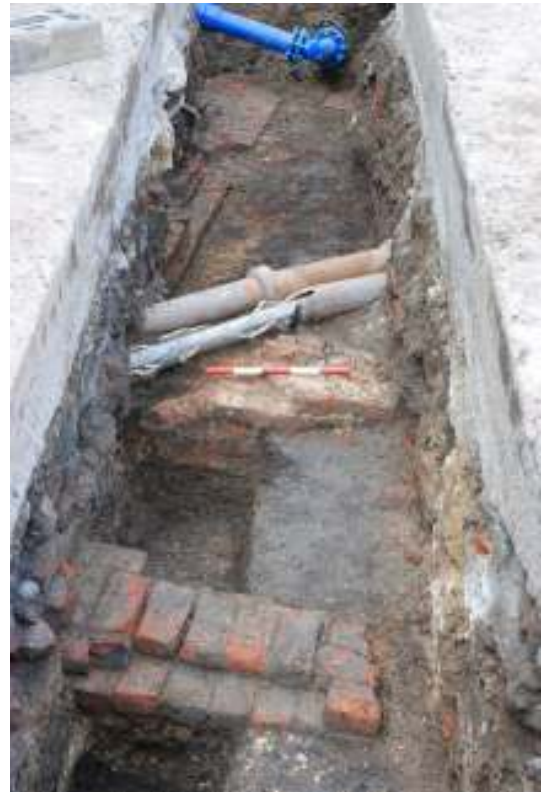
Fig. 63: Photo of section 12, looking west, with context [63] (underneath the scale), and context [67] beyond (forming the outline of the building)
