1EW03 - Enabling Works Central AWH - Survey Report for Woodlands Evaluation

**Site Codes: 1C20JHWHL,
1C20WIFHL, 1C20FCWHL,
1C20HACHL, 1C20FCGHL,
1C20WIHHL**

Document no.: 1EW03-FUS_IFA-EV-REP-C000-000004

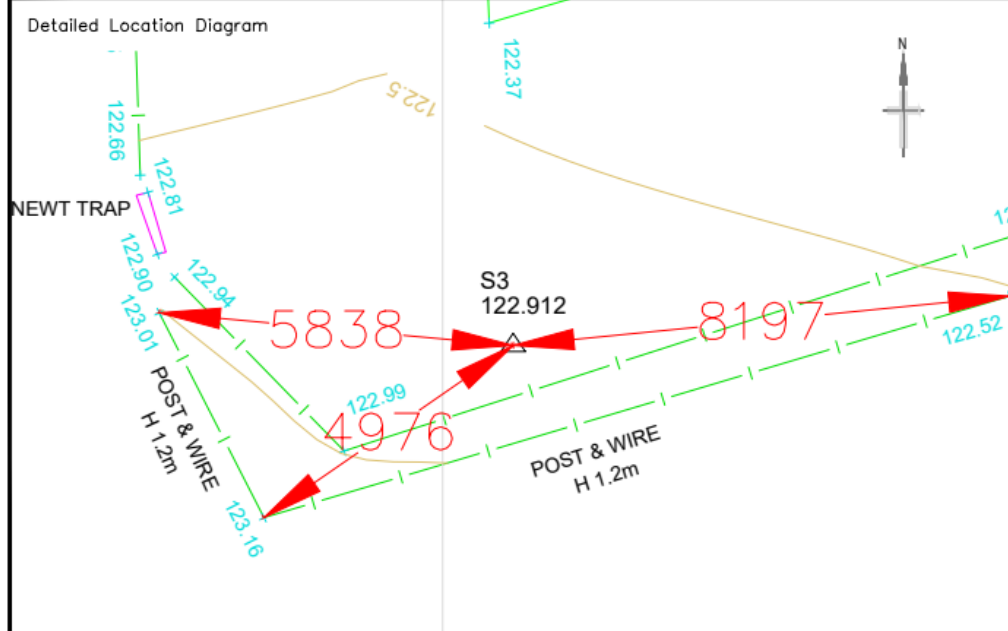
| Arbitrary/N.G.Coordinates | E 442441.157 | N 259210.714 | Level 122.912 |
| <p>Detailed Location Diagram</p> <p>The diagram shows a survey area with a newt trap (pink rectangle) and a post & wire fence (dashed line). A ground marker S3 (yellow triangle) is located near the fence. Elevation points are marked with numbers: 122.66, 122.81, 122.90, 122.94, 122.99, 123.01, 123.16, 122.37, 122.52, 122.55, 122.912 (S3), 5838, 4976, and 8197. Distances are marked with red arrows: 5838, 4976, and 8197. A north arrow is present in the top right corner.</p> | | | |

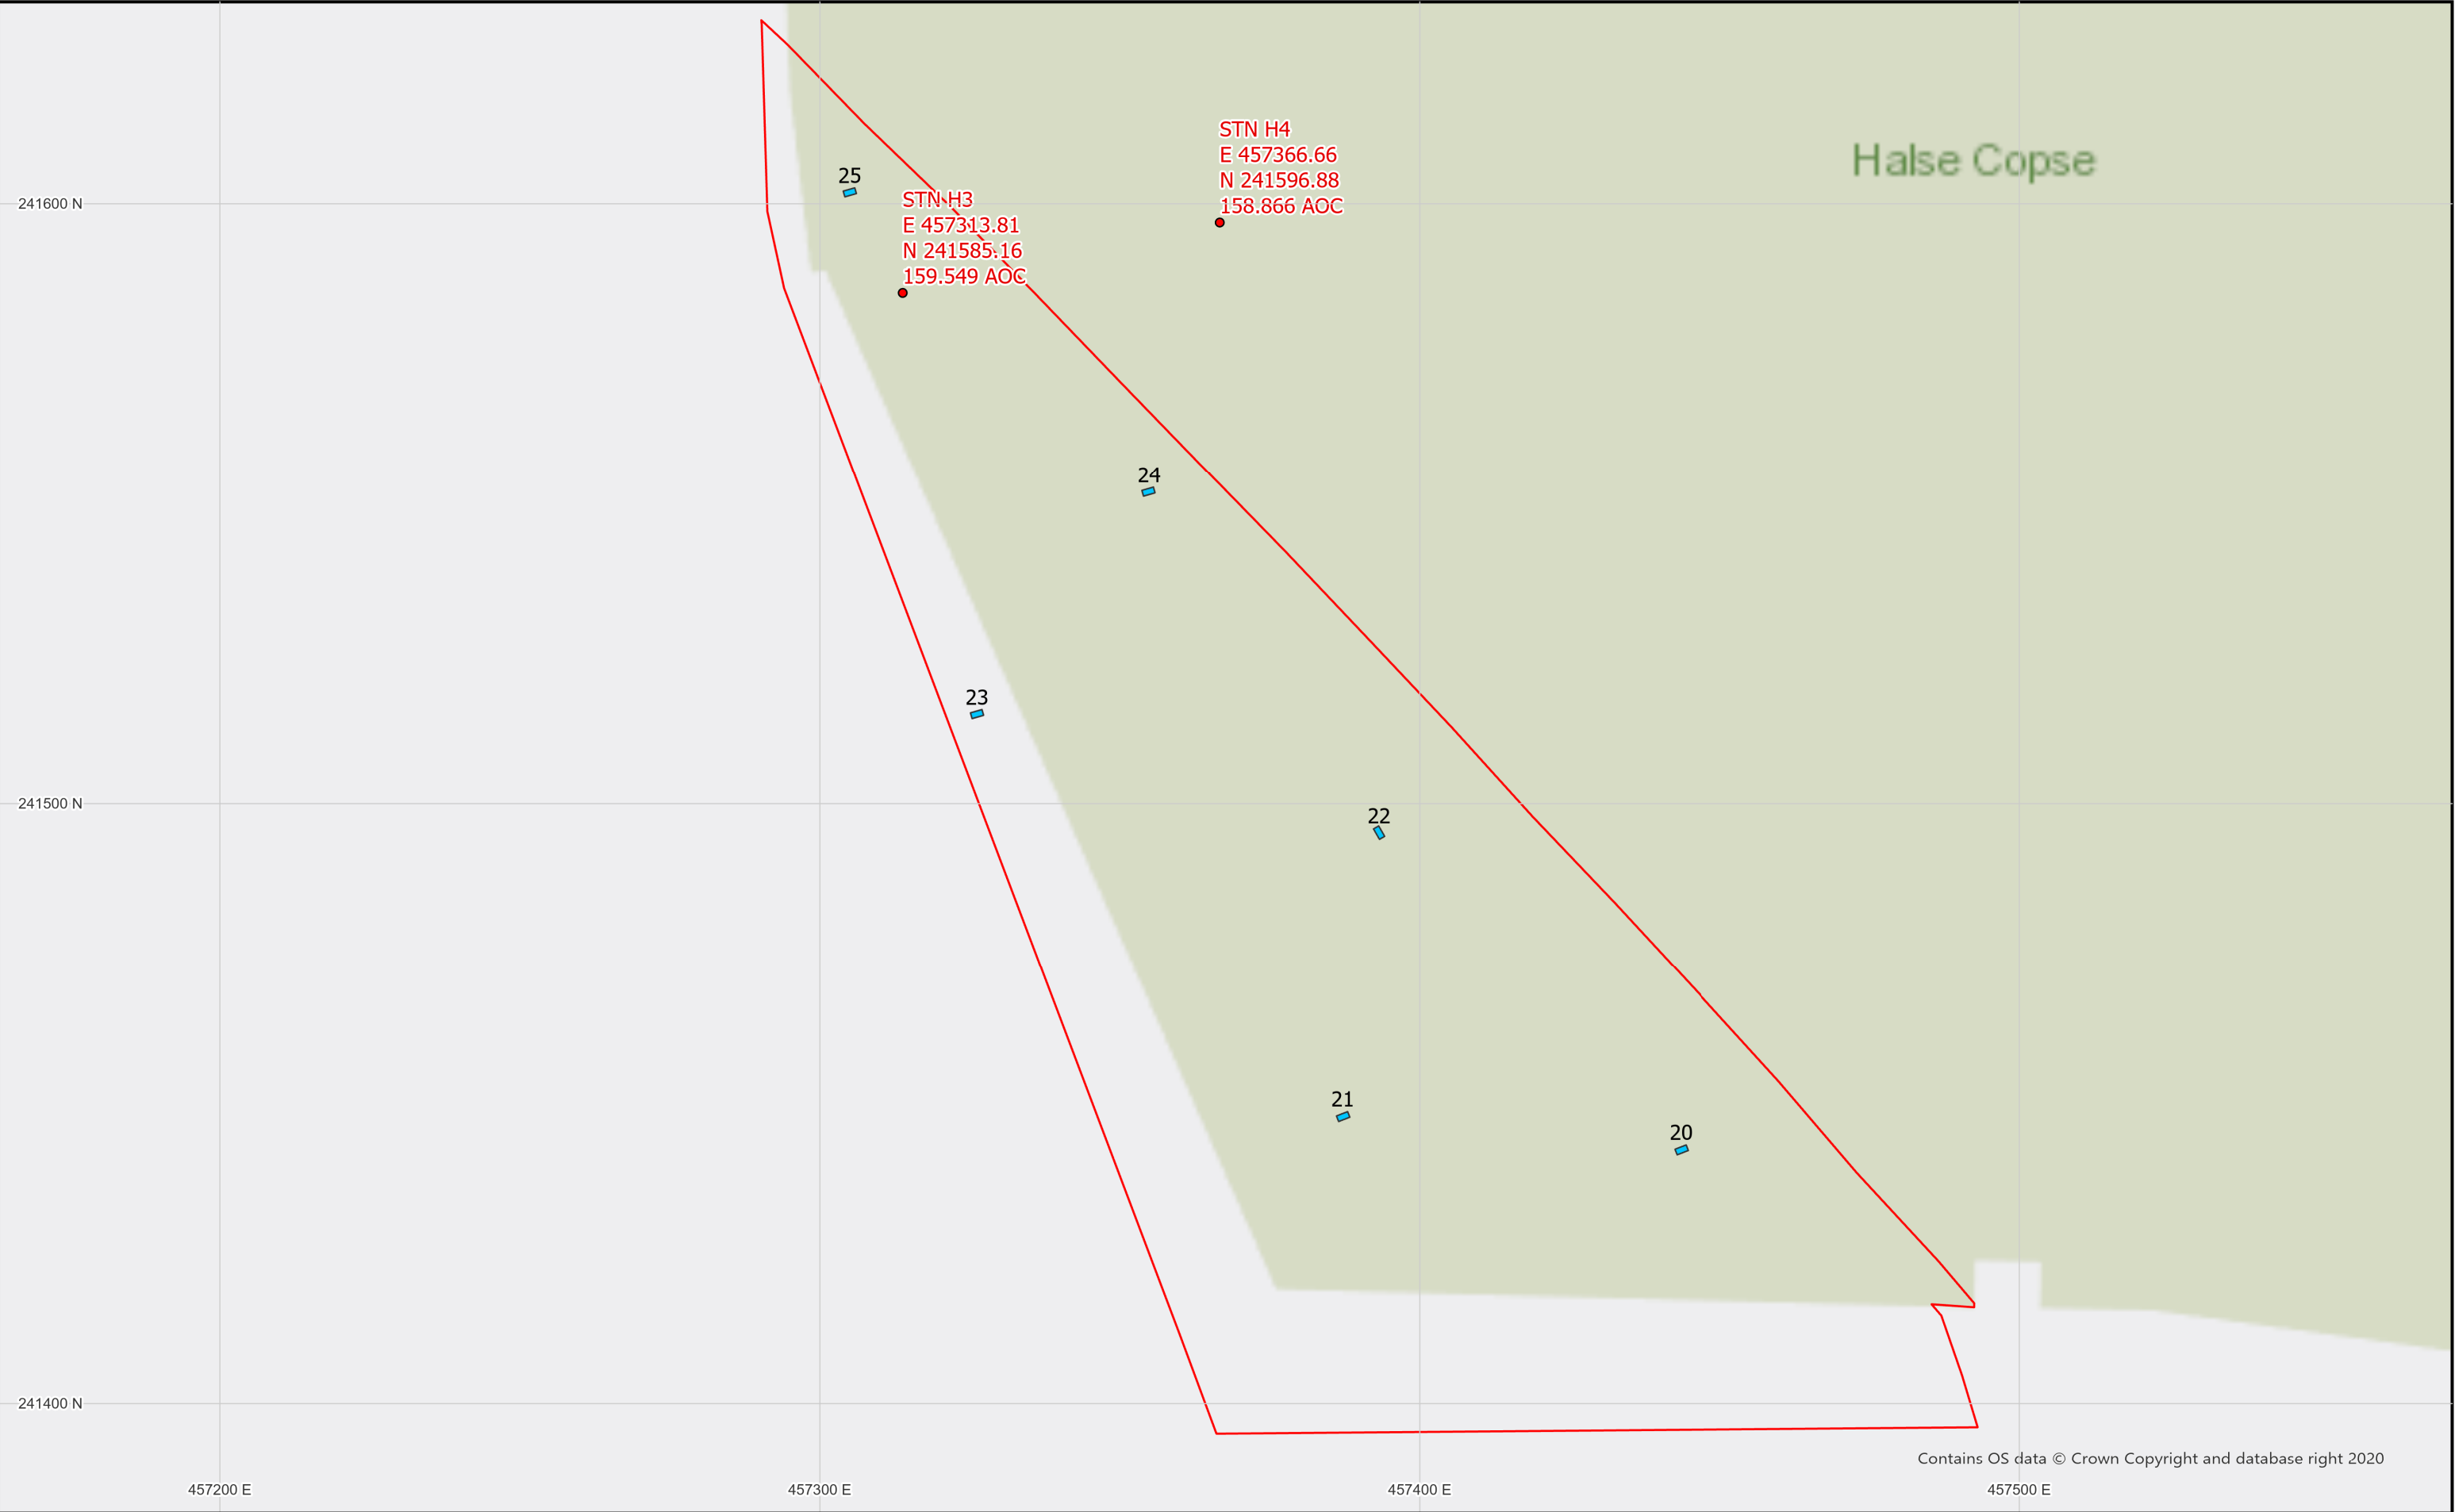
High Speed Two
HS2C184 Woodlands
C30027 Halse Copse Farm
Figure 9 -
Location of control points and test pits

- Site extent
- Control points
- Test pits

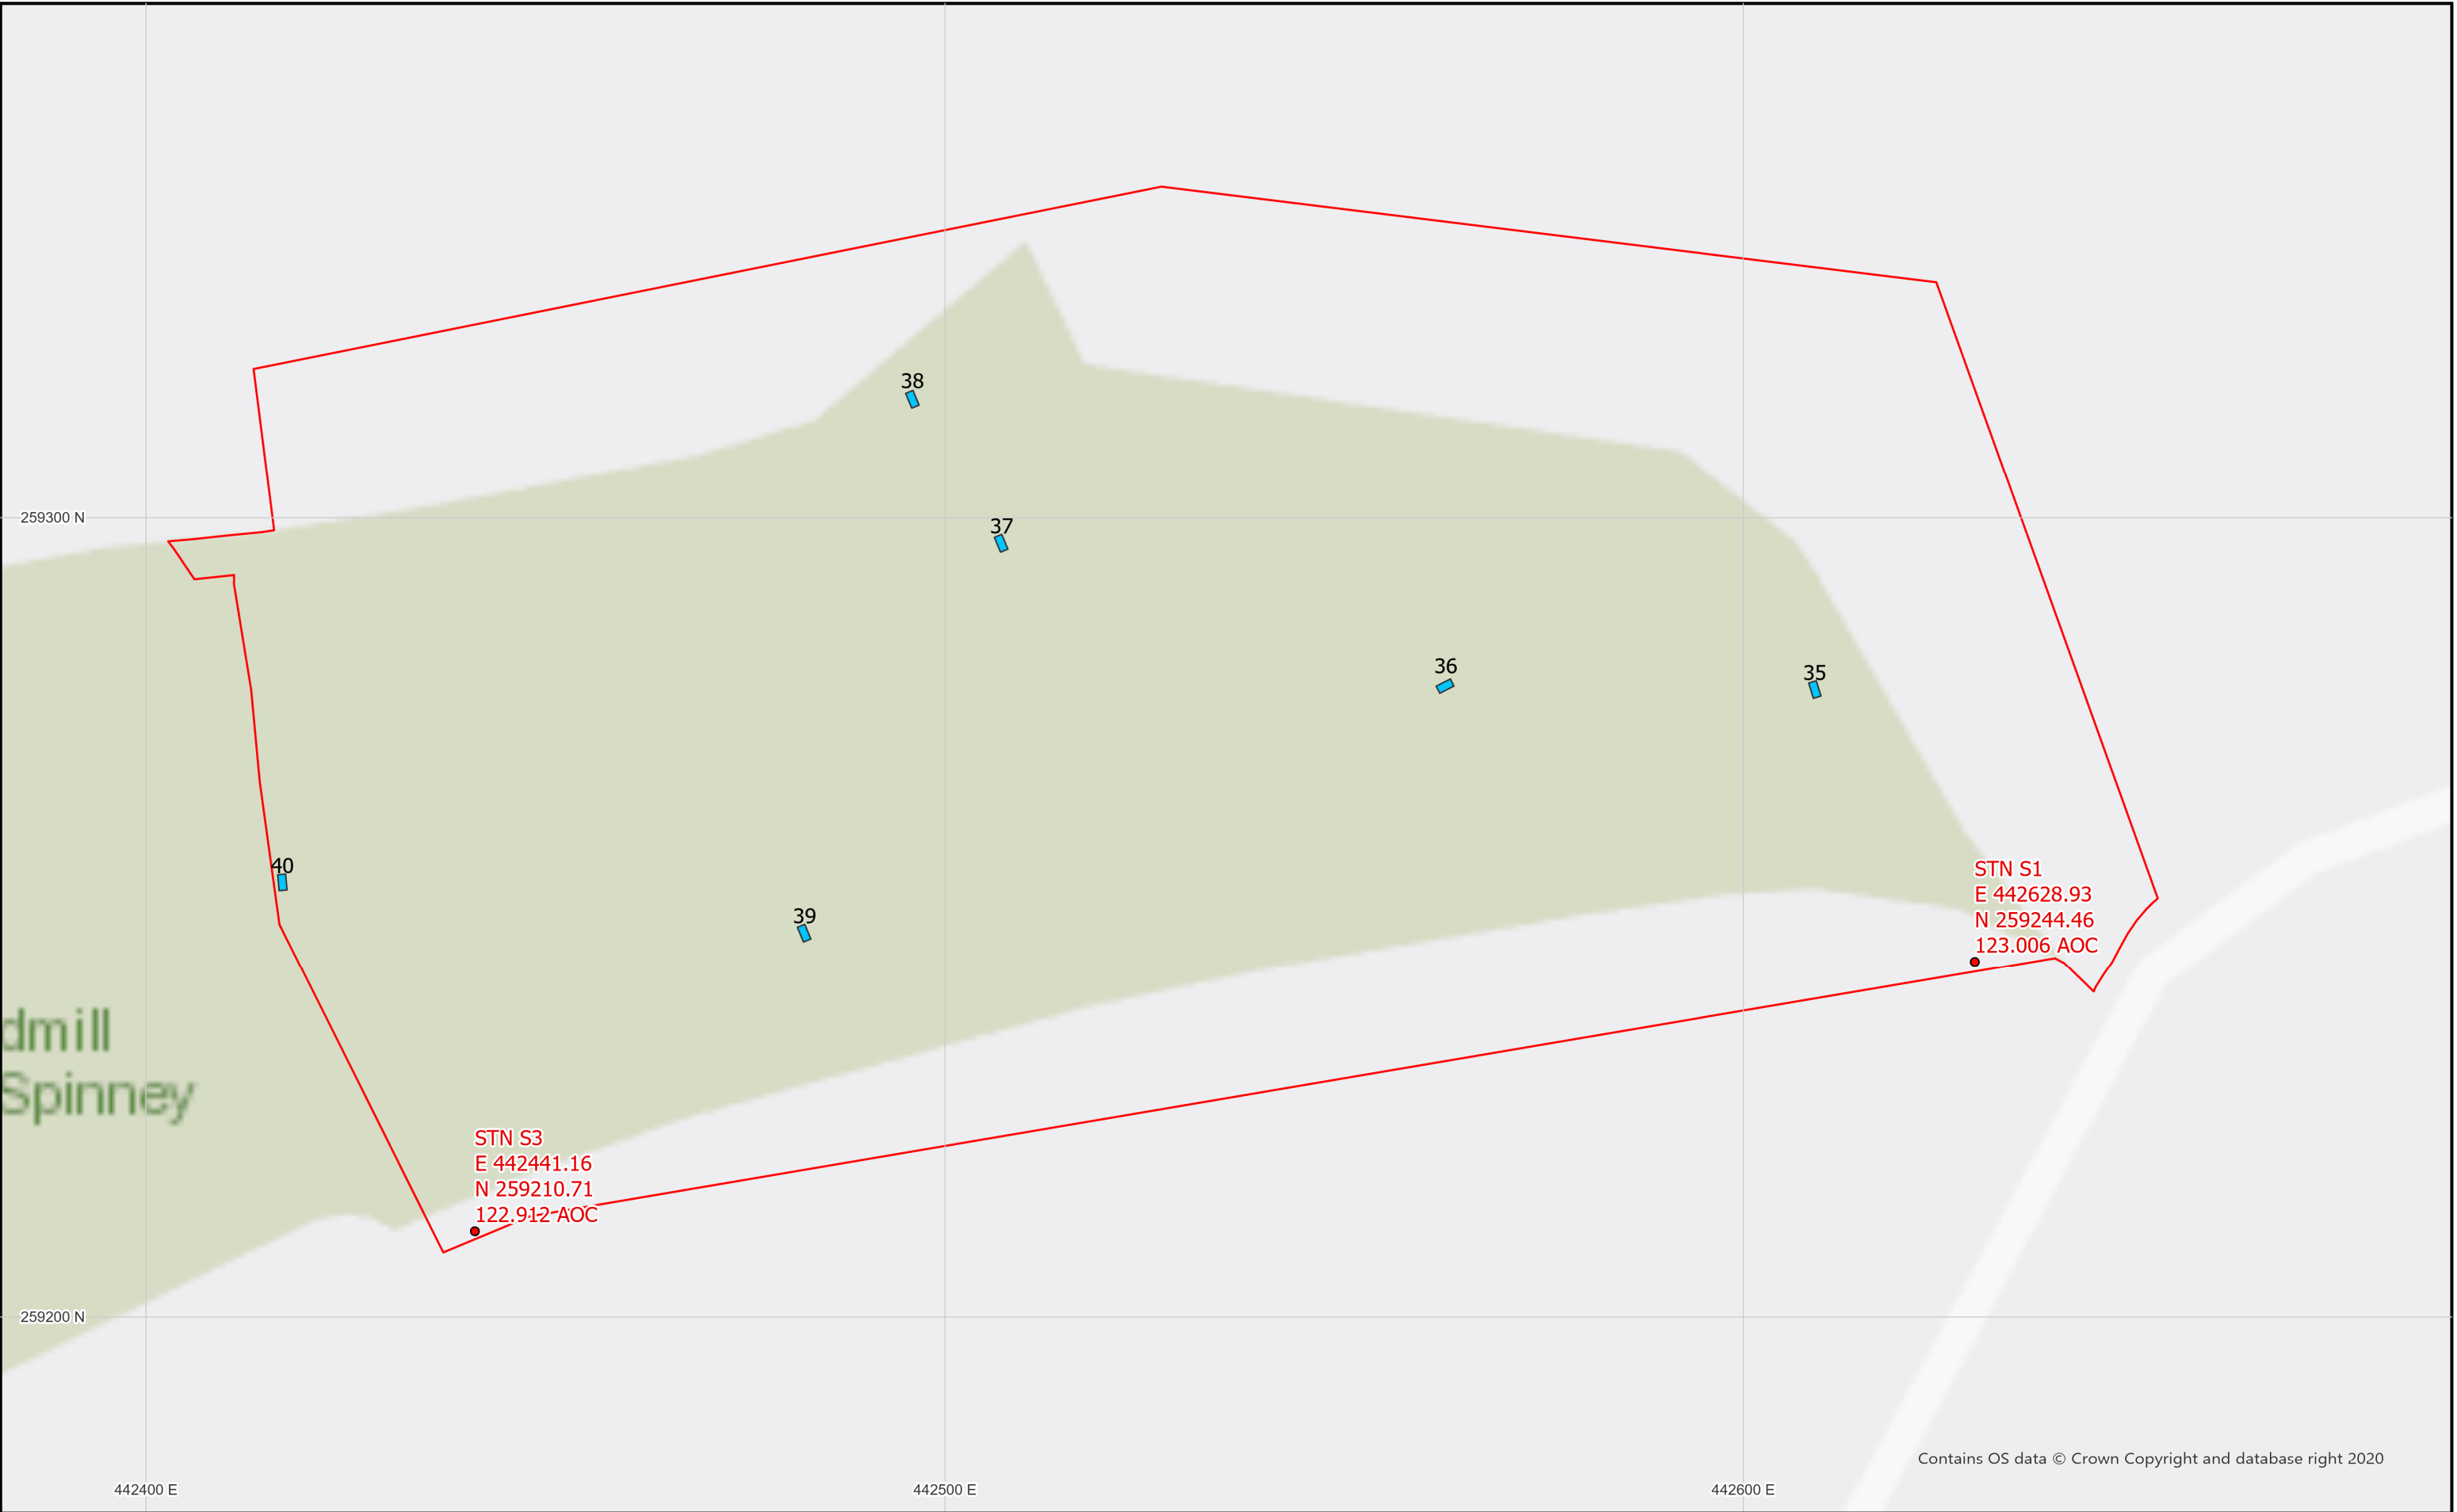
High Speed Two
HS2C184 Woodlands
C32030 Windmill Hill Spinney
Figure 13 -
Location of control points and test pits

- Site extent
- Control points
- Test pits
