# CHURCH OF ST HELEN, LITTLE EVERSDEN, CAMBRIDGESHIRE

## TREE-RING ANALYSIS OF TIMBERS FROM THE BELL FRAME AND WINDLASS

SCIENTIFIC DATING REPORT

Dr Martin Bridge

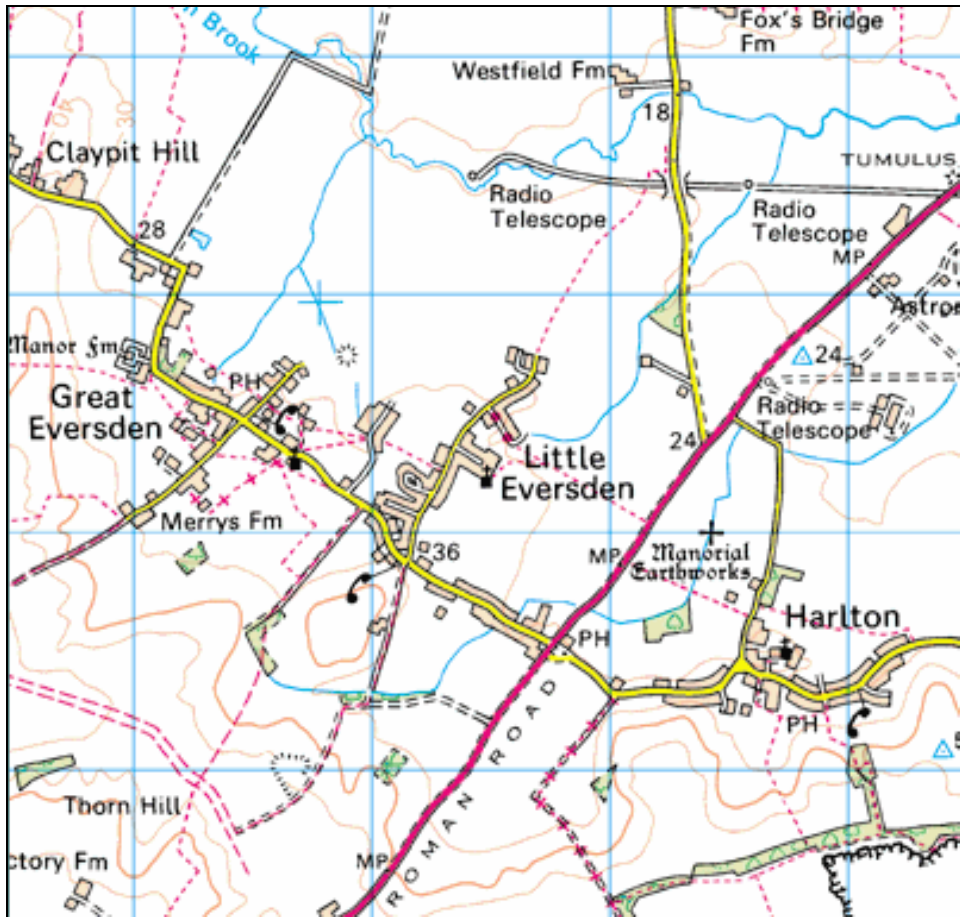
*Figure 1: Map showing the location of the St Helen's Church, Little Eversden, Cambridgeshire.*

The grade II\*-listed parish church of St Helen's, Little Eversden (NGR TL 375 533; Fig 1) contains a winch or windlass at the top of the tower, thought to be medieval in date, and a rare survival outside cathedrals. The windlass (Fig 2) is integral with the original ridge piece of the tower roof, which runs east-west. It consists of a roughly rounded beam supported at either end by short posts morticed at the top into the ridge piece, and resting on stone corbels below. The bellframe (Fig 3) is immediately above a floor and rests on foundation beams on offsets on the north and east walls, and transverse beams against the west and south sides. The frame is now in the form of a hollow square, having four bell pits surrounding a central opening. There have been extensive repairs to the frame, possibly in 1778 – a date carved on one of the top rails, but the east and west outer trusses and the north and east pit trusses appear to be largely original. These are thought to be contemporary with the building of the tower itself, and therefore likely of early fifteenth-century age (Baggs 2005).

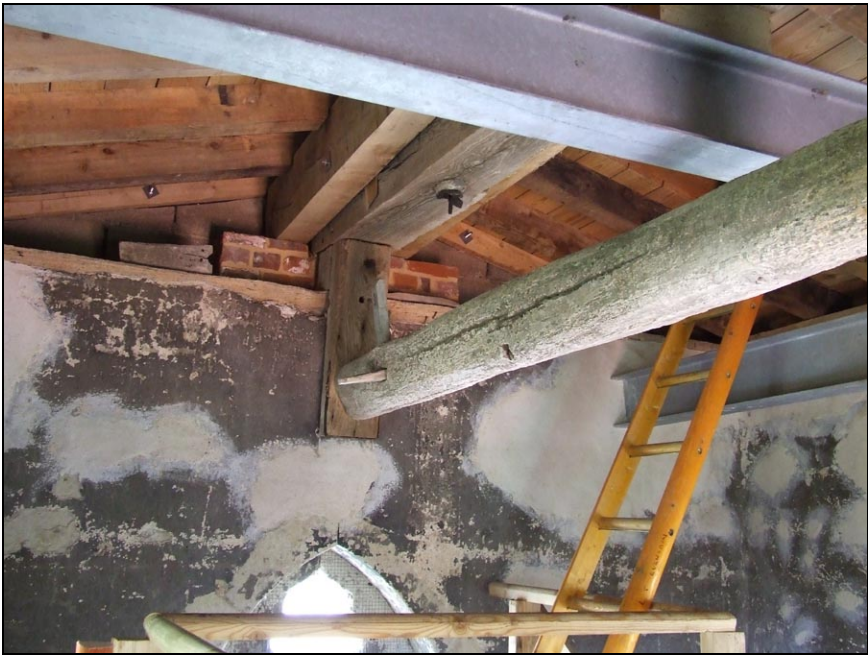
*Figure 2: Photograph of the windlass in position under the repaired roof*

The windlass and its supporting frame were quickly assessed as having too few rings to make tree-ring dating a possibility. The bellframe however contained several large timbers with heartwood-sapwood boundaries that superficially looked to contain sufficient numbers of rings to make sampling viable.

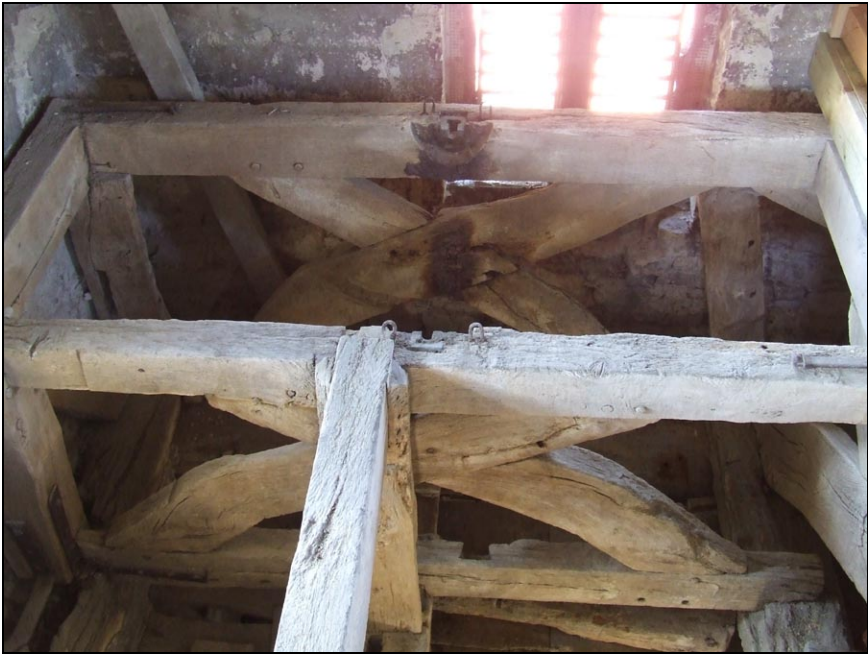
*Figure 3: Photograph of part of the bellframe*
