Tadcaster Bridge, Tadcaster, North Yorkshire: Assessment of Significance

Research Report Series 27-2016

Assessment of Significance

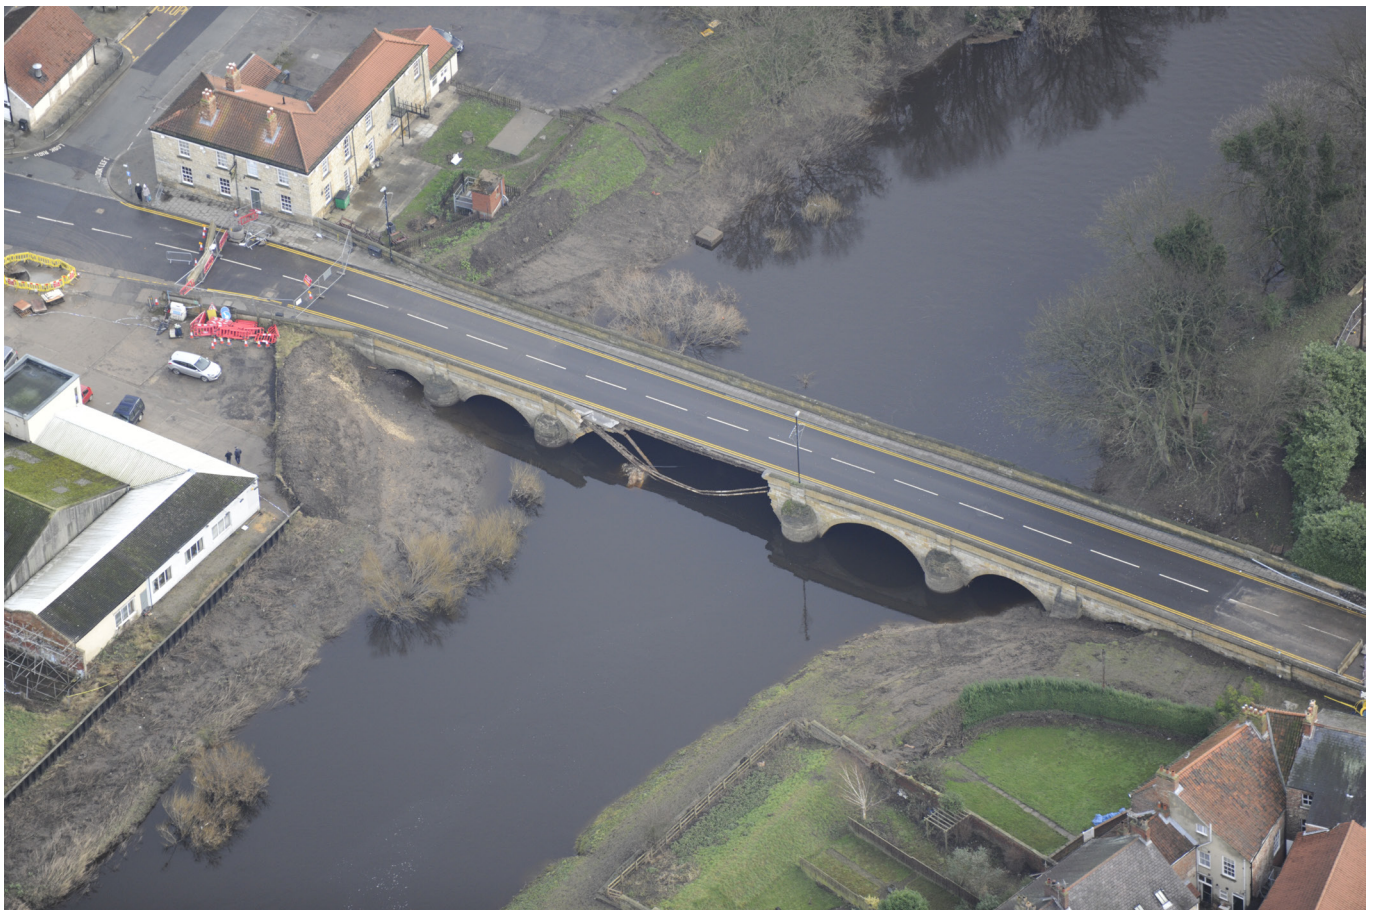
Cover: Aerial view of Tadcaster Bridge looking towards the east, showing the collapsed section of the upstream face. The historic centre of Tadcaster lies to the right-hand side of this picture, the road to York on the left-hand side. Taken on 13 January 2016. AP 28846/028 © Historic England/ David MacLeod .

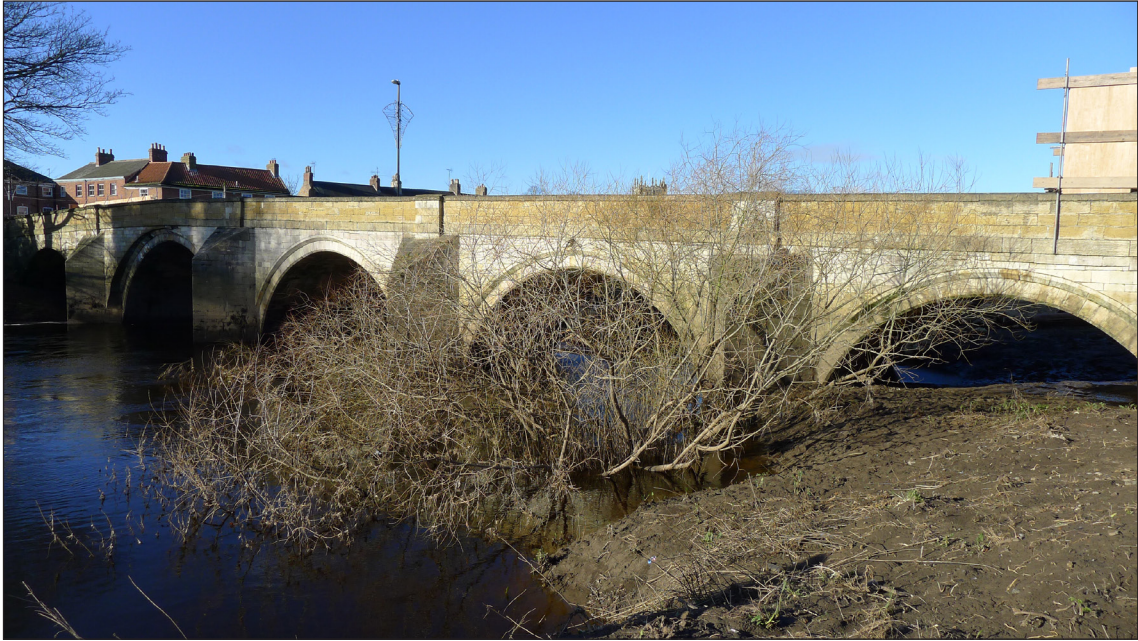
The 1698 bridge [Figure 3] consists of nine segmental arches, approached at either end by short causeways. Before the recent collapse, only the downstream elevation of this bridge was visible because of the later widening built directly against its upstream side. It appears to be constructed entirely in finely tooled ashlar quarried from the local Magnesian limestone which is distinctively fine-grained and creamy in colour. The blocks are well-laid, extremely finely jointed, exhibit minimal weathering and apart from root damage on the cutwaters show almost no movement or subsidence.

Numbered from east to west, then, only arches 3, 4 and 5 now span the river when in normal flow, the remainder being mostly (arches 1, 2, 6 and 7) or wholly (arches 8 and 9) choked by silt or buried in the river banks [Figures 2 and 3]. The bridge has angled cutwaters with sloping tops that are bonded into, and integral with, the downstream face of each of the eight intervening piers. This suggests that when the bridge was first built the active river channel was wider and water flowed beneath

Figure 3: The downstream arches 2 to 5 (from right to left) of the 1698 bridge, showing the problems of silting in arch 2. (AF00398015 © Historic England/Lucy Jessop).

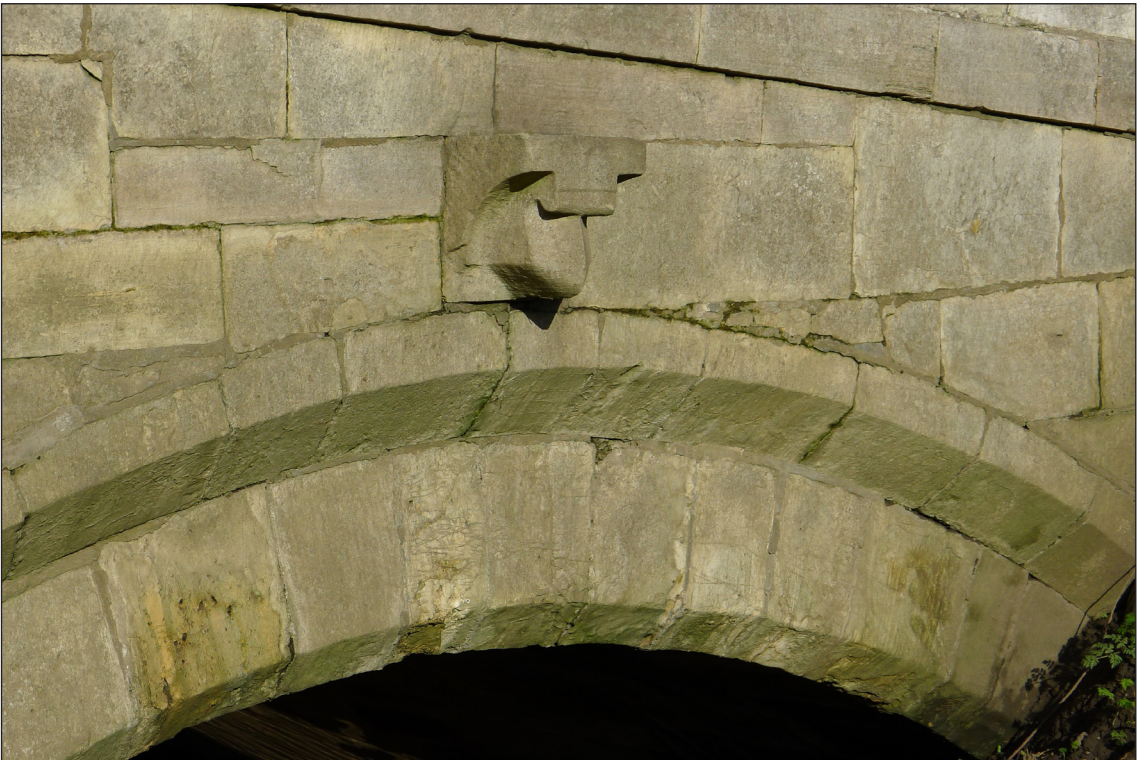
The voussoirs in each arch ring have a small chamfer to their lower edge and are surmounted by an archivolt (an ornamental moulding or band that follows the curve on the underside of an arch). The archivolt splays outwards and upwards, echoing and emphasising the chamfer in the arch rings [Figures 4 and 5]. The spandrels are laid flush with the upper edge of the archivolt and are filled by blocks of stone laid in courses. Original arch rings and spandrels are now only visible in arches 1 to 4 and the eastern half of arch 5; the remaining arches are obscured by a squinch arch that springs from the crown of arch 5 and marks the start of a narrow downstream extension or widening of the western end of the bridge only. This is described in more detail below. Finely carved corbels comprising a roll moulding above a shield-like device, which survive immediately above the archivolt in the crown of arches 1 and 3, must be decorative only and are presumably in lieu of keystones [Figure 4]. Arch 2 has – slightly off-centre – a stone of the correct dimensions which appears to have been hacked back, but this could be a coincidence; much of the stonework in this area has been disturbed. Similar examples may once have existed above every arch and presumably on both elevations but been lost to later remodelling; they may originally have been painted with heraldic devices.

Above the downstream elevation of the three easternmost arches are the intermittent traces of a narrow string course. This is traceable rising at a shallow angle from arch 1 towards the crown of arch 5 at the centre of the bridge. A single course of Magnesian ashlar that survives above the string course over arch 1 presumably represents the start of the original parapet, but this is now truncated by a second string course, laid closer to the horizontal and consisting of more massive limestone blocks of a different colour and texture; this progressively cuts into the earlier string course with the result that the latter has been completely removed above arches 4 and 5. This shows that the original bridge deck was considerably more ramped than at present, and at some time has been levelled out by raising the height of the approach causeways and lowering the height of the deck over the central arches [Figure 5]. Documentary evidence indicating that this raising and levelling dates to 1736 is presented in section 3 below. It is conceivable that, from casual inspection, the existence of this early string course could be mistaken as evidence of lateral movement in the stonework, possibly consequent on the recent flood, but considered analysis makes it clear that it is a deliberate constructional device and an integral part of the design of the 1698 bridge [Figure 6]. The fact that the sloping tops of the cutwaters appear to be aligned to the height of this early string course is additional evidence in support of the latter as an *in-situ* feature. The existing parapets are a later feature described in more detail as part of the discussion of the 1791 widening below.

Figure 4: Detail of the downstream arch ring and archivolt of arch 1, showing also the corbel over the crown and the early string course rising at an angle above it. (AF00398021 © Historic England/Lucy Jessop).

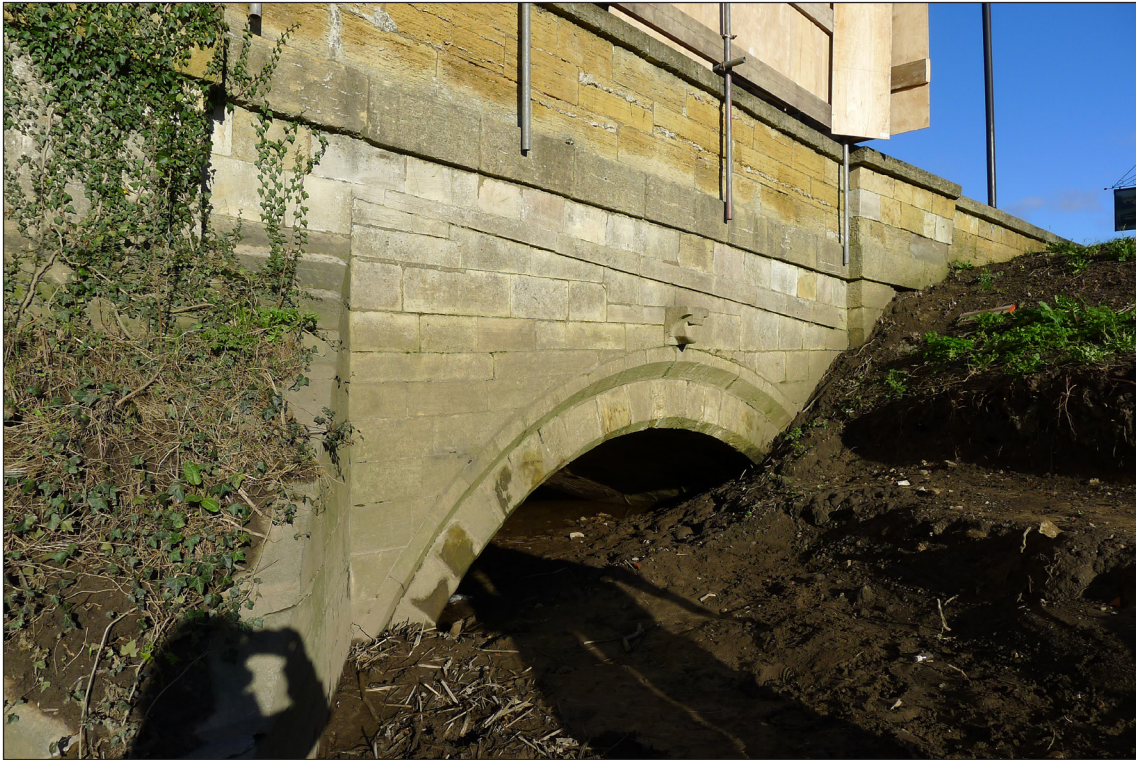
Figure 5: The downstream elevation of arch 1, showing the string course and lowest course of the parapet as built in 1698 surviving below the present heightened deck level. (AF00398011 © Historic England/Lucy Jessop).

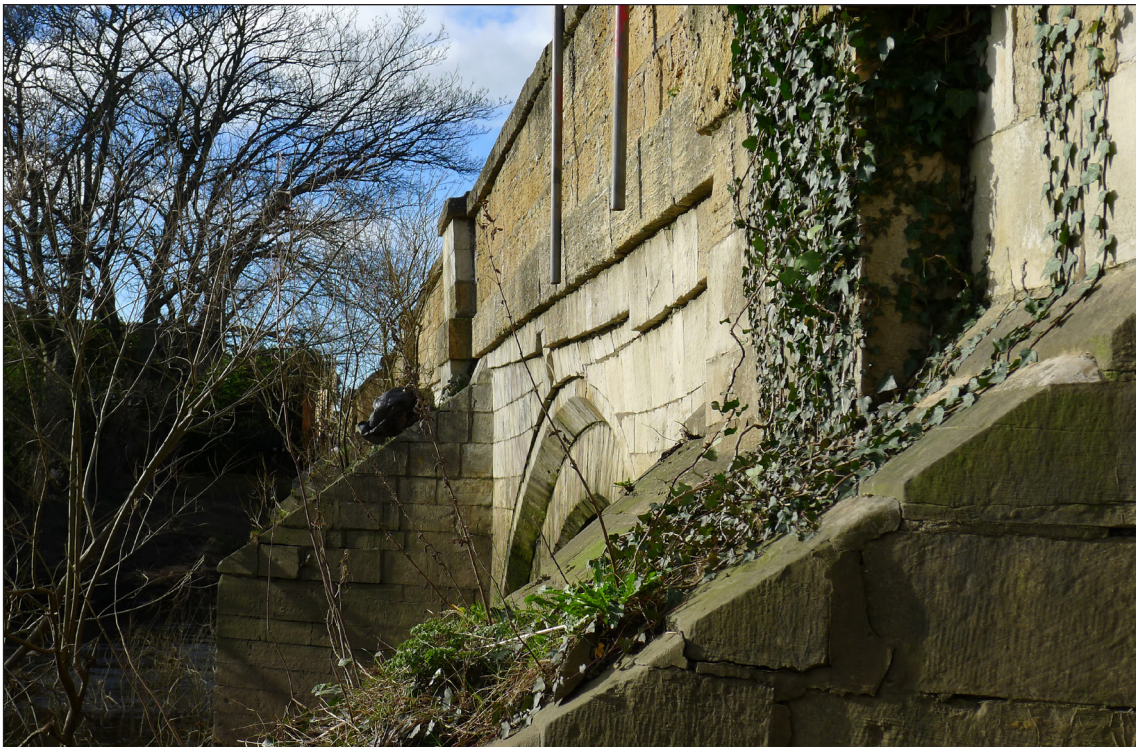
Figure 6: View westwards along the downstream elevation of arch 2. The oversailing course of ashlar immediately above the archivolt is not displaced or bulging stonework, but the remains of the original string course superseded by a new, higher, string course when the deck was raised and flattened out. (AF00398024 © Historic England/Lucy Jessop).

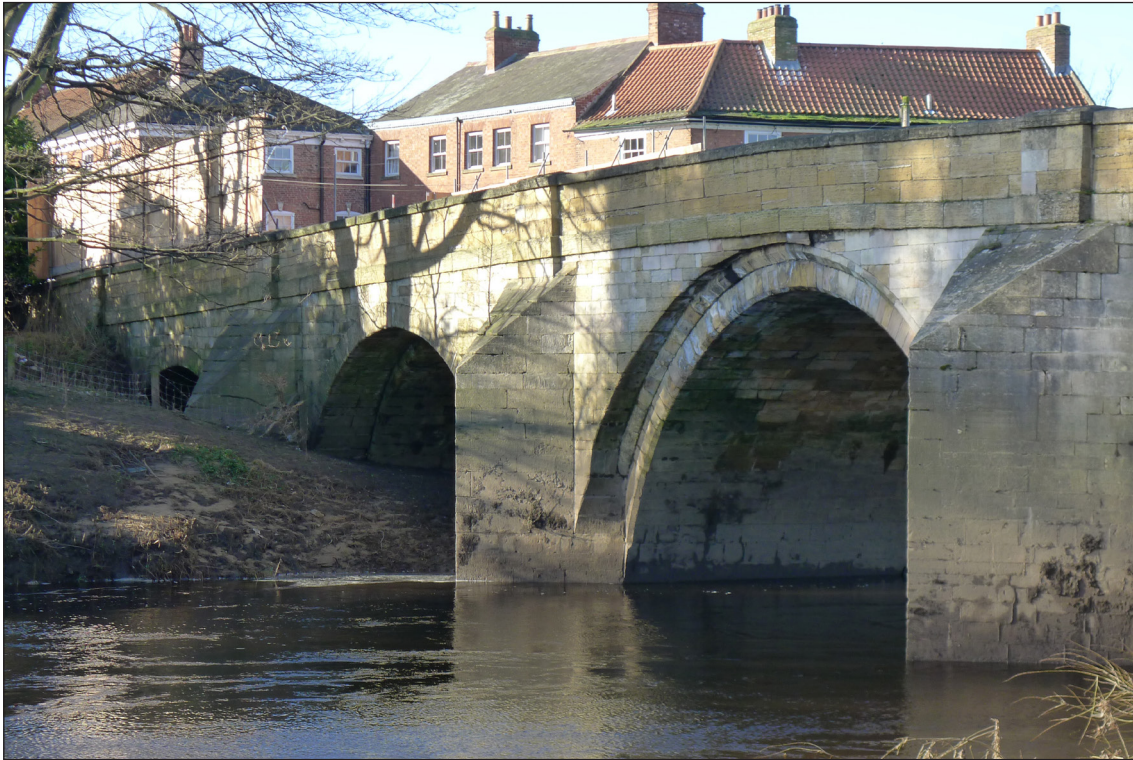
Figure 7: View of the squinch arch springing from the crown of arch 5 on the downstream side of the bridge. Note the difference in the form of the arch rings: the extension associated with the squinch arch has effectively refaced the western spandrel of arch 5 and all subsequent arches in the western half of the bridge. Note also the difference in the colour of the parapet's stonework. (AF00398018 © Historic England/Lucy Jessop).

A squinch arch [Figure 7] springs from the crown of arch 5 in the centre of the bridge, and marks the start of a narrow downstream widening or extension of the western end of the bridge only. This extension appears to increase progressively in width towards the west: from nothing at the crown of arch 5 to 1.15m wide in the western intrados of arch 6 [Figure 8]. Silting prevented measurements being taken in arches 7, 8 and 9. The likelihood is that the extension represents an attempt to ease exit off the bridge in relation to the south-eastern street frontage in Bridge Street which leads away from the western end of the bridge. The extension is clearly built around and encapsulates the cutwater that stands against pier 5, which appears 'narrower' than the others in consequence. The dating of the extension is uncertain from field evidence. The style and lithology of the stone used to construct it appears very similar to, if not exactly the same as, that used for the 1791 widening upstream. Against the idea of the two widening events being contemporary, however, is the evidence of masons' marks: the only marks noted on the masonry of the squinch arch and associated downstream extension are an arrow (->) and vertically conjoined V and W, whereas those on the upstream widening comprise VIIIIX and a capital I with serifs and additional horizontal bar mid-stroke.

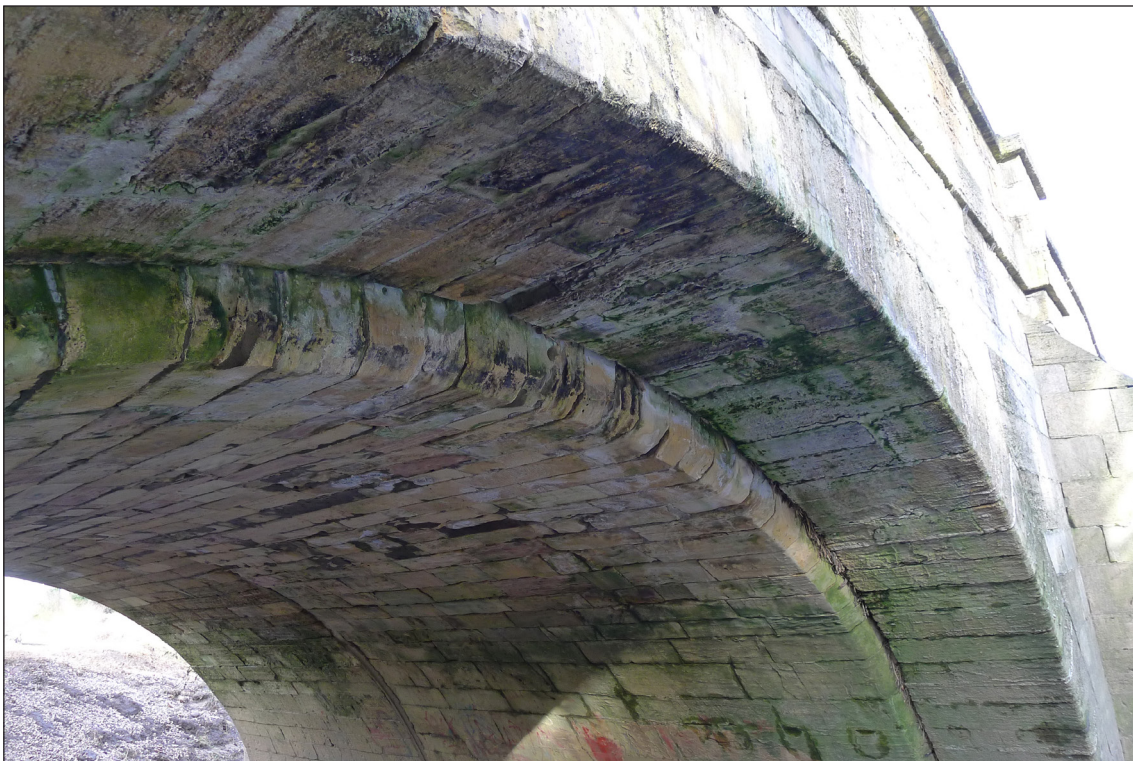
Figure 8: The intrados of arch 6, showing the 1698 bridge (centre) flanked by the new arches for (right) the downstream extension and (left) the 1791 upstream widening. (AF00398057 © Historic England/Lucy Jessop).

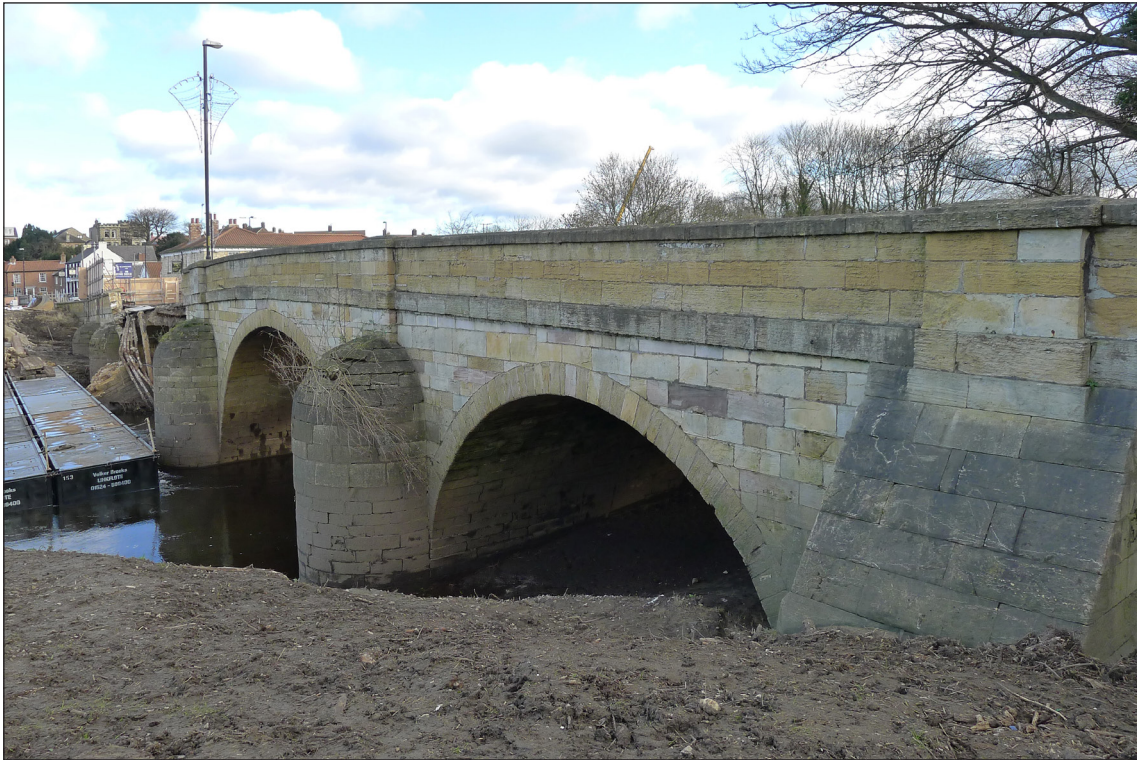
The upstream widening of 1791 mirrors the general plan of the 1698 bridge; in other words, it has nine segmental arches [Figure 9]. Decorative treatment and stone type, however, differ markedly from the earlier structure. The build quality of the 1791 bridge is also not as good, being typically much less finely jointed with wide mortar beds between individual stones. The span of each arch is identical to its downstream counterpart, although where close inspection was possible – of arches 1, 2, 6 and 7 – the crown appears slightly higher, indicating perhaps that the arches are more truly segmental. The voussoirs are plain rectangular blocks without chamfers and there is no archivolt above them. In addition, the visible cutwaters are rounded in a heavy, bull-nosed fashion with the exception of that against pier 6, which although partly buried in silt, appears more rectangular and to have an angled top akin to those in the original structure [Figure 9]. If cutwaters exist against piers 7 and 8 they are now completely obscured and their form is unknown. The apparent absence or difference in the form of the cutwaters at the western end of the bridge may be an indication that arches 6, 7, 8 and 9 were already heavily silted when the new bridge was built and that functioning cutwaters against these piers were unnecessary.

Figure 9: The 1791 upstream widening, with its vast, cylindrical, bull-nosed cutwaters. Note the different form of the cutwater against pier 6 (right of frame). (AF00398046 © Historic England/Lucy Jessop).

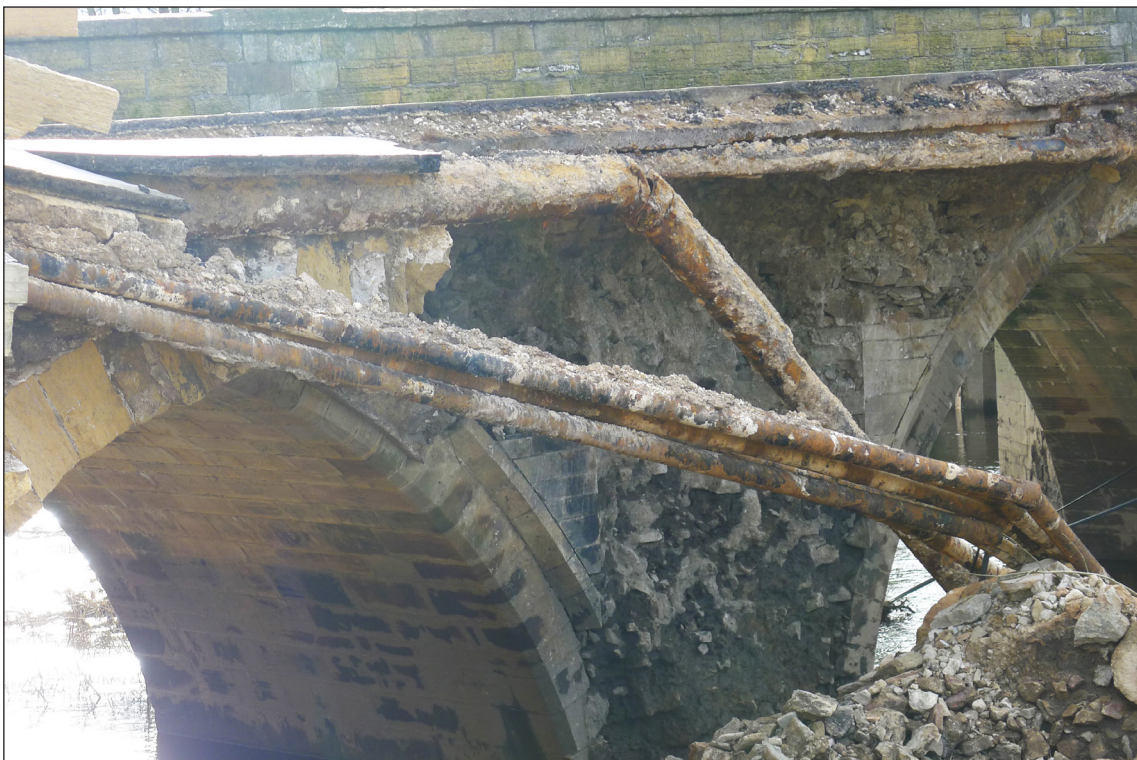
It was pier 3 of the 1791 bridge and its associated cutwater that collapsed in the recent floods, bringing down the adjacent arches 3 and 4 [Figure 10]. No close inspection of the flood-damaged section of the bridge was possible, but from a distance it appears that it is only the 1791 widening that has been affected: no

Figure 10: View of the collapsed (upstream) pier 3 of the 1791 bridge. Note the arch ring, archivolt, spandrel-facing and exposed scar of the removed cutwater of the exposed 1698 bridge behind, with arches 3 and 4 all apparently undamaged. (AF00398043 © Historic England/Lucy Jessop).

cracks or subsidence are readily apparent in the arch rings, archivolt, or spandrel facing-stones of the upstream elevation of the 1698 bridge now exposed behind the collapse. The scar of the original upstream cutwater (removed when the bridge was widened so as to be able to build the new bridge directly against the old) is also visible, and likewise exhibits no obvious signs of bulging or collapse. Close inspection by qualified structural surveyors is needed to confirm or refute this suggestion, however.

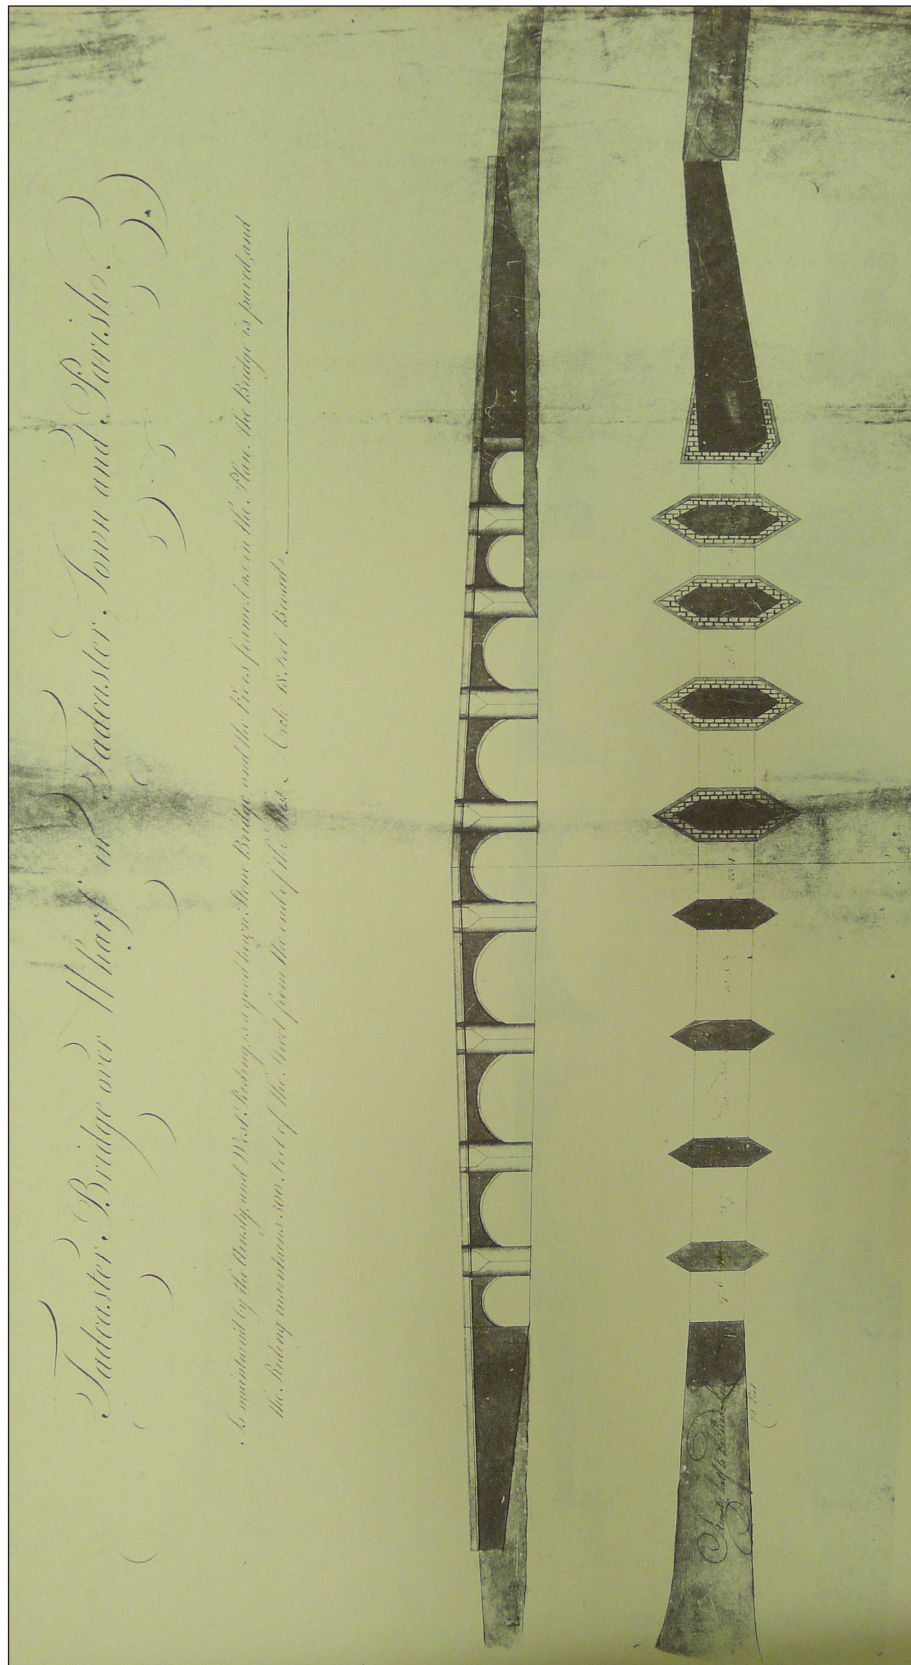
In 1752 John Watson and Robert Carr were employed to draw plans and elevations of all bridges whose upkeep was the responsibility of the West Riding, and the resultant ‘Bridges Book’ duly contains drawings of Tadcaster Bridge. The accompanying index describes the bridge as ‘a good hewn Stone Bridge, paved, consisting of seven whole and two half Arches, and the Piers of it framed, as in the annexed Plan... and in Breadth 18 Feet’ (WYAS QD1/461). The reference to seven and two half arches is obscure, though ‘half arches’ probably means arches 8 and 9 which the elevation shows as standing out of the bed of the river; presumably they were designed to function as flood arches only. Together, the elevation and plan [Figure 11] clearly depict a somewhat humpbacked bridge of nine arches of varying heights and spans approached by causeways and with timber setting (that is, timber frameworks retaining piled stone, intended to protect against scour of the river bed and undermining of the bridge foundations) around the base of the western abutment and piers 5 to 8. The elevation depicts the upstream side of the bridge (now obscured by the 1791 widening), and clearly shows angled cutwaters with sloping tops, a low parapet and moulding over each of the arches. These features are identical to those still visible on the eastern half of the extant downstream elevation (that is, those unencumbered by the squinch arch and associated extension) confirming that what survives today is the 1698 bridge. It is strange, however, that the documented raising of the western end of the bridge appears not to be depicted. It is possible that Watson and Carr copied a pre-1736 elevation of the bridge into their book, rather than drawing it as it was in 1752.

Figure 11: Plan and upstream elevation of Tadcaster Bridge as depicted in the 1752 West Riding Bridges Book. Arch 1 is to the left. (WYAS QD1/461. Reproduced by permission of West Yorkshire Archive Service, Wakefield, copyright reserved).
