An Iron Age hillfort
and its environs
on West Hill, Northumberland

Alastair Oswald, Marcus Jecock and Stewart Ainsworth

SURVEY REPORT

Archaeological Investigation Report Series AI/12/2000

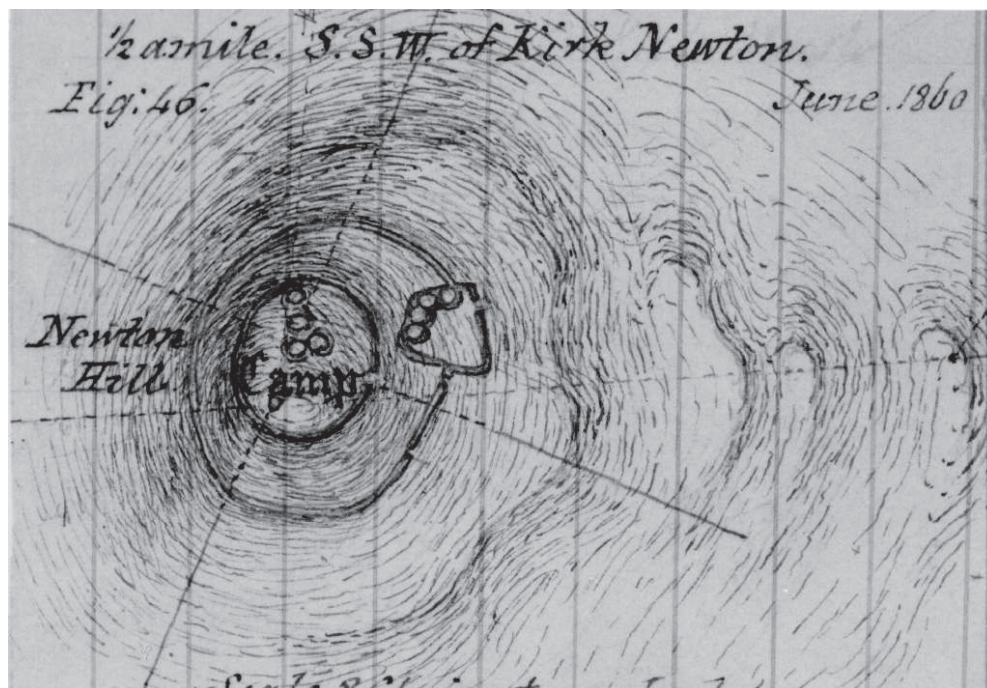
Figure 2.
HH MacLauchlan's
plan of the hillfort,
surveyed 1860

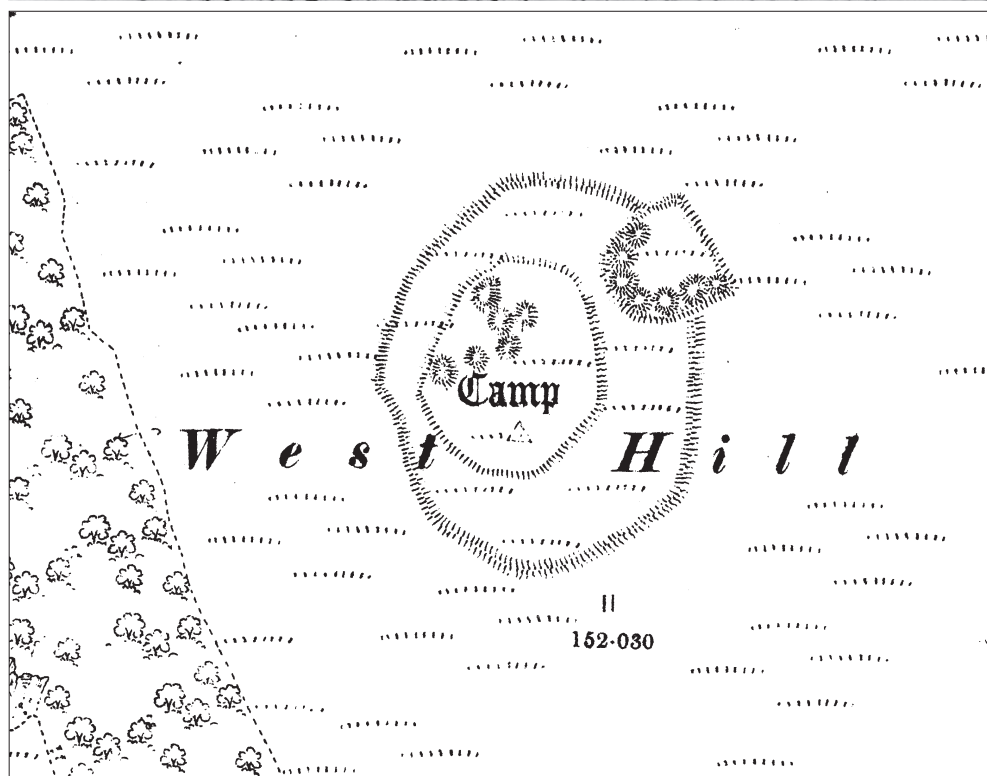
Figure 3.
Ordnance Survey
plan of the hillfort,
surveyed 1860

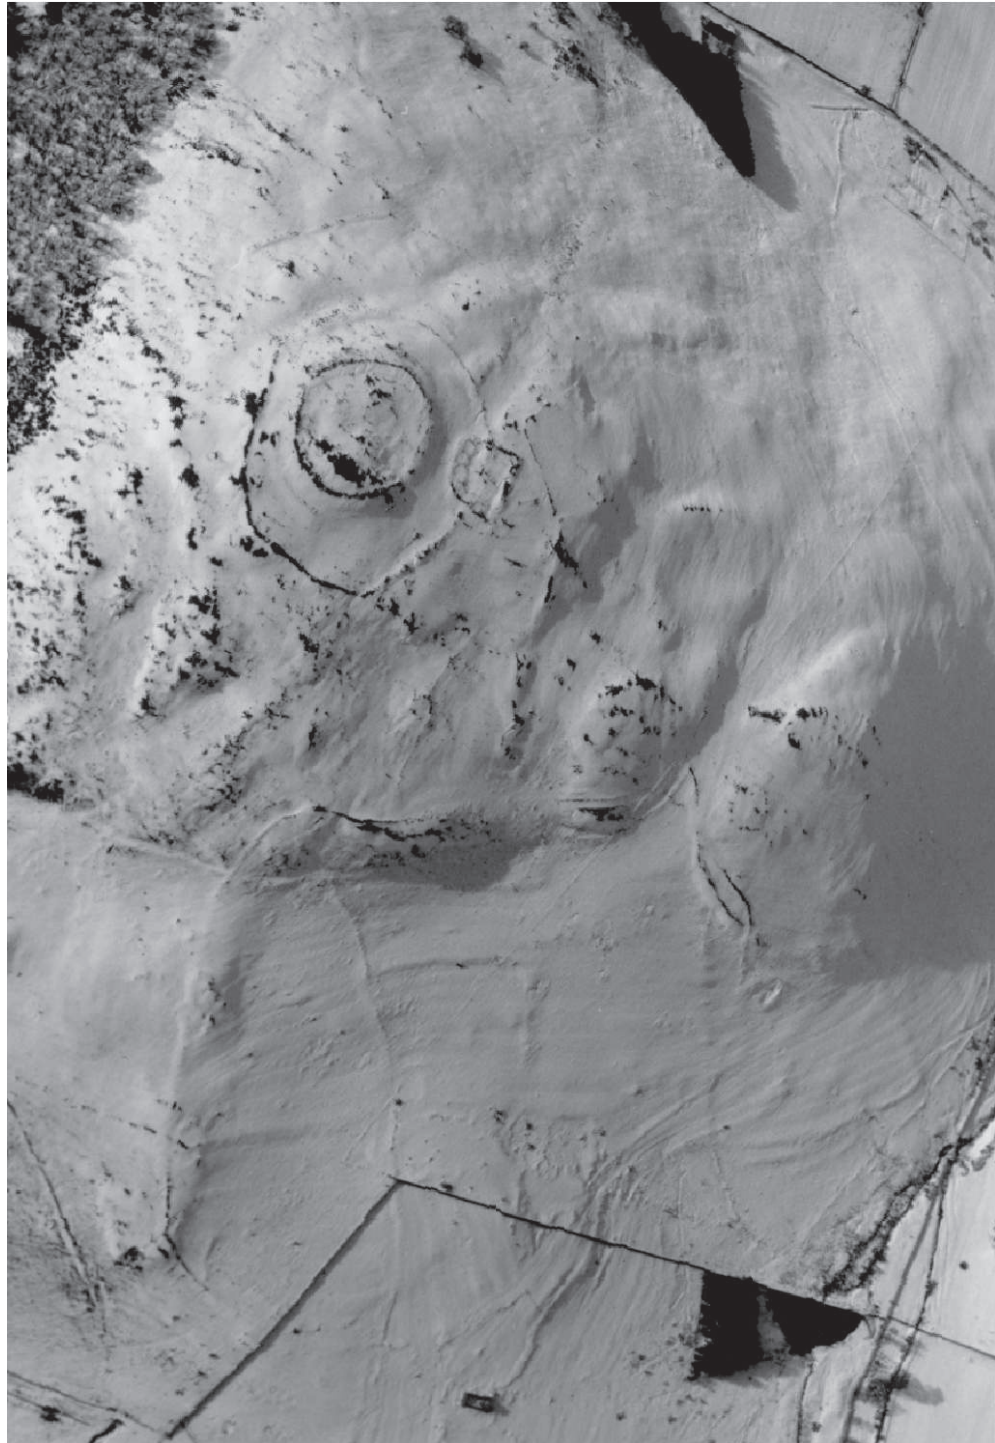
*Figure 5.
Aerial photograph
of West Hill
from the south-east*

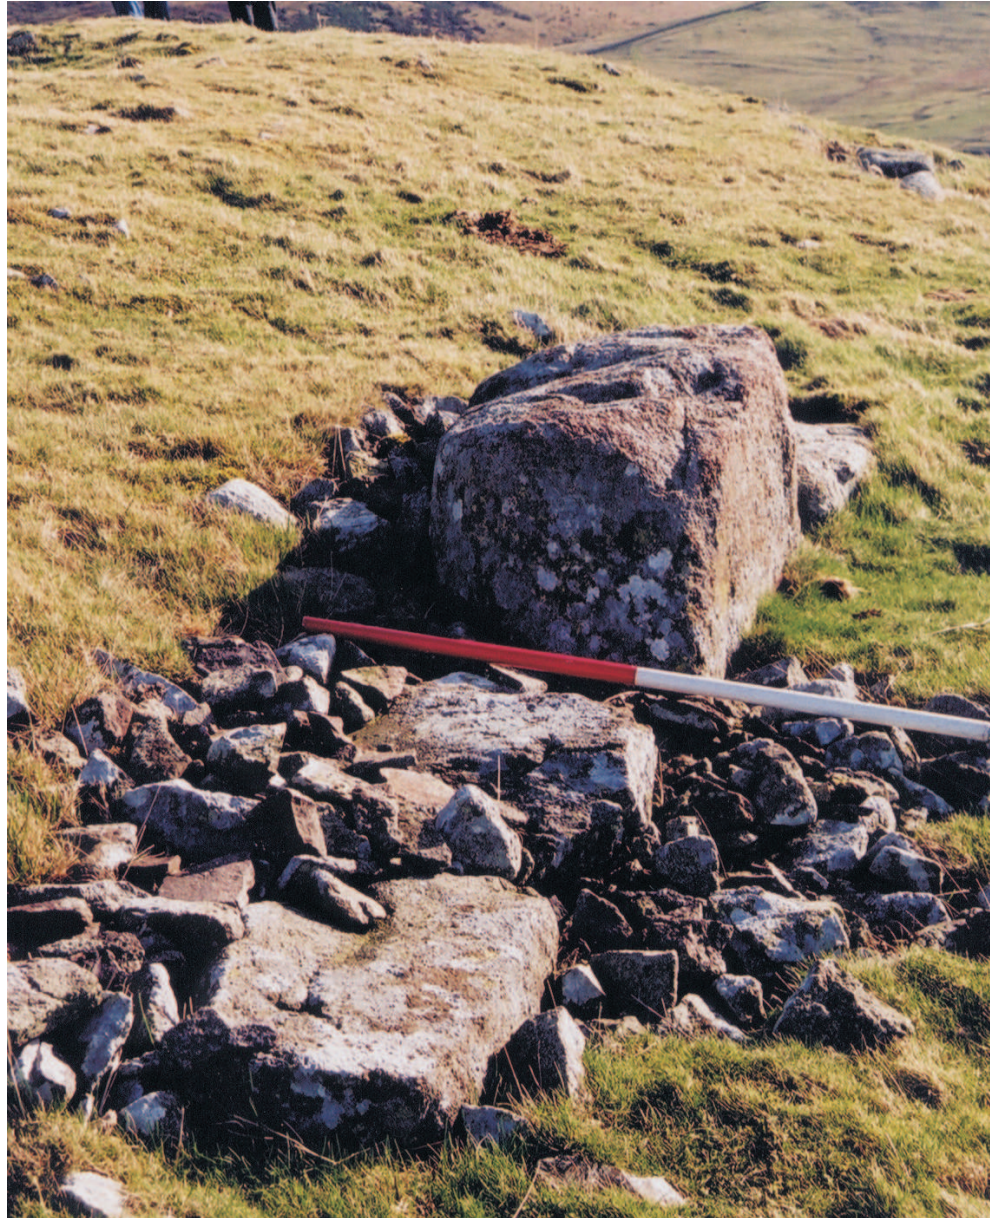
*Figure 7.
Photograph of the
rampart on the
south-west of the
hillfort*

dressed. Most of the exposed lumps of stone in the core of the rampart are roughly fist-sized, and are generally sharp and unweathered, suggesting that they too were obtained by quarrying or splitting rather than the collection of boulders exposed on the surface. A continuous hollow running immediately behind the rampart, notably on the north and south-east sides of the circuit, probably results from quarrying. However, it is possible that the stretch on the northern side originally related to the possible earlier enclosure described above.

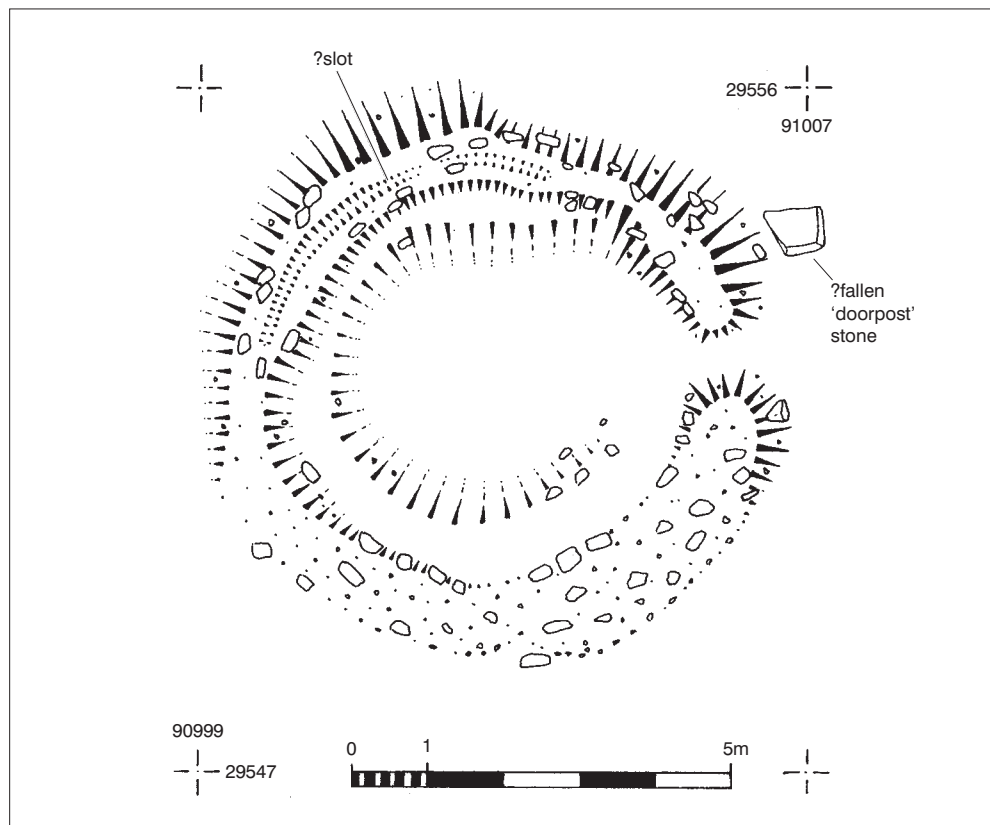
Figure 8.
Plan of Structure 22
(at 1:100 scale)

perimeter of the structure extends north-eastwards for some 10m, and seems to overlie the main bank enclosing the settlement. The site of Structure 23, whose existence is fairly conjectural, lies opposite Structure 22, backing onto the line of the bank of the earlier outer enclosure. Its existence is partly suggested by a near vertical face cut into the edge of a natural outcrop of granite. The site of Structure 24 lies immediately outside the south-eastern corner of the enclosed settlement. It is defined by a circular stance 5.5m in diameter, cut into the natural slope at the rear and terraced slightly at the front. The entrance was presumably on the downslope side, facing north-east. The earthwork has been cut into by ploughing (see below).

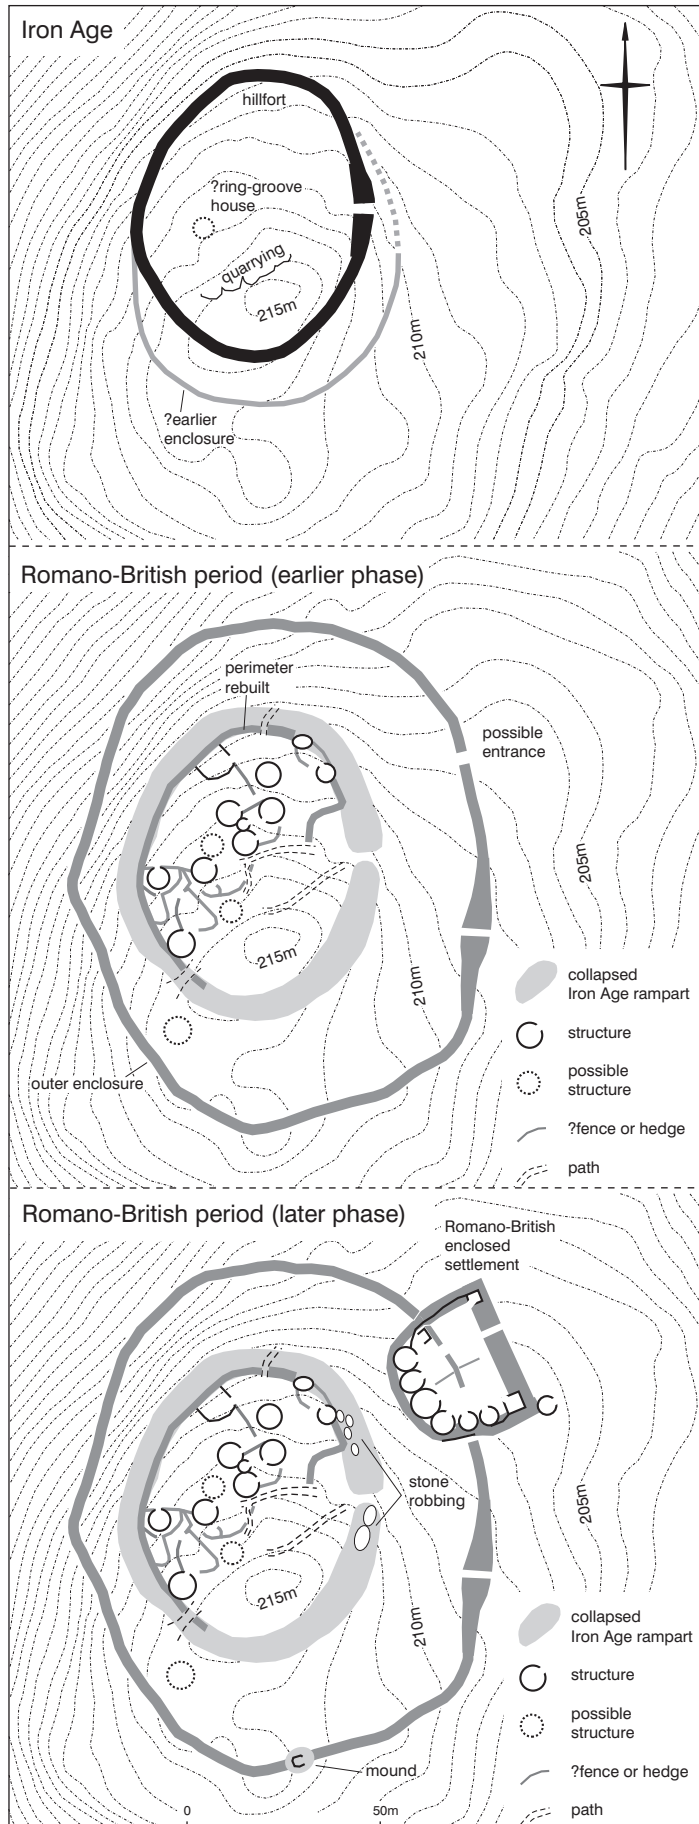
Figure 9.
Interpretative plans
of the hillfort and
its immediate
environs

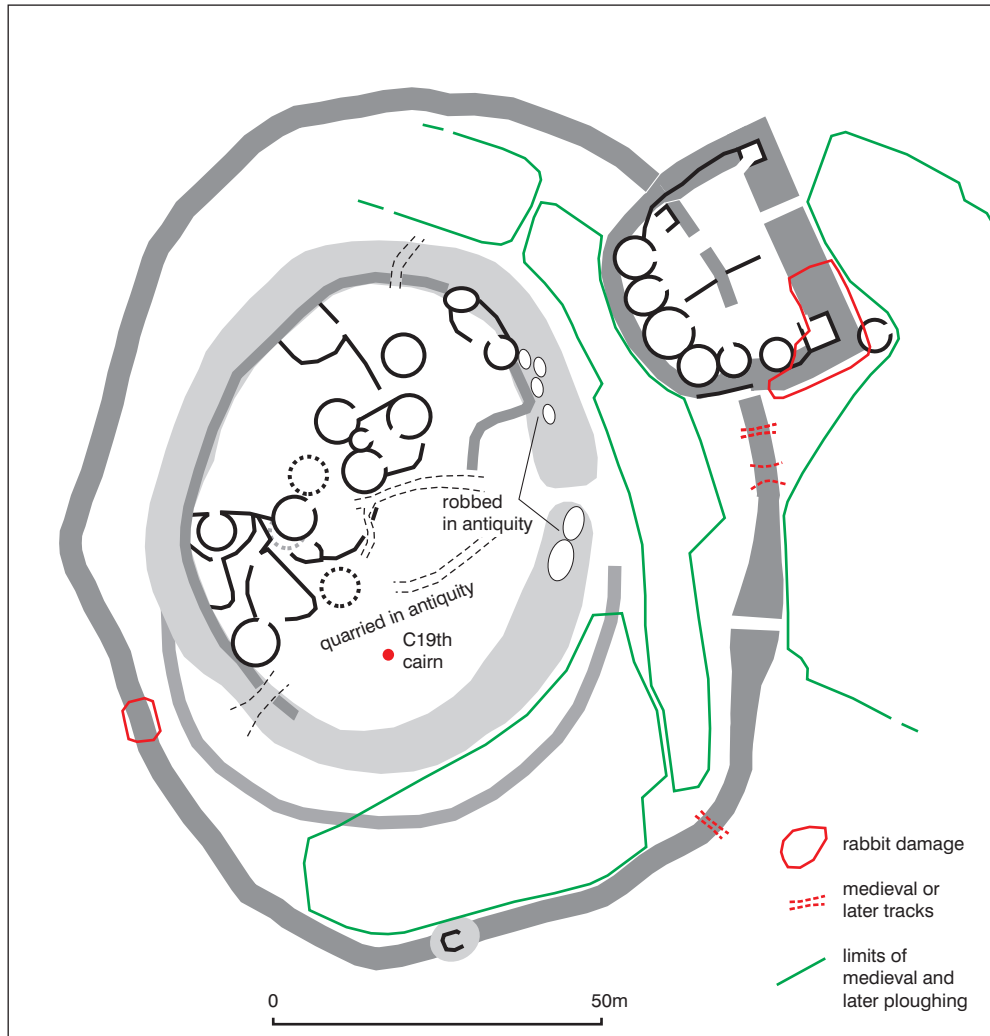
Figure 10.
The condition of
the hillfort and its
immediate environs

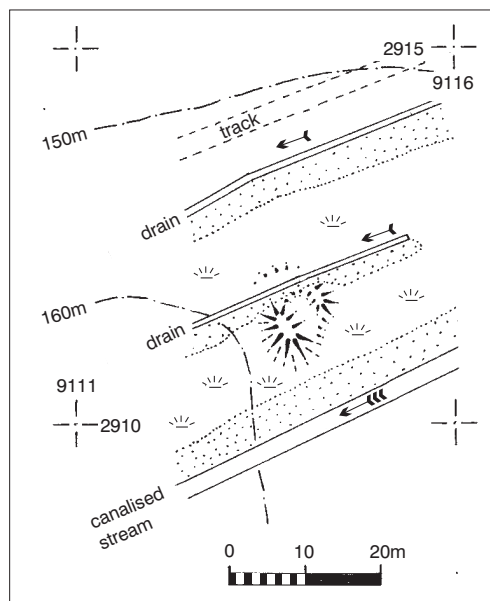
Figure 13.
Plan of the
possible barrow
or 'burnt mound'
(at 1:1000 scale)

On the valley floor overlooking the minor tributary stream to the south of West Hill lies a roughly oval earthwork, formed by two conjoining mounds of differing size resting on a raised platform up to 13.0m in overall diameter. The present course of the stream follows an artificially cut channel, probably dug in the late 19th century or more recently, but the area remains very boggy, and it seems likely that any natural watercourse would originally have flowed within a few metres of the mound. A second drainage channel, also probably dug in recent times, cuts through the northern edge of

the earthwork. The larger mound combines with the smaller to form a horseshoe-shaped bank up to 0.7m high around a more level central area, with the open side facing towards the stream. If this represents the original form of the earthwork, its plan, together with its siting in relation to the stream, would suggest it to be a so-called 'burnt mound'. On excavation, such mounds generally prove to comprise masses of small chips of burnt stone, often in close proximity to a sunken trough, sometimes lined with timber. These features are thought to represent the residue of Bronze Age 'sweat houses' (that is, saunas) or large cooking hearths (Buckley 1990; Hodder and Barfield 1991). Alternatively, it may be that the central level area is the result of stone-robbing or looting; a mound of this size in a more regular form could be consistent with a later Neolithic or early Bronze Age funerary monument.

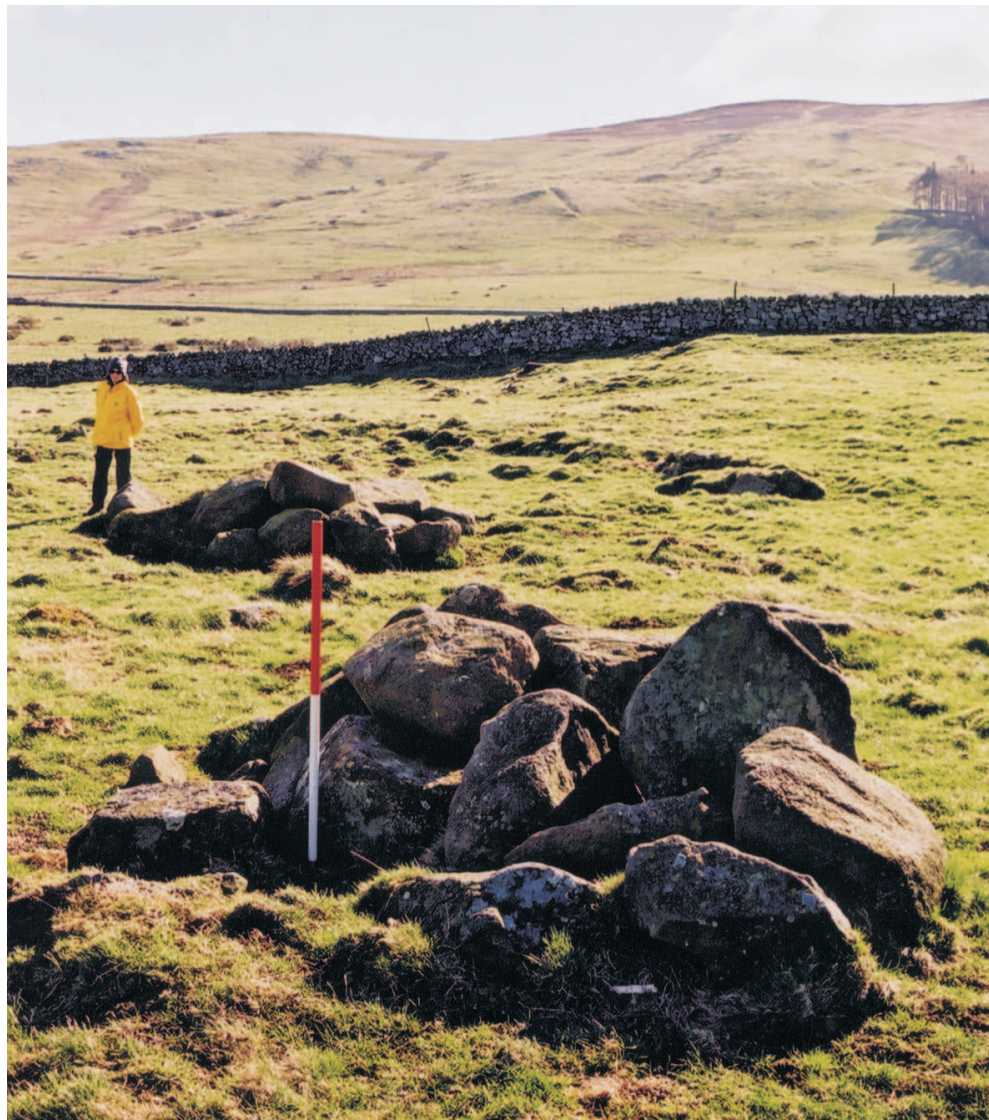
On the southern slopes of West Hill, the fieldwork identified some thirty roughly circular mounds of loosely packed portable boulders and smaller stones, which are in many cases piled up around larger immovable boulders. The largest mounds are up to 6m in diameter and 0.8m high, and some are entirely grassed over. The smallest comprise scatters of small fragments of rock, or occasionally two or three large stones in close proximity to each other. In many instances, the appearance of these smaller examples is almost certainly the outcome of later stone robbing to obtain material for field walls, presumably at various times between the medieval period and the 19th century. As noted above, the cup-marked boulder may have been subject to this process of burial and later robbing. Excavation in Northumberland and elsewhere in England has shown that funerary cairns occasionally acted as focuses for later field clearance, and that burials were sometimes inserted into established field clearance cairns (Jobey 1981; Leach 1983; Barnatt 1994). However, none of the

*Figure 14.
Photograph of
field clearance
cairns to the
south-east of
West Hill*

examples collectively referred to in this report as field clearance cairns shows any positive signs of having been carefully structured, and it seems probable that most, if not all, can be fairly securely interpreted as the straightforward products of field clearance for agriculture.

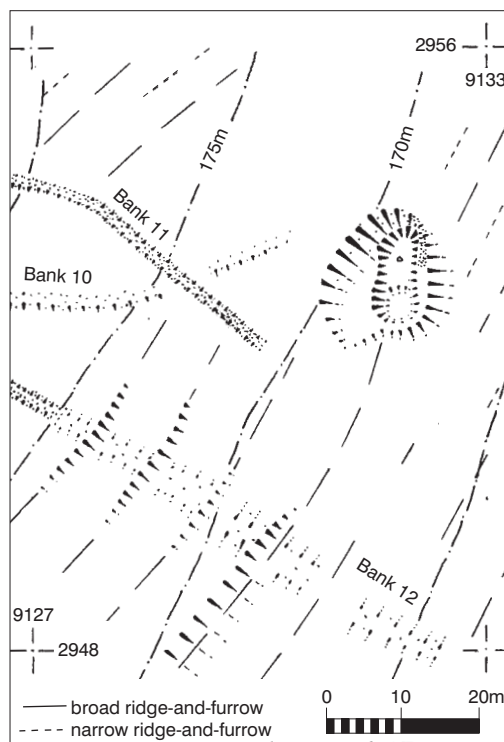
What may originally have been a complex of several platforms lies on the gentle south-eastern slope of West Hill. The most prominent surviving earthwork is an oval scoop, with a fairly prominent embankment skirting the downhill side, which appears to have enclosed two adjoining circular platforms. The scoop is 12m long from south to north by up to 6m wide, and is cut up to 1.0m into the natural slope. The embankment around the downslope side is best preserved at its northern end, where it is particularly stony and clearly represents the remnant of a tumbled wall. The southern end of the earthwork has been more severely damaged by medieval and later ploughing, but it is

Figure 16.
Plan of
Scooped Settlement 4
(at 1:1000 scale)

possible that this may have been the point of entry into the scoop. Very degraded earthworks suggest that there may have been more platforms to the south-west, perhaps extending as far as Bank 11, which seems to terminate *c.*10m away from the most clearly evident element of the settlement. Bank 10 heads directly towards the upslope side of the main scoop. However, the intensive medieval cultivation has made it impossible to securely infer any relationship between the scooped settlement and the two banks through earthwork survey alone.

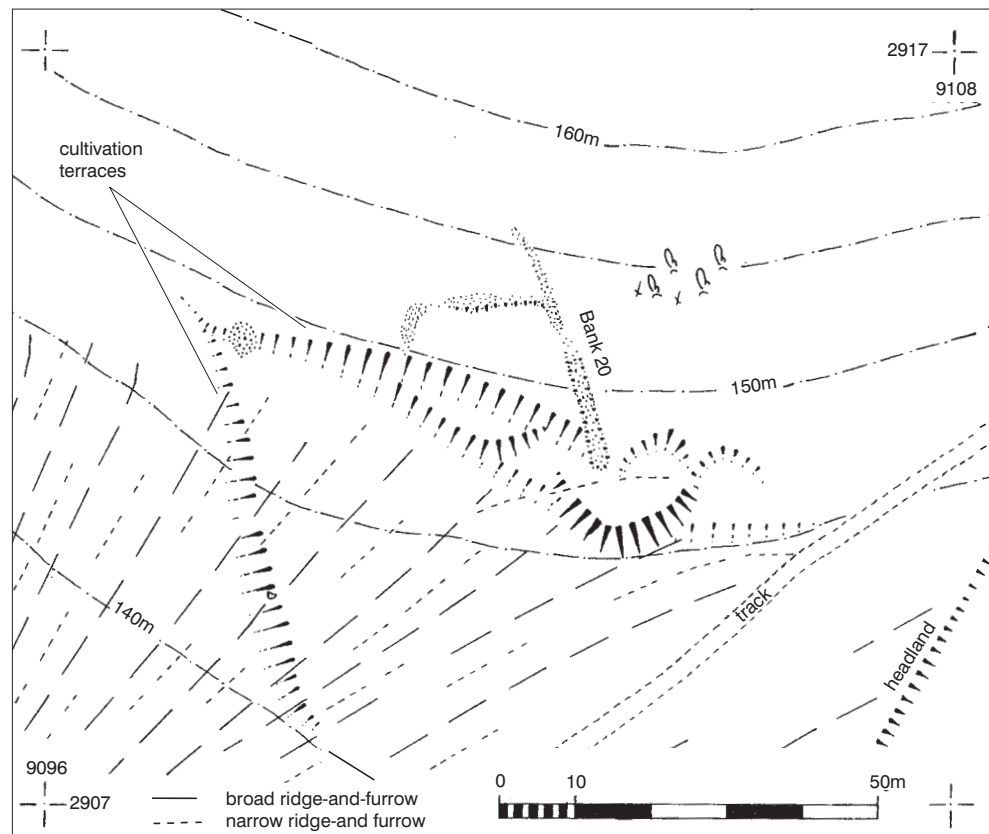
The site was examined by English Heritage, but not surveyed in detail.

Figure 17.
Plan of Scooped
Settlement 5 (at
1:1000 scale)

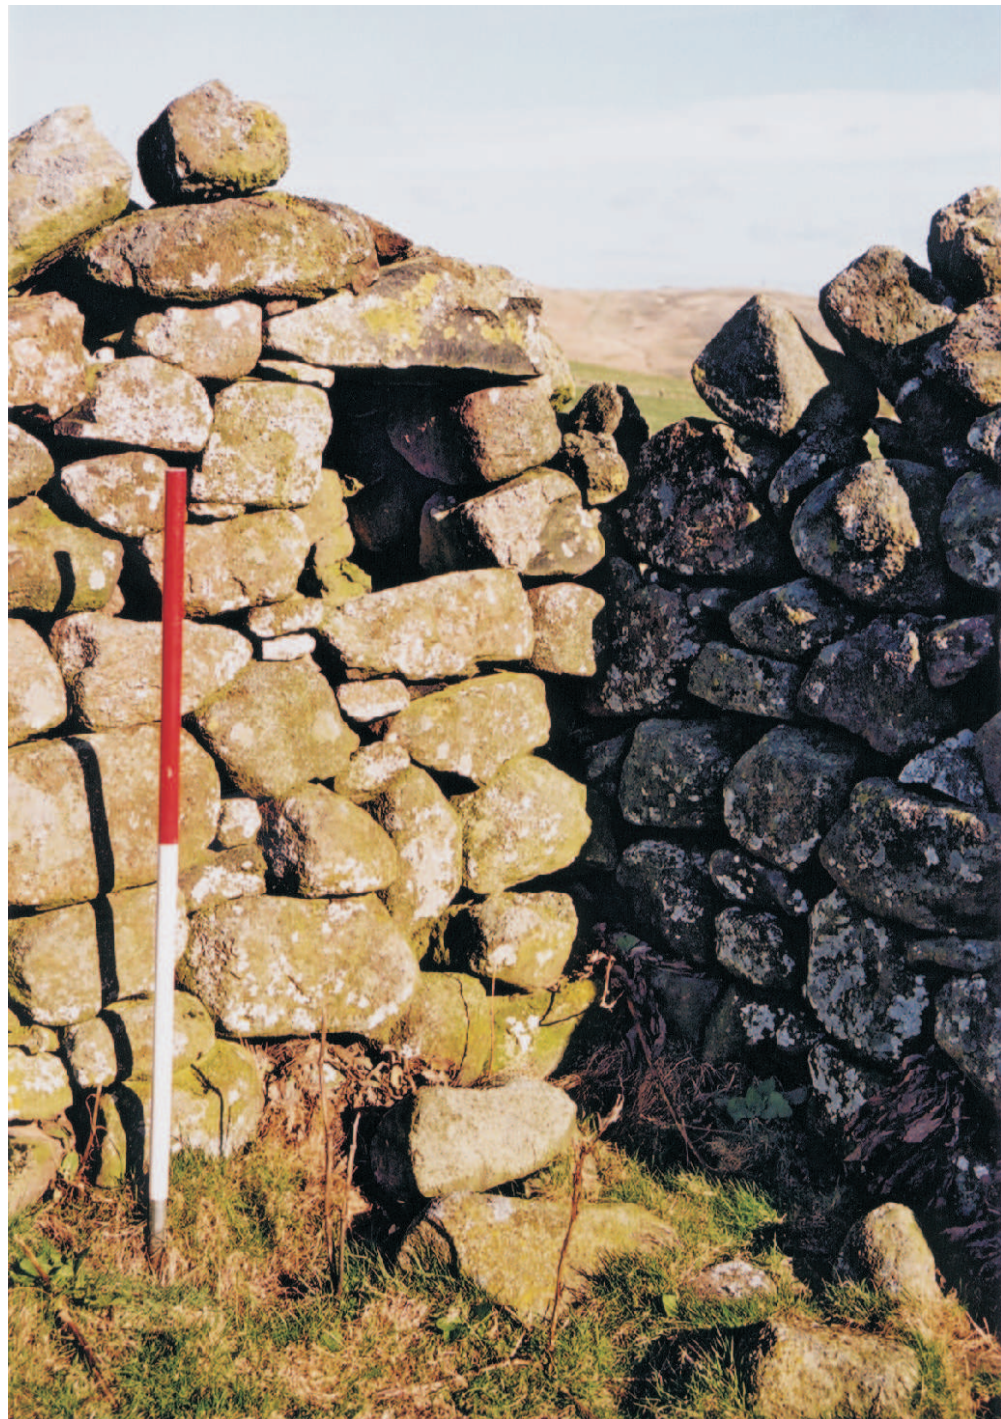
*Figure 19.
Photograph of the
interior of the
post-medieval
cottage*
