Research Department Report 4/2006

Chiswick House Facilities Development Project
Project 4584
Archaeological Evaluation Assessment Report

Dave Fellows

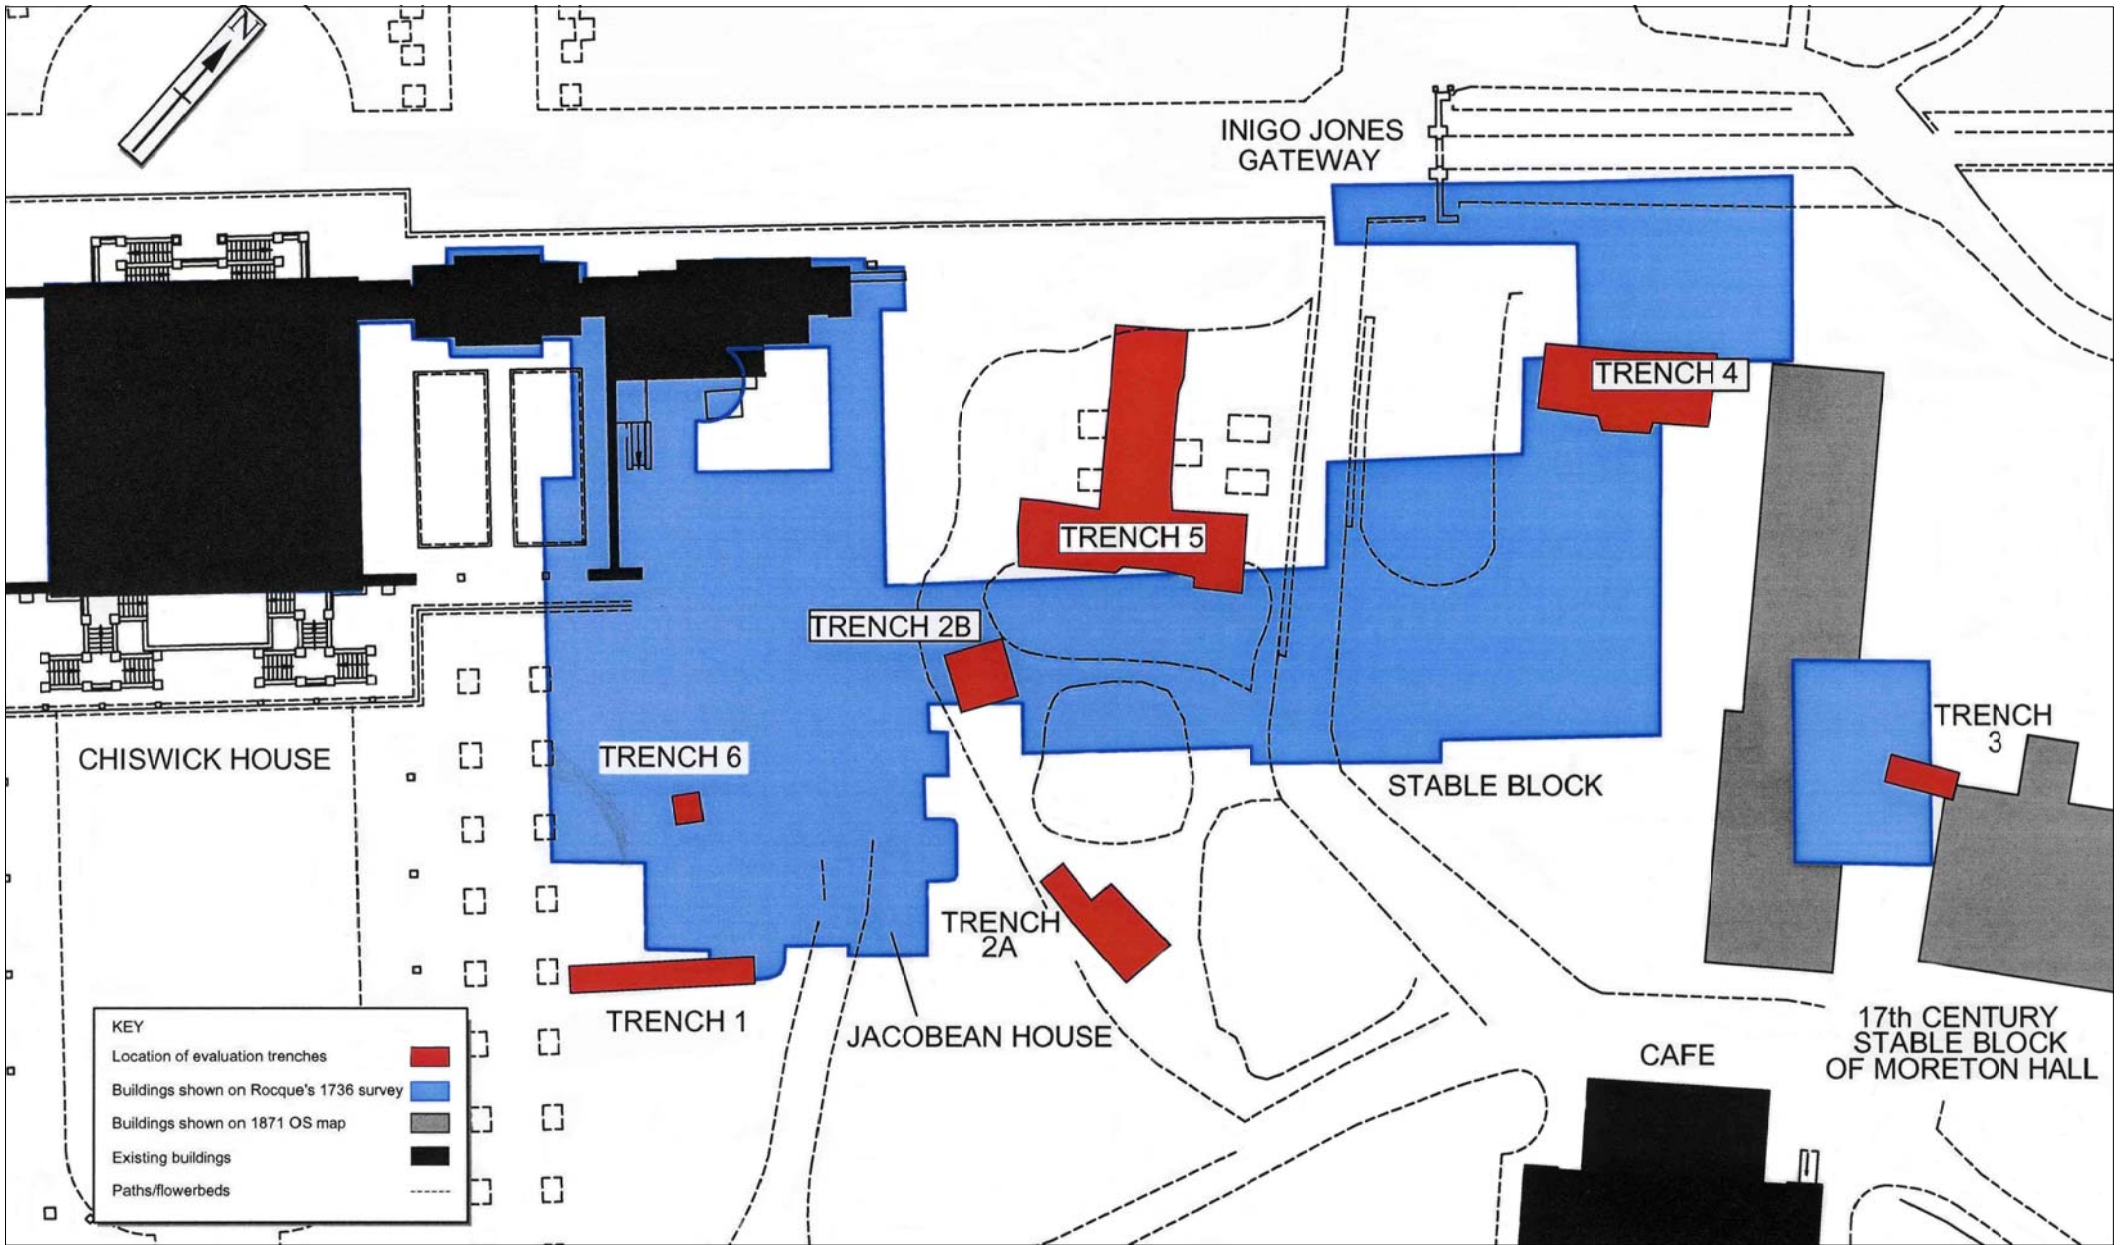
Figure 2: Plan showing the location of the evaluation trenches

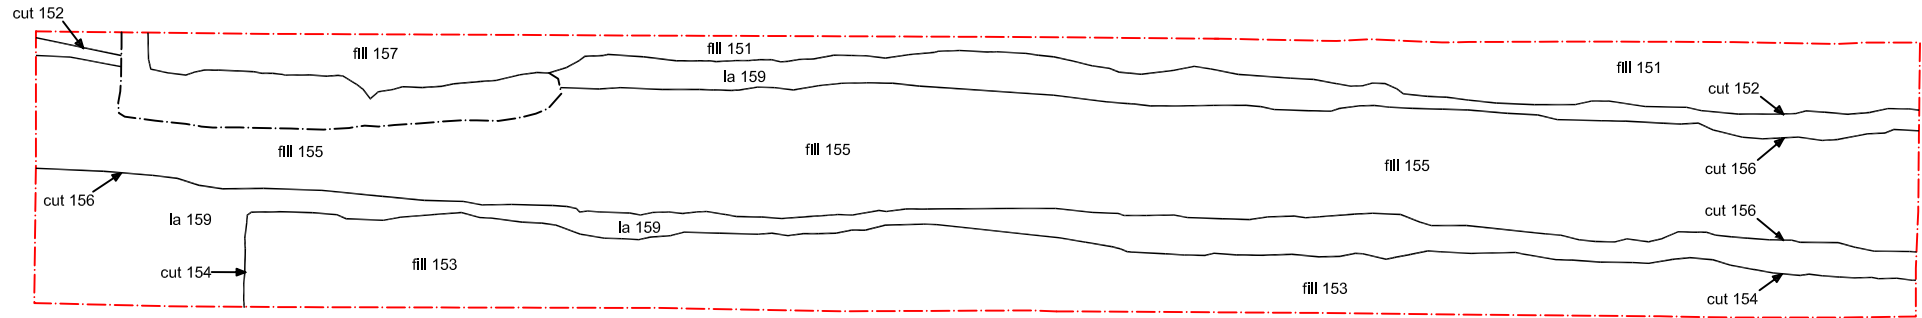
Figure 7: Plan showing the excavated features in Trench 1

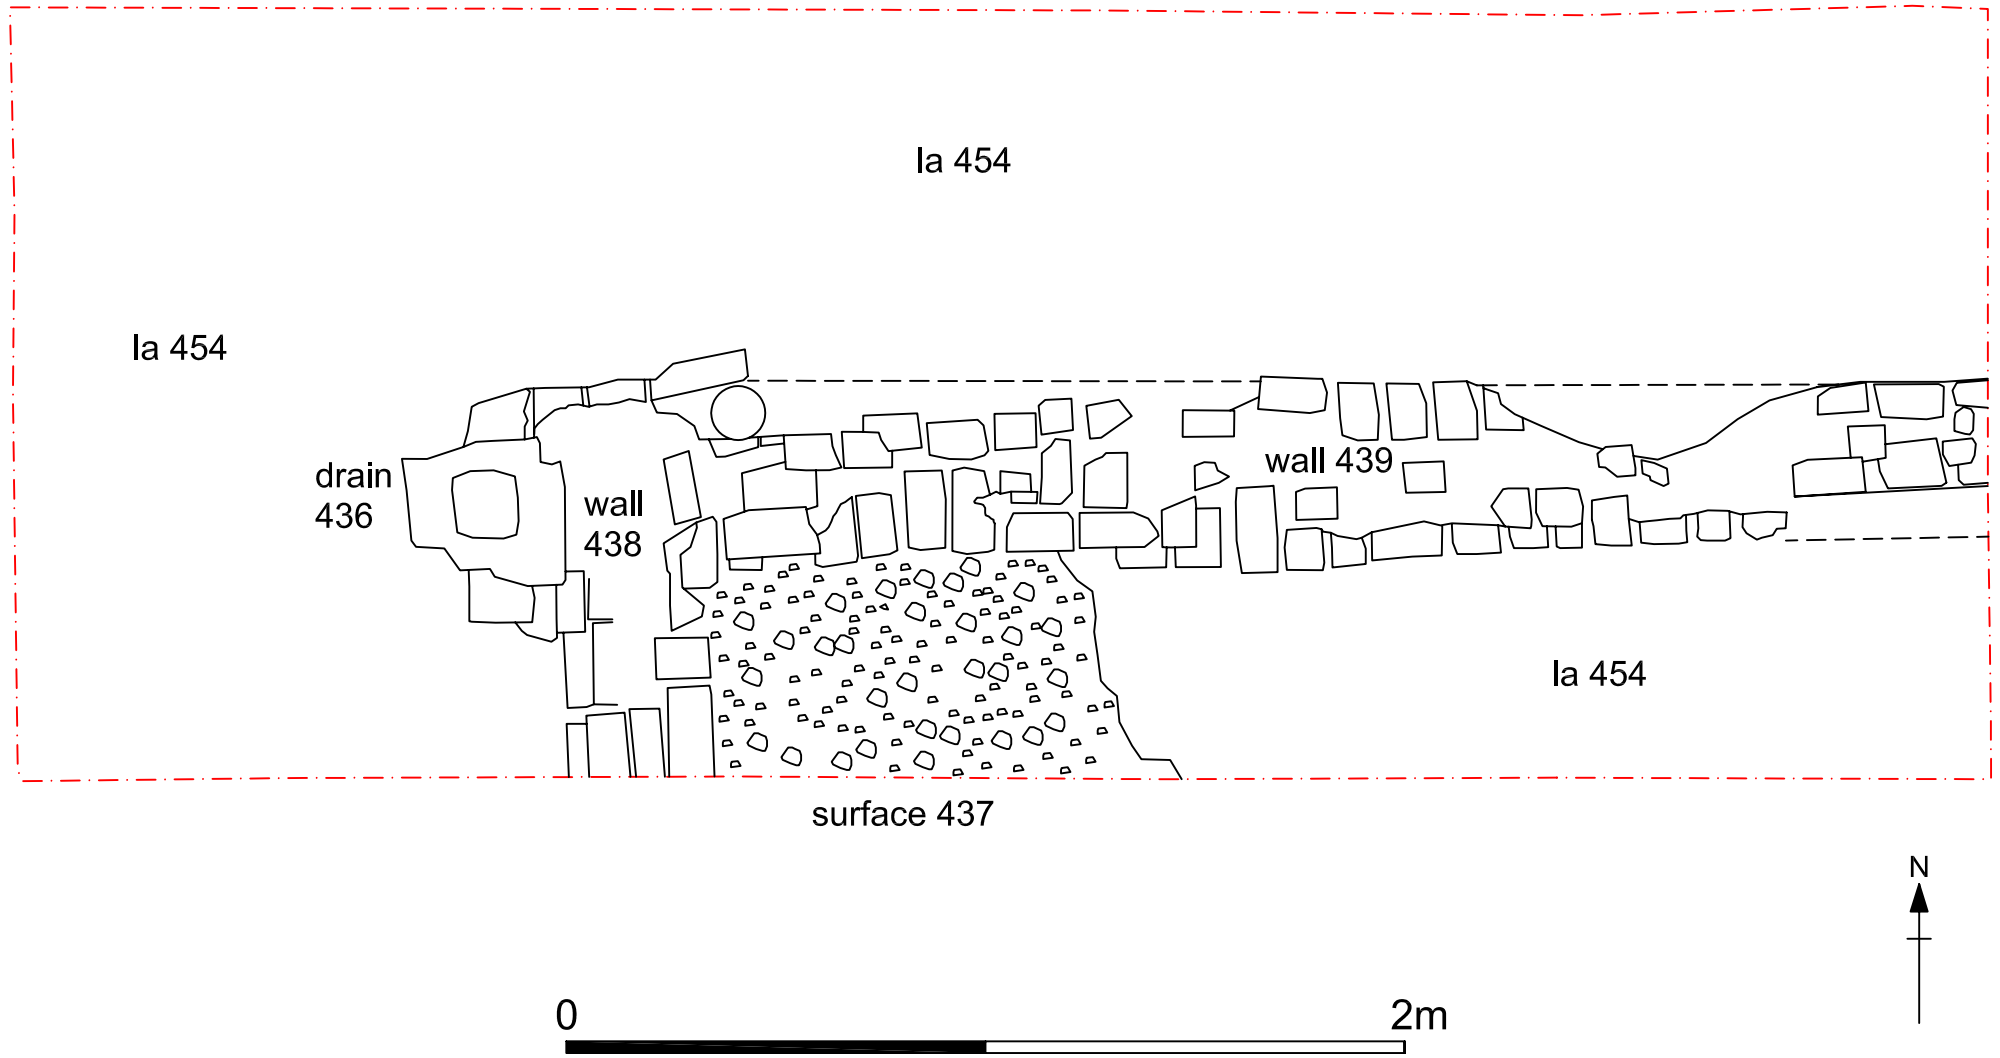
Figure 14: Plan showing the excavated features in Trench 3

and condition of the surviving remains, and this was located over a readily-identifiable corner of a wall. A trench measuring 4.7 x 1.9m was excavated, and the brickwork of the walls (contexts 438 and 439) was encountered very close to the surface (c0.20m deep - at a height of 6.85mAOD) (**see Figure 14 and Plate 11**). This brickwork appears to have been from the north-western corner of the Stable Block of Moreton Hall, and within the building there was a roughly-pebbled floor surface (context 437).

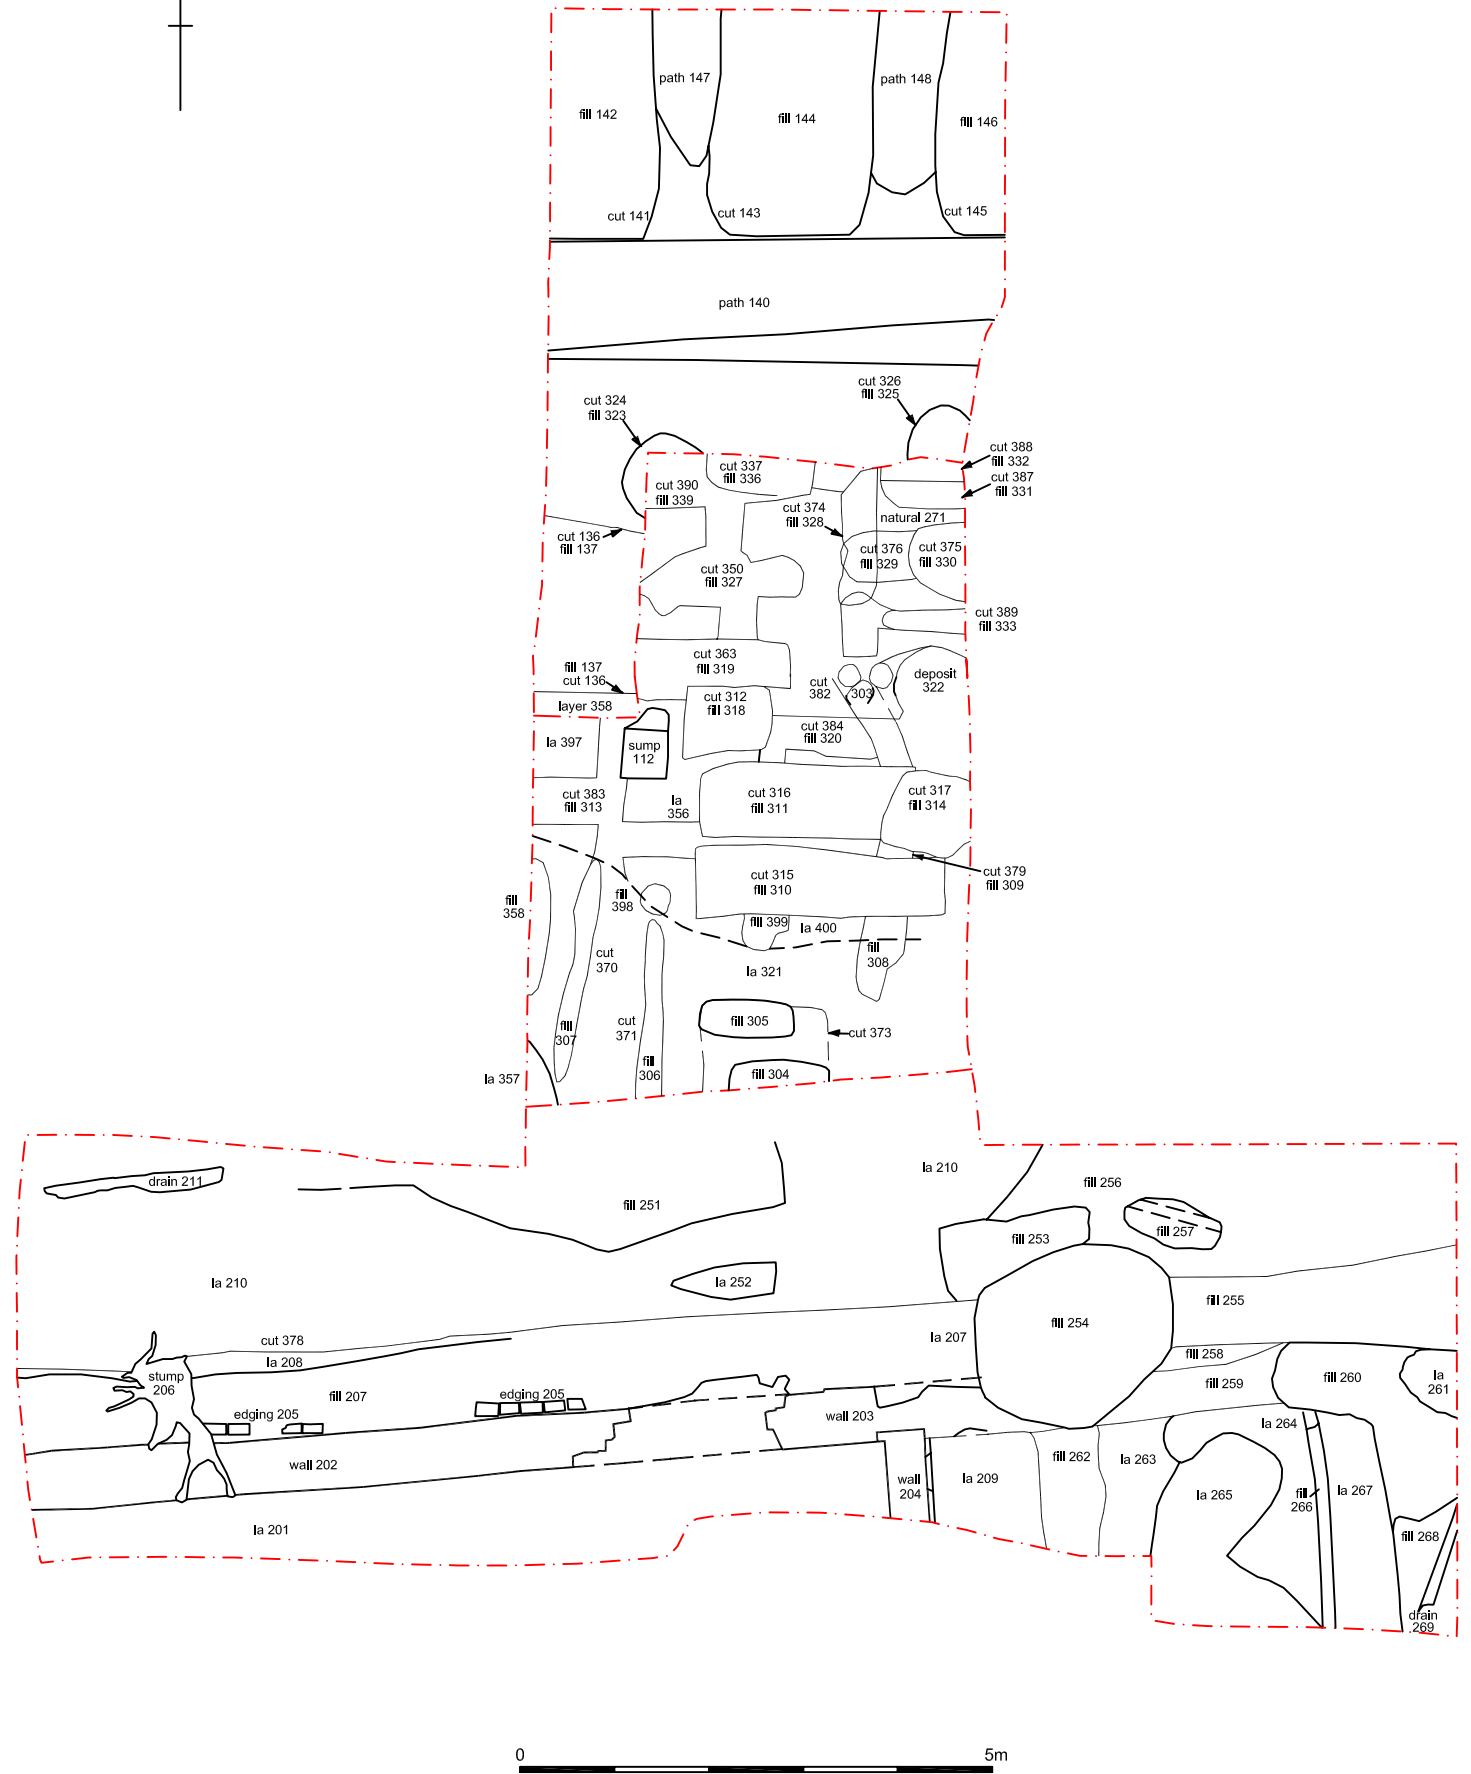
Figure 18: Plan showing the excavated features in Trench 5

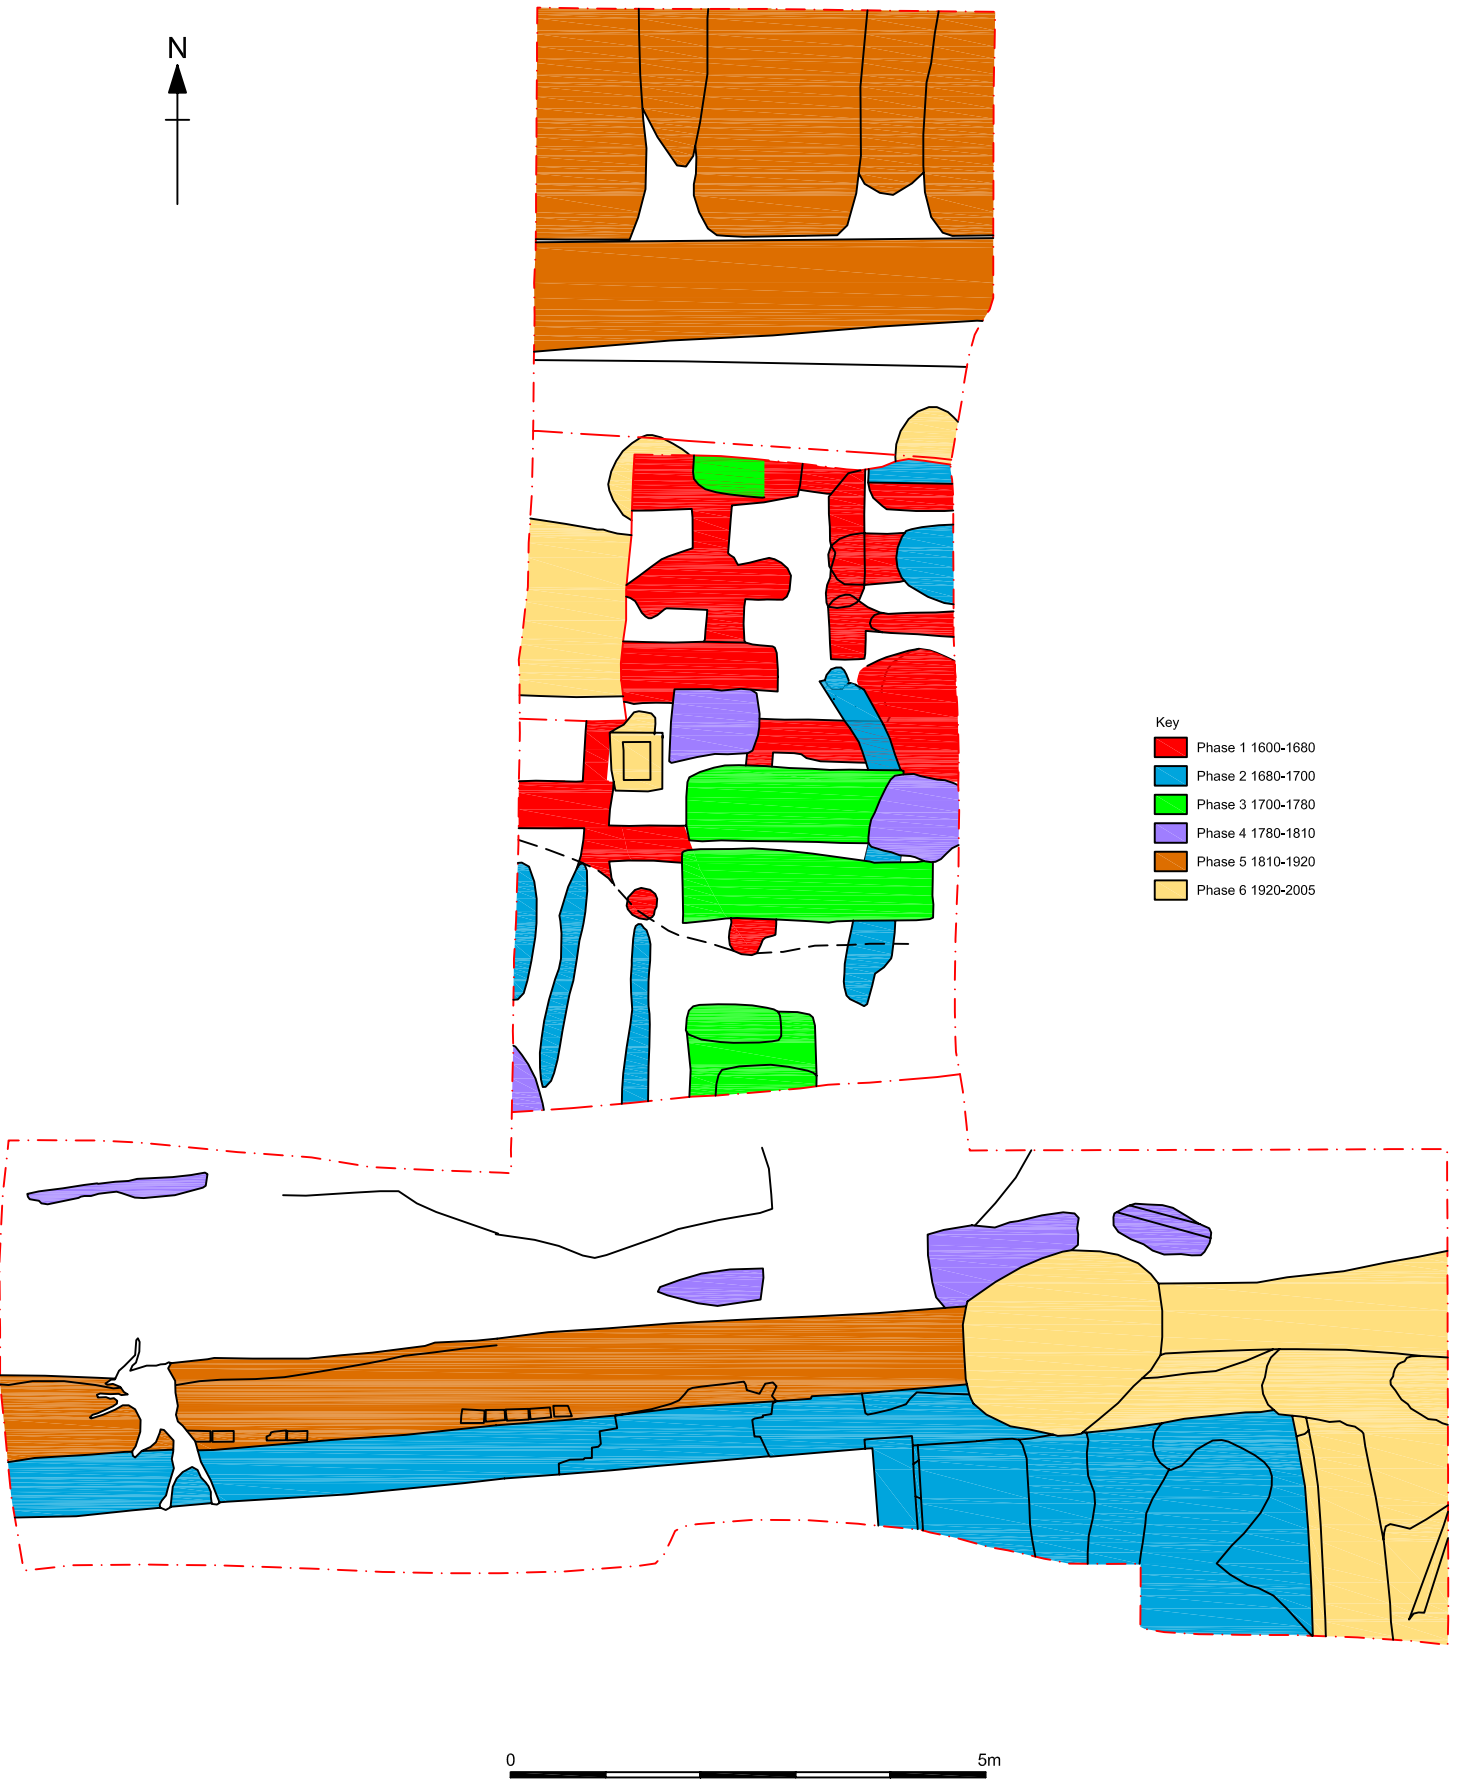
Figure 20: Plan showing the phased archaeology in Trench 5

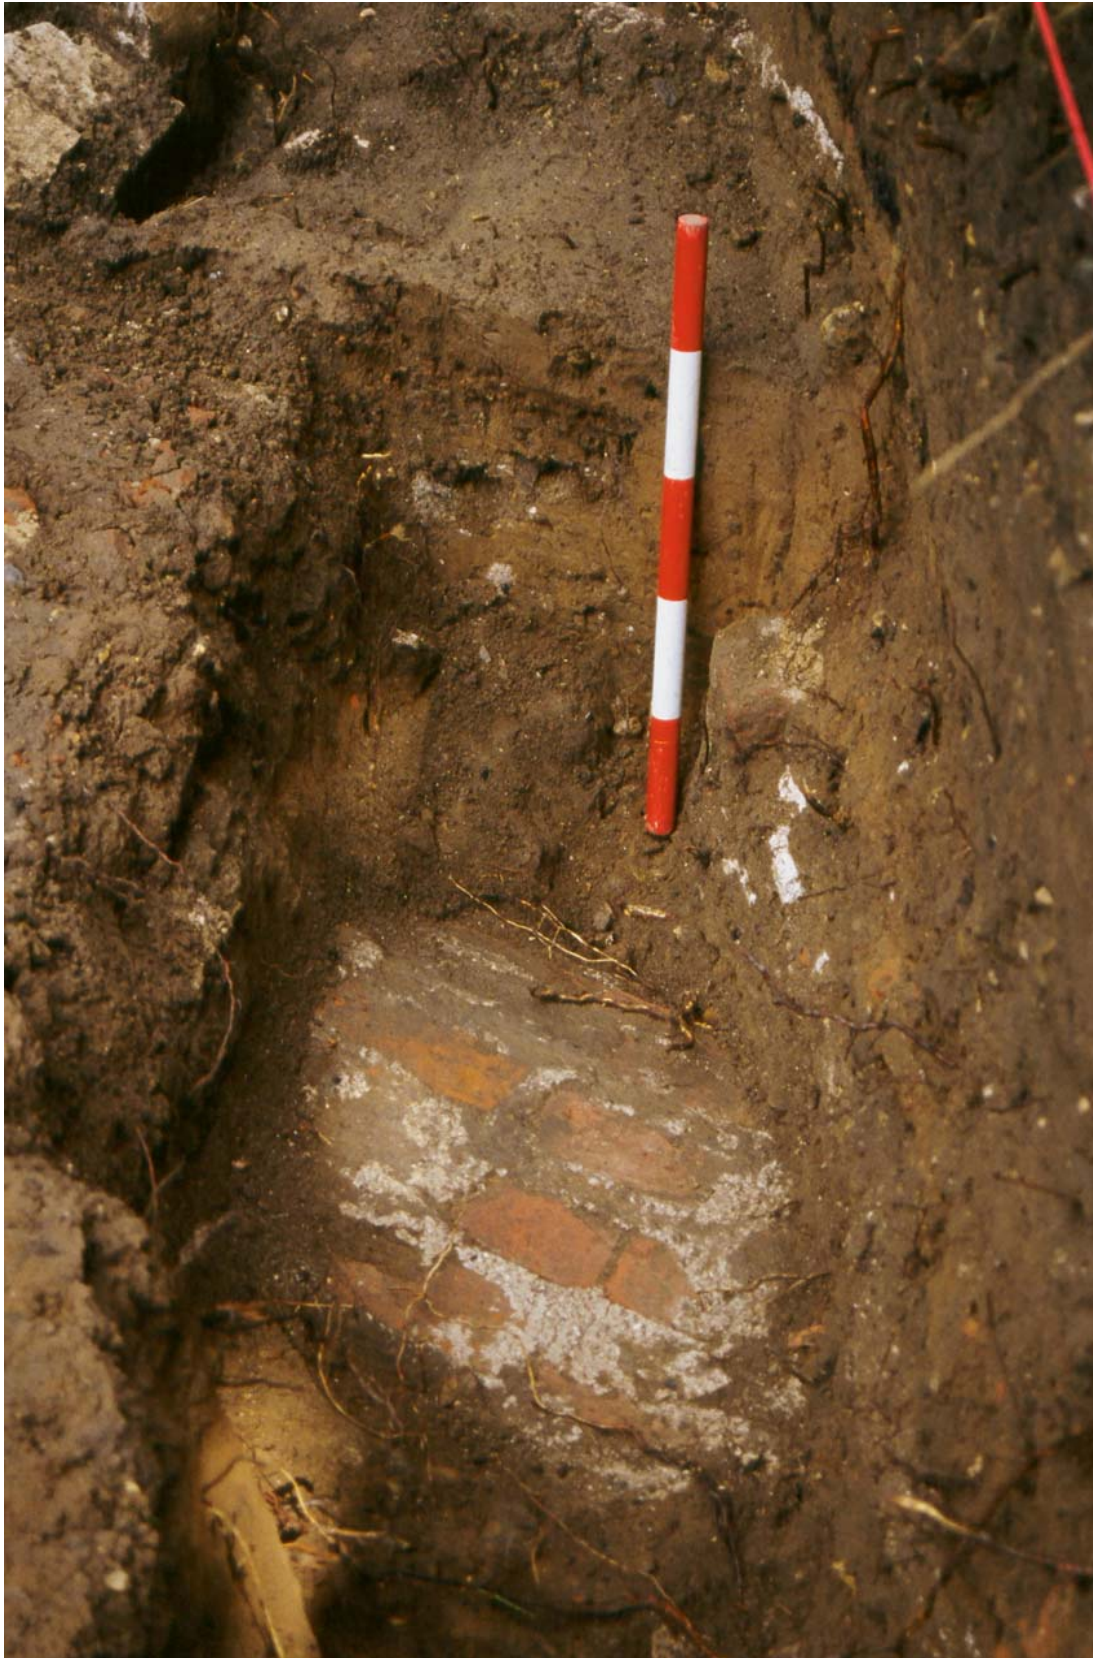
Plate 4 Detail of brick culvert in Trench 2A, looking west (0.5m scale)

The brick culvert had been heavily disturbed and repaired along its length. Several distinct repairs or modifications were seen and recorded, with at least three separate cuts into the brick arch of the culvert (cuts 225 and 233, repairs 226, 227, 228 and 229). These had been filled or repaired using re-used limestone slabs creating what have been interpreted to be inspection or access hatches.

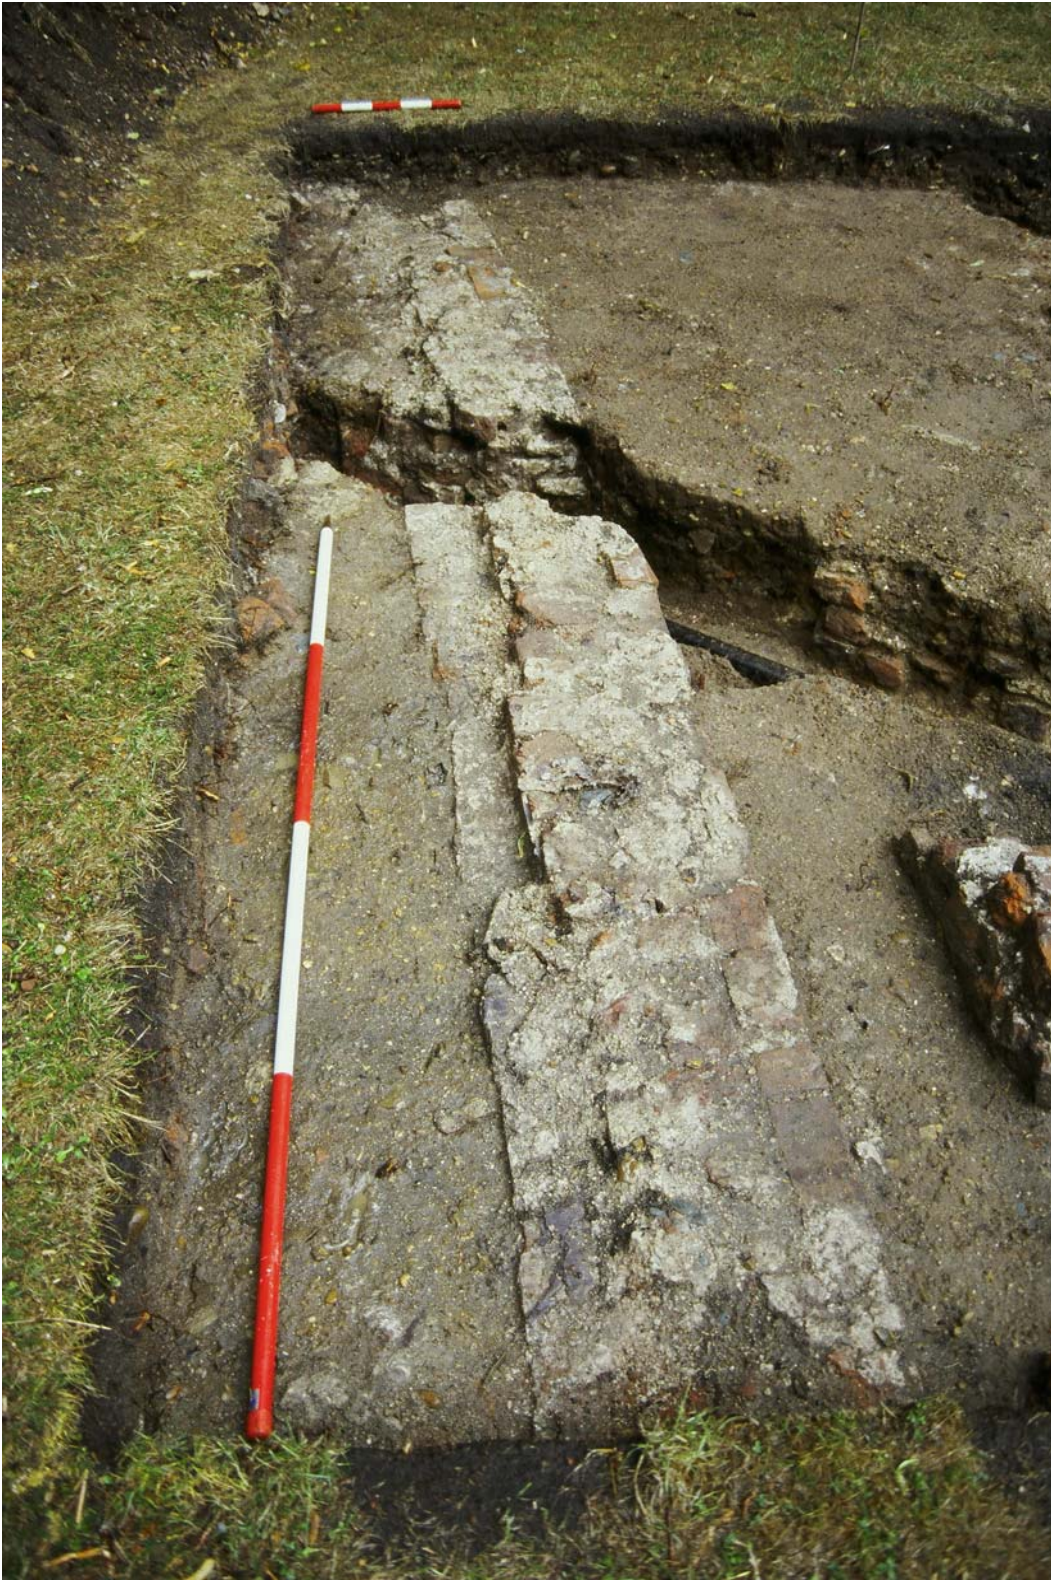
Plate 7 View of Trench 2B showing the curved late 18th-century wall, looking north (2m scale)

At the western side of the evaluation trench was a gently curving brick wall (213) (*see plate 7*). This wall was cut through by the later service cut, and in the sides of the service trench the brick footings to the wall could be seen. The curved wall survived for a height of two courses, beneath which were at least three further courses forming the foundations to the wall, with the foundations offset a distance of c0.10m to the eastern side of the wall line. This wall would have been the curved wall of the connecting passageway between the western end of the Stable Block and the eastern wing of the villa, dating from the late 1780s.

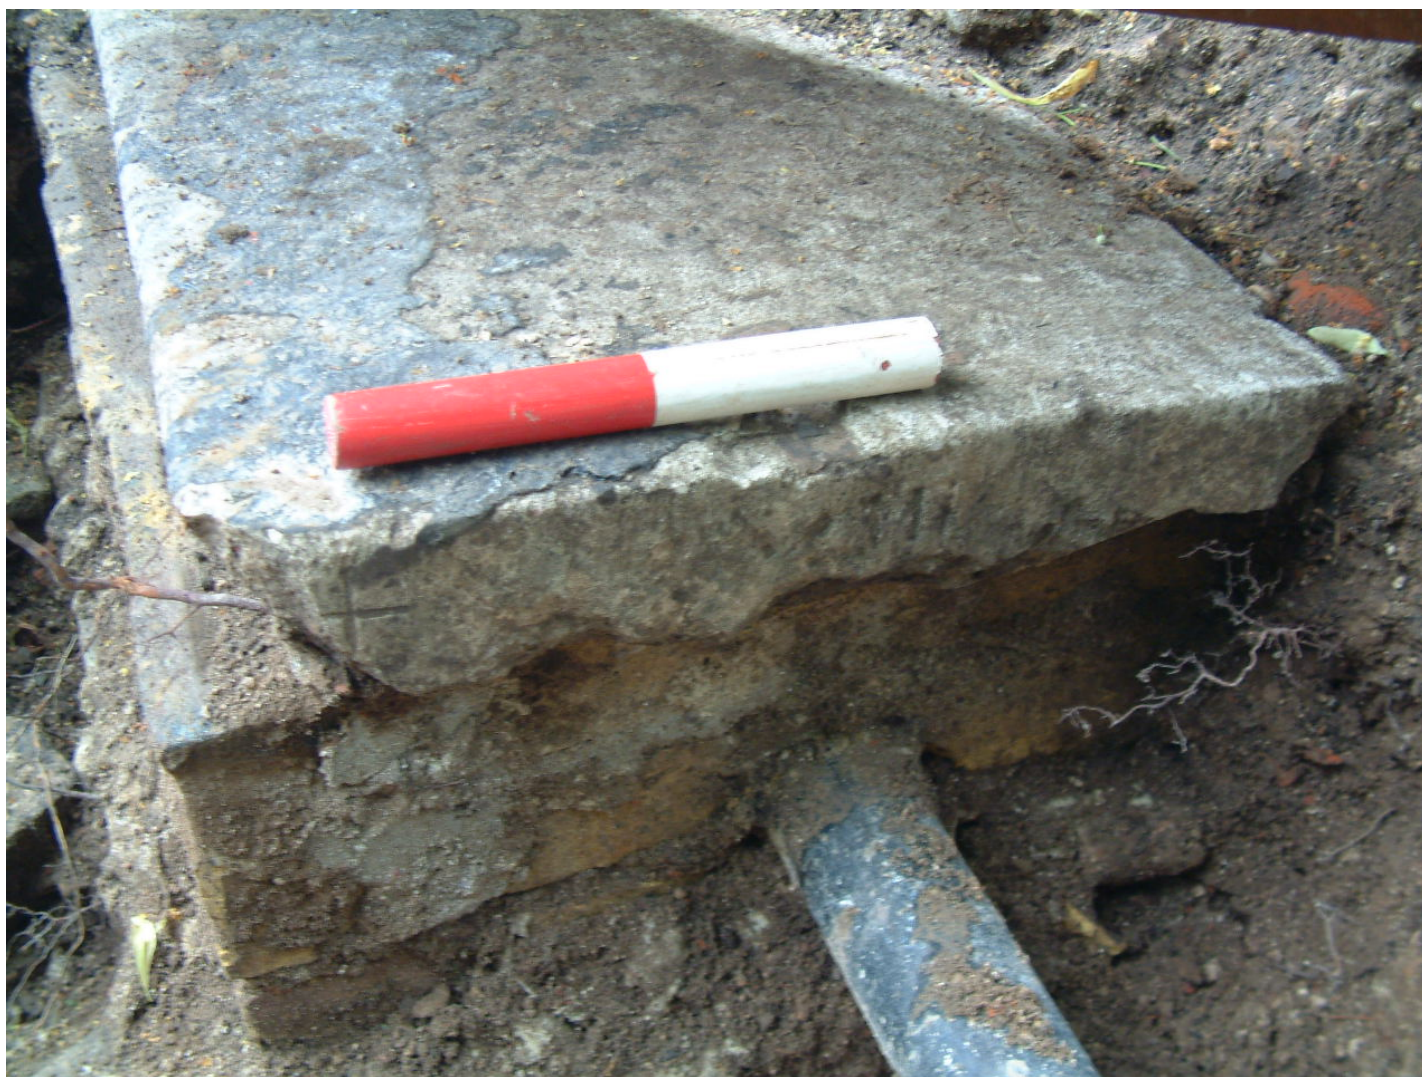
Plate 9 View of Trench 2B showing the re-used moulded limestone slab with mason's marks, looking east (0.2m scale)

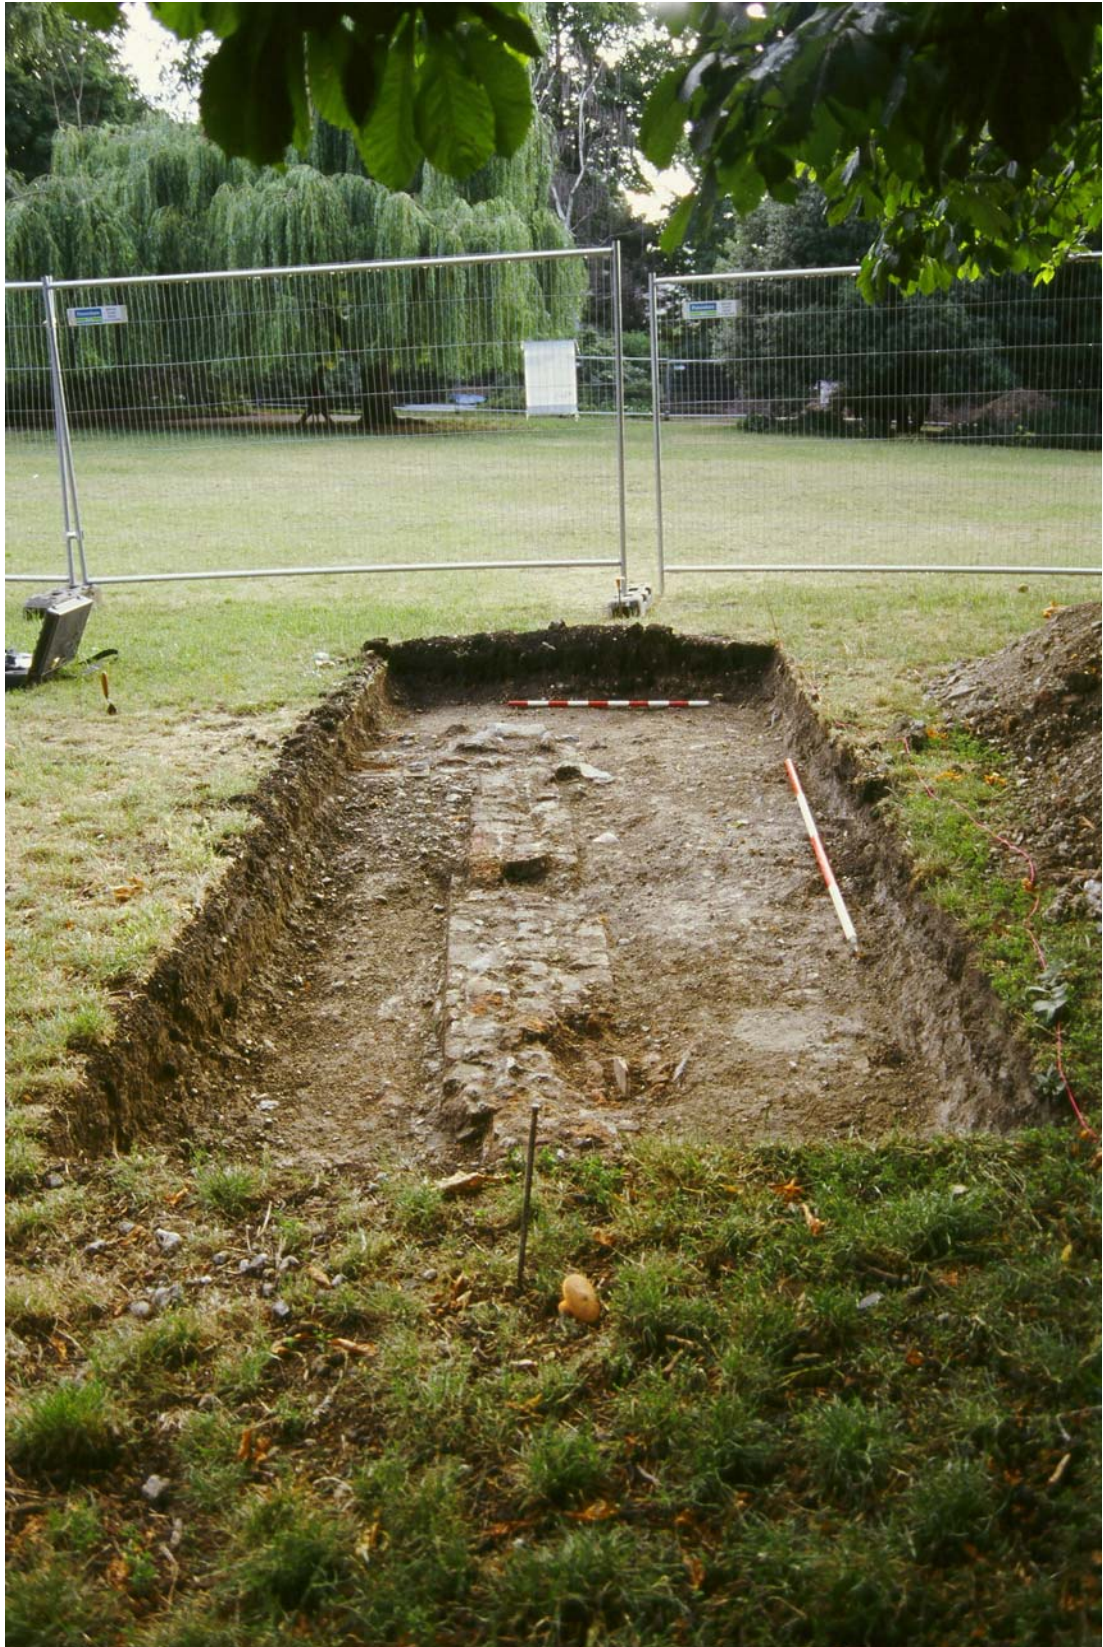
Plate 11 View of wall corner in Trench 3, looking west (2m and 1m scales)

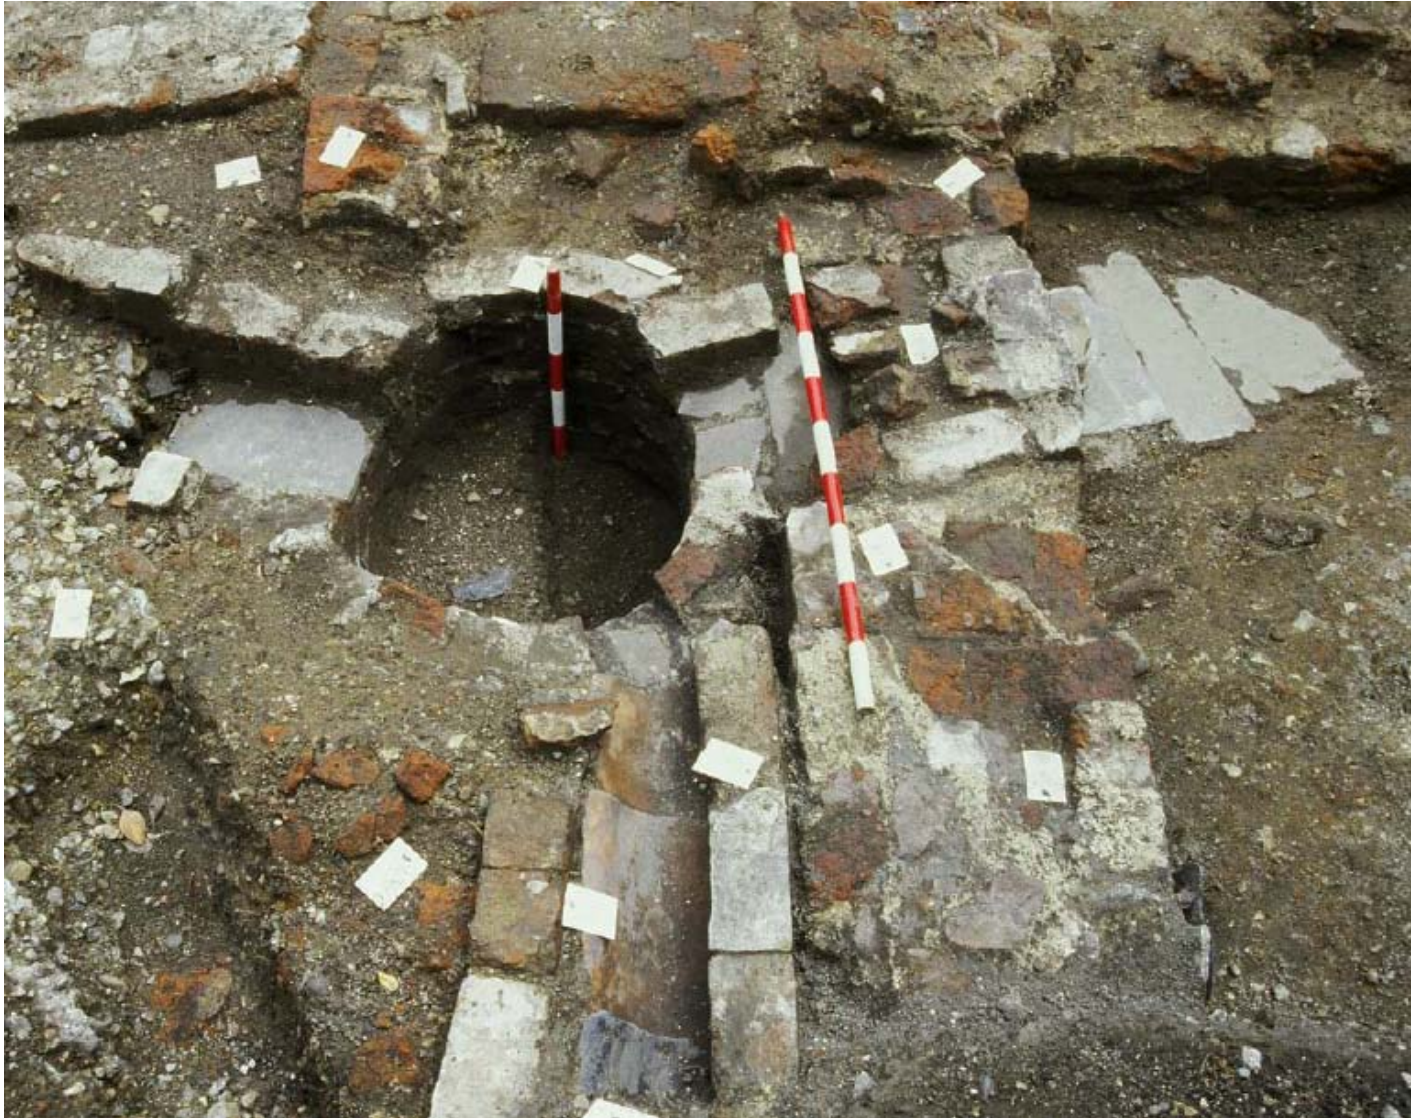
Plate 14 View of circular brick sump and drains in Trench 4, looking south (1m and 0.5m scales)

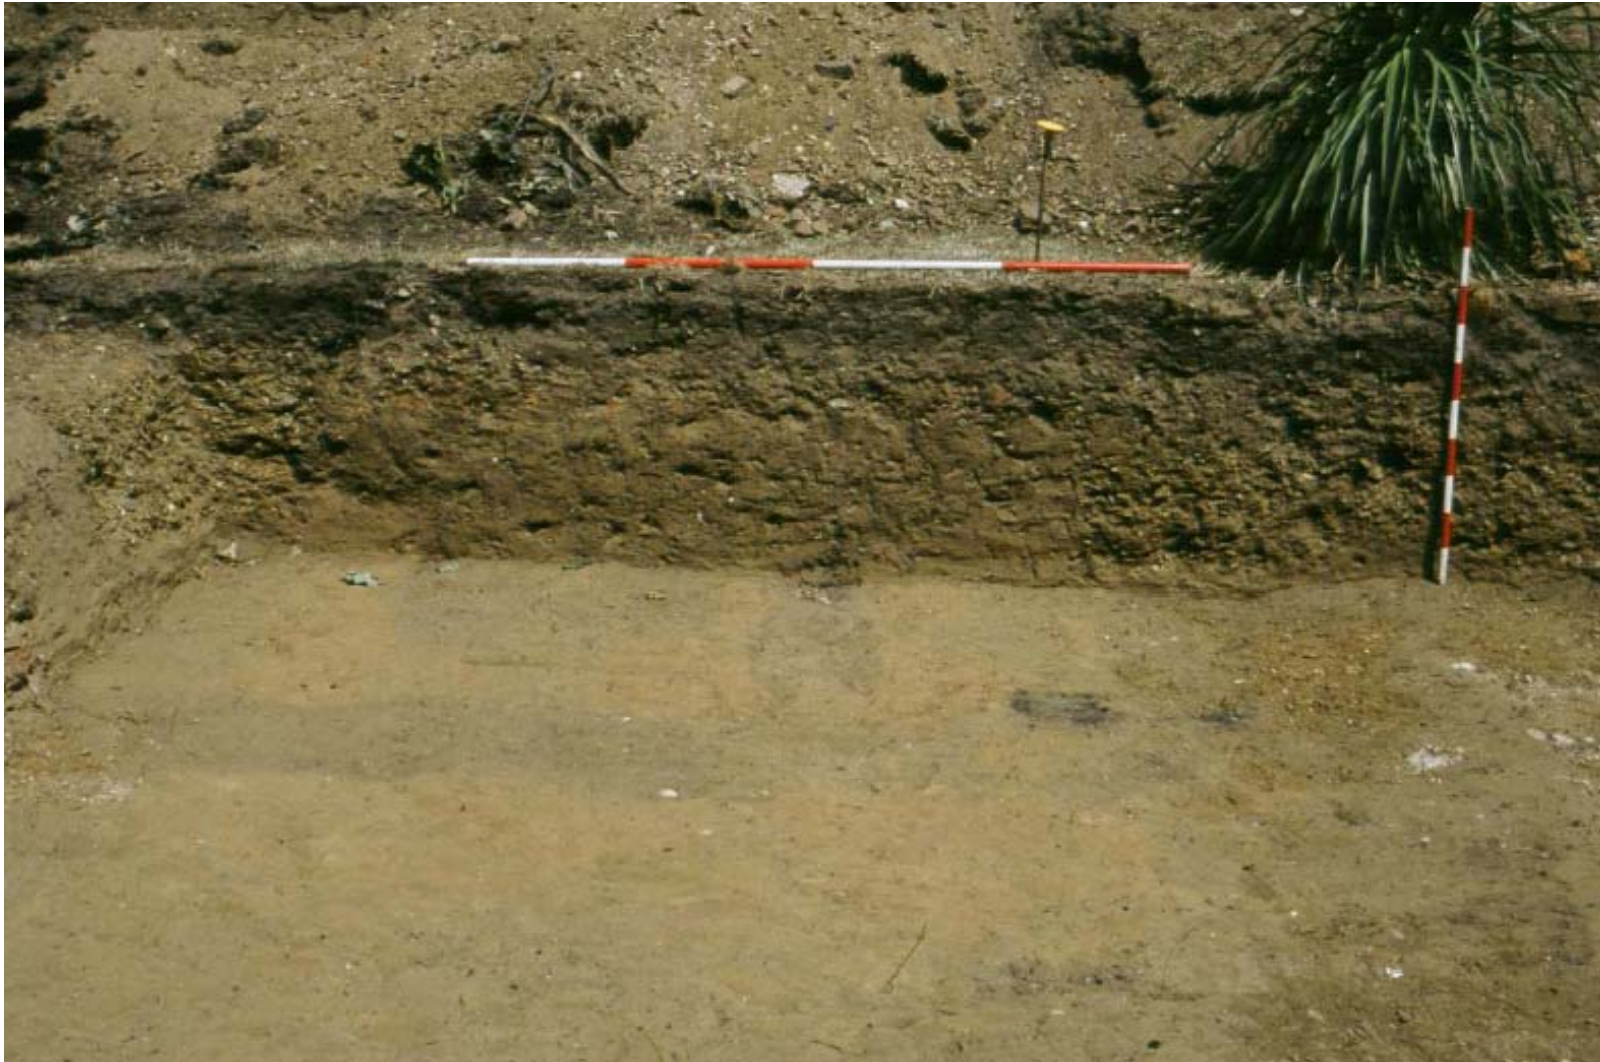
Plate 15 View of the formal flower beds in the base of Trench 5, looking east (2m and 1m scales)

The excavations to the north of the Stable Block revealed a sequence of extremely significant and important garden deposits, including evidence for the early formal knot garden layout (objectives 2.2.5 and 2.2.8). A grid pattern of inter-connected linear beds was uncovered, and an early 17th-century Nuremberg jeton was retrieved from the fill of one of these. The date and condition of the jeton suggest that the knot garden beds recorded were part of the early formal garden design of the Jacobean House.
