Research Department Report 4/2006

Chiswick House Facilities Development Project
Project 4584
Archaeological Evaluation Assessment Report

Dave Fellows

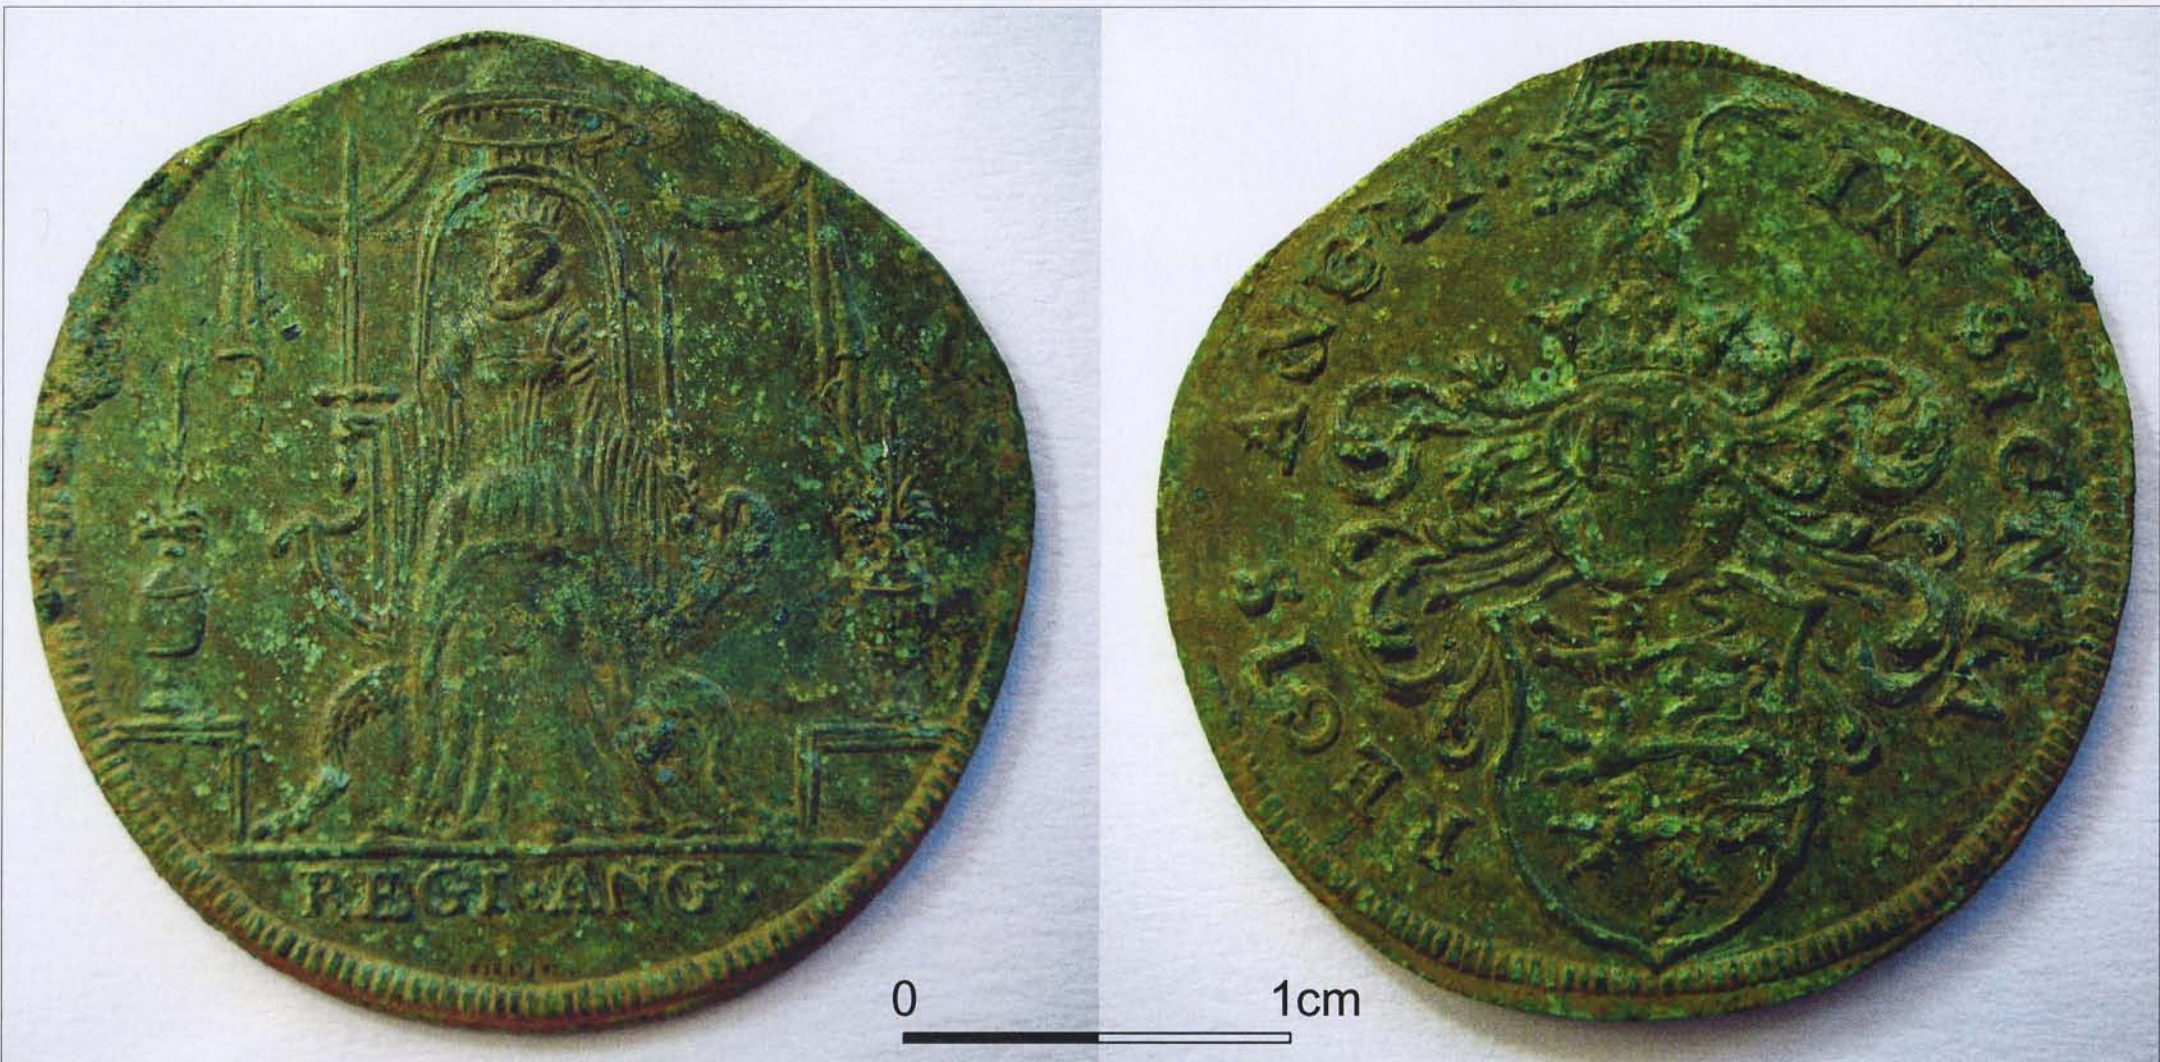
Plate 16: Photograph of obverse and reverse of the Nuremberg Token found in one of the Knot Garden beds

The most significant item was a Nuremberg token (200508003), possibly made by Hans Krauwinckel although from an unsigned series, dating to 1610-1616 (Seaby vol 1, 471). Probably made in brass, this token is in unusually good condition as most are worn or very worn, suggesting it might not have been in circulation very long before it was lost. Copper alloy items are represented by a small coat button (200508005) and part of a ring (200508006). The only significant glass find was a small part of the flaring rim of a vessel, probably a table glass. This was fine and of good quality. The remainder of the glass was from wine and beer bottles, or was fairly modern window glass.

Three copper alloy finds (200508003, 200508005, 200508006) were x-rayed (X-radiograph P2170). Investigative conservation was undertaken on token 200508003: overlying soil and voluminous corrosion products were selectively removed to clarify the detail on the token for the purpose of identification. The majority of the surface detail of the token is visible and the surface has a relatively smooth patina with some localised pitting.

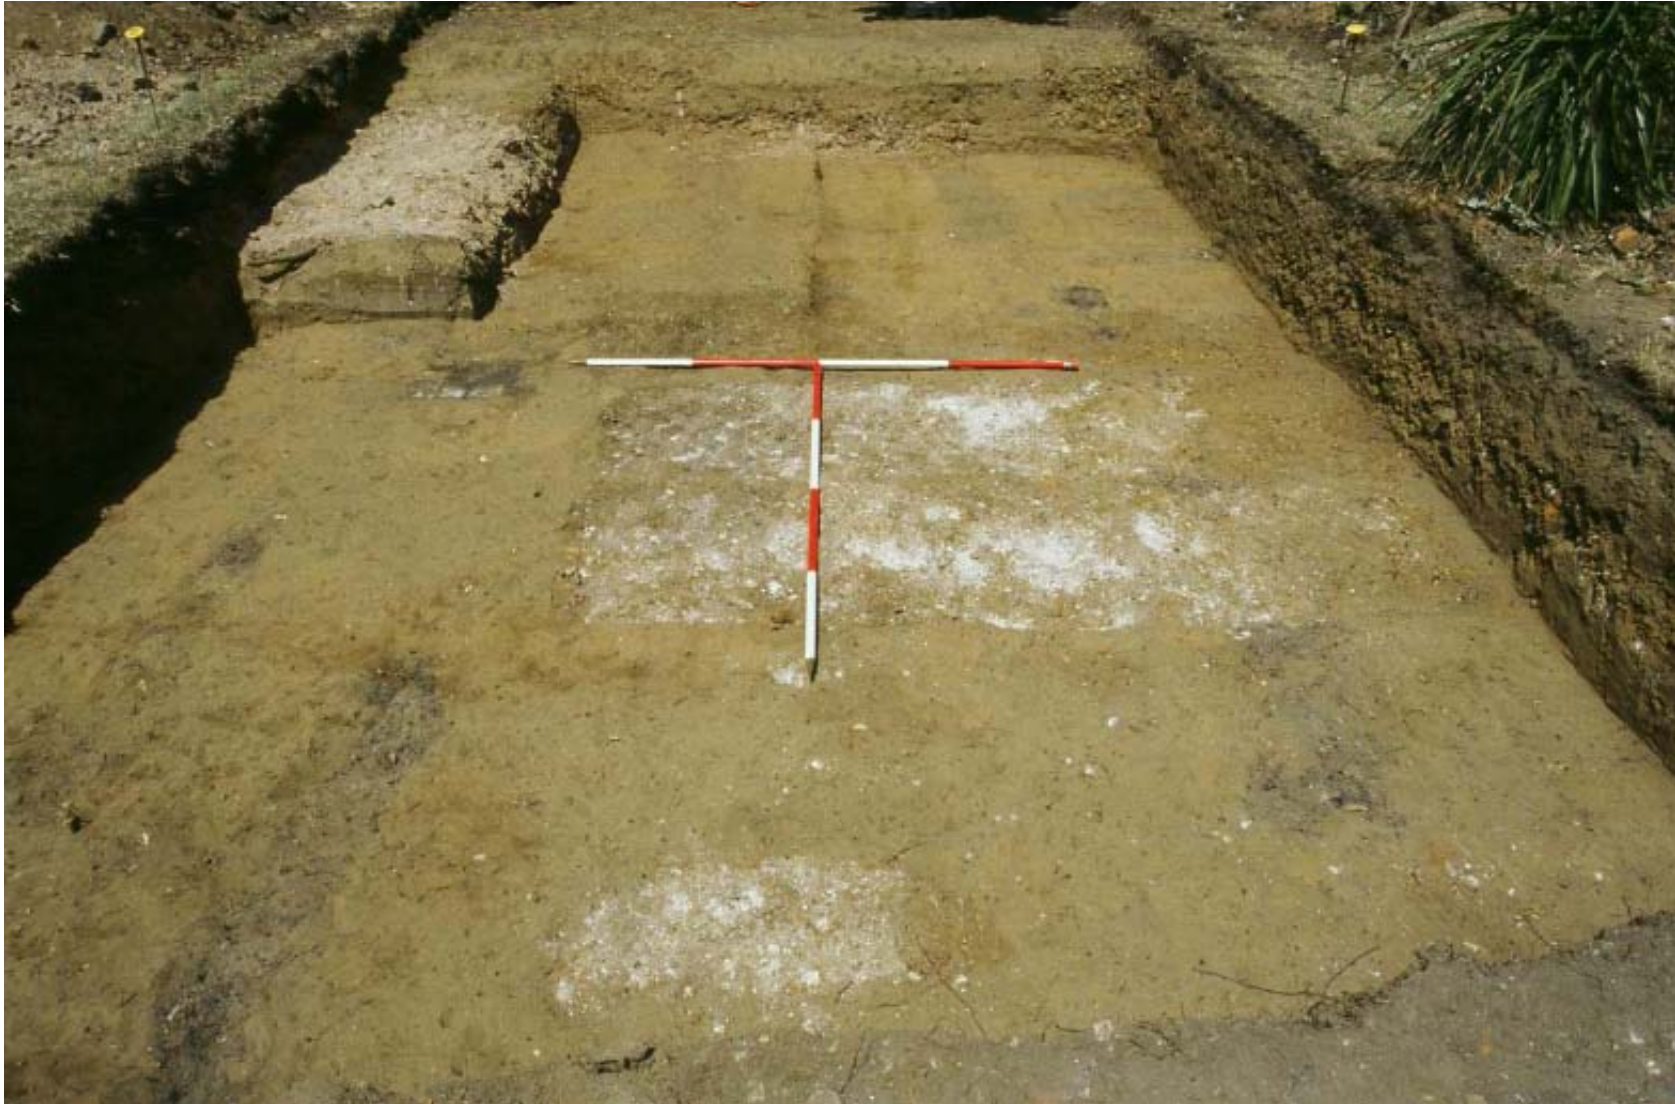
Plate 17 View of the rectangular mortar-rich features in the base of Trench 5, looking north (2x2m scales)

An alignment of mortar and rubble footings seen in the same trench may have been the foundations of the aviary building constructed in Lady Burlington's garden and depicted on John Rocque's 1736 survey of Lord Burlington's Estate, and if so this is very significant as it is one of only a handful of investigations ever undertaken on this hitherto little-studied archaeological element of 18th-century pleasure garden design.

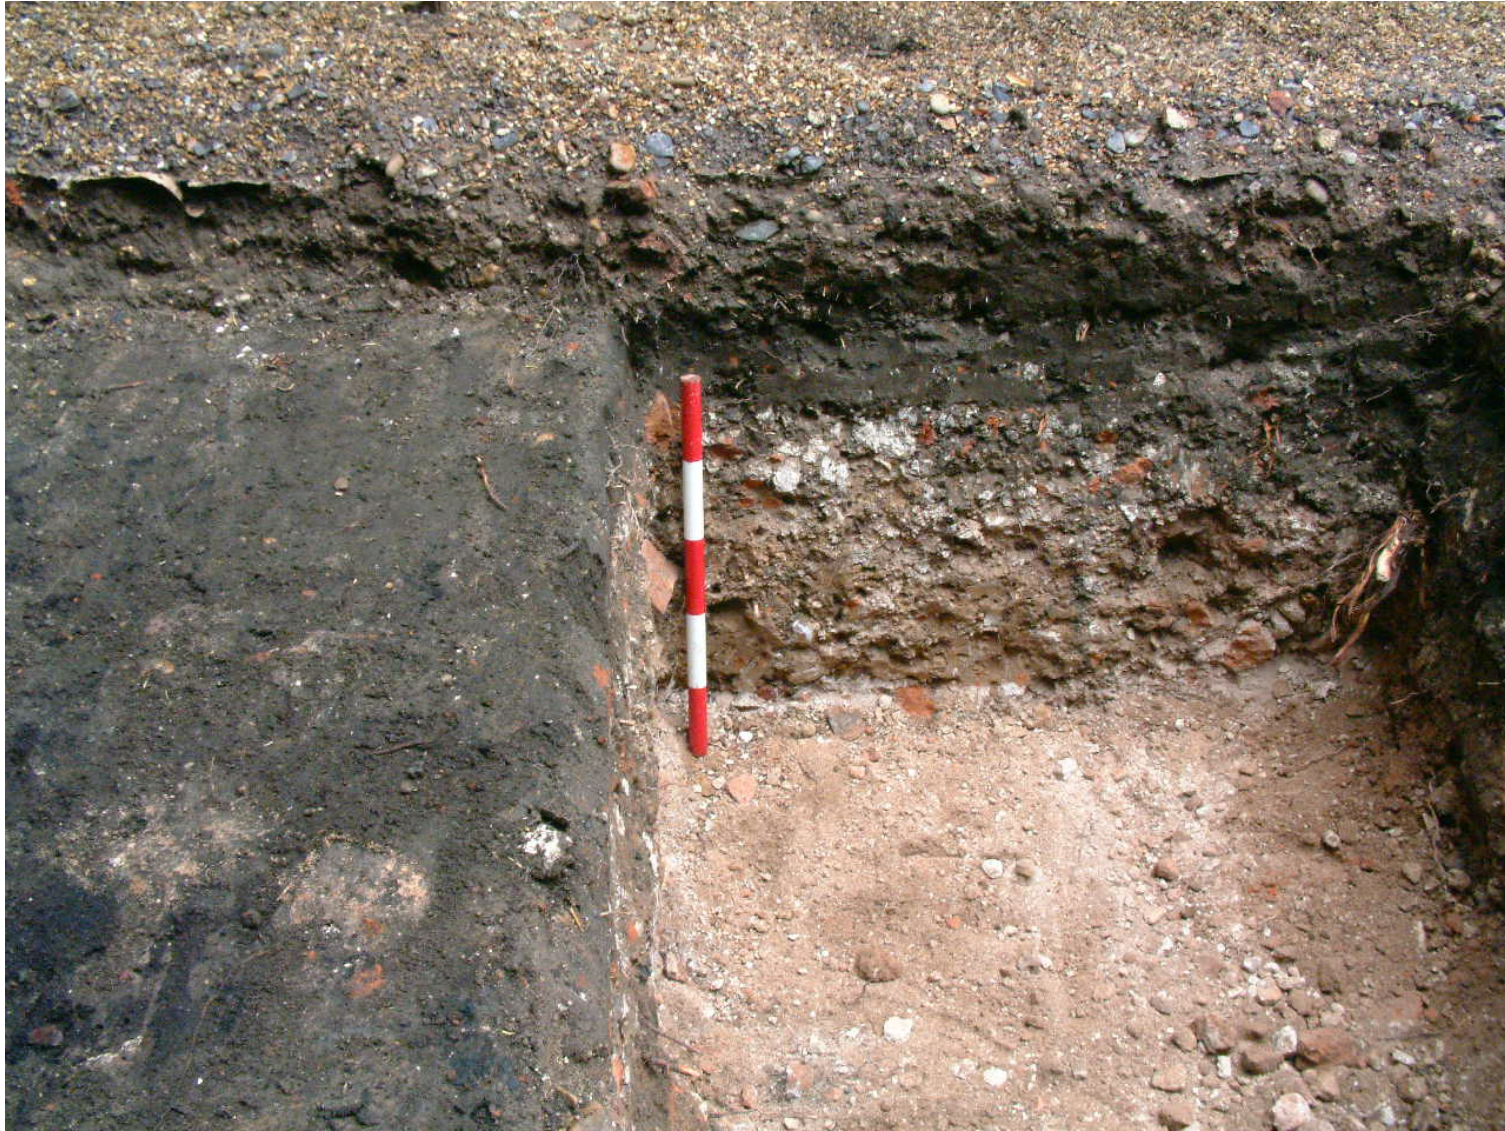
Plate 19 View of the mortar-rich demolition rubble in Trench 6, looking west (0.5m scale)

Trench 6 measured 2 x 1.9m and was located within the footprint of the Jacobean House. It was excavated to a depth of 0.8m (down to a level 6.10mAOD), and encountered a sequence of dump layers and demolition rubble deposits. The lowest of these that was excavated was a loose mortar layer (context 344) containing a high proportion of early brick fragments, and it is likely that this layer (at 6.15mAOD) is the demolition rubble that came from the Jacobean building when it was demolished in the late 18th century (**see Plate 19**). No internal walls or surfaces were seen during the excavation of this trench, although to assess whether the house had been cellared – one of the original research aims of the project – would have required a larger excavation and machine access, something that was not possible during the short time available for the evaluation.
