# Creeksea Place Ferry Road Burnham-on-Crouch Essex

Tree-ring Analysis of Oak and Elm Timbers from the  
North and North-West Ranges

Research Report Series no. 266-2020

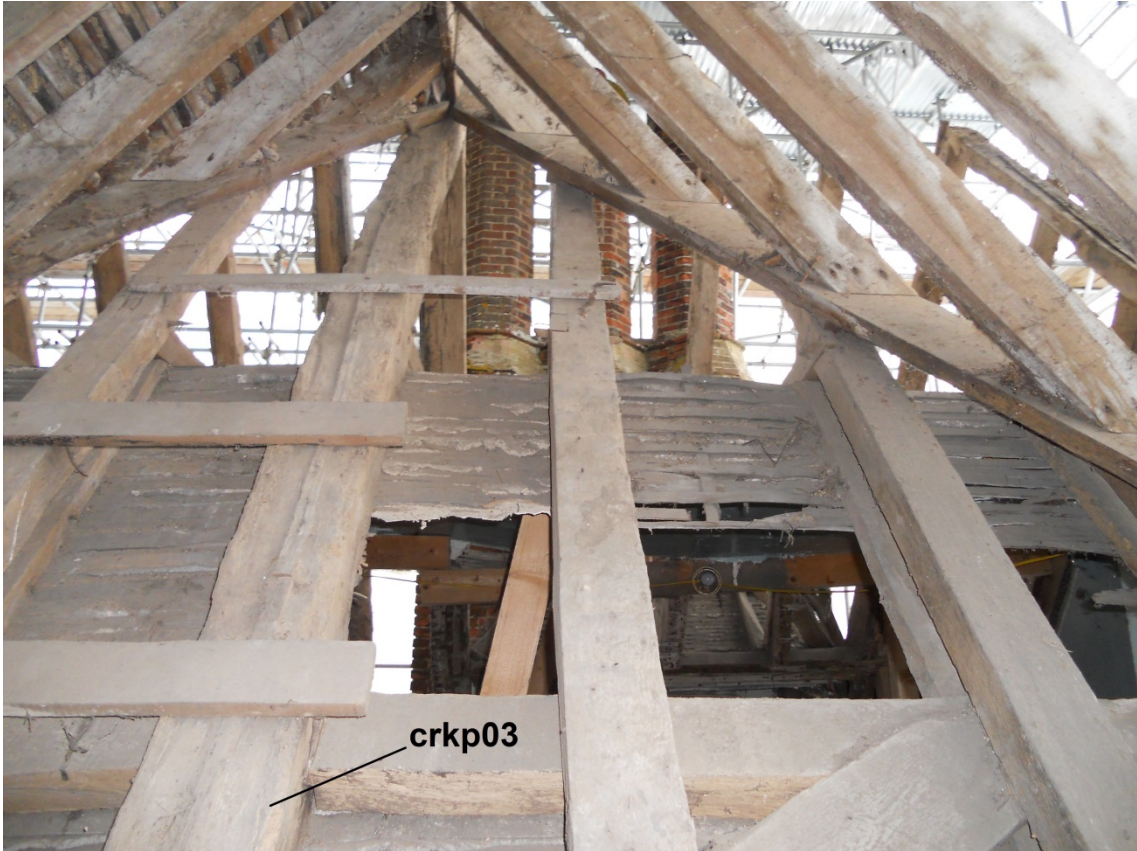
*Figure 5: View of the east end bay of the north range, looking north, showing the south principal rafter sampled for dendrochronology (photograph Martin Bridge)*

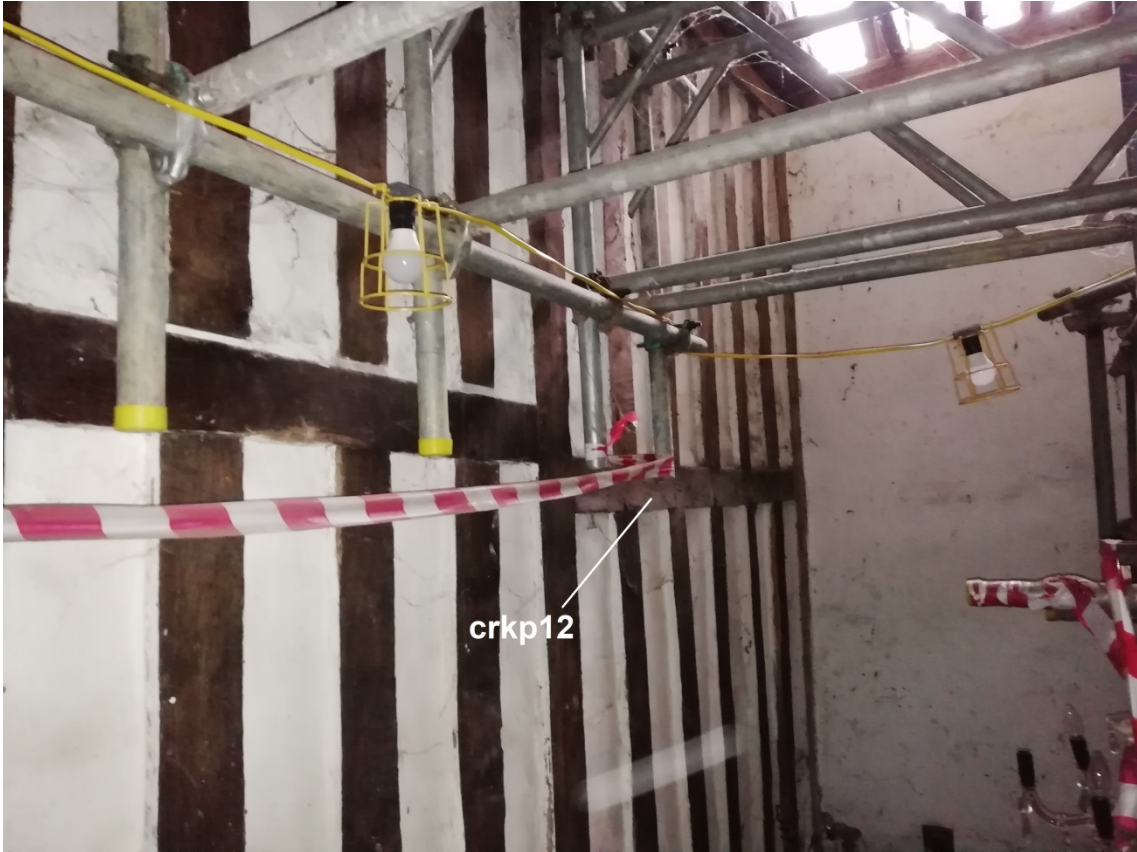
*Figure 7: View of the north-west corner of the first-floor east-most room of the north range, showing the mid-rail sampled for dendrochronology (photograph Martin Bridge)*

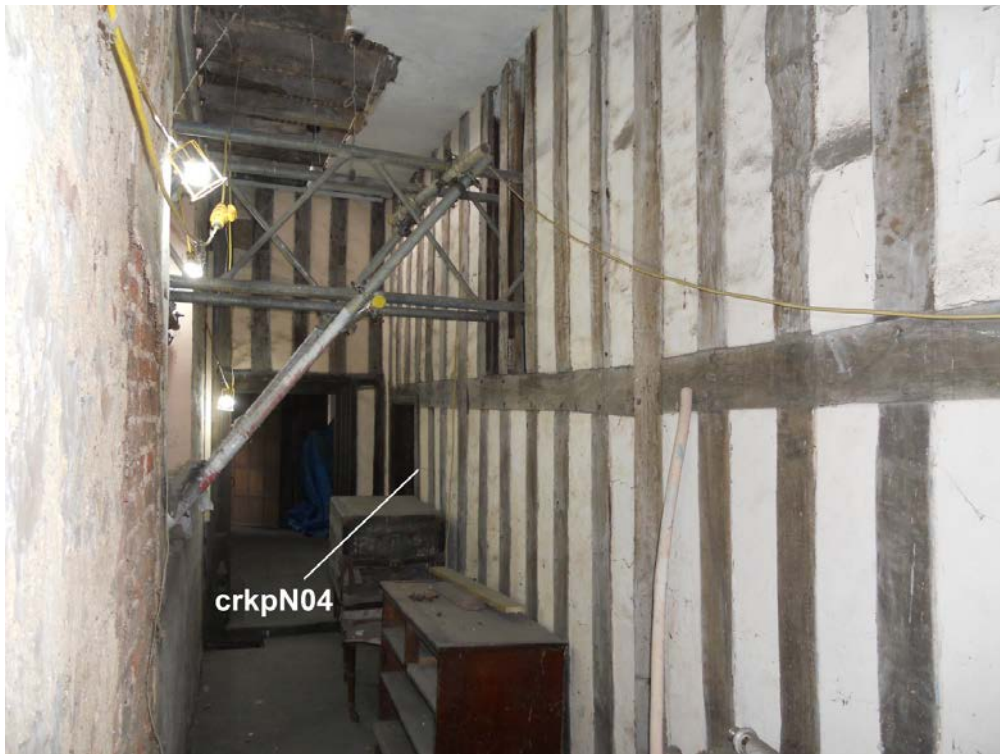
Figure 9: View looking west along the ground floor corridor to the north-west range, showing the position of the timber sampled as crkp04 (photograph Martin Bridge)

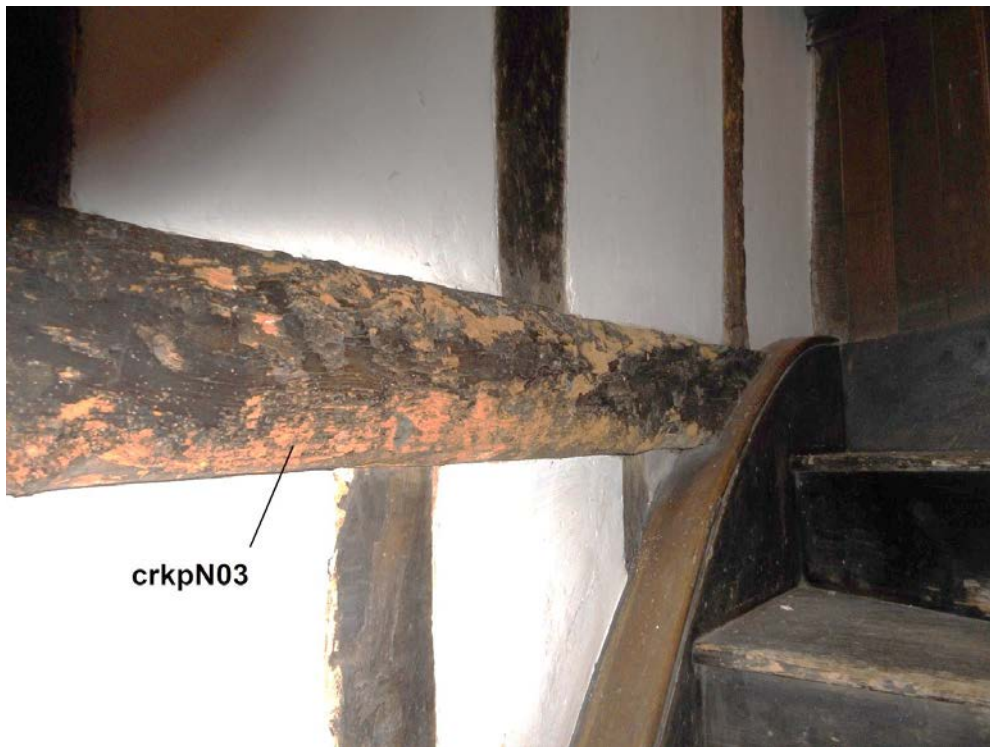
Figure 10: View of the elm mid-rail at the west end of the east section of the north-west range, sampled as crkpN03 (photograph Martin Bridge)
