Whitehouse Farm, Back Lane, Aston, Oxfordshire

Archaeological Desk-Based Assessment

September 2020

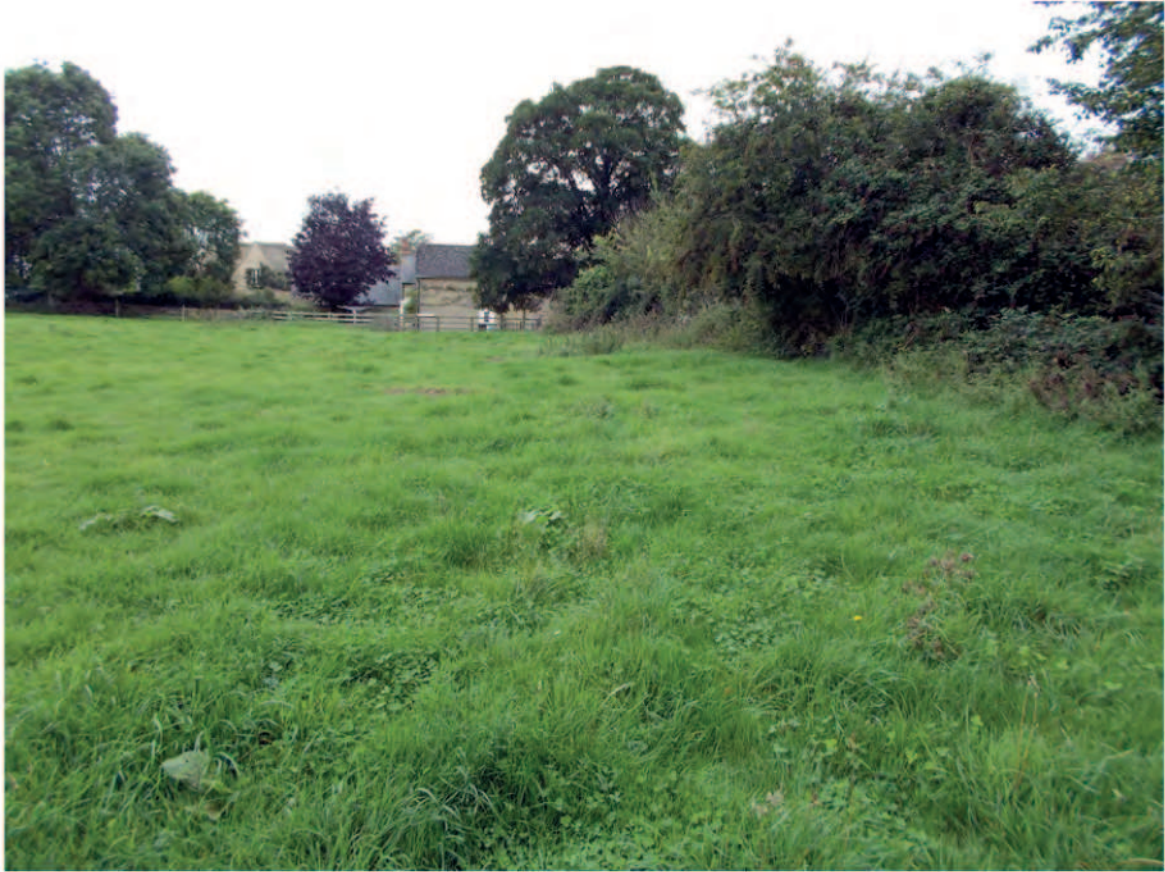
Plate 5: View of the possible eroded bank, facing south-west

- 6.1.5 The site is bounded by a line of trees and scrubs along the northern edge (Plates 5 and 6). A 1m height difference was observed between the northern edge of the site and the road to the north. The slope of a bank and a ditch covered in vegetation was also observed immediately north of the site. The top of this feature was aligned SW–NE (OA 36) and was observed within the northern part of the site (Plates 5 and 6). The bank was about 3m wide and 0.4m high and it extended parallel to Back Lane to the north. Several eroded patches were noted at the base of the bank, which may have been caused by livestock. The eroded patches contained areas of small yellow-white gravel in a matrix of light-brown soil overlain in several areas by grey-stone gravel chips within a darker grey soil. In one of the eroded patches, a sherd of pottery was observed on the surface (Plate 7). This has been tentatively dated to the later medieval period, c 1100–1500 (J Cotter pers. comm.). The sherd was left where it was found.

- 7.6.3 During the walkover, a 3m-wide earthwork (OA 36) was observed at the northern end of the site. This possible bank was aligned NE–SW, parallel and adjacent to Back Lane to the north. The earthwork was c 0.4m high, and eroded patches of earth and gravel were recorded towards the base of the feature. The bank sloped down towards Back Lane with a drop of 1m and a possible ditch was located at the base of the bank which was filled with vegetation. Another 1m-high bank and an associated ditch filled with vegetation were recorded during the walkover 100m south-west of the site on the eastern side of Back Lane. This is likely to be the same ditch recorded by the HER at this location (OA 19). LiDAR analysis shows that the bank may have originally continued north-eastwards from the site to join North Street, because a faint trace of it can be seen in the field to the north-east of the site where it is truncated by a series of ridge and furrow, which therefore clearly post-date the feature. A piece of later medieval pottery (c 1100–1500) was recorded as a surface find in an eroded patch of soil towards the base of the earthwork.

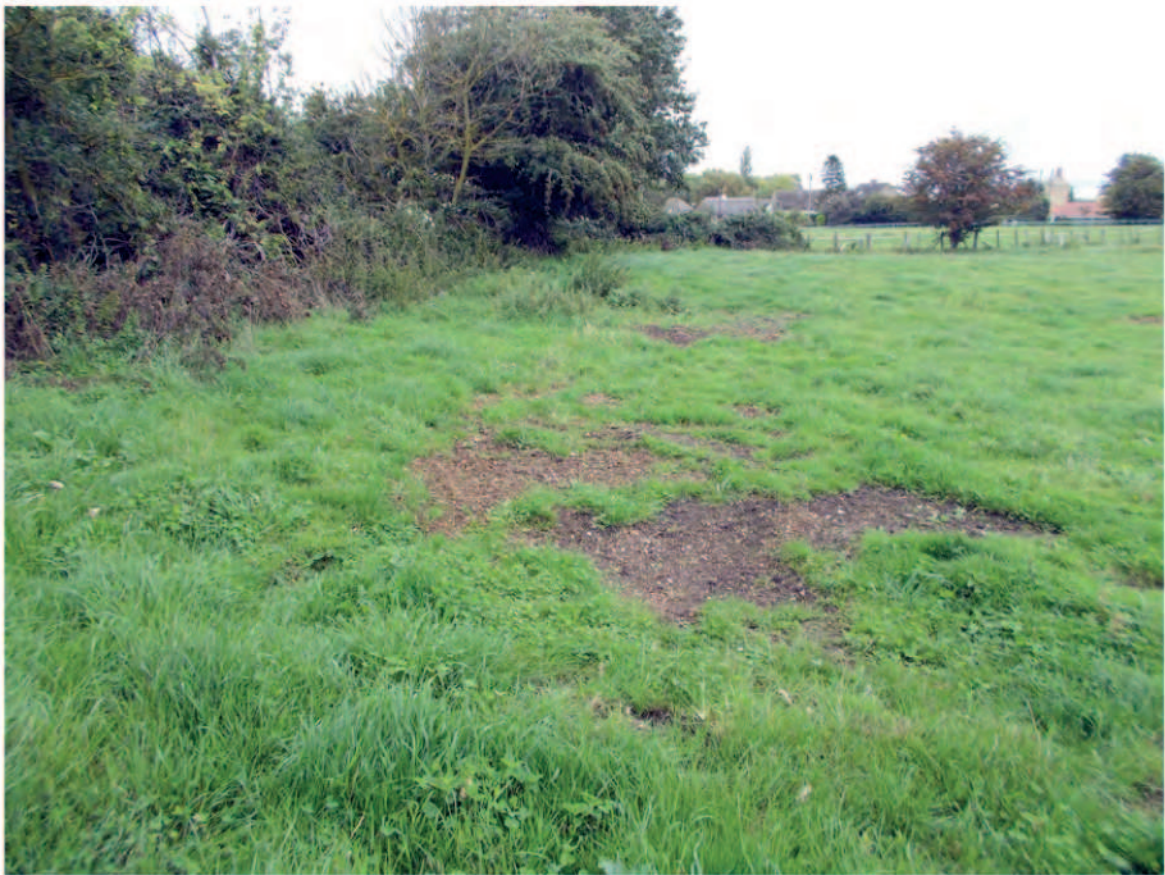
Plate 6: View of the possible bank, facing north-east

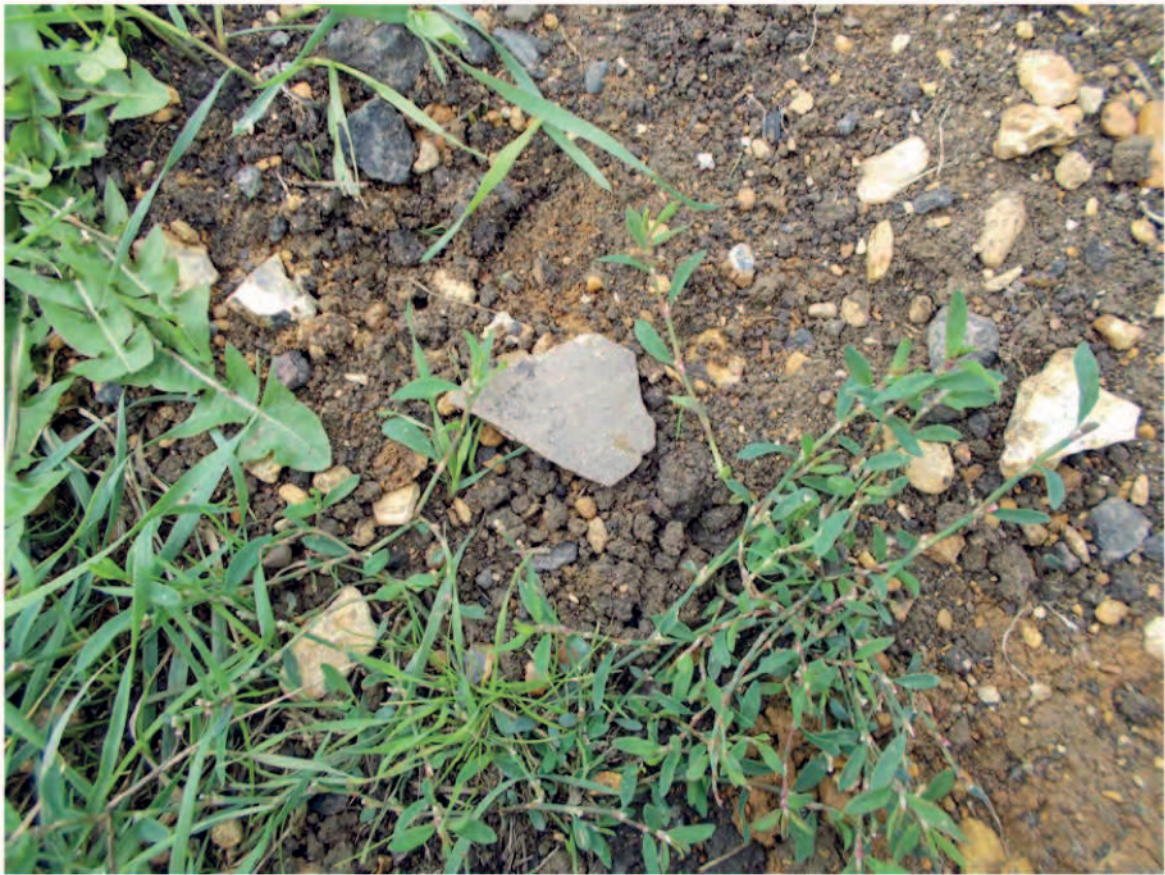
Plate 7: A pottery sherd located at the eroded base of the possible bank

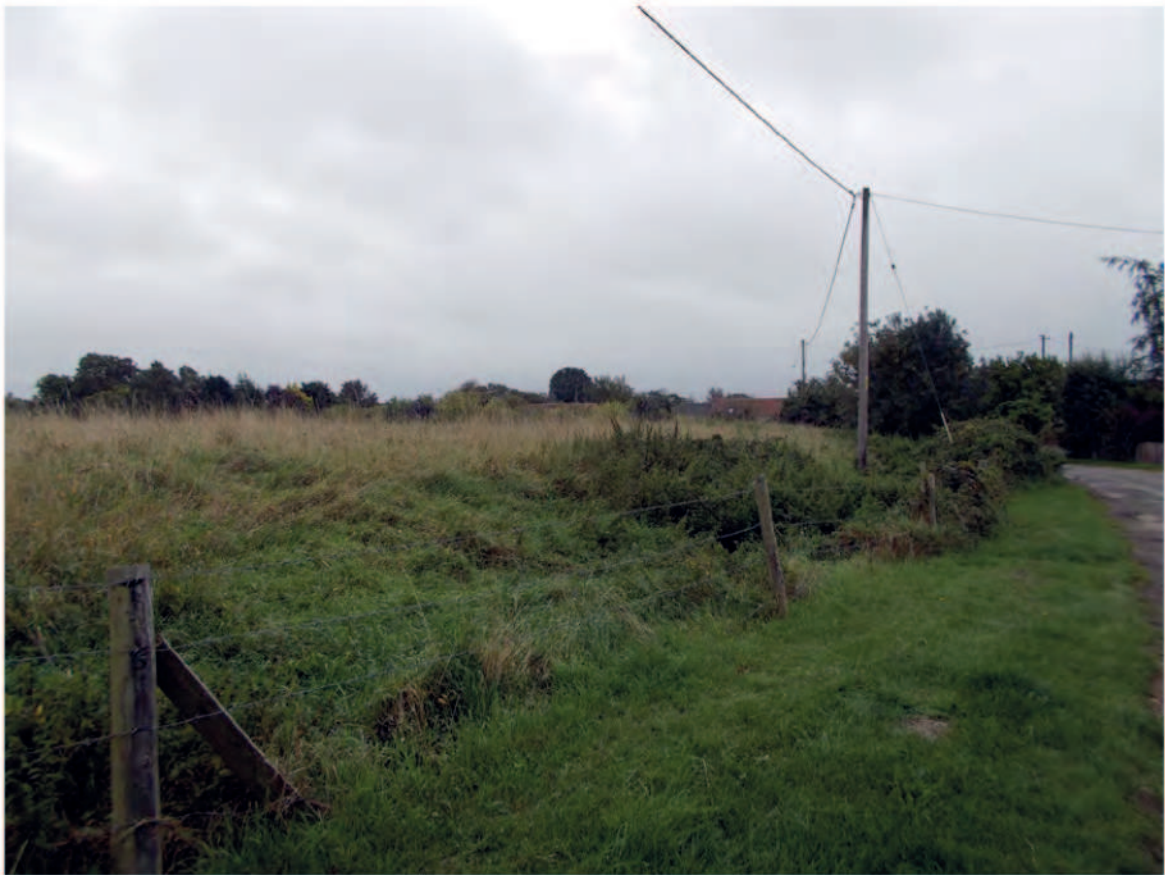
Plate 8: View of a bank earthwork, located 100m south-west of the site

- 6.1.6 A handful of concrete slabs measuring c 0.5m x 0.5m were recorded at the north-western edge of the site. These appeared to be modern in date.
- 6.1.7 Another bank and ditch was observed 100m south-west of the site and to the south of Back Lane (Plate 8). The bank was c 5m wide and 1m high and covered in vegetation. A possible ditch was observed to the west of the bank and next to the road, but this was infilled with vegetation. This suggests that there may have been an earthwork along the eastern side of Back Lane.
