## CONTEXT RECORD

| Project Code: | HS2C14 | Sub-division | 1020 / CTNAR | Context no: | 30001 |

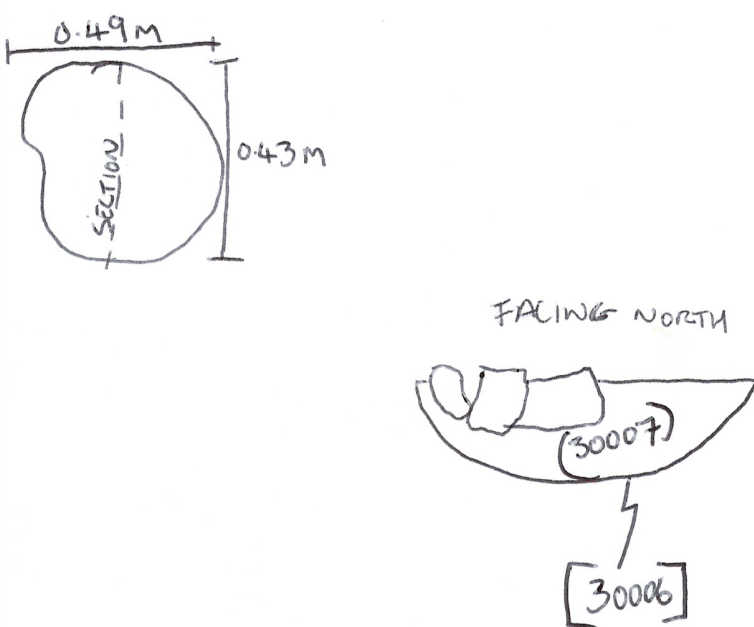
| <b>Description</b><br>① APPROX 8M FROM EAST EDGE, NEAR CENTRAL<br>② Irregular circle<br>③ —<br>④ Shallow U Shape POST HOLE<br>⑤ 0.49m x 0.43m x 0.10m<br>⑥ DIFFUSE / CLEAR<br>⑦ MOIST<br>⑧ —<br>⑨ — | | | | <b>Cut</b> <input checked="" type="radio"/><br>1. Location<br>2. Shape in plan<br>3. Orientation<br>4. Profile<br>5. Dimensions (m)<br>6. Clarity of edge<br>7. Weather and ground conditions<br>8. Other<br><b>Group</b> <input type="radio"/><br>1. Includes<br>2. Description | | | | | | | | | | | | | | |

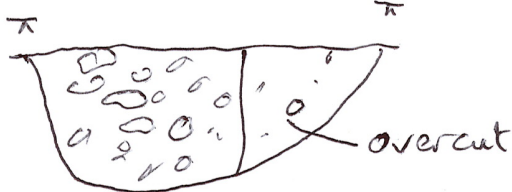
| <b>Description</b><br>1. Eastern bank area<br>2. circular<br>3. /<br>4. small post hole<br>5. length 0.26 width 0.25 depth 0.17<br>6. clear /<br>7. dry / very muddy / waterlogged | | <b>Accession no:</b><br><b>Cut</b> <input checked="" type="radio"/> <b>Fill</b> <input type="radio"/> <b>Layer</b> <input type="radio"/><br>1. Location<br>2. Shape in plan<br>3. Orientation<br>4. Profile<br>5. Dimensions (m)<br>6. Clarity of edge<br>7. Weather and ground conditions<br>8. Other<br><b>Group</b> <input type="radio"/><br>1. Includes<br>2. Description<br>1. Location<br>2. Soil matrix: colour texture, consistency<br>3. Inclusions<br>4. Clarity of horizon<br>5. Dimensions (m)<br>6. Method of excav.<br>7. Weather and ground conditions<br>8. Other<br><b>9. Finds</b><br>(nature/interpretation) |
| <b>Interpretation and discussion</b> — NOT A POSTHOLE — NATURAL VARIATION<br>Cut of post hole. One in a series of three the other two being [30008] [30010] which most probably form a rectangle / the fourth being under water. Most probably a granary / storage platform.<br>Sample taken at hill for analysis | | |

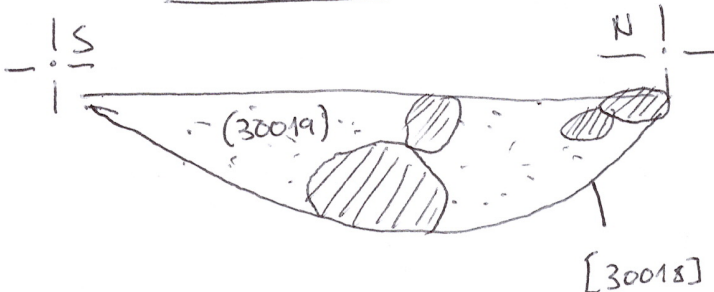
| | | | | | | | | | | | | | |
|---|---|---|---|---|--|---|--|--|---|--|--|--|--|
| <b>Project Code:</b> | <b>HS2C14</b> | <b>Sub-division</b> 1C20 / CTNAR | <b>Context no:</b> (30019) | | | | | | | | | | |
| <b>Same as</b> | <b>Fill of/<del>Filled</del> by (circle)</b><br>[30018] | <b>Group no.</b> | <b>Accession no:</b> | | | | | | | | | | |
| <b>Description</b><br>1. N OF THE SITE<br>2. MID BROWN / SILTY CLAY / LOOSE<br>3. FREQUENT BIG ANGULAR FLINT INCLUSIONS<br>4. CLEAR<br>5. <1m / 0.12 deep / 0.9m wide<br>6. BY HAND<br>7. WET AND WET | | | <b>Cut</b> <input type="radio"/> | <b>Fill</b> <input checked="" type="radio"/> <b>Layer</b> <input type="radio"/> | | | | | | | | | |
| | | | <b>Group</b> <input type="radio"/> | <b>9. Finds</b><br>(nature/interpretation) | | | | | | | | | |
| <b>Sketches</b><br>SHALLOW PIT<br>WEST FACING<br>

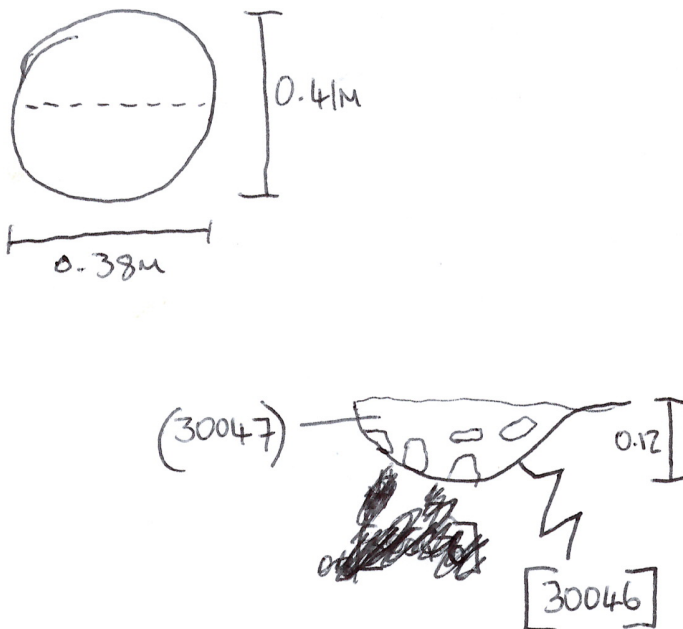
| <b>Description</b><br>① NORTHERN END OF STRIPPED AREA TOWARD NW CORNER<br>② CIRCULAR<br>③ -<br>④ U SHAPED<br>⑤ 0.41M X 0.38M X 0.12M DEEP<br>⑥ CLEAR<br>⑦ HEAVY SHOWERS, WATERLOGGED<br>⑧ - | | | <b>1. Location</b><br><b>2. Shape in plan</b><br><b>3. Orientation</b><br><b>4. Profile</b><br><b>5. Dimensions (m)</b><br><b>6. Clarity of edge</b><br><b>7. Weather and ground conditions</b><br><b>8. Other</b><br><b>Group</b> <input type="radio"/><br><b>1. Includes</b><br><b>2. Description</b> | | | | | | | | | | | | | | | | | | | | | | | | | | | | | |
| | | | <b>9. Notes on finds</b><br>SMALL FRAGMENT OF BLACK POT APROX 2cm X 1cm TRIANGULAR<br>NOT RECORDED AS SMALL FIND | | | | | | | | | | | | | | | | | | | | | | | | | | | | | |

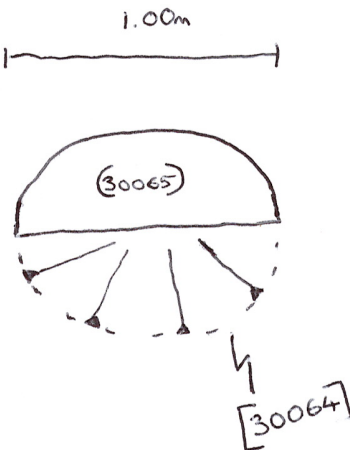
| Project Code: | HS2C14 | Sub- 1C20<br>division CTNAR | Context no: [30064] | | | | | | | | | | | | | | | | | | | | | | | | | | | | | | | | | | | | | |
|---|---|---|---|--|---|--|--|---|--|--|--|--|---|--|--|--|---|---|---|--|--|---|---|---|---|---|--|---|--|--|---|---|--|---|--|--|---|--|--|---|
| Description<br>1. GROUPING OF POST HOLES<br>2. CIRCULAR<br>3. N/A<br>4. GRADUAL SIDES<br>5. DIAMETER: 1m , DEPTH 0.25m<br>6. CLEAR IN PLAN<br>7. WET OVERCAST | | Cut <input checked="" type="checkbox"/><br>1. Location<br>2. Shape in plan<br>3. Orientation<br>4. Profile<br>5. Dimensions (m)<br>6. Clarity of edge<br>7. Weather and ground conditions<br>8. Other<br>Group <input type="checkbox"/><br>1. Includes<br>2. Description | Fill <input type="checkbox"/> Layer <input type="checkbox"/><br>1. Location<br>2. Soil matrix: colour texture, consistency<br>3. Inclusions<br>4. Clarity of horizon<br>5. Dimensions (m)<br>6. Method of excav.<br>7. Weather and ground conditions<br>8. Other<br>9. Finds<br>(nature/interpretation) | | | | | | | | | | | | | | | | | | | | | | | | | | | | | | | | | | | | | |
