**ARCHAEOLOGICAL RECORDING
AT EVANS WEIR, PARKWOOD ROAD,
TAVISTOCK, DEVON**

Prepared for the Environment Agency

Exeter Archaeology

Report No. 11.14

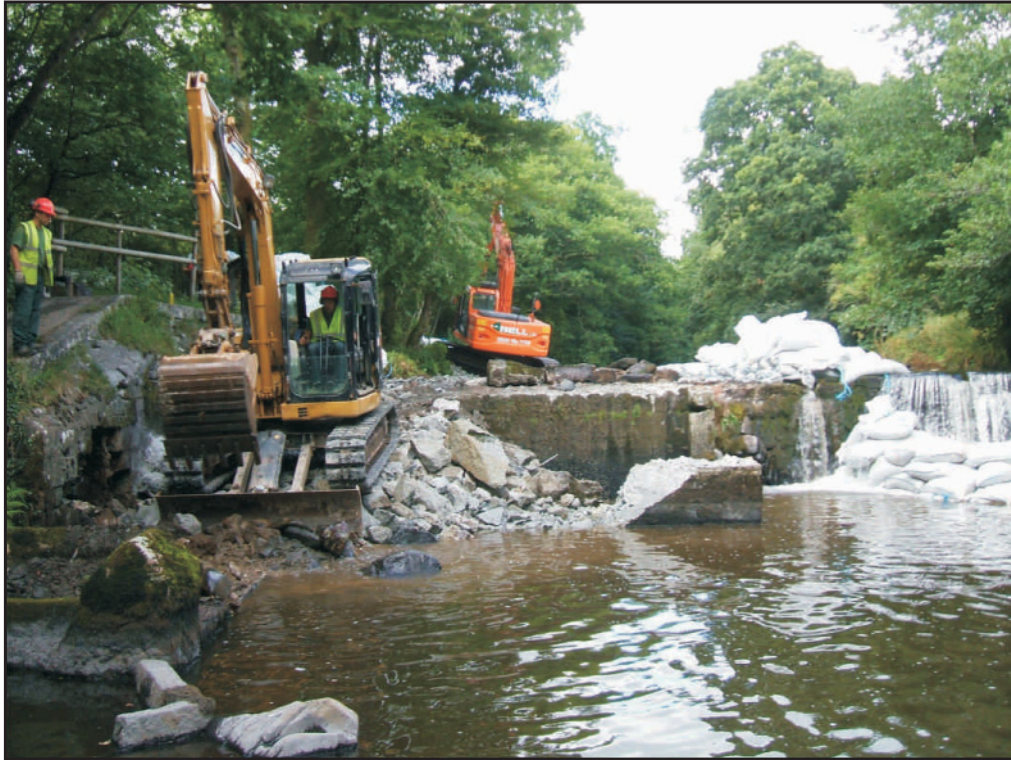
Photo. 1 View looking upstream (northwest) showing the weir (rear), partially-removed 1960s fish pass and part of the 19th-century fish pass (left).

This report presents the results of archaeological recording undertaken by Exeter Archaeology between August and October 2010 during the replacement of a fish pass (or Salmon Leap) at Evans Weir, River Tavy, Parkwood Road, Tavistock (SX 49284 75301; Fig. 1; Photo 1). The present fish pass dates to the 1960s, but the date of the surviving (earlier) weir structure is unknown. The weir is situated at the head of the leat that powered Mount Foundry, an early 19th-century former iron and brass foundry that is located within the heart of Tavistock, within the Cornwall and West Devon Mining Landscape World Heritage Site. The archaeological recording was commissioned by the Environment Agency and was required as a condition of the grant of planning consent (WDBC 00471/2010) for the replacement of the existing fish pass. Advice on the archaeological recording was provided by the Devon County Council Historic Environment Service (HES).

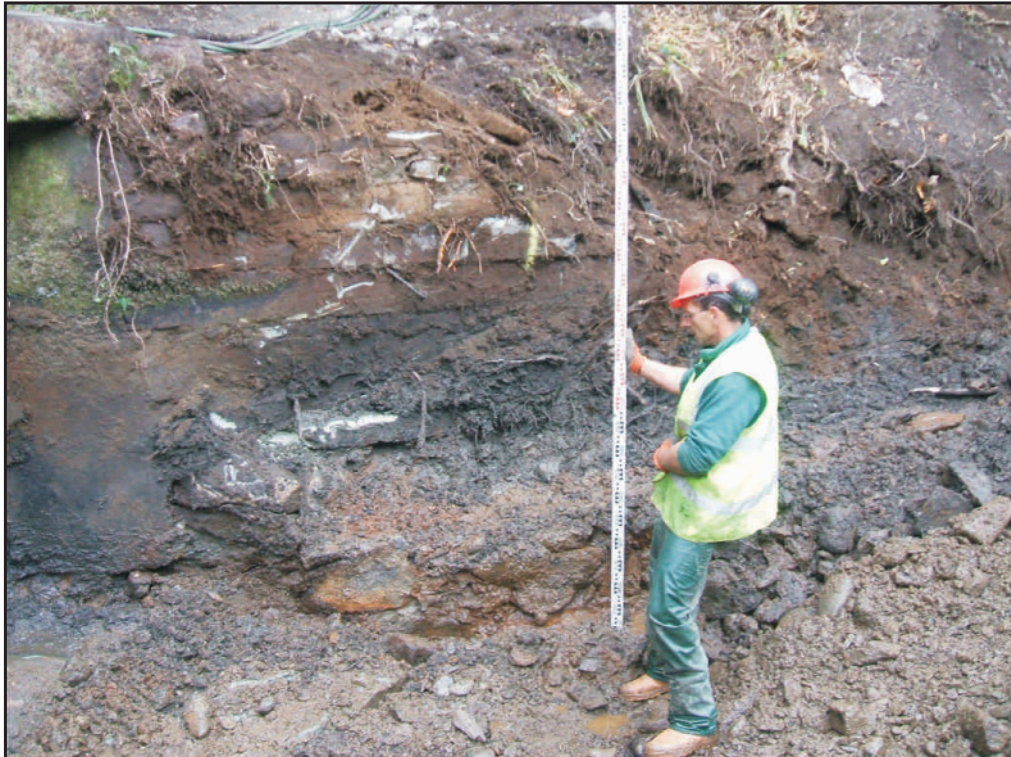
The remains of the lower courses of an early river bank revetment wall were exposed underneath river gravels within the river bed. The wall was located immediately above the sluice gate at the entrance of the leat and was constructed of roughly coursed slate boulders, which at the western end were overlaid by the masonry of the current river revetment wall. The wall was aligned northeast to southwest, and its position indicates the river at this point was subsequently widened.

Photo. 2 The early river bank revetment wall (behind bottom of staff), showing later wall above, looking north.

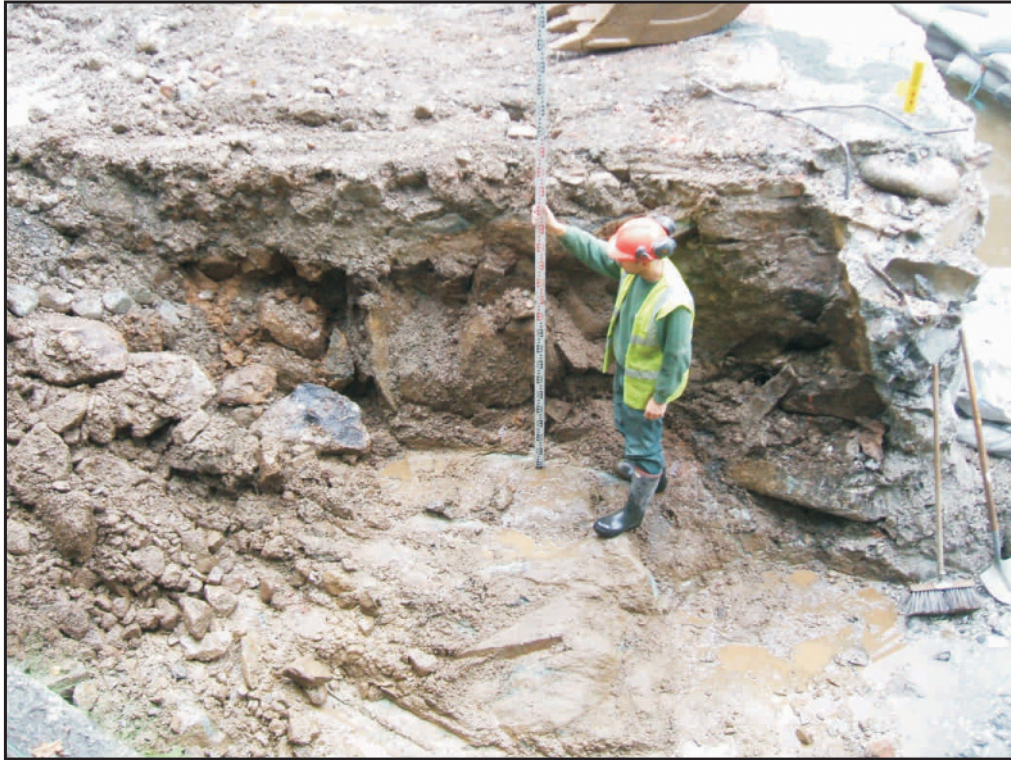
The original weir was constructed with a base layer of slates, of varying shapes and sizes, and clay laid onto bedrock that had been chopped away to form a series of terraces. (The bedrock can be seen at a higher level projecting out from the west bank wall.) At the front of the weir a series of large vertical slates, laid on edge, had been set into the clay. In places at the front of the weir these slates were supported on smaller squared blocks of slate. Above and behind the slates were further rows of smaller slates, again laid on edge.

Photo. 3 The weir showing stone and clay infill and terraced cuts into bedrock, looking east.

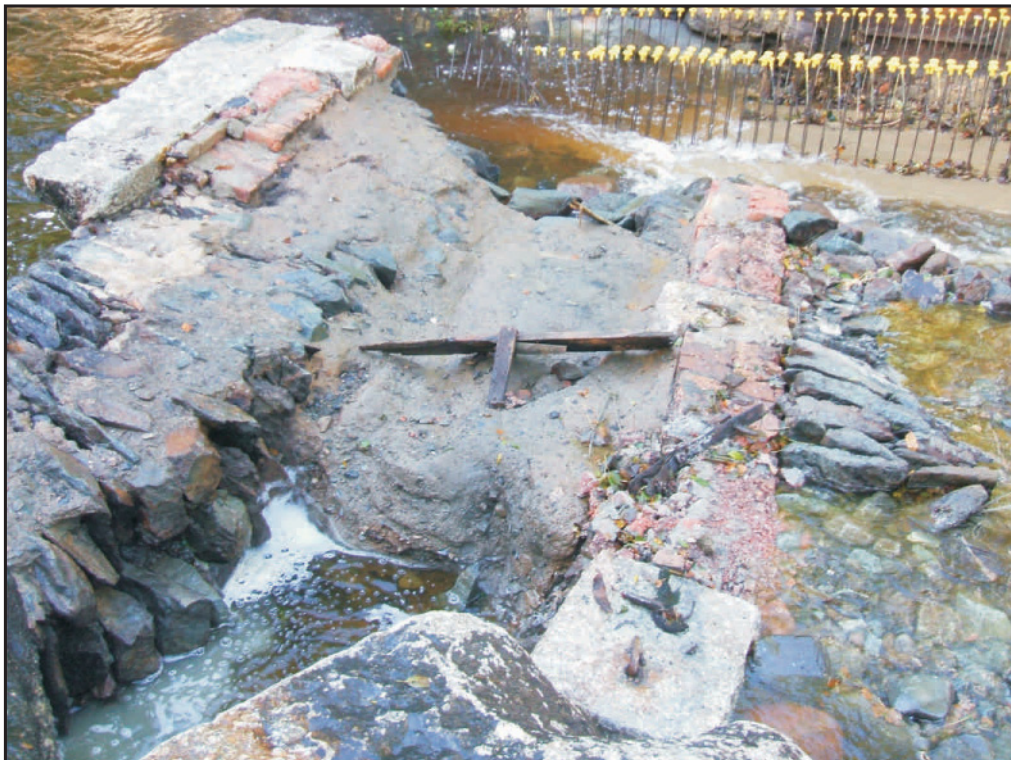
Fabric associated with the rear of the weir was partially exposed. Adjacent to the 19th-century fish pass a single course of stones was found laid onto the lower stone and clay deposit. In the centre of the weir at least three courses of stones were present, and these may represent the infilling of a deliberately-left void in the rear masonry (see below). The stones supported granite 'sleepers', between which were courses of orange red brick. Attached to the sleepers using iron bolts and L-shaped brackets were wooden beams. Granite sleepers were also present at the front of the weir, although any timbers had been removed.

The gap between the masonry forming the front and back of the wear had been infilled using a layer of sterile clay. During a flash flood part of this clay was washed away from the centre of the weir exposing the remains of a wooden culvert structure aligned north-south through the weir. Neither end of this culvert was visible, although the three courses of masonry at the rear of the weir described above were present over the top of the culvert indicating that it had been constructed late in the building sequence.

The top of the weir was formed from orange bricks with a coarse sandy gravel fabric course laid on end. At the front of the weir, and to a certain extent at the rear of the weir, the bricks between the granite sleepers had been replaced with bricks set into concrete. The top of the weir had been covered in concrete but part of this surface had been removed.

Photo. 4 The weir following the washout showing the masonry at the front and rear, as well as part of the removed culvert, looking northwest.

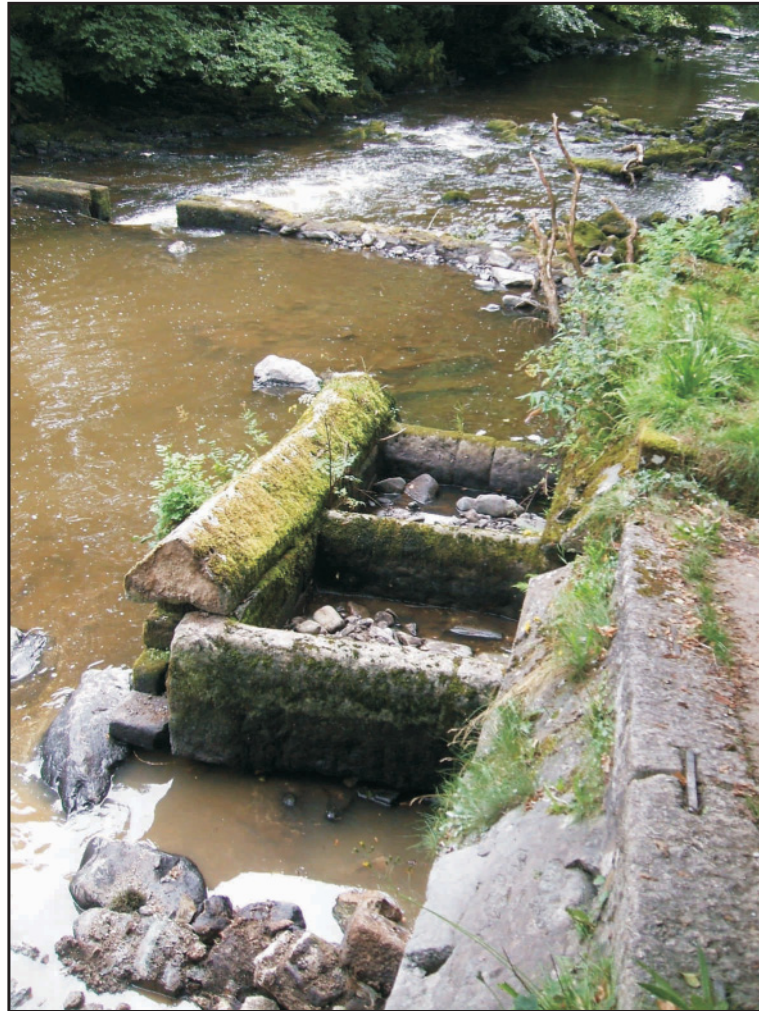
During the middle of the 19th century a fish pass was added to the west side of the weir; it is first depicted on the OS 1:2500 map surveyed in 1883. At the same time the adjacent river bank wall was realigned and moved to the west, with the upper section of the existing wall rebuilt on its original alignment. The wall is constructed of large blocks of granite, coursed, with sloping upper courses of local slate stone. These are capped with granite blocks held together with iron ties. The fish pass was partially replaced in the 1960s, but its structure partly survives, mostly down stream of the weir, and its original 'ladder' shape could be discerned.

Within the weir, the top of the pass was formed by three large granite blocks with flat tops and rear faces and a tapering front face. Below the weir, the pass would have comprised a series of ponds formed by a river bank wall, a parallel wall in the river and rows of dividing walls (of which three survived intact), decreasing in height away from the weir.

The masonry of the pass is constructed using rows of granite blocks, which display feather and tare drill holes (indicating a nineteenth-century date), with the upper course of the side wall tapered to counteract the drop in the height of the pass. The capstones were chamfered, and those on the side wall incorporated hipped ends. The

base was mostly covered by river gravels but some larger cobbles were visible within the upper surviving pond.

Photo. 5 The remains of the 19th century fish pass, looking southwest

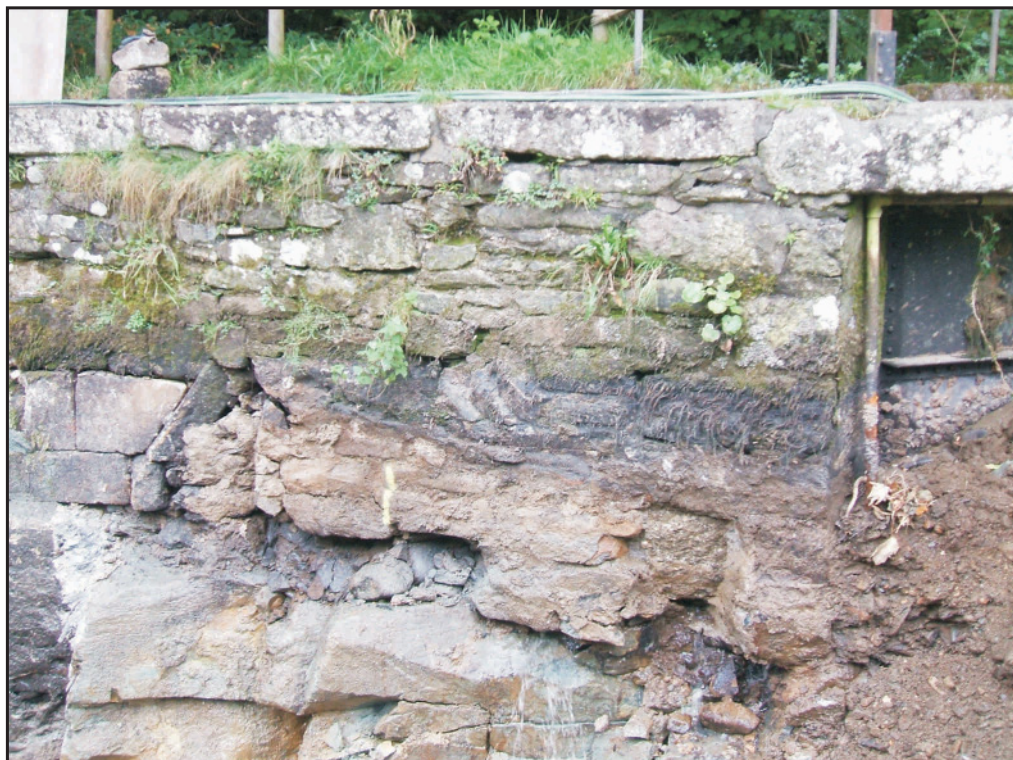
Photo. 6 The weir bank revetment wall showing (from bottom to top) bedrock, early revetment wall and the 19th century rebuild, looking northwest.
