**BISHOP BLACKALL SCHOOL,
PENNSYLVANIA ROAD, EXETER
AN ARCHAEOLOGICAL SURVEY**

**Prepared for
Morgan Sindall (Construction) Ltd**

Exeter Archaeology

Report No. 11.53

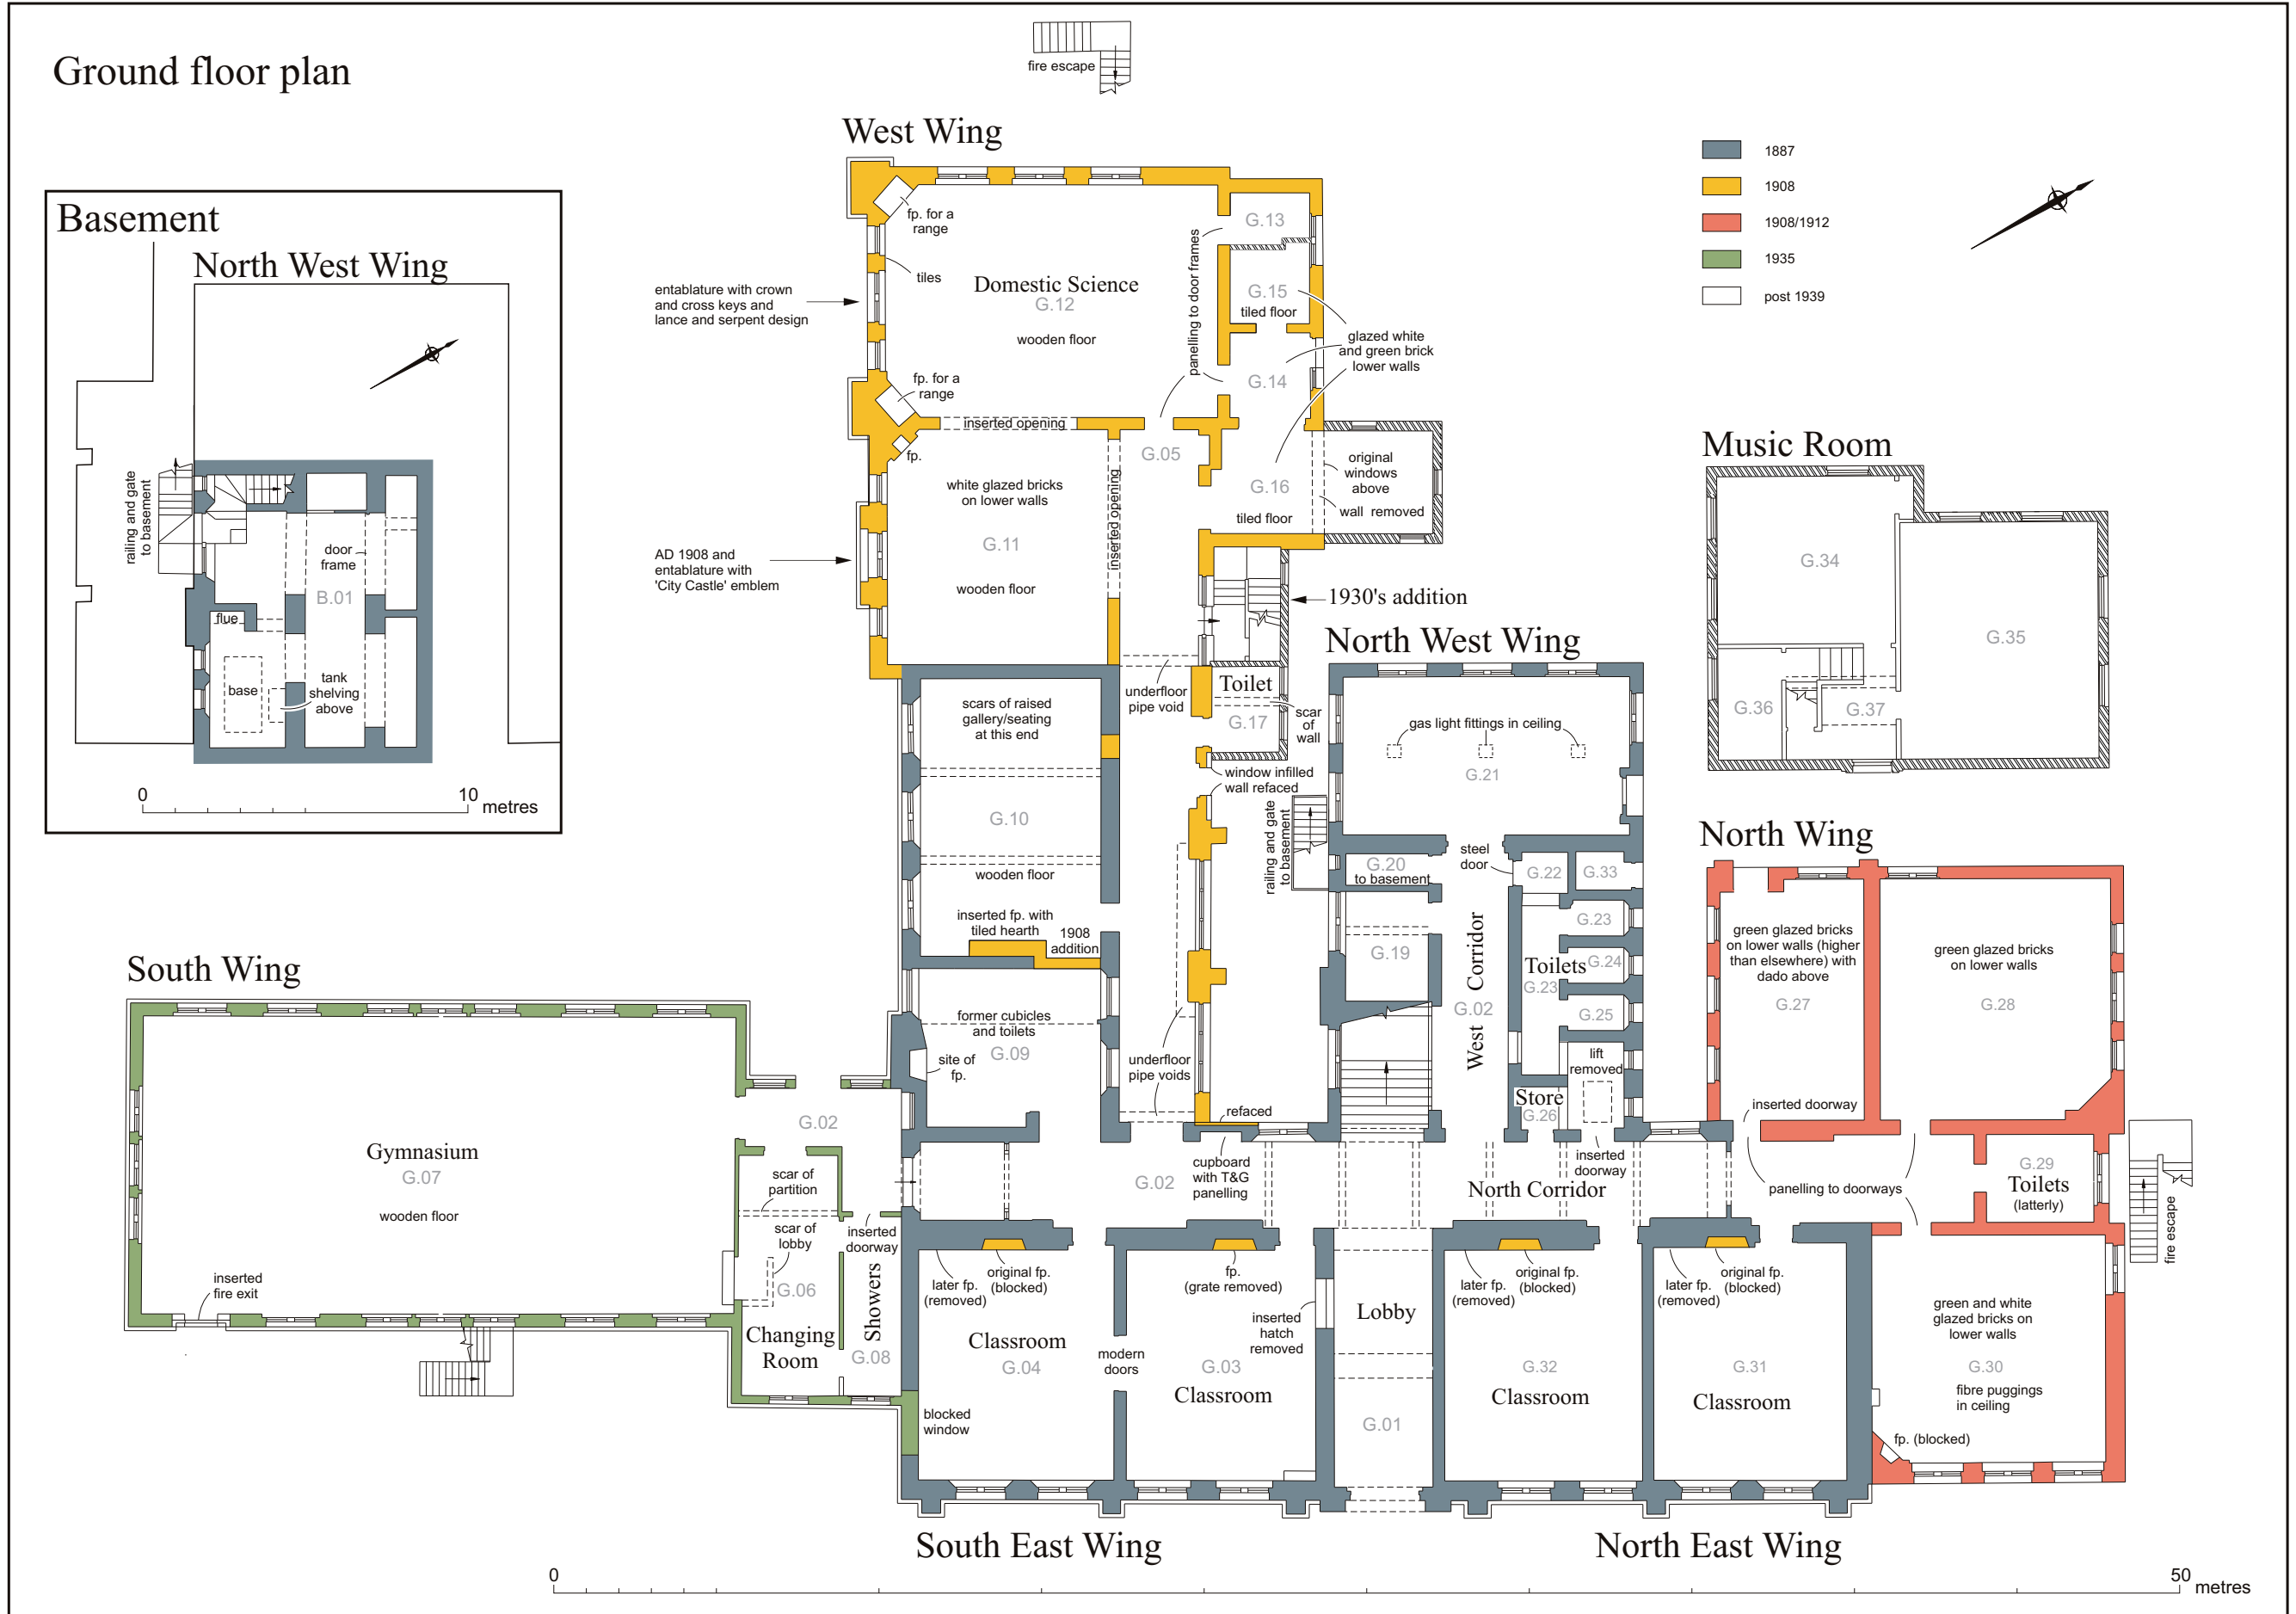
Fig. 11 Phased plan of the school.

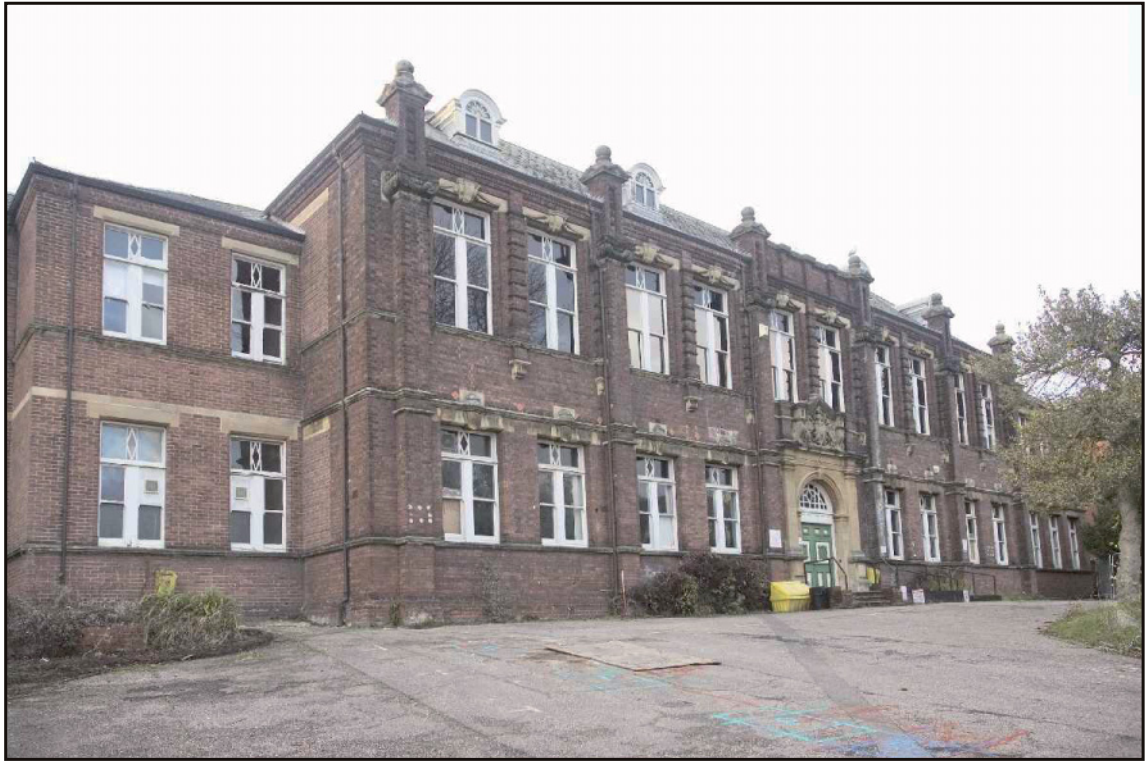
Photo. 1 The north east and south east wings, fronting Pennsylvania Road, looking north west. 1m scale.

The building was designed by James Jerman in a Flemish renaissance style with a front elevation articulated by brick pilasters with swagged Ionic capitals framing pairs of tall windows. The main doorway has a freestone surround surmounted by a cartouche and, prior to a fire in 1979 the front was surmounted by an ornate gable containing a coat of arms under an open pediment. The building was constructed using orange-red brick with Portland stone dressings, using a cavity wall technique with two skins of brick. The site slopes down to the south and the wooden floors are suspended on brick sleeper walls. The first floor of the north east and south east wings is also lit by arched dormers and was, until the 1979 fire, ventilated by a spiky cupola (*ibid.*, 35).

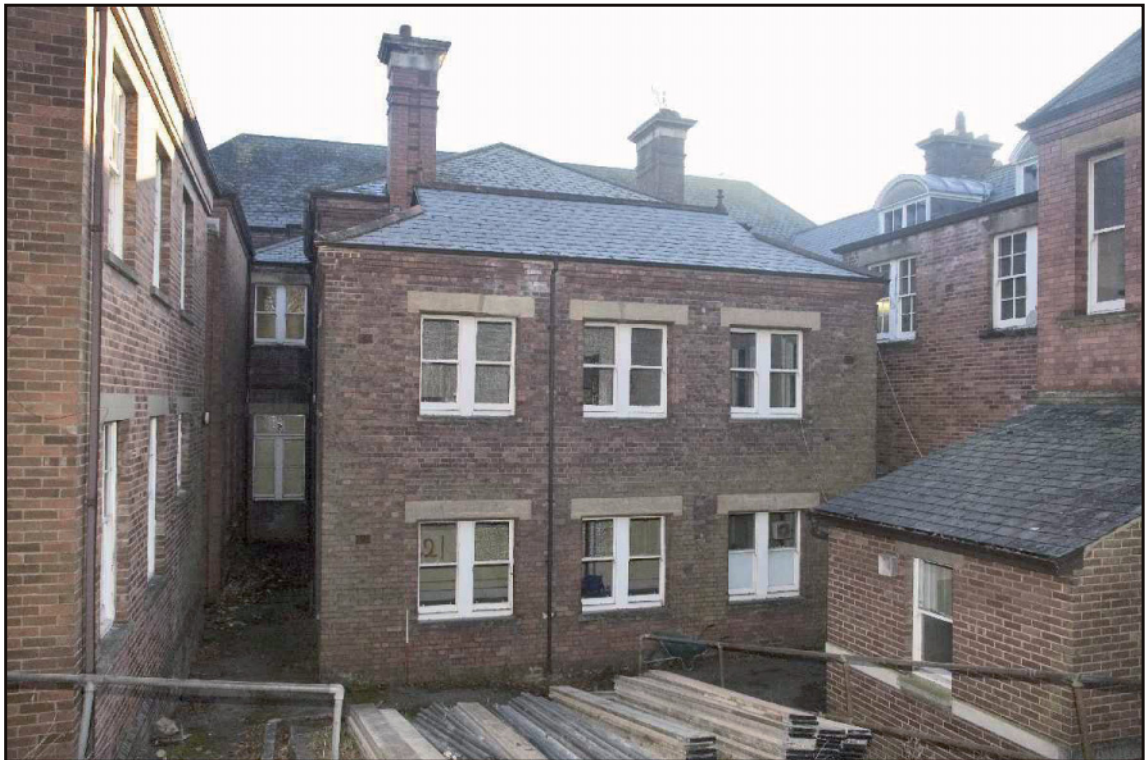
Photo. 2 The north west wing, showing the west elevation, looking east. 1m scale.

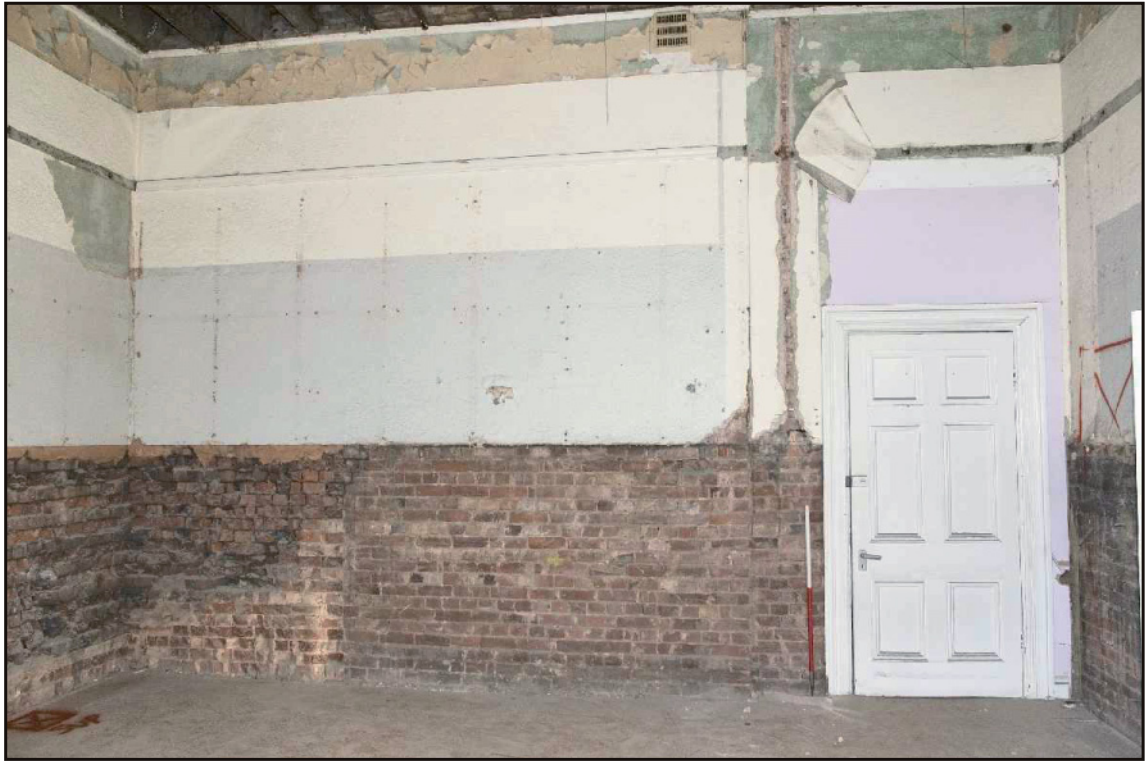
Photo. 3 A ground floor classroom, showing altered fireplaces, looking west. 1m scale.

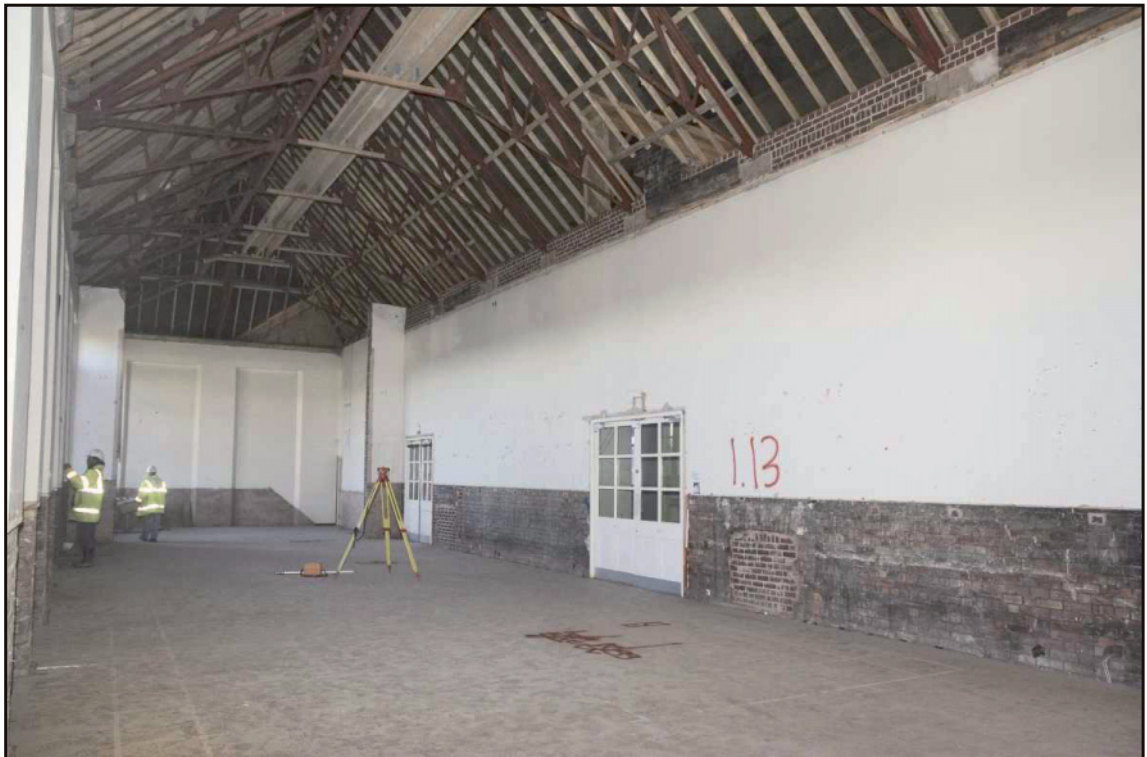
Photo. 4 The first floor hall, looking southwest. 1m scale.

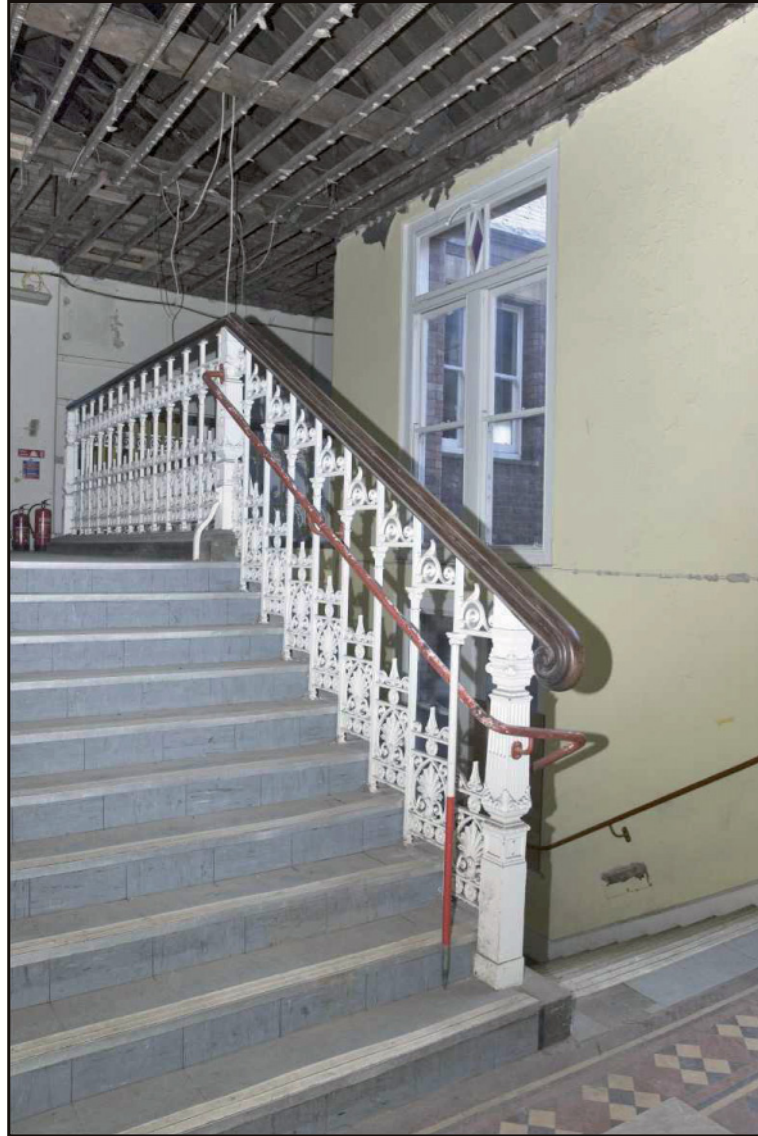
Photo. 5 The main staircase, looking south east. 1m scale.

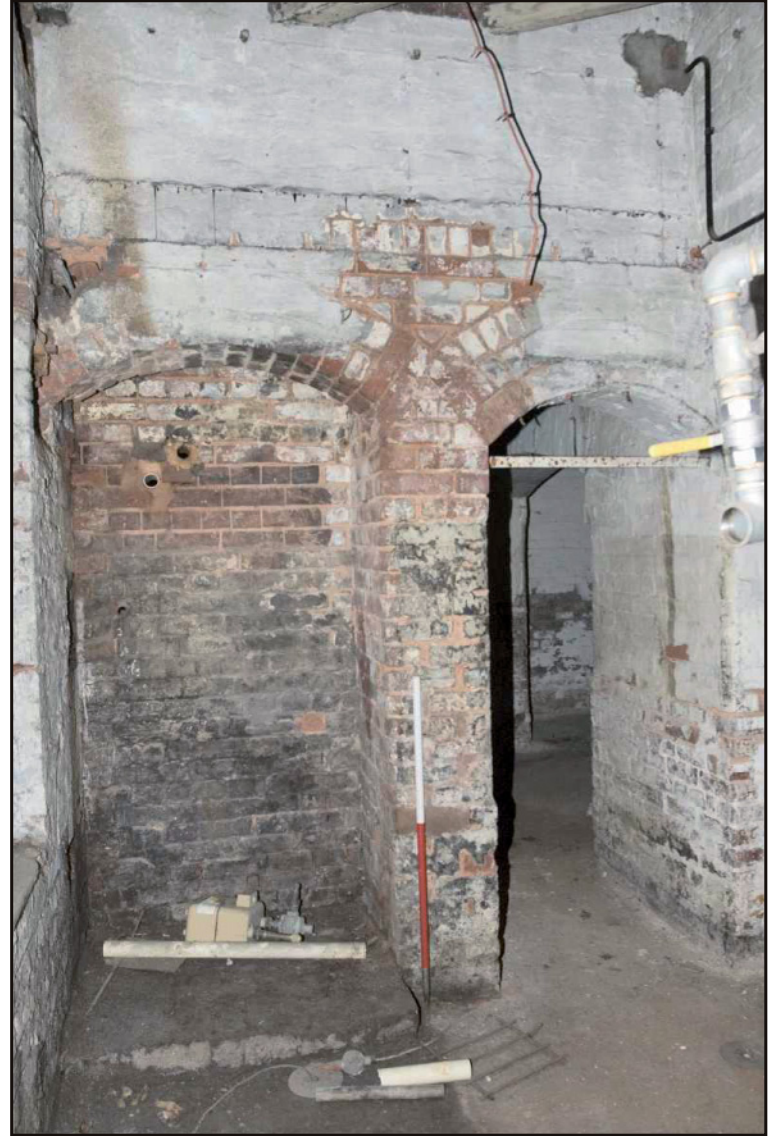
Photo. 6 The basement, showing coal cellar, looking south east. 1m scale.

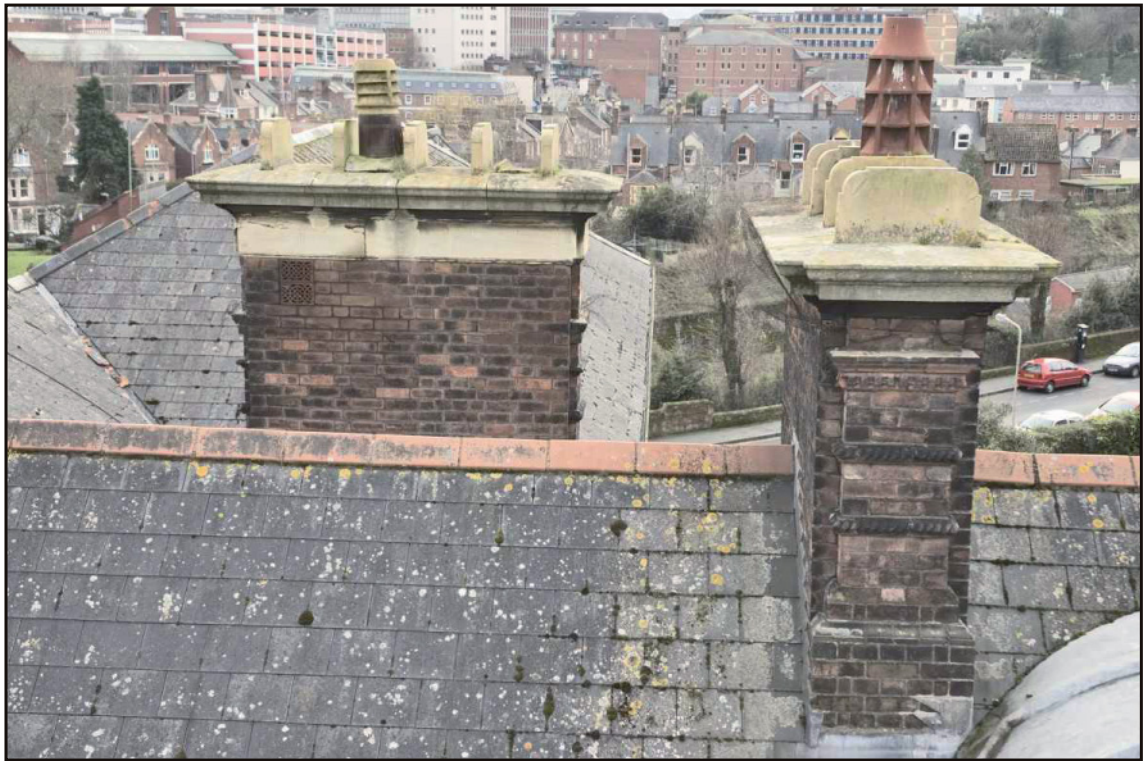
reduced in height owing to cracks that had developed in the stone capping. This was recorded prior to removal and its description (below) is typical of the 1880 chimneys.

The substantial brick structure had two open flues with a possible blocked, third flue in the centre. The chimney brickwork was constructed using English bond with two decorative moulded string courses also in brick. Additional embellishment adorned the elevation in the form of twisted rope-style string courses set within a slightly recessed panel. On the contemporaneous west wing much of the decorative work was placed on the more visible south-western elevations. The moulded Portland stone capping was topped with upstanding vertical plates that separated each flue. These rectangular plates had mouldings on the upper corners and were apparently made from a cast imitation stone that matched the buff-coloured capping.

Photo. 7 Original chimney stacks, looking south.

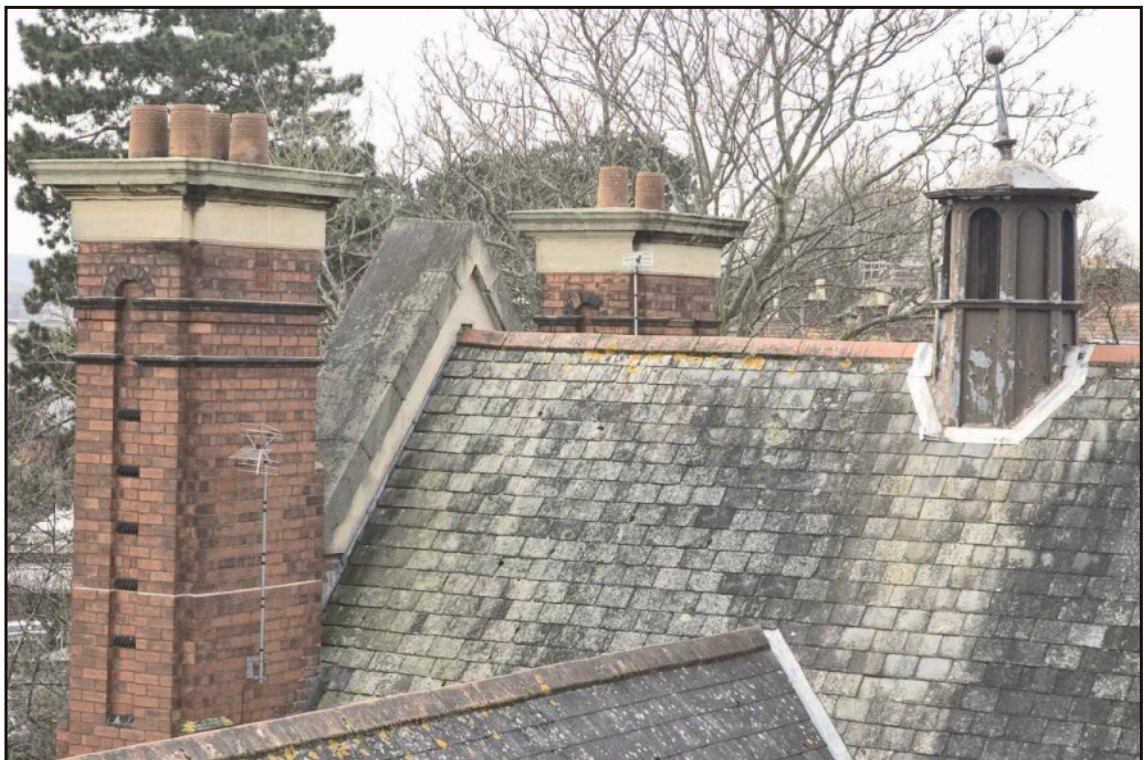
Later chimney stacks were also constructed of brick but were less ornate with fewer twisted rope-style string courses and without the vertical plates above the capping. Ceramic chimney pots adorn the capping.

Photo. 8 Chimney stacks of 1908 and vent above science rooms.

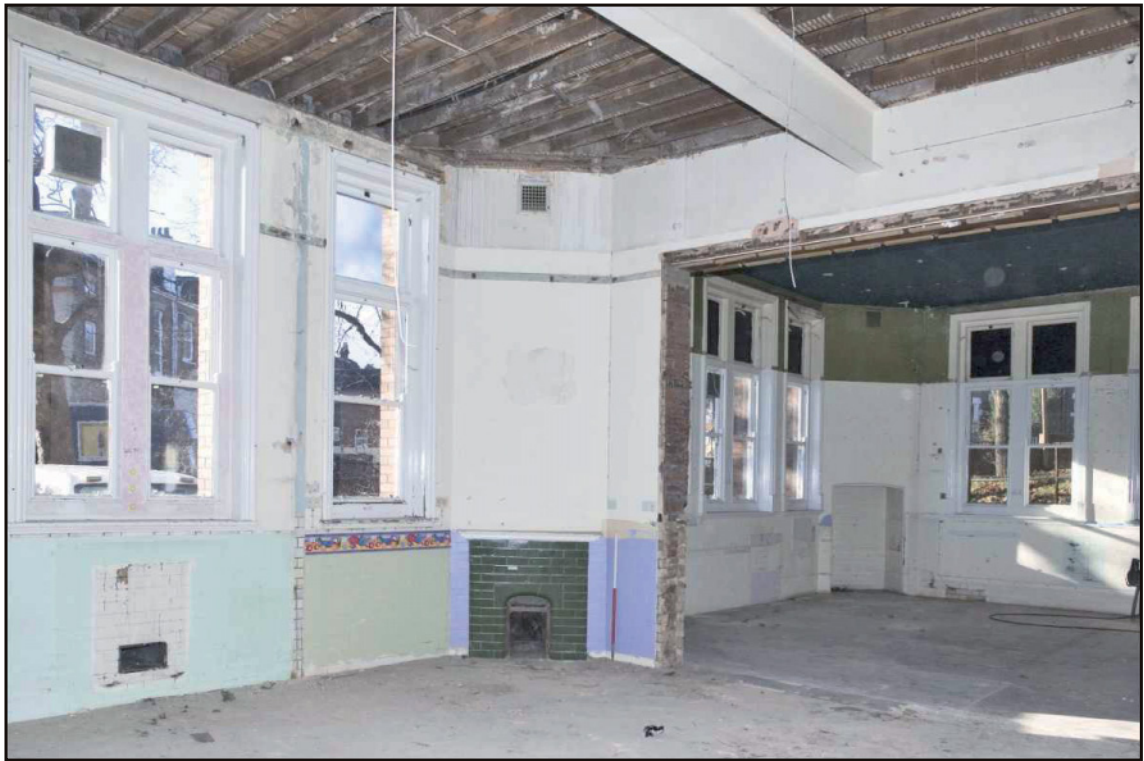
Photo. 9 The 1908 ground floor science rooms, showing fireplaces and tiled walls, looking west. 1m scale.

The proposals were for a 'new laboratory, kitchen, class and other rooms'. The first floor plan (Fig. 6) depicts a laboratory, classroom, balance room, store and toilets. The ground floor plan does not exist, and this area has been substantially altered. However, from the surviving fittings, its plan would have been identical to the first floor. The teaching rooms would have comprised a kitchen, characterised by large fireplaces probably for housing cast-iron ranges, and a smaller classroom, possibly also a kitchen since this also had a wooden floor (although this may actually be an architectural feature of this extension rather than a reflection on the room's function).

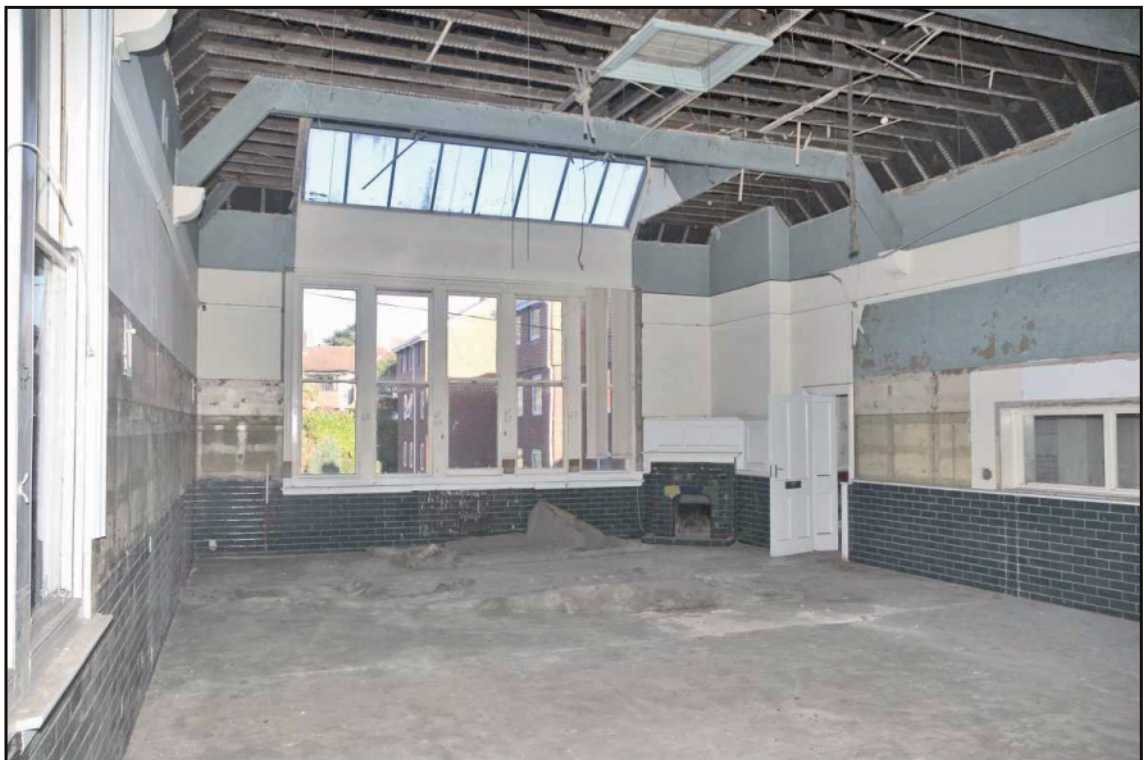
Photo. 10 The art room of 1908/1912, looking north. 1m scale.

On the ground floor three classrooms were provided, whilst on the first floor a new classroom and an art room were created. The latter is characterised by tall windows with dormer windows above, along with internal windows into the adjacent corridor. All rooms were heated by fireplaces, either flush with the walls or angled into the corners of rooms. Further small rooms were created at the north-east end of the corridors, but their original functions are unknown.

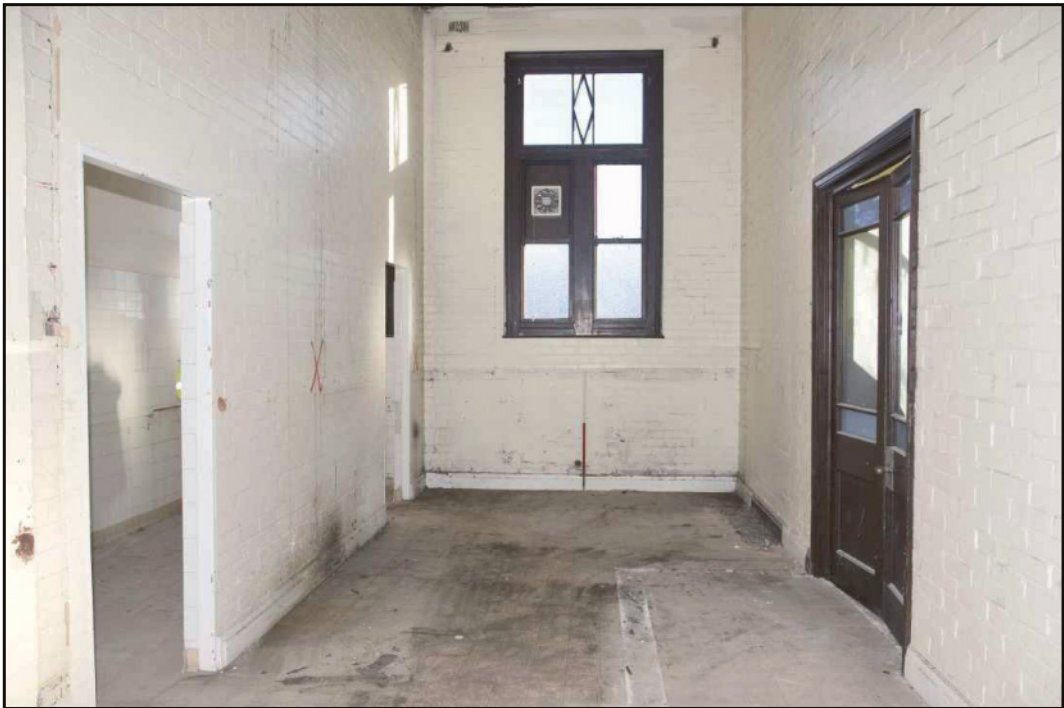
Photo. 11 The changing room and showers in the 1935 extension, looking east. 1m scale.

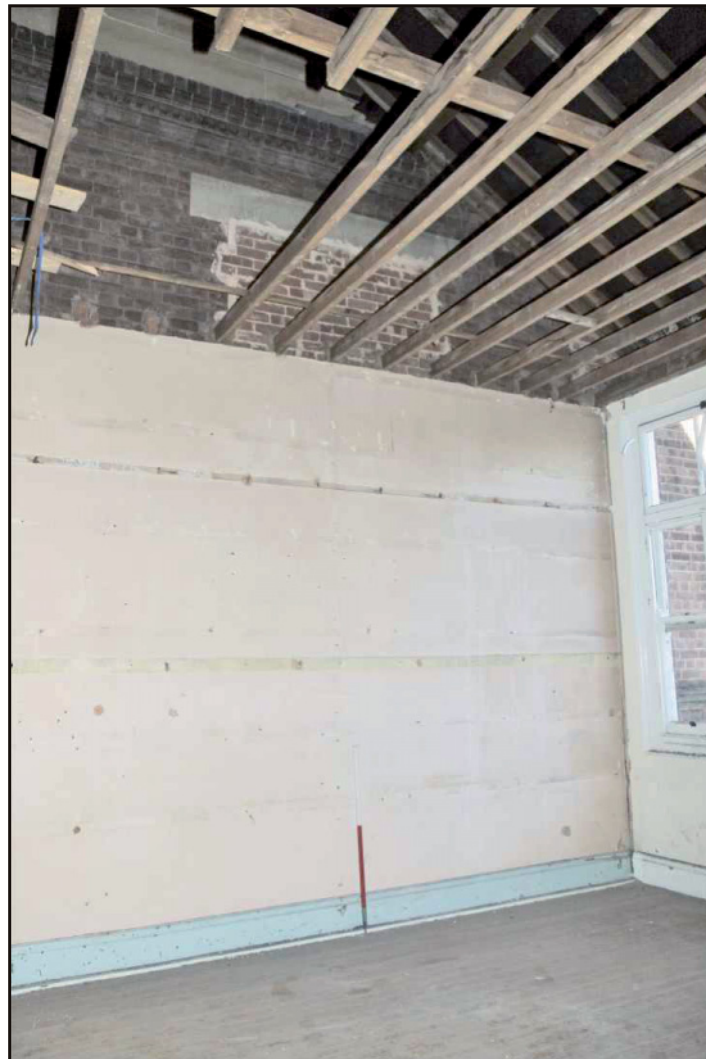
Photo. 11 The first floor of the 1935 extension, showing blocked window in the original school building, looking north east. 1m scale.
