**ARCHAEOLOGICAL RECORDING
OF THREE BUILDINGS AT
NORTON MANOR CAMP,
NORTON FITZWARREN, SOMERSET**

**Prepared for
Debut Services (South West) Ltd**

Exeter Archaeology

Report No. 09.03 (6723)

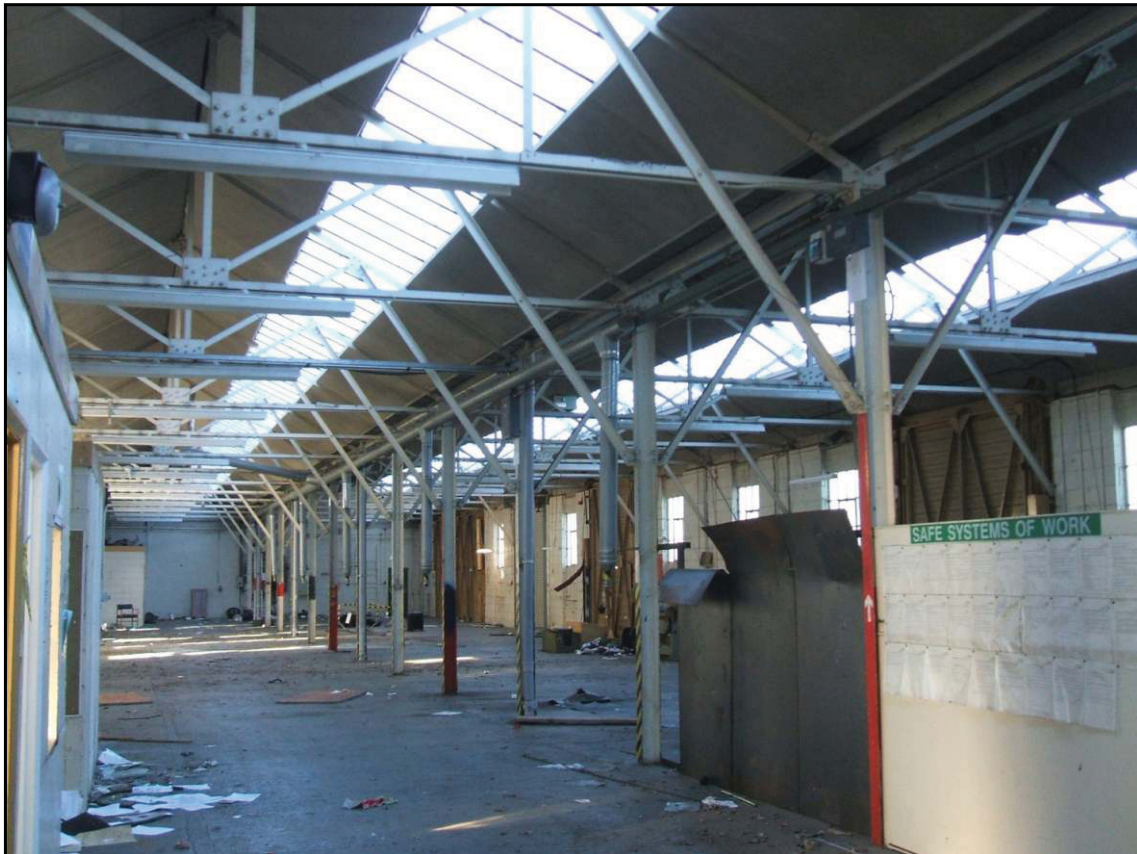
Plate 1 Interior view of building 46, looking north-west, showing double span plan and roof truss arrangement.

The buildings were of double-span construction with steel trusses supported on vertical steel posts located along the sides and the centre of the building. The trusses had tie beams with king posts and diagonal braces above and further braces below the trusses attached to the vertical posts (pls 1 and 2). These posts were stamped 'British Steel Dorman Long & Co Ltd Middlesborough England 2'. The reference to 'British Steel' and the 'Dorman Long & Co Ltd' name may indicate a mid-1960s date prior to the formation of the British Steel and Tube company in 1967, of which Dorman Long & Co Ltd was part. The roofs were covered with asbestos sheets incorporating rows of skylights, and were internally clad with plasterboard panels. All the drainpipes were modern. The bays between the trusses were infilled with either concrete block walls containing windows, doors, or an original design of upward sliding doors for vehicles (pl. 3). In building 46 the windows were tall, metal framed with 20 panes, with the central four-panes opening. In buildings 38 and 39 the windows were also tall and metal framed but with 15-panes, with the central two panes opening (pl. 4). The floors were concrete with vehicle maintenance bays located opposite the doors defined by stripped yellow paint.

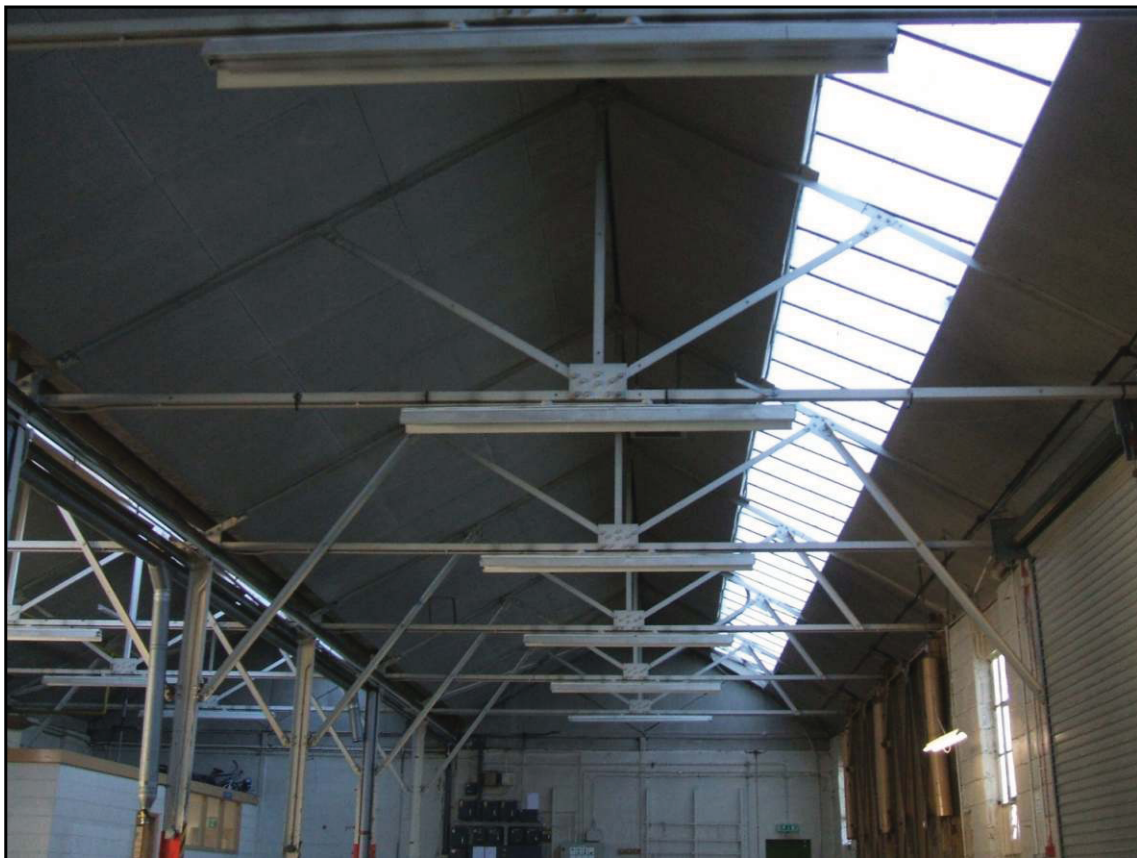
Plate 2 View of the roof trusses in building 46, looking north-west.

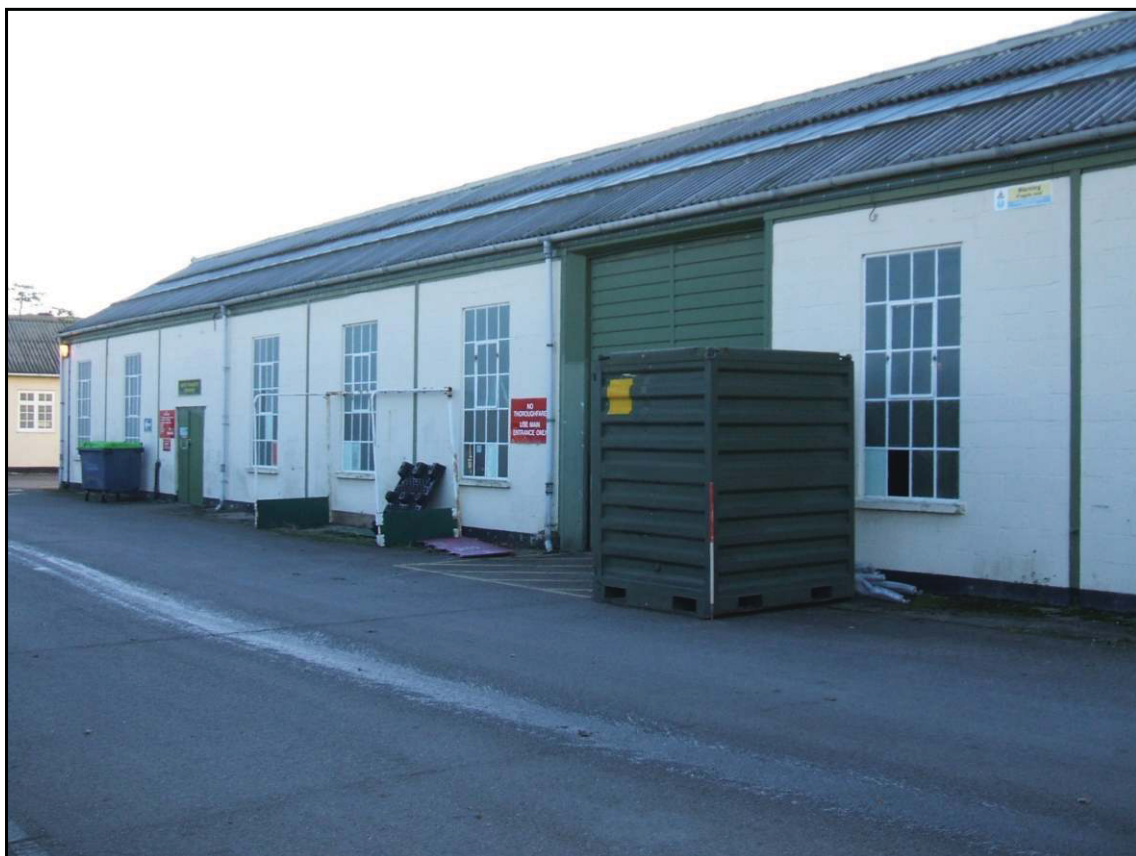
Plate 3 South end of the east elevation of building 46 showing windows and sliding doors, looking south. 1m scale.

This building was 17 bays long and internally was largely open as a garage but with some subdivisions. There were two fire doors in the northwest elevation. The northeast elevation incorporated four original doors for vehicles and a smaller door for pedestrians, as well as an inserted roller door for vehicles. In the southwest elevation were two doors for vehicles and a fire exit. There were no openings in the southeast elevation. All other bays incorporated the standard windows, except in the southwest corner of the building where two two-pane top-opening windows with wooden frames lit the kitchen.

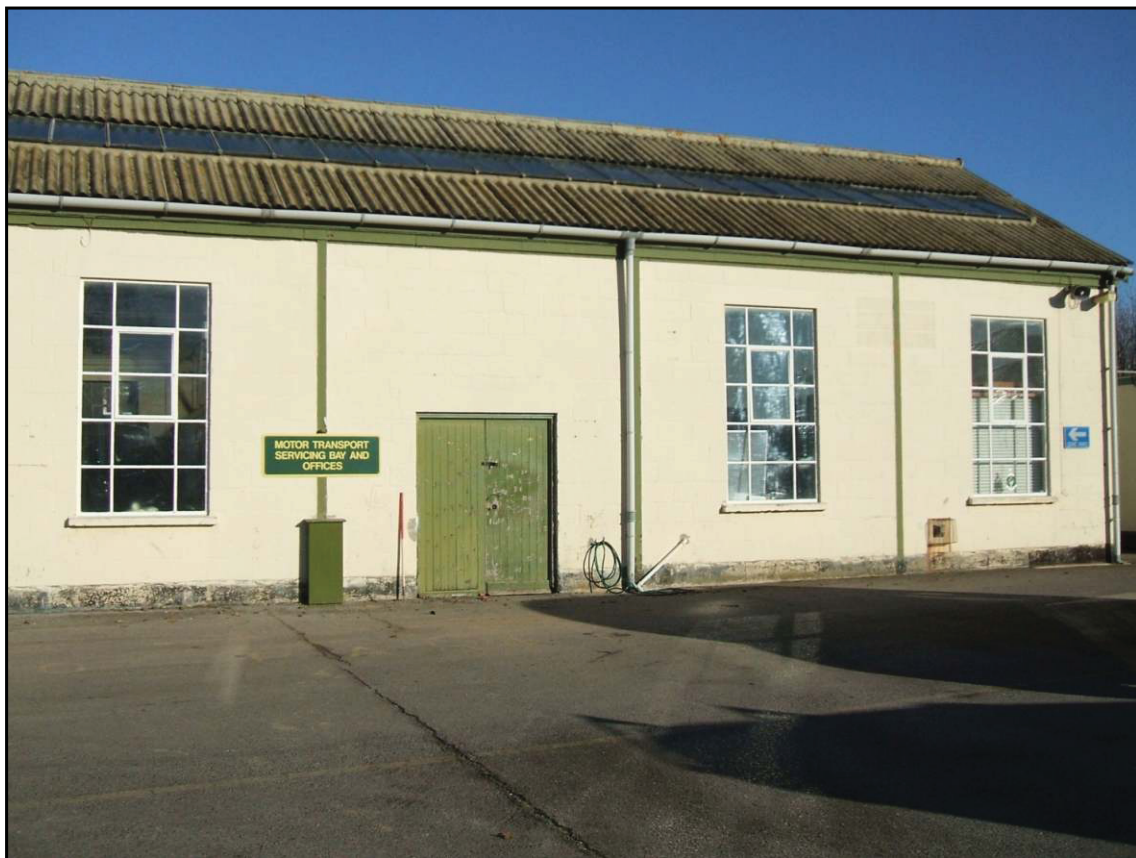
Plate 4 South end of the west elevation of building 38, looking north-east, showing windows. 1m scale.

This building was slightly smaller than building 45 and was 12 bays long. The building was not aligned perpendicular to the other MT sheds around the parade ground and its orientation must reflect the position of earlier buildings or roads to the north. The southwest elevation incorporated three original doors for vehicles, an inserted roller door for vehicles and a set of double doors for pedestrians. In bay 5 a door opening, possibly for a further set of double doors, had been blocked. In the southeast elevation there was a double door for pedestrians and a low top-opening 12-pane window. In the northwest elevation was a fire door. Attached to the exterior of the northwest elevation was an oil/hydraulic fluid store that returned along the northeast elevation.

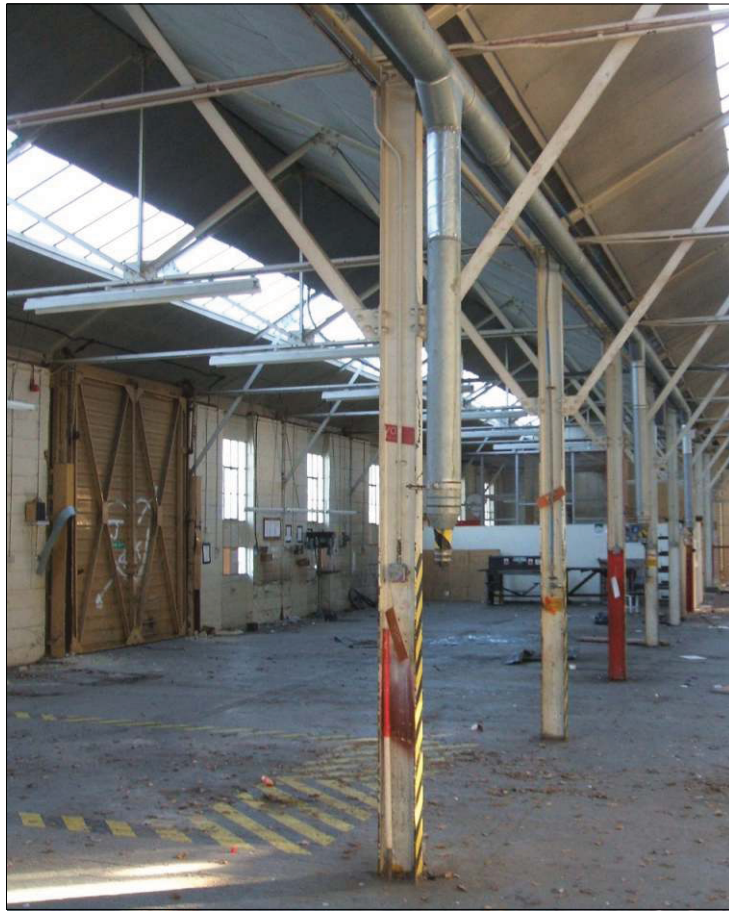
Plate 5 Interior of building 46 looking south-east, showing vehicle exhaust vent system, with the rear of a sliding door and the metalsmith's shop in the background. 1m scale.

Buildings 46 and 38 had been refitted with modern services partly installed to comply with health and safety regulations. These fittings included two types of strip lights, high level heaters and vents for exhaust fumes. The latter took the form of pipes attached to the central posts that were fitted with nozzles onto which hoses from vehicle exhaust pipes could be attached. The pipes were attached to extractor fans at roof level (pl. 5).

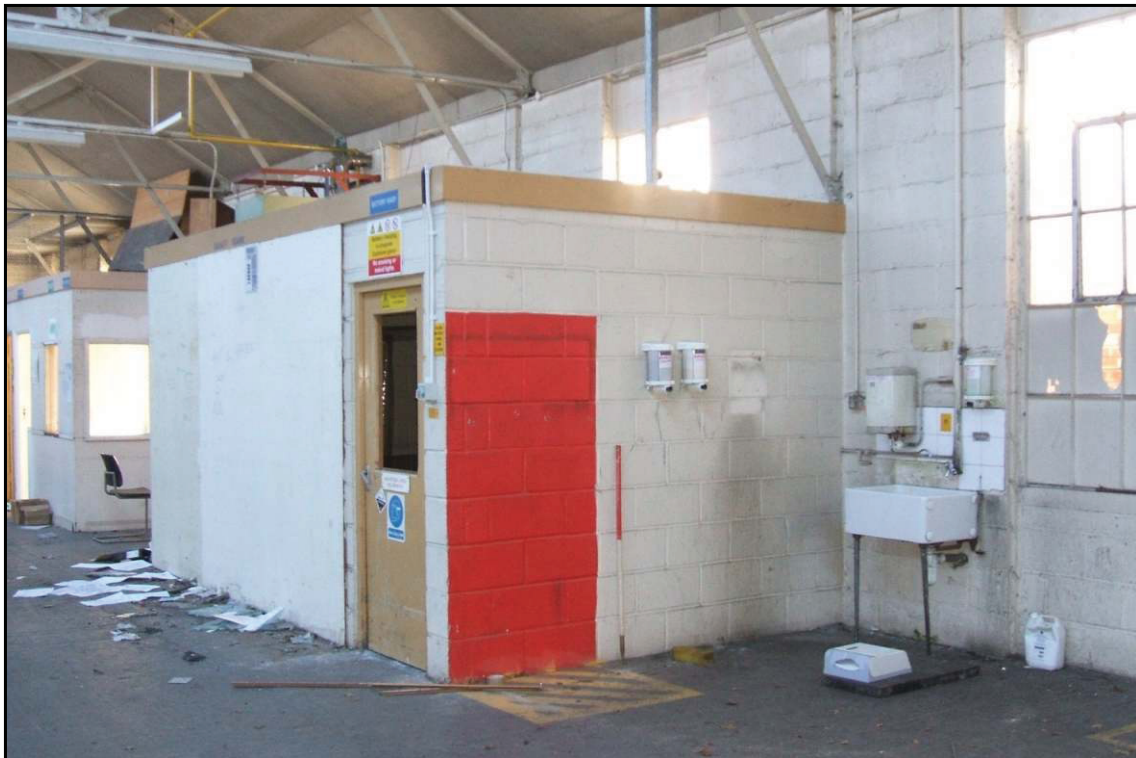
Plate 6 Interior of building 46 looking south, showing sanitary areas, battery charging room and offices in the background. 1m scale.

Internally, three separate, single-storey rooms, situated along the southwest side of the building, had been subdivided from the main garage (pl. 6). These were all constructed of concrete block and plasterboard on wooden frames. In the west corner was a kitchen with surviving fittings including a heater, water heater, sink and storage unit. A door from this kitchen led into a small store and a shower and a separate water heater. Towards the centre of the building was a small battery charging shop containing a Belfast sink, wooden racks and a charging bay. Adjacent to this room were two offices with surviving fittings of notice boards, curtains and a lino floor.

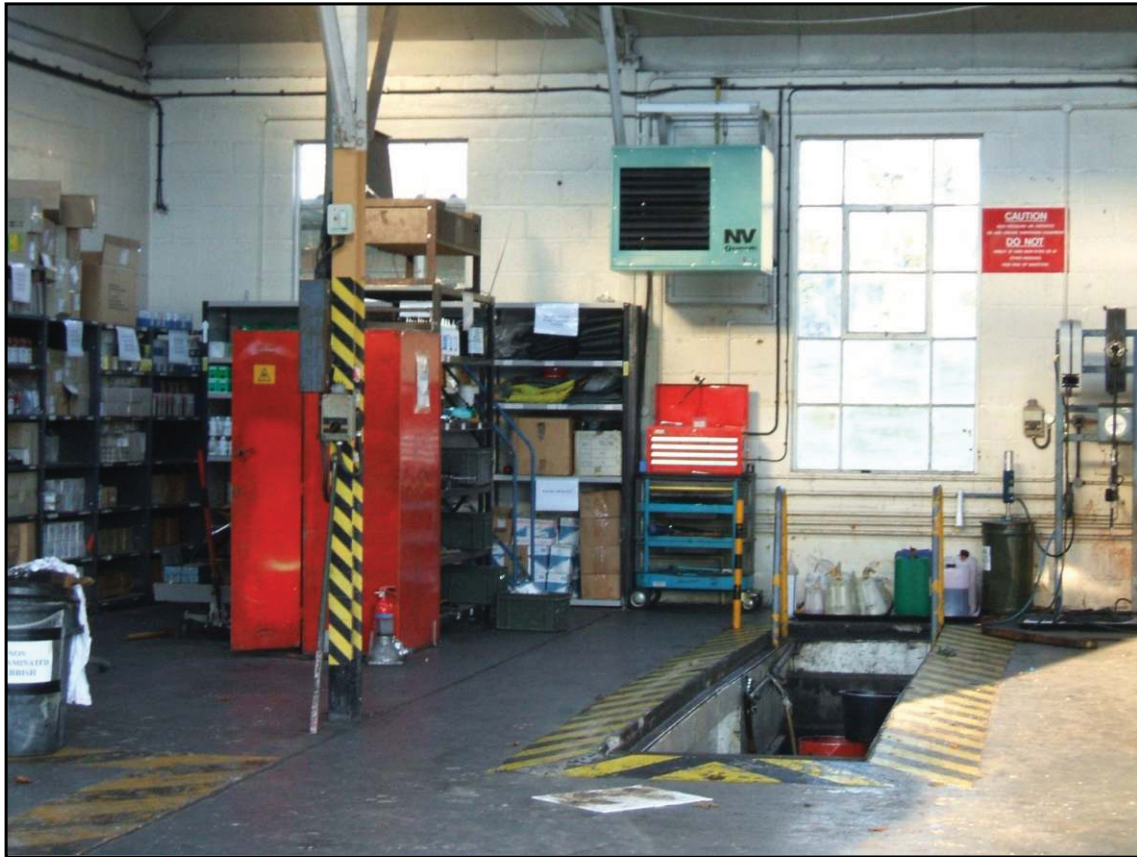
Plate 7 Building 38, west garage looking north-east.

Internally, the building had been partitioned using concrete blocks into two main garages with a smaller garage occupying the western three bays, and a larger garage within the rest of the building. The smaller garage contained two vehicle inspection pits (pl. 7), one with raised ramps. The fittings in the garage included safety features as present in building 46 and services such as pipes (providing for example water for windscreen washing) as well as a small sanitary area with wash basin and water heater. The garage also contained portable shelving that was not present in building 46 (presumably having been moved to its present location when the building was vacated).

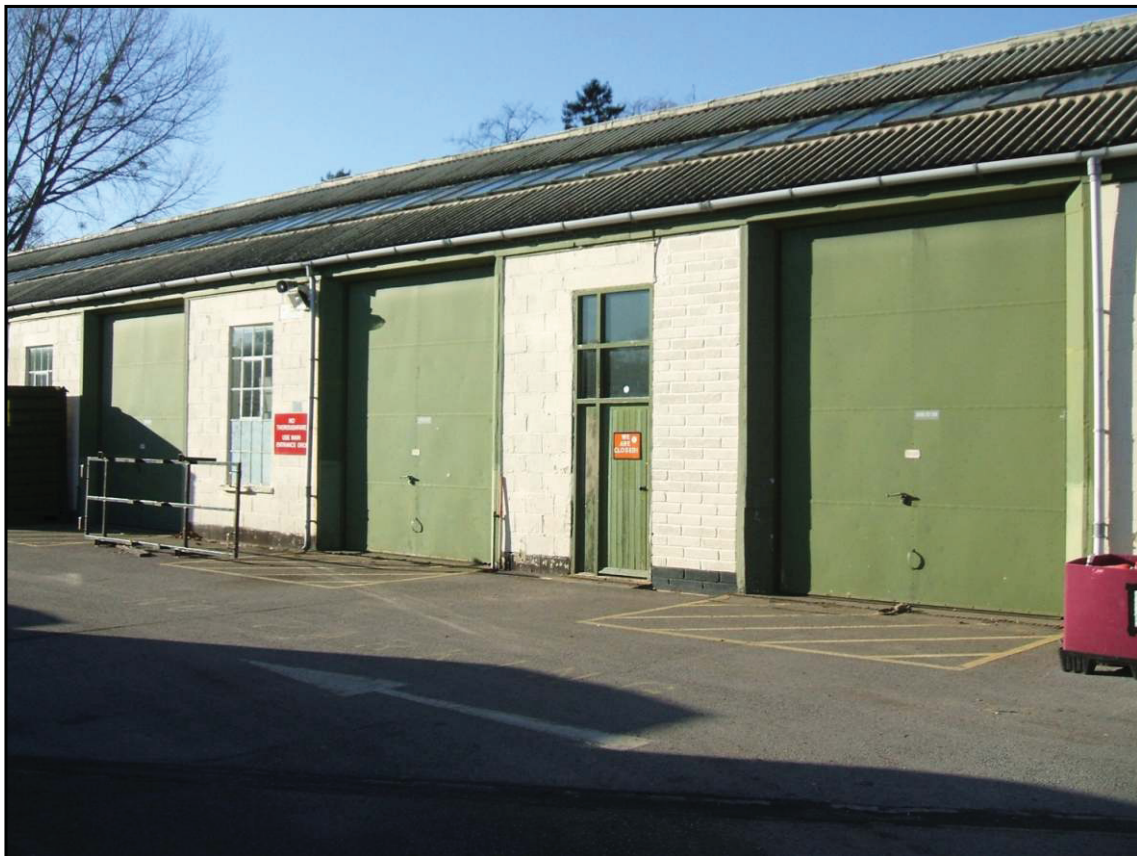
Plate 8 Middle part of the south elevation of building 39 looking west, showing altered opening and masonry. 1m scale.

This building was the same size – 12 bays long – as building 38. In the southeast elevation were four original doors for vehicles and two single doors for pedestrians. One of these doors had been inserted into an original window opening and above which was a window filling the larger opening. To the northeast of this door the masonry between the opening and adjacent roller door was constructed from concrete blocks laid on their sides rather than their bases. The reason for this is unclear and it is unknown whether this masonry was part of the original construction or a later alteration. The other door appeared to be original. There were no openings in the southwest elevation. There were no doors for vehicles in the northwest elevation and all bays, except the eastern bay that contained double doors for pedestrians, incorporated windows. In the northeast elevation there was a single door for pedestrians and two UPVC windows lighting offices.
