**ARCHAEOLOGICAL SURVEY
AND RECORDING AT
No. 1 NEW BRIDGE STREET, EXETER**

By R. W. Parker

Exeter Archaeology

Report No. 08.03

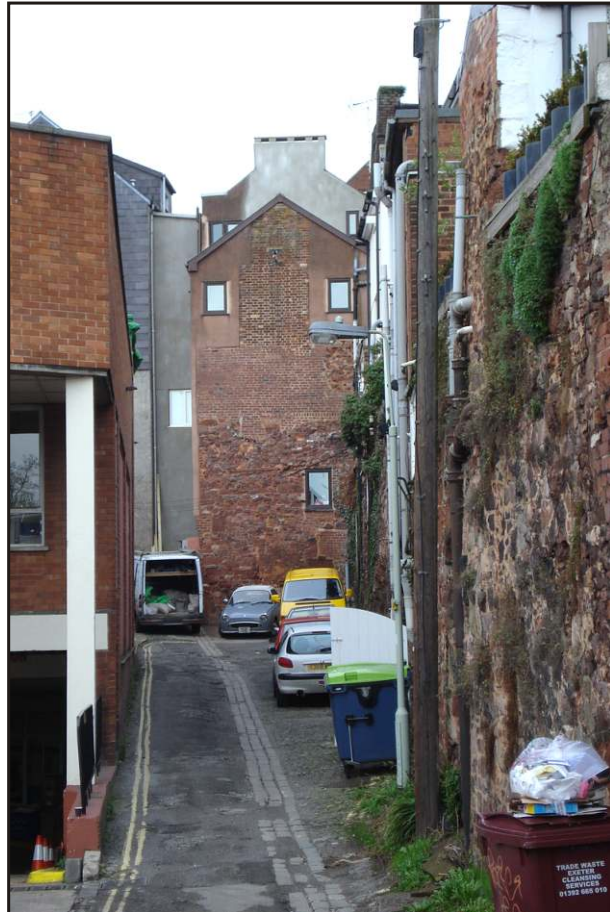
Fig. 3 View along Rackclose Lane from the site of the West Gate showing the south-eastern gable of the house (centre) standing against the city wall (right) and the narrow building (recently refaced with grey render) infilling the end of the lane alongside the original frontage.

In 1777-8, following more than a century of disuse after damage in the Civil War, the ruins of Allhallows church, with its tower and part of the city wall, were demolished for the construction of a viaduct bearing a new street linking Fore Street Hill with a new bridge across the Exe. The viaduct cuts Rackclose Lane into two sections and supports the new street at a height roughly two storeys above ground level outside the city wall. The upper parts of the house were then rebuilt to respect the new street, and the main entrance to the existing house is thus now at its second floor level, with the original ground and first floors of the property forming two storeys of 'cellars' beneath. The lowest storeys are reached from the lower part of the lane, which still extends as far as West Gate (Fig. 3).

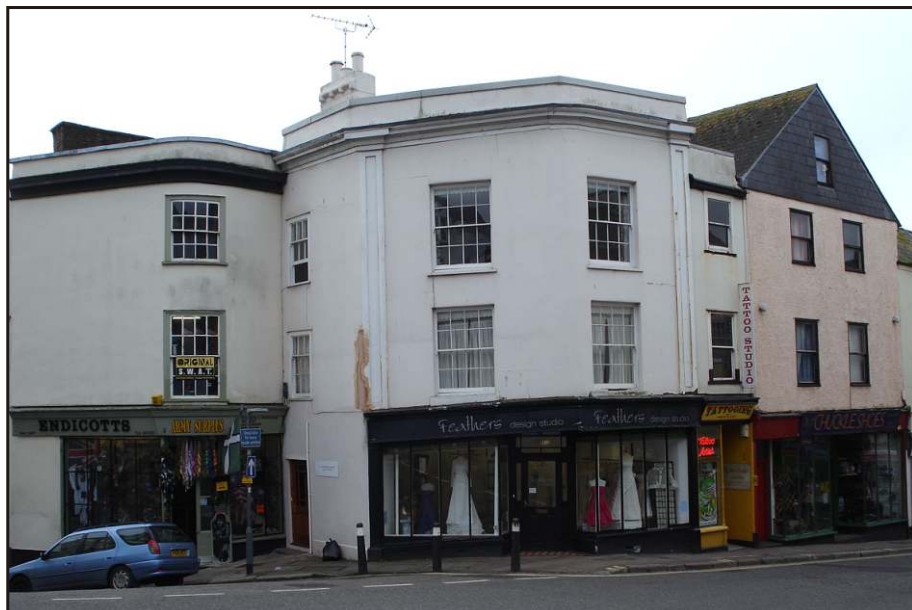
Fig. 4 The frontage of the rebuilt house towards West Street (left) and New Bridge Street (right) showing the narrow frontage of the adjoining house infilling the lane.

Above the level of the viaduct the main façade of the building now faces onto New Bridge Street and West Street. The façade to New Bridge street forms a single composition turning through an obtuse angle (Fig. 4). The second-floor frontage is given over to a shop front with slender vertical mullions and later stained glass panels inserted at the top of every light. The present doorway has double doors with margin lights and coloured glass panels, probably a modern replica of the original. On either side of the doorway, in the soffit of the fascia, are a pair of tubular features. The purpose of these is unknown; they suggest sawn off down pipes and may have drained a gutter above the fascia, or the roof itself. Above the shop front the original curving fascia board with bold, Greek Revival mouldings survives behind a modern, angled fascia. The upper part of the façade is rendered and rises through two storeys, consisted of two canted bays flanked by a pair of panelled pilasters. The façade is surmounted by a moulded timber cornice and a parapet concealing the roof. The windows have large sashes without horns, retaining narrow glazing bars. These sashes are of late 18th-century character and may well be the originals.

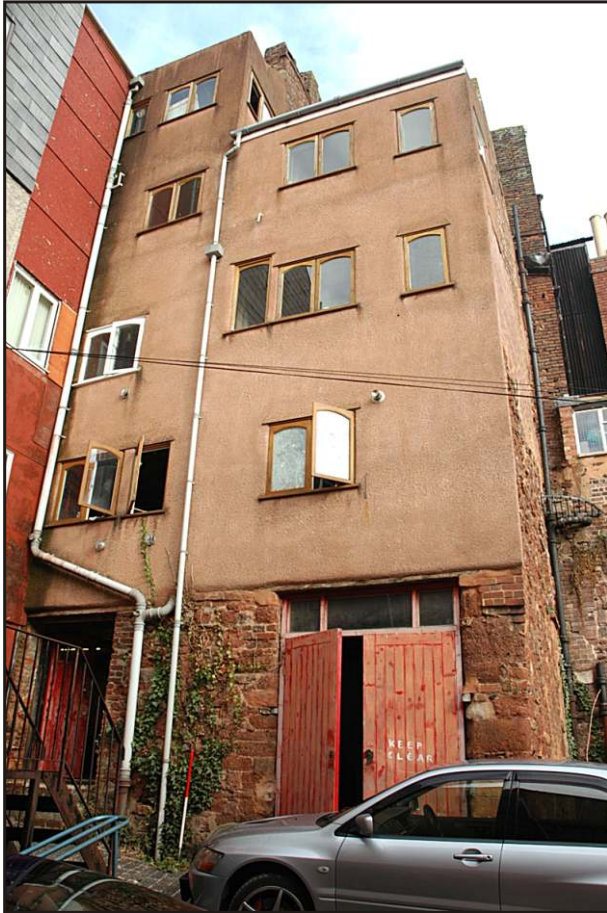
Fig. 5 View of the house from Rackclose Lane showing the exposed parts of its south-western façade.

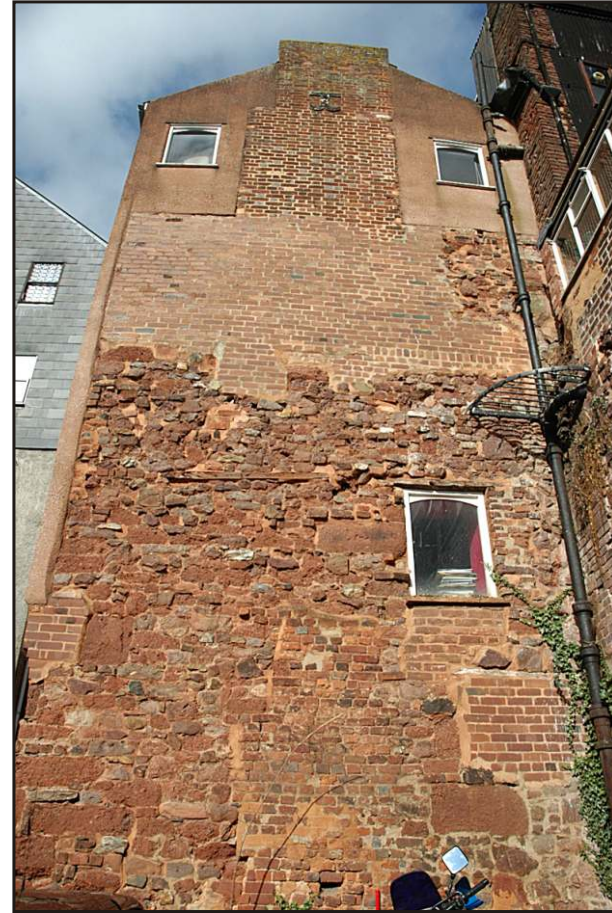
Fig. 6 View of the gable end of the extension showing the brick chimney inserted at ground-floor level (bottom centre), the refacing of the second-floor elevation (centre, top) and the later 18th-century fabric enveloping the chimney stack above.

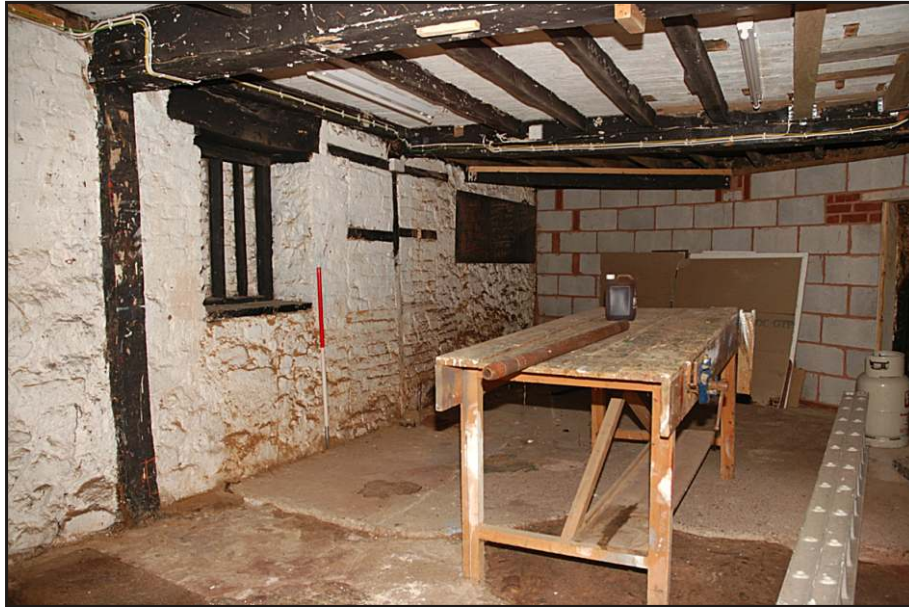
The ground floor consists of a large rectangular room with whitewashed, unplastered rubble walls (Fig. 7); these include the city wall, which forms the north-eastern wall. The north-western wall is obscured by a curving wall of modern concrete blocks concealing the fabric of the house and the viaduct and its relationship with the city wall. A small area close to its junction with the city wall is visible and contains a recessed feature set low in the wall, with its roof supported by decaying timber lintels and arches of brick. There appears to be a vertical flue or shaft in the ceiling of the recess, and the remains of a timber door-frame around the opening. The purpose of this feature is unknown; it seems unlikely to have been either an oven or a garderobe.

Fig. 7 interior of the ground-floor room in the main building, looking north west showing the blocked window and doorway in the south-western wall and the modern partition hiding the relationship of the house and the viaduct.

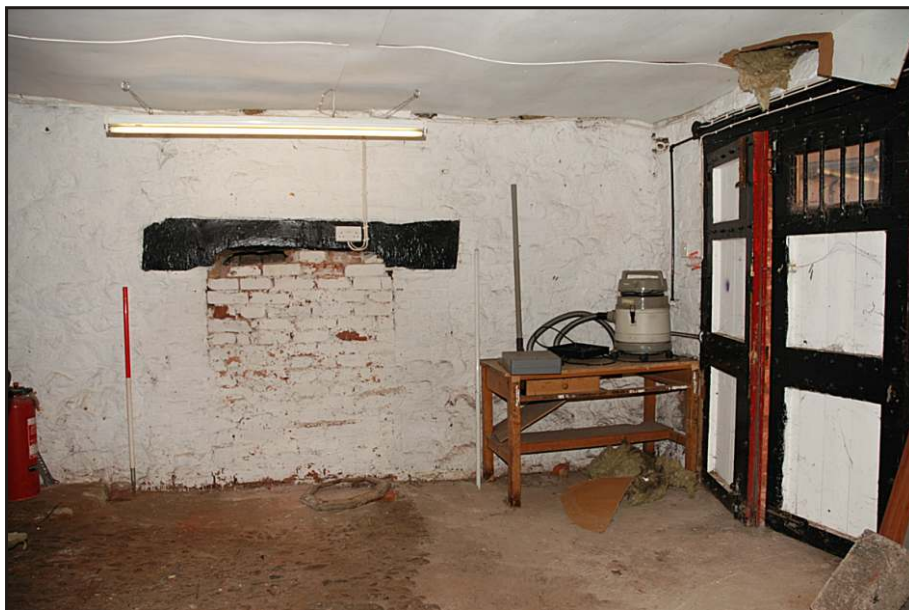
The south-eastern wall of the room is also constructed of rubble. Integral with the masonry is a fireplace opening with brick jambs. The jambs are bonded with the rubble in the manner of quoins and the fireplace has a timber lintel with a chamfered soffit terminated at each end by stepped ogee stops. The central part of the lintel has been cut away to increase the height of the opening and the rear of the fireplace has been broken through in an attempt to create a doorway to the adjacent room; this opening has since been blocked (Fig. 8).

Fig. 8 View of the south-eastern end of the room showing the blocked 17th-century fireplace.

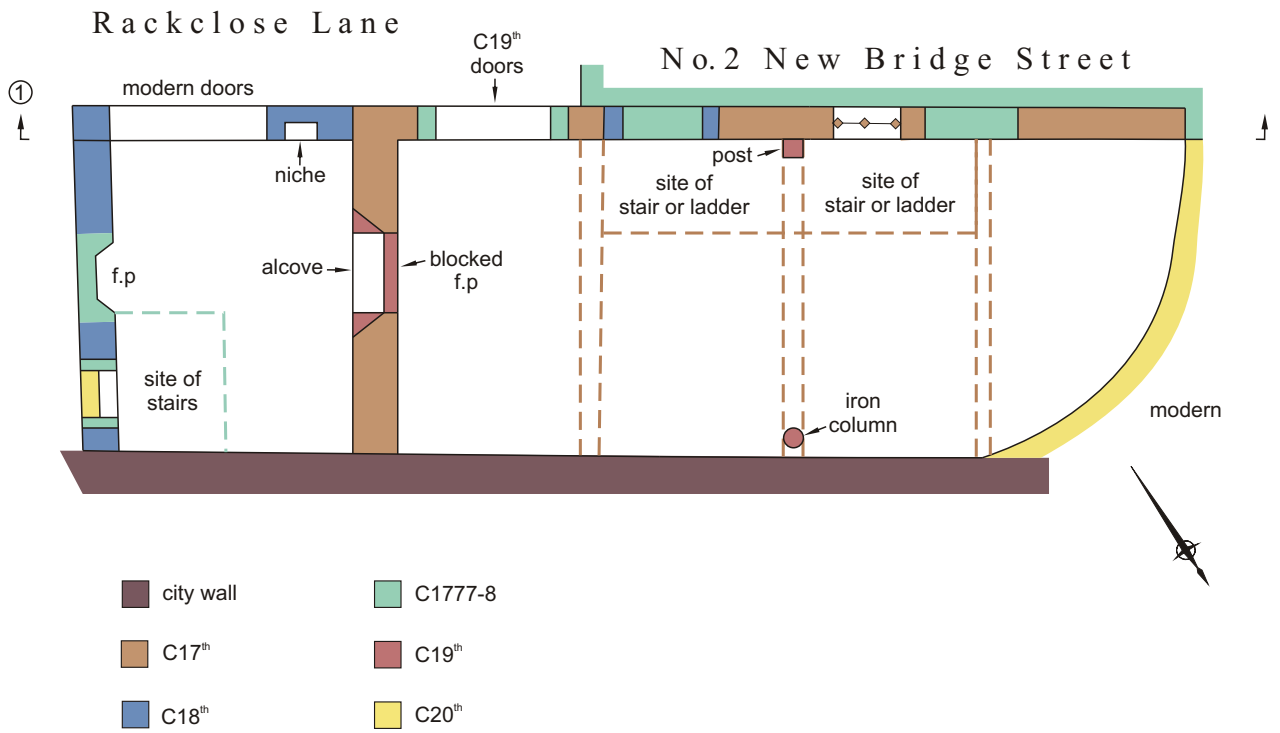
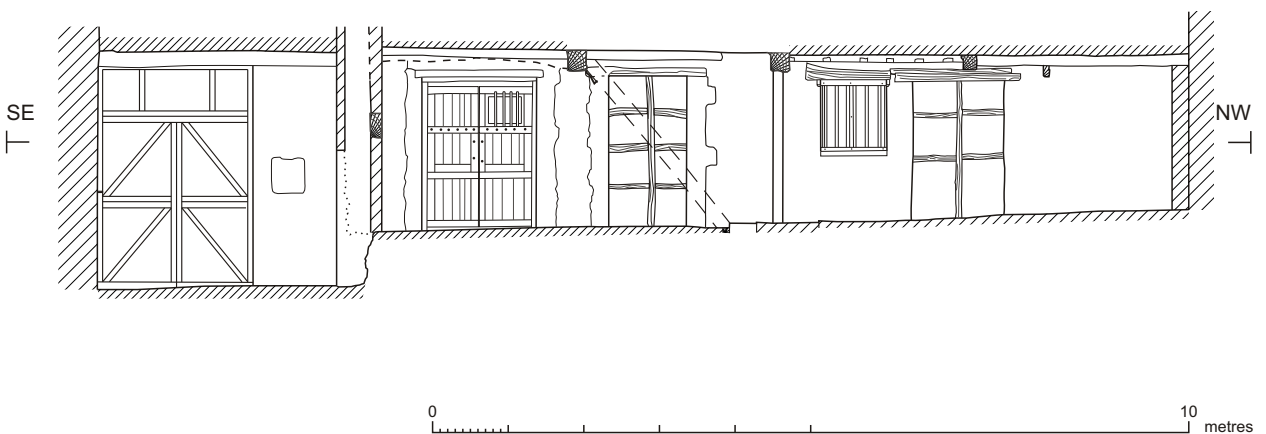
In the south west wall (Fig 9, Section 1) the access from Rackclose Lane is by a pair of double doors, probably of early 19th-century date, set in an opening with brick jambs. The upper part of the north-western jamb is constructed in soft, orange bricks and may be earlier than the lower part of the jamb, which is more crudely constructed. The opposite jamb contains similar anomalies. It is possible that the present door represents an enlargement of an earlier window opening by cutting away the masonry below the sill to create a full-height opening.

Fig. 9 Plan of the ground floor and Section showing the internal elevation of the lower part of the south-west wall (based upon drawings by Exeter Archaeology).

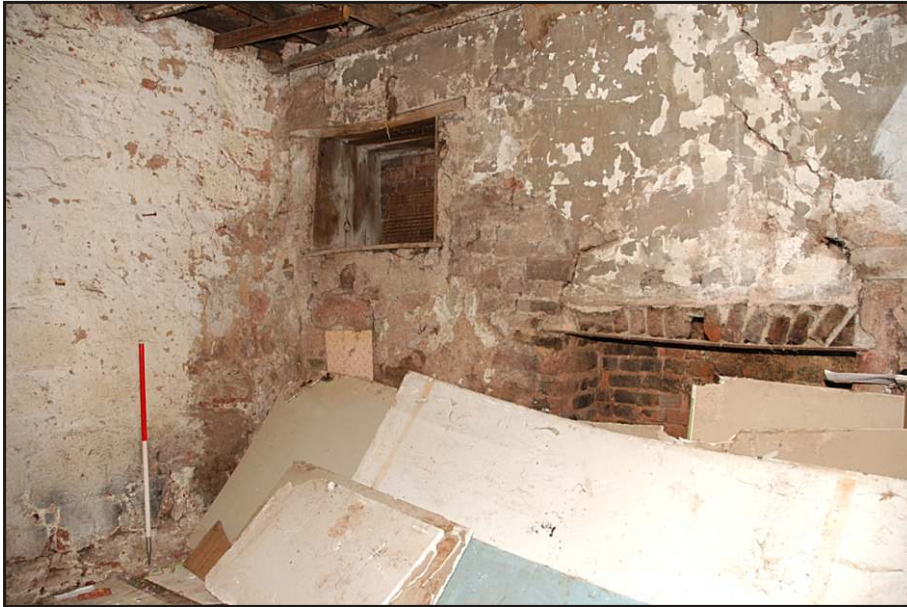
The adjoining cellar within the south-eastern extension to the house is a small rectangular room with a very lofty ceiling (Fig. 11). The rear wall of this room is the exposed fabric of the city wall, which consists of large Heavitree breccia blocks overlying earlier volcanic masonry low in the wall. Such mortar as is visible is white, with very large gravel inclusions. The north-west wall is of mixed rubble and in poor condition with many large structural cracks. The wall contains a chimney flue serving the adjoining room, and constructed of soft, red, hand-made bricks which appear to be

Fig. 11 View of the room within the extension showing the fireplace and window in the plastered south-east wall and the city wall forming the north-east wall.

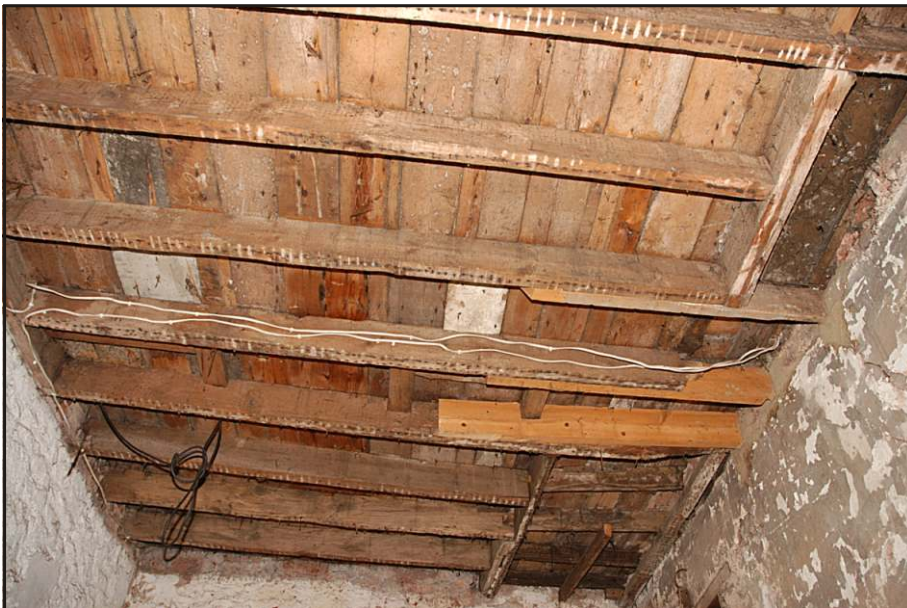
Fig. 12 Detail of the ceiling in the extension showing the provision for a staircase.

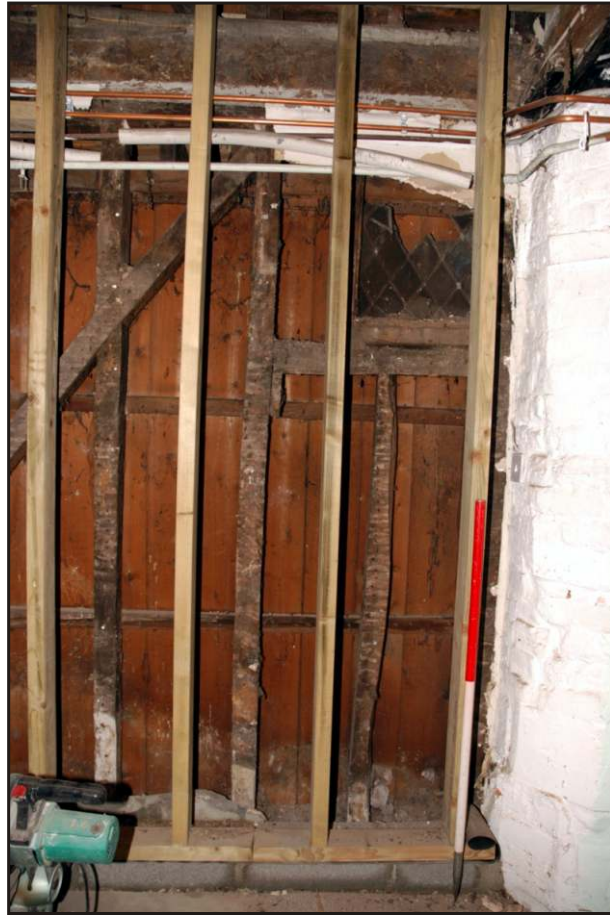
Fig. 14 Detail of the small window discovered at first-floor level in the south-west wall, showing the character of the timber framing at this level.

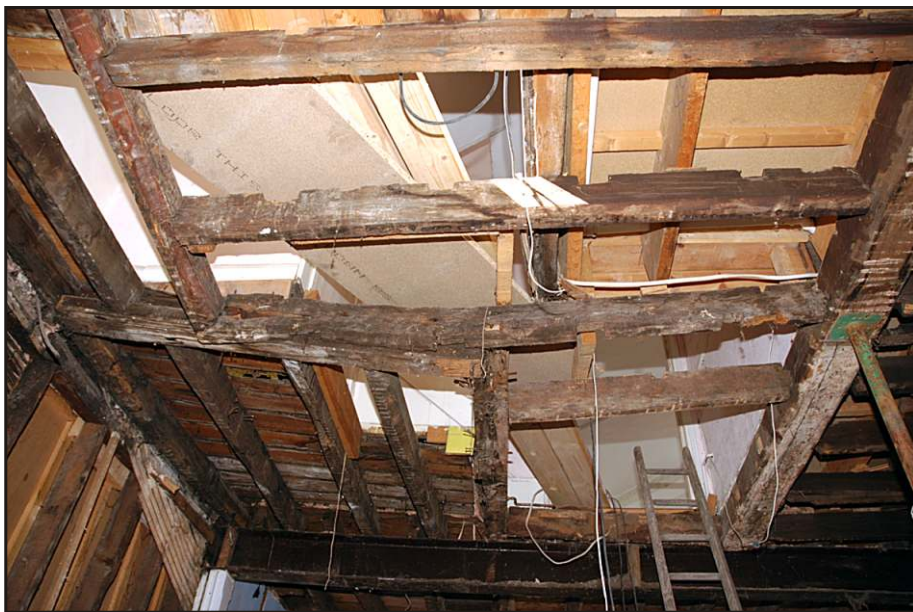
Fig. 15 Detail of the ceiling structure seen from the second floor, showing the crude infilling of the void of the 18th-century staircase and the poor structural condition of the building.

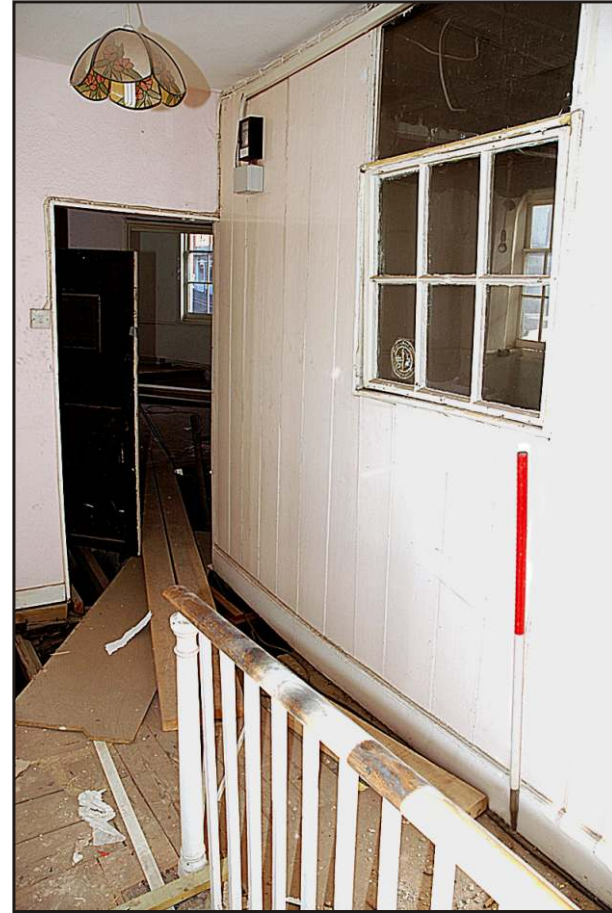
Fig. 18 View of the 19th-century corridor at third-floor level, showing the timber screen incorporating a reused sash and the handrail of the 19th-century staircase to the second floor.

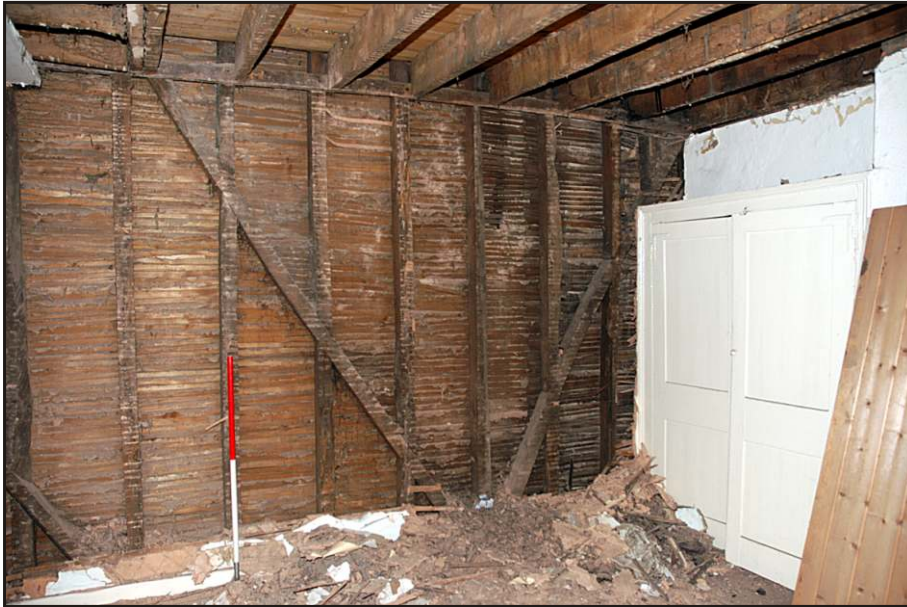
The south-eastern room is a large room and was presumably of some status, but it has no cornice or other decorative features. In the eastern corner is a large alcove filled by a cupboard with two-panelled double doors hung on 'L'-hinges. This is almost certainly of late 18th-century date and represents a relatively rare survival of a piece of fitted furniture in its original context. The fireplace in the south-eastern wall has a small opening with a brick arched head; its grate and chimneypiece have been removed, but part of a moulded dado around the room remains. The north-east wall of the south-eastern room was stripped of plaster at the time of the recording and proved to be massively constructed of vertical studs and diagonal braces but, unlike the floor below, without brick nogging. The ceiling joists supporting the fourth floor are supported on a trimmer which was simply nailed against the studwork, suggesting that the studwork is earlier than the ceiling, and relates to the adjoining property (Fig. 19).

Fig. 19 View of the south-eastern room at third-floor level showing the construction of the late 18th-century upper storeys of the building. The ceiling joists are supported by a trimmer nailed against the studwork of the adjoining building, which is unrelated to them structurally. The late 18th-century fitted cupboard is also shown.

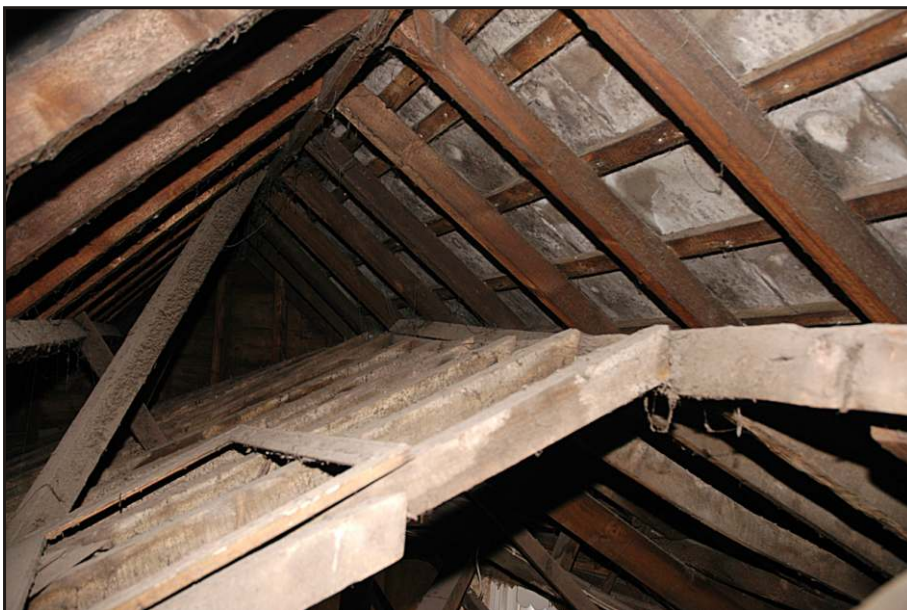
Fig 20 Detail of the roof space showing the superimposed roofs of the north-western parts of the building.
