# Archaeology and Cultural Heritage

- 1 This chapter presents the results of a desk-based archaeological and historical assessment of the Phase 1 works to the Beach Road on Lundy, Devon (Centred on SS 1424 4381). In addition, a site inspection has been undertaken to establish the presence of any known and hitherto unrecorded archaeological sites that might be affected by the development.

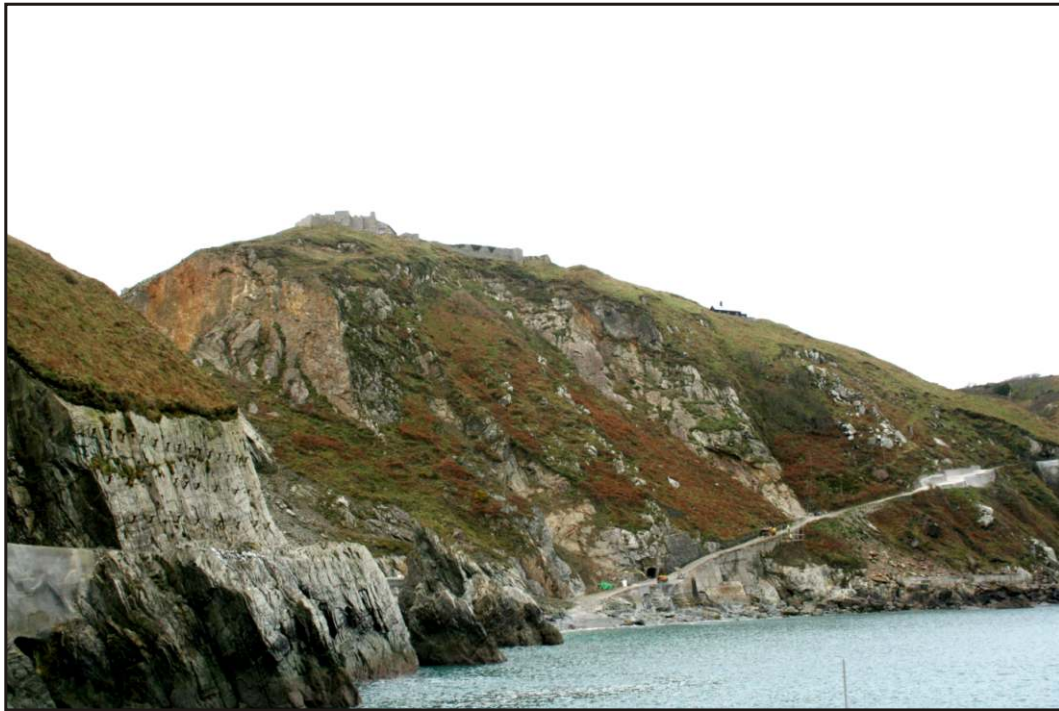
Plate 1 View of the Beach Road, showing landslips behind and Marisco Castle above. Looking northwest.

- 2 The study area centres on a 100m length of the Beach Road (Figs 2 & 3; Plate. 1), although archaeological sites within a wider landscape have been considered. The road links the Landing Beach – the only accessible beach by large boat – with the village and farm on the plateau above, and is in active use between April and October when the island is served by the MS *Oldenburg*.

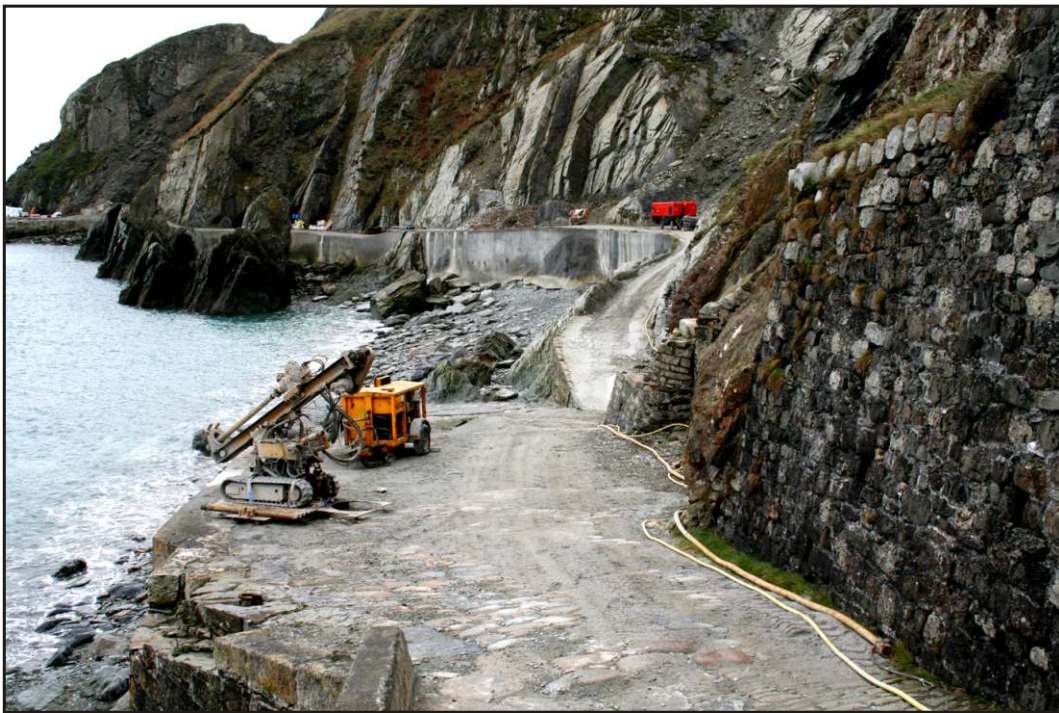
Plate 2 Upper section of the Beach Road showing platform to left and revetment wall to right. Looking south.

- 24 This is a rough track from the Landing Beach to the village and farm. It was built by William Hudson Heaven from the Quay to 'Peeping Corner' in 1838, before which time it had been impossible to use carts for haulage from the beach. The previous access was via a steeper path (NT SMR 109363). Trinity House was approached to collaborate in its construction and cost, but their engineers said that the proposed road would be impossible. Thus, William Hudson Heaven determined to be his own engineer and had it constructed. Trinity House then had to negotiate a legal agreement to use the road [NT SMR]. The surface of the Beach Road varies across its length, and the following description has been made of the road in the vicinity of the works. Adjacent to Site **24** the road is constructed of rows of slate and granite blocks set on end. Incorporated within this fabric are what appear to be two larger granite railway sleepers with holes on their upper surfaces for the attachment of iron chairs. These must have been reused, but their original location is unknown. They do not derive from the island's quarry railway, but could perhaps have been used in the inclines associated with the quarries. Much of this surface has been replaced with flat-laid slates or pieces of concrete and granite debris. Further south, there is an area of granite setts, retained at intervals by longer granite slabs set on edge. Below this is a short stretch of slates set on edge. Adjacent to the retaining wall these slates have been replaced by very small, neatly-laid granite setts. Outside and to the north of the boathouse, there are remnants of large flat interlocking slates and occasional granite slabs. These are associated with the wider section of the road, forming a platform, outside the boathouse, and are contemporary with the stone retaining wall of the road. This fabric has been largely replaced with irregular-shaped slate slabs laid flat.

- 51 Above the boathouse there are two main lengths of retaining wall on the upper side of the Beach Road. The southern wall (centred on SS 1432 4833) starts immediately north of the boathouse and continues for a distance of 22m, up to a height of approximately 6m. The wall is constructed of squared granite, slate and sandstone blocks bonded in hard granitic cement, and incorporates rounded granite and slate stones. The former is also used as a decorative capping to the walls. There are no obvious tool marks on the stones, and it is possible they have been reused from an earlier structure. The north end of this wall truncates an earlier curving slate retaining wall. The north end of this earlier wall has been rebuilt in roughly coursed slate. The northern wall (centred on SS 1421 4385) is located between the southern building and Site **24**, and is 32m long. This wall survives up to 1m high and is constructed of roughly-coursed slate bonded with a gravelly granitic mortar, and incorporates a series of square drain holes and ceramic drain pipes. This fabric may represent one of the earliest walls on the upper side of the road. On the outer side of the Beach Road there are two stretches of historic fabric associated with the wider platform in the road outside the boathouse; these are punctuated by an area of concrete sea wall built in the 1960s. The southern section, measuring 4m in length, forms the south face of the platform and lies at right angles to the road. It is constructed of bands of mainly thin pieces of slate. This appears to be historic fabric, but is different in character to the northern stretch of wall (described below) and may therefore be more recent in date. The northern stretch of wall is curved and forms the north face of the platform; its southern extent is obscured by the later concrete re-facing. Approximately 4.5m of this masonry is visible. This wall is constructed of large, long blocks of slate infilled with smaller packing stones laid in rows, and has been repointed in cement. The upper course is formed by large granite capping stones that form the edge of the Beach Road. To the north of this platform the next stretch of the retaining wall was rebuilt in concrete in the 1960s, although a small patch of earlier stone masonry survives. Further north, there is a small patch of masonry, constructed in shale, overlaid by a later rebuild that extends for some 25m along the road. This is constructed generally of larger blocks of slate than the wall it replaced and is bonded in a hard slightly granitic lime mortar. The wall incorporates a plinth at its northern end, four courses below road level.

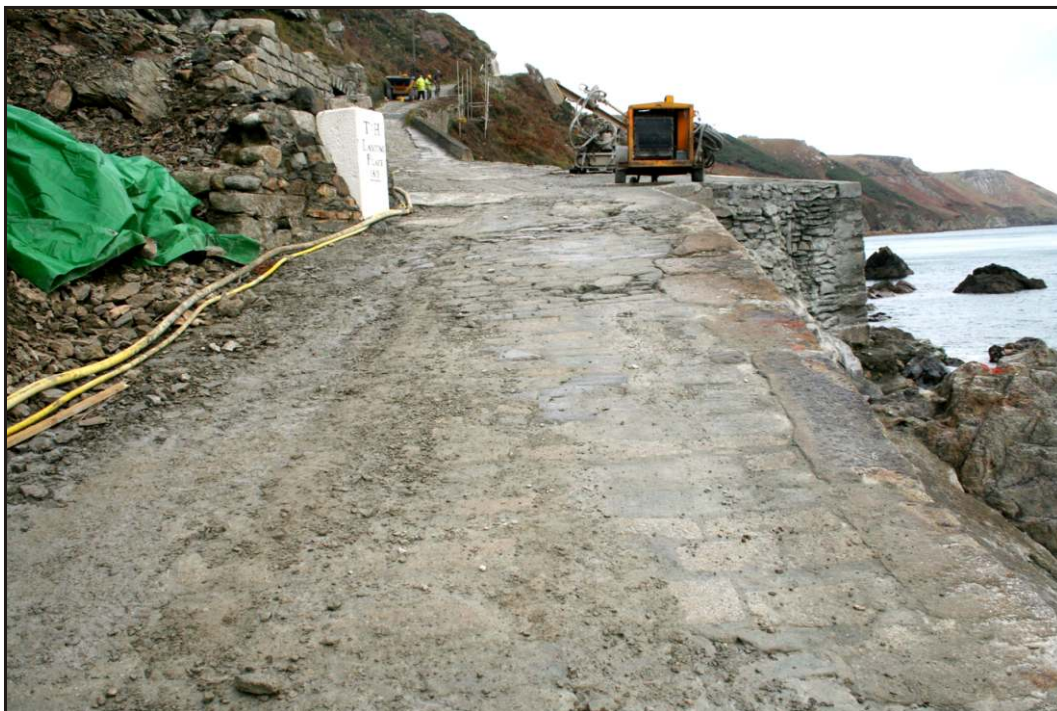
Plate 3 Lower section of the Beach Road showing revetment wall to right and Trinity Stone to left. Looking north.

- 33 A stone used to be on the Quay, next to the limekiln, but was lost in a landslip of 1954. The stone is thought to have been placed there by Mr. Heaven and dated from an occasion when a dissident group of trippers disputed their rights with the owner. It read: 'This island is entirely private property. There are no public roads, footpaths or rights of way whatever hereon'. A Trinity House marker stone on the Landing Beach has survived. It reads: 'T.H. Landing Place. 1819'. The Ordnance Survey 1st edition 1:2500 map of 1886 depicts the two stones either side of the limekiln [7; Fig. 6]. The Trinity Stone is constructed of granite with chamfered corners, and measures 0.66m wide by 0.41m deep by 1.09m high. The stone is painted white [site visit description].

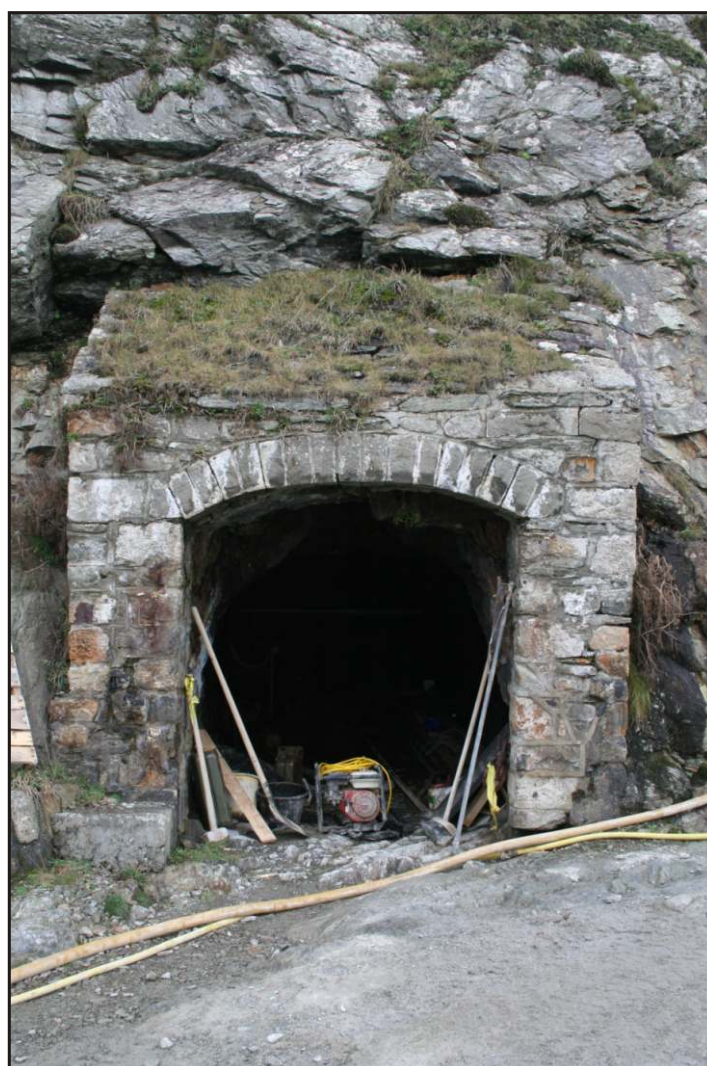
Plate 4 Entrance to the Boathouse showing masonry. Looking west.

- 32 'The Landing Quay cave was excavated out of the shale, with a stone arch. At present it is used as a boat store'. This boathouse is actually formed from a man-made opening driven into the hillside for a distance of approximately 9.40m. The profile of the inside of the boathouse is irregular, possibly reflecting the structure of the geology, with generally vertical sides and a flat floor. The structure measures 2.10m wide by a minimum of 1.90m high. The front of the boathouse has a stone entrance comprising two piers with a shallow, round-headed arch formed from dressed granite voussoirs. Above this the roof tapers back over the bedrock. The masonry comprises dressed granite blocks with feather and tare marks (dating to after 1800), dressed slate with toolmarks and heavily weathered sandstone, bonded in hard granitic cement/mortar. There is evidence of coal dust on the sides and rear of the boathouse, indicating extensive storage of coal in the past [site visit description]. The location is suitable being above the level of tides while close to the shore and slipway. The proximity of the structure to the limekiln (Site 4) may indicate that coal stored in the boathouse was used in the limekiln.

Site No	Description	Importance	Impact	Mitigation
		probably a natural feature		
9	Boathouse	Local	Major. The stone front will be taken down and replaced, and stabilisation works undertaken to the roof of the cave.  Works will secure the long-term stability of the site.	None – a photographic and written record was prepared during this assessment
10	Stone/Site of Stone	Local	None. Surviving stone will be retained <i>in situ</i> .	Measures should be put in place to protect the stone during the construction works
11	Platform	Local	No change. Not directly affected by the works.	None
12	Wreck	Local	No change. Not directly affected by the works.	None
13	Wreck	Local	No change. Not directly affected by the works.	None
14	Lighthouse	Regional	No change. Not directly affected by the works.	None
15	South Light Garden Terraces	Local	No change. Not directly affected by the works.	None
16	Lynchet	Local	No change. Not directly affected by the works.  Works may secure long-term stability of the site.	None
