**ARCHAEOLOGICAL BUILDING SURVEY
OF PARADISE COTTAGE,
TOTNES, DEVON**

Exeter Archaeology

Report No. 07.63

August 2007

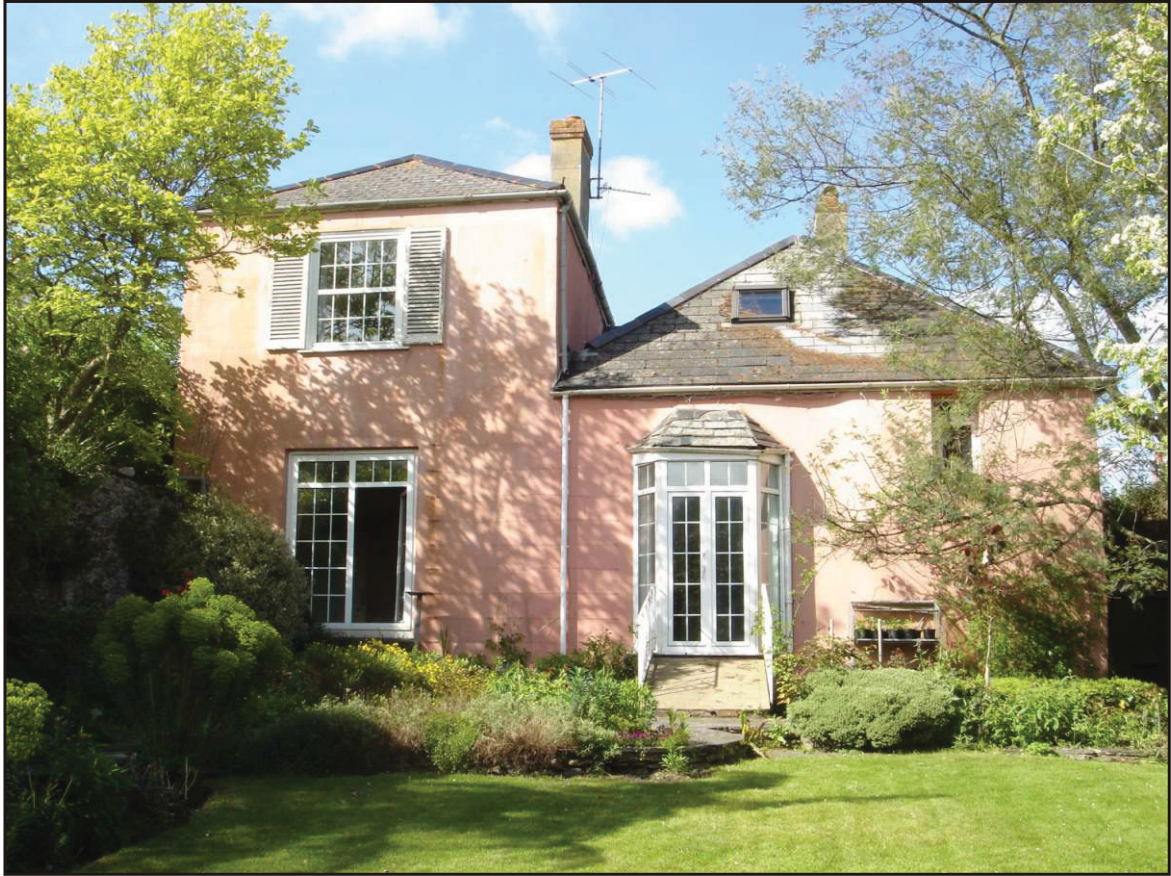
Plate 1 Southern elevation of Paradise Cottage, clearly showing the central and eastern sections of the building. The western section is obscured from view by the garden wall on the left. Photograph provided courtesy of Casper Holst, Sustainable Design Collective.

The southern elevation was finished in stucco, scored to imitate ashlar. The elevation contains two openings: a small first-floor window, offset to the east, and French windows in a bay on the western side. It may be noted that the internal width and position of the bay window is comparable with the doorway in the northern elevation, as it appeared prior to its alteration.

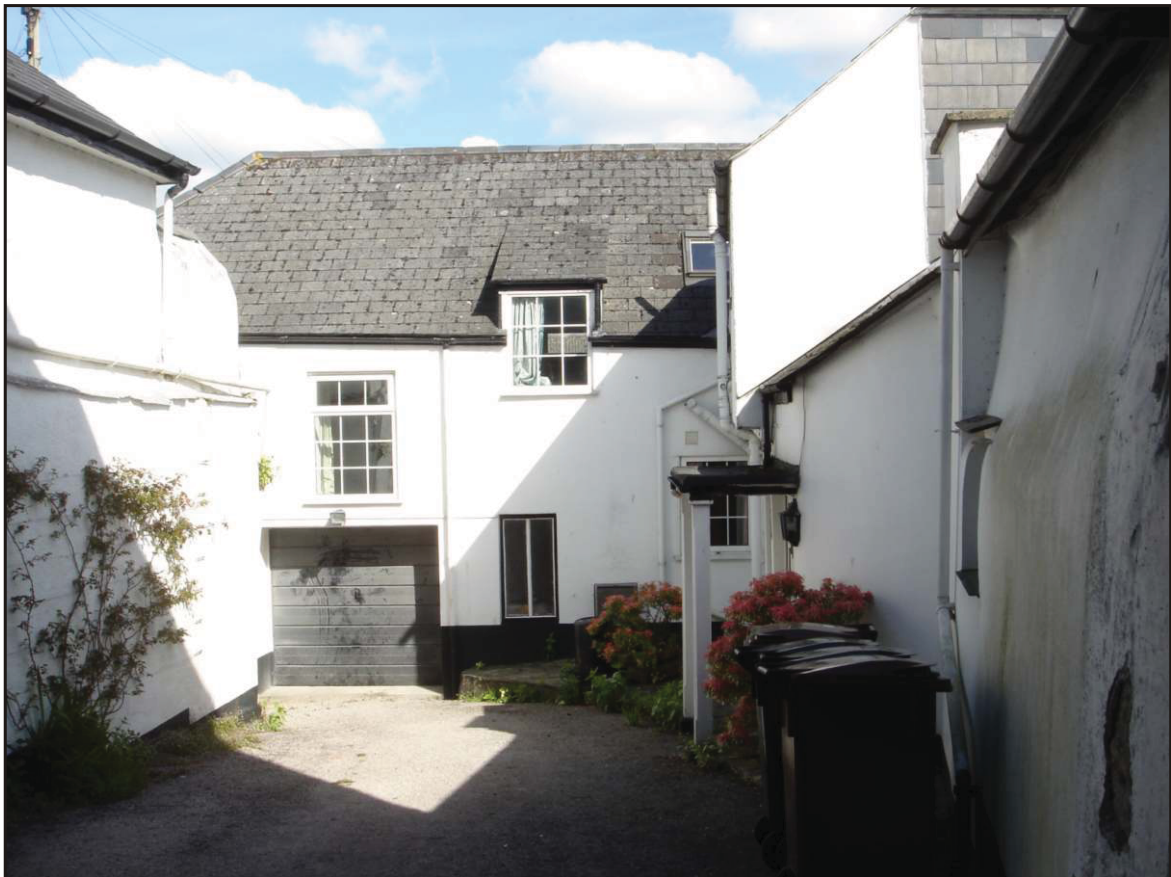
Plate 2 Western elevation of Paradise Cottage. The eastern section is in the background whilst the curved wall of the western section is visible on the extreme right. Photograph provided courtesy of Casper Holst, Sustainable Design Collective, Totnes.
