**ARCHAEOLOGICAL RECORDING OF THE
FARM BUILDINGS AT VENMORE FARM,
WOODBURY, DEVON**

Exeter Archaeology

Report No. 08.34 (6541)

June 2008

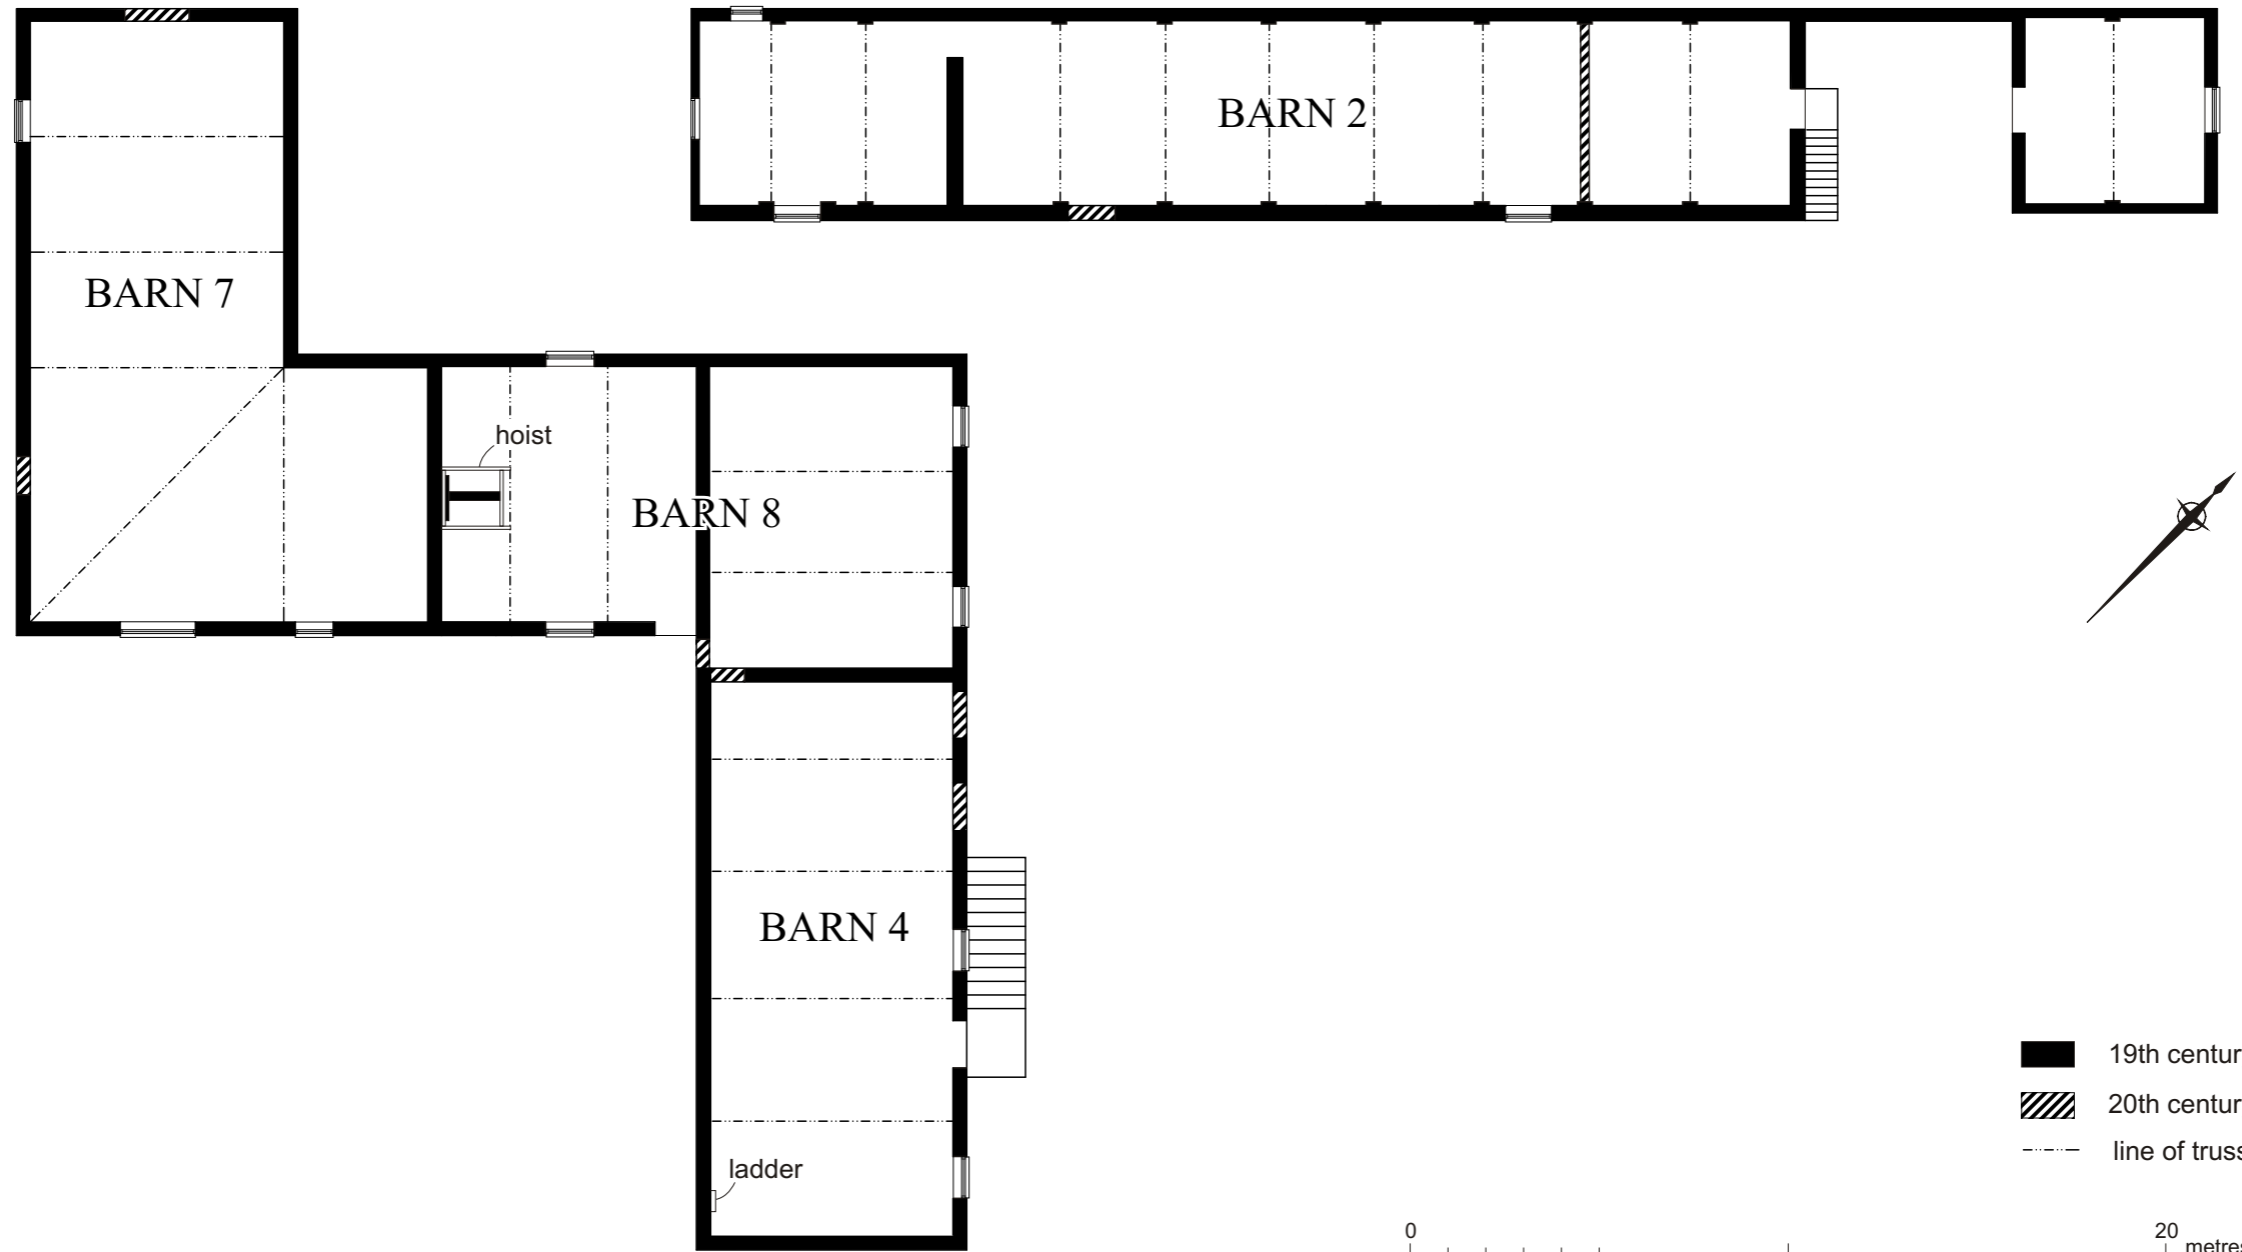
Fig. 3 First floor plan of farmyard buildings (based on ARA architect's plan 5812-20).

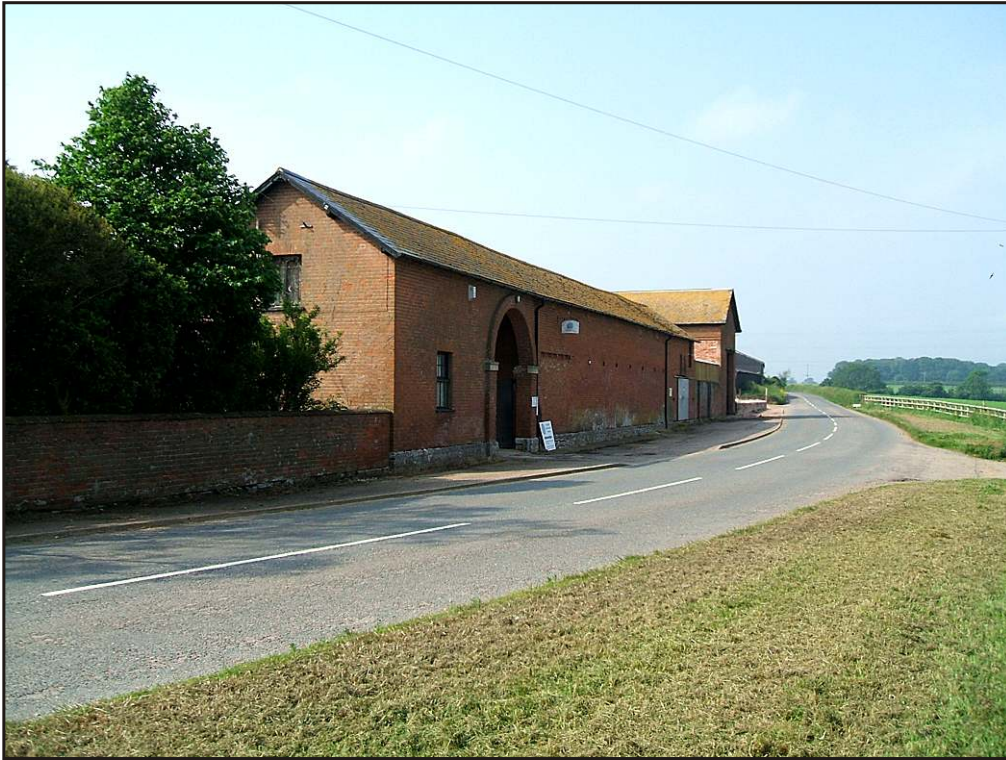
Plate 1 View of the farm from the road showing barn 2. Looking southwest.

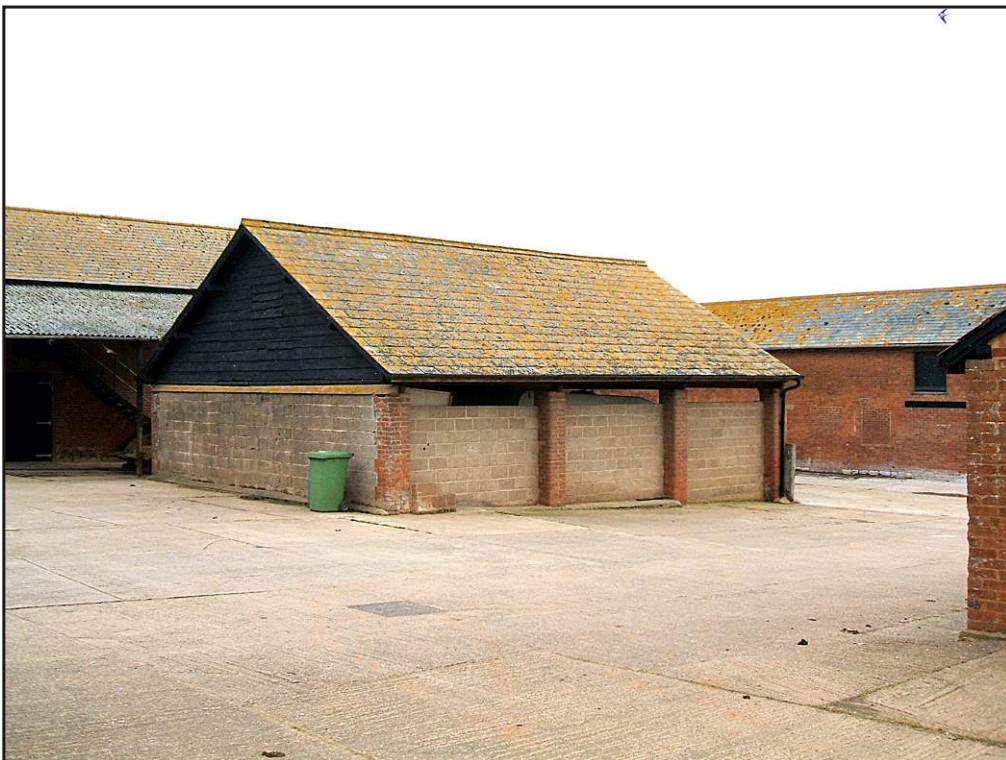
This building is located in the centre of the yard, and was originally an open-fronted structure with the roof supported on eight large brick piers. Three sides have subsequently been infilled with concrete blocks, the north side remaining open providing access for storage. Fittings on the southeast corner pier indicate that prior to this infilling there was some form of division or enclosing of at least part of the building. The roof is a version of the standard design described above, but with the addition of queen posts and further diagonal braces reflecting the wider span of the building. The roof has two rows of trenched purlins. The gables of the north and south elevation are weather boarded. The central section of the roof in the southern bay has been boarded over to create a loft. The sides have wooden boards, with a slatted front. Access was via a removed ladder to an opening in the east side of the loft.

Plate 2 View of the farmyard showing barn 3 (centre) and barn 2 (right). Looking northwest.

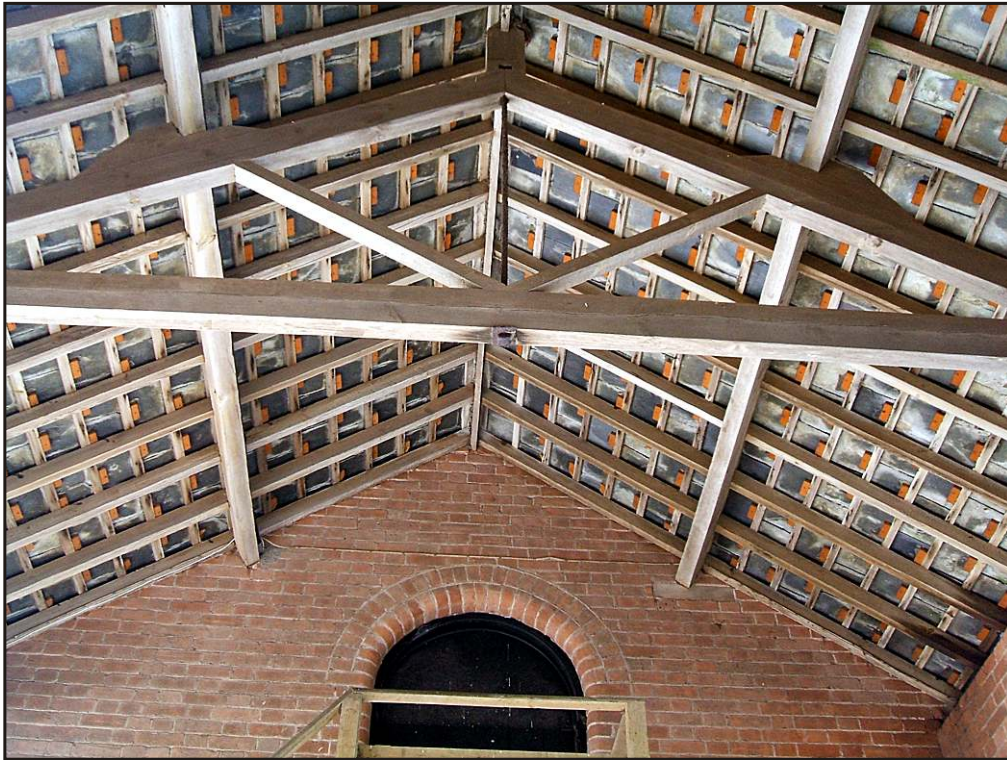
With a couple of exceptions the roofs of the buildings are all of the same style with principle rafters resting on ties attached to the top of the walls (pl. 3). These rafters are supported by diagonal braces flanking a central vertical iron 'king post'. There is a single row of either through or trenched purlins on each side and a ridge purlin set within a yoke. The roof coverings are slates nailed to batons, with small ceramic wedges used to support their lower ends. It is unclear whether these wedges are contemporary or later than the original roof.

ridge purlin rests between the top of the rafters. The roof of the adjacent covered way is of the standard type described in section 4.1 above (pl. 3).

Plate 3 The roof over the entrance of barn 2. Looking southwest.

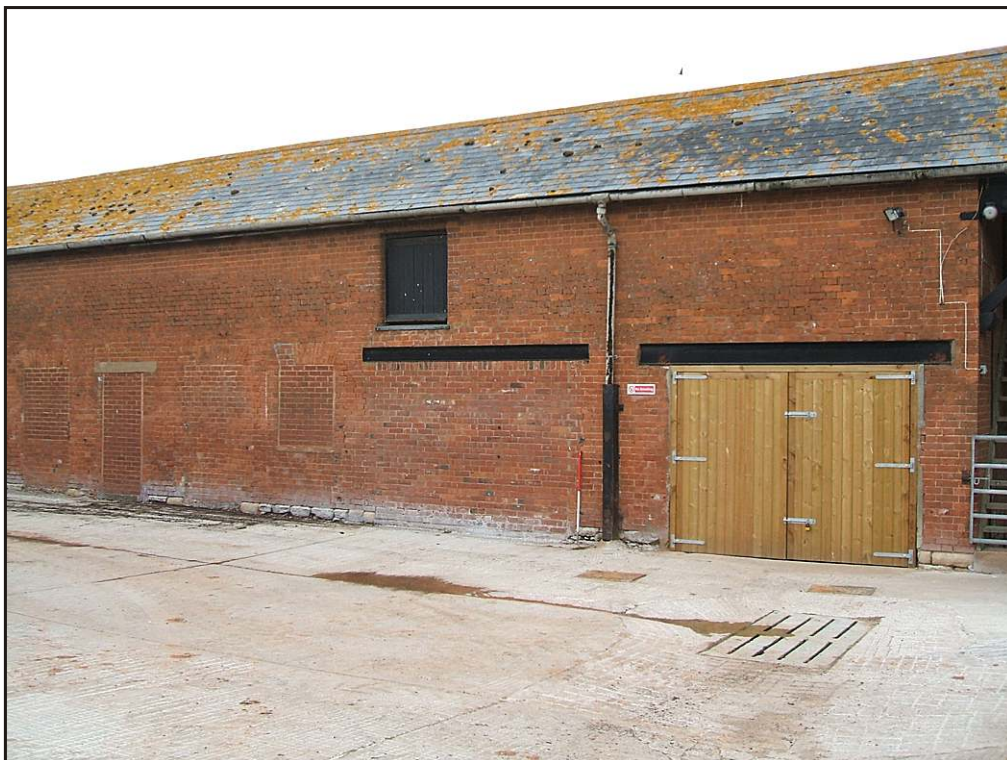
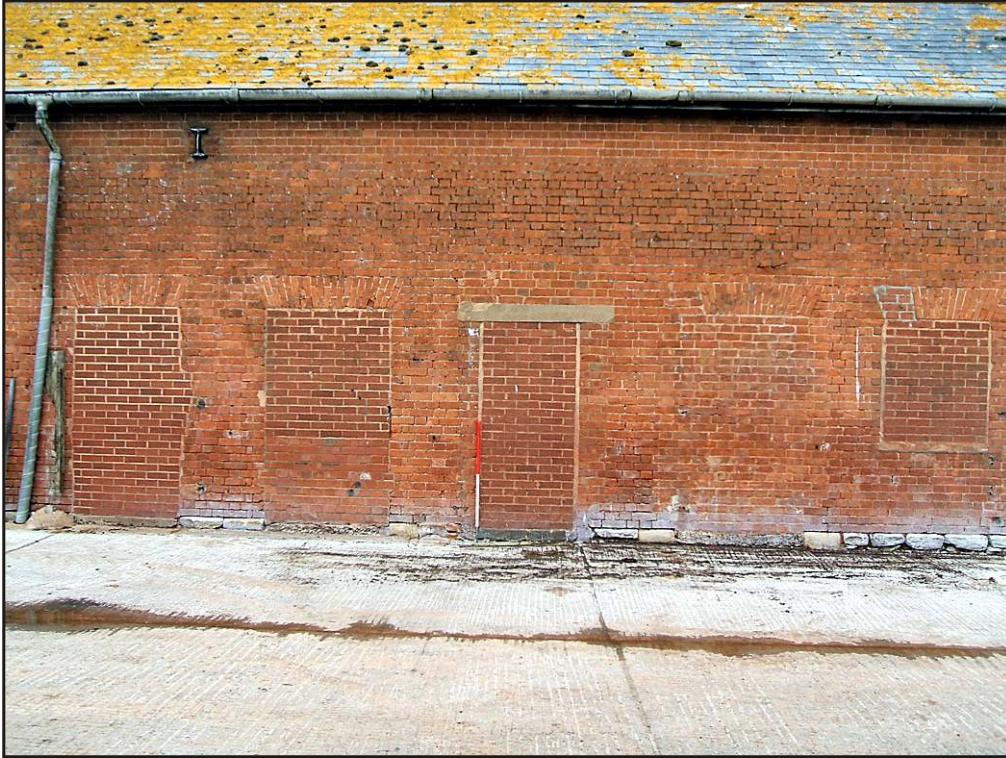
To the west of the covered way this range contains a large room, with a smaller room at the west end. On the ground floor there are a series of open and blocked door and window openings facing the farmyard (pls 4-5). Within the east room there were originally five doorways, and at least two windows. Two further doors have been added, one of which is blocked. At the east end of the room there are two large openings with rolled steel joist lintels. The west opening has been blocked and the east opening is opposite a blocked opening on the north elevation. There is a similar opening with rolled steel joist lintel in the west room, blocked in two phases (initially to form a smaller door), along with a blocked window. There is also a blocked opening into the east room in the east elevation from the covered entrance way. The west room has a wide arched opening in the east elevation providing access from the small yard. This has been blocked in two phases, initially to provide a central door. There is an interconnecting door between the two rooms. In the north elevation the only original openings are a series of small iron vents serving the east room. Modern doorways have been added to facilitate access to both rooms.

Plate 4 Barn 2, south elevation showing blocked openings, looking west. 1m scale.

Plate 5 Barn 2, south elevation showing blocked openings, looking northwest. 1m scale.

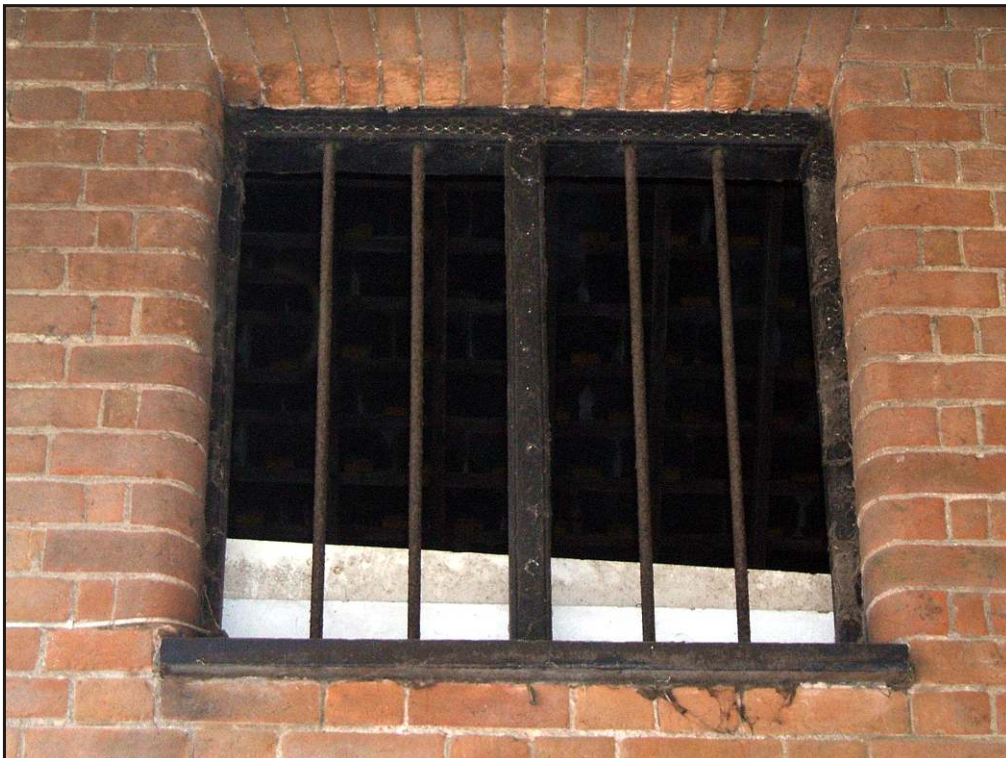
This building forms part of the west side of the yard, and is structurally integral to, and under the same roof as, barn 8. The building is two storied. In the east elevation there is evidence for one primary door and two windows, all now blocked. Later double doors and a large opening may have removed evidence for further openings. The latter was provided to allow vehicular access to the farmyard. There is a similar opening on the west elevation of the barn. There is a blocked door in the south elevation providing access from the north return of barn 5, and a blocked central door into barn 8. There are four windows serving the first floor loft (pl. 6), two of which are blocked, along with a door that is entered by a modern flight of stairs. Internally, there is a wooden loft ladder in the southern bay. Attached to the south gable is a weathervane.

Plate 6 Barn 4, close-up view of first floor window, looking southwest.

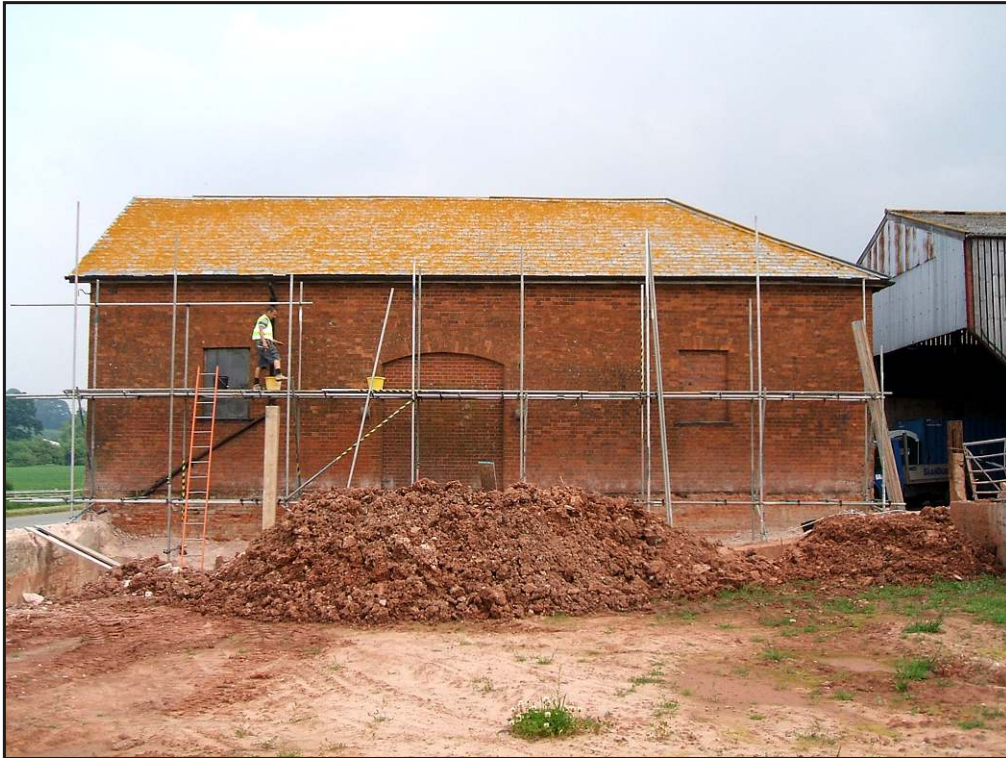
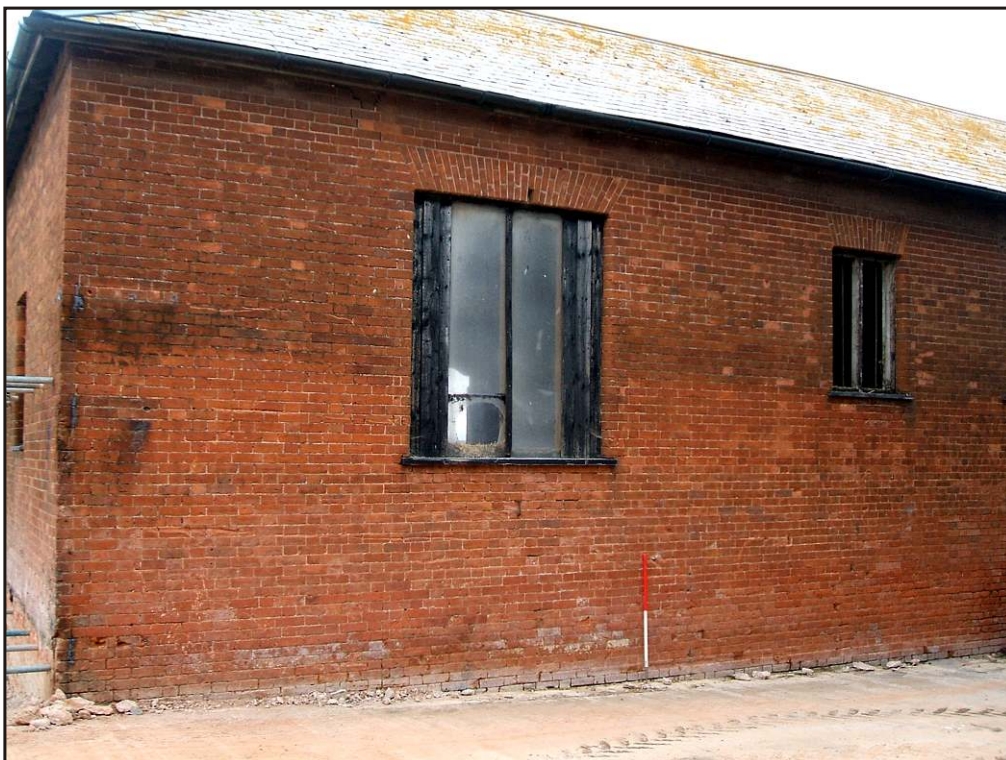
This building forms the west side of the small western yard. The building is L-shaped and two-storied in height but designed with a tall ground floor open to the roof. The building has slightly staggered large opposing entrances in the east and west elevations, the latter being blocked, and having granite corbels and sockets for a removed canopy or porch. The opening is flanked by two windows, one of which is blocked (pl. 7). In the north elevation fronting the road is the remains of a high-level rounded-head window, which has been truncated by the insertion of a large modern opening allowing vehicular access. In the south elevation are two high-level windows of different sizes (pl. 8). In the eastern part of the building there is a door and a window in the north elevation. These share the same arch, the only example in the complex to have such an arrangement. In the east elevation there is a blocked doorway giving access to barn 8. Two large timbers have been inserted through the archway of this door. These support a horizontal beam onto which is attached a small axle bearing containing part of a driveshaft. To the south of this door were joist sockets, possibly for a mezzanine floor associated with machinery.

Barn 7 was designed as a threshing barn. Although its architectural style is consistent with the rest of the planned farm the building displays the distinctive large central loading doors associated with (earlier) threshing barns, the west door also originally having a canopy or porch. The building is situated on the west side of the range and receives the southwesterly winds that would have aided threshing. These factors indicate that threshing was undertaken by hand when the building was constructed. The remains of an inserted driveshaft survive passing through the east wall. What this powered and the layout of machinery is unclear. However, it seems likely that a small steam engine was inserted into the eastern part of this building (as evidenced by the alterations to the masonry) that could have powered a threshing machine, as well as machinery in building 8 (see below).

Plate 7 Barn 7, south elevation, looking northeast.

Plate 8 Barn 7, south elevation, looking north.

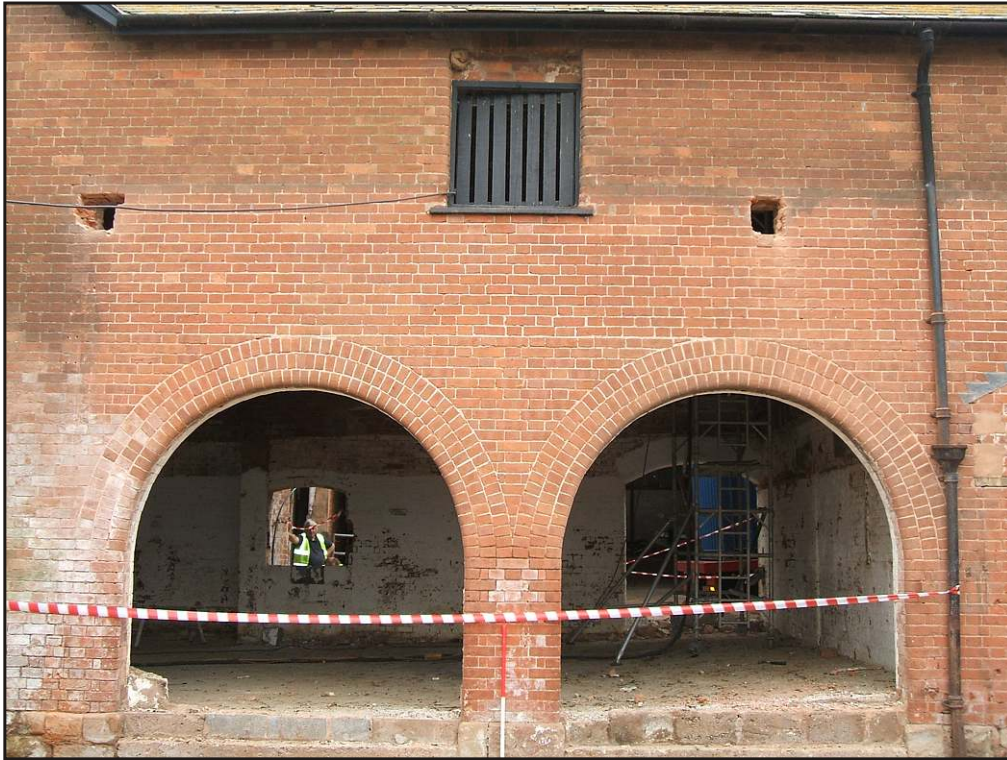
The west room is entered through two large round-headed openings in the north elevation that would have provided access for carts from the small yard (pl. 9). There are also two doors in the south elevation, one of which had been blocked. The first floor had been removed, but remains of a central large beam survive, as do sawn-off joists in the west elevation. At first floor level there is a door and a window in the south elevation, the former entered by a flight of external stairs of which only the top limestone step survives (pl. 10). There is a single window in the north elevation. Attached to the roof at the west end of the building is a drum for a hoist with a rope/belt drive at one end (pl. 12). The drum has a hand-operated brake; the chain to operate the brake is missing. The only other fitting is a small metal drinking trough attached to the west elevation. The concrete floor, which is raised above the 19th-century floor level, has sockets for removed vertical posts.

Plate 9 Barn 8, north elevation. 1m scale.

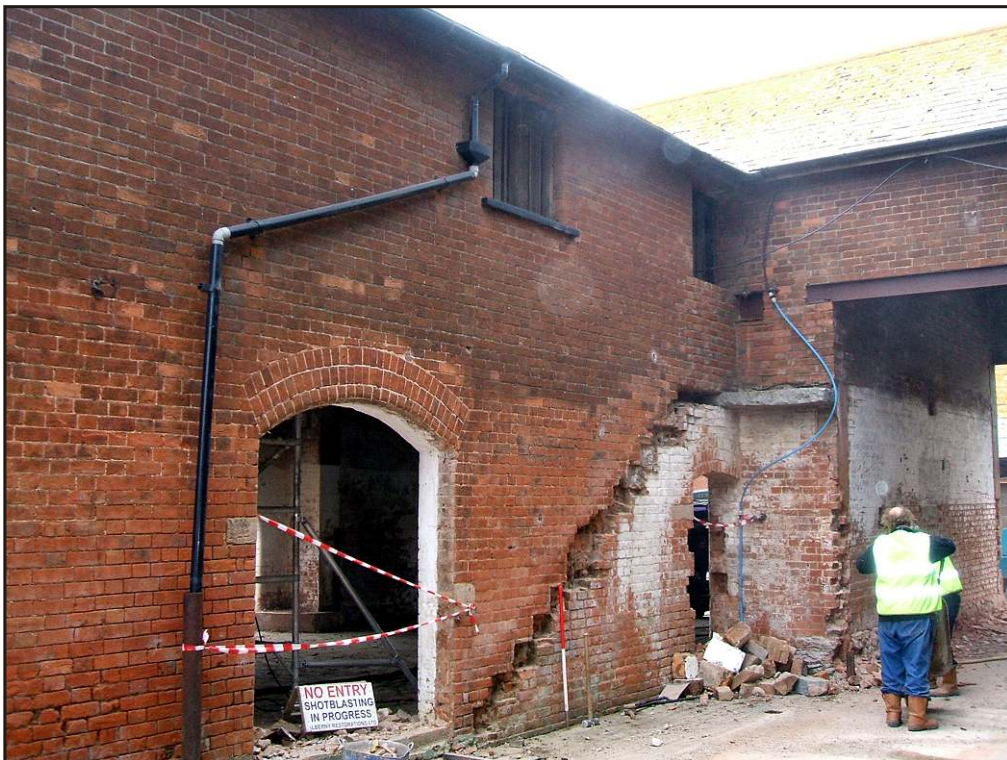
Plate 10 Barn 8, south elevation showing former steps, looking north. 1m scale.

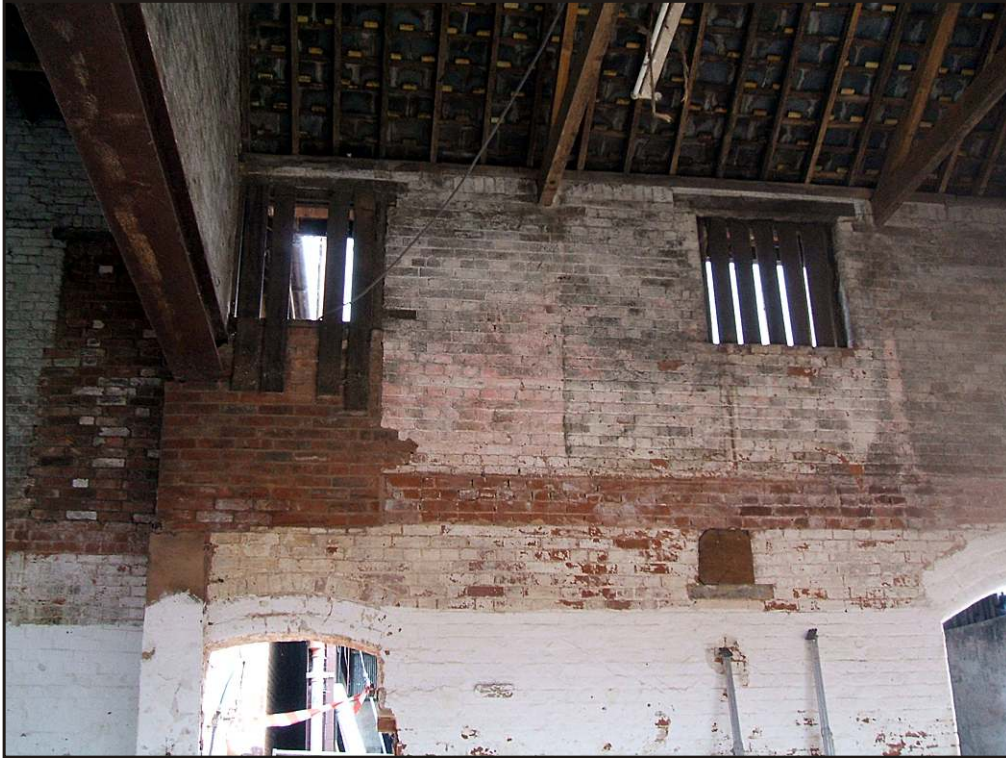
This building is attached to barns 4 and 7 and forms the northwest side of the main yard and the south side of the small yard. The building was originally divided into two rooms, but the internal wall on the ground floor has been removed, along with the first floor joists creating a large space (pl. 11).

Plate 11 Barns 7 and 8, south (inside) elevation showing removed wall (left) and beam (right) looking southeast.

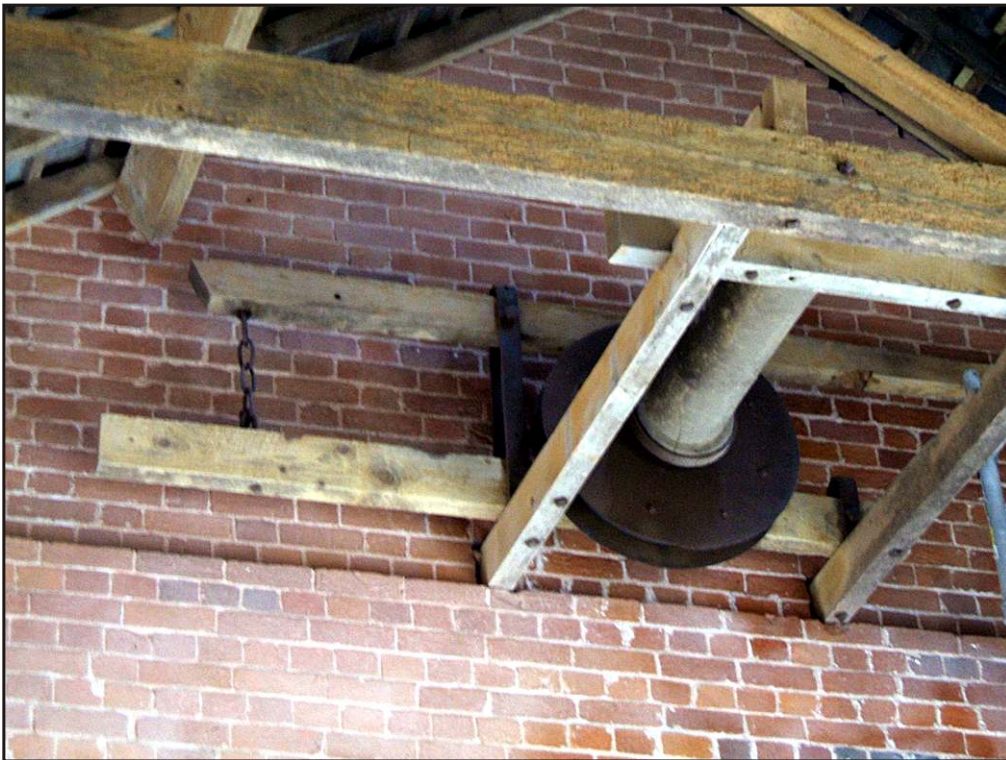
Barn 8 probably had several functions. The west room is open-fronted to the north fronting allowing access for carts from the small yard. The hoist above indicates that the loft was used for storage. This hoist may at some stage have been powered using the driveshaft from barn 7. Hay, or other crops, could have been directly hoisted from carts below into the loft. The function of the ground floor of the east building is uncertain. The building appears to be too large for housing animals, although could have provided further stables. Another possible interpretation is that the building was a pound house containing an apple crusher. Such

Plate 12 The hoist in barn 8. Looking northwest.
