**ARCHAEOLOGICAL RECORDING
OF A BARN AT UPCOTT COTTAGE,
COOKBURY, DEVON**

Exeter Archaeology

Report No. 08.76

November 2008

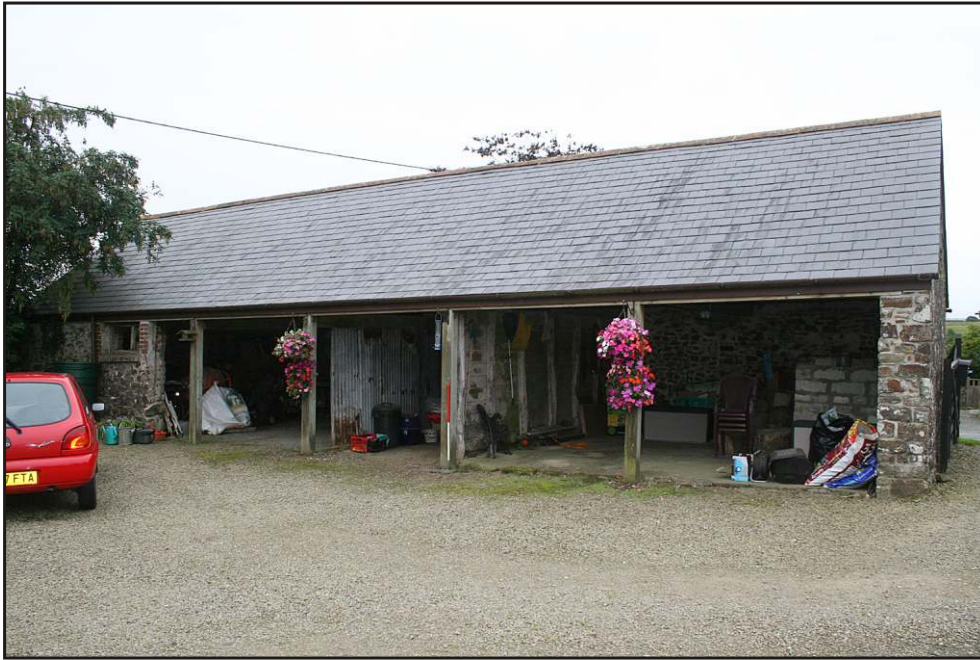
Plate 1 North elevation of barn, looking south. Scale 1m.

In the north elevation bays 1 and 2 have been enclosed with a wall constructed of irregularly-laid sandstone bonded in grey-white cement with patchy intense inclusions of slate-derived gravel. The wall incorporates a high-level window with brick jambs on its west side and a wooden frame. In the west end of the wall is a chase for a removed door frame.
