ARCHAEOLOGICAL MONITORING AT CLEEVE ABBEY, WASHFORD, SOMERSET

Prepared on behalf of English Heritage

Exeter Archaeology

Report No. 09.24

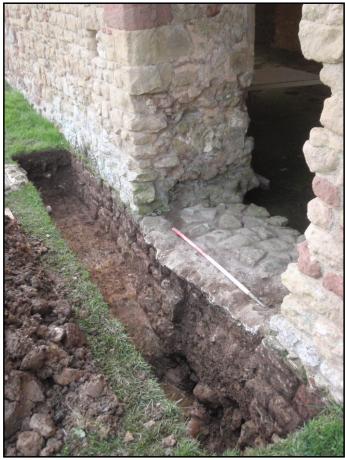
Pl. 1 General view of Trench 1. Looking south-west. Scale 1m.

This trench measured 4.3m x 0.6m, was orientated N-S and was excavated to a maximum depth of 1.05m. The remains of a modern drain were located at the northern end of the trench. A single archaeological feature was present and consisted of the remains of an E-W aligned ditch, cutting natural subsoil at a depth of 0.4m below current ground level. This was sealed by Dissolution demolition deposit (101). Detailed context descriptions for this trench are set out in Table 1, Appendix 2.

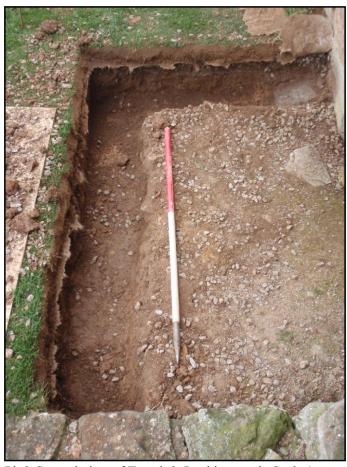
Pl. 2 General view of Trench 2. Looking south. Scale 1m.

This trench measured 2m x 1.6m, was orientated NW-SE and was excavated to a maximum depth of 2m. Alluvial clay (204) was exposed at a depth of 1m below ground level (5.68mAOD), overlain throughout the trench by probable 19th-century made ground (203), which was in turn overlain by modern made ground (201-2). No archaeological features, pottery or other finds were present. The layer sequence is set out in Table 2, Appendix 2.

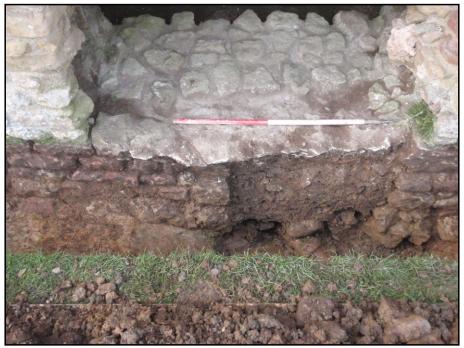
Pl. 3 General view of wall foundations truncated by modern drain Trench 1. Looking west. Scale 1m.

The earliest structure present on the site was represented by the rubble foundation of the east wall of the Day Room (106). This is part of the mid 13th-century phase of works and like other portions of the claustral buildings constructed at an early stage in the building programme, this was built of red sandstone.

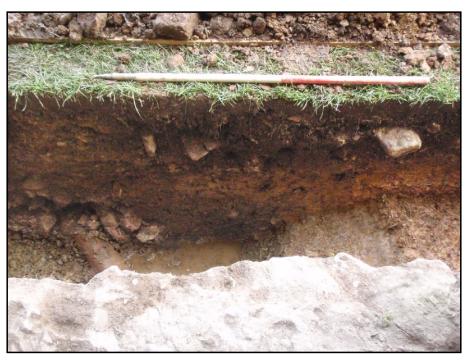
Pl. 4 Section through medieval drainage ditch [102], Trench 1. Looking east. Scale 1m.

Feature 102 was a linear feature aligned approximately E-W. This probable ditch was at least 1.3m wide and 0.63m deep, with a gradually breaking western side and a flat base. It was heavily truncated along its eastern side by a modern drain. No finds were recovered from its fills (103 and 104). These consisted of a primary deposit of gradually silted in mid grey silty clay (103) and a deliberate infilling of probable bank material represented by a mid yellow brown silty clay (104).

The remains of a roughly E-W aligned linear [102] were uncovered at the northern end of Trench 1. This was truncated by the foundations of the eastern range of buildings and is therefore likely to precede the construction of the Abbey in the late 12th century. It would seem to have been deliberately backfilled prior to the construction of the Day Room and the Infirmary cloister, with bank material (104) pushed in from the southern edge. Additional evidence from environmental analysis of fill (103) would suggest that the plant macrofossils recovered are typical of scrub or hedge-banks. This linear may have been part of a more extensive field system dating to the medieval period.
