**ARCHAEOLOGICAL MONITORING  
AT PRIORY COTTAGE, SNAPPER,  
BARNSTAPLE, DEVON**

**Exeter Archaeology**

**Report No. 09.64**

**May 2009**

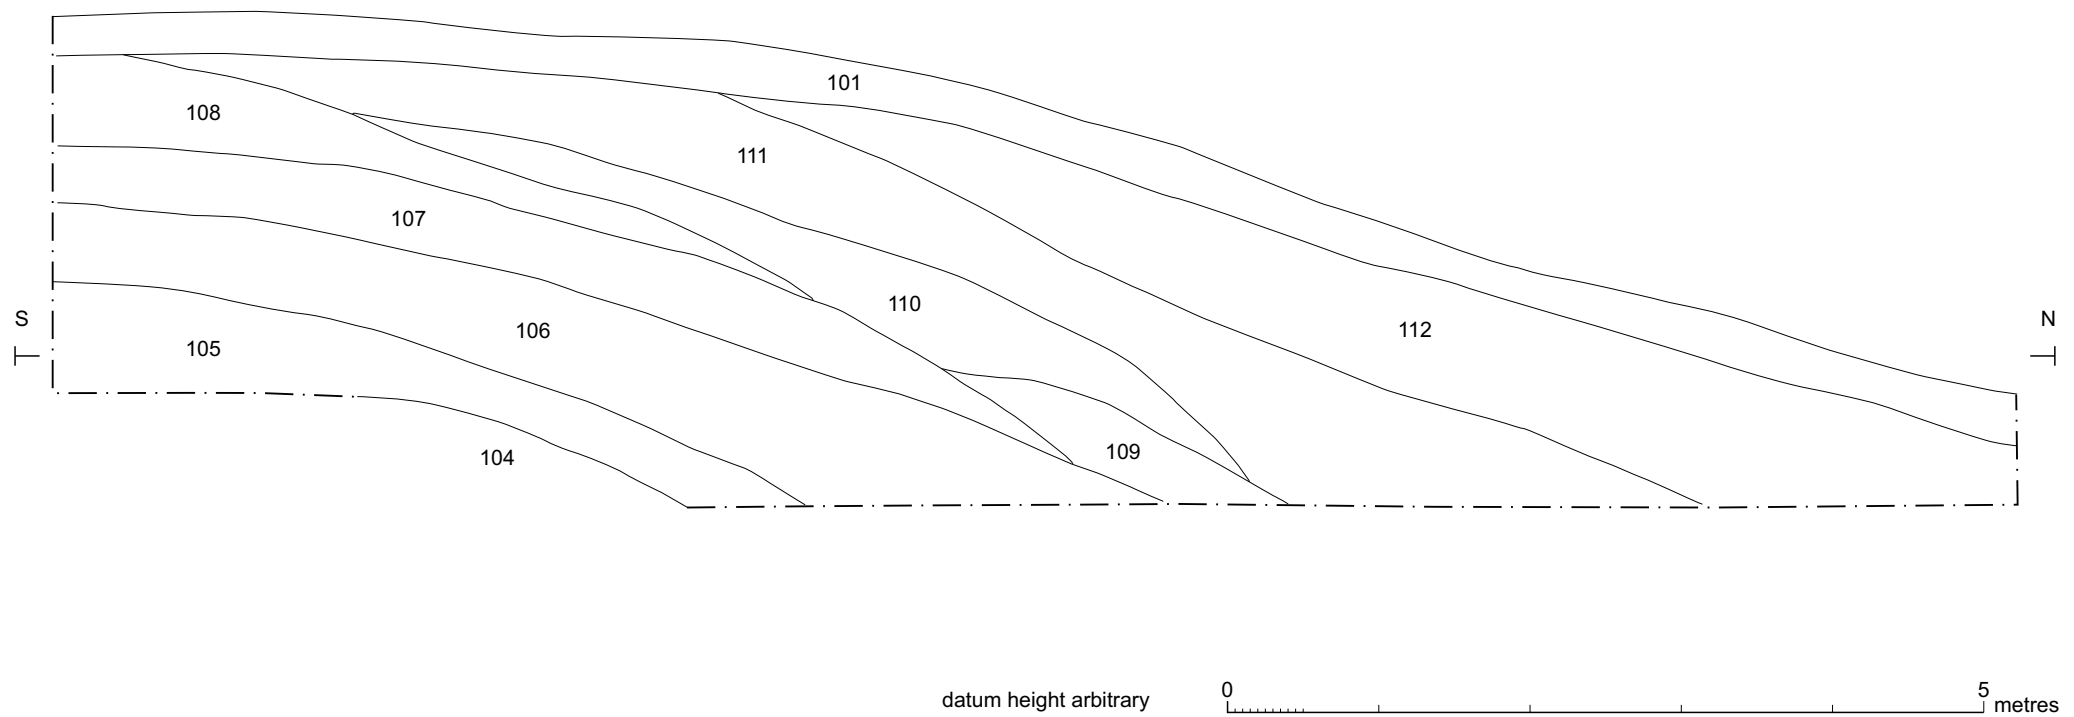
Fig. 3 Section through earthwork bank. Scale 1:50.

The area behind the converted outbuilding was excavated to the site boundary, and would have involved the removal of some archaeological remains related to the earthwork in the next field. A section was recorded through the earthwork bank, which survived to a height of 3.1m. This consisted of material removed during the construction of the building terrace to form an artificial southeastern boundary. No finds were recovered from the fills.

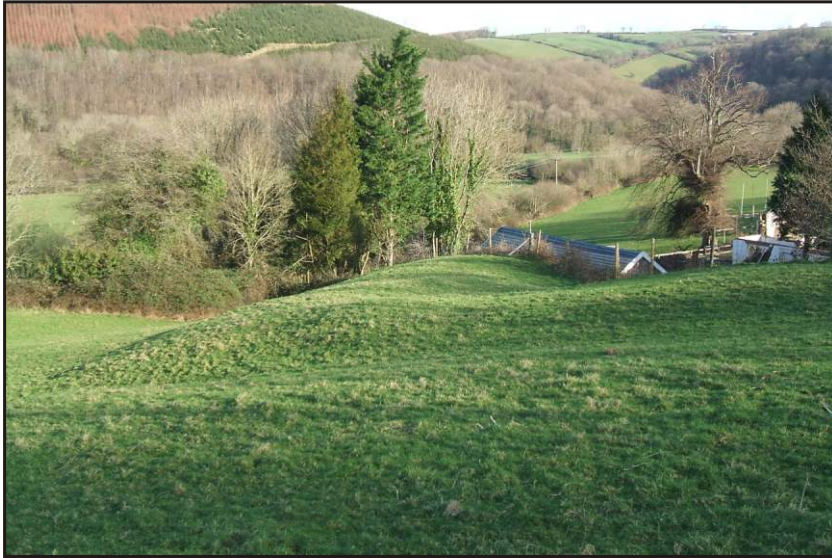
Pl.1 General view of earthwork. Looking north-east.

This linear bank extended 20m southwest from the edge of the site. This was completely removed by the current development within the construction area. The bank was up to 11m wide with a maximum height of 3.1m. It had a gradual northwest

face and sloped away very gently at the back. The bank appeared to merge with earthwork (3).

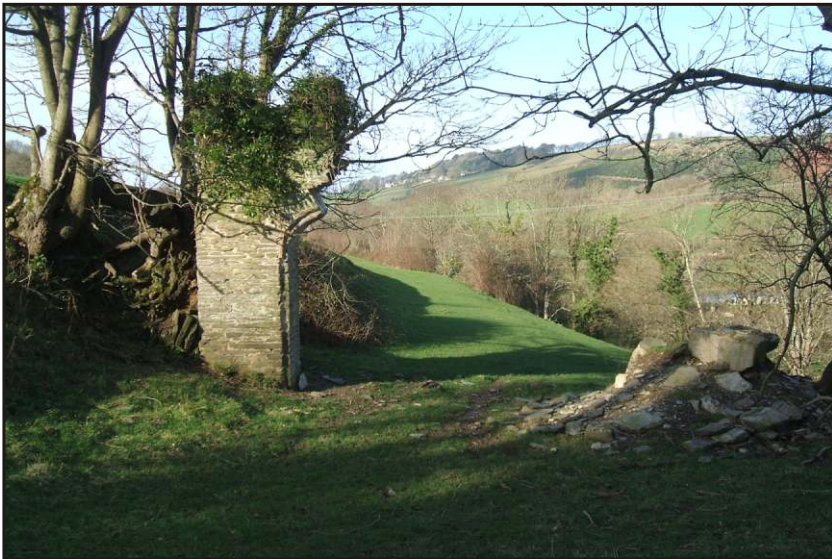
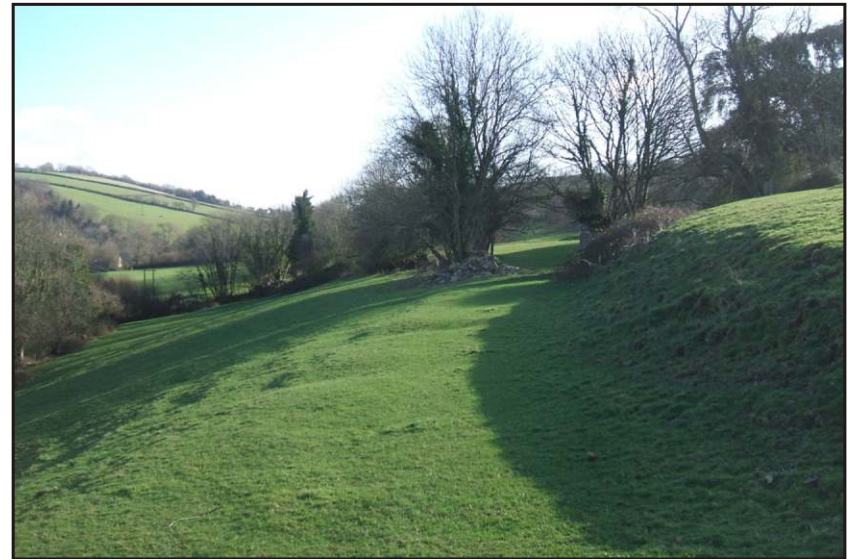
This consisted of the remnants of a four-centred archway and the possible remains of a flanking tower. The remains consisted of one jamb of a four-centred arch, and although overgrown with vegetation, the remains of a parapet. The stonework was of good quality and was bonded with lime mortar. This type of arch was in use between the 15<sup>th</sup> and early 17<sup>th</sup> century; a gateway of this size would not have been used for a farm and indicates the presence of a fairly affluent country house on the site. The pile of rubble to the north of the surviving upright is unlikely to be the return of the arch, as it is considered to be too far away, but could possibly be the remains of a flanking tower or stair turret.

Pl. 3 General view of gatehouse remains. Looking north-west.

Pl. 4 General view of remains of gatehouse front. Looking south-east.

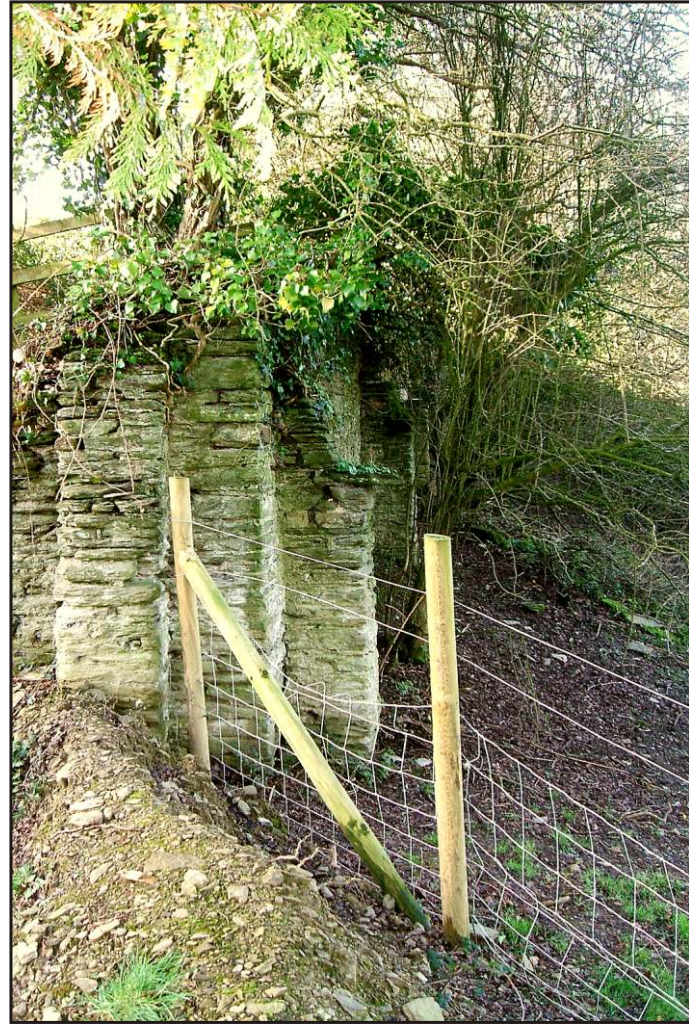
Pl. 6 General view of stone retaining wall at the front of building terrace. Looking north-west.

This large terrace was cut into the hillside; it covered a semi-circular area c. 112m long and 60m wide. This was revetted along the north edge by a stone wall with buttresses at regular intervals, and which survived in places to a maximum height of 1.2m. The sides were heavily weathered along the southwest and southern edges, with the southeast edge consisting of an earthwork bank (2). The base of the terrace showed signs of erosion leading away from the centre to the northeast. The main access would presumably have been via a gatehouse (6) located at the northwest edge, with a road (7) leading away to the west and which was traced for approximately 200m. Two smaller trackways (4) and (5) may have provided access to the southeast and southwest. A smaller, secondary, building terrace may have been located in the southern corner near track (5).
