**ARCHAEOLOGICAL WATCHING BRIEF
ON THE ST ENDELLION TO ST MABYN
PIPELINE, WADEBRIDGE CORNWALL**

**Prepared on behalf of
South West Water**

Exeter Archaeology

Report No. 09.95

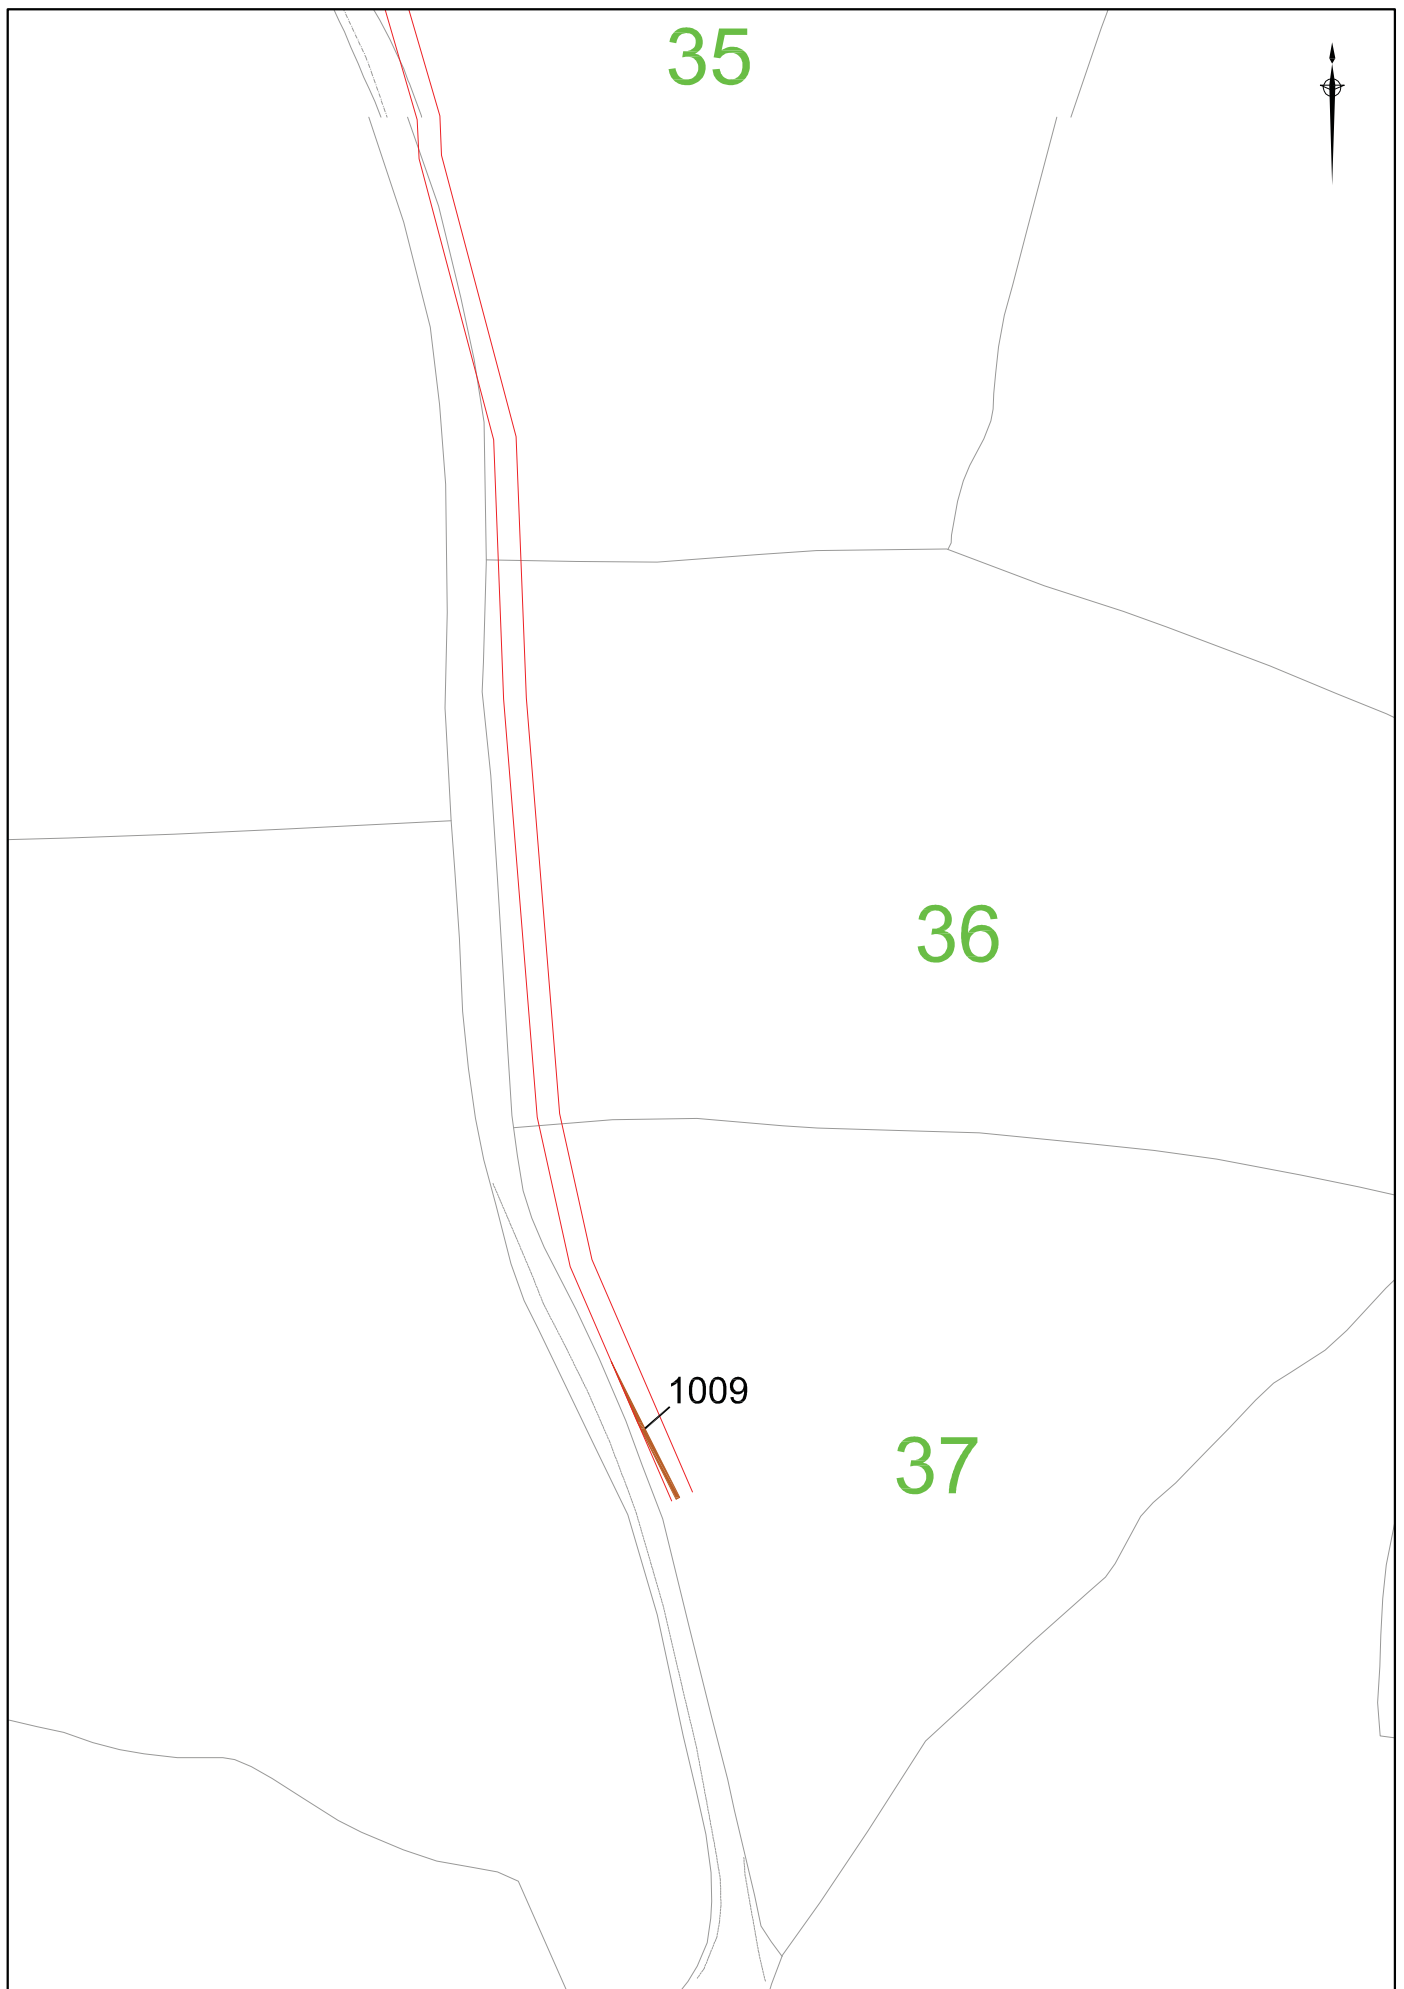
Fig. 6 Fields 35-37 showing easement (red) and location of archaeological observations (brown). All rights reserved. © Crown copyright South West Water WR 98035. Scale 1:2000.

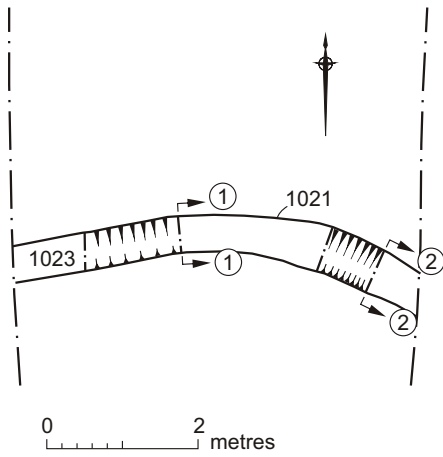
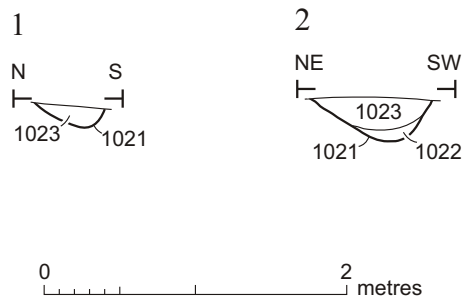
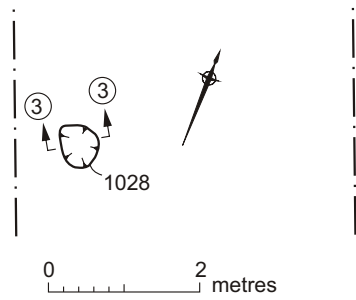
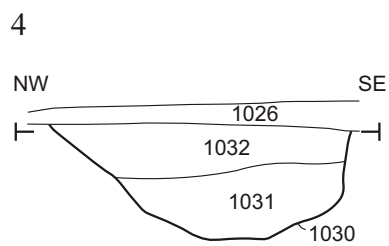
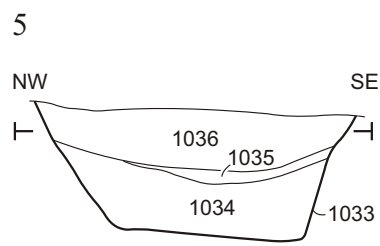
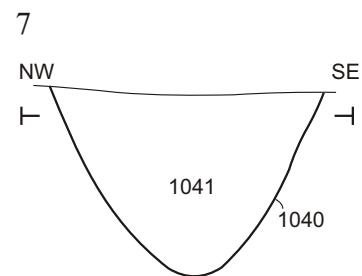
Fig. 7 Plans and sections Fields 15 and 16

The initial topsoil strip exposed a curvilinear ditch (1021) at the southern end of field 15 (Plate 2). This curved from W to SE and measured 0.61m wide and 0.29m deep. The linear feature had gradually breaking sides which showed evidence of weathering, and a concave base. No finds were recovered from the two clay-based fills (1022) and (1023).

The topsoil strip in field 16 was insufficiently deep in places to expose natural subsoil. However a small, irregular, pit (1028) was uncovered at the SE end of the field. This measured *c.* 0.6m long, 0.52m wide and 0.1m deep. The edges were shallow and gradually inclined with a flat base. Although the pit contained only a single, charcoal rich, fill (1029) there was no evidence of *in situ* burning.

During the subsequent trenching operation four further features were identified in field 16. All appeared in the opposing sections of the trench and were probably the remains of linear features. Feature 1030 was linear in form and aligned approximately NE-SW (Plate 3). This probable ditch was 2.01m wide and 0.76m deep. It had a vertical SE edge, a gradually breaking NW edge and a concave base. The ditch contained two separate clay based fills (1031 and 1032). This feature appeared to be associated with linear feature 1033. This was aligned in an identical direction and measured 2.15m wide and 0.82m deep. It had sharply breaking sides and a flat base and was infilled with three clay based fills (1034, 1035 and 1036).

Additional elements of what may well be a contemporaneous field system were exposed further to the SE - features 1037 and 1040. Both were similar in character and lay broadly parallel to each other. Feature 1037 was *c.*1.95m wide and 1.02m deep, with gradually breaking sides and a concave base. It contained two clay based fills (1038 and 1039). Feature 1040 was *c.*1.8m wide and 1.2m deep, with gradually breaking sides and a concave base. It contained a single clay based fill (1041).

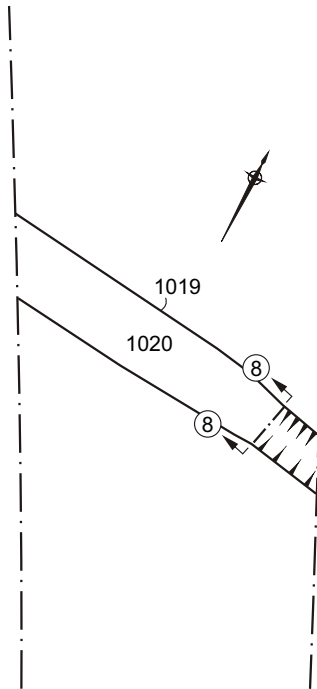
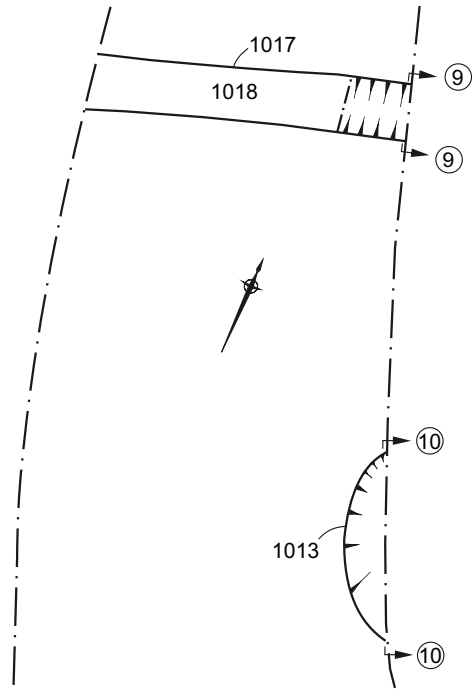
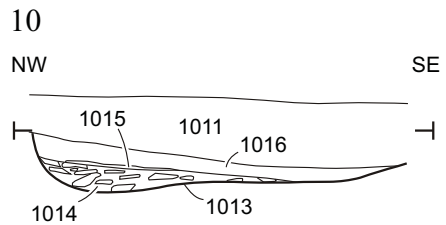
Fig 8 Plans and sections Field 28

Peri-glacial feature 1019 was NW-SE aligned and exposed at the north end of the field. It measured 0.97m wide and 0.33m deep, with gradually breaking sides and a flat base and contained a single clay based fill (1020), a mixture of the overlying topsoil and natural subsoil. A second peri-glacial linear feature (1017) was uncovered at the far S end of Field 28. This was a small narrow ditch measuring 0.7m across and 0.2m deep and was aligned in a NE-SW direction. It was fairly shallow with gently sloping edges and a flat base, and contained a single fill (1018).

Immediately to the south of 1017 a large feature (1013) was partially exposed in section. This was *c.* 2.5m wide and 0.3m deep and contained three fills (1014, 1015 and 1016). The primary fill (1014) comprised layers of shillet laid flat with some fragments showing signs of burning. The overlying deposit (1015) was an extremely thin layer (0.02m thick) of charcoal, which was sealed under a burnt orange clay deposit (1016). The NW edge of the feature was sharply breaking and well defined. However, the SE edge was quite diffuse and truncated by roots. It was difficult to interpret the function of the feature, as it was only partially exposed, but it seems likely from the fills and inclusions that it was a small post-medieval or modern hearth or fire pit.

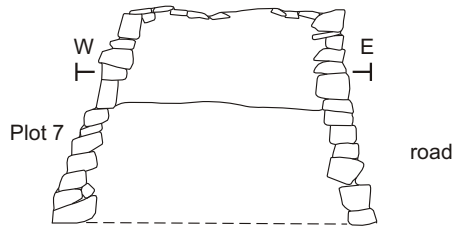
Fig. 9 Sections Fields 7, 33 and 37.

Due to the presence of crops in this field there was no initial topsoil strip. Trenching revealed a large, slightly rounded V-shaped feature (1002), measuring 1.54m wide and 0.94m deep. This was visible in both sides of the trench and was therefore interpreted as an E-W aligned linear feature. It contained a single homogenous fill (1003) and produced no datable material. The feature was located in the northern half of the field, halfway down a steeply graded contour and may represent the remains of a post-medieval field boundary.

In the southern half of field 33 a diffuse feature (1004) was noted. This measured 1.39m wide and 0.28m deep and was only visible in the western trench section. The feature contained two fills (1005 and 1006). Due to the irregular form of the feature, the lack of finds or charcoal and the nature of its fills it is considered to be a naturally formed tree throw or animal disturbance.

A linear feature (1009) was located along the eastern edge of the easement, aligned parallel with the existing hedgebank. It was visible for approximately 40m, with only the eastern edge exposed by the initial topsoil strip. Two separate sections were recorded. In both cases the feature contained redeposited natural infill (1007 and 1010) which produced no datable material. The ditch is likely to be contemporary with the existing hedge.

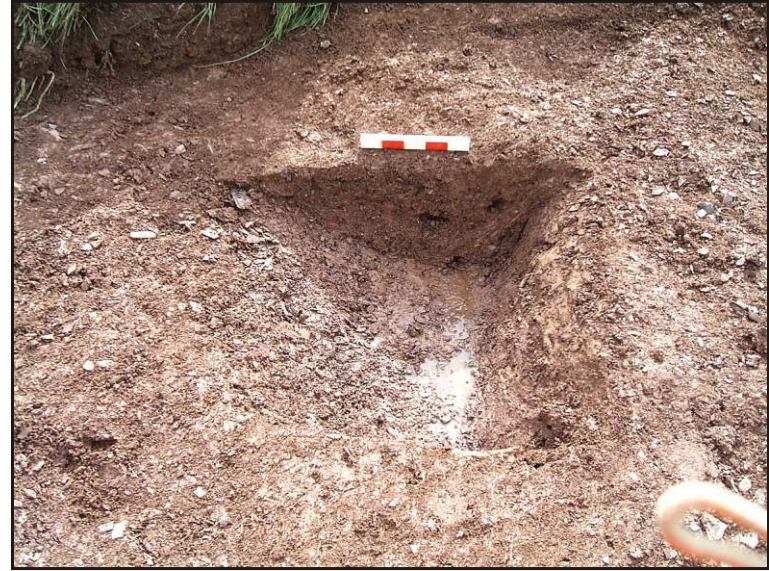
Pl. 2 Section through ditch (1021). Looking south-east. 0.25m scale.

Evidence for early activity within the route of the pipeline is limited to a single feature, ditch 1021 in field 15. In contrast to the majority of the ditches exposed, its line was irregular and more difficult to discern. It also correlates poorly with the alignments of existing banks, and the sides of the ditch were markedly more weathered and eroded. The ditch also appeared to have suffered from a greater degree of truncation than those seen elsewhere within the site. Although no dating evidence was found, the general character of the ditch is not inconsistent with a boundary feature of prehistoric date.

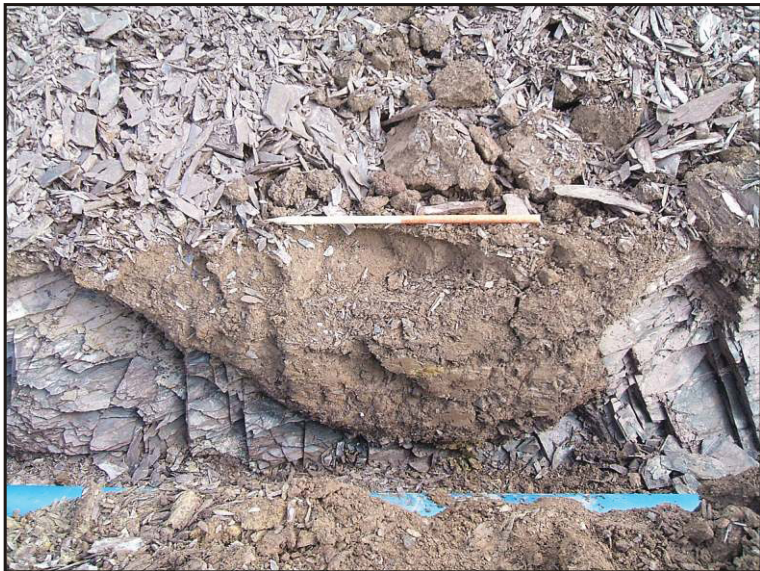
Pl. 3 Section through ditch (1030). Looking north-east. 1m scale.

The principal concentration of post-medieval features was identified in field 16 and comprises two possible trackways that bisect the route of the pipeline on a broad NE-SW alignment. The northern track, formed by ditches 1037 and 1040 is approximately 5m wide, while the southern track comprises ditches 1030 and 1033 and is up to 7m wide. There was no indication that these would have featured any form of laid surface. The tracks share the same broad NE-SW orientation of elements of the existing field system, and in particular, correspond well with the alignment of an extant hedgebank to the north west.
