**AN ARCHAEOLOGICAL WATCHING  
BRIEF AT BRIONY,  
BRATTON CLOVELLY, DEVON**

**Exeter Archaeology**

**Report No. 09.69**

**June 2009**

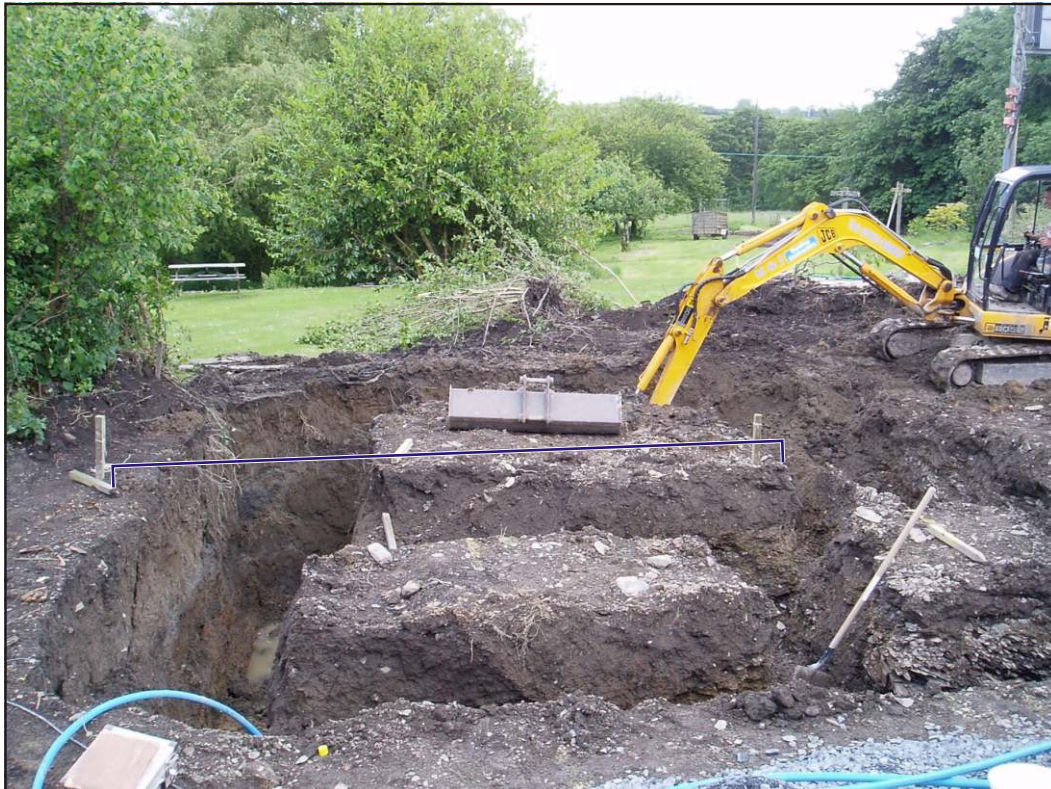
Pl. 1 Working shot looking northeast. The clayey fills of feature 104 can be seen in the deep foundation trench to the left. Blue line indicates location of Section 1.

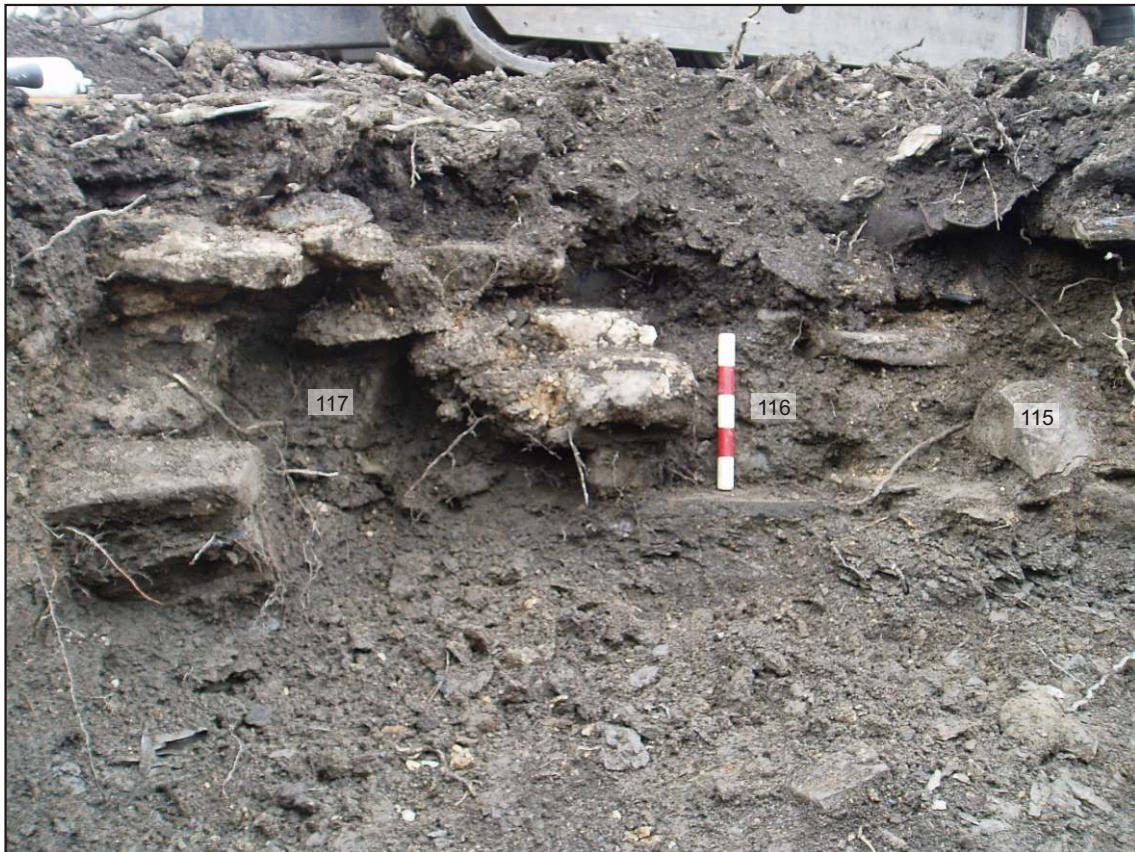
Pl. 2 Walls 115 and 117 and possible drain 116 looking southeast (0.5m scale)

Two sections of wall (115, 117) and a probable drain (116) were exposed, close to the southern edge of feature 104 (Fig. 2; Plate 2). Wall 115 was aligned NE-SW and constructed using faced limestone blocks and a rubble core, bonded with soft lime mortar. At the south-west end it appeared to have been demolished, leaving only a 1.7m surviving length. The northern end was faced, and appeared to form the southern edge to drain 116. Drain 116 was lined with slate, measured 0.4m in width, and appeared to be contemporary with walls 115 and 117. Wall 117 was aligned NW-SE and formed the north-eastern edge of drain 116. It was bonded with hard lime mortar, with a facework of rectangular limestone blocks and a rubble core.

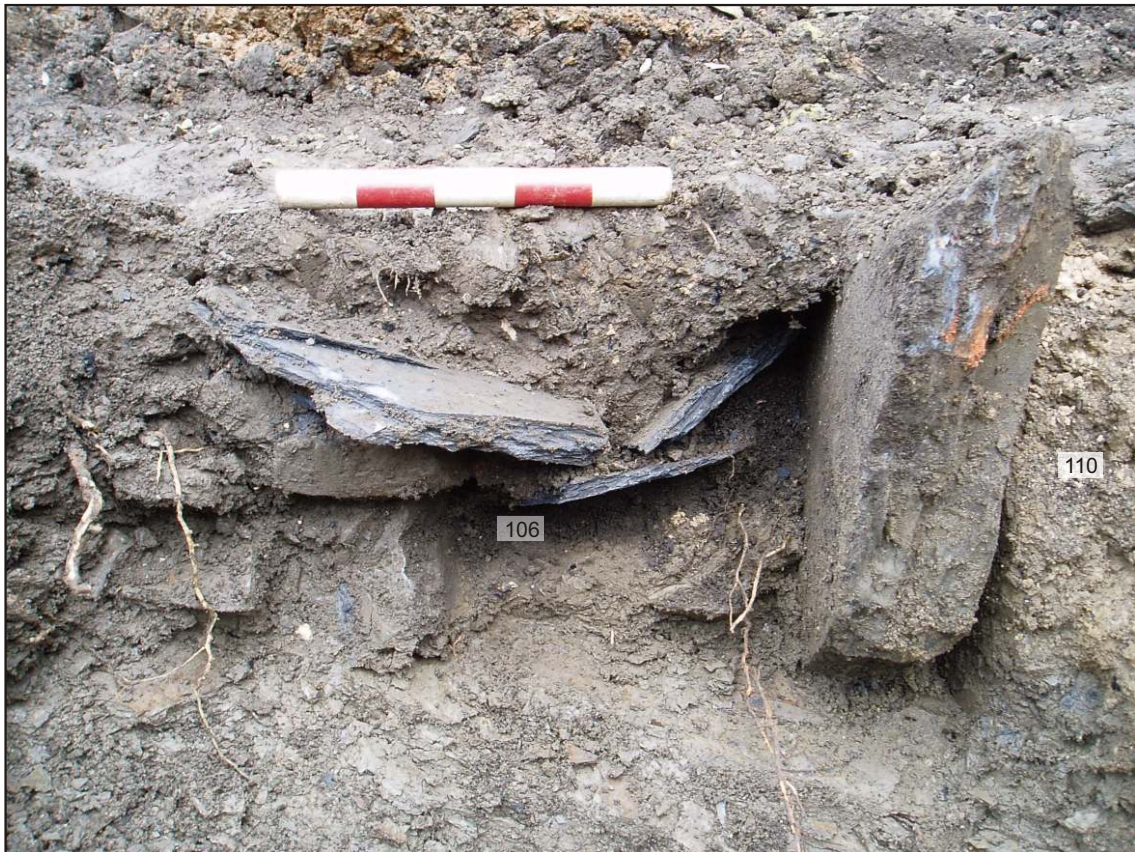
Pl. 3 Drain 106 and layer 110 looking northeast (0.5m scale)

A NE-SW aligned stone-lined culvert (106: Plate 3) cut through layers 109 and 110, hence post-dating wall 115. A layer of dark brown silty clay garden soil or levelling deposit (105) sealed deposits across the site.
