**ARCHAEOLOGICAL TRENCH
EVALUATION AND WATCHING
BRIEF ON LAND AT PIXTON STABLES,
JURY ROAD, DULVERTON, SOMERSET**

Exeter Archaeology

Report No. 09.79

July 2009

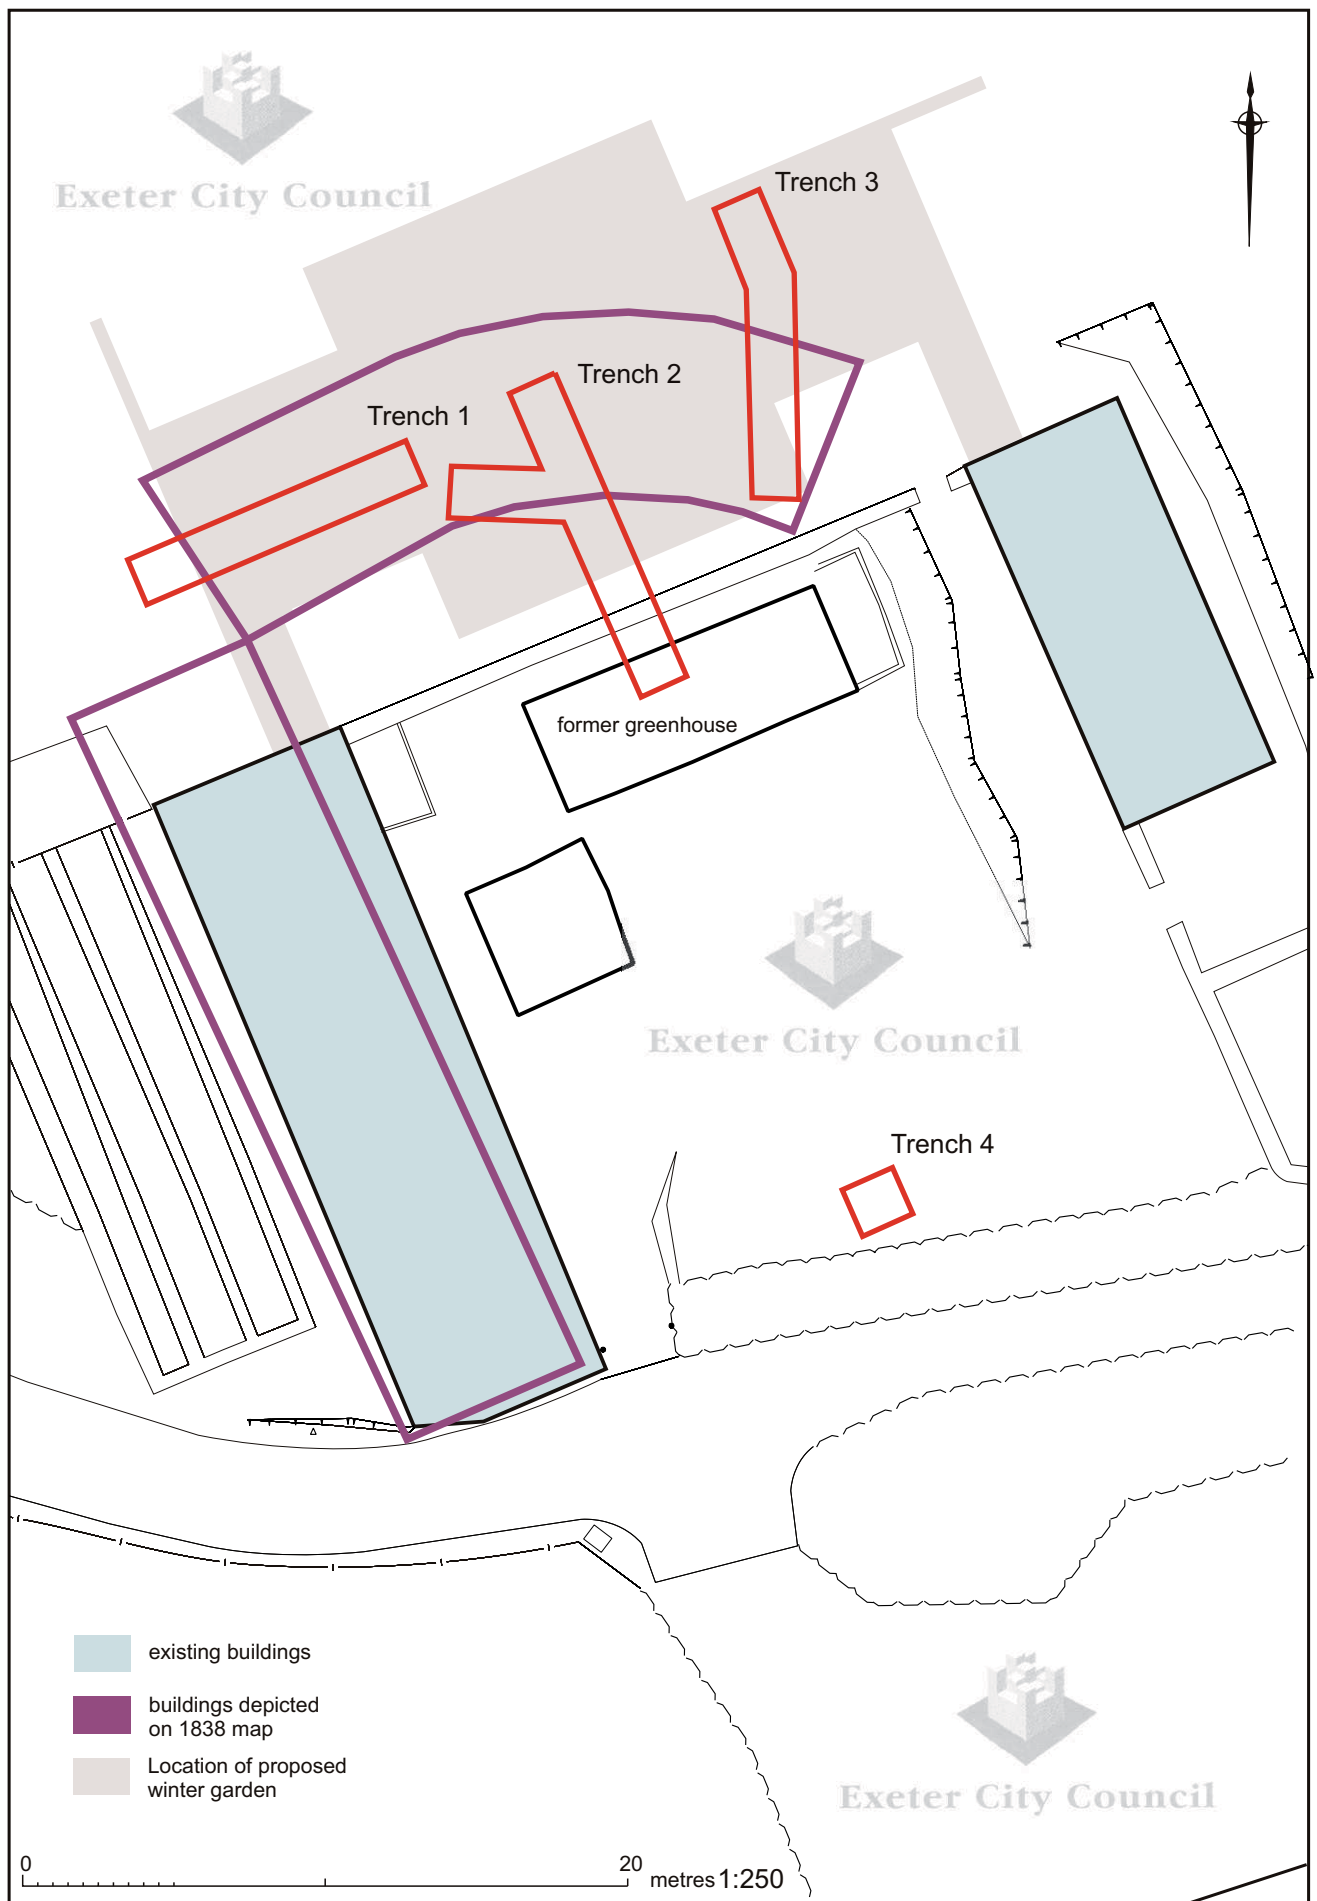
Fig. 2 Trench locations, showing approximate position of buildings present in 1838. Scale 1:250 @ A4. Reproduced from a plan supplied by Louise Crossman Architects.

The existing structures comprise a former stables/laundry on the west side of the site and a potting shed on the east side positioned around a former central courtyard area. A comprehensive assessment and report on these standing buildings has been carried out (Richardson 2007). Historic mapping depicts buildings present on the site since at least 1800. The map of 1838 shows an additional east-west aligned curving structure occupying the approximate area of the proposed winter garden. Buildings appear in their present form by 1890. Fig. 2 shows the approximate position of buildings present on the site in 1800 and 1838.

Three trenches totalling 32m in length were excavated using a tracked excavator fitted with a toothless grading bucket. They were sited across the footprint of the winter garden building in order to establish the potential for survival of *in-situ* archaeological deposits. A small trench (Trench 4) was also excavated within the southern part of the site, along the proposed route of a tunnel connecting the winter garden building to the main house. Trench positions were agreed with ENPA prior to commencement on site (see Fig.2).

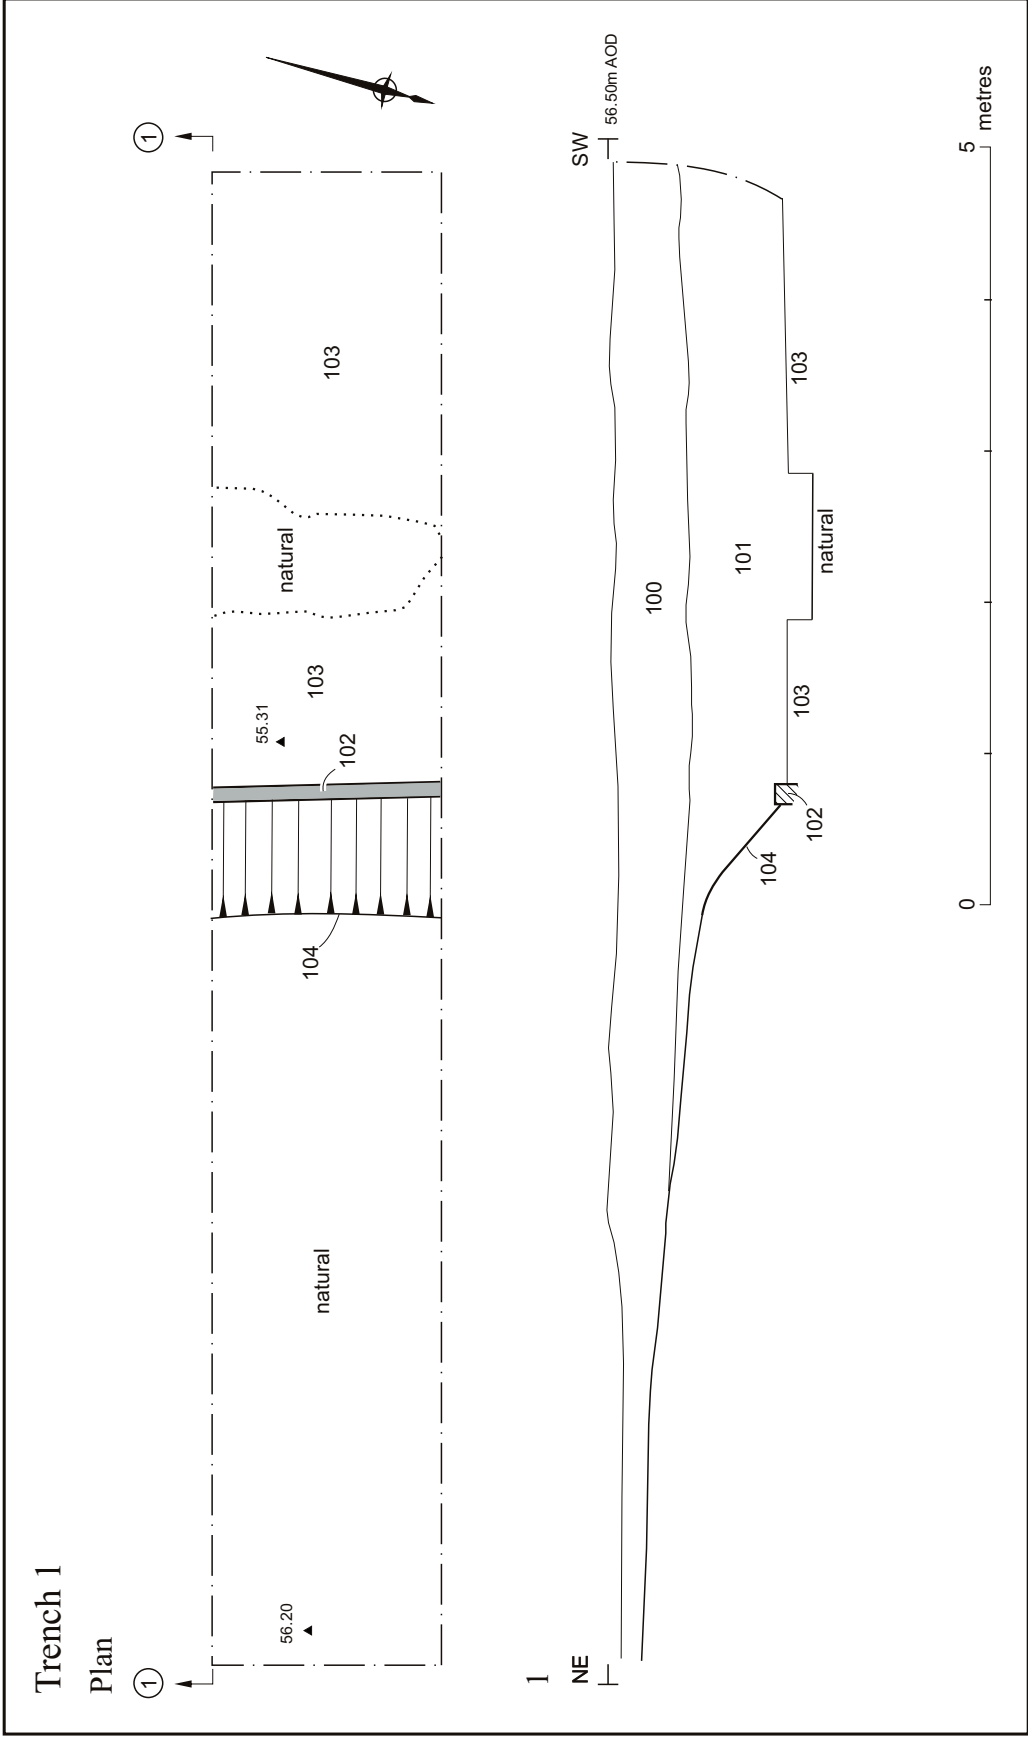
This trench was aligned parallel with the north end of the laundry building. All deposits within the western half of the trench had been removed by a deep terrace (104) for a concrete floor, which extended into natural subsoil to a depth of 0.5m. A single course of stone walling (102) survived along the base of the eastern side of the terrace. The base of the trench consisted of a sub-base (103) for the concrete floor, which was sealed by a mixed levelling deposit containing glass, bricks, broken plant pots and other modern debris. No pre-modern features, deposits or artefacts were exposed.

Fig. 3 Trench 1, plan and section. Scale 1:50 @ A4.

In Trench 1 the remains of a wall and a concrete surface terraced into the natural subsoil, correlate with the wall line and floor level of the existing early 20th century laundry building to the south. This may indicate an original northwards extension of the laundry which is perhaps confirmed by the observation that there are phases of blocking in the north gable end wall of the standing building of the laundry (Richardson 2007, 5). The stone structure (203) located in Trench 2 was not fully excavated. It does not appear on any of the available mapping and could be a well or a sump associated with the laundry building.

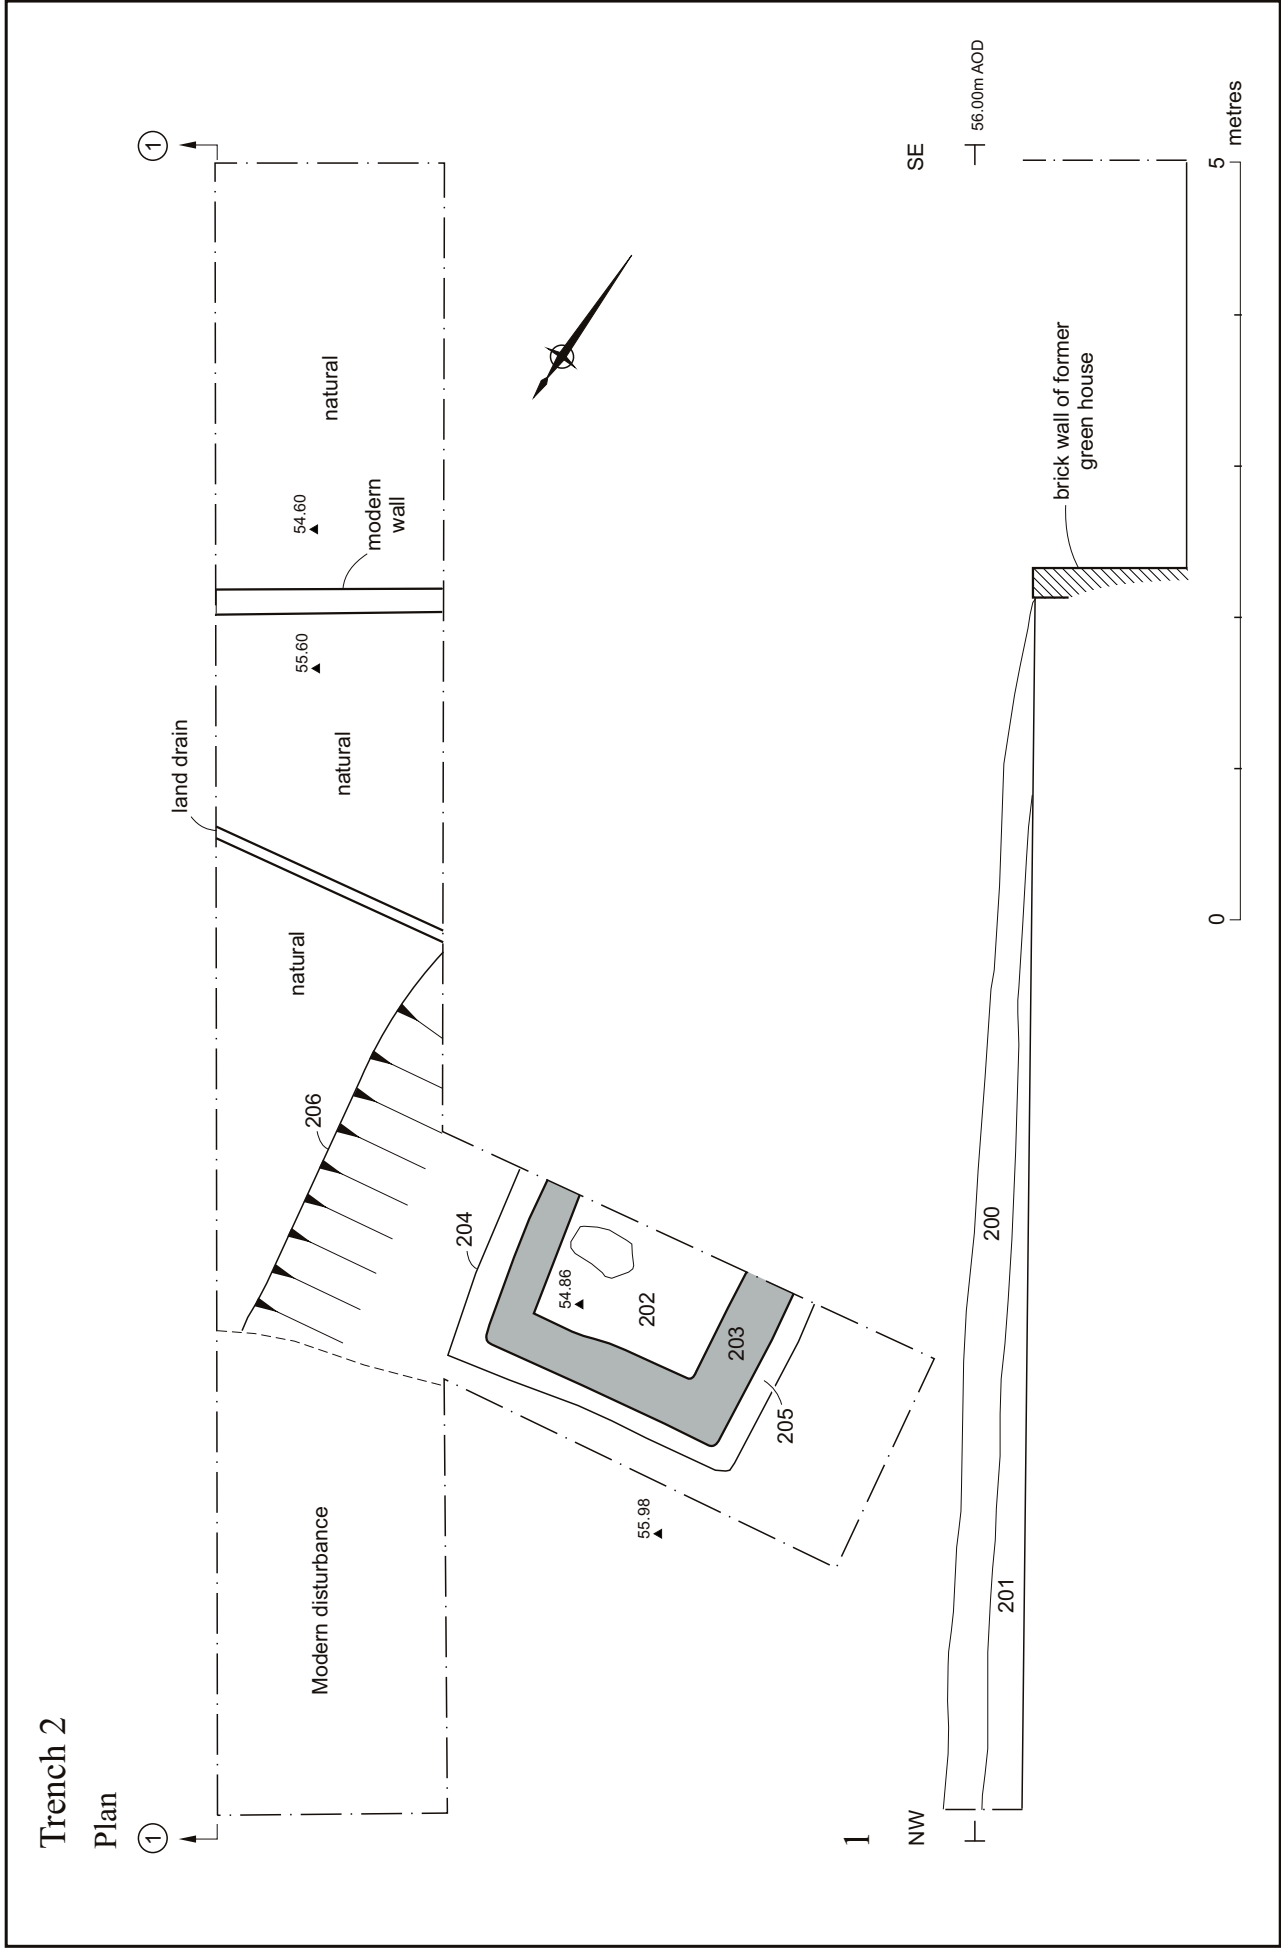
This trench was positioned to determine the presence of intact archaeological deposits to the north of a brick wall, which had formed part of a former greenhouse, terraced into the sloping ground.

The northwestern outer brick wall of the former greenhouse was exposed 2.5m from the south-east end of the trench. To the north of the wall, natural subsoil was exposed at a depth of between 0.2 and 0.5m overlain by modern deposits. A stone-built structure was revealed 3m to the north of the wall. Set within a terrace cut (206) it was square or rectangular in plan and consisted of mudstone walls measuring 0.45m thick. It contained a fill of silty loam, which probably accumulated following its disuse. It was sealed by redeposited soil containing stone, glass and iron nails.

Fig. 4 Trench 2, plan and section. Scale 1:50 @ A4.

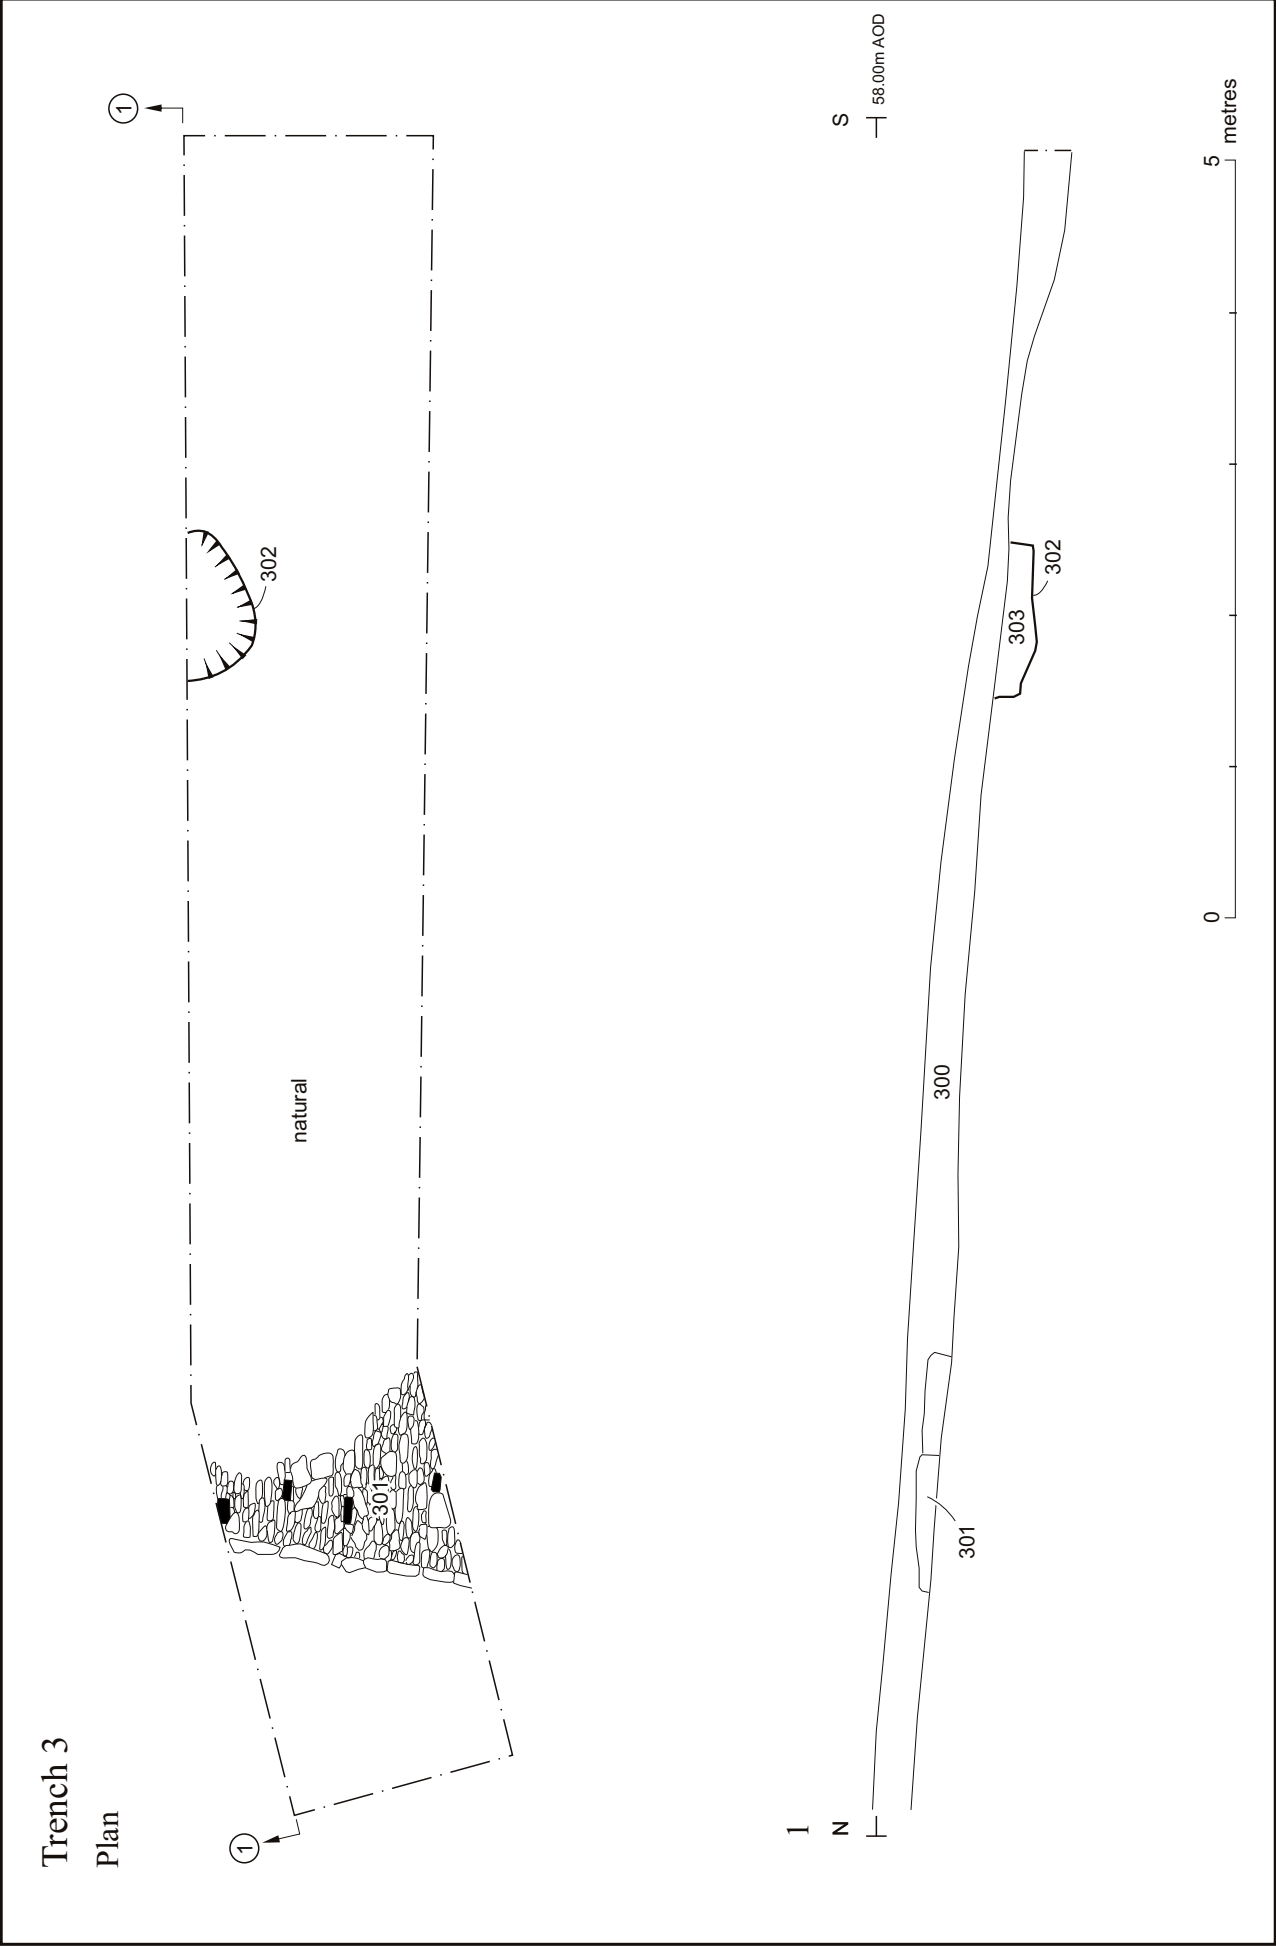
This trench was positioned to investigate east-west aligned curving structure depicted on the map of 1838. Natural subsoil was exposed directly beneath modern overburden at a depth of 250mm. Two features were identified: a coarse cobbled surface and a post pit. The cobbled surface (301) extended over an area approximately 1.2m x 0.5m. Interpreted as a pathway, it was built of mudstone and brick and was edged with larger cobbles to the north. It had been disturbed to the south. The post pit (302) measured 1m across and 0.25m deep. It was exposed 3m from the southern end of the trench. No finds were recovered from the features or the trench.

Fig. 5 Trench 3, plan and section. Scale 1:50 @ A4.

Direct evidence of former 18th-19th century stable buildings on the site, depicted on the map of 1838, was absent and was only hinted at by a section of cobbled pathway within Trench 3. The pathway appears to be situated to the outside of the northern wall of the former building, running parallel with it. The post pit, located within the suspected interior of one of the former buildings represents the only possible structural evidence.

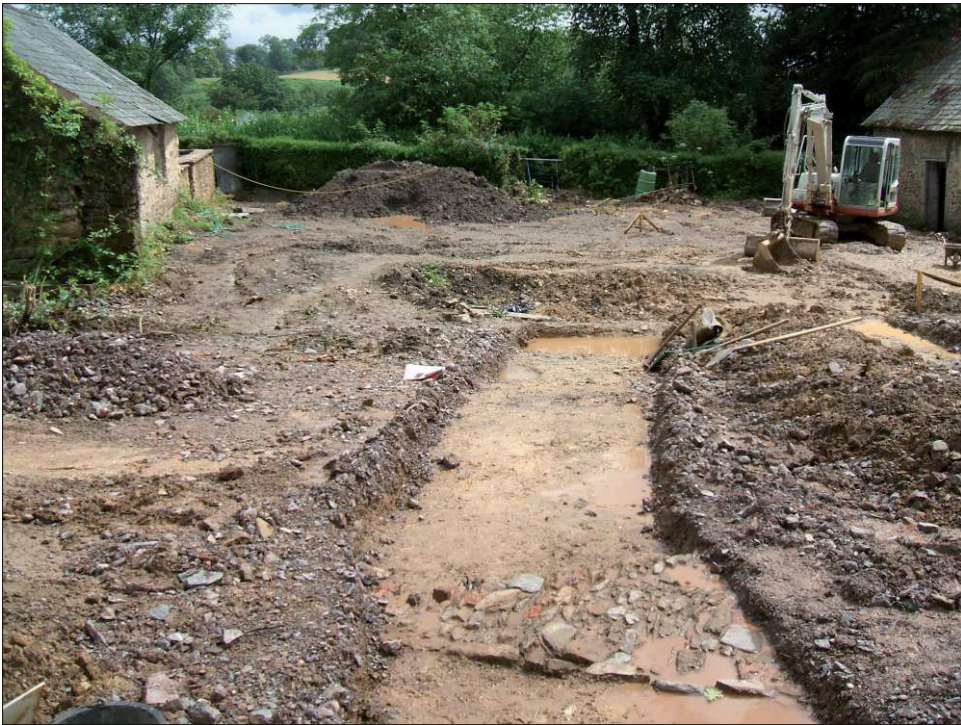
Plate 2 View of trench 3, looking south
