**AN ARCHAEOLOGICAL WATCHING BRIEF  
AT HACCOMBE HOUSE ESTATE, NEWTON ABBOT, DEVON**

**Exeter Archaeology**

**Report No. 08.63**

**October 2008**

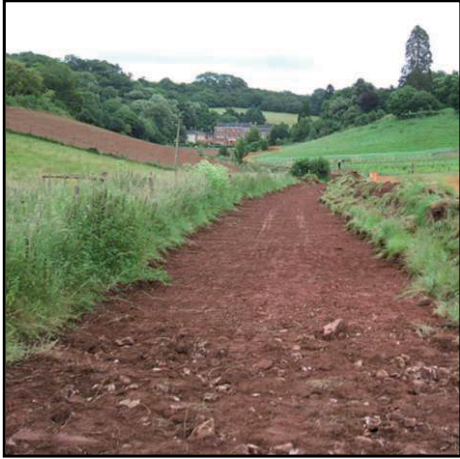
Both plots were stripped of dark reddish brown sandy silt topsoil, which ranged in thickness from 0.15-0.20m (Plate 1). The topsoil deposit overlay a mid to dark reddish brown sandy silt deposit which contained patches of pea-sized gravel. Inspection of the pipe trench revealed this material to be a build up of colluvial deposits.

Plate 1 Pipeline route after turf removal. View to south-east, showing Haccombe House in background.

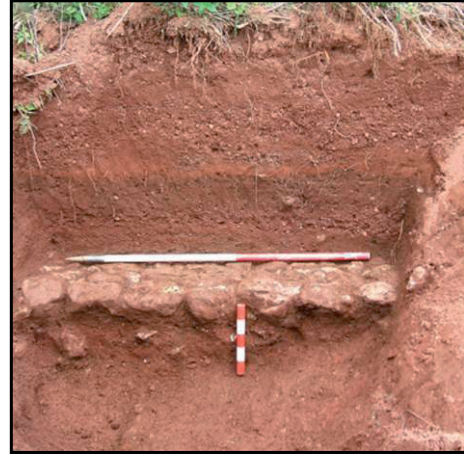
There appears to be a number of different phases in the build up of colluvium. In places a lens of buried topsoil measuring 0.2m thick and at a depth of 0.6m, was visible sandwiched between the hill wash (Plate 2). Patchy lenses of demolition material measuring between 0.3-0.45m thick and at a depth of 0.3m, could also be seen through out the length of the trench (Plate 3). This contained large amounts of limestone mortar, moderate amounts of sub-rounded flint nodules, and frequent large red sandstone conglomerate boulders, very similar to the building blocks in the church. This rubble could indicate the remains of the medieval dwellings, which originally stood in the grounds leading up to Haccombe House. However, although no definite structures or patterns were discernable it is most likely the material comes from these cottages, and represents backfilling and levelling processes rather than the remains of building foundations.

The presence of a well defined stone surface was observed within a trail hole to the north of the pipe trench (Figure 3a & b and Plate 2). The true extent of the surface was not fully exposed, but it was visible for 1.6m, and measured 0.62m in width and was 1.8m deep. The cobbles were randomly placed and set in a red clay silt matrix with patches of limestone mortar.

Plate 2 Stone surface [107] within section AA. View to north-east.

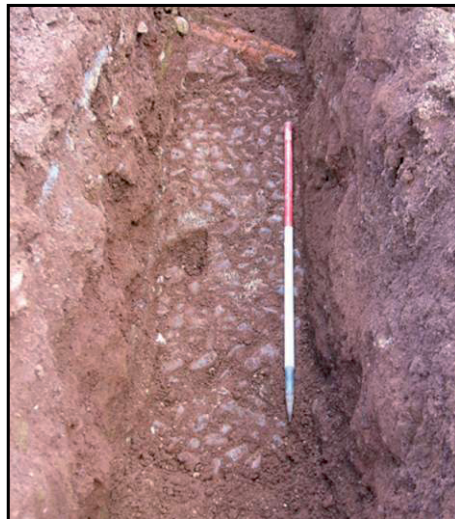
Another cobbled surface (Figure 3c and Plate 4) was exposed within the very base of the southeastern part of the trench. This was visible for 2m. The north western edge of this surface was abutted by a brick and slate lined drain, which measured 0.2m wide and run along an east west alignment.

Plate 3 Cobbled surface [108] with brick and slate drain [109] to rear. View to north-west.
