**ARCHAEOLOGICAL WATCHING BRIEF
ON THE STITHIANS TO ROSKROW SWW
PIPELINE, CORNWALL**

Prepared on behalf of South West Water

Exeter Archaeology

Report No. 09.84

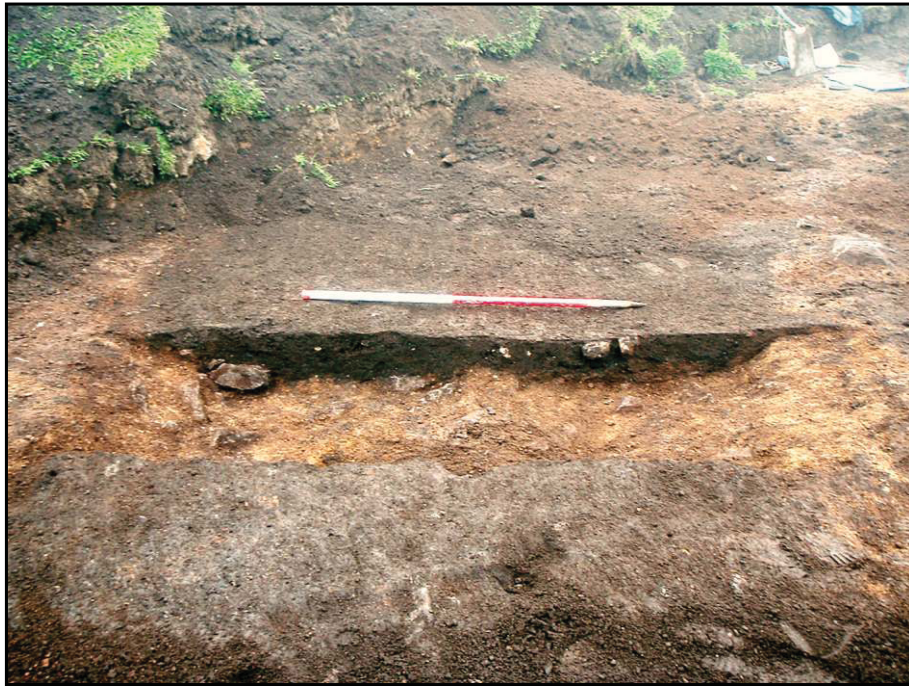
Pl. 1 North-east facing section of slot through ditch (104). Scale 1m.

Located within the eastern side of the field was ditch (104) aligned northeast-southwest and measuring at least c.17m long (Pl. 1 and 2). At its northeast extent it split, just before the limit of excavation, into two separate smaller linear ditches (not

separately numbered). The profile of the widest area of the ditch was gently sided with a flat base. The base was occasionally irregular, due to the nature of the inclusive granite fragments within the natural subsoil through which it was cut. From southwest to northeast the ditch became gradually thinner. Infilling the ditch was a single homogenous deposit consisting of a dark black to grey clayey sand. Included within the fill was a single pottery sherd of 19th century Staffordshire cream ware.

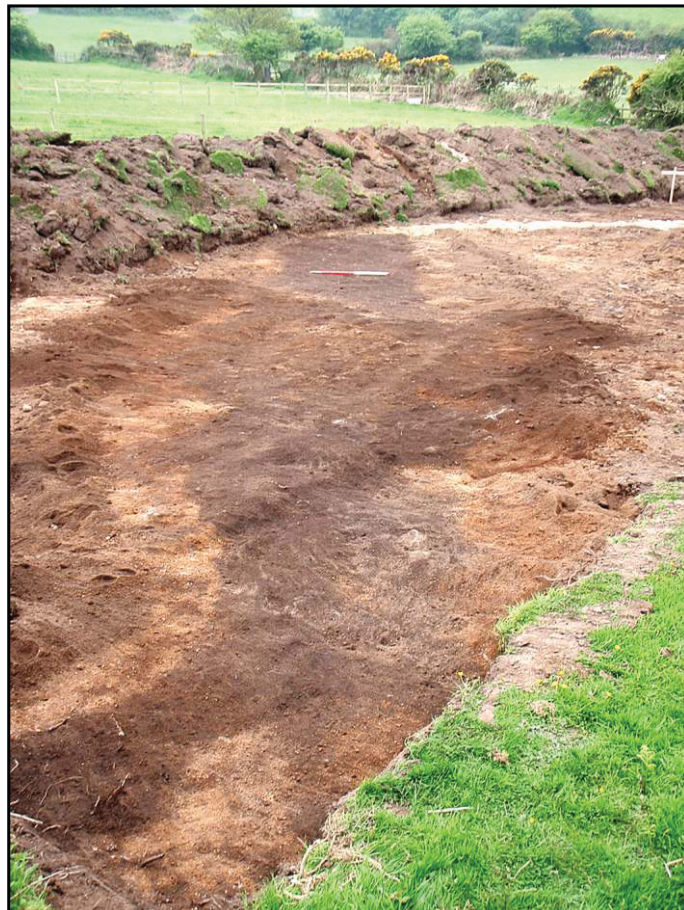
Pl. 2 Ditch (104) looking south-west. Scale 1m.

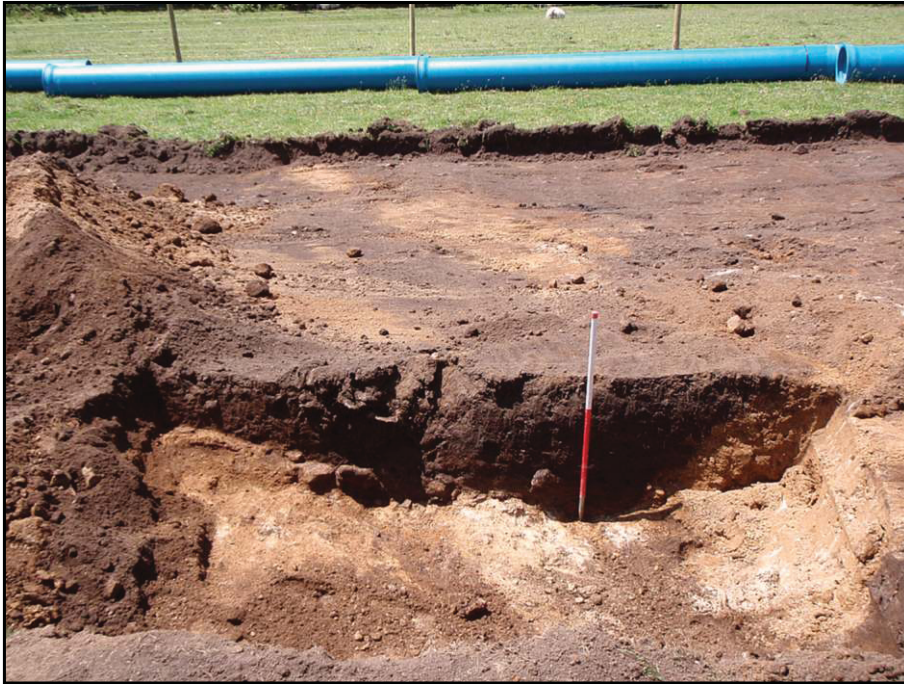
Pl. 3 North-east facing section of slot through ditches (107/108). Scale 1m.

The initial topsoil strip exposed two merged curvilinear ditches (107 and 108) towards the centre of the field (Pl. 3). A length of approximately 9m of these ditches was exposed. Both ditches were observed to be curving from east to southwest. Ditch (107) was 2.20m wide and 0.75m deep with gently breaking sides, which showed evidence of weathering; it had a concave base. Infilling the ditch were four clay-derived silt deposits (110-113). No finds were recovered. It could be observed in section (see Fig.2) that ditch (107) had cut through the fill of an earlier ditch (108) perhaps as a replacement. Measuring c.1.20m wide and 0.35m deep with gradually breaking sides, ditch (108) contained a single clayey silt fill (109) which included large fragments of granite. No finds were recovered.

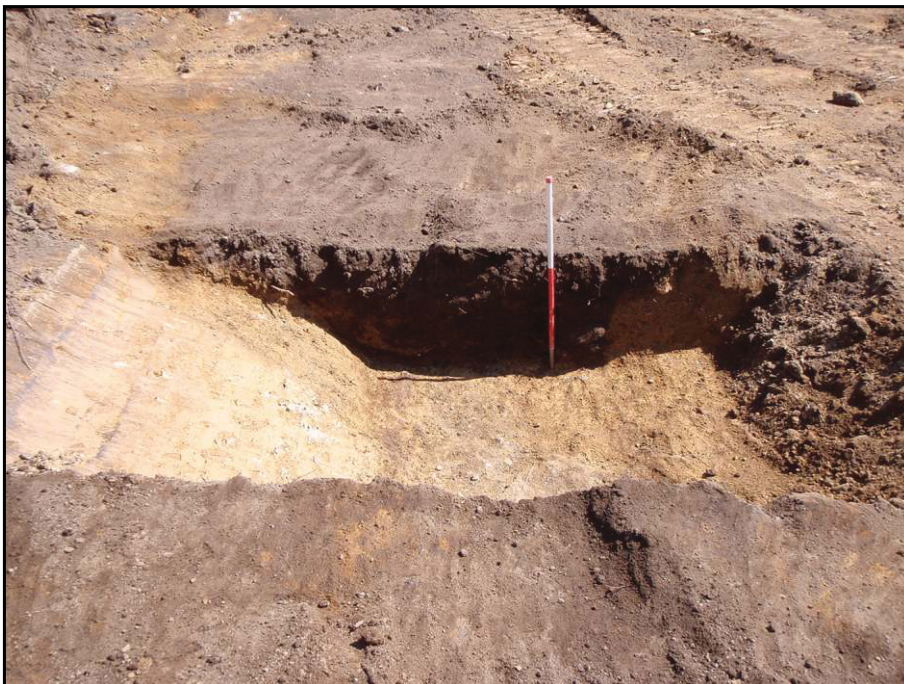
Pl. 4 North facing section of slot through ditch (115). Scale 1m.

Located c.30m to the south of ditches (107 and 108) was a further curvilinear ditch (115) (Pl. 4). It was observed for a distance of at least 8.00m curving from south to northwest. Measuring 1.60m wide and with a depth of 0.70m the western side was steeply sloped while the opposing side had gently breaking slope; the ditch had a flat base. Infilling the ditch were several deposits, the first three (116-118) being slight lenses predominately composed of clayey silt included with quartzite flecking. The remaining deposits (119, 120, 122) were thick dark brown clay silts, deposit (120) containing large granite fragments on the western side of the cut. The incidence of such large fragments may indicate the collapsed remains of a former revetted hedge wall-bank. No finds were recovered from the fills of this ditch.
