**ARCHAEOLOGICAL RECORDING AT THE  
BRITISH CERAMIC TILE FACTORY,  
HEATHFIELD, BOVEY TRACEY, DEVON**

**Exeter Archaeology**

**Report No. 09.59**

**November 2009**

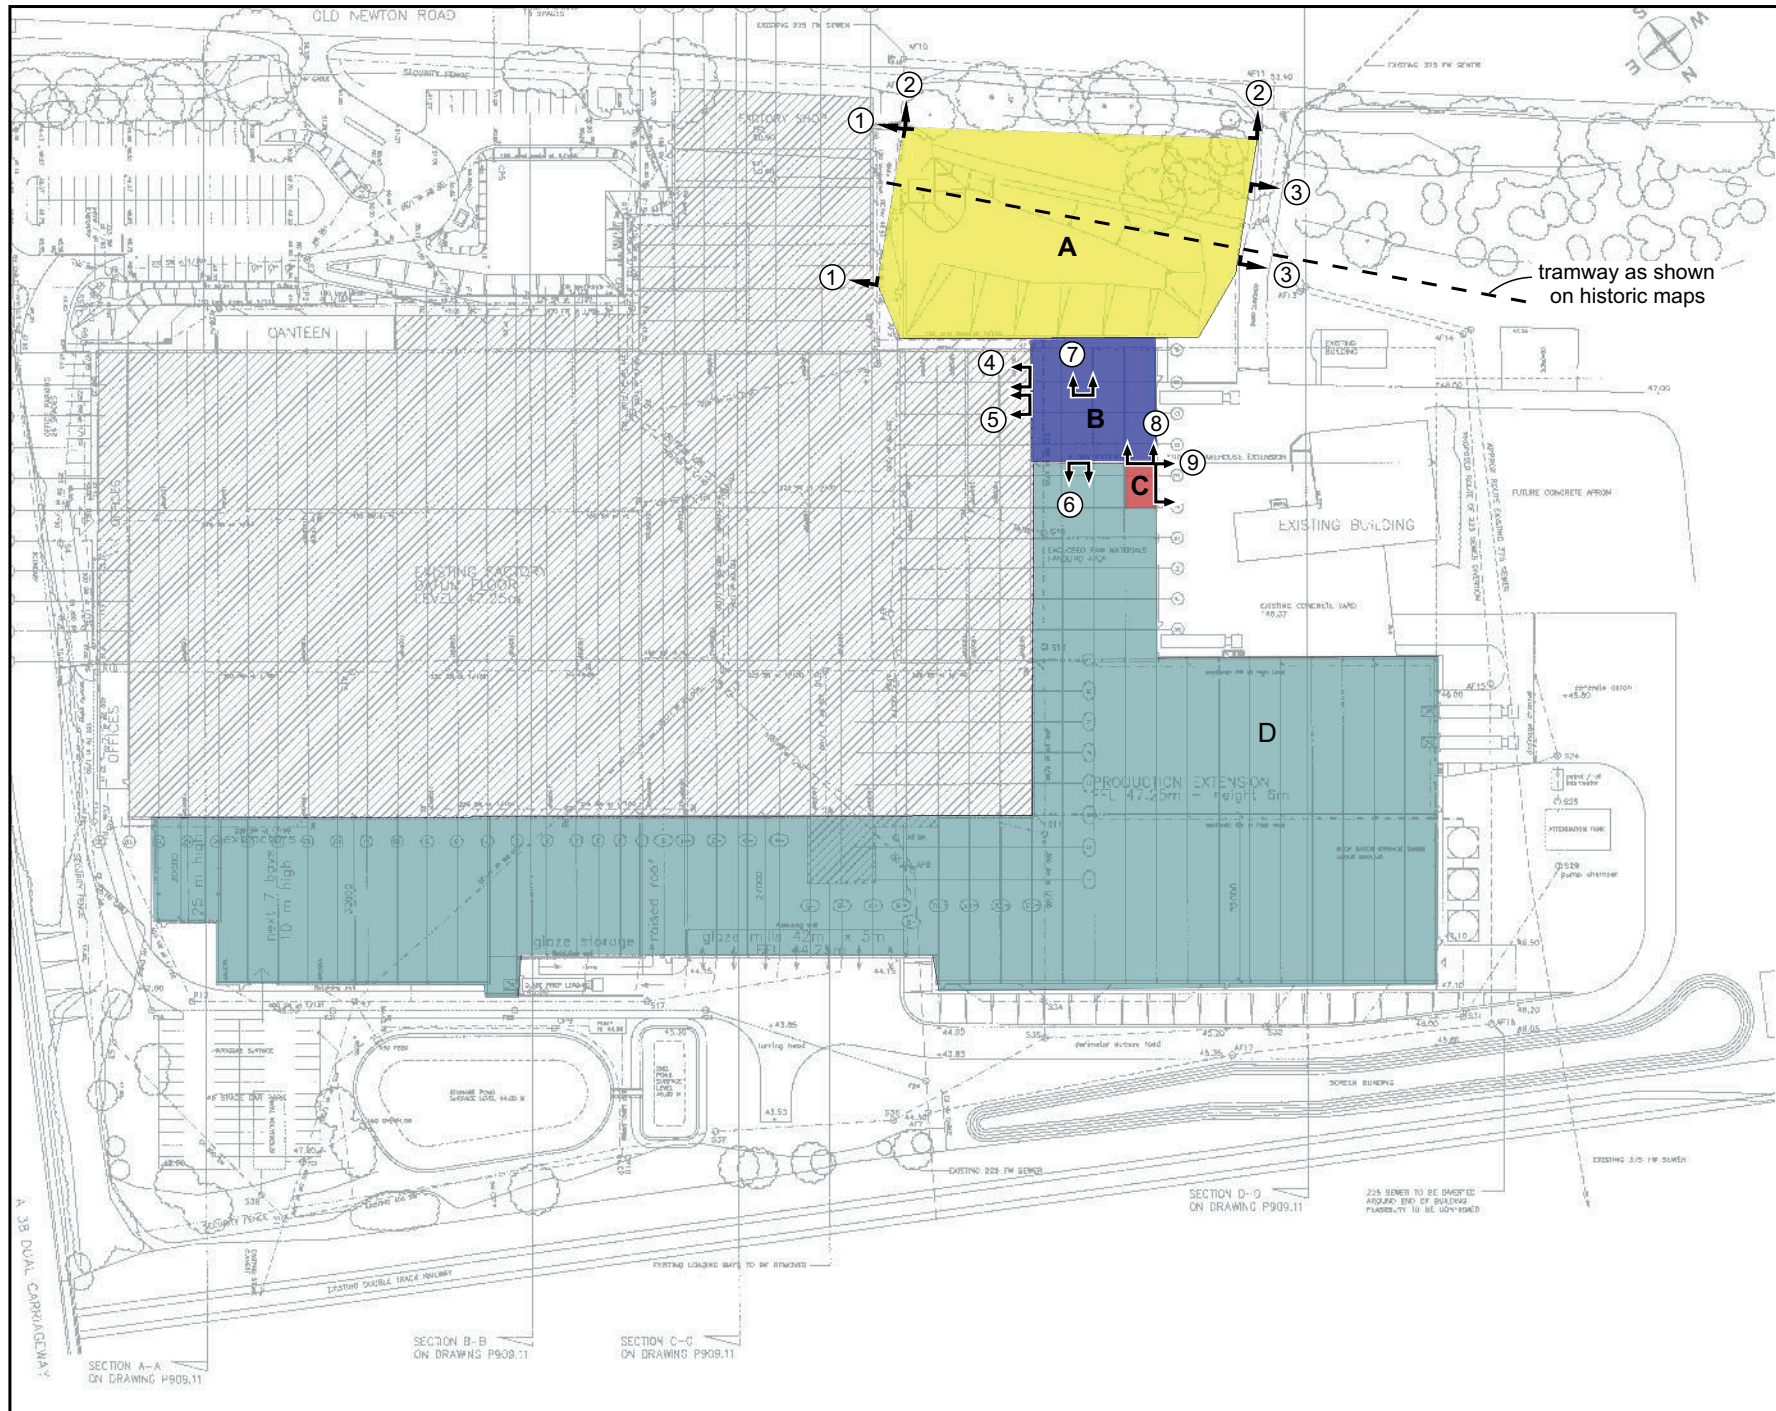
Fig. 2 Location of areas monitored and sections (based on plan supplied by Pearn and Procter, drawing No. P909.07 04/04/05). Scale 1:2000.

Four areas were monitored as part of the watching brief (Fig. 2): Area A, the site of the bulk raw materials extension; Area B within the south-west corner of the existing factory and measuring approximately 30m long by 20m wide; Area C immediately to the northeast, measuring 10m long by 7m wide; and Area D constituting the remaining portion of the site.

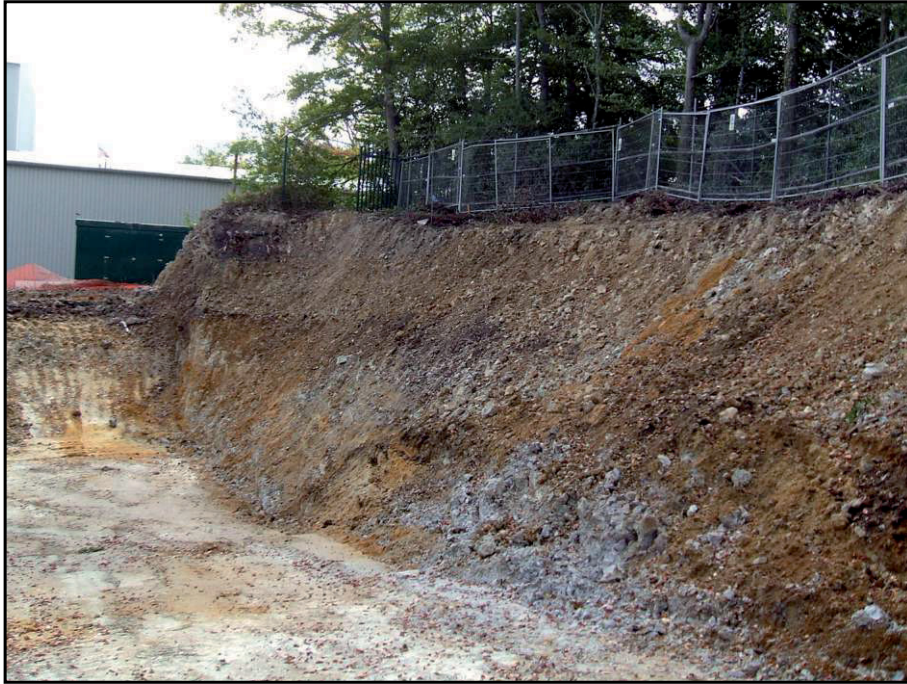
comprised 2m of bank material [102] sealing 0.40m of topsoil [100] over natural clay subsoil [101]. Elsewhere the sequence consisted of 0.30–0.40m of topsoil over natural clay. No archaeological features or deposits were exposed within the observed sections.

Plate 1 Area A: section 2, view to south-west.

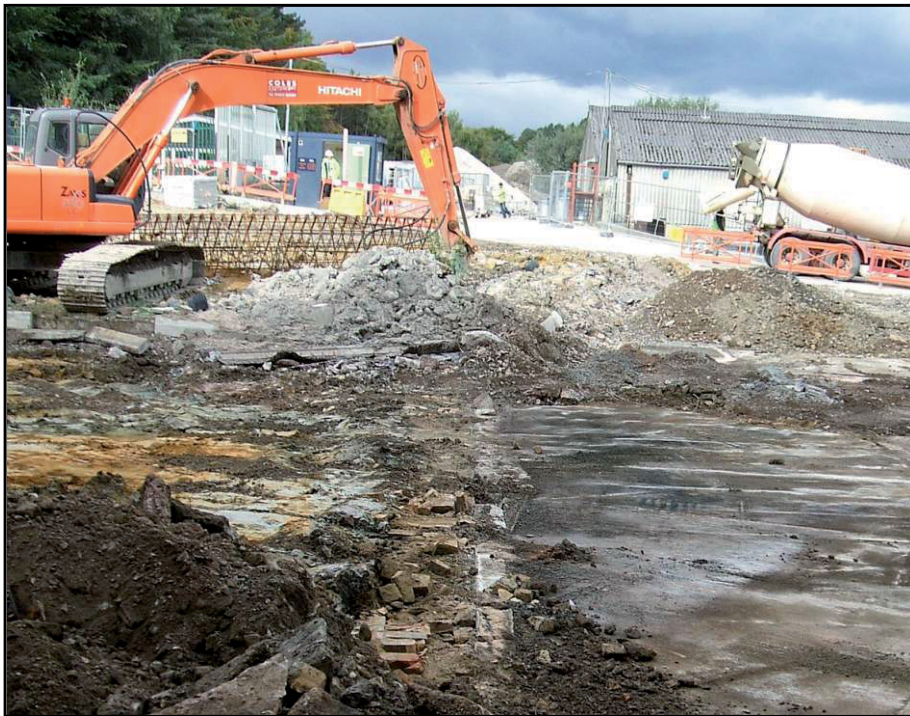
Ground reduction within Area B ranged from 1.70m to 2.15m in depth. Removal of the existing concrete yard surface [103] and underlying rubble and gravel make-up [104] exposed clay natural subsoil [101] within the southern half of Area B and a second concrete surface [105] within the northern half. This abutted a north-west to south-east aligned wall [106] consisting of outer skins of mortared brick enclosing a void or flue that had been filled with brick and stone rubble [107]. Where the surface [105] abutted wall [106], it was edged with concrete kerbstones. A 1m by 1m stub of brick wall [109] was also exposed at the south-eastern end of [106], which abutted its south side.

Plate 2 Area B: brick wall [106] and concrete slab [105] to right, view to north-west.

The features exposed in Area B appeared to represent part of a structure that had been terraced into the clay subsoil, with wall [106] forming its southern edge. Brick surface [117], which covered most of the eastern half of the area and the tiled surface [114] that replaced it, were probably internal floors associated with [106]. The brick structure [109], which was partly exposed along the southern edge of the area and was abutted by or abutted [106], also appeared to be broadly contemporary. The function of the structure with its internal sunken mortar floor [130] remains unclear, as it was enclosed along the north and west sides, but was open on the east side, which ended in flush, faced brickwork that continued down to form the foundations. The depth of these foundations, at least 3–4m, shows it was a substantial feature, which perhaps served as a bin or receptacle.

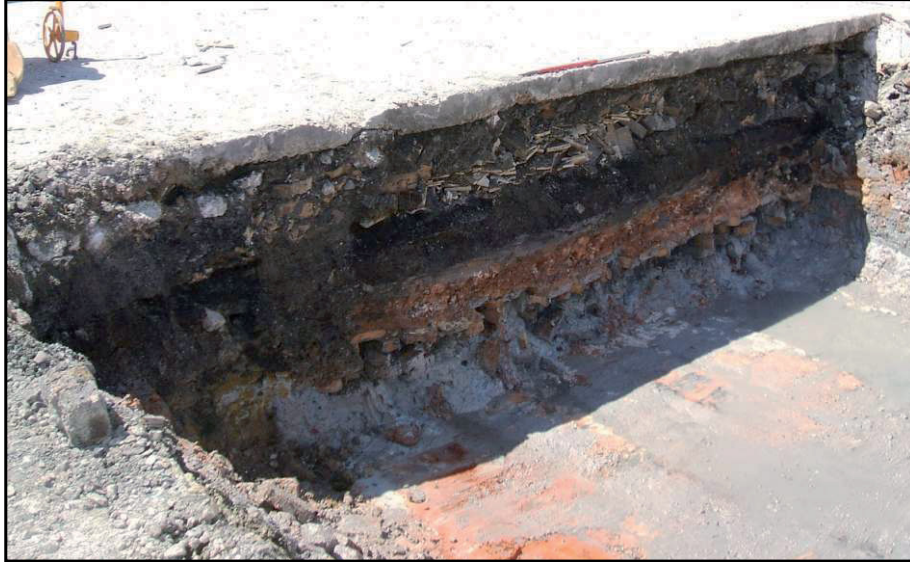
Area C was monitored after excavation by the contractors, reduced to a depth of 1.80m. Removal of the existing concrete surface [103] had exposed two layers of kiln waste, on either side of a partially robbed north-west to south-east brick wall [127]. The deposits comprised a loose brick and tile rubble layer [118] over a deposit of kiln debris [119], which in turn overlay a tile surface [120]. This sealed a further deposit of kiln waste [121], composed of crushed brick and tile. Removal of [121] exposed a network of eighteen rectangular brick flues [122] within the southern edge of the site (Fig. 6; Pl. 3). These flues were orientated north-east to south-west and opened into a large brick flue at the north-east end [123], which extended across the site from north-west to south-east. The flues [122] were constructed within a brick ‘floor’ [124] 0.30m deep that extended from the north side of wall [127] over the whole of the excavated area. The large flue [123] was built onto [124] and was of integral construction with it.

Plate 3 Area C: north-east facing section of kiln structure.

Structural evidence observed within Area C more clearly relates to the site's use as a tile and brick kiln. The exposed structures were probably part of a rectangular kiln. The series of brick flues [122] would have channelled the hot air produced by the furnace and directed it towards the kiln site for use in the firing process. The redundant air would then have run into the adjoining brick culvert [123] and finally been emitted from a nearby chimney. Tiled surface [120] would have served as the base of the kiln, whilst the robbed out wall [127]/[128] may have constituted the eastern extent of the structure.

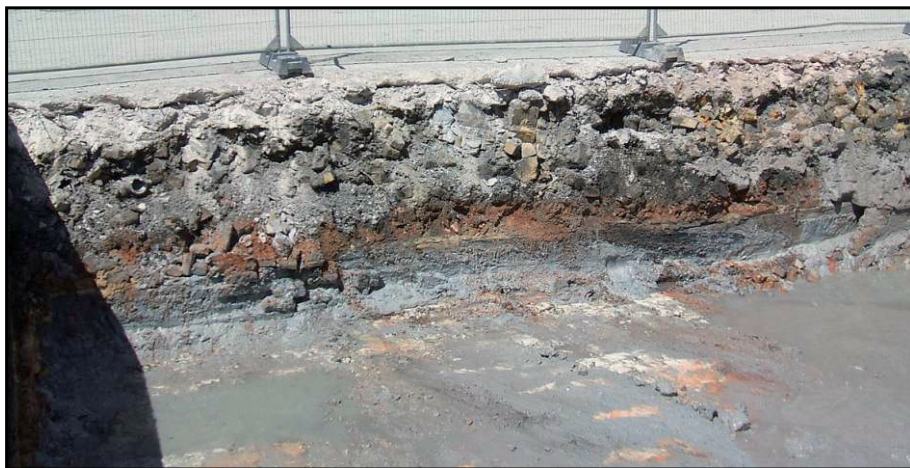
Plate 4 Area C: south-east facing section of kiln structure (south end).

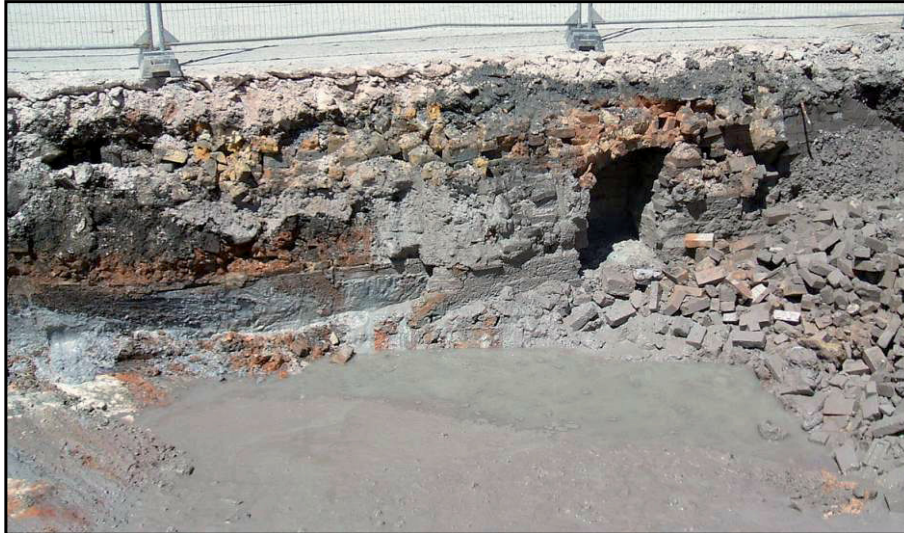
Plate 5 South-east facing section of kiln structure (north end) showing flue [123].
