**ARCHAEOLOGICAL EVALUATION
OF THE SITE OF A PROPOSED
MEMORIAL AT THE MOUND,
ROYAL CITADEL,
PLYMOUTH**

**Prepared on behalf of
Gilmore Hankey Kirke Ltd**

Exeter Archaeology

Report No. 10.12

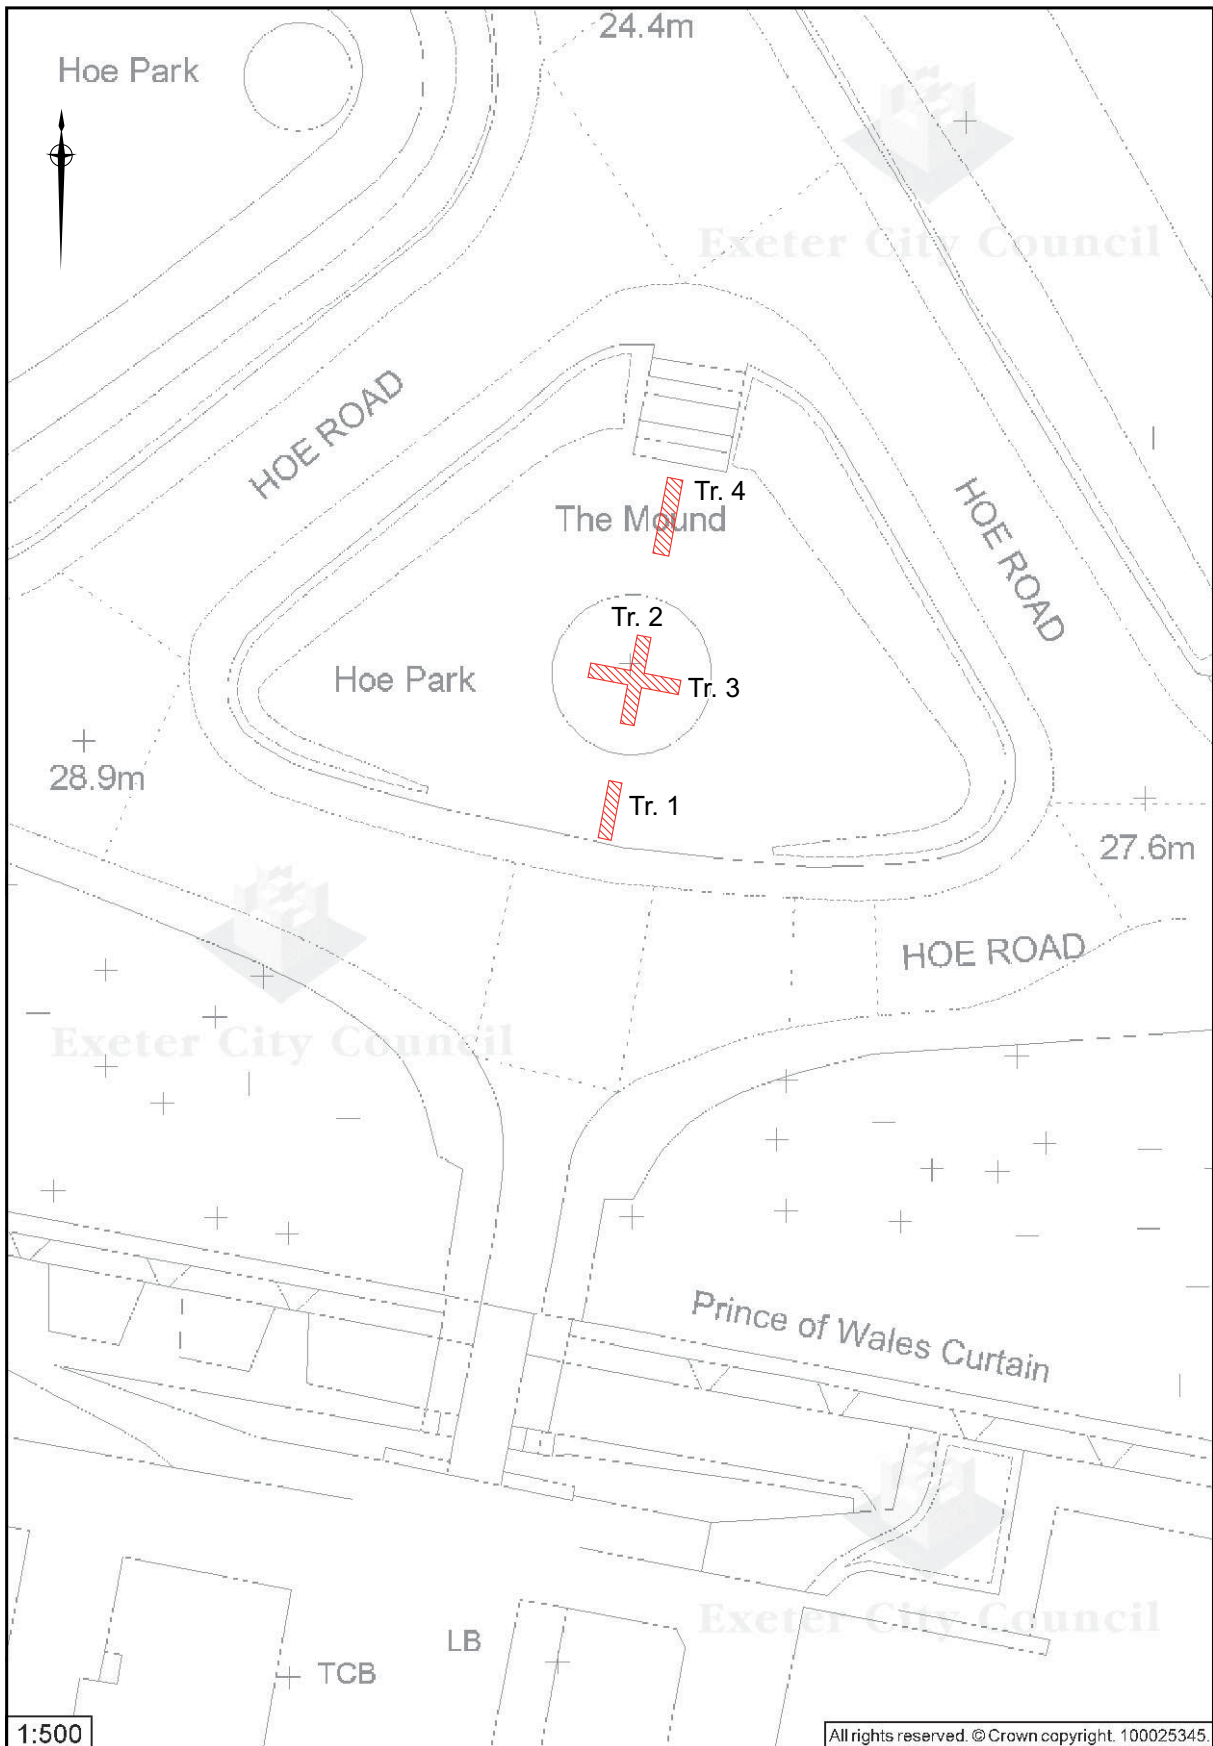
Fig. 2 Trench location plan.

A brief for the trench evaluation was provided on behalf of English Heritage by Plymouth City Council's Historic Environment Team (PCC HET). All work was carried out in accordance with the requirements of the brief, with trenches sited as per a trench plan prepared by EA and submitted to and approved by PCC HET (Fig. 2).

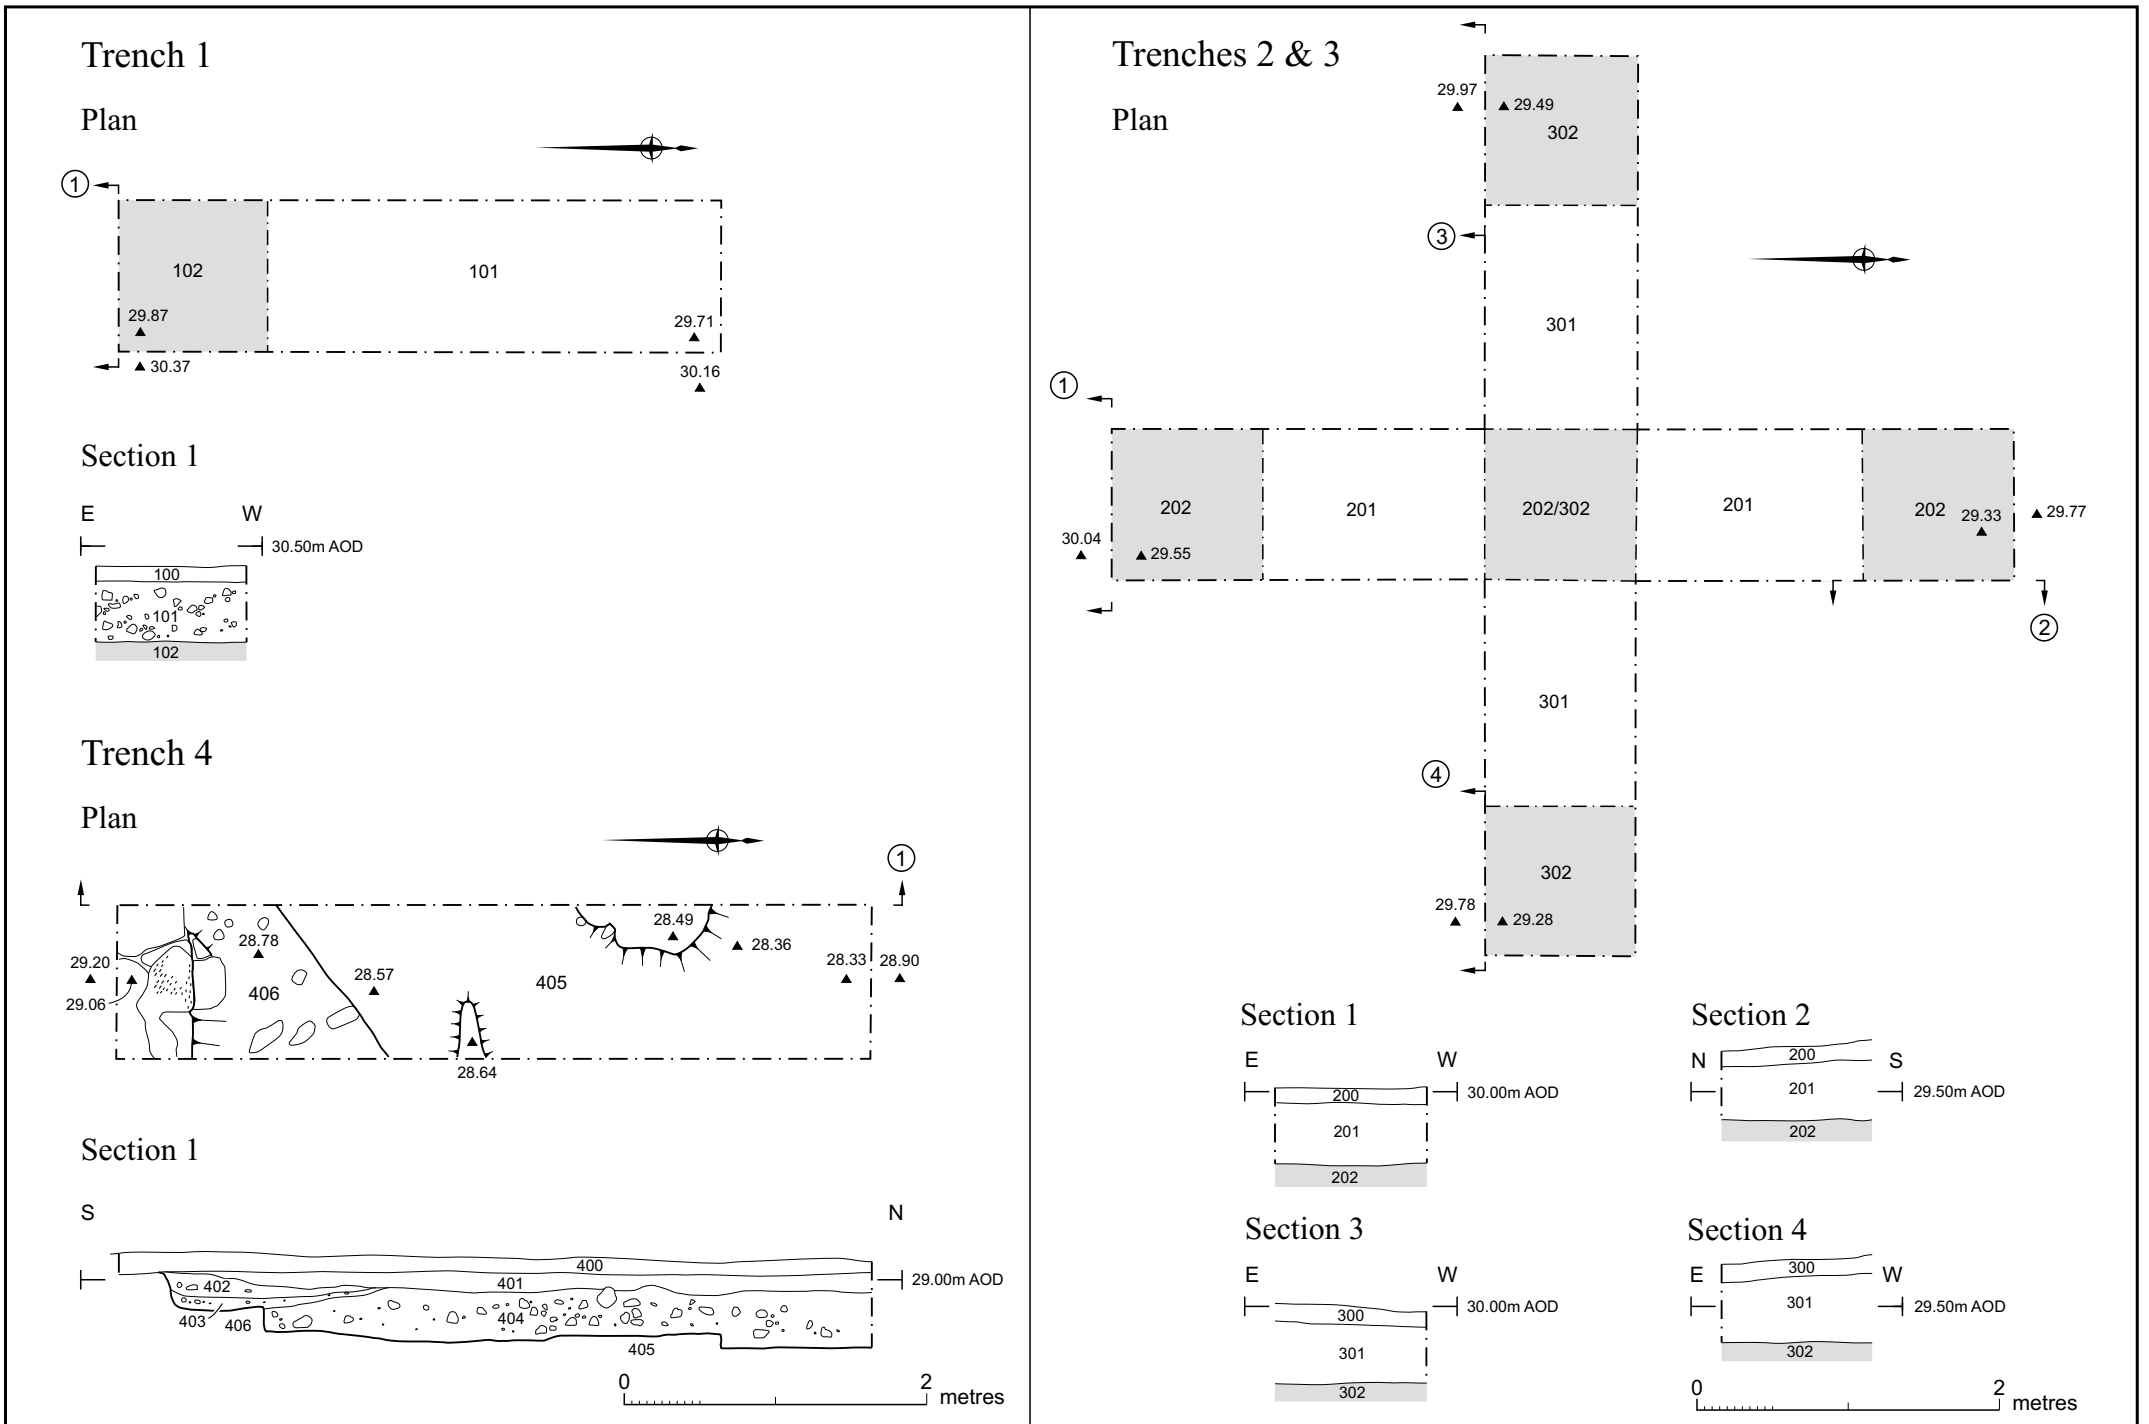
Fig. 3 Plans and sections: trenches 1, 2, 3 and 4.

Relevant detailed plans and sections are included as Fig. 3 and detailed context descriptions for each trench are set out in Appendix 1.

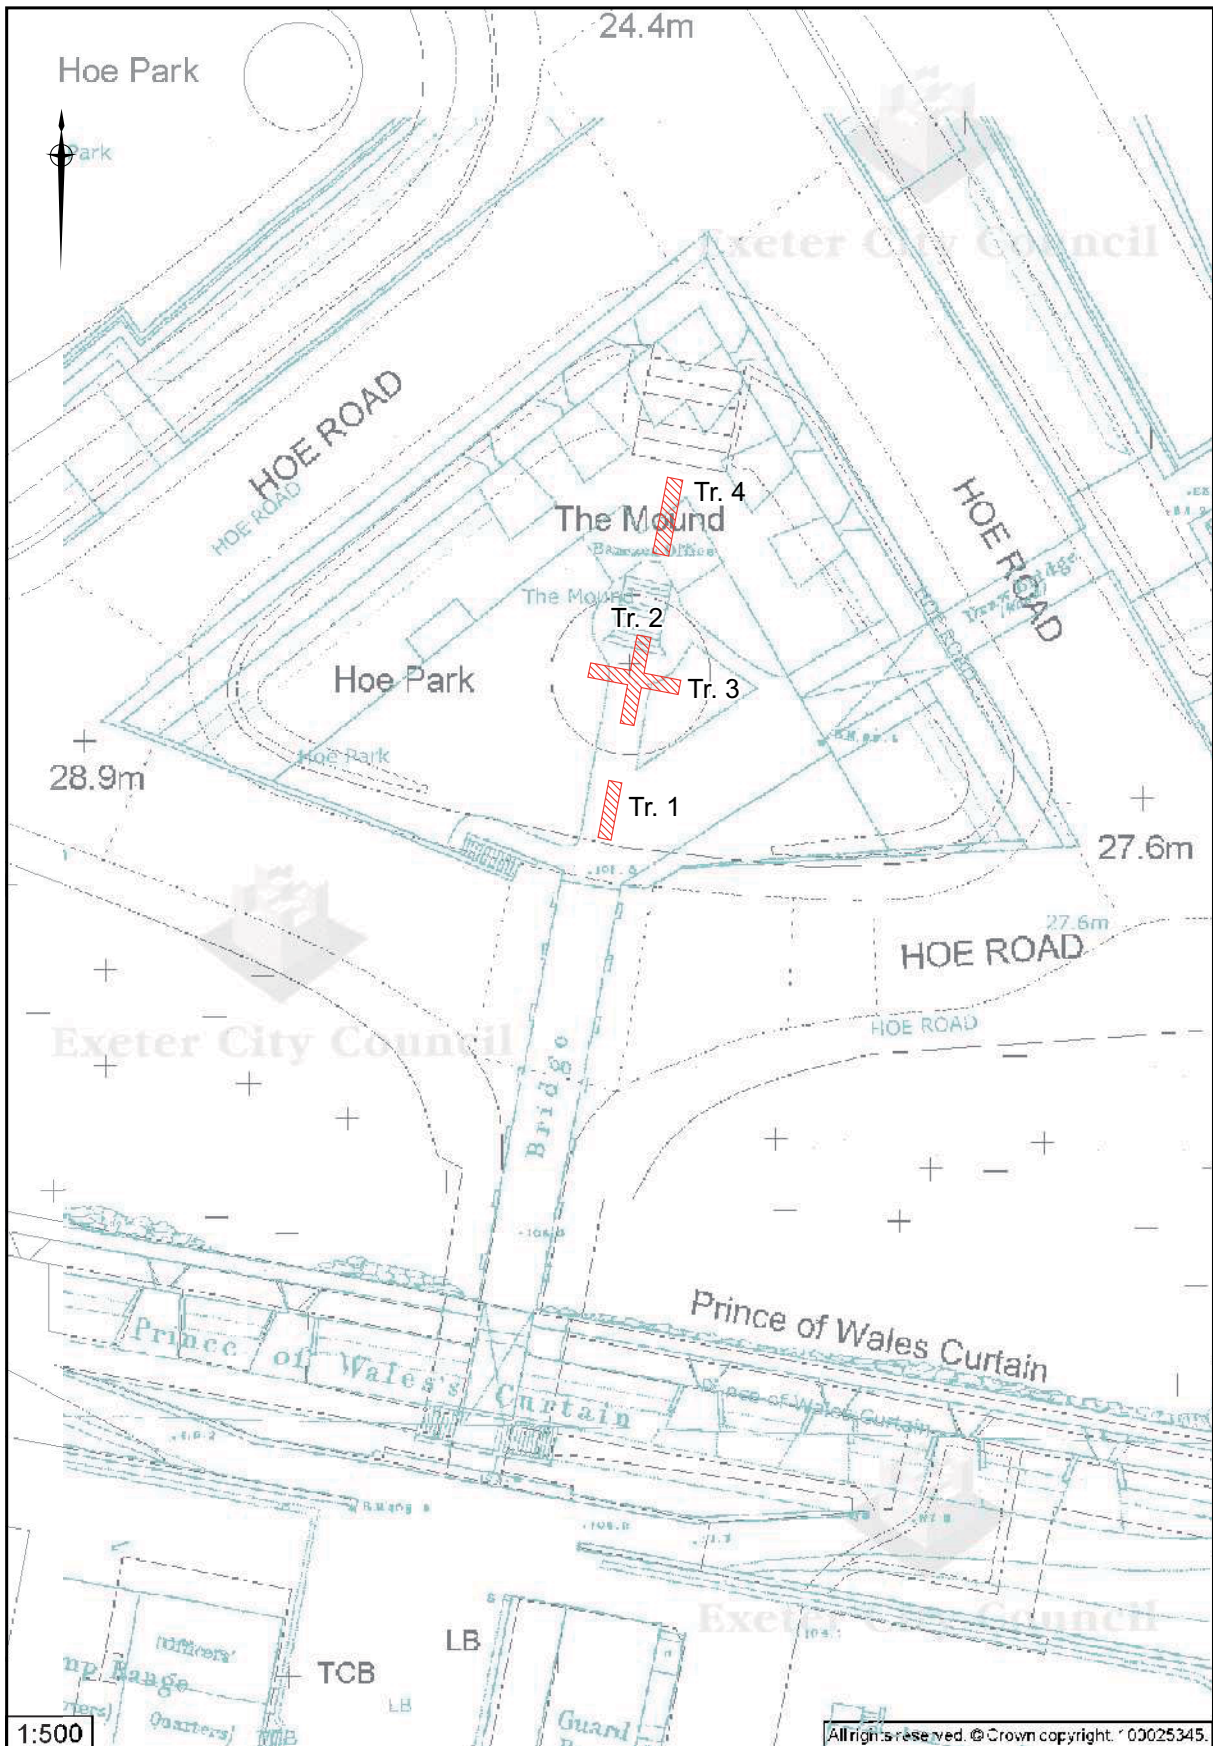
Fig. 4 Trench positions in relation to detail from the Ordnance Survey map of 1856 (blue).

Towards the northern apex, trench 4 uncovered remains of the massive ravelin scarp wall and a smaller structure immediately to the south. The larger blocks (406) identified at the southern end of the trench may well be associated with the guard house, shown on a plan of 1677 (Fig. 5) and a map of 1856 (Fig 4), while the smaller limestone rubble (405) across the remainder of the trench represents the solid core of the ravelin scarp wall. The possible remains of the guardhouse survive to within 140mm of current ground level, sealed only by topsoil, while the wall core lies at a slightly greater depth (500mm) sealed beneath a succession of demolition and levelling deposits (401-404), most likely associated with the dismantling and landscaping of the ravelin during the late 19th century.

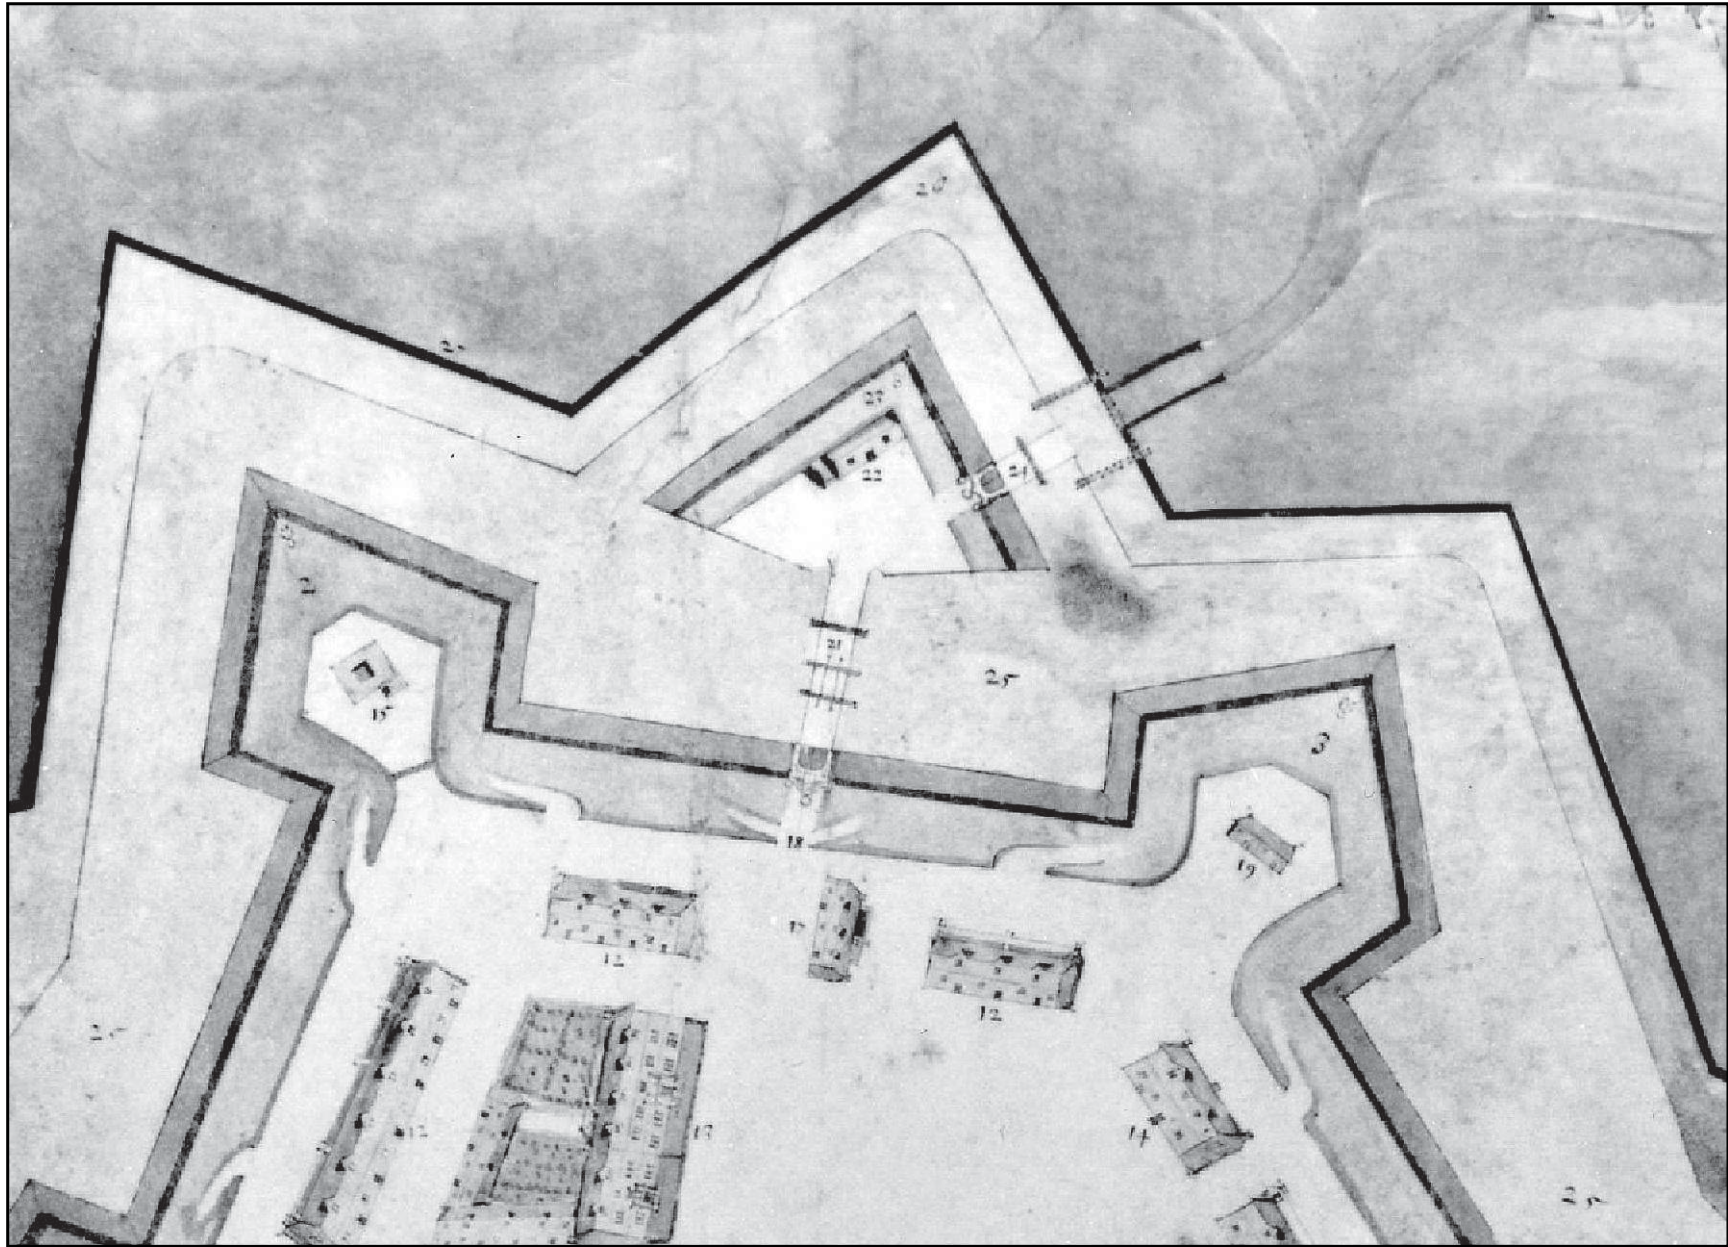
Fig. 5 Detail of the 1677 plan of the Royal Citadel showing the north ravelin.

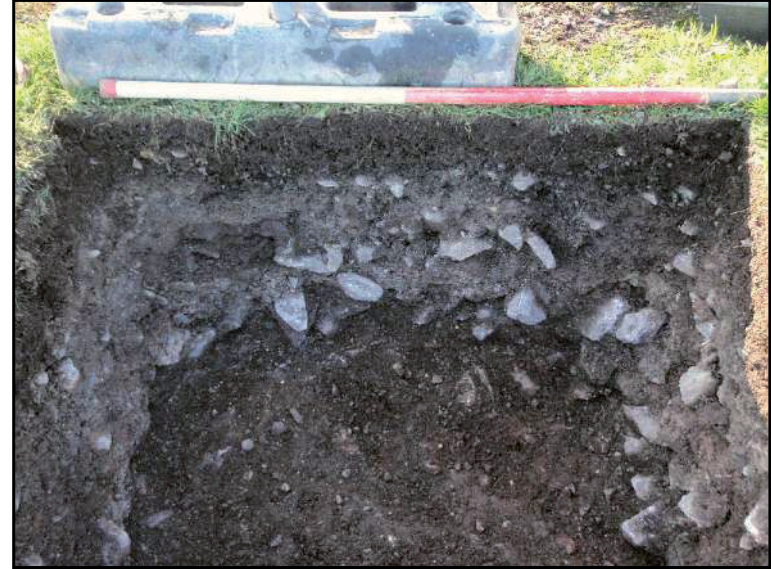
Made ground (102), comprising reddish brown silty clay was exposed at a depth of 450mm. This was sealed by a demolition deposit (101) measuring 350mm thick and containing a large amount of limestone rubble. This was in turn overlain by topsoil (100). Detailed context descriptions for this trench are set out in Table 1, Appendix 1.

Pl. 2 General view of sample section Trench 1 showing demolition deposit (101) and top of made ground (102). Looking south. 1m scale.

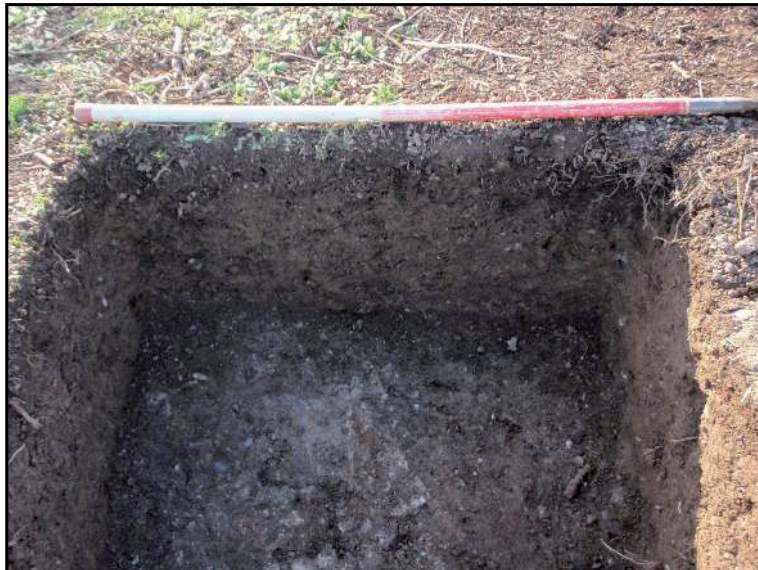
Made ground (202) comprising grey silty clay was exposed at a depth of 450mm below ground level. This was overlain throughout the trench by brownish yellow loamy clay (201), which was in turn overlain by topsoil (200). The layer sequence is set out in Table 2, Appendix 1.

Pl. 3 General view of sample section Trench 2 showing top of made ground (202). Looking south. 1m scale.

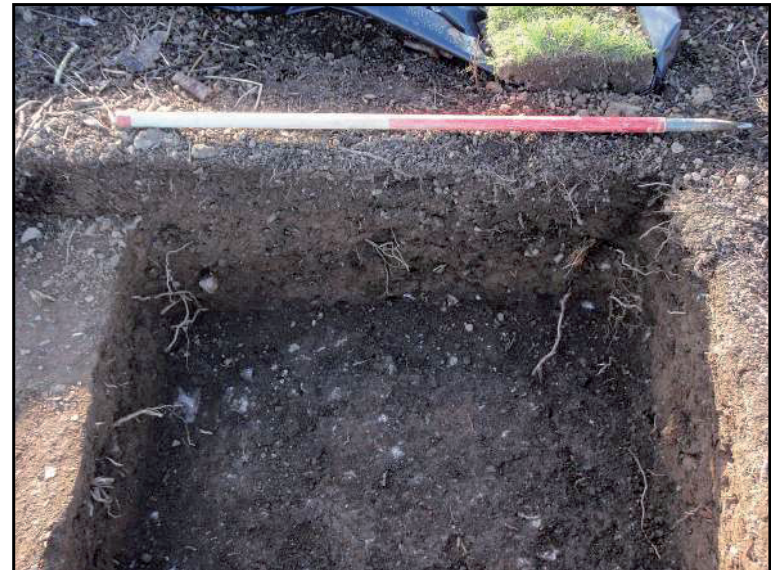
Made ground (302) comprising grey silty clay was exposed at a depth of 450mm below ground level. This was overlain throughout the trench by brownish yellow loamy clay (301), which was in turn overlain by topsoil (300). Detailed context descriptions for this trench are set out in Table 3, Appendix 1.

Pl. 4 General view of sample section Trench 3 showing top of made ground (302). Looking south. 1m scale.

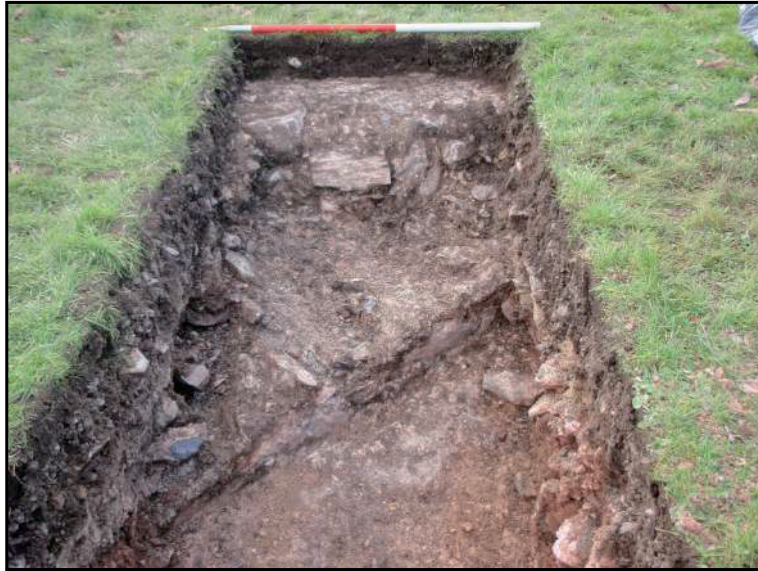
Structure 405 was a NE-SW aligned linear feature exposed at a depth of 500mm and measuring in excess of 3m wide. It was constructed of small limestone rubble bonded with light yellow/white lime mortar. It is interpreted as the heavily robbed rubble core of the north ravelin scarp wall. The face of the wall was not recovered as it lay beyond the excavated area.

Structure 406 was a NE-SW aligned linear feature exposed at a depth of 140mm and measuring at least 1m wide. It was constructed of large limestone rubble bonded with white lime mortar and may represent the remains of the guard house.

Pl. 5 General view of 'Barrack Office' wall (trench 4) with rubble core of ravelin scarp wall in foreground. Looking south. 1m scale.

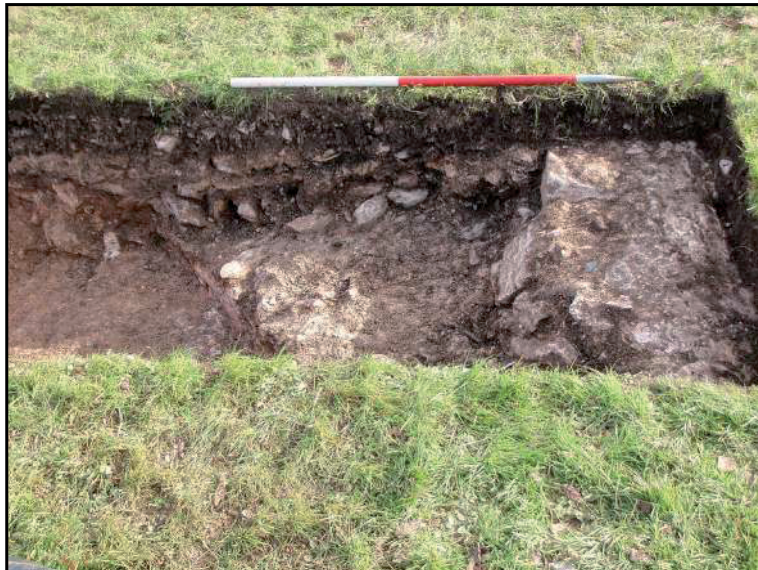
Pl. 7 Detailed view of rubble core of ravelin scarp wall and 'Barrack Office' wall. Looking east. 1m scale.

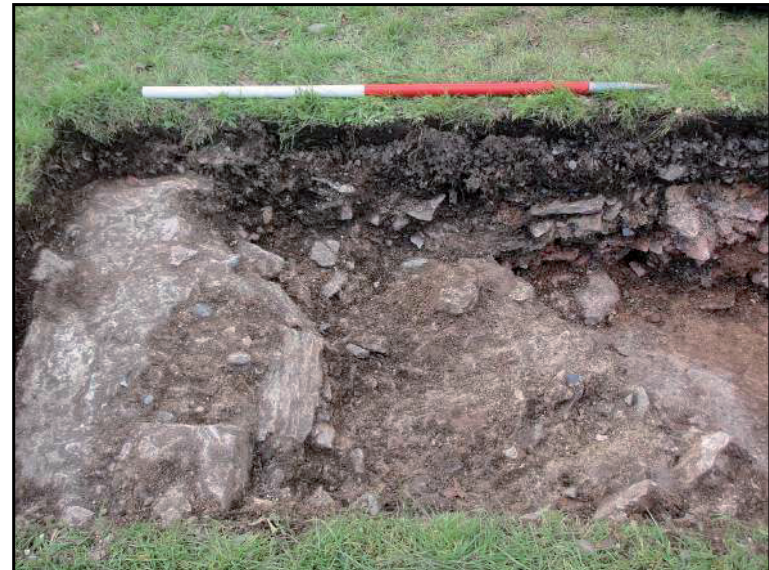
Pl. 8 Detailed view of rubble core of ravelin scarp wall and 'Barrack Office' wall. Looking west. 1m scale.
