**THE FORMER TIVERTON AND DISTRICT  
HOSPITAL: ARCHAEOLOGICAL EVALUATION  
AND HISTORIC BUILDING APPRAISAL**

**Prepared for Devonshire Homes Ltd**

**Exeter Archaeology**

**Report No. 10.14**

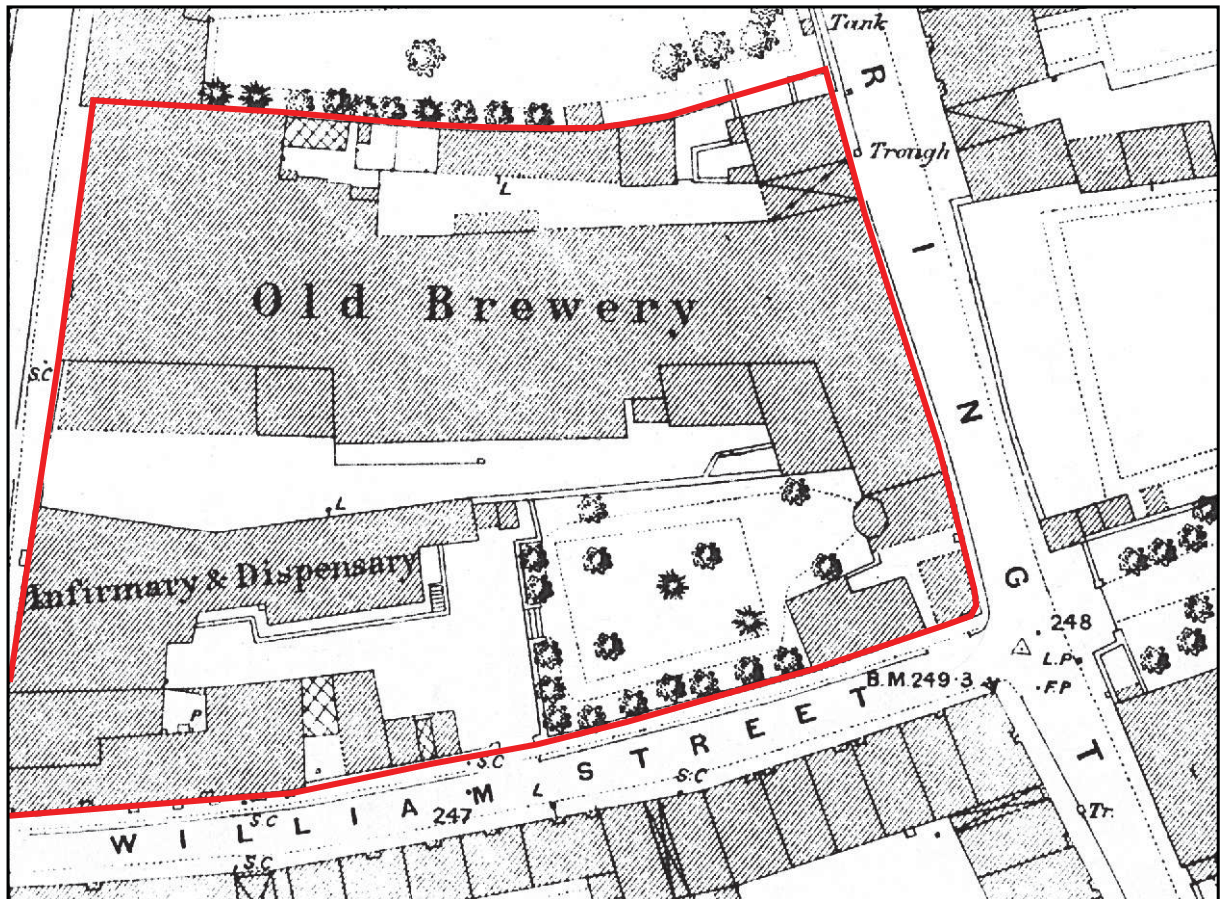
Fig. 3 Extract from the Ordnance Survey 1889 map sheet XCV.7.4 (not to scale). Site in red.

By the mid 19th century the site was in multiple ownership comprising domestic properties and a brewery. The latter occupied the northern two-thirds of the present site (Fig. 3), and incorporated no. 57 Bampton Street. The hospital started life in 1852 as a dispensary situated on Bampton Street. In the later 19th-century this was rebuilt, and further properties located to the south were annexed. Hospital wards were also added to the east and were later extended. Further additions were made in 1904 and 1906 when a laundry and mortuary, and the Coles Institute, were erected.

the east infilling the space between the two rear wings. The south-west room within the eastern extension retains its brick surface. The building was extended in the 19th century when it was used as a brewery (see fig. 3). Following the demolition of the brewery after 1947 the elevations of the rear wings and southern 19th-century extension were refaced in brick, removing much but not all of the earlier fabric (see first floor below).

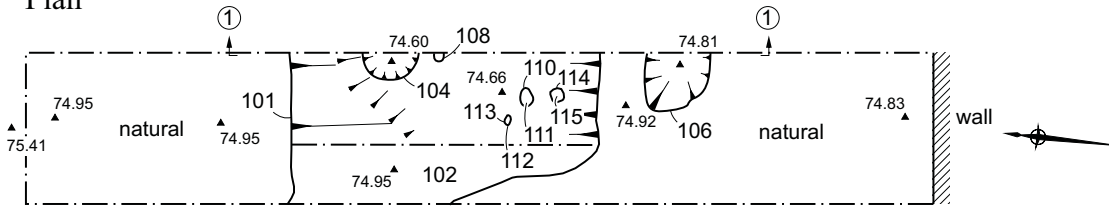
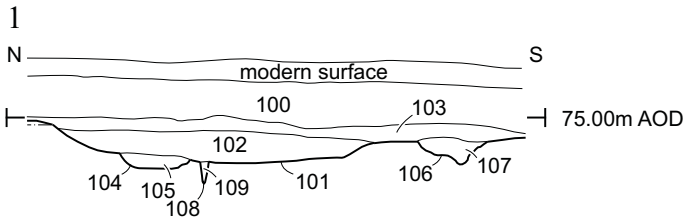
Fig. 5 Evaluation: plans and sections of trenches 1–3.

Natural gravel and clay was encountered between 74.83 and 74.95m AOD, approximately 0.60m below the present surface. In the centre of the trench this was cut by a shallow, flat-based, roughly linear feature (101), backfilled with stony silt (102) that contained later post-medieval pottery and an 18th- or 19th-century clay pipe stem. In the base of the feature was a series of small stakeholes (108, 110, 114 and 112) and a possible posthole or planting feature (104). A small posthole (106) was exposed to the south of feature 101.

These features were sealed by late 19th- or early 20th-century demolition and levelling deposits (103 and 100 respectively) overlain by the present tarmac car park surface and its associated make-up layers.

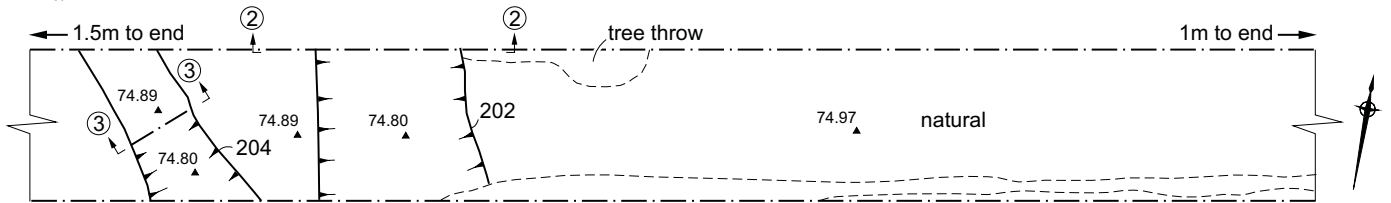
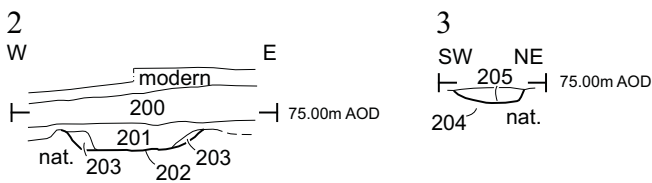
Natural gravel and clay was encountered between 74.89 and 74.97m AOD, up to 0.45m below the present surface. Two modern features were exposed within this trench, a shallow north-west to south-east aligned ditch (204) and north-south aligned ditch (202). The former contained 18th-20th-century pottery, whilst the latter was filled with a demolition deposit (201) that was also present throughout the trench. This was sealed by a contemporary levelling layer (201) with inclusions of yellow Candy bricks as used in the hospital extensions of 1897, 1904 and 1906, overlain by the present tarmac car park surface and its associated make-up layers

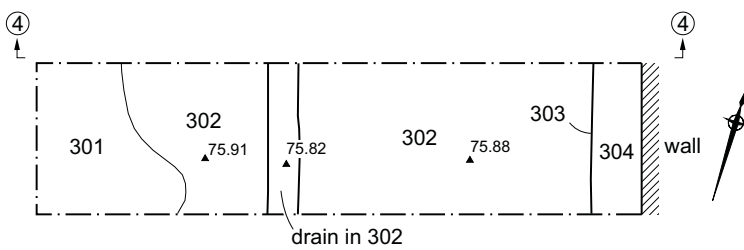
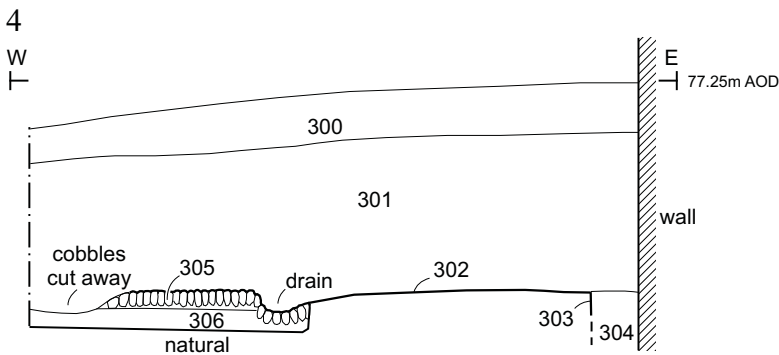
This trench was located in an area of raised ground adjacent to laundry and mortuary of 1904. Within the hospital grounds level access is provided to the first floor with a ramp down to the ground floor.

Natural gravel and clay was encountered at 75.61m AOD, up to 1.90m below the surface. This was overlain by a probable post-medieval garden soil (306), in turn overlain by a 19th-century cobbled surface (302) and its associated make-up layer (305). A small north-south aligned drain had been incorporated into the cobbled surface. The west end of the surface had been truncated, and the east end cut away by the construction trench (303) for the 1904 laundry. Following construction of the laundry, ground level was raised up by 1.40m using layers of rubble and clay (301), here sealed with topsoil (300) forming part of a garden adjacent to the building.

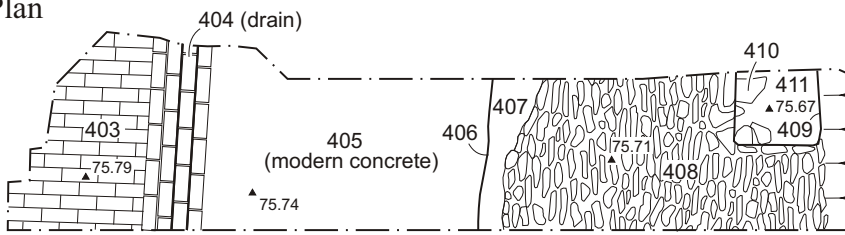
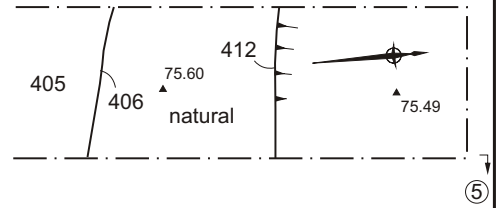
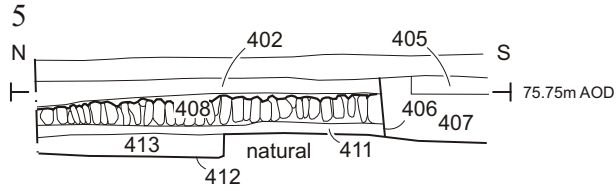
Fig. 6 Evaluation: plans and sections of trenches 4–6.

Natural clay was exposed at the north end of the trench at a height of 75.60m AOD, 0.50m below the present surface. This clay was truncated by a shallow, east-west aligned ditch (412), whose fill (411) contained 17th-18th-century pottery, along with two sherds of residual medieval pottery. The north side of the ditch was not exposed, the feature having been truncated by the excavation of a geotechnical pit.

The ditch was sealed by a cobbled surface (408) laid on a thin make-up layer (411), both of which were exposed for a distance of 2.30m. The surface incorporated a limestone post-pad (410) that had been inserted flush with the top of the cobbles. At the south end of the trench a brick surface (403) was exposed immediately below the present tarmac surface. The bricks were laid on edge in stretcher bond in rows aligned both north to south and east to west. The

latter arrangement incorporated a shallow brick-lined drain (404). The surface represents an internal floor within the 19th-century brewery.

Surfaces 408 and 403 were truncated by a modern concrete surface (405) laid flush with the level of bricks 403. This concrete was overlaid by the existing tarmac surface and its associated make-up.

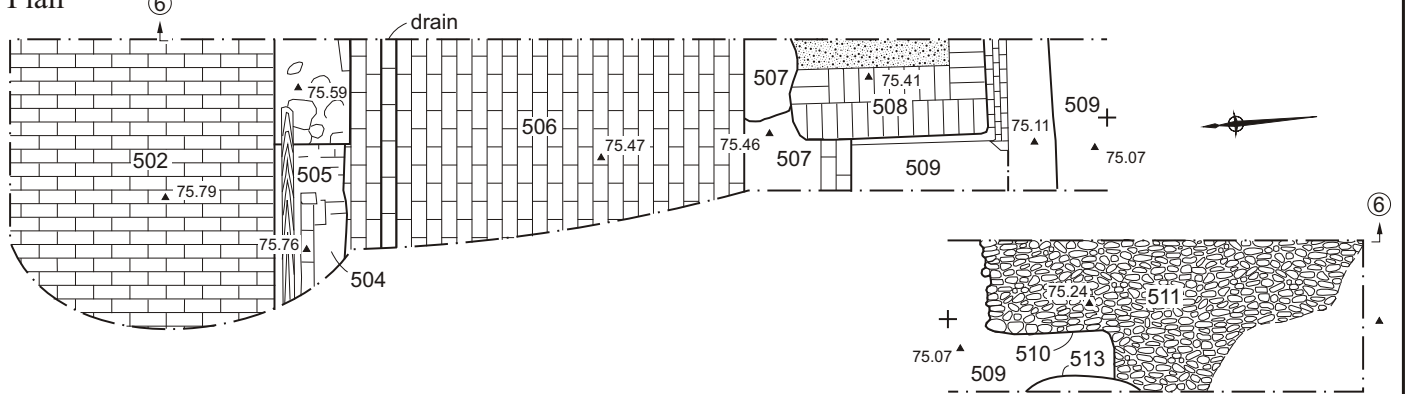
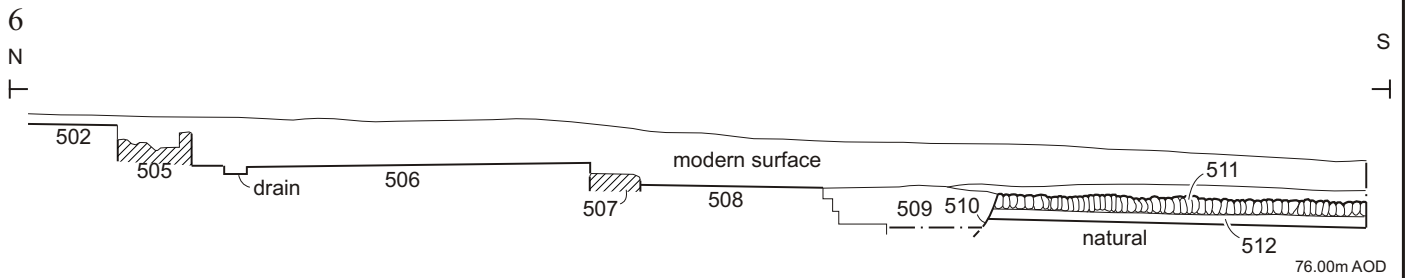
Natural clay was exposed at the south end of the trench at a height of 75.09m AOD, 0.50m below the present surface. Part of a shallow, small pit (513), possibly of 17th-century date, was exposed cutting into this clay. The pit was sealed by a cobbled surface (511) laid on a thin make-up layer (512).

The cobbled surface was truncated by a large construction trench (510) that continued below the level of the natural clay. Within this trench a series of features associated with the 19th-century brewery were had been constructed. Two walls were exposed; the south wall (507), represented by a footings of cement-bonded rubble and slate, and the north wall, which comprised two builds, an earlier stone structure (505) with a later rebuild (or extension westwards) in brick (504). Respectively, these walls represent the outside (southern) wall of the main brewery building (as depicted on the 1889 OS map), and an internal wall. To the north of wall 504 a horizontal timber (503) indicates the position of a large doorway. Between walls 507 and 504 was a brick surface (506), incorporating an integral brick-lined drain. To the north of wall 504 another brick surface was exposed (502), at a slightly higher level than surface 506. Surface 502 almost certainly represents a continuation of surface 403 in trench 4. To the south of wall 507, part of a further brick surface was exposed (508), set on projecting brick footings laid onto concrete.

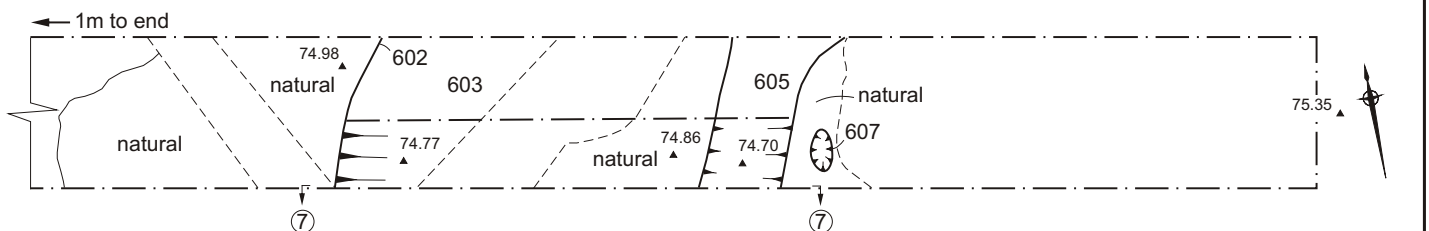
Natural clay and gravel was exposed at a height of 74.86m AOD, around 0.40m below the surface. Three features were exposed cutting into these deposits. Ditch 602 was a shallow feature, aligned south-west to north-east, whose west side had been truncated by a modern service trench. Feature 604 may represent a second ditch, although its irregular shape may indicate it was dug as a garden feature. Adjacent to this feature was a small posthole (607). These features were overlaid by levelling deposits (600 and 601), which were sealed by the modern tarmac surface and associated make-up.

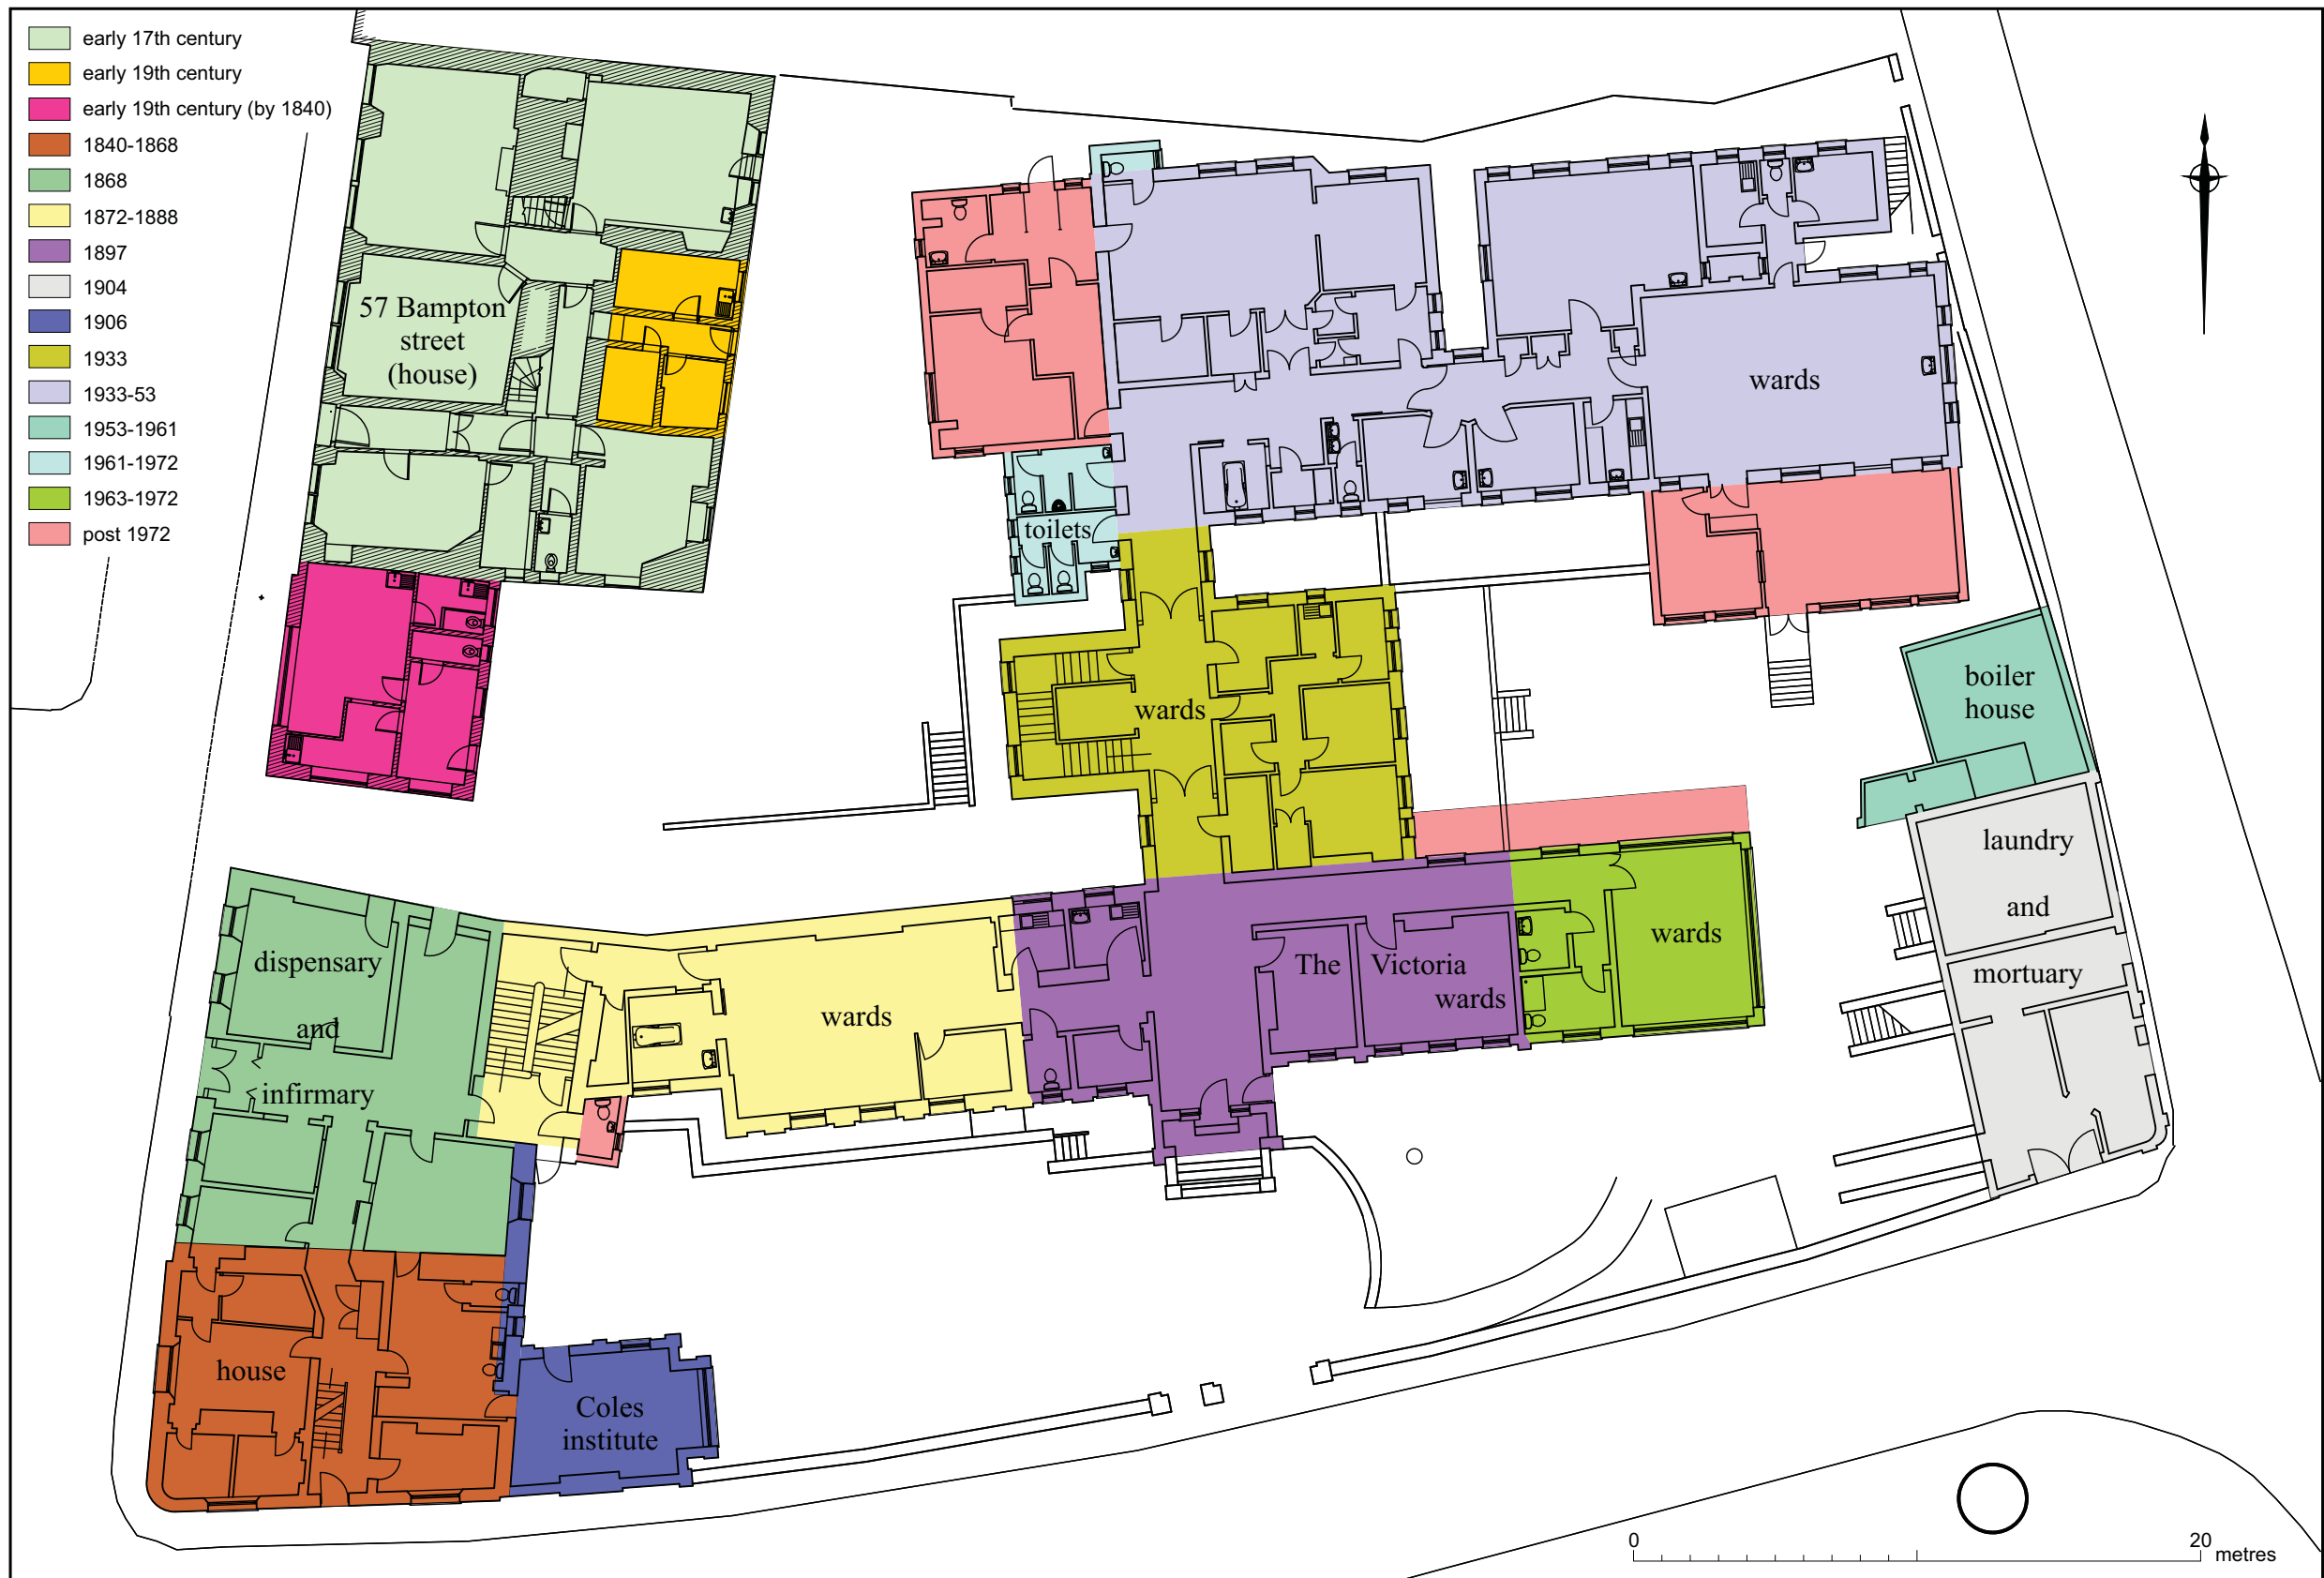
Fig. 7 Phased plan of the buildings on the site.

The brewery was demolished in phases during the first half of the 20th century, and by 1947 the whole of the present site was occupied by the hospital. The hospital buildings were further extended during the 20th century with new additions constructed on the site of the old brewery. From 1947 onwards no. 52 Bampton Street was used as nurses' accommodation, and most recently as offices.

The overall development of the buildings on the site has been presented by Heritage Vision (2009a, appendix 3), and an updated version of their plan is presented as Fig. 7 to include phasing of the 20th-century hospital buildings.

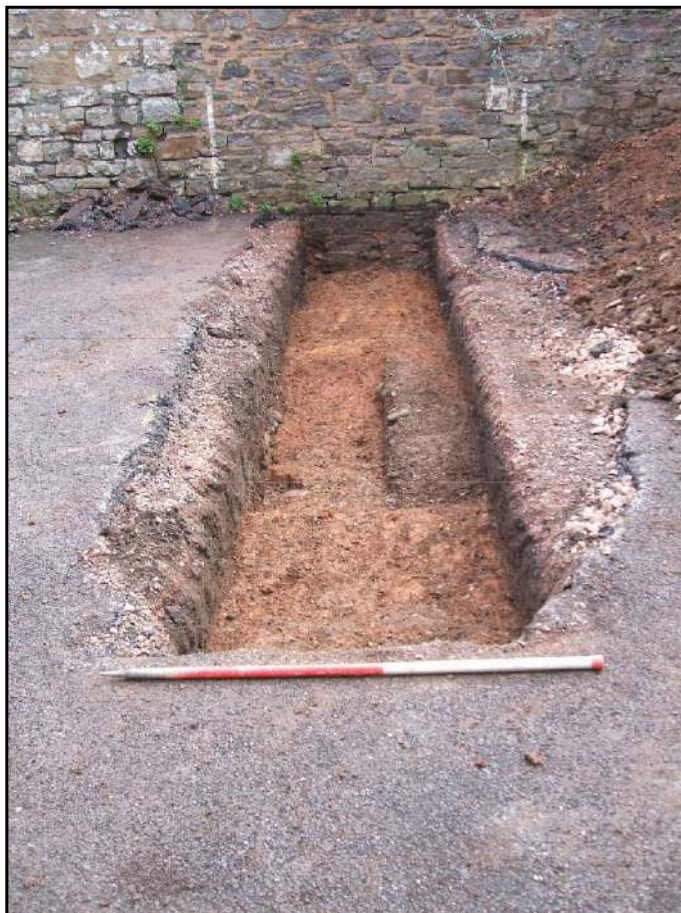
Pl.1 Trench 2 showing shallow depth of natural deposits and feature 101, looking south. 1m scale.

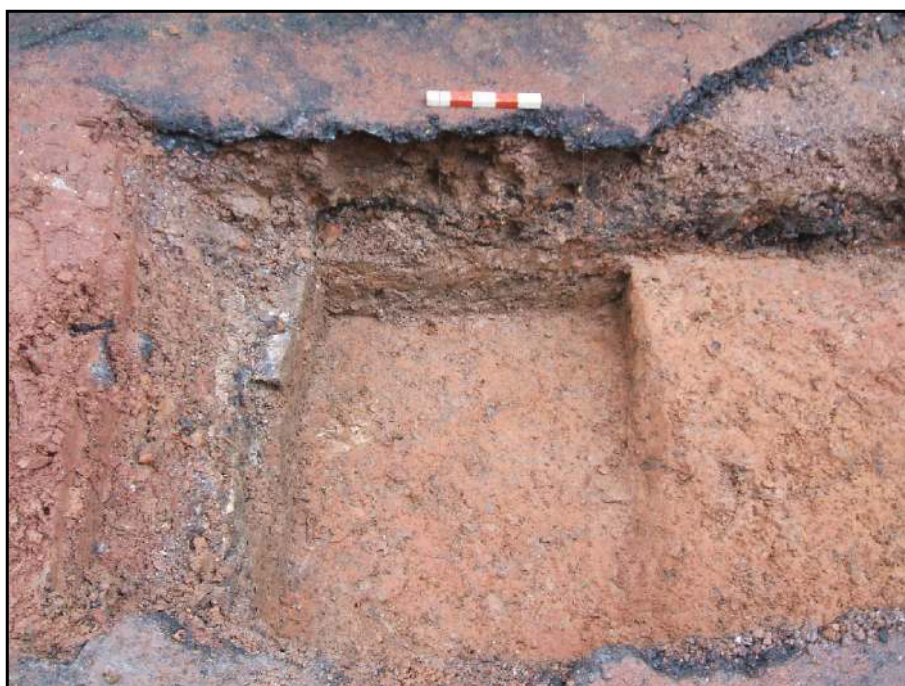
Pl. 2 Trench 4 showing ditch 412, looking east. 0.25m scale.

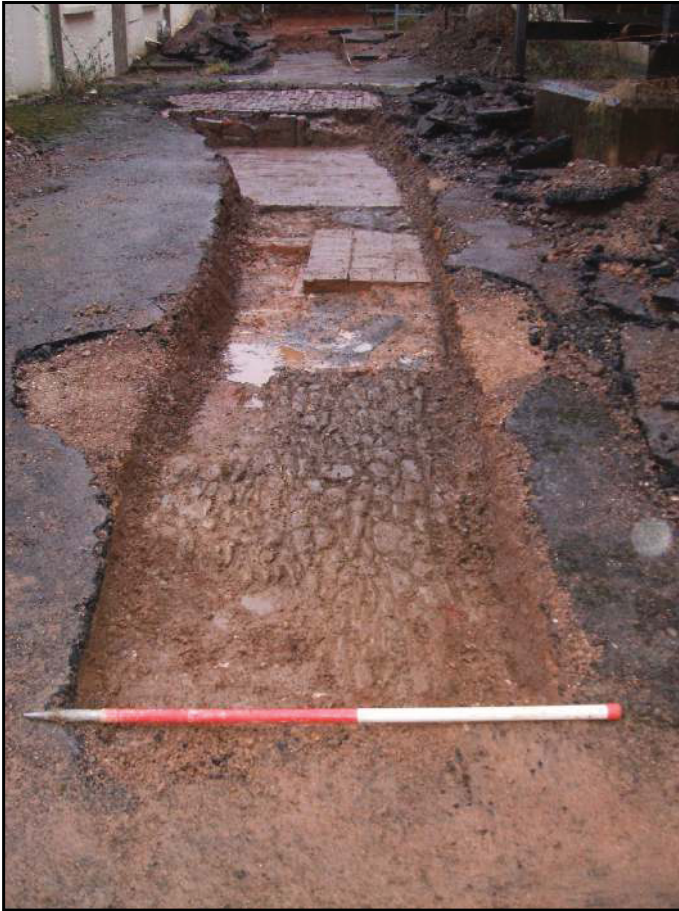
Pl. 3 Trench 5 showing cobbled surface 408 and walls and surfaces of the 19th century brewery beyond, looking north. 1m scale.

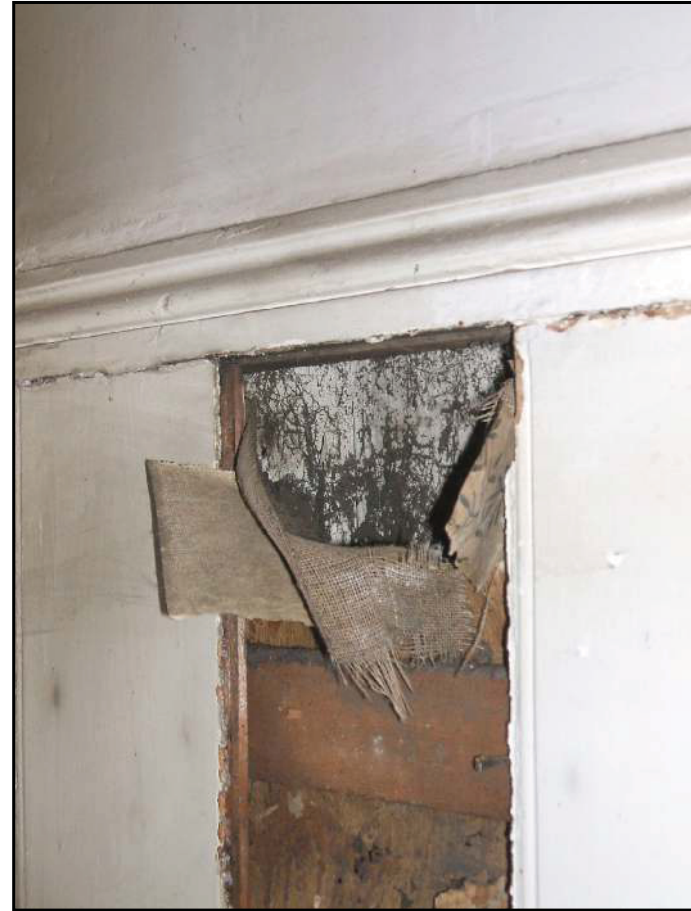
The cross passage is entered directly from the street, via the original door, now surrounded by a later doorframe. The service room, possibly a former buttery, is separated from the passage by a plank-and-muntin screen, now largely encased by later cladding. Both the cross passage and the service room have chamfered beams; the latter currently boxed in. Some brickwork is visible on the line of the screen between the hall and the cross passage. It is unclear whether this marks the position of a blocked doorway, or whether the whole screen has been replaced. Evidence of reused timbers from elsewhere in the building points to the latter. In the south-east room two timbers displaying chamfers and run-out stops have been incorporated into (as yet undated, but probably 19th- or 20th-century) partitions. These timbers probably originated as posts around a doorway within the screen. In the 18th-century cupboard on the first floor several reused timbers are visible, including one post with drilled holes for rods, also from a screen.

Pl. 4 57 Bampton street: plank-and-muntin screen behind later cladding, looking north-west.

- Cross passage – lower screen: removal of a section of the plank-and-muntin screen to create new access to reception area of suite 1. Item may also impact on original floor beams above;

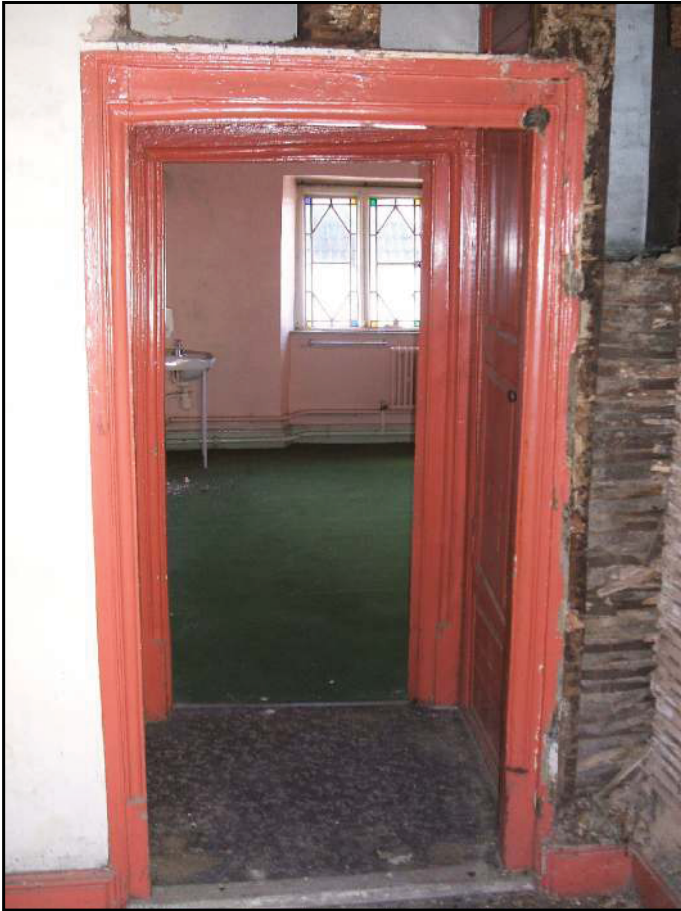
The original arrangement between these rear rooms is unclear. The present lobby probably originated in the 17th century, but it is not clear whether the corridor was an original feature – the presence of two staircases probably indicates not – or whether this was added in the 18th century when the second floor was utilised for accommodation.

Pl. 5 57 Bampton street: 17th-century doorframes on first floor, looking south.

- Replacement of first-floor doorway in lobby to the rear of units 5 and 6: this doorway is one of four original 17th-century doorframes with chamfers and stops surviving apparently *in situ* within the building.

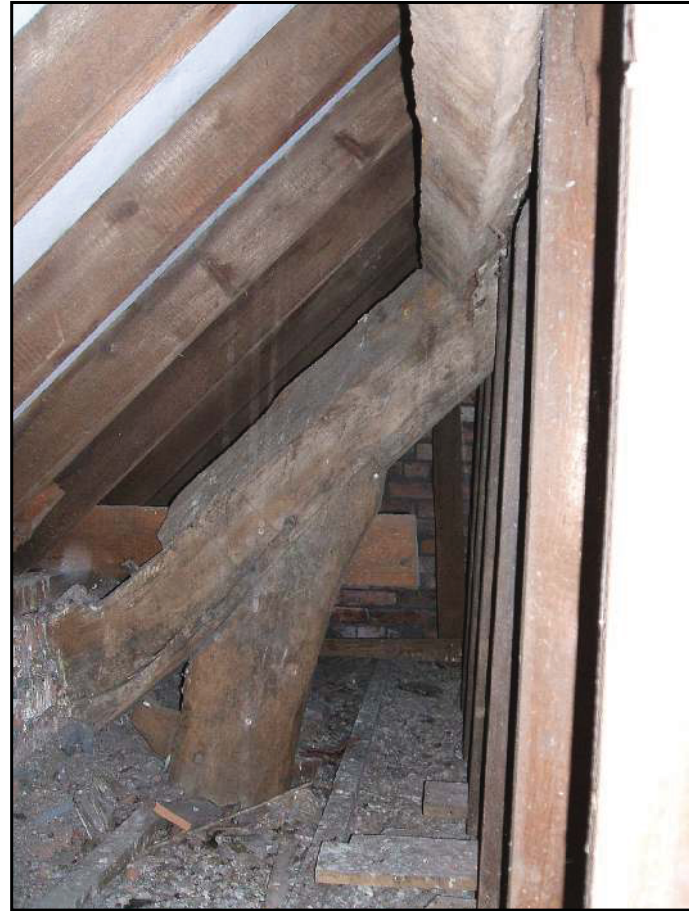
The roof structure comprising jointed-cruck trusses with dovetailed lap-jointed collars survives throughout much of the building including throughout the front main range. It has been replaced in the north rear wing, but the trusses and purlins survive within the south wing. There is also a fragment of an original truss surviving over the first floor corridor. There is no evidence for original cocklofts within the main ranges, although plaster within the roof space over the first floor corridor may provide an indication that this area was once fully accessible. The present room in the roof over the corridor is a later, smaller, alteration. Elsewhere, rooms in the roof have been added within the rear wings, and over the part of the main range. The conversion to accommodation probably dates to the 18th or early 19th century.

Pl. 6 Jointed-cruce truss in the southern rear wing, looking east.
