**BELMONT HOSPITAL TIVERTON, DEVON:
AN ARCHAEOLOGICAL EVALUATION AND
HISTORIC BUILDING RECORDING**

**Prepared for
Devonshire Homes Ltd**

Exeter Archaeology

Report No. 10.20

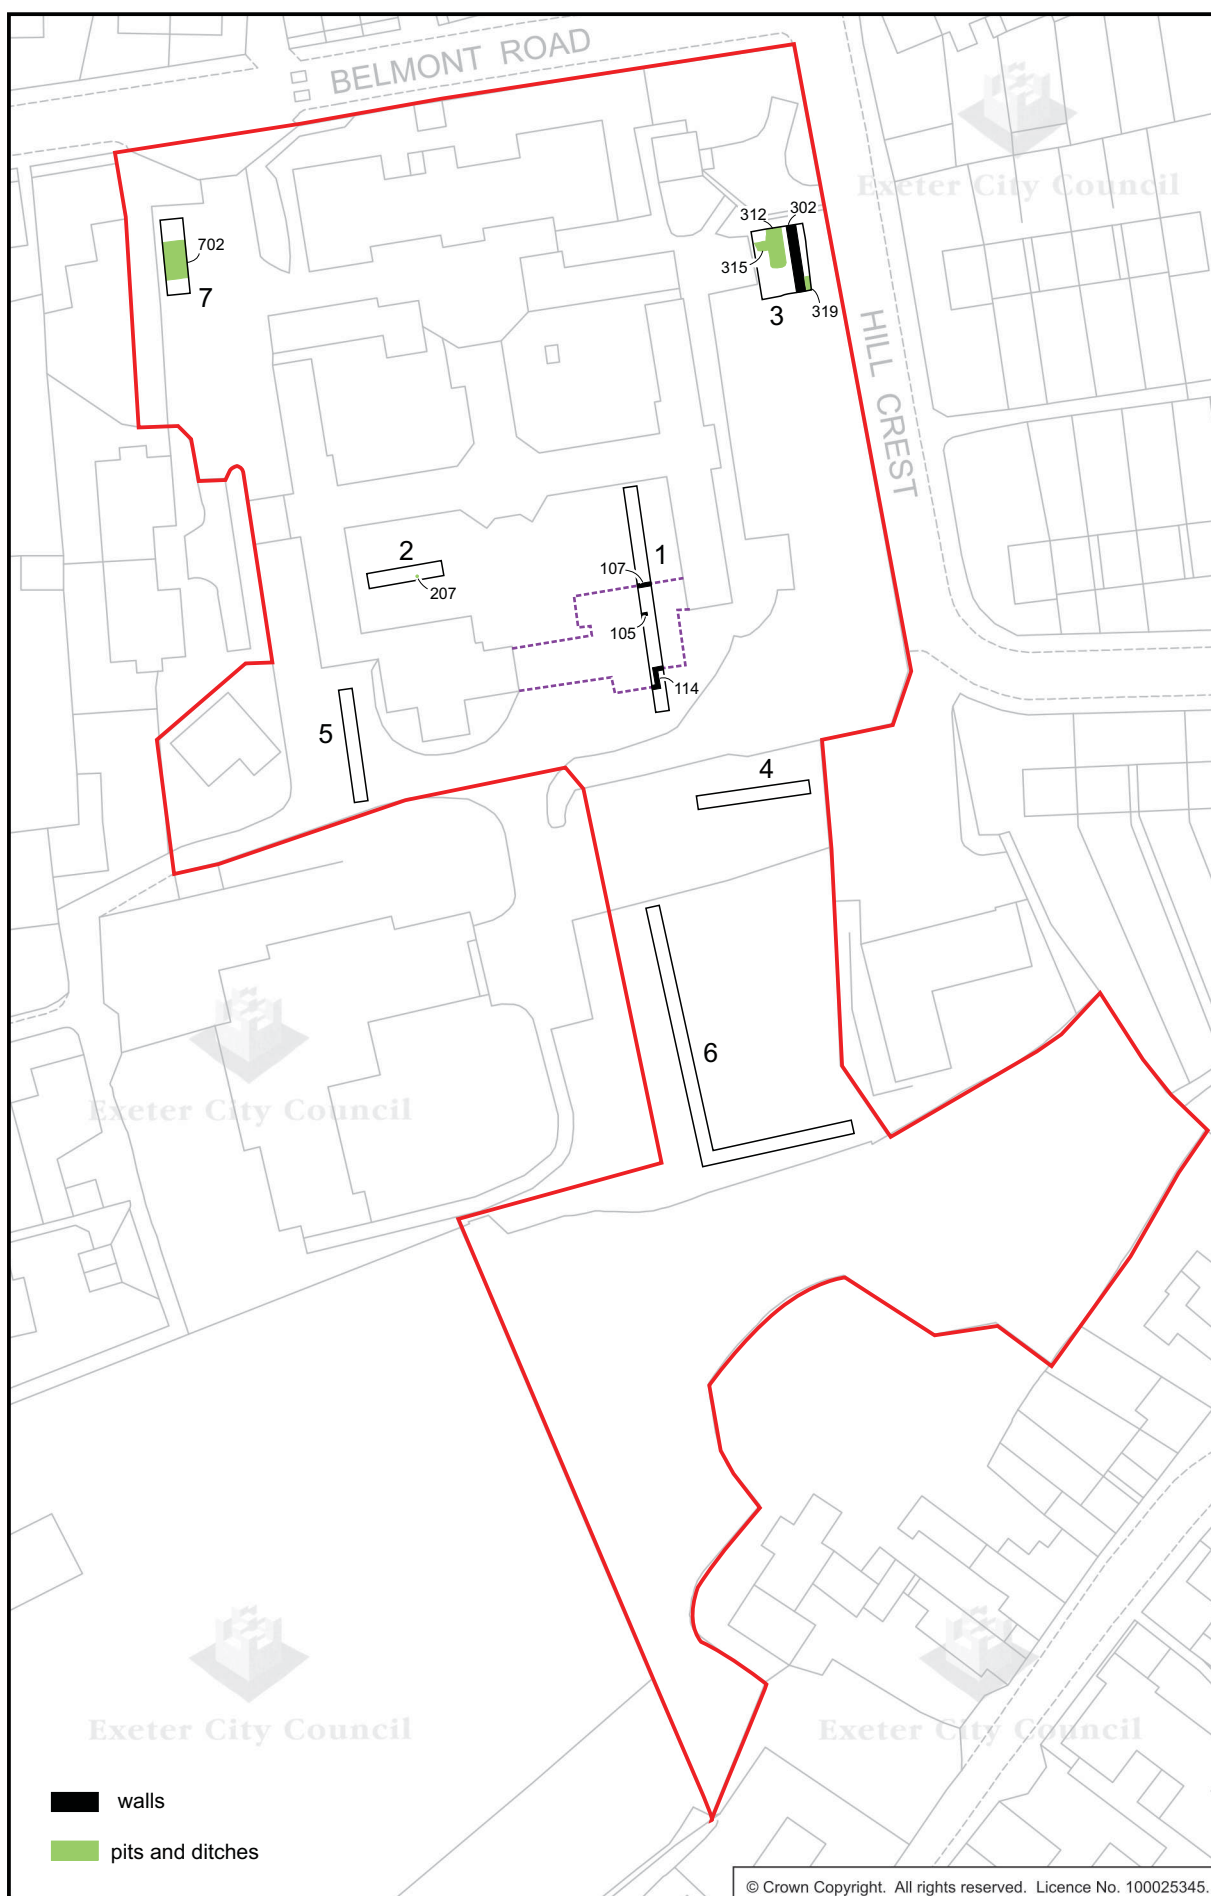
Fig. 5 Trench plan showing principal features. Scale 1:1000.

repositioning of some of the trenches. The positions of the trenches are shown on Figs 4 and 5.

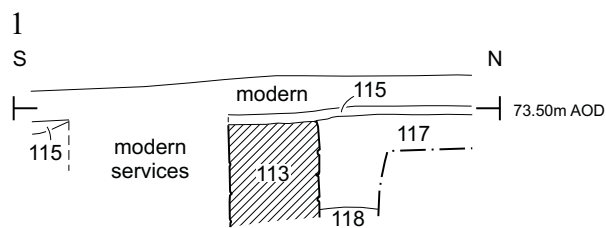
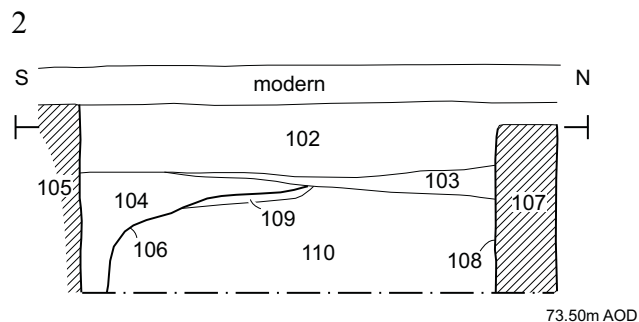
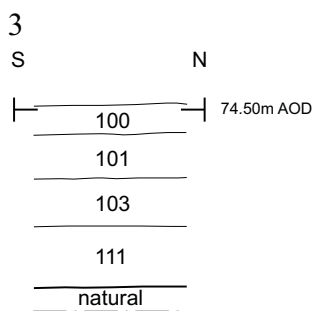
Fig. 6 Plans and sections: trench 1.

This trench measured 30m x 1.8m, was orientated approximately north to south and was excavated to a maximum depth of 1.8m. Two east to west aligned walls (105 and 107) were located towards the centre, while a further wall (113) was located at the southern end of the trench. Natural subsoil was located at a depth of 1.6m below current ground level (72.4m aOD). Detailed context descriptions for this trench are set out in Appendix 2, Table 1, and all archaeological features are described below.

Wall 105 was aligned approximately east to west, was 0.26m wide and at least 1.5m deep. It was constructed of roughly squared random coursed limestone slabs bonded with light yellow-red lime mortar. This wall represents part of the 1837-8 Workhouse.

Wall 107 was aligned approximately east to west, was 0.4m wide and at least 1.5m deep. It was constructed of roughly squared random uncoursed limestone rubble bonded with light yellow-red lime mortar. This wall represents part of the 1837-8 Workhouse.

Wall 113 was Z-shaped, was 0.6m wide and at least 0.7m deep. It was constructed of roughly squared, coursed limestone bonded with light yellow-red lime mortar. This wall represents part of the 1837-8 Workhouse.

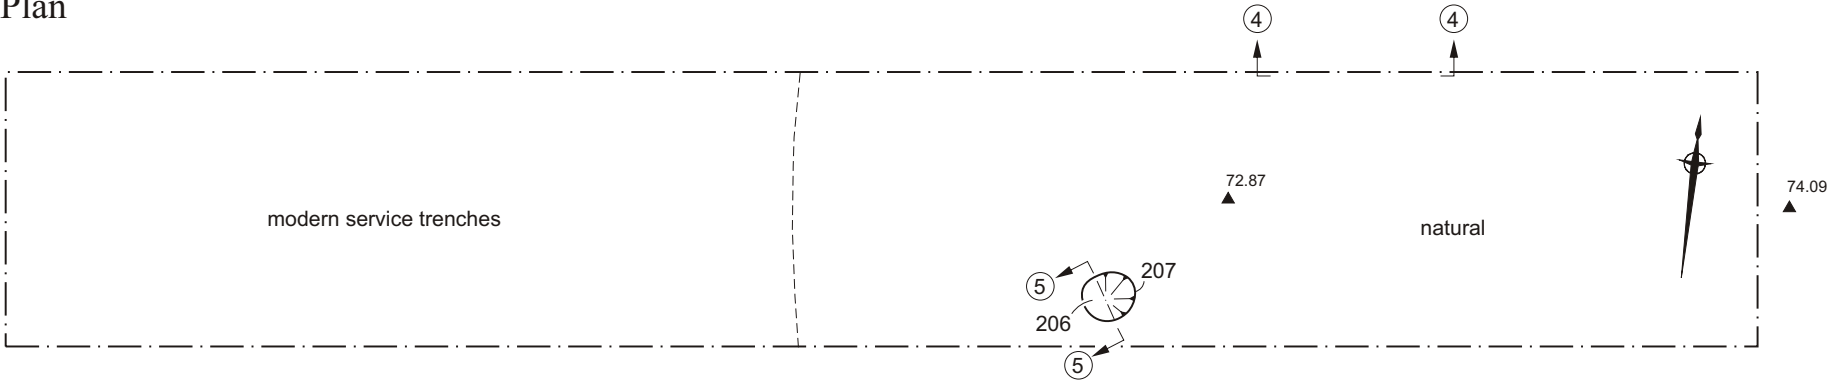
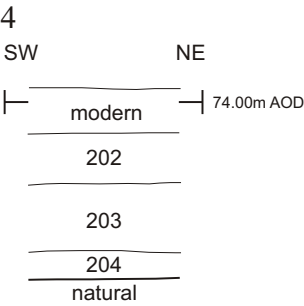
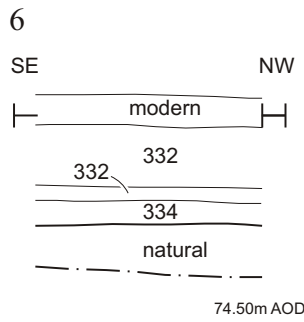
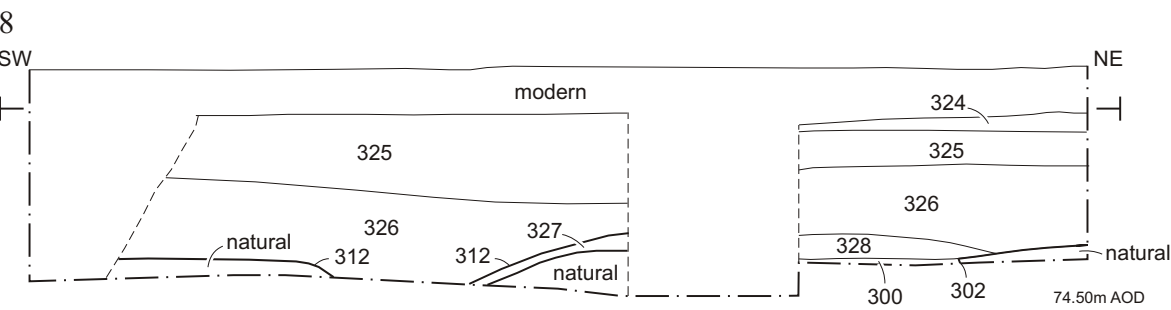
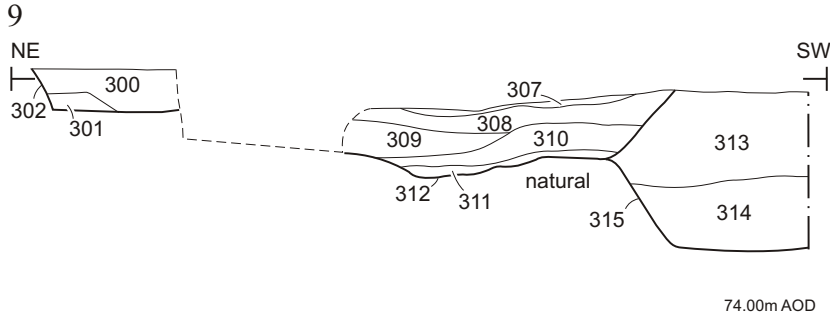
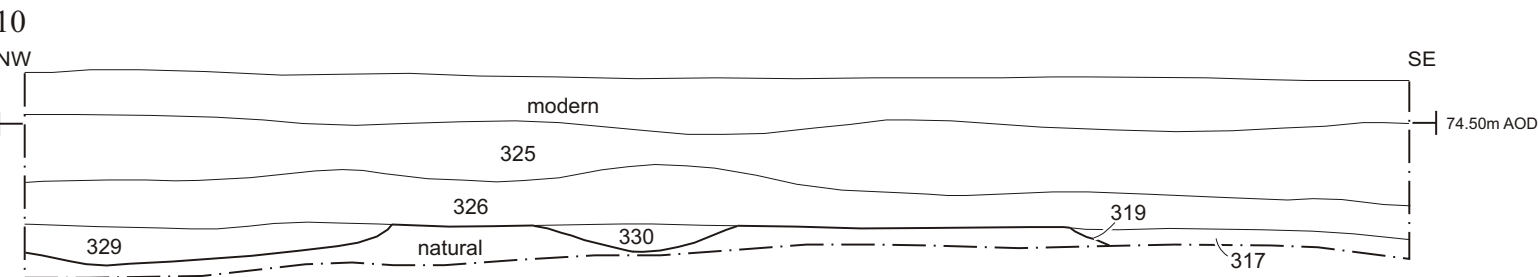
Fig. 7 Plans and sections: trenches 2 and 3.

This trench measured 12m x 1.8m, was orientated approximately east to west and was excavated to a maximum depth of 1.25m (72.74m aOD). The only feature present was a single posthole (207). Detailed context descriptions for this trench are set out in Appendix 2, Table 2, and the posthole is described below.

Feature 207 was a small roughly circular feature, with gradually breaking sides and a flat base. It had a diameter of approximately 0.32m and was 0.25m deep. No finds were recovered from its single fill (206). This consisted of a uniform clay similar to the subsoil

This trench measured 9m x 7m, and was excavated to a maximum depth of 1.5m. Four archaeological features were exposed in the trench. An approximately north to south aligned linear feature (302) was located along the eastern edge of the trench, cutting through natural subsoil at a depth of 1.5m below current ground level (72.2m aOD). Two irregular pits (312 and 315) were located in the northwest corner, while a third pit (319) was located in the southeastern corner of the trench. Detailed context descriptions for this trench are set out in Appendix 2, Table 3, and archaeological features are described below.

Feature 302 was a linear feature aligned approximately north to south. This probable robber trench was 1.3m wide and 0.4m deep, with sharply breaking sides and a flat base. A small amount of redeposited natural (301) was encountered at the base, with the remainder deliberately backfilled with a single silty clay deposit (300). A large number of early 18th-century sherds were recovered from this fill.

Feature 312 was a large irregular feature, with gradually breaking sides and an irregular base. It was approximately 2m wide and 0.45m deep. The pit was deliberately backfilled with successive silty clay deposits (307-311, 327). A large number of early 18th-century sherds were recovered from fill 310. This feature truncates pit 315.

Feature 315 was a large irregular feature, with sharply breaking sides and a flat base. It was approximately 1.1m wide and 1.05m deep. The pit was deliberately backfilled with successive silty clay deposits (313-314). A large number of early 18th-century sherds were recovered from fill 313. This feature is truncated by pit 312.

Feature 319 was a large irregular feature, with sharply breaking sides a flat base. It was approximately 1.7m wide and 1.1m deep. The pit was deliberately backfilled with successive silty clay based deposits (317-318, 331 and 335). A large number of early 18th-century roofing tiles and slates were recovered from fill 318.

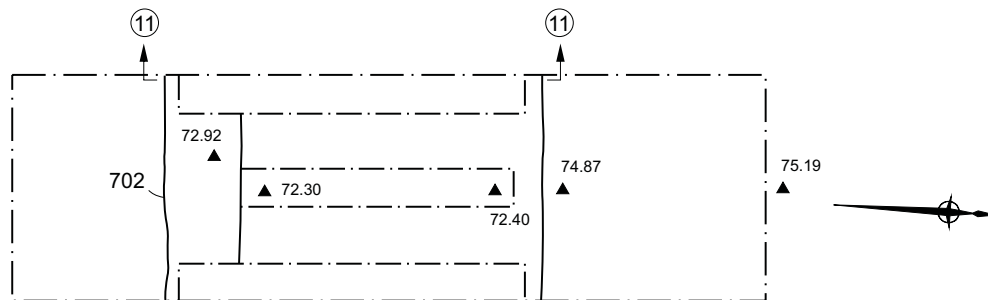
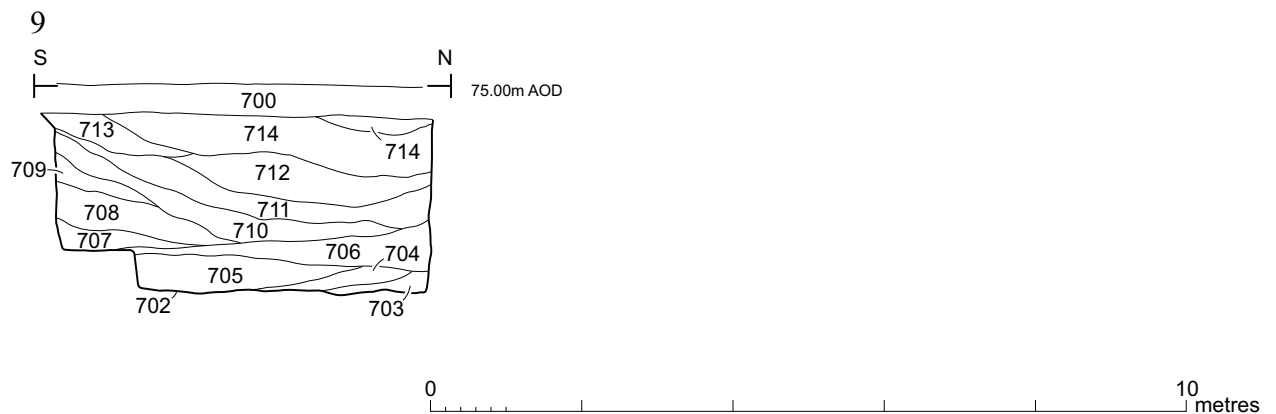
Fig. 8 Plans and sections: trench 7.

This trench initially measured 10m x 1.8m but was expanded to 3m in width, was orientated approximately north to south, and was excavated to a maximum depth of 2.78m. A single east to west aligned linear feature (702) was located in the centre of the trench. This cut through natural subsoil at a depth of 0.4m below current ground level (74.6m aOD). Detailed context descriptions for this trench are set out in Appendix 2, Table 7, and archaeological feature is described below.

Feature 702 was a large linear feature aligned approximately east to west. This probable robbed-out basement was 5.2m wide and 2.4m deep. It had vertical sides and a flat base. A 1m wide ledge was located along the southern edge of the feature, approximately 0.5m above of the base. The feature was deliberately backfilled with successive silty clay deposits (703-715). A large number of early 18th-century sherds, brick fragments and other artefacts were recovered from fill 706.

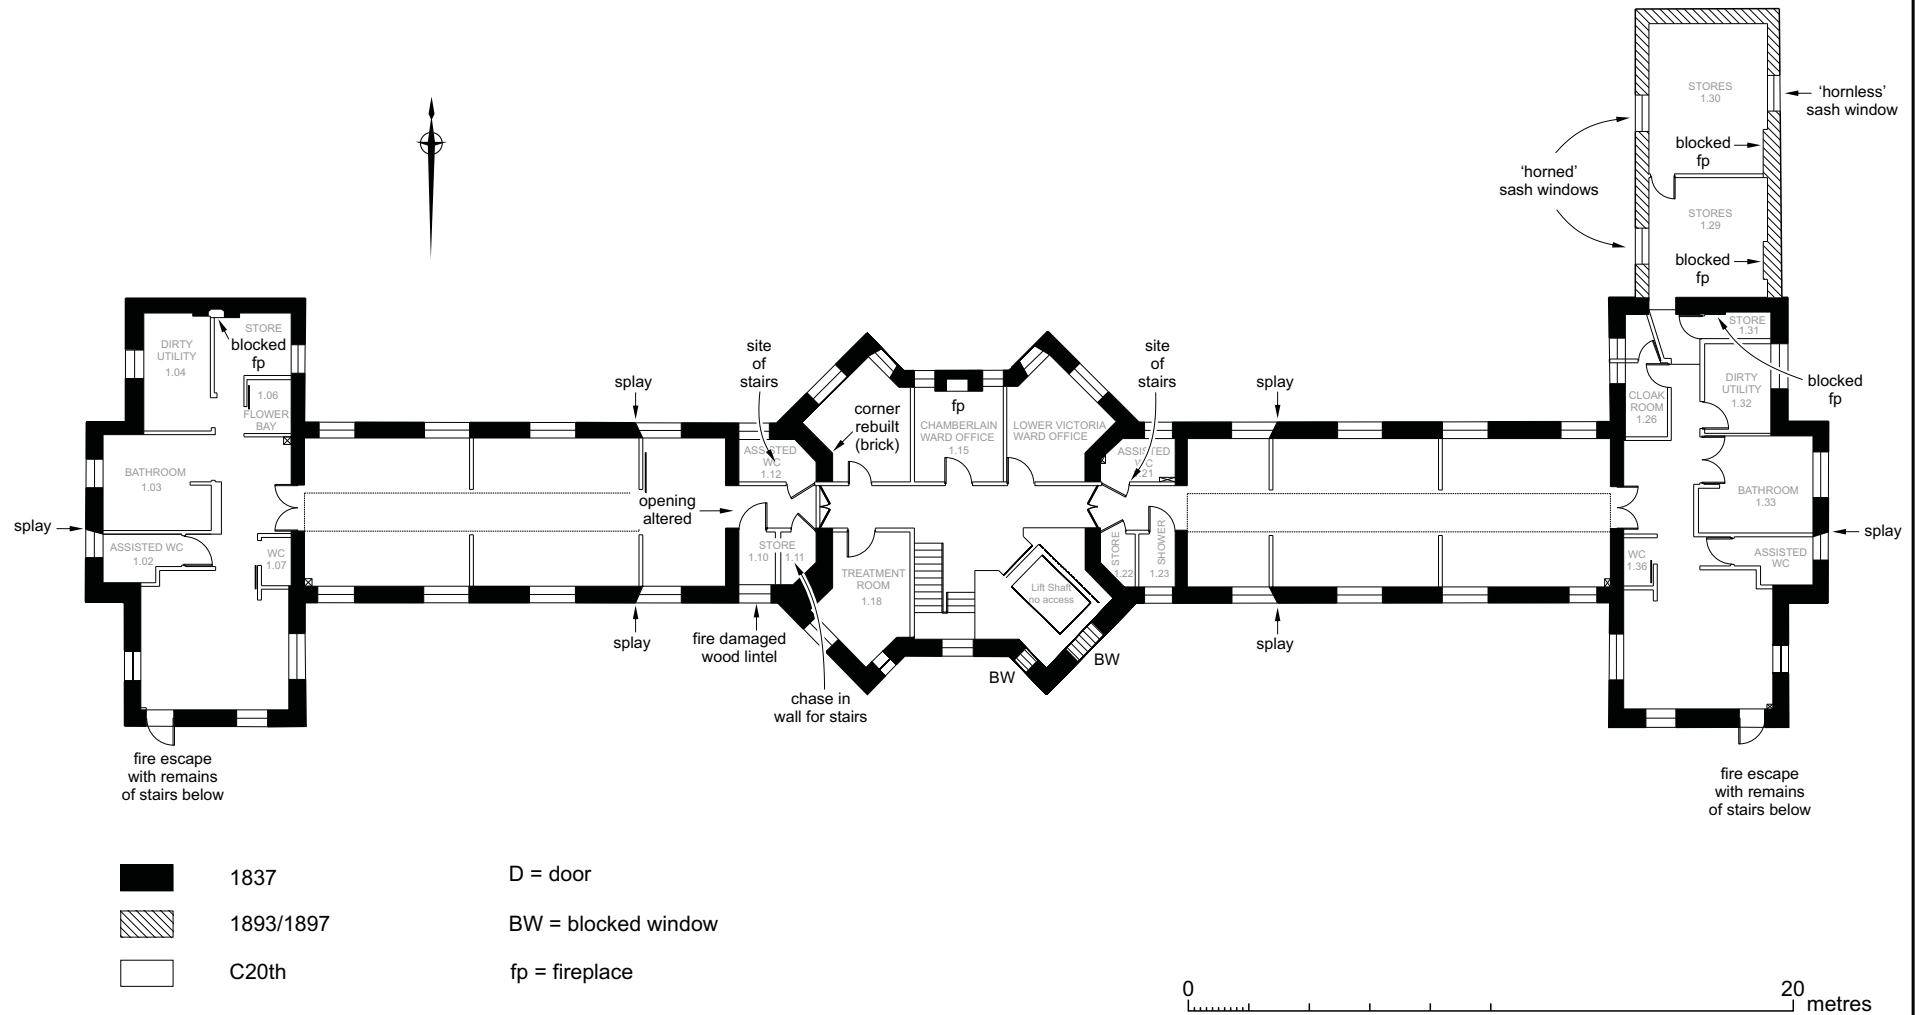
Fig. 10 The Workhouse: first-floor plan.

The first floor of the workhouse was originally confined to the central range and the central sections of the east and west ranges. In the late 19th century a first floor was added to the north end of the east range.

The present arrangement of the octagonal tower reflects the modern use of the site as a hospital, and all the partitions are modern. However, the building must have been divided into smaller rooms, mirroring the surviving layout on the ground floor. As a minimum there were rooms either side of the stairs, and further accommodation to the north of the corridor. Whether there were three small rooms as at present or a large one is unknown. The north elevation incorporates a central fireplace, which may hint at only one room being present north of the corridor.

The east and west wings of this range were both originally divided into two rooms: a large dormitory with small lobby adjacent to the central tower. Unlike the ground floor there are no lobbies at the outer ends of the dormitories. This indicates the inner lobbies contained stairs from the ground to the second floor, whereas the outer lobbies contained stairs rising only to the first floor. In the west wing lobby there is a chase in the wall marking the position of the stairs to the second floor. The lintel above adjacent the adjacent lintel is fire damaged.

The west and east ranges were probably originally large open rooms, but have since been subdivided. The only original features are fireplaces in the north elevations. In the projecting sections of the outside (east and west) elevations one window in each range is splayed. As with the central range, described above, the narrowing of these windows probably relates to the insertion of the present 20th-century partitions rather than being original features. In both ranges fire exit doors have been inserted into the south elevations. These led to external metal stairs (now removed but see www.workhouses.org.uk for a photograph showing the stairs in place). The only surviving external evidence for these stairs are large brackets for the treads below the doors.

In the late 19th century the east range was extended, with the provision of two rooms on the first floor over the existing northern ground-floor rooms. The rooms were heated by fireplaces in the east elevations, and lit by sash windows in the east and west elevation. These are of two designs, with both horned and hornless sashes, which almost certainly reflects their reuse from an earlier building.

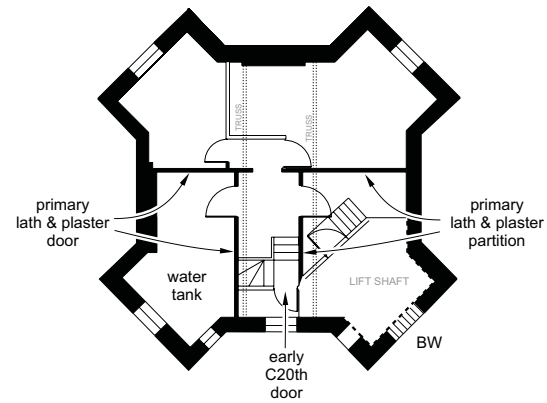
Fig. 11 The Workhouse: second- and third-floor plans.

The second floor layout was originally almost identical to the first floor being present in the central range and the central sections of the east and west ranges.

The present arrangement of the octagonal tower reflects the modern use of the site as a hospital, but partially retains original partitions and layout. There would have been a room on each side of the stairs, of which the western room survives with its original lath and plaster partitions, now covered over by later boards. There would have been further accommodation to the north of the corridor, and possibly comprising two or three small rooms. The present east and west rooms incorporate niches in their southeast and southwest elevations respectively. These features may have been for storage, but it is also possible they have been altered from original fireplaces. Further evidence for the latter is supported by the presence of three chimney stacks above the roofline, two of which are located in the east and west elevations. No other evidence for fireplaces that these side stacks served has been identified.

The east and west wings were originally large open dormitories that have been subdivided during the more recent use as a hospital. The roof structure over these wings has a shallow pitch and is supported on trusses with queen posts rising from a low collar. All the joints are fixed with iron bolts. The roof has been ceiled over below the collar and only one row of purlins is visible.

The west and east ranges were probably originally large open rooms, but have since been subdivided. The only original features are fireplaces in the north elevations. In both ranges fire exit doors have been inserted into the south elevations.

The roof structure is visible and is as of the same design as above the wings of the central range, but with the addition of hips above both the north and south gable elevations. Where the masonry projects out in the centre of the ranges the roof trusses are supported on long wall plates that span the opening.

The central tower incorporates a third floor that contains three main rooms with a smaller fourth room adjacent to the stairs. This floor retains its original lath and plaster partitions. The original use of the rooms is not known. The main southern rooms now contain a water tank and lift winding gear, whilst the northern room has been subdivided into two rooms.

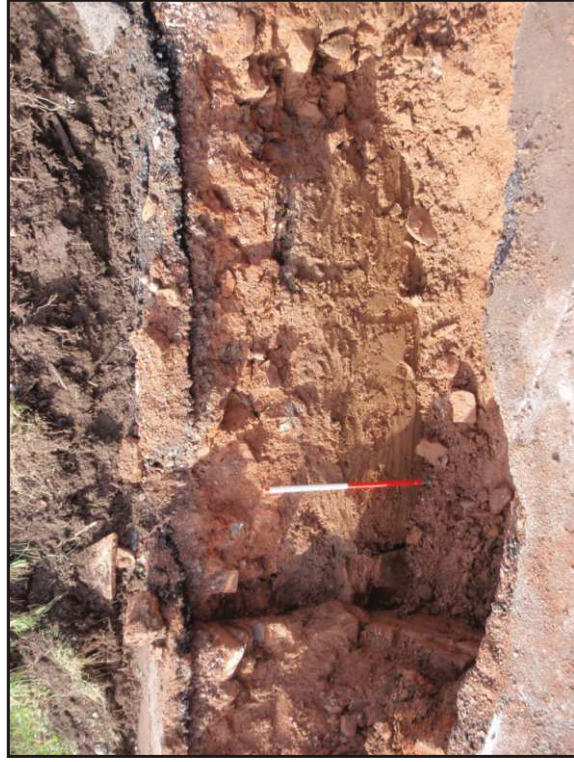
Plate 1 General view of walls 105 and 106, looking west. 1m scale.

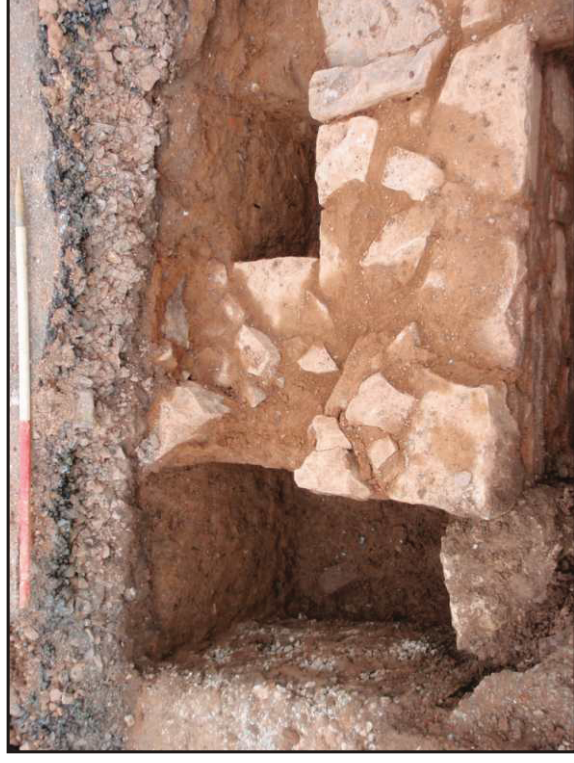
Plate 2 General view of wall 113 showing deposit sequence, looking west. 1m scale.

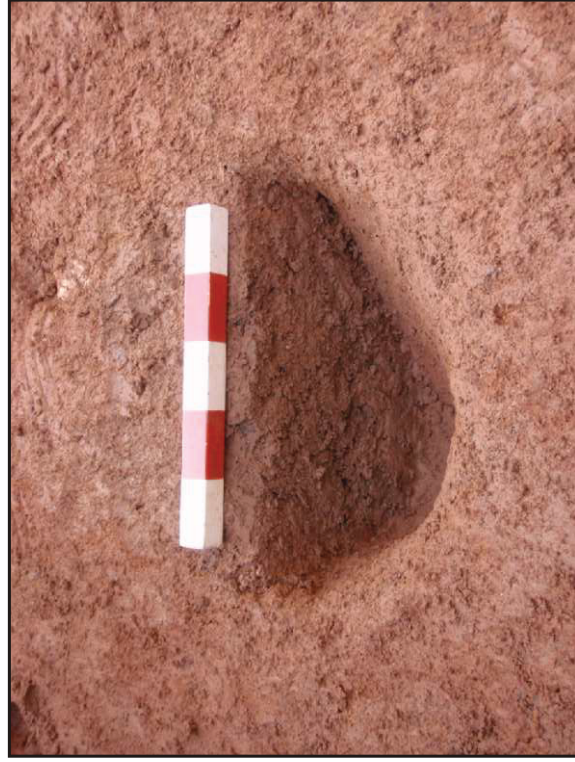
Plate 3 Section through posthole 207, looking south-west. 0.25m scale.

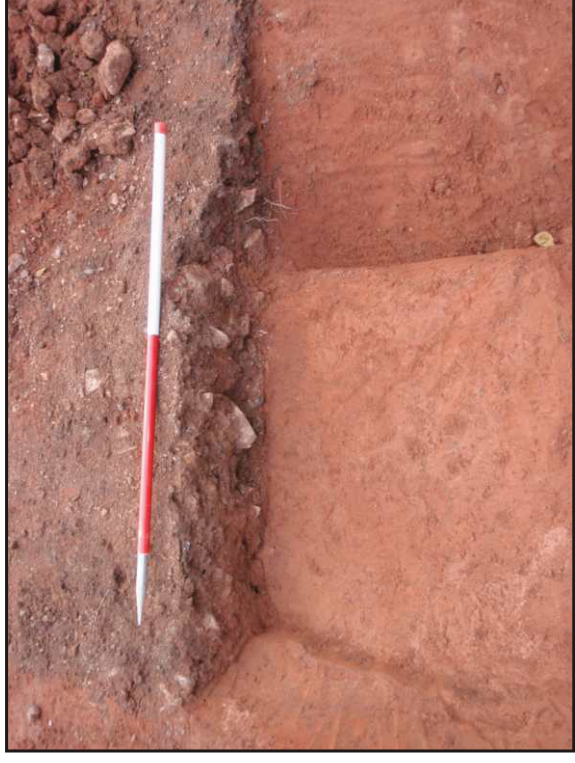
Plate 4 General view of robber trench 302, looking south. 1m scale.

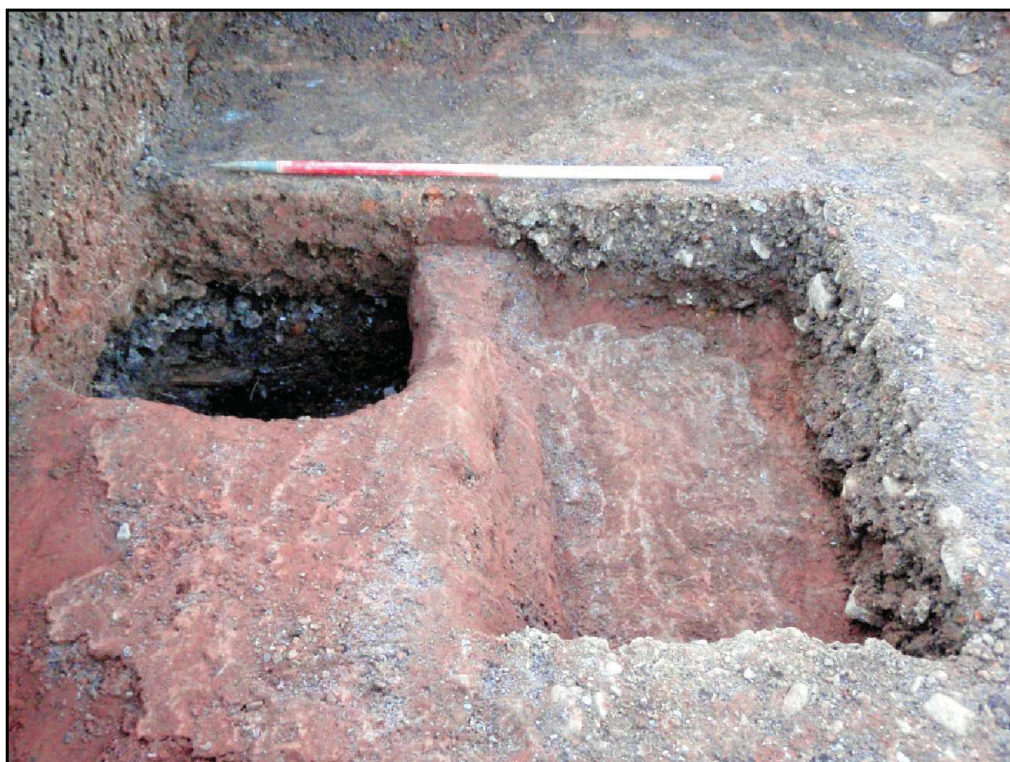
Plate 5 General view of pit 319 and robber trench 302, looking south. 1m scale.

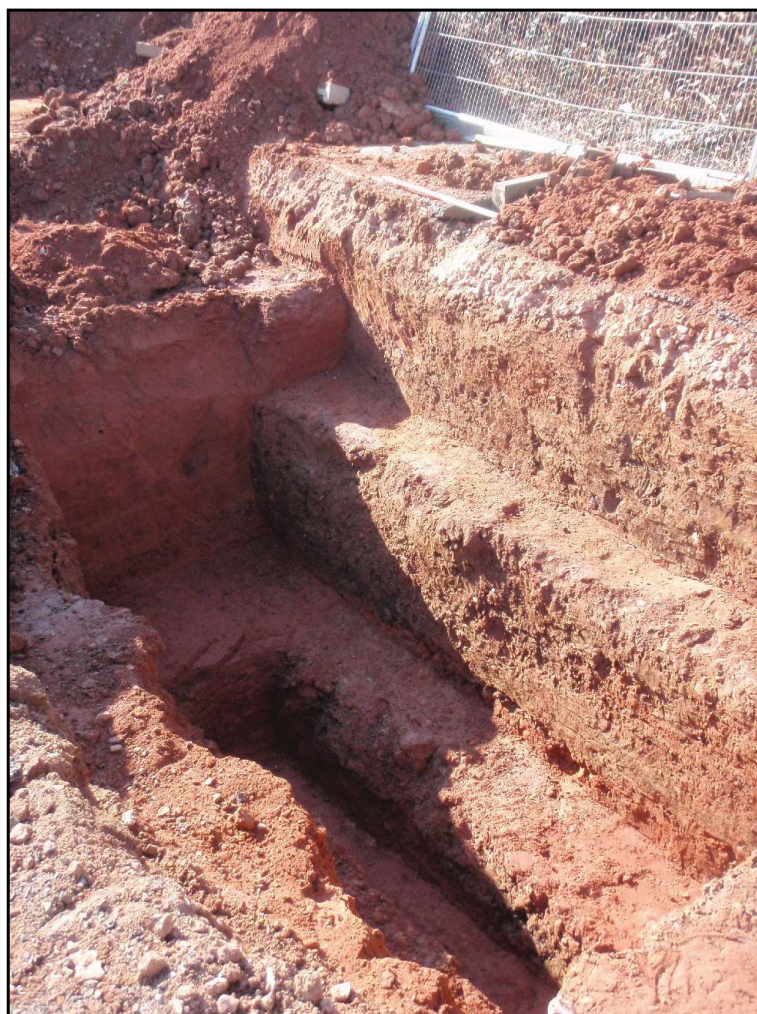
Plate 6 View of feature 702, looking south-west. 1m scale.

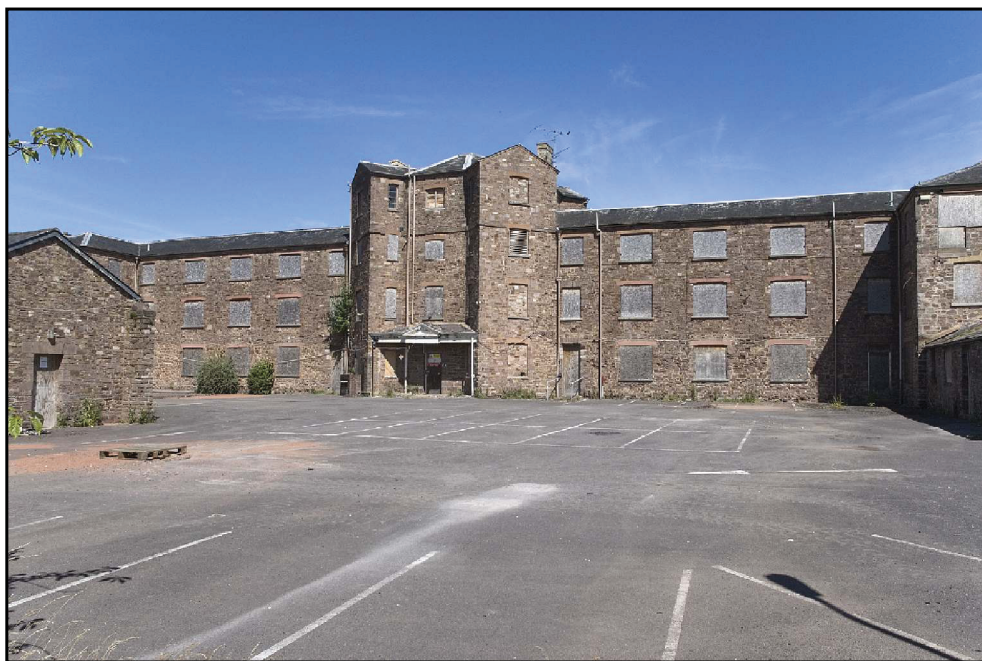
Plate 7 The Workhouse, central range, looking north. 1m scale.

The central range comprises an octagonal, four-storey tower, with three-storey wings to the east and west, and a single-storey kitchen block to the north. The tower is entered from the south and leads into a lobby that originally gave access to four rooms; the southeast room (on all floors) has been replaced by a lift shaft. The introduction of the lift shaft has necessitated the blocking of windows, although one remains open but with louvred vents. From the lobby the original staircase rises to the first floor (and on up to the third floor) and there are also doors to the adjacent wings and kitchen. The opening into the western room is arched and is the only visible example of this type of opening in the building. Although the opening is rectangular the masonry above the door in the adjacent north elevation also incorporates a brick arch. The northern two rooms have tiled walls, and retain 19th-century doors, the door in the northwest room being of the 'stable' type. The floor of the lobby has been relaid in tiles, with the inscription 'R G & S 1910'. On the outside of the building the southernmost corners project outwards as piers for former gates situated at the end of the entranceway.

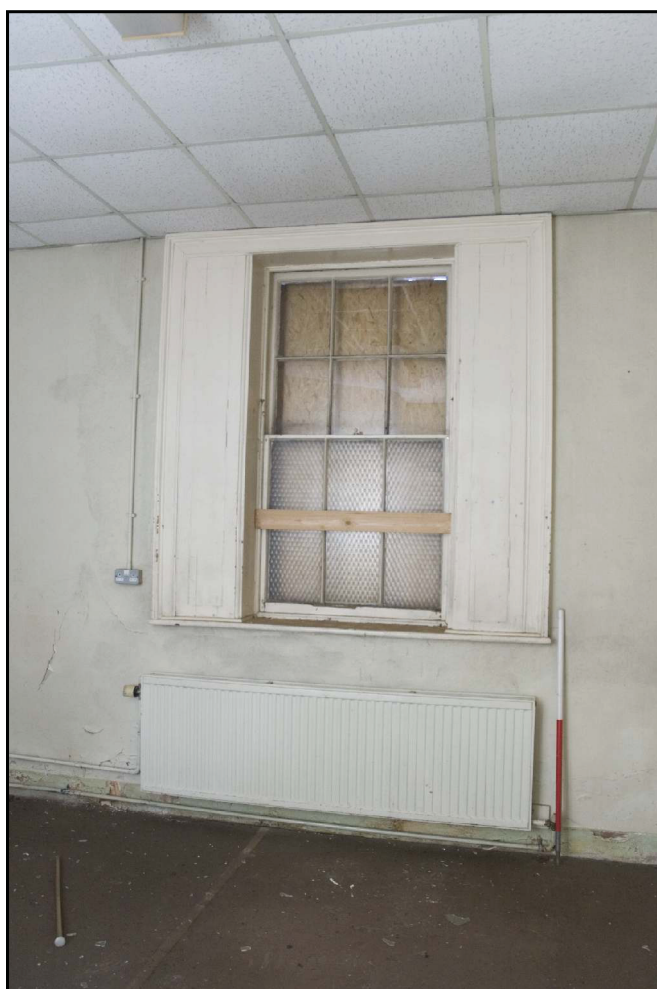
Plate 8 The Workhouse, window with surround in boardroom, looking south. 1m scale.

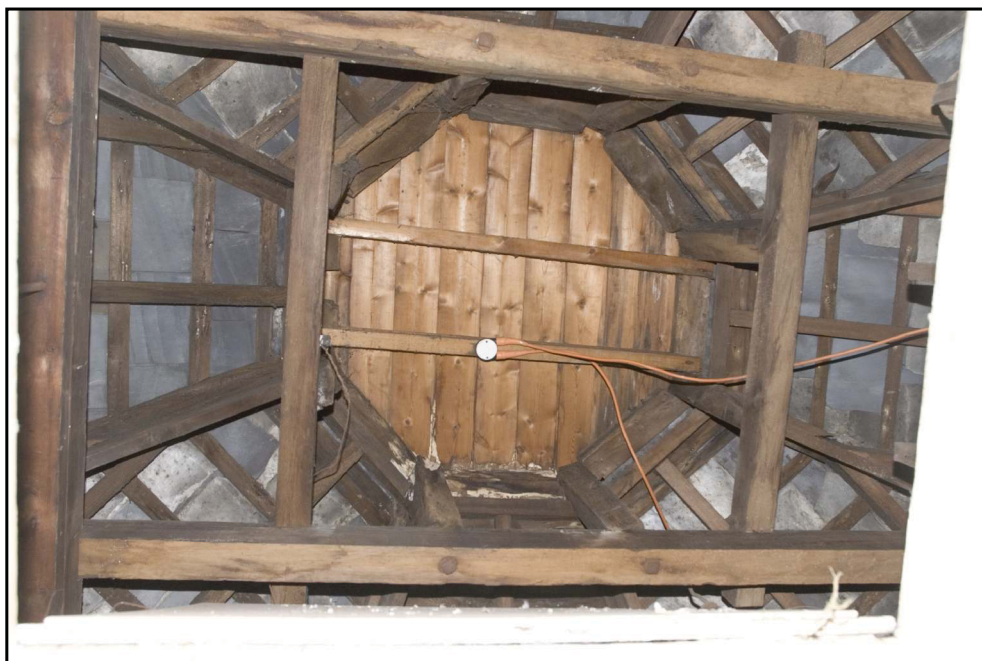
Plate 9 The Workhouse, supports for removed turret in the tower, looking north.

The roof has four pitched sections terminating in a central flat peak. Double pitched roofs over the projecting masonry abut the main roof. The lower part of the roof structure comprises two trusses with a double king post arrangement. These trusses support queen posts above onto which is sat an octagonal frame. The frame would have supported a turret or lantern (as restored at Williton; Heritage Vision 2008, fig. 13).

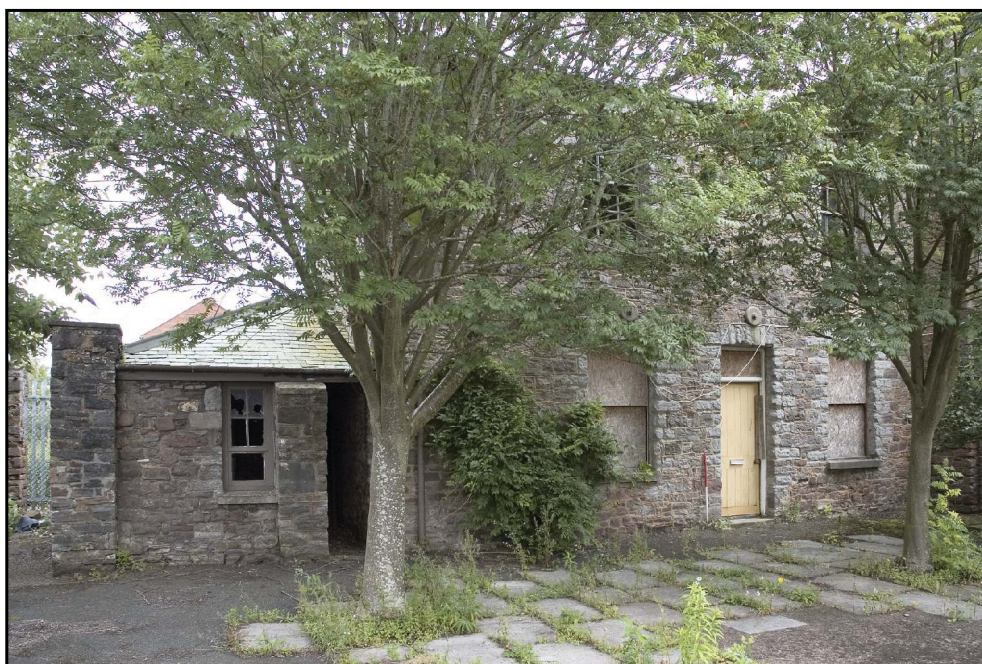
Plate 10 The Workhouse, east range showing added first floor, looking south-east. 1m scale.

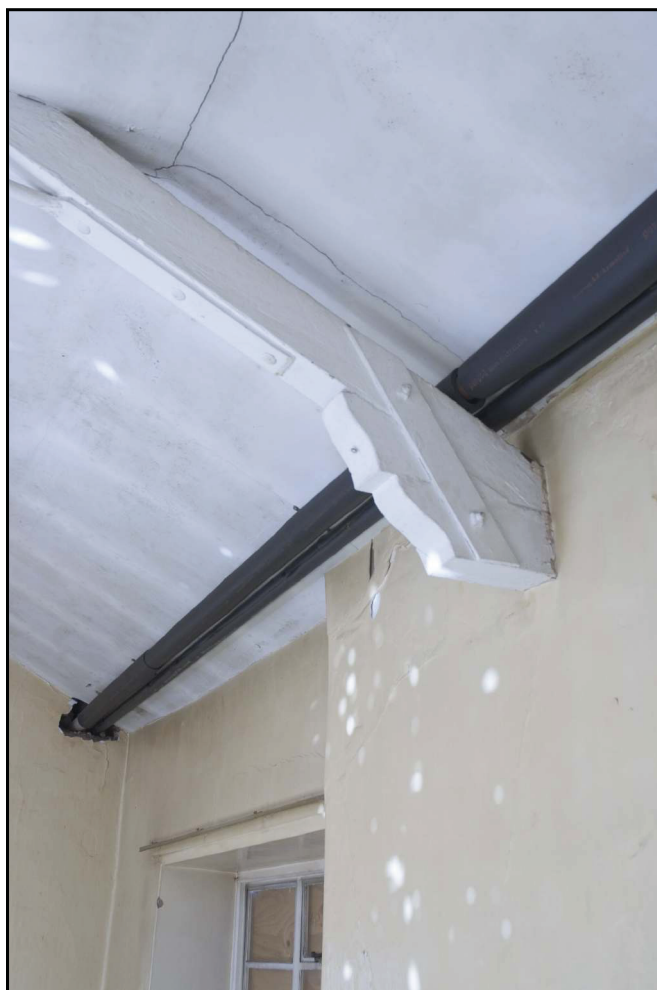
Plate 12 The Infirmary, detail of the roof structure over the central range, looking north-west.
