**ARCHAEOLOGICAL RECORDING AT
30 COUNTESS WEAR ROAD, EXETER**

Exeter Archaeology

Report No. 10. 35

May 2010

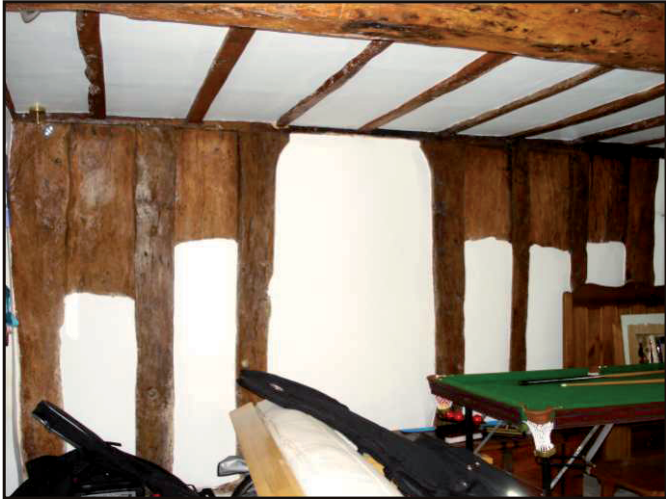
Plate 1 The cross-passage screen, looking southeast.

The present main entrance to the property lies in the modern extension, but an earlier entrance lies to the south of this, under a glazed porch. This opens into the northern room of the original medieval building and cannot represent the entrance to the cross passage, which must have lain to the south of the lateral stack within the adjacent property. No traces of the doorways to the passage are visible on either the front or rear of this house; however the wall dividing the properties retains a massive plank and muntin screen with a central doorway with a shouldered arched head, which springs from the southern jamb of the fireplace and seems certain to be associated with a cross passage (Pl. 1).

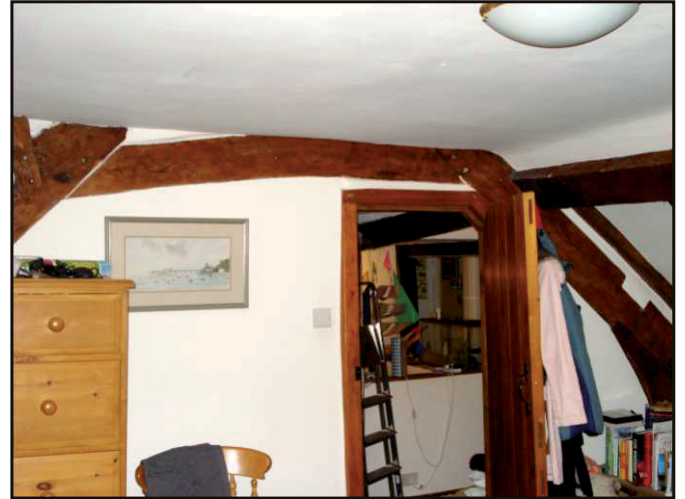
Plate 2 View of first floor showing jointed-cruck truss, looking northwest.

The partition dividing the hall from the northern room projected into the roof space and was smoke-blackened on both sides, showing that the northern room was also heated by an open hearth. The apex of the truss was infilled with a plaster panel supported upon vertical studs interwoven with wattle. The timbers and the plaster have been whitewashed right up to the ridge, showing that the open hearth went out of use before this room was ceiled, perhaps when a first floor, or a fireplace, was inserted.

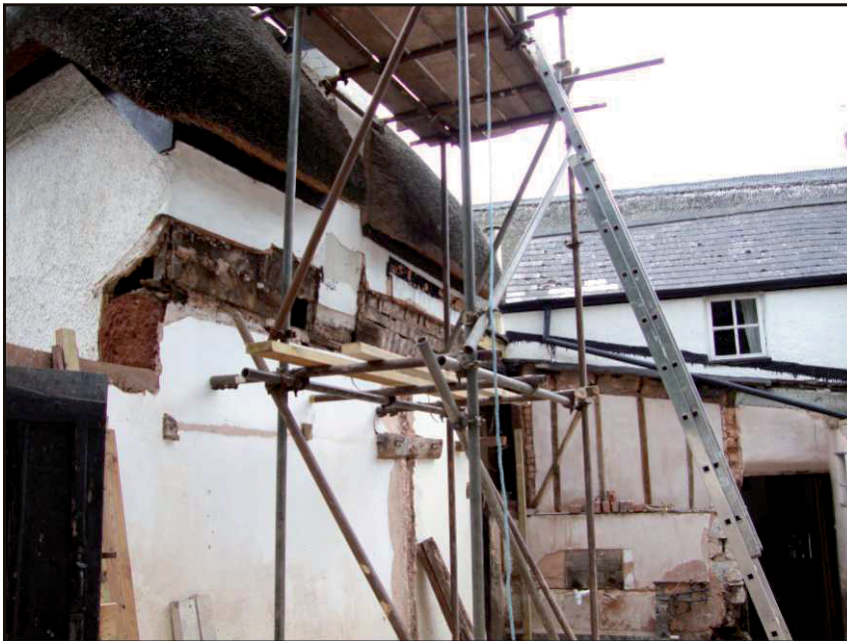
Plate 3 The turret showing cob and timber-framed construction, looking southwest.

The present, very low-pitched roofs of the eastern extension were observed when they were removed; they had been entirely rebuilt in the late 20th century, and were of flimsy construction and in poor repair. Their removal exposed the construction of the north wall of the turret. The lower part of the wall, against which stands a fireplace proved to be of cob construction to the height of the demolished roof, above which the upper part of the turret could be seen to be timber framed (Pl. 3). The framing is clad with wide, horizontal boarding, the edges of the boards being butted, rather than lapped. The boards meet none too accurately

at the edges and it is evident that this was not intended as the finished surface treatment; widely-spaced cleft laths had been nailed diagonally over the boarding forming a base for a coat of render. As far as could be determined, none of the original render had survived. It may have been renewed when the roofs of the lean-to were replaced in the 20th century. Much of the existing render was supported on modern expanded metal lath. No new evidence of the original form or function of the turret building has been observed.
