**ARCHAEOLOGICAL RECORDING  
AT NEW INN FARM,  
CALVERLEIGH, LOXBEARE, DEVON**

**Report No. 10.57**

**Project Number 7258**

**August 2010**

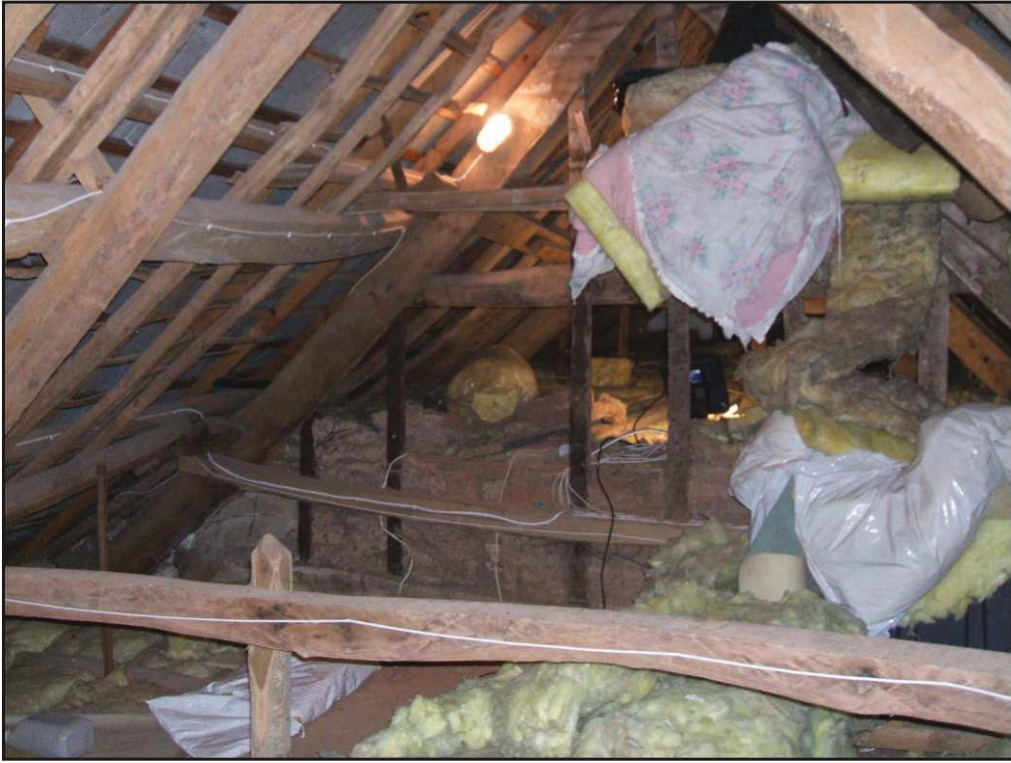
Truss 3 is of a different design from truss 1, and is constructed from larger timbers. It was formerly closed to the apex but has been partially reopened. Between the trusses are vertical posts, attached to a lower, secondary collar, that are infilled with cob and covered with lath and plaster painted white. The cob and covering generally survive only at the base of the truss, below the raised ceiling of the rooms below. The lower collar has pulled away from the principal rafter, and a modern brace has been added above to provide structural support. There is a primary collar higher up the truss. The lower collar is lap-jointed and the higher is notched lap-jointed and attached with pegs. The side purlins are trenched into the back of the principal rafters. The common rafters are thin and frequent, and are of a less regular form than around trusses 1 and 2. The ridge purlin to the west is set diagonally into the apex of the rafter, whereas the later ridge purlin to the east is set into a raised yoke.

Plate 1 Roof truss 3, showing part of truss 2 in foreground, looking west.

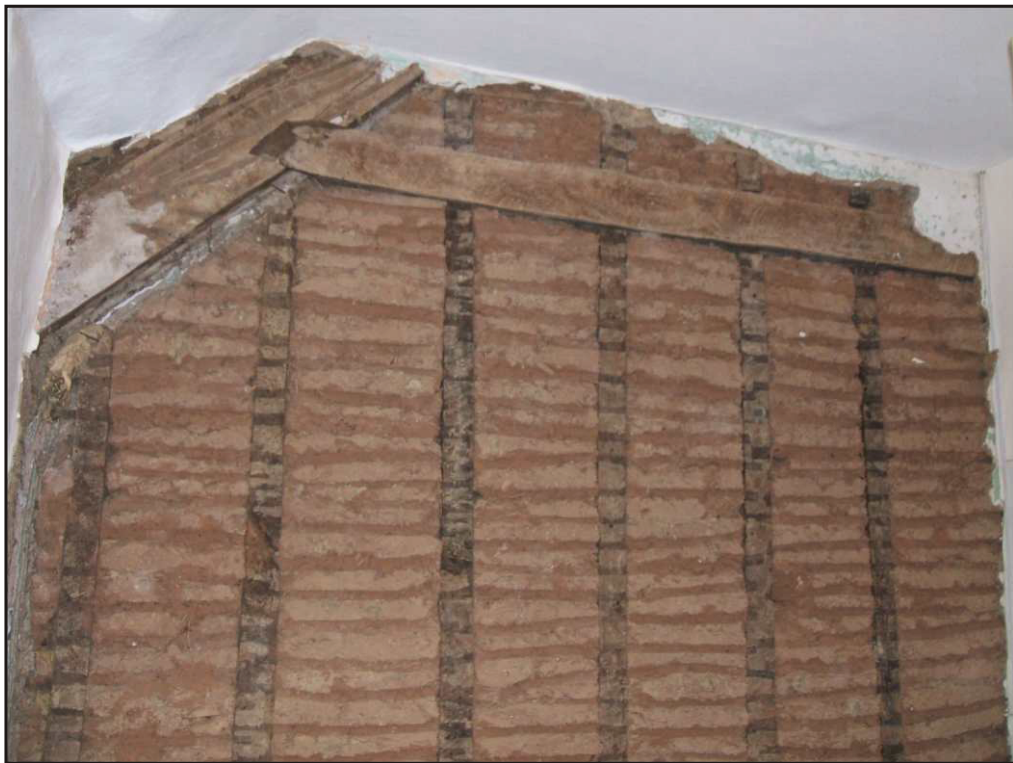
This partition is located at the west end of the building over the ground-floor hall, and divides two bedrooms from a corridor and another bedroom. The partition is formed from vertical studs attached to the lower collar, which extend upwards as far as the ceiling. Several of the studs have been reused; these display rows of pegholes. The voids between the studs are infilled with cob, and the partition is covered with lath and plaster. Throughout the first floor layers of plaster, both painted and covered with wallpaper, are visible, along with patches of modern cement render. In the southwest bedroom this lath and plaster supports a moulded cornice that lines up with a moulded beam above the south side of the room. The partition was observed to overlie some of the earlier layers of plaster, indicating that the partition is a secondary feature. The partition incorporates a central doorway, that has been raised in height. The single visible post has a chamfer and a high-level flat stop. At its north end the upper section of the partition, below the dislodged collar, has recently been repaired.

The insertion of these partitions was poorly planned. Whilst they are located over ground-floor ceiling beams, these beams do not form part of the original ground-floor partitions. (Note that one partition has been removed.) The weight of these partitions, and in particular the cob infill, has caused the partitions to sag, with the secondary lower collars pulling away from the principal rafters.

Plate 2 The western partition showing the collar and partition dropping from the truss, looking west.
