ARCHAEOLOGICAL RECORDING ON THE SITE OF A FORMER GARAGE, BROAD STREET, WRINGTON, SOMERSET

prepared for Summerfield Developments Ltd

Exeter Archaeology

Report No. 11.04

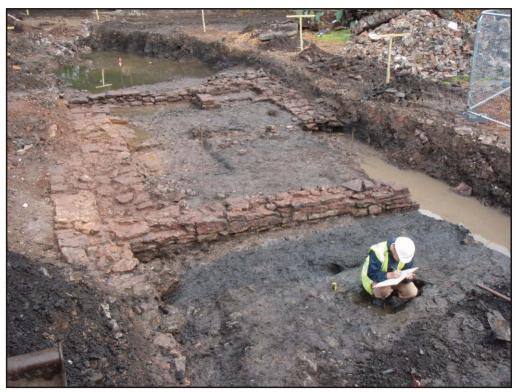
Plate 2 Building fully exposed. Earlier drainage ditches (113 and 130) in foreground. Looking northeast.

Several drains were positioned around the building. These consisted of two intercutting earth-cut ditches (113 & 130) which appeared to predate the building and wall 118; a stone-lined drain extending along the outside of the eastern wall of the building and contemporary with it (134, described below) and finally a poorly constructed stone gully positioned to the north of the building and postdating the demolition of the structure. Ditch 130 was aligned approximately east-west, measured 700mm wide, 240mm deep and was exposed to a length of 4.5m. It contained a single mid grey brown silty clay fill (131). Ditch 113 was aligned approximately NE-SE, measured 1m wide, 460mm deep and was exposed to a length of 4.25m. It contained a single dark grey silty clay fill.

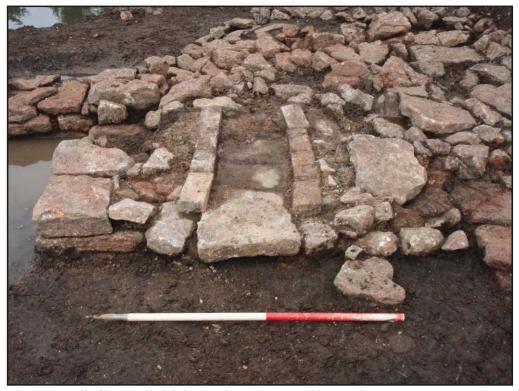
Plate 4 Detail of inserted brick furnace base (128). Looking north.

keyed into the western wall of the building (124) and was most probably part of the primary construction. The original form of this feature is unknown, as it appears to have been remodelled at a later date. The base of an inserted oven or furnace survived above the original hearth and consisted of sandstone slabs with two parallel rows of hand-made bricks loosely bonded with a lean ashy mortar (128).

There is some evidence to suggest that the building described here is the smithy reportedly operating on the site during the 19th century, shown on the 1903 OS Epoch 2 map of Wrington (reference and information provided by the NSCA). Firstly the possible furnace base construction in the north east corner of the room and secondly, the smithing hearth bottom recovered from immediately next to the brick furnace base. This iron slag lump would have been potentially just one of many removed and discarded during the working life of the smithy.

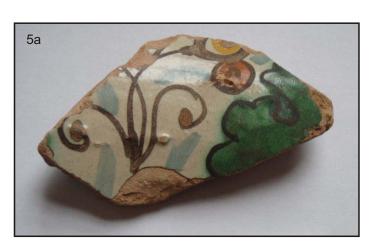
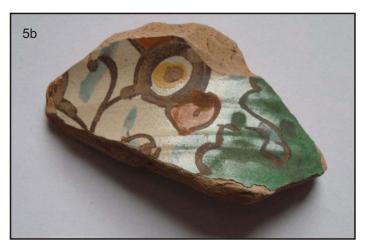
Plate 5 1–2. Rim and base fragments from a Netherlandish or English tall beaker decorated with a 'chequered spiral trail' in *façon de Venise* style, *c*.1600 [contexts 114, 154]. 3. Drawing showing an example of this kind of vessel from Exeter. 4. Base of a Netherlandish or English beaker in *façon de Venise* style, *c*.1600, with fine applied threads and an applied notched foot [100]. 5a–b. Interior and exterior of a rim sherd from a polychrome *tazza* from Montelupo, Tuscany, *c*. 1580–1640 [132]. Scale 1:1

The post medieval pottery consisted principally of South Somerset coarsewares with a smaller constituent of East Somerset Coarseware and North Devon gravel tempered ware. A single sherd of Montelupo tin-glazed pottery was recovered (132; Plate 5). This is an unusual vessel outside English ports and its form is associated with feasting and displaying expensive exotic fruits. The post-medieval pottery was associated with the infilling of ditches 113 & 154 and external makeup layers 108 & 132 contemporary with the primary construction of the building.

Two fragments of 17th-century façon de Venise beaker glass (100 & 114) and a single base from a mould-blown beaker of 16th/17th century (154).
