46 HIGH STREET

EXETER

PAINT ANALYSIS REPORT

HUMPHRIES & JONES
SCULPTURE AND ARCHITECTURAL CONSERVATION

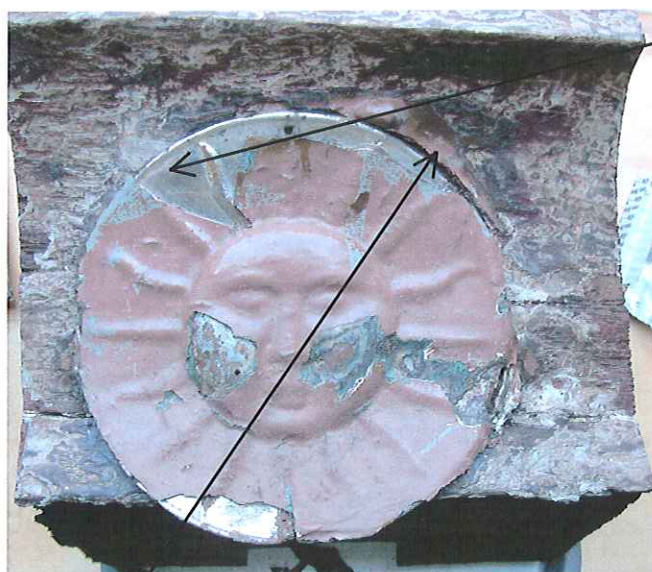
Sample 1 The face of the embossed sun disc

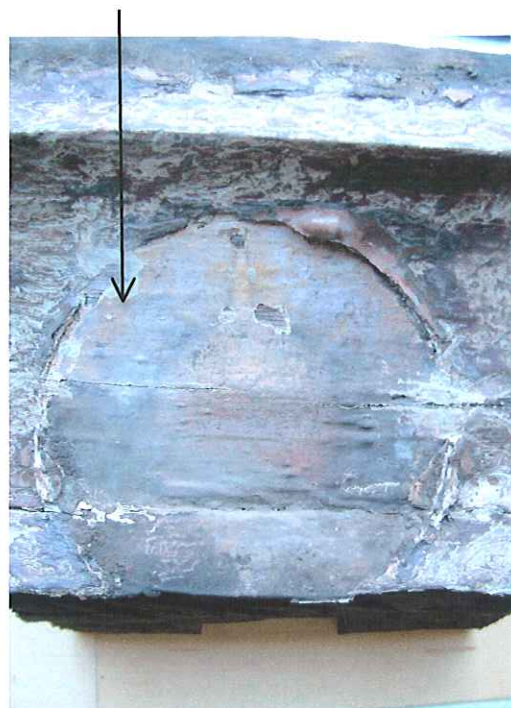
Sample 2 The timber behind where the sun disc was fixed

Sample 3 The timber immediately adjacent to the sun disc

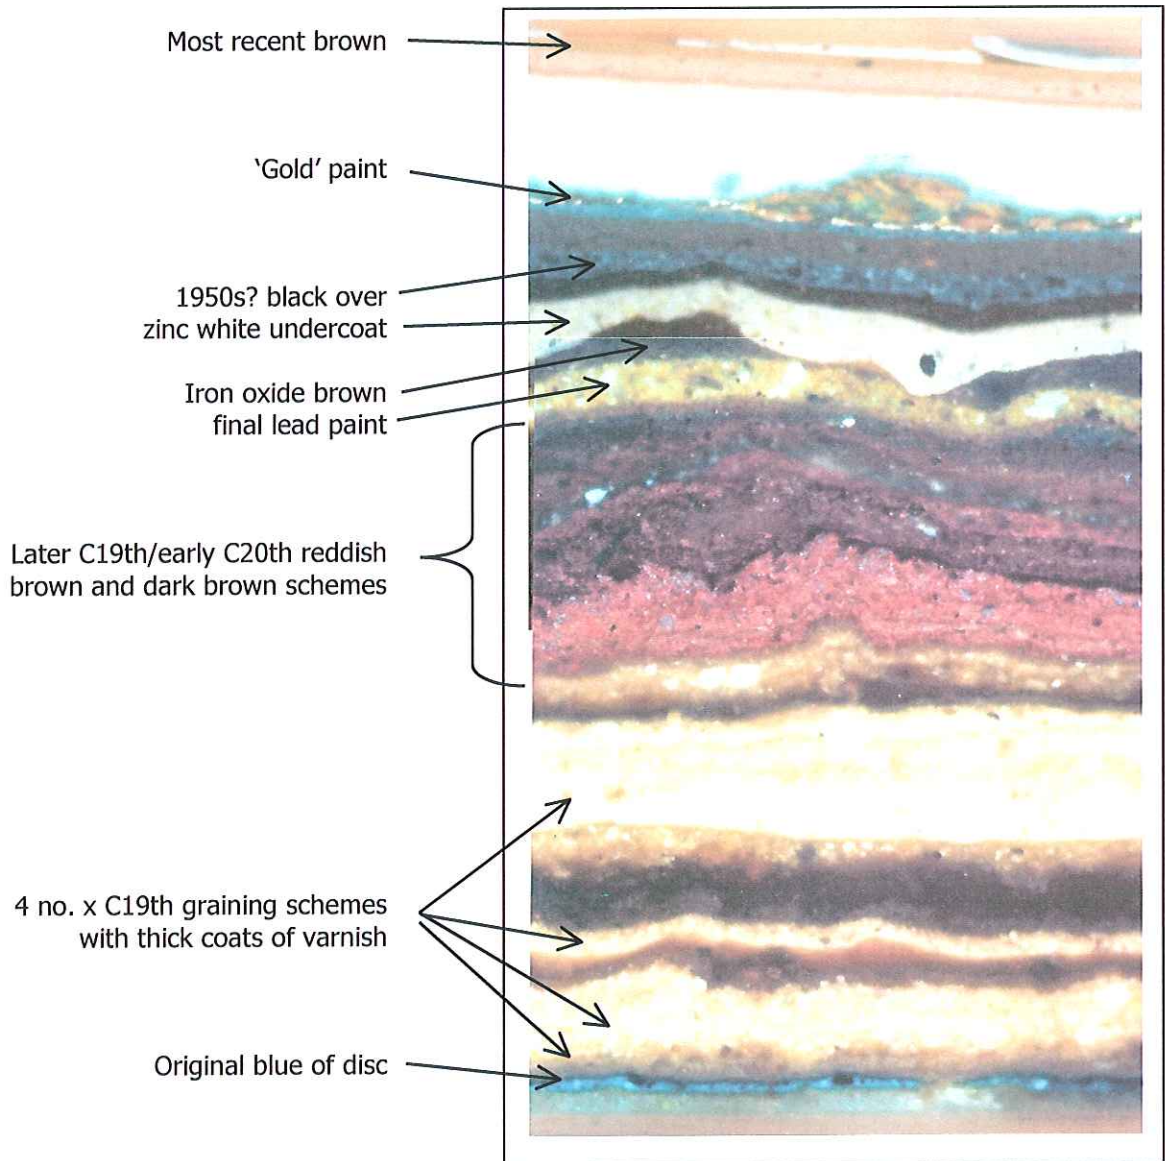
4.1 SAMPLE 1 - Face of the embossed sun disc - Magnification x 200

5.4 THE SUN DISC

The metal of the disc was painted blue. The sample was taken from a flat background area, which may have been meant to represent sky. The sun itself may have been painted yellow or gold. A gilded layer is evident on the raised areas.

A grey undercoat/primer was applied first, mixed from lead white and carbon black, then a coat of Prussian blue and lead white was brushed over the top.

The use of Prussian blue means this paint scheme must be later than 1704 when that pigment was invented. The disc may be late eighteenth or early nineteenth-century as the paint layers which follow the blue are typical nineteenth-century grainings.

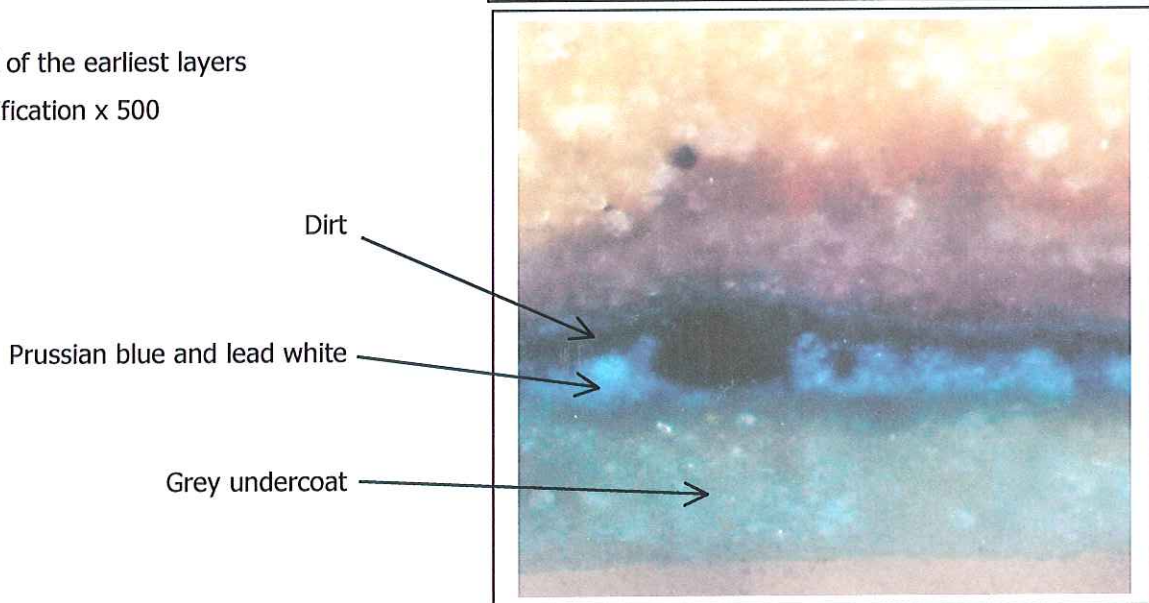
Detail of the earliest layers
Magnification x 500

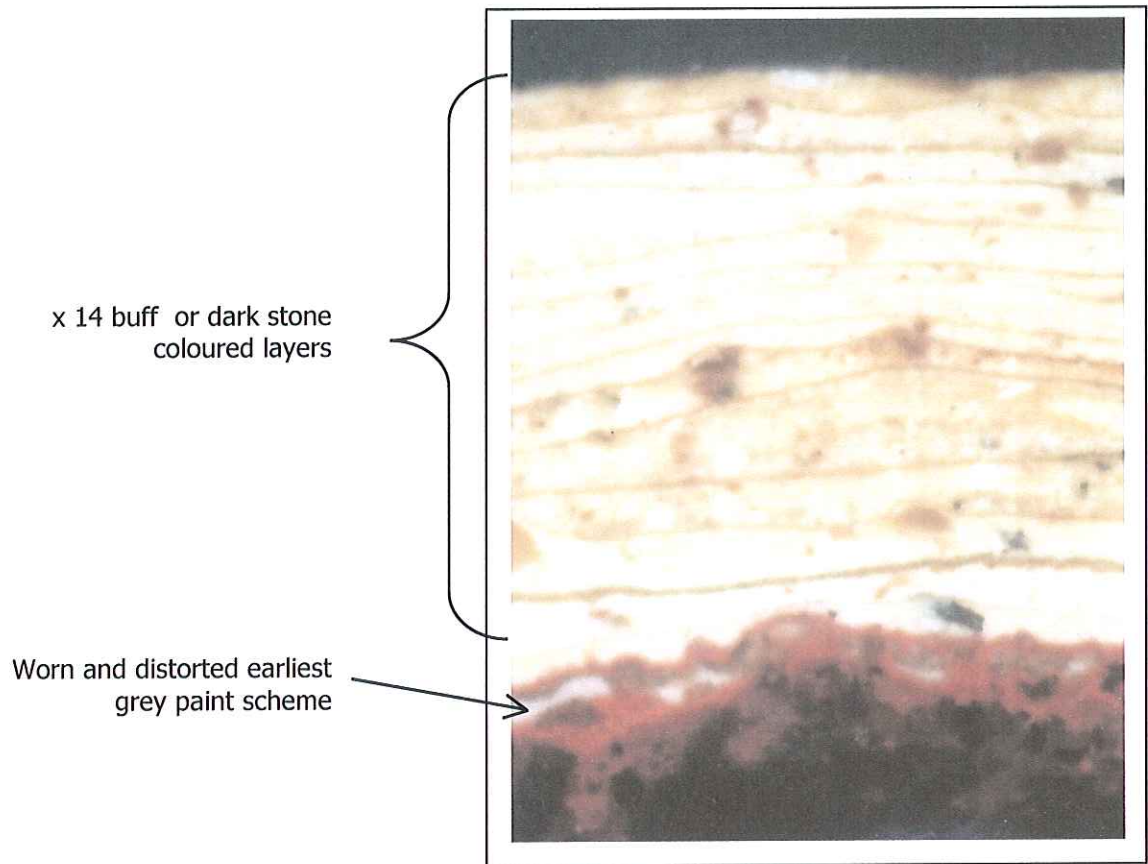
4.2 SAMPLE 2 – Layers beneath the sun disc - Magnification x 200

5.1 EARLIEST DECORATION ON THE TIMBER

The wood was first primed with a dark red preparation based on pure red ochre, it was then painted a pale grey based on lead white and finely ground carbon black.

This paint scheme must have been in place many years as it had become worn, dirty and cracked by the time it was eventually painted over.

5.2 SECOND DECORATION ON THE TIMBER

A fresh red ochre primer was applied, and then the building was painted buff or dark stone colour mixed from lead white and iron oxides.

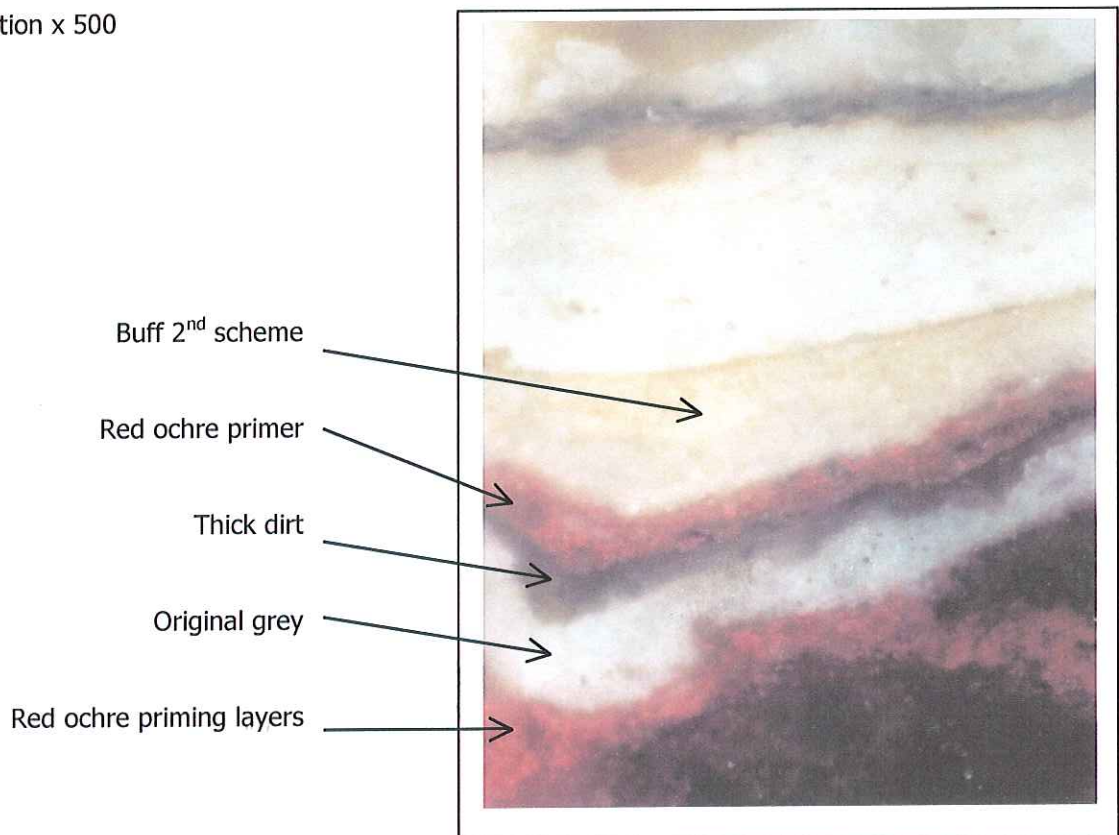
Detail of the earliest layers
Magnification x 500

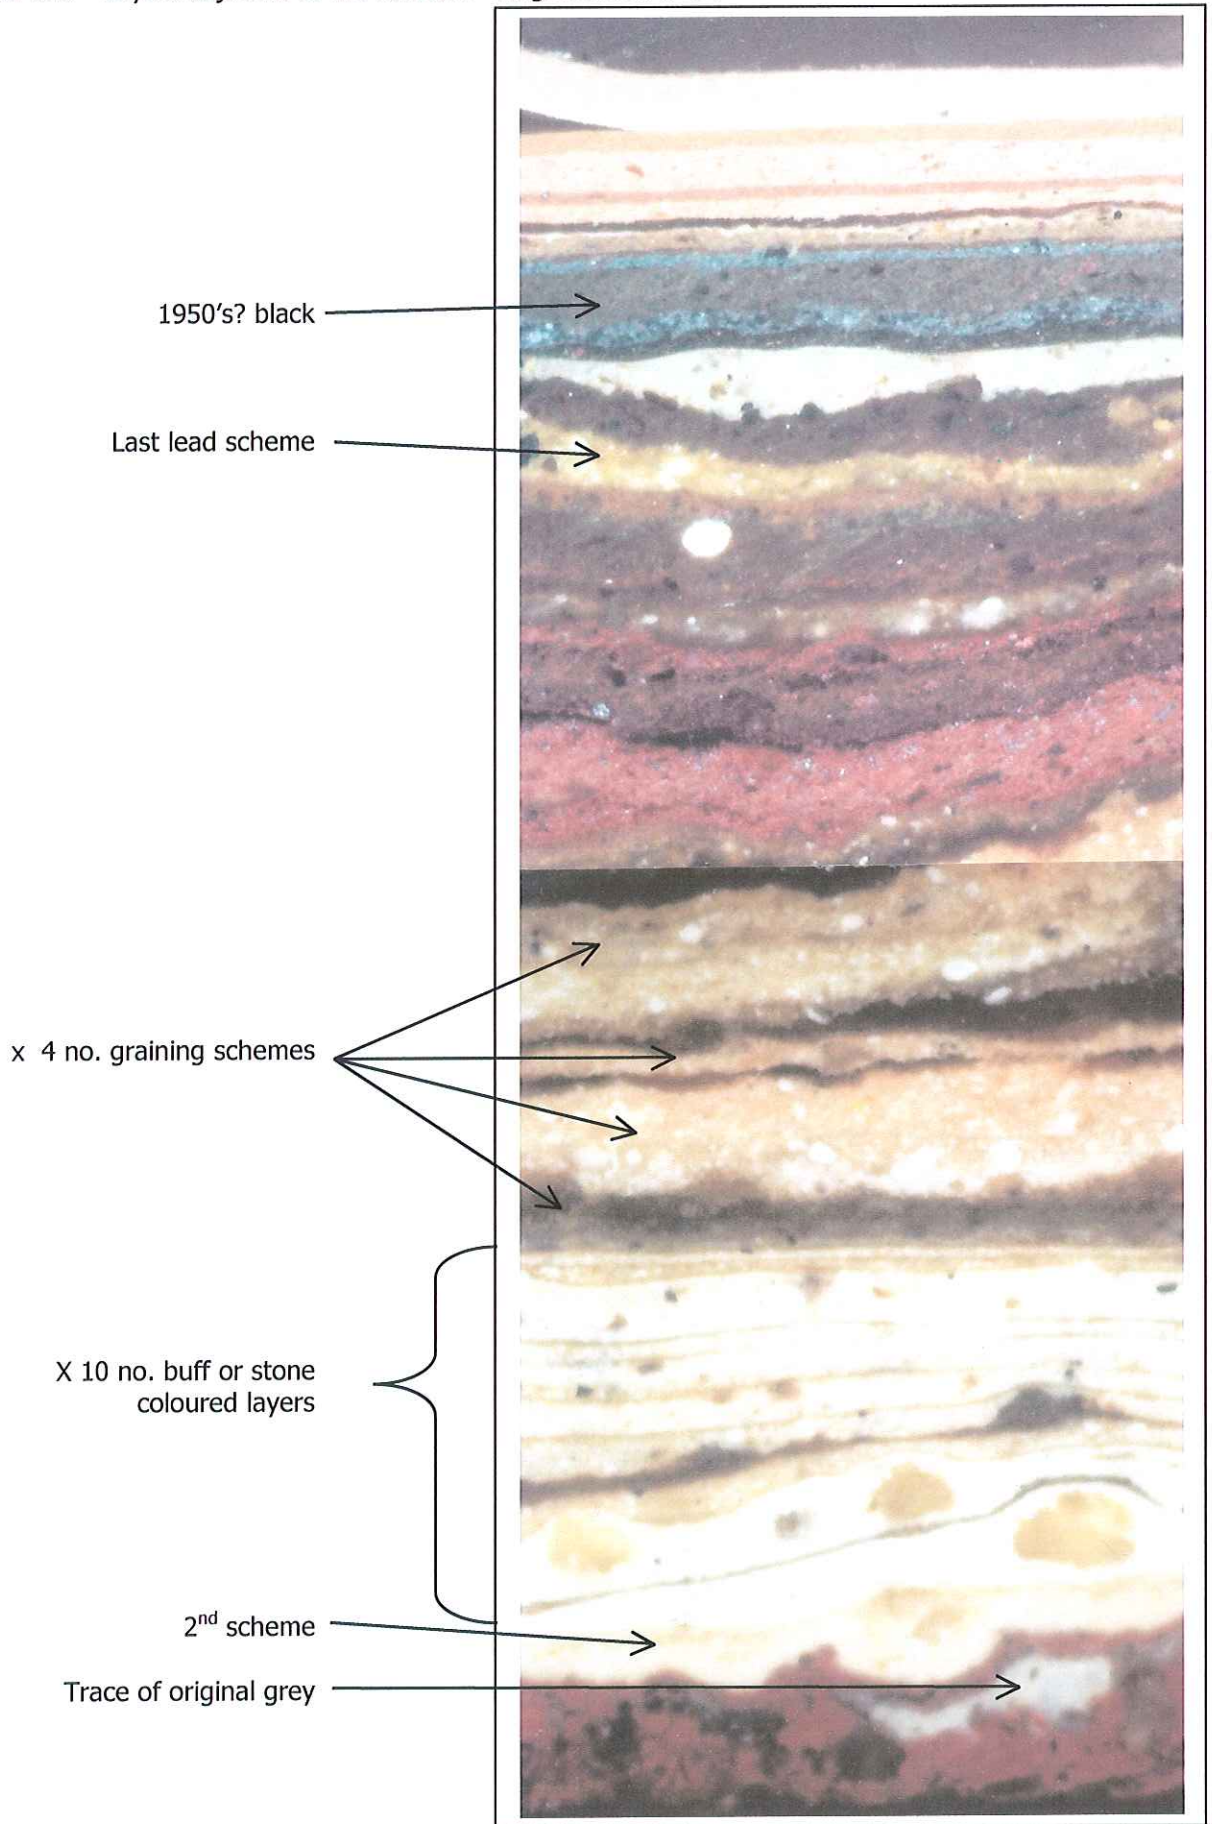
4.3 SAMPLE 3 – Layers adjacent to the sun disc - Magnification x 200

The building was painted a further thirteen times with stone-coloured paints. Slightly fewer layers were found in Sample 3, taken from next to the disc, and layers must have flaked off.
